Environmental Monitoring Report

Semestral Report
December 2017

GEO: Urban Services Improvement Investment Program – Project 3

**GEORGIA: URBAN SERVICES IMPROVEMENT INVESTMENT PROGRAM
(TRANCHE 3)**

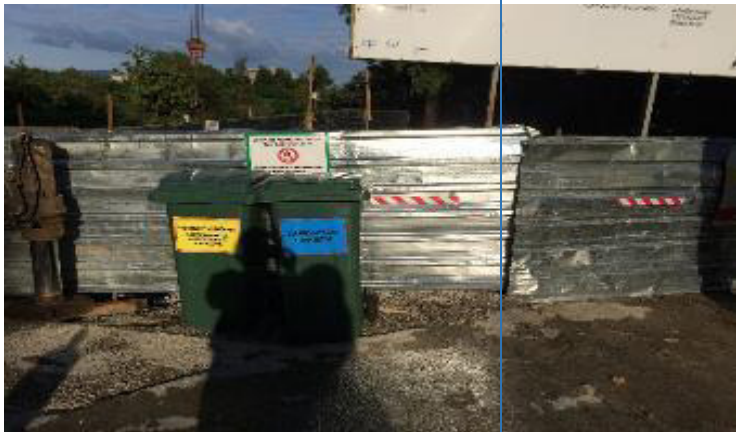
Project	Specific Issues	Deadline for submission/Implementation	Implementation Status
Status of findings of ADB mission carried out on 28 September – 2 October 2017			
Ure-01 Rehabilitation of the Water Supply System in Ureki			
	<p>Waste Management: There were separate waste containers for municipal and hazardous waste at the site with signatures, but they were not placed at special designated area with roofing and concrete base/secondary drip tray</p>

September 2017	<p>Completed (Please see the improved site photo below)</p>

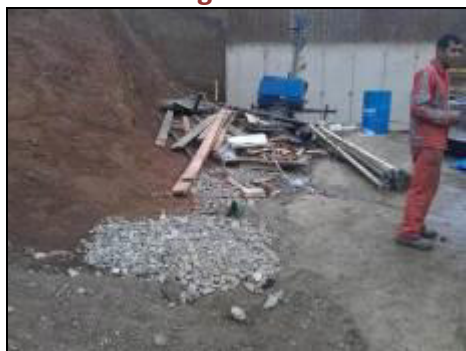
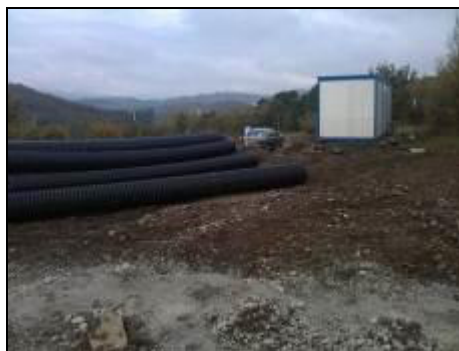
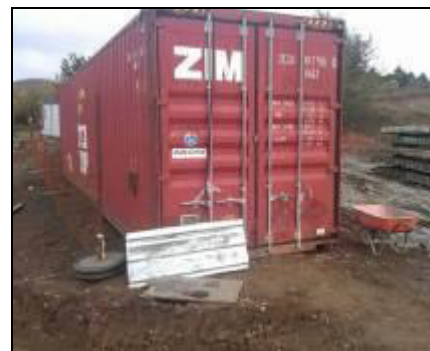
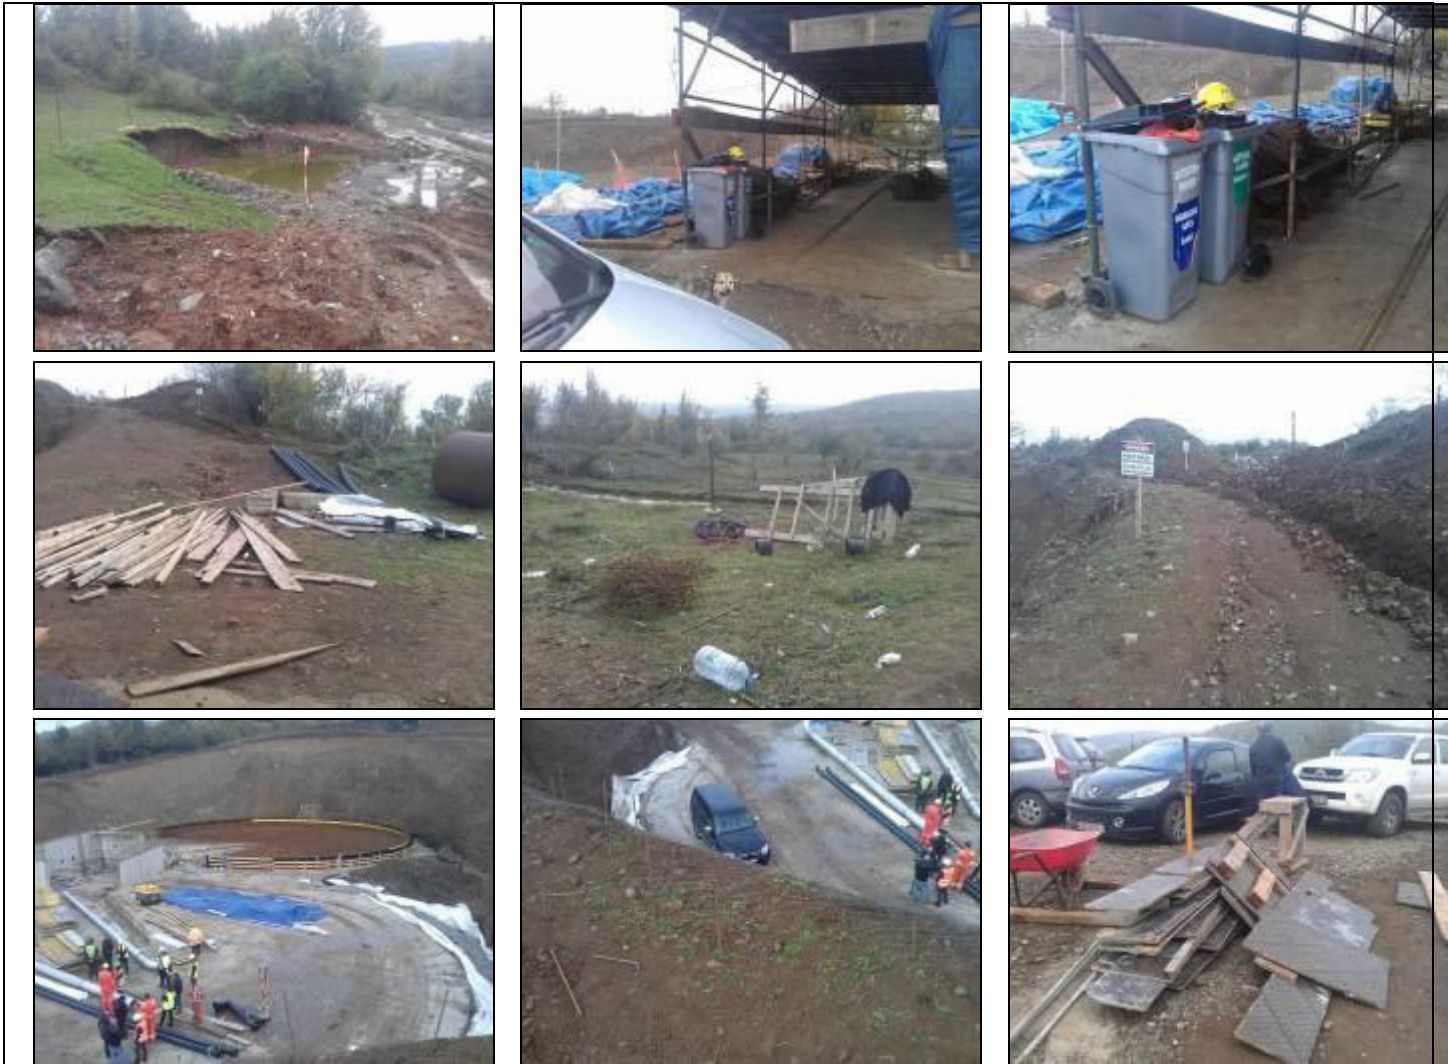
Photos of Godogani Reservoir

- Safety signs/tapes and trench side barriers around of deep open excavation should be installed from all sides to avoid accidents
- Trees at the construction site and nearby deep excavation zone should be well isolated and protected to avoid its falling and damage

- The access road and internal roads should be gravelled and arranged properly
- Waste should be placed only at the proper waste container
- Hazardous Waste container with proper sign should be installed

- Parking area should be better organized, transport should be parked only at the designated parking area
- Workers always should use complete PPE
- Site internally should be arranged properly and cleaned regularly, including construction materials segregation

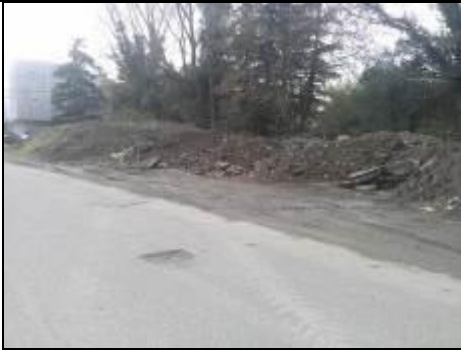
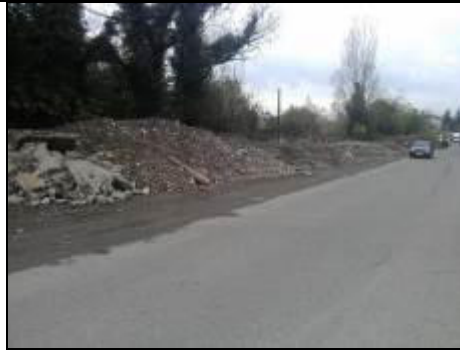
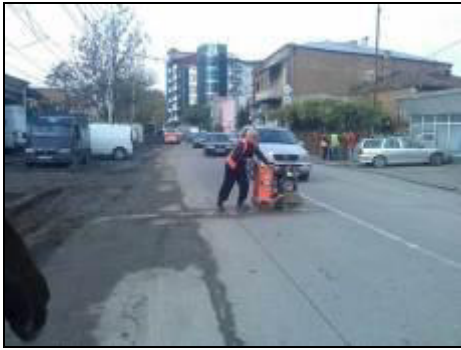
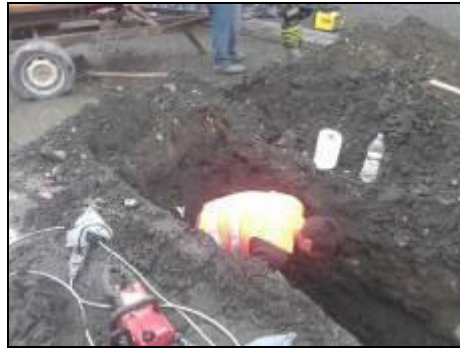
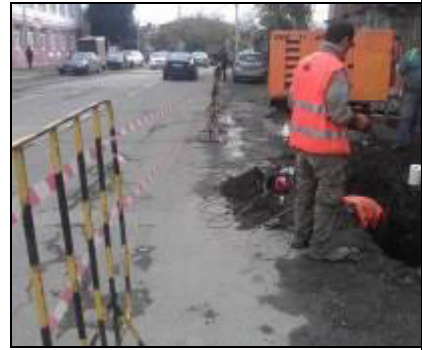
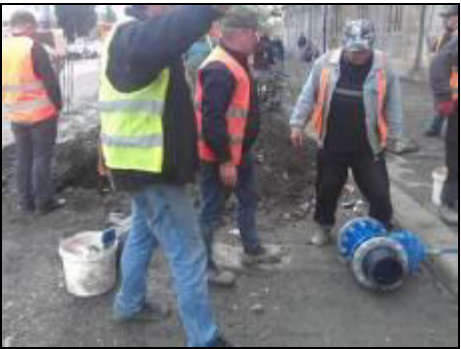
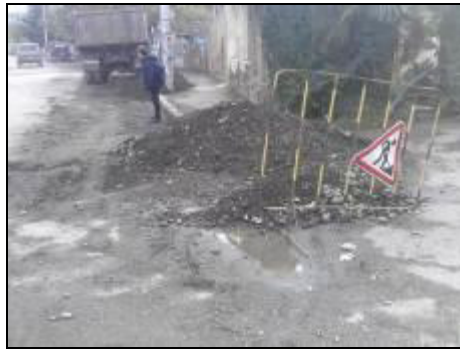
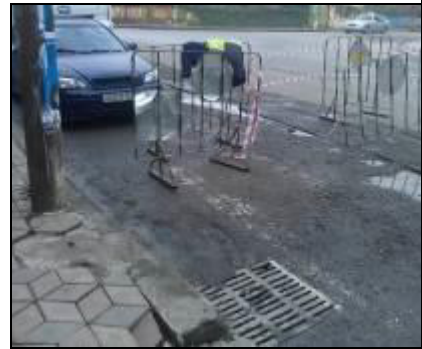
Photos of Kutaisi Network

- Construction activities information signs should be installed at each construction segment
- Trees of nearby construction zone should be protected to avoid its damage

- Workers always should use complete PPE
- Refilling/compaction and reinstatement process should bring site at the same or better condition as it was before construction

All these conditions have to be remedied within seven days (by the 16 November 2017) by the prime Contractor (SMK).

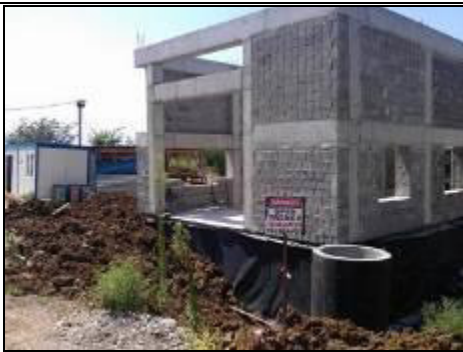
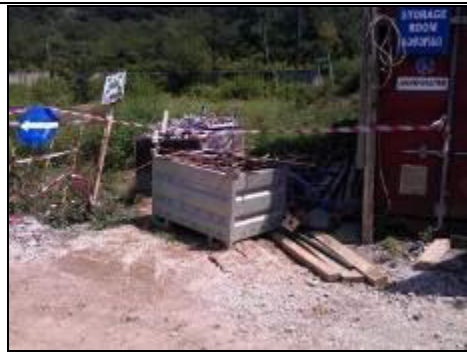
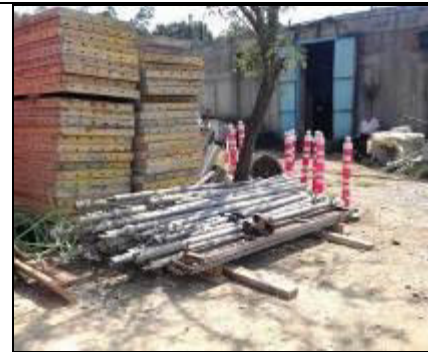
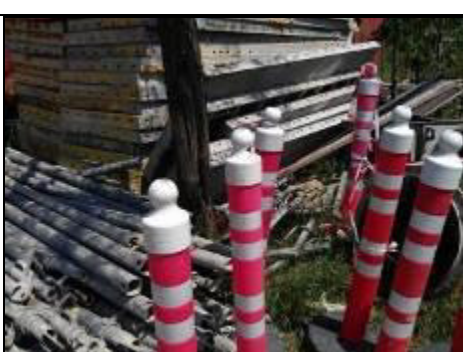
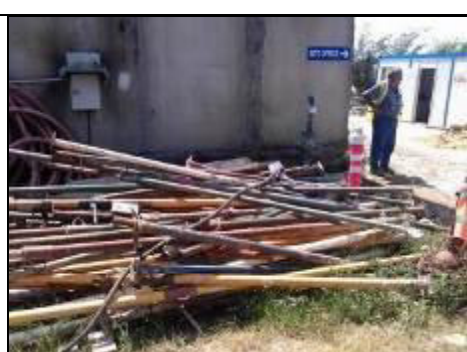
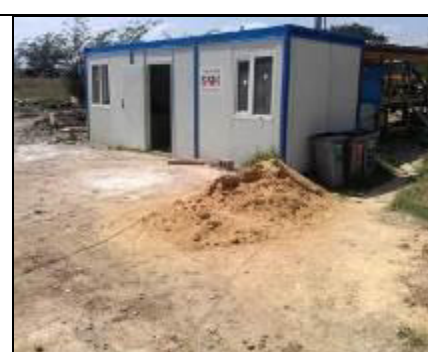
Kutaisi – Mukhnari and Godogani reservoirs	
This notice is to advice you, the prime Contractor, on the referenced Contract, of the following notice on environmental measures to be implemented urgently .	
NON-COMPLIANCE IN KUTAISI	
Mukhnari Reservoir	
<ul style="list-style-type: none">- Safety tapes should be installed around of all open tranches- All trees at the construction site should fenced and protect (trees should be exempt from materials) to avoid its damage- All workers (even personnel of subcontractor) should be equipped with complete PPE- Special equipment during working at heights should be used (proper scaffoldings etc.)- Safety norms during works at the height should be respected- Ladder safety should be ensured- Proper fuel/oil spill response items (sand, sawdust, special containers) should be available at the site- Site internally should be arranged properly, and construction materials segregated/stored accordingly- Construction waste (wooden, iron waste and its.) should be removed timely and completely

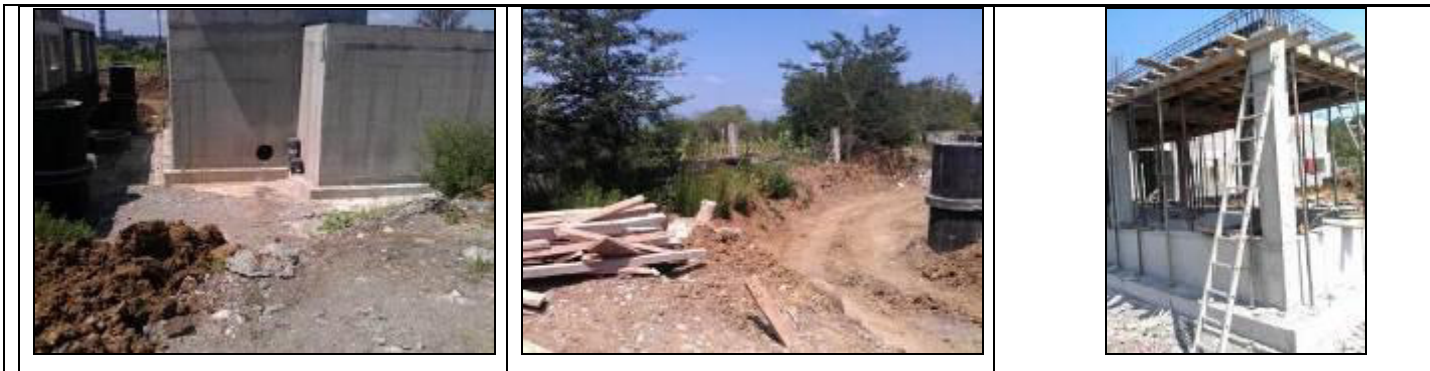
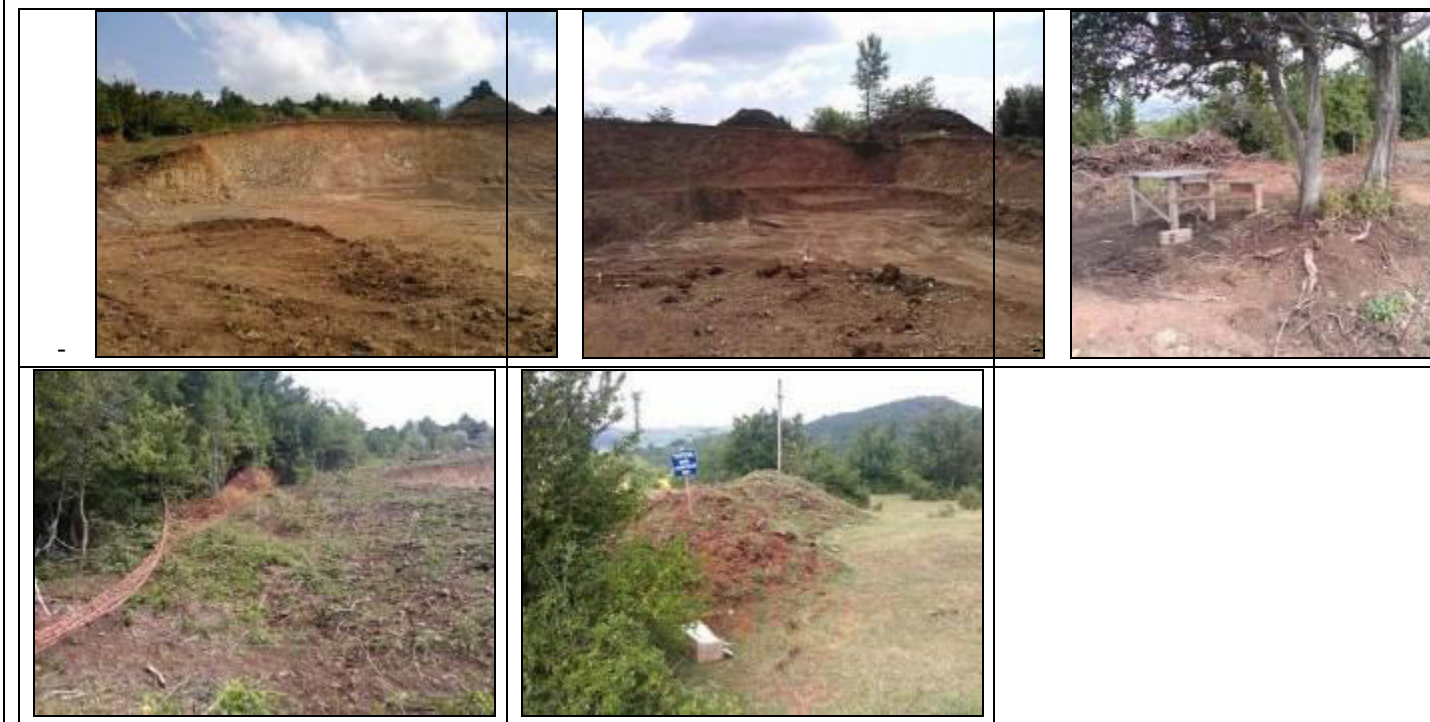
Godogani Reservoir

- Site should be properly fenced from all sides
- Proper warning and information signs should be arranged at the entrance and perimeter of the site
- Safety signs/tapes and trench side barriers around of deep open excavation should be installed from all sides to avoid accidents

- Trees at the construction site (high attention to red listed trees) and nearby deep excavation zone should be fenced protect to avoid its falling and damage

- Household Waste container with proper sign should be installed
- Hazardous Waste container with proper sign should be installed
- Proper fuel/oil spill response items (sand, sawdust, special containers) should be available at the site

- Proper Parking area with relevant sign should be arranged
- Site internally should be arranged properly and cleaned regularly
- Site should be arranged according to the SSEMP document, including storage, office, toilets etc.

All these conditions have to be remedied within seven days (by the 18 August 2017) by the prime Contractor (SMK).

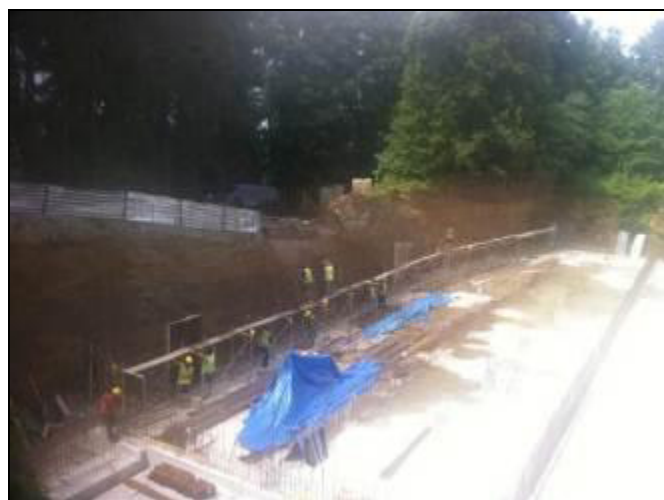
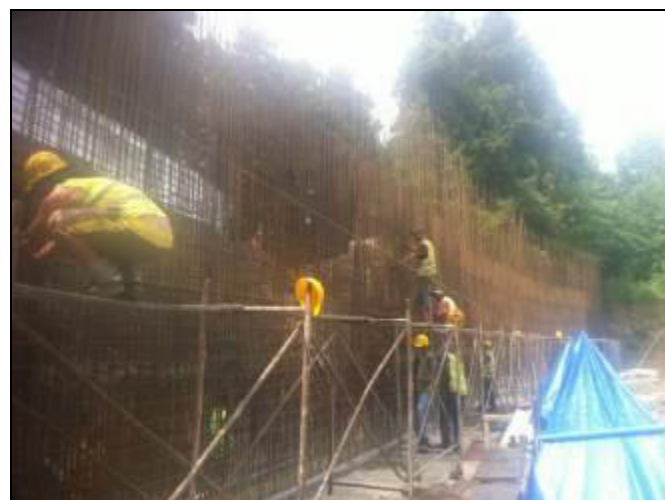
RESERVOIR

- Safety rules during high-altitude works should be respected to avoid workers damage
- During high-altitude works special protection equipment should be used
- Implementing works without special protection equipment is strictly prohibited
- Workers always should use complete PPE

All these conditions have to be remedied within three days (by the 7 August 2017) by the prime Contractor (Peri).

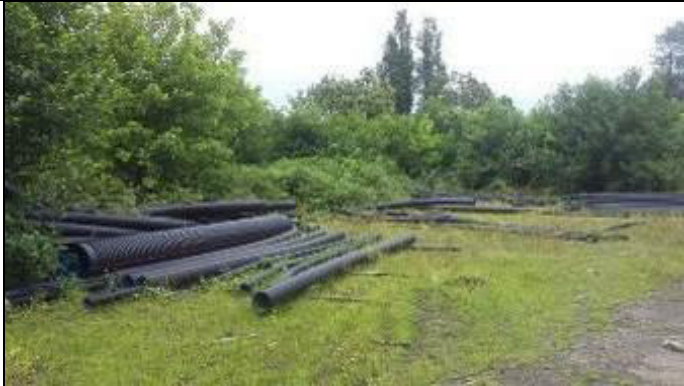
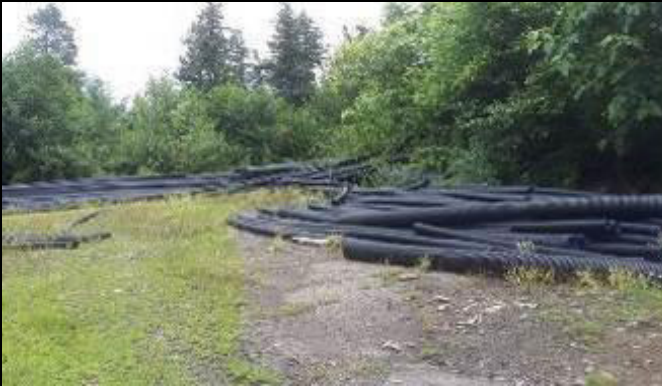
Project: USIIP	Non-compliance Notice UREKI
Contract No: URE-01	
Contractor: PERI	
Reference: UREKI – NETWORK	
<p>This notice is to advise you, the prime Contractor, on the referenced Contract, of the following notice on environmental measures to be implemented urgently.</p> <p><u>NON-COMPLIANCE IN UREKI</u></p> <p>NETWORK</p> <p>All construction materials (pipes) should be accurately stacked and stored properly at the special dedicated place</p> <p>Special warning and information signs should be installed</p> <p>Trees (nearby territory) should be freed from pipes to avoid its damage</p> <p>Piles dedicated warehouse should be fenced, protected and organized as suggested for warehouse arrangement</p>

All these conditions have to be remedied within four days (by the 16 July 2017) by the prime Contractor (Peri).	
Irakli Legashvili EPTISA - Environment

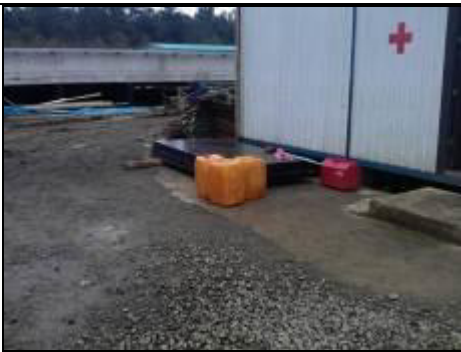
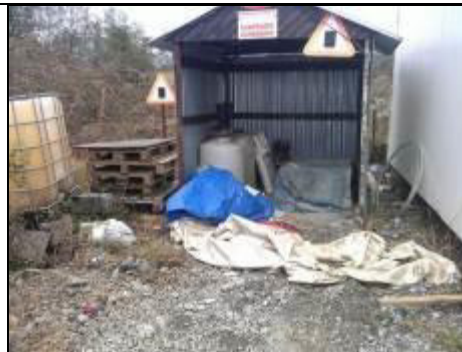
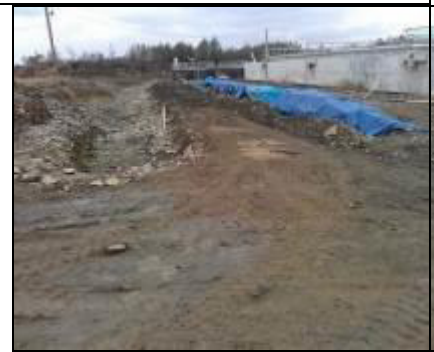
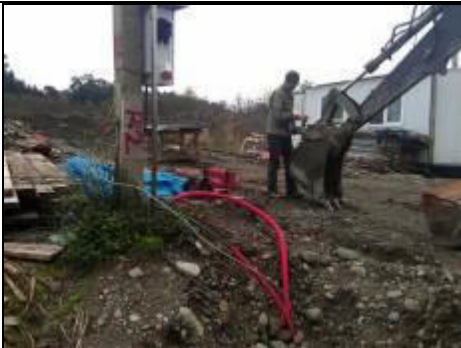
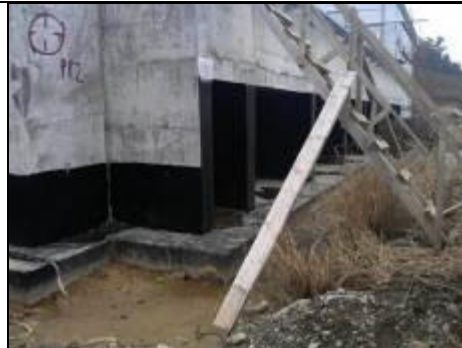
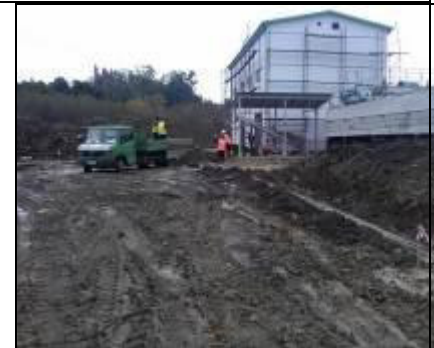
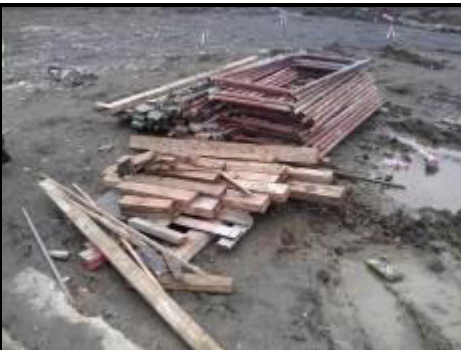
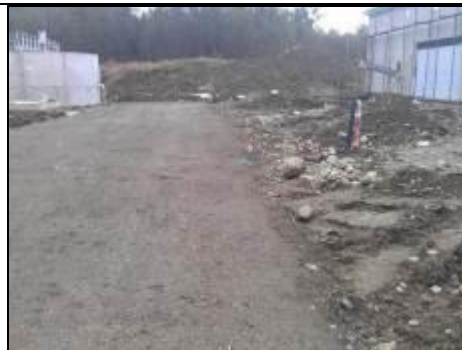
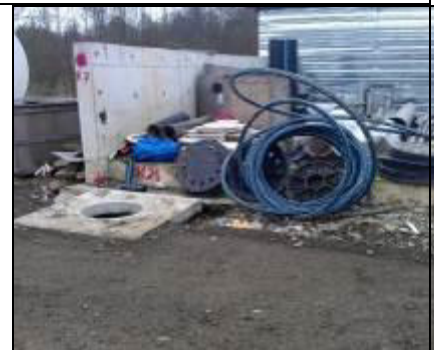
UREKI WWTP SITE

- All construction materials should be properly segregated and stored adequately
- Ladder safety should be ensured
- During high-altitude works should be used special protection equipment
- Tanks of fuel/lubricants should be managed properly
- Proper fuel/oil spill response items (sand, sawdust, special containers) should be available at the site
- Waste should be placed only at the proper container and discharged timely
- Waste materials, including hazardous waste should be removed timely and regularly
- Safety signs/tapes around of all open trench/excavations should be installed
- Soil (surplus/accumulated soil) for backfilling purposes should be managed/stored properly
- PPE equipment should be used always and completely by all workers
- Site internally should be arranged properly and cleaned regularly

All these conditions have to be remedied within three days (by the 17 November 2017) by the prime Contractor (Pfeiffer).		
Date of site visits: 09.11-10.11.2017		
Irakli Legashvili - EPTISA Environment

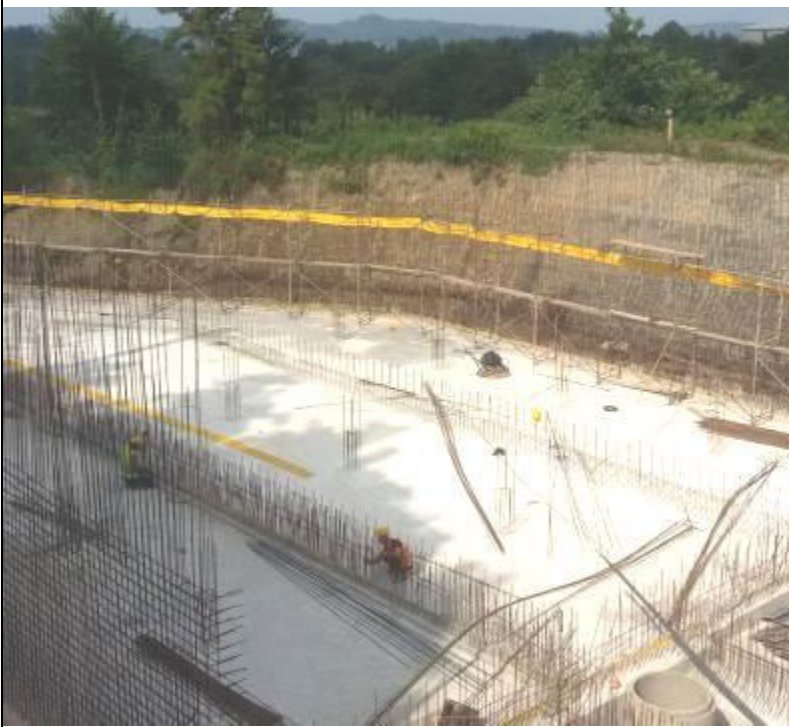
Photo 1

Scaffold are installed for working at heights;

Minor						
No	Requirement reference	Details of non-conformity	Corrective Action Taken	Evidence provided	Date reviewed	Reviewed by
1.	Non-compliance Notice UREKI; Project: USIIP Contract No: URE-01 Contractor: PERI Reference: UREKI – RESERVOIR	Safety rules during high-altitude works should be respected to avoid workers damage	Appropriate Scaffolds has been installed, with hardened platforms and mid rails. Working at Height is performed under permanent supervision of Site HSE Officer.	Please find photo below	07.08.2017	G. Tkemaladze

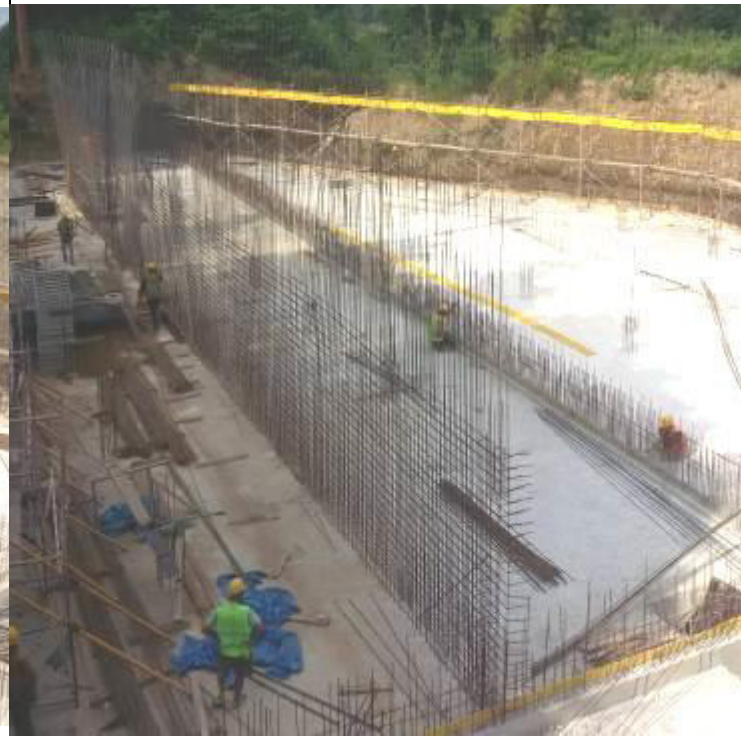
Photo 2

Site staff are equipped with required PPE;
