Environmental Monitoring Report

Semi-annual Report (January - June 2019)
July 2019

GEO(COL): Urban Services Improvement Investment Program – Tranche 3

Reporting Period: January-June 2019

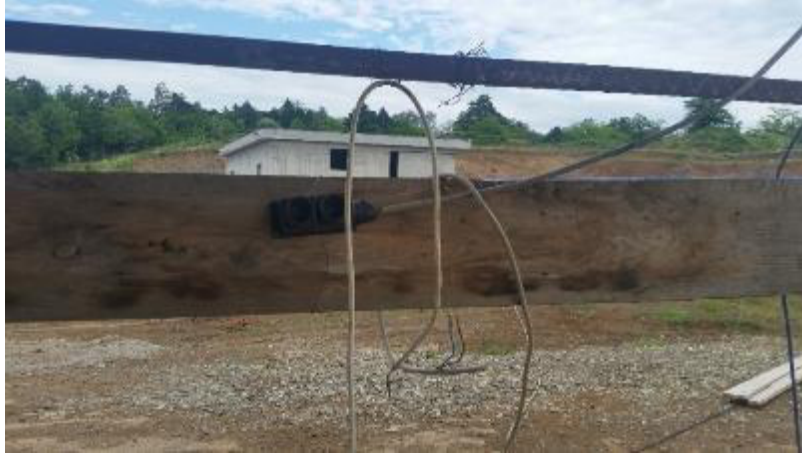
Photo: Near Miss Under KUT-01 project, Godogani Reservoir

110. Near Miss Example No3 under KUT-01 sub-project included not properly used electrical cables. Electrical plug was missing, no insulation on place.

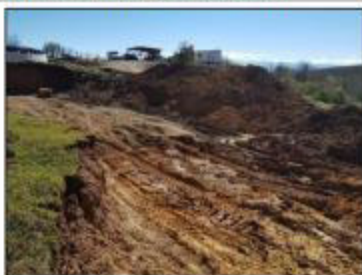
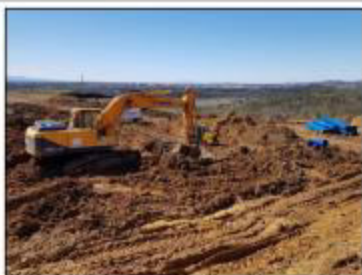
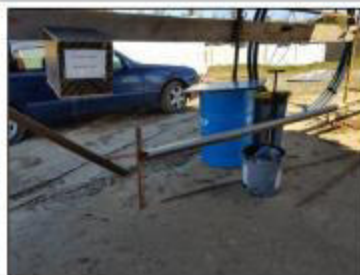
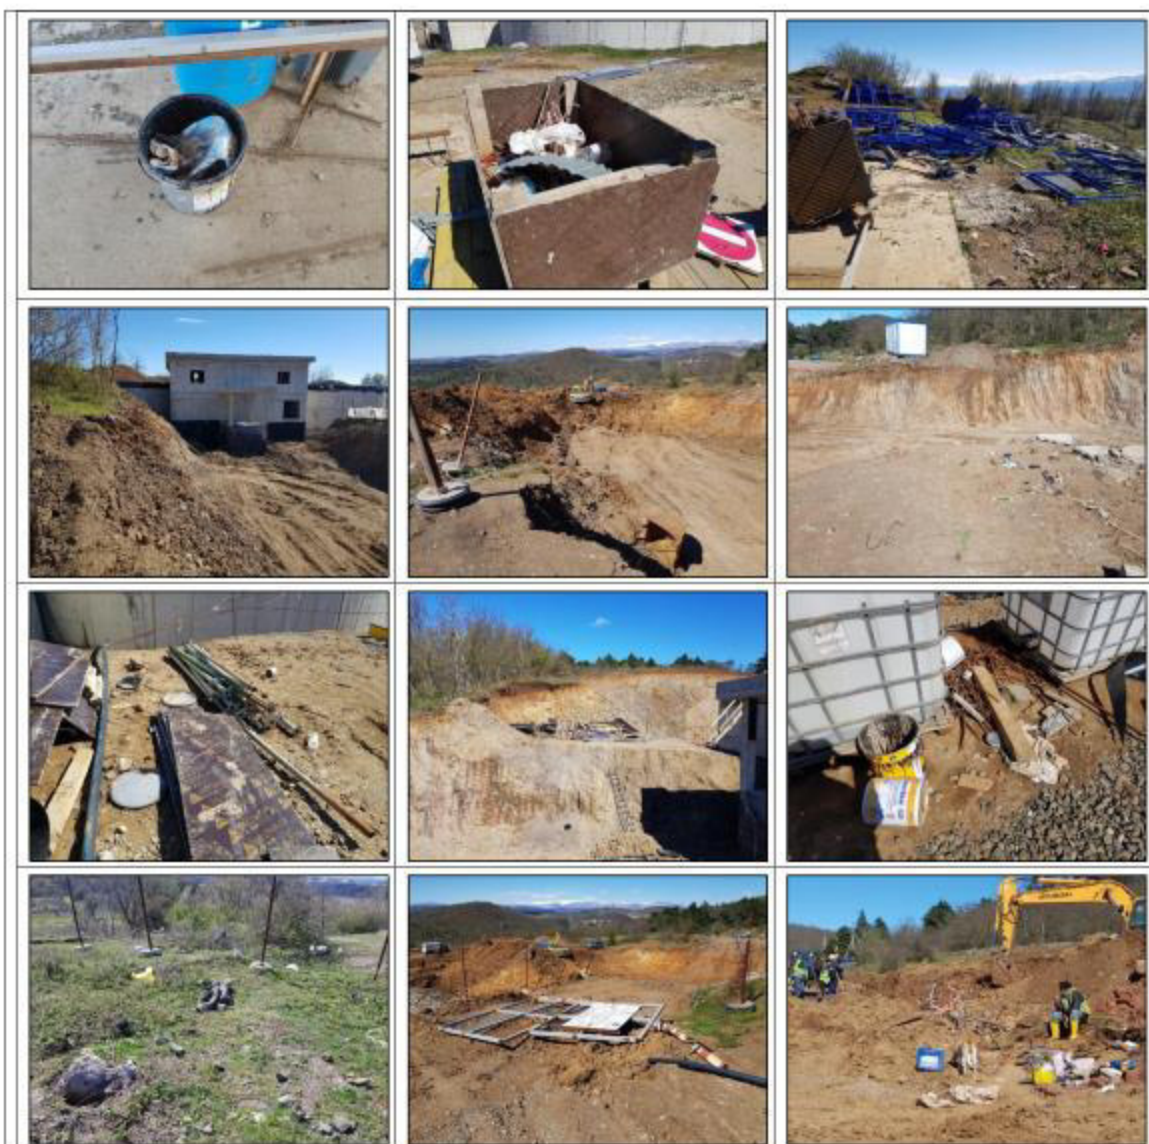
Photos of Godogani Reservoir

- Trees at the construction site and nearby deep excavation zone should be protect to avoid its damage
- Construction waste should be timely removed from the construction site and disposed properly

- Safety norms during working at height should be provided
- Containers with fuel/lubricant should be managed properly (stored at the proper organised place with concrete floor and roofing) to avoid leakage and ground contamination

- Workers always should use complete PPE
- Site internally should be arranged properly and cleaned regularly

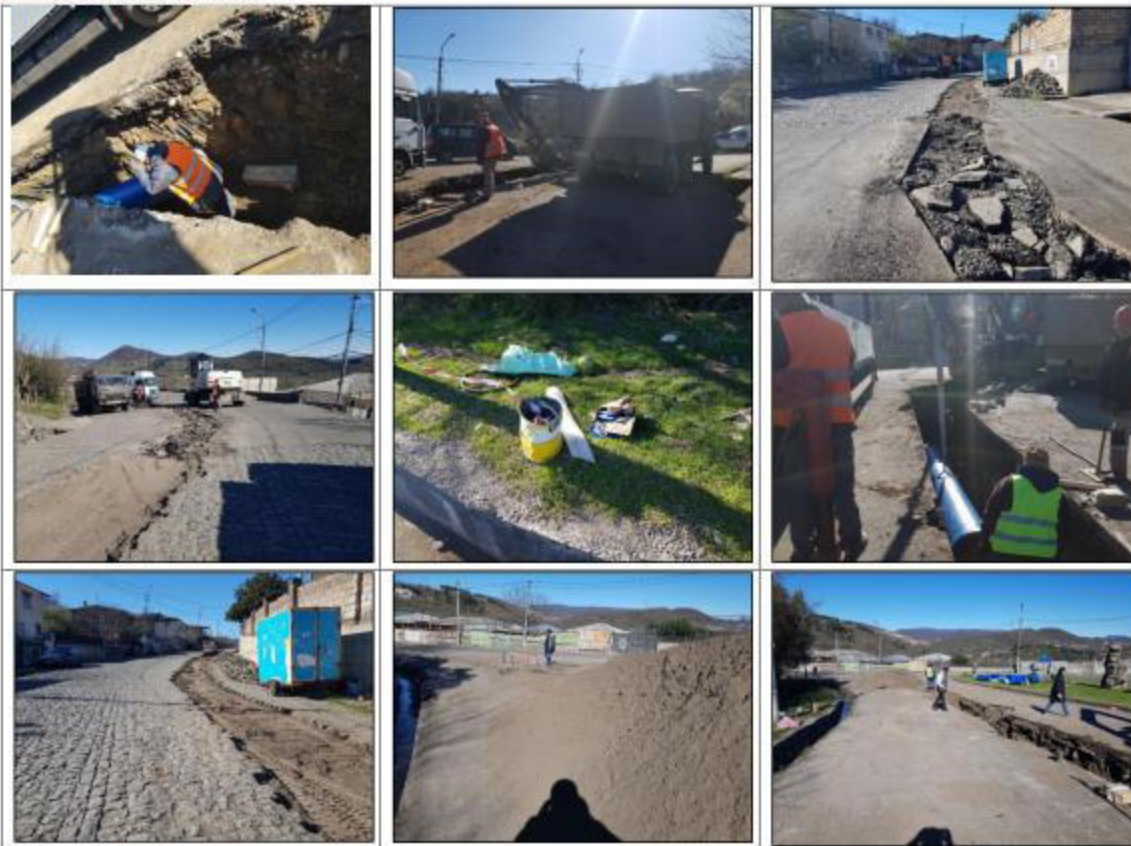
Photos of Kutaisi Network

- Safety signs/tapes around of all open trenches should be installed to avoid accident of population
- Walls of the deep trenches (>1.5m) should be strengthened by boards to avoid landfall of the soil and accidents (workers damage)
- Construction activities information signs should be installed at each construction segment
- Construction materials should be brought when needed to avoid its long time disposal in the streets and disturbance of residents and businesses
- All transmission line construction segments should be cleaned/well organized on regular bases
- Workers always should use complete PPE

- Refilling/compaction and reinstatement process should bring site at the same or better condition as it was before construction

All these conditions have to be remedied within four days (by the 5 April 2019) by the prime Contractor (SMK).

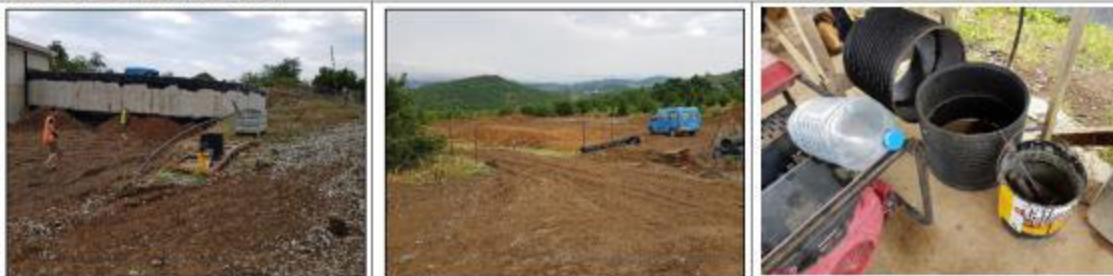
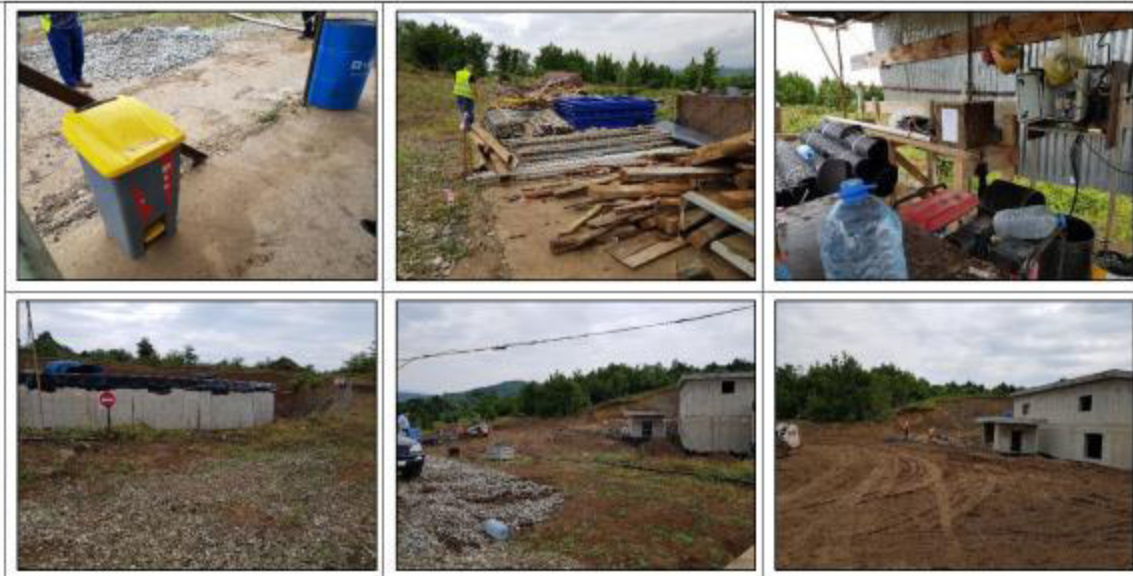
Photos of Godogani Reservoir

- Soil (surplus/accumulated soil) for backfilling purposes should be managed/stored properly
- Trees at the construction site and nearby excavation zone should be protect to avoid its damage

- Complain box should be placed at proper place
- Site internally should be arranged properly and cleaned regularly

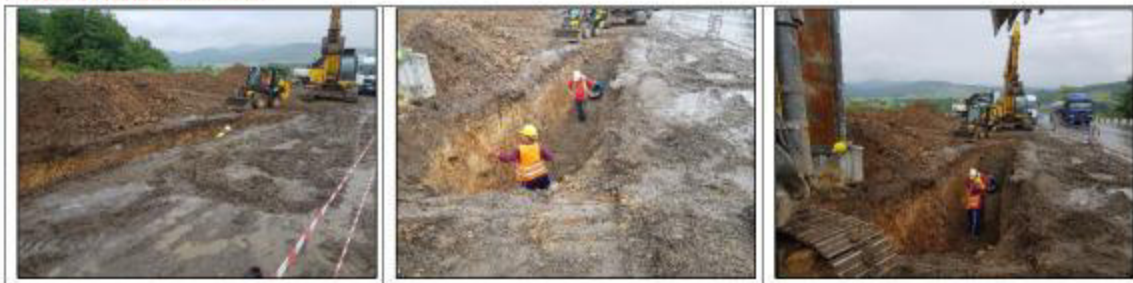
Photos of Kutaisi Network

- Walls of the deep trenches (>1.5m) are not strengthened by boards to avoid landfall of the soil and accidents
- Construction activities information signs should be installed at each construction segment
- Special signs and blinking signs should be installed near to main road
- During materials transportation tarpaulins cover should be used always
- Construction materials should be brought when needed to avoid its long time disposal in the streets and disturbance of residents and businesses
- All transmission line construction segments should be cleaned/well organized on regular bases
- Workers always should use complete PPE
- Refilling/compaction and reinstatement process should bring site at the same or better condition as it was before construction

All these conditions have to be remedied within three days (by the 6 July 2019) by the prime Contractor (SMK).	
Date of site visits 28.06.2019	
Irakli Legashvili EPTISA - Environment

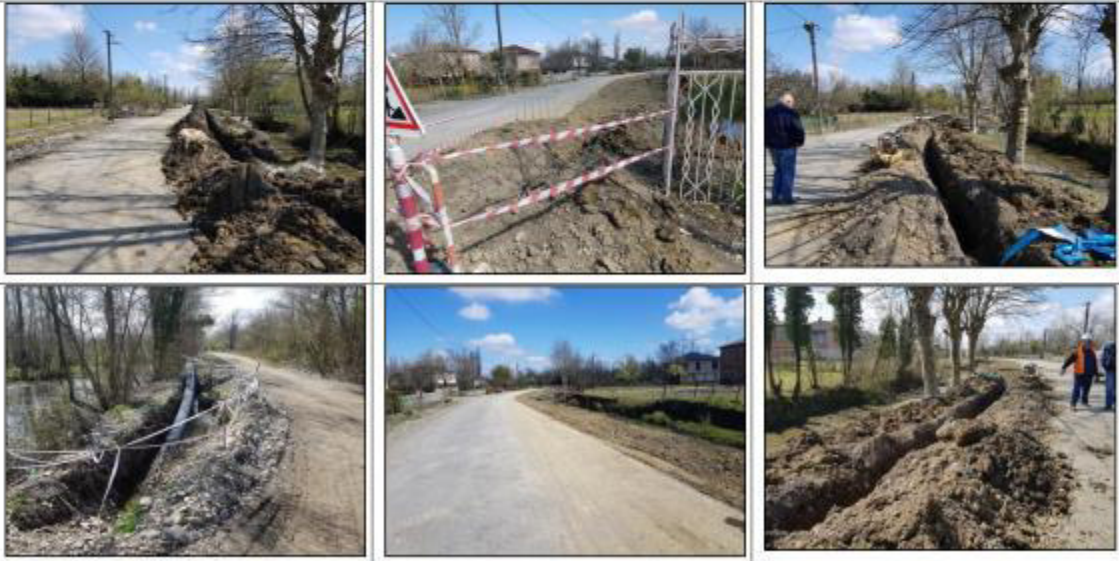
Photos of Abasha Network

Project: USIIP	Non-compliance Notice ABASHA
Contract No: ABA-01	
Contractor: As Inshaan-N	
Reference: ABASHA – Network	
This notice is to advise you, the prime Contractor, on the referenced Contract, of the following notice on environmental measures to be implemented urgently .	
<u>NON-COMPLIANCE IN ABASHA</u>	
NETWORK <ul style="list-style-type: none"> - Trees of nearby construction zone should be protected to avoid its damage - Safety signs/tapes around of all open trenches should be installed - Surplus/accumulated soil for backfilling purposes should be managed/stored properly - Construction activities information signs should be installed at each construction segment - Safety/warning signs/tapes and trench side barriers around of deep open trenches should be installed to avoid accident of population - Workers always should use complete PPE - Refilling/compaction and reinstatement process should bring site at the same or better condition as it was before construction

All these conditions have to be remedied within three days (by the 4 April 2019) by the prime Contractor (As Inshaan-N).	
Date of site visits: 27.03-28.03.2019	
Irakli Legashvili EPTISA - Environment

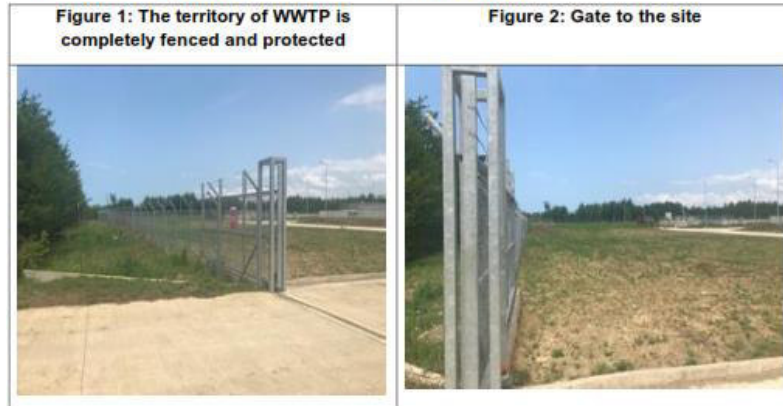
27. The construction of WWTP was fully accomplished satisfactorily, all kinds of waste, including construction waste were removed from the site, and territory of the WWTP construction site was fully fenced and cleared (Figures 1 and 2).

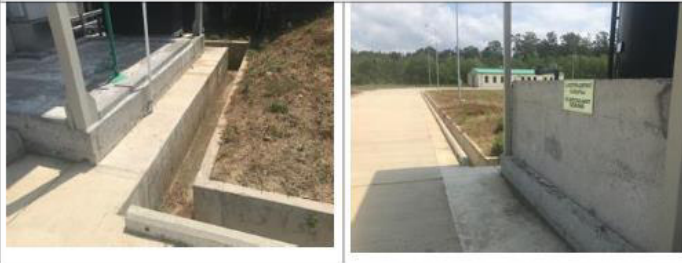
Figure 3 and 4: Drainage system in the project area

28. The drainage system well installed on all the territory of WWTP (Figures 3 and 4).

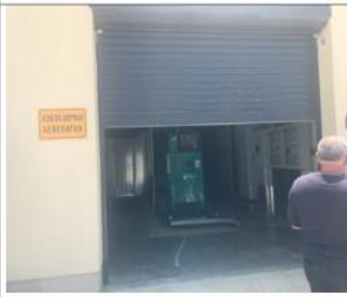
Figure 5: The generator is placed in a covered area

29. The generator is also installed according to the standards. The given generator is placed on the secondary protective container, at the location protected against the precipitations (Figure 5 and 6).

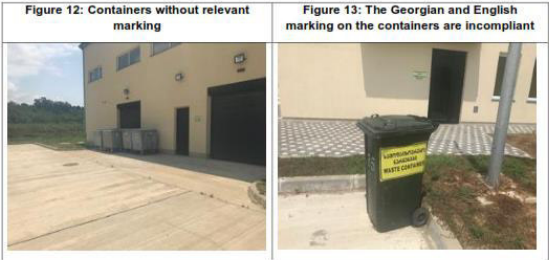
Figure 14: The containers miss some marking or have incompliant inscriptions

42. Some containers in the project zone do not have relevant marking (Figures 12 and 14), while the Georgian and English inscriptions on some of them are incompliant (Figure 13 and 14).

43. The containers found in the project zone are not duly labeled.

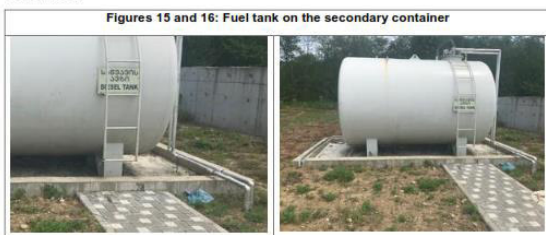
47. The hazardous substance container is placed on the secondary containment. The volume of the secondary containment is 110% less the volume of the container containing hazardous substances.

48. The volume of the protection tank must be increased at least by increasing the walls of the tank.
