Environmental Monitoring Report

Semi-annual Report (July - December 2019)
February 2020

GEO(COL): Urban Services Improvement Investment Program – Tranche 3

**GEORGIA: URBAN SERVICES IMPROVEMENT INVESTMENT PROGRAM
(TRANCHE 3)
(FINANCED BY THE ASIAN DEVELOPMENT BANK)**

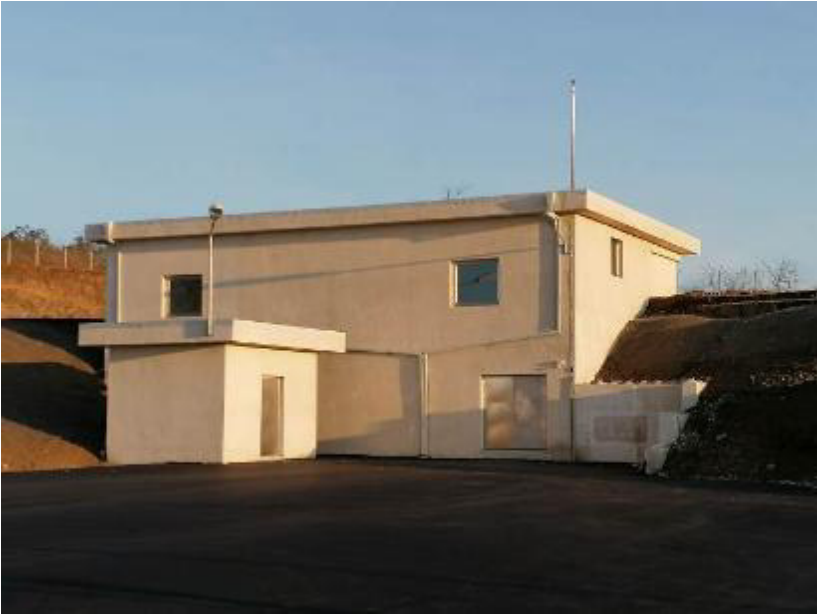
Kut-01 - Godogani reservoir (New East Reservoir)

➤ New East Reservoir

38. Activity in Godogani reservoir has been progressed thanks to numerous workers.

- Fence is finished
- Flow meter is installed
- Chlorination system is operational
- Plate forms details should be finished
- Electrical installations are finished

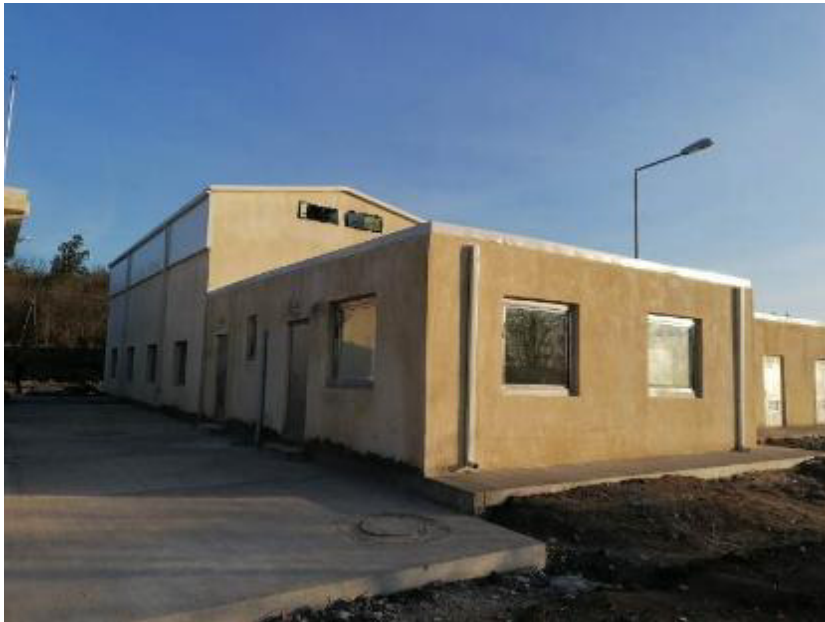
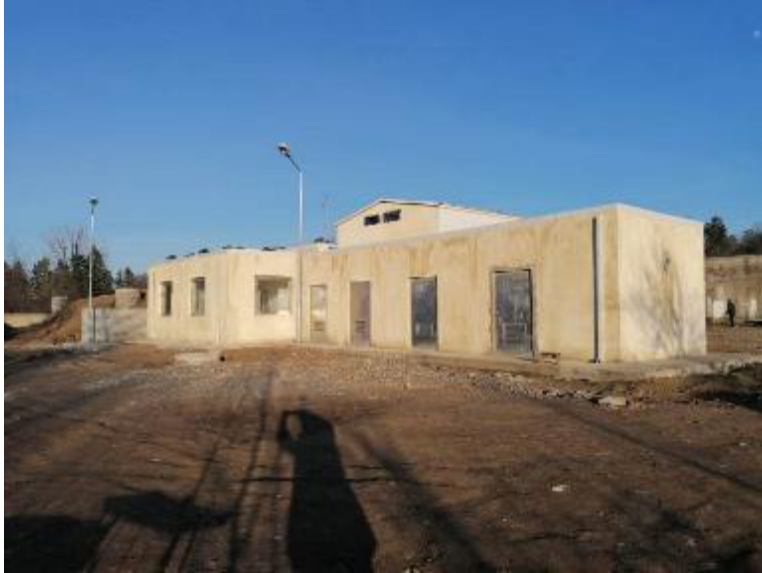
KUT-01 - Mukhnari Reservoir

➤ Mukhnari

39. Situation is similar as in Godogani because many workers are active. It was done:

- Plate forms and handrails are finished
- Mechanical installation in reservoir and pumping room is complete including flow meters.
- Temporary surge vessel has been connected

40. Remaining works:

- Final surge vessel installation after delivery
- Toilets and drainage
- Access road.

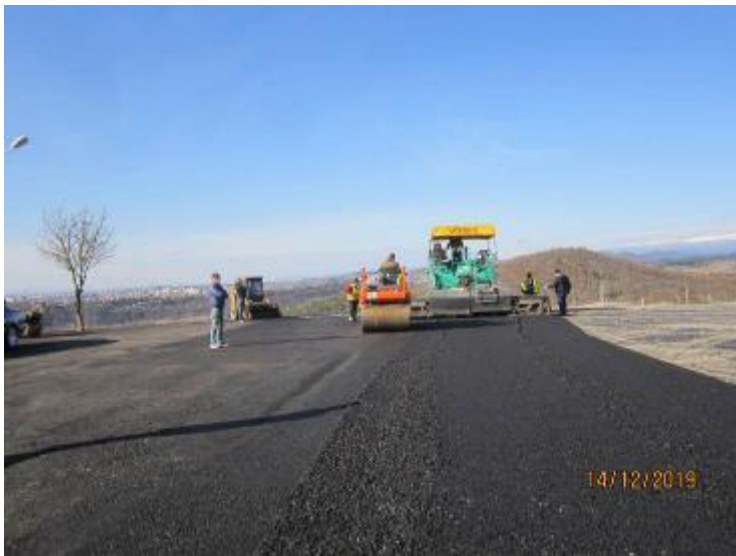
37. Access road of Godogani reservoir has been finished including the surface of parking in front of reservoirs. Access gate to site has been installed.

KUT-01 First layer of asphalt front of Godogani reservoir

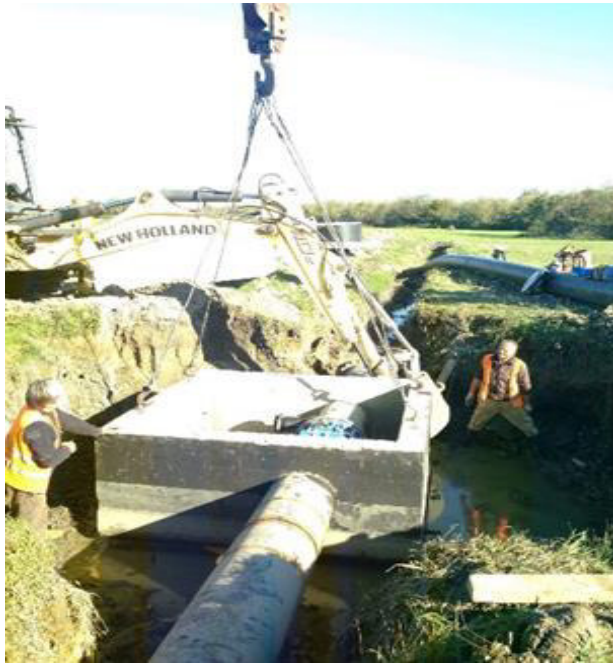
Photo: Aba-01 Construction of Network

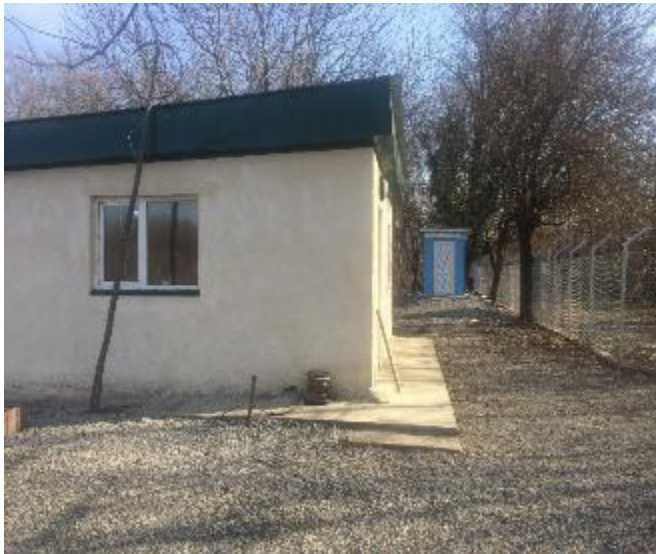
ABA-01: Guard's Box

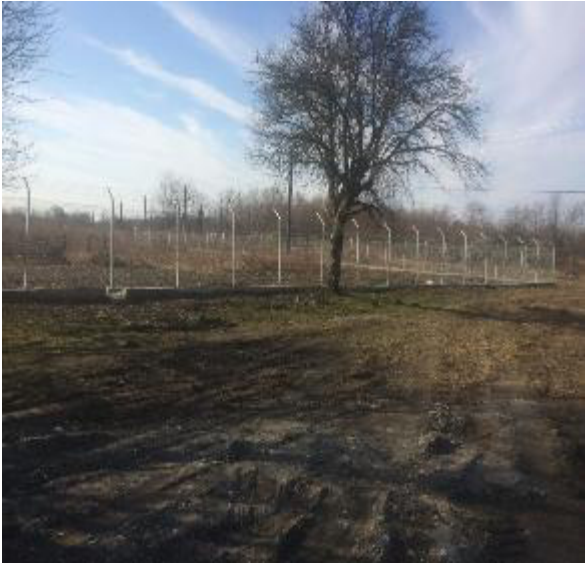
49. Installation of fence at the headwork is completed in the front side. Installation the fence on the back side of headwork with barbed wire is on-going.

ABA-01: Insolation of the fence on the front side of Headworks
