# Environmental Monitoring Report

Bi-annual report  
Covering the period of July - December 2016

## **KGZ: Power Sector Rehabilitation Project, Phase 1**

Project Number: 44198 - KGZ  
ADB Loan/Grant Number: L2869/G0294-KGZ  
Prepared: January 2017

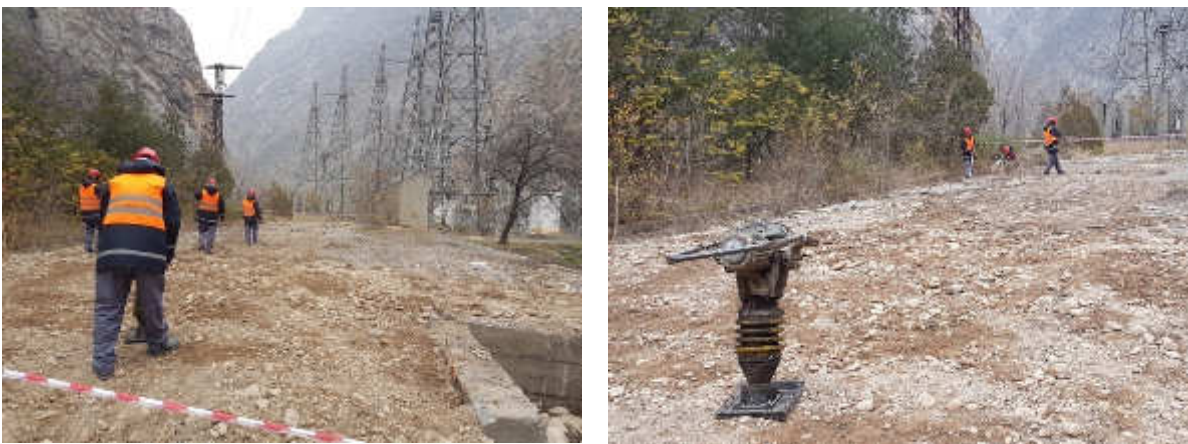
25. The earth works to build the trenches for the oil storage area foundation were completed ahead of the work schedule. During the period of the Project staff's stay on the site, soil compaction measures of the site for the scrap metal storage were under implementation at the end of November 2016 (Picture 2).

Picture 2. Works to compact ground on site, preparation the area for the oil and scrap metal storage construction are implemented in accordance with environmental requirements (workers equipped by PPE, area is fenced by band) – status in November 2016.

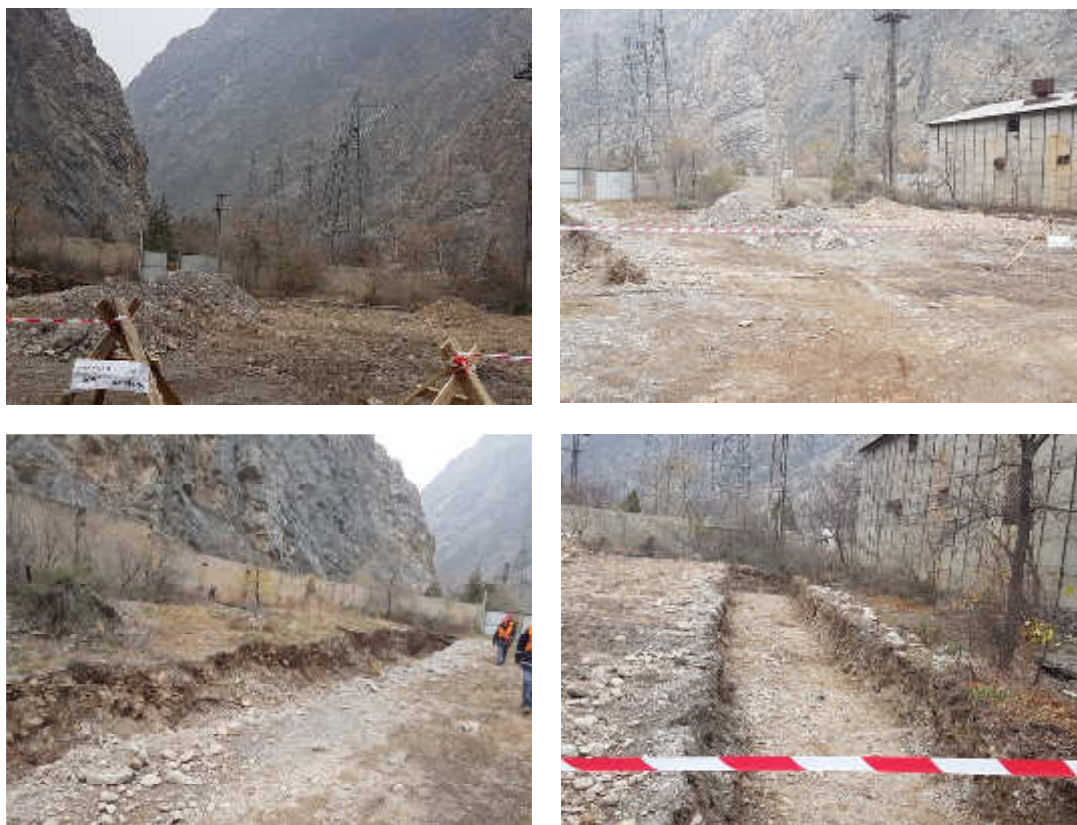
26. All works were carried out in accordance with the safety requirements. Areas with trenches for the foundation are marked by a bright red-white colored ribbon and a caution board prohibiting entering to unauthorized people. The working personnel's PPE complies with all technical requirements. Used equipment for soil compaction was in good condition, no emissions were observed. Pictures below shows the status of works implemented in reporting period (Picture 3).

Picture 3. Completed earthworks at the site «Area for oil storage» - area is fenced by the red-white ribbon and warning signs are installed - status in November 2016.

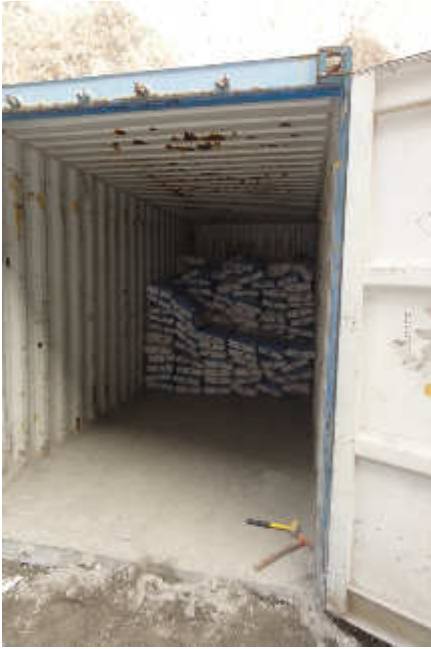
32. The construction site for the oil storage area consists of the site itself and a concrete mixing area located very close to the storage area (about 500 m upstream). At the concrete mixing zone a closed container is placed where the cement bags are stored being safe in case of rainfall (Picture 5).

Picture 5. Container for keeping cement bags to protect them of rainfall – oil storage construction site, status in December 2016.

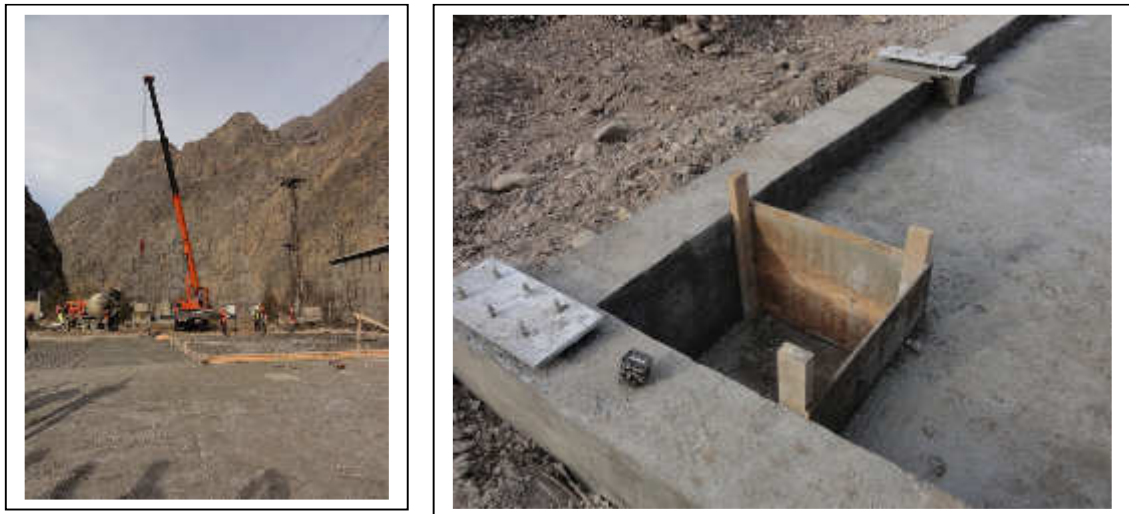
33. The size of the future oil storage area is now  $25 \times 25 \text{ m} = 625 \text{ m}^2$  as tendered. Concreting was ongoing during the site visit. Around the concreted site a small trench leading to four small concreted pits are foreseen to collect oil in case of leakages. The storage site will be roofed in March-April 2017.

Picture 6. Future oil and scrap metal storage area with construction equipment. The floor of the oil storage area at each corner is equipped with oil catchers in the case of oil leaks.

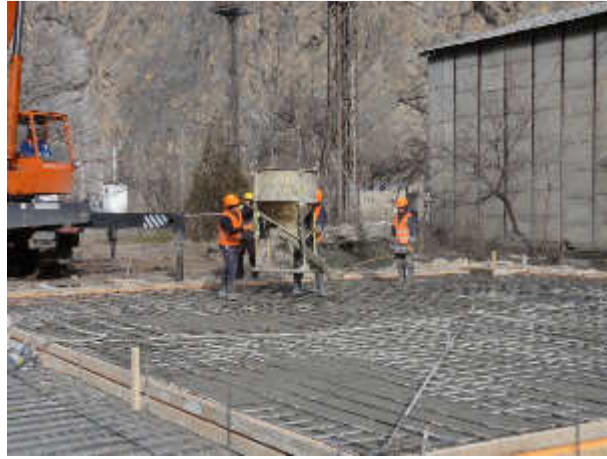
34. All workers were wearing helmets and proper working clothes (PPE) (Picture 7).

Picture 7. The worker' PPE comply with all the safety requirements -November 2016

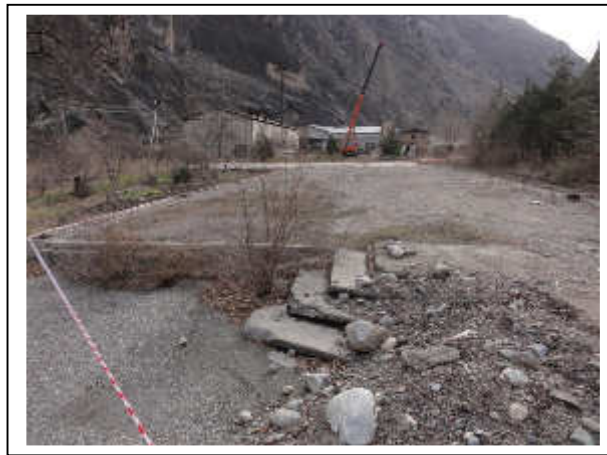
36. The scrap metal storage is another site located nearby the future oil storage area. The scrap metal storage site is intended for keeping parts of demounted power equipment and has already been levelled and will be finalized until January 2017 (

Picture 8. Scrap metal storage area fenced with the red-white ribbon and prepared for further works.

38. It is recommended to analyze oil from the equipment to be replaced for PCB (eventually other oil too) and the concrete waste for possible occurrence of asbestos. Then, the IEE/EMP developed to the overall rehabilitation project for Toktogul HPP Phase 1 shall be updated with these findings. This will be a part of the Corrective Action Plan.

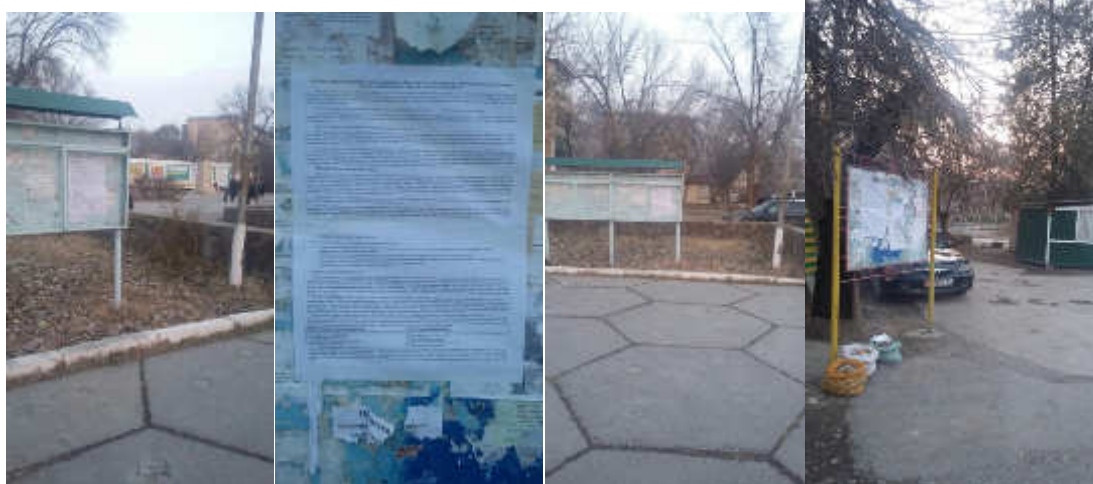
93. GRM leaflets were placed in the Seryi's street, next to the City House of Culture, and on Lenin Street, in the city center, near the cafe "Edelweiss" in Kara-Kul city. Photos are provided below.

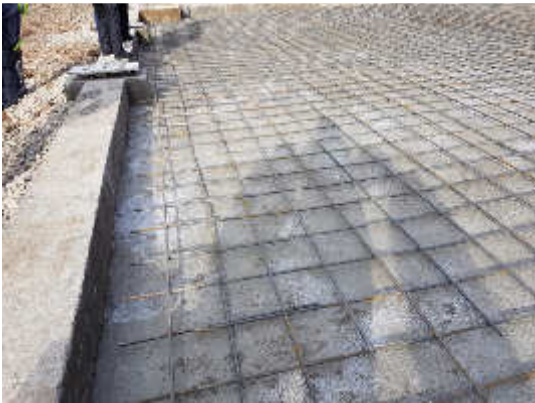
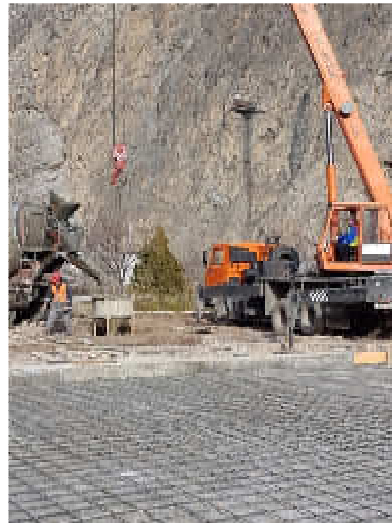
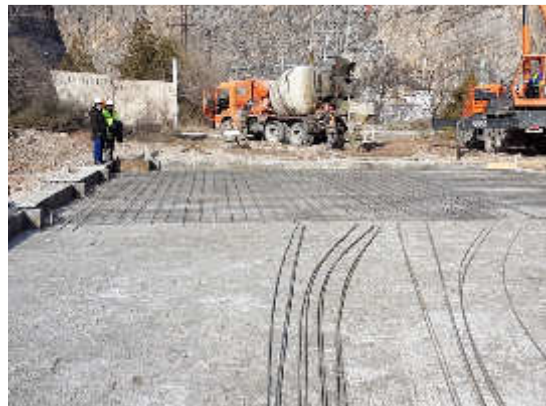
**Photo 1-4. Location of oil storage area****When transporting the waste oil, it is necessary to comply with the following requirements:**

Temporary storage of oil before transporting it to its final destination point (Osh TPP) is administered by the Toktogul HPP. The oil in the tanks will be located on the territory of the area oil storage area of Toktogul HPP (see Photos 1-4 below). The oil storage site will be provided with a roof and protective belt made of concrete. Due to the fact that there are some risks of oil leaks in the event of improper handling/storage, overflow launders located around the oil storage area perimeter will be arranged with a descending gradient so as to allow to drain the oil in the event of a spill to one of four oil catchers at the corners of the building. The volume of each oil sump is 1 cubic meter. The amount of the old cable oil is about 210-230 tons.

Photo 1. Future oil storage area

Photo 2. Future oil storage area

Photo 4. Future oil storage area

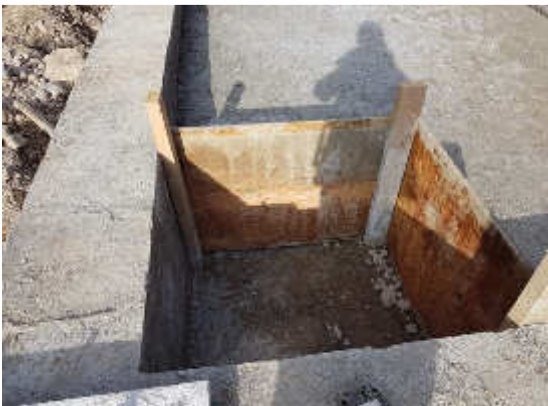
Photo 3. Oil catchers

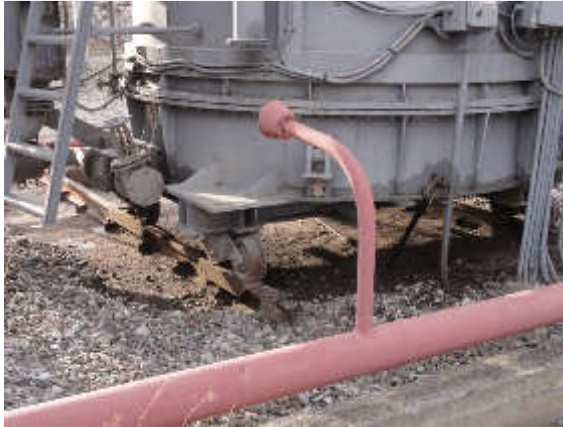
Photo1. Reactor to be replaced (containing about 40 t of oil)

- Oil samples especially from the reactor shall be taken and analyzed for PCB;
- Probes from the concrete to be disposed of (from cable channel) shall be analyzed for asbestos;
- An appropriate landfill for concrete waste shall be selected;
- The additional measures shall be incorporated into the existing IEE/EMP either as Annex or directly into the main text body;
- The implementation of the new EMP shall be part of the tender and contractual documents;
- The new contractor shall develop a general Health and Safety Plan and implement a general Health & Safety Management System at construction site;
- The selected construction contractor shall set up a site specific EMP (SSEMP) focusing on the handling of concrete construction waste.

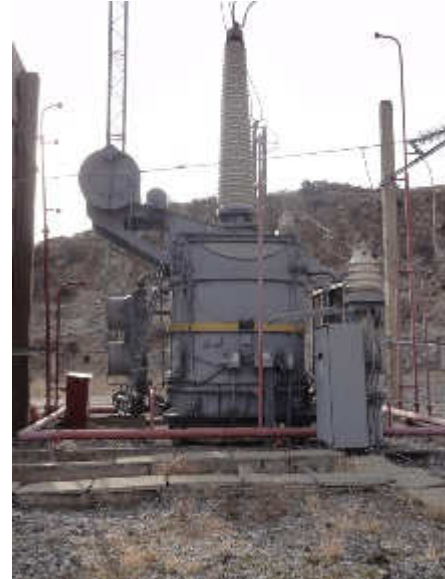
Photo2. Actually installed reactor

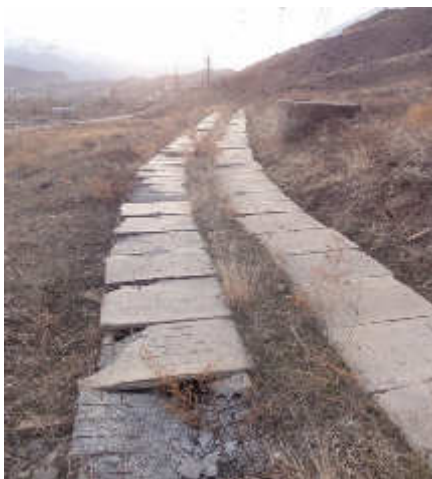
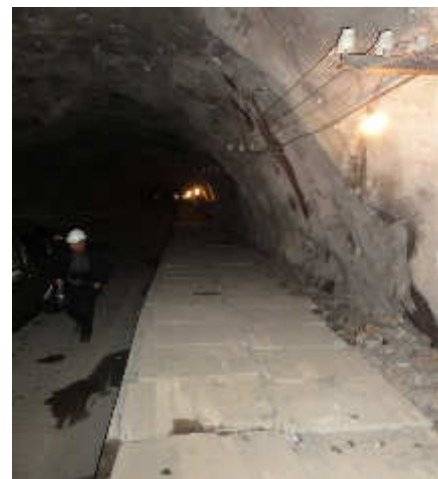
Photo3. Cable duct to be rehabilitated outside and inside the tunnel

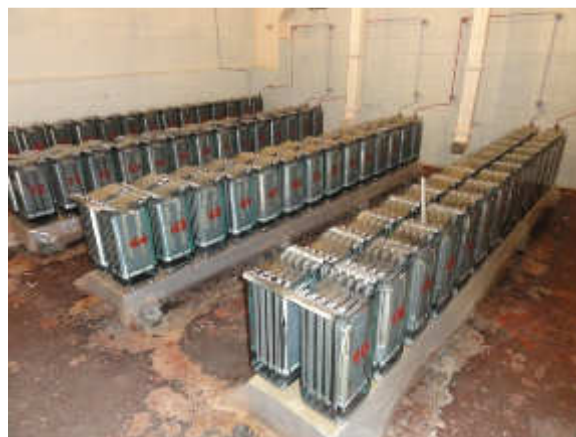
Photo4. Batteries to be replaced
