Bi-Annual Environmental Monitoring Report

Project Number: 44198 – KGZ
ADB Loan/Grant Number: L2869/G0294-KGZ
Reporting period: July - December 2017

Kyrgyz Republic: Power Sector Rehabilitation Project, Phase 1

Prepared by the Open Joint Stock Company Electric Power Plants, with the assistance of the Project Implementation Consultant (Fichtner GmbH & Co. KG –Energy, Germany) for the Kyrgyz Republic and the Asian Development Bank.

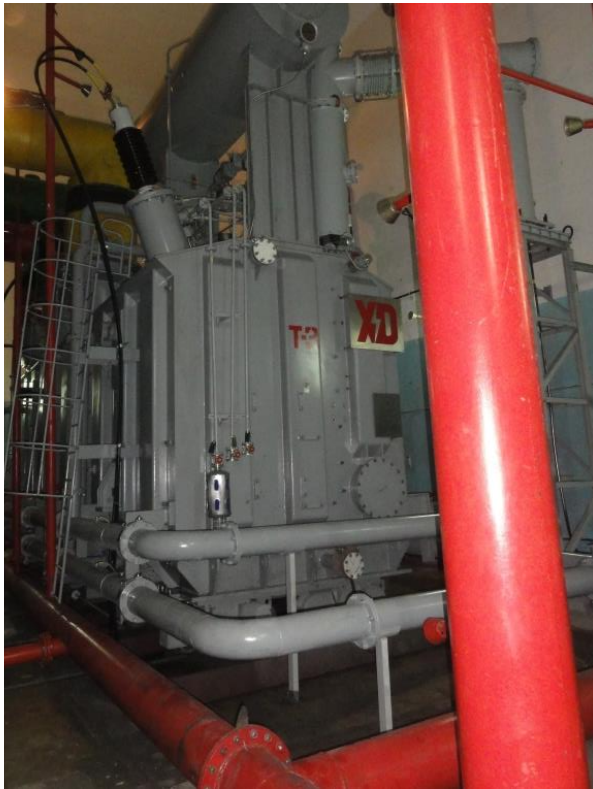
Picture 2: New main transformer T3 operational since August 2017 - Status for September 2017.

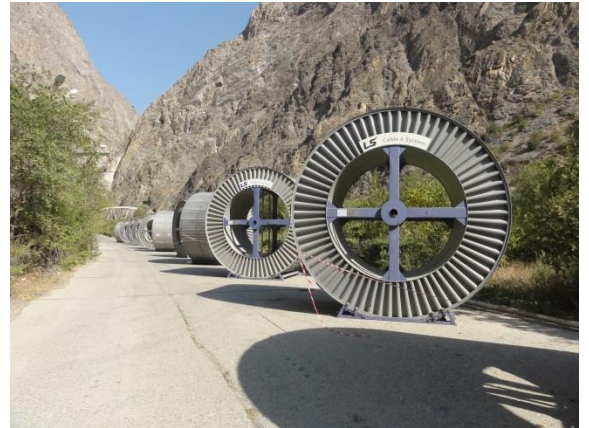
Picture 3: Cable drums for delivery of 500 kV cables - Status for September 2017.

#	Month, 2017	Activity
1	July	<ul style="list-style-type: none"> Finalization of installation of 500 kV cable Unit 3 and its sealing, and connection to Unit 3. Delivery of 500 kV cables rolled up on drums (Picture 3).
2	August	<ul style="list-style-type: none"> Delivery of all remaining 500 kV cables rolled up on drums¹. Commissioning of the 500 kV cable of Unit 3. The cable has been operational since 10th of August 2017. Dismantling of the 500 kV cable of Unit 2. Storage of oil in drums at the oil storage area. Dismantling of brickwork at the Transition Point Phases A,B,C
3	September	<ul style="list-style-type: none"> Dismantling of the old 500 kV cable of Unit 2. Installation of the new 500 kV cable of Unit 2.
4	October	<ul style="list-style-type: none"> Installation of the new 500 kV cable of Unit 2 and its accessories.
5	November	<i>Picture 7)</i>
6	December	<ul style="list-style-type: none"> Connection of the 500 kV cables to the transformer. Completion of the commissioning Unit 2 Cable Line 500 kV XLPE cable and 525 kV GIB

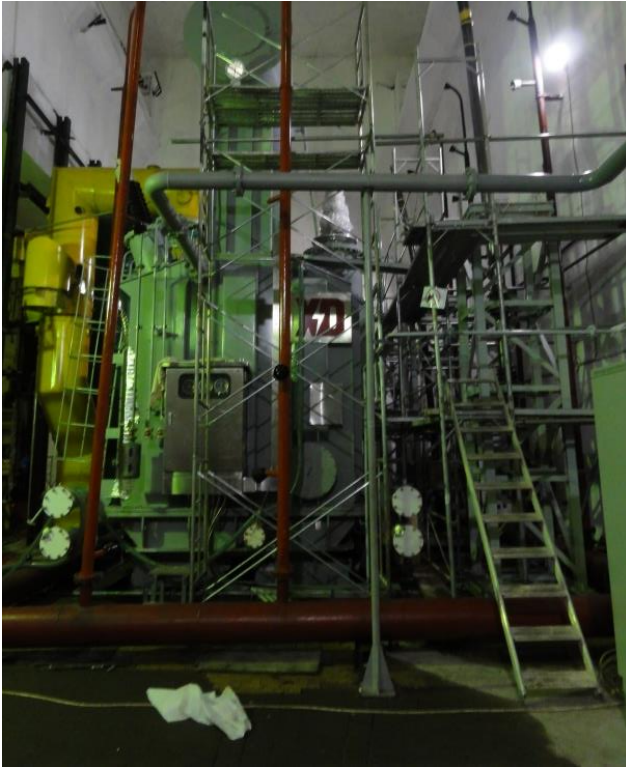
Picture 4: Newly installed main transformer T2 - Status for December 2017.

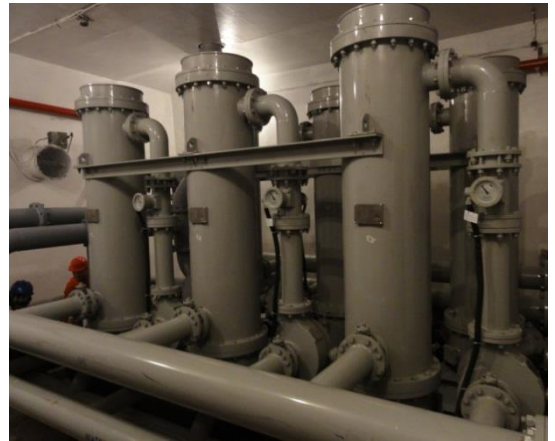
Picture 5: New cooling system for T2 - Status for December 2017.

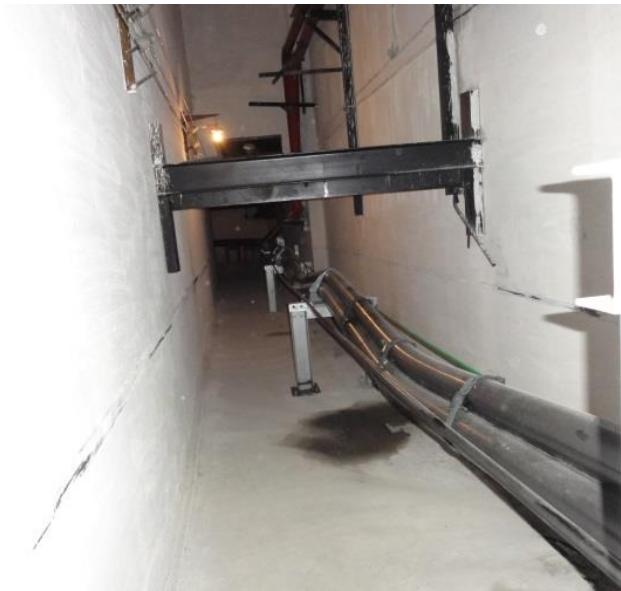
Picture 6: New 500 kV cables of Unit 2 - Status for December 2017.

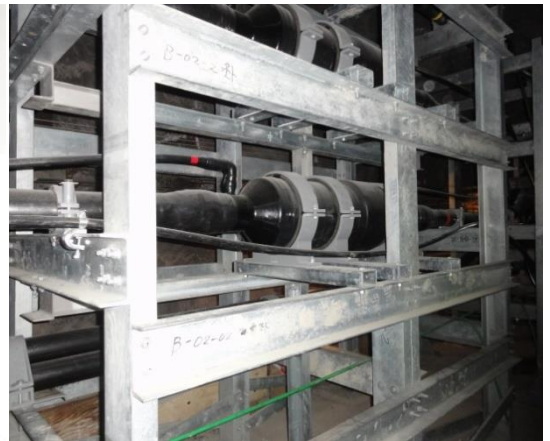
Picture 7: Cable Joint of new 500 kV cable - Status for December 2017.

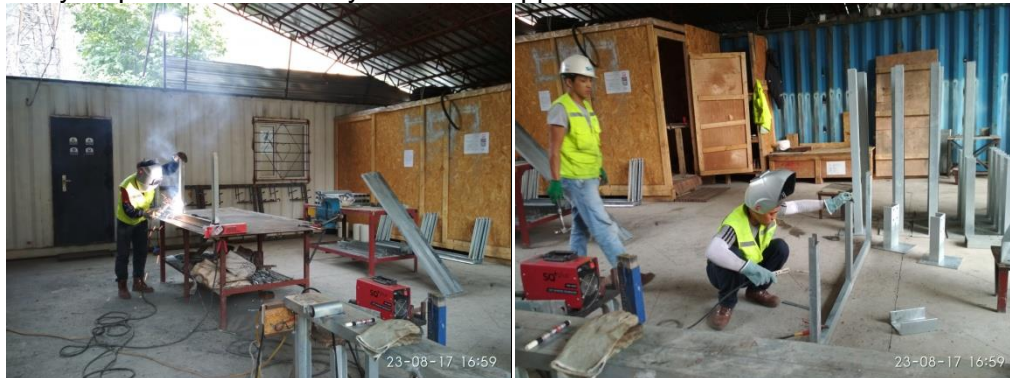
45. The visit showed that all the workers at the site wear PPE and strictly observe safety requirements. No any accident happened at sites.

Picture 8. Workers of Korean CC wearing PPE met relevant H&S requirements – August 2017.

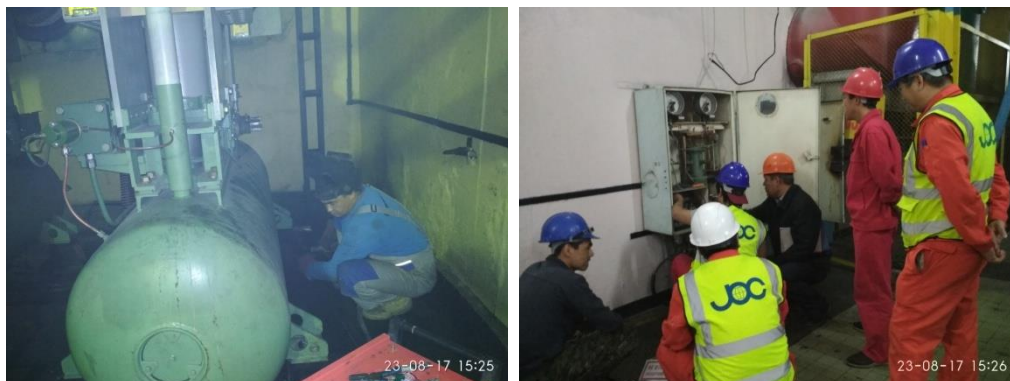
46. During the inspection no serious non-compliances were found. The ones, which were found, were immediately corrected by the relevant HSE staff.

Picture 9. Workers of Chinese CC wearing PPE met the relevant H&S requirements, August 2017.

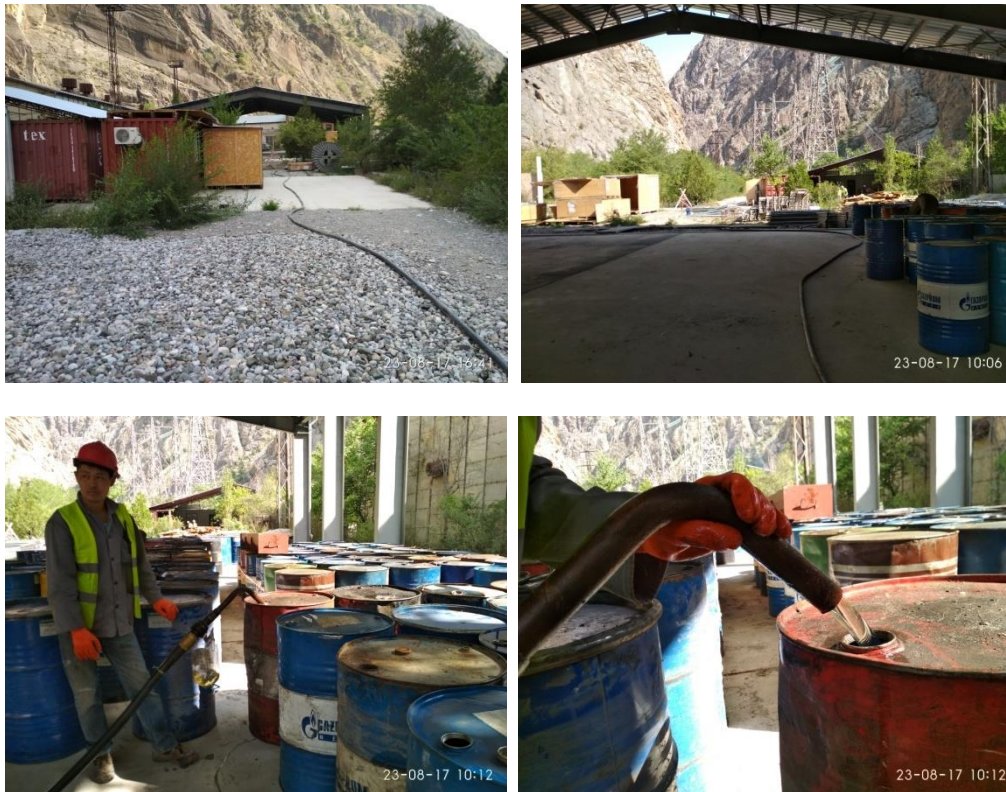
47. As planned, the pipeline for draining the cable oil in the barrel was installed. The oil from the cable was drained to the barrels via the transfer point. The selected way of the oil drain was reliable as it reduced the risks of oil spills and saved the time and effort of the workforce. No oil leaks took place and all the works passed sustainably (see below Picture 10). Drained oil from the cable line Unit 2 was stored in 185 l drums (total about 32,5 tons) at the oil storage area (Certificate of Acceptance is in Annex 2: Acceptance certificate of services dated 16 October 2017 to the Contract #34-20/408 of 12 October 2015).

Picture 10. Oil draining from Unit 2 Cable Line 500 kV of Toktogul HPP. Using of the pipeline for draining the cable oil in the barrel.

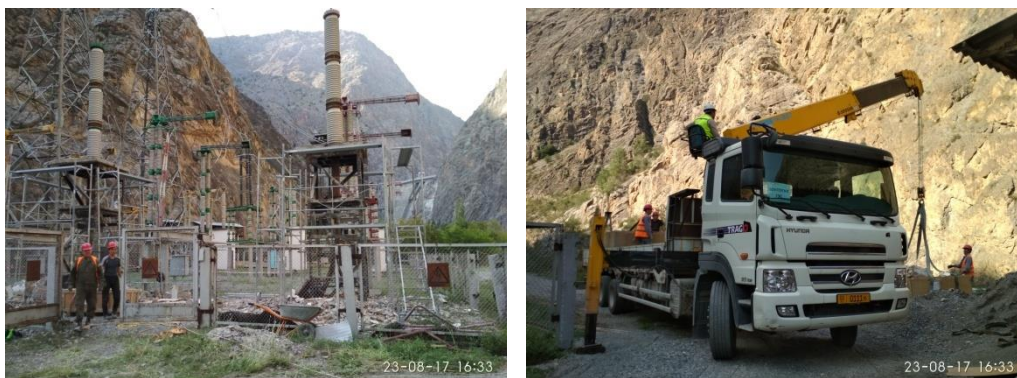
50. Dismantling of brickwork at the Transition Point was implemented with health and safety and environmental compliances by Korean CC. The used heavy truck was in a good condition without oil leakage.

Picture 11. Dismantling of a brickwork at the Transition Point of Toktogul HPP and used heavy truck.

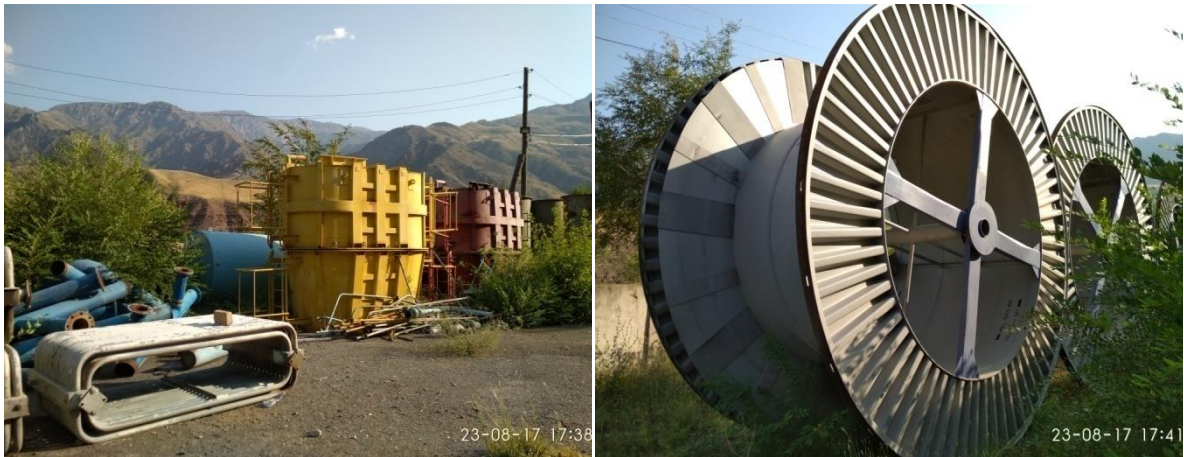
51. For appropriate management of construction waste during the Project, the Order #498 "On construction waste storage" was issued by the Cascade of Toktogul HPPs on 3rd of July 2017 (Annex 3). According to this Order, construction wastes are stored

at the special area of the storage #3 of the Toktogul HPPs by the Contractors (Picture 12).

Picture 12. Construction waste and scrap metal storage at the protected and fenced storage #3 of Toktogul HPP – Status for August 2017.

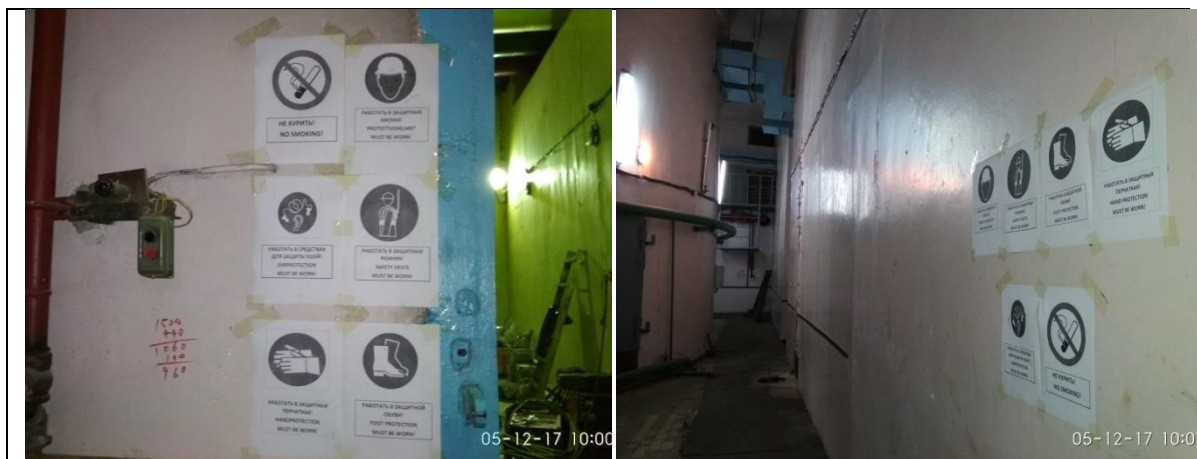
57. During the construction site visit no serious non-compliances have been found. The construction sites looked clean and well organized. Warning signs and instruction plates are in place (*Picture 14*).

Picture 14: Warning and instruction signs inside of Toktogul HPP of CC JOC – Status for September 2017.

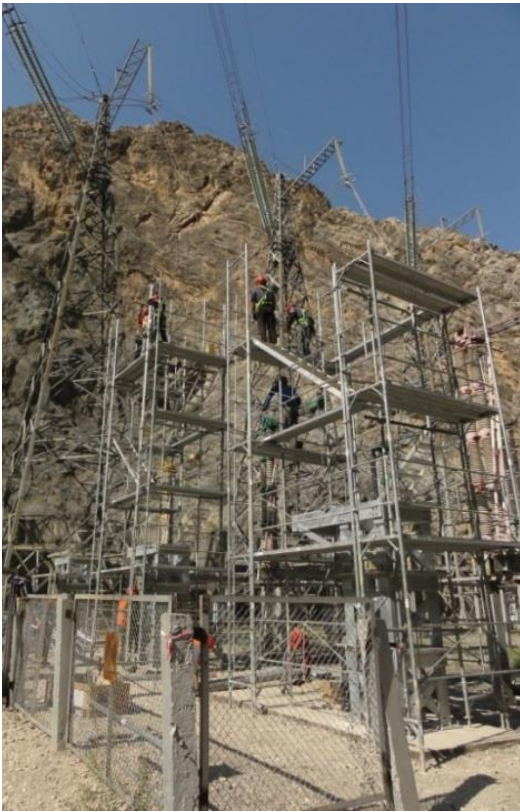
58. Visited sites inside of Toktogul HPP demonstrated that all the safety requirements are met by the working personnel of the Construction Contractors. All the workers wear PPE during working at height, e.g. at the switchyard site workers are wearing and using harnesses (*Picture 15*, *Picture 16*).

Picture 15: Working at height at LV switchgear – Status for September 2017.

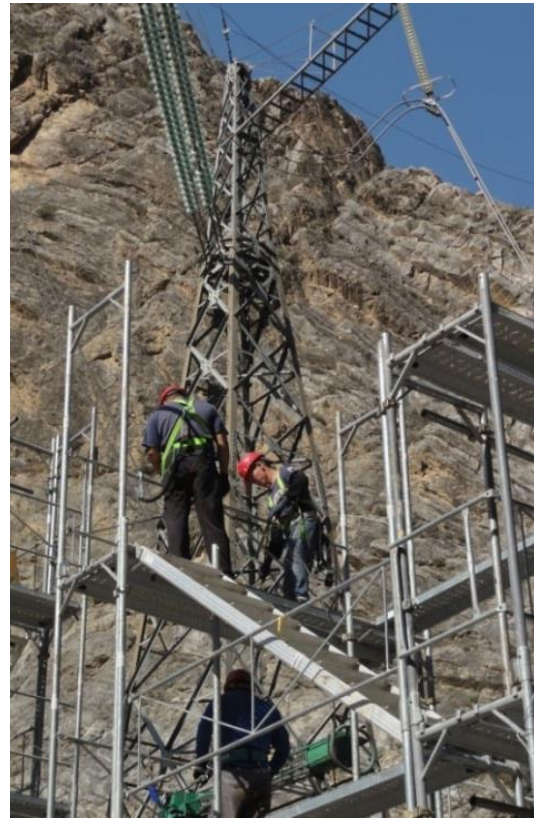
Picture 16: Workers are wearing and using proper harnesses – Status for September 2017.

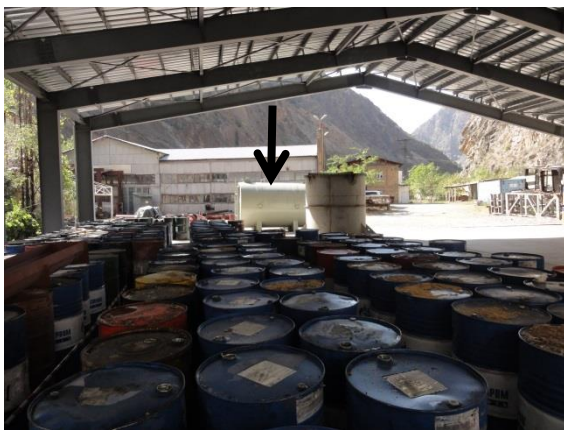
60. Oil from the main transformer T2 is now stored in tanks at the oil storage area and at the fenced storage site #3 of Toktogul HPP (*Picture 17*, *Picture 18*). According to EMP, oil from main transformers shall be reused. Oil can be refined on HPP Toktogul site.

Picture 17: Oil storage tank for transformer oil from main transformer T2 (black arrow). Cable oil from Unit 2 is stored in the blue drums - Status for September 2017.

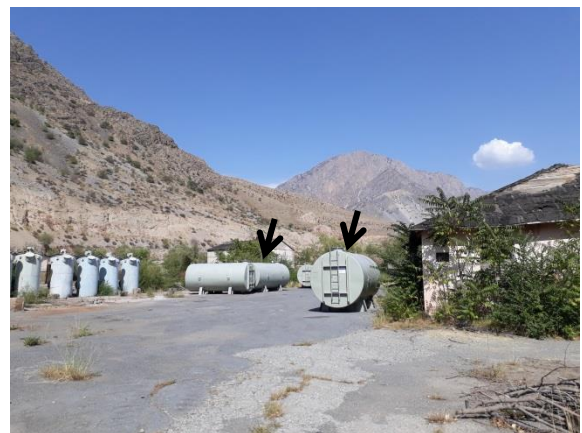
Picture 18: Storage tanks for old transformer oil in the fenced storage area of Toktogul HPP - Status for September 2017.

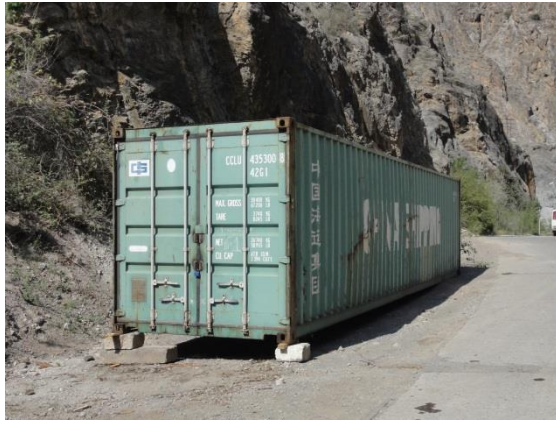
Picture 19: Containers with cut pieces of cable of Unit 2 are stored temporarily along the access road to Toktogul HPP site -Status for September 2017.

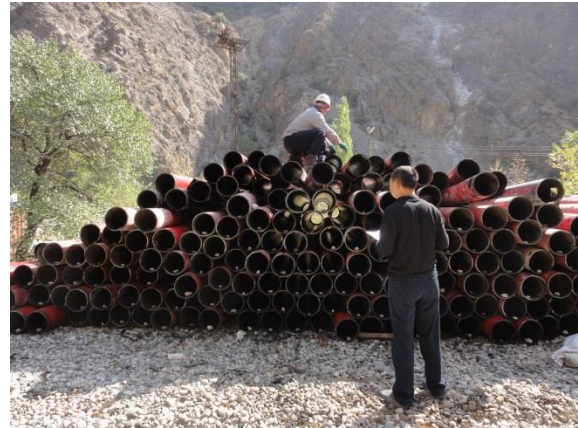
Picture 20: Cut metallic tubes covering the former 500 kV cable to be prepared for recycling - Status for September 2017.

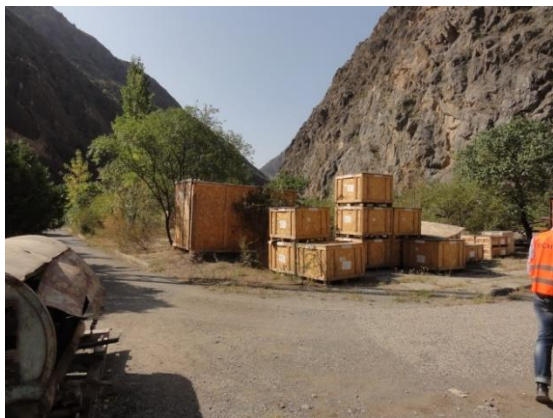
61. The cable cut in pieces is temporarily stored in containers set at storage area of Toktogul HPP inside the fenced and protected area (*Picture 23*). Cut metallic tubes covering former 500 kV cables are prepared for recycling. (*Picture 20*). Wooden containers used for delivery of electrical equipment are temporarily stored near the scrap metal area (*Picture 21*).

Picture 21: Temporary storage of empty wooden containers used for delivery of different equipment – Status for September 2017.

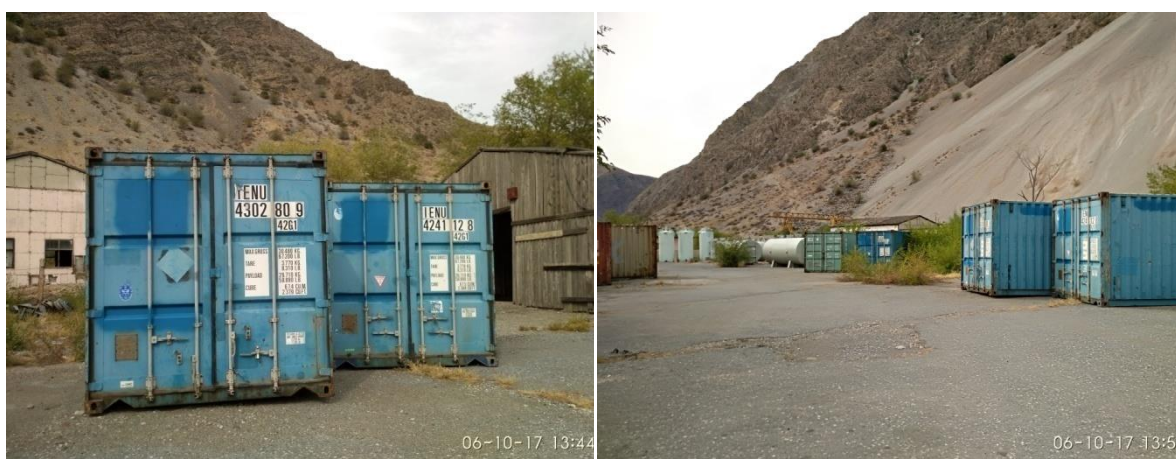
64. Dismantled cable 500 kV of Unit 2 was cut and put in containers with full implementation of environmental and health and safety requirements. Those containers were stored at fenced and protected storage #3 of Toktogul HPP outside of HPP until recycling along with previous containers with dismantled cable 500 kV of Unit 3 (*Picture 23*).

Picture 23. Metalic containers containing the dismantled cable line of Unit 2 of Toktogul HPP. Clean surrounding area – status for October 2017.

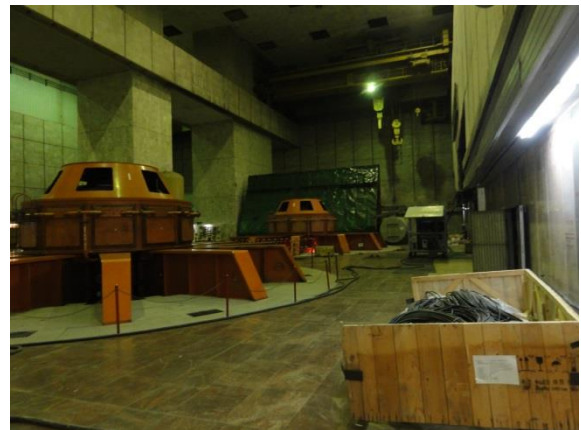
Picture 25. Clean construction site in the power house of Toktogul HPP - Status for December 2017.

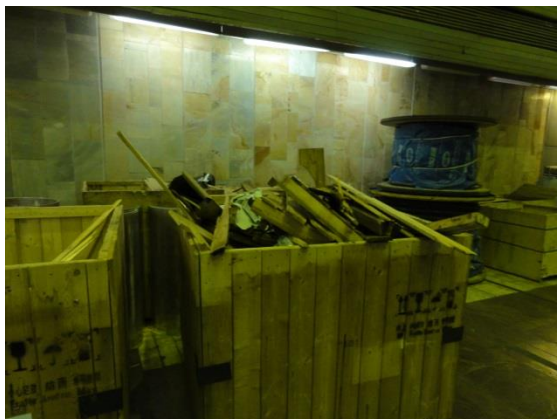
72. Waste is segregated and stored in separate wooden containers (*Picture 27, Picture 27*).

Picture 26: Container for wooden waste and paper waste - Status for December 2017.

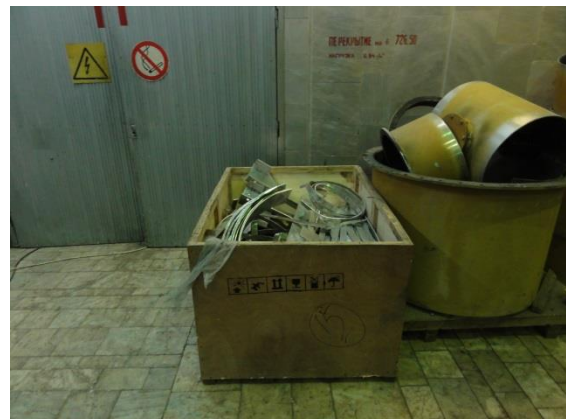
Picture 27: Container for scrap metal - Status for December 2017.

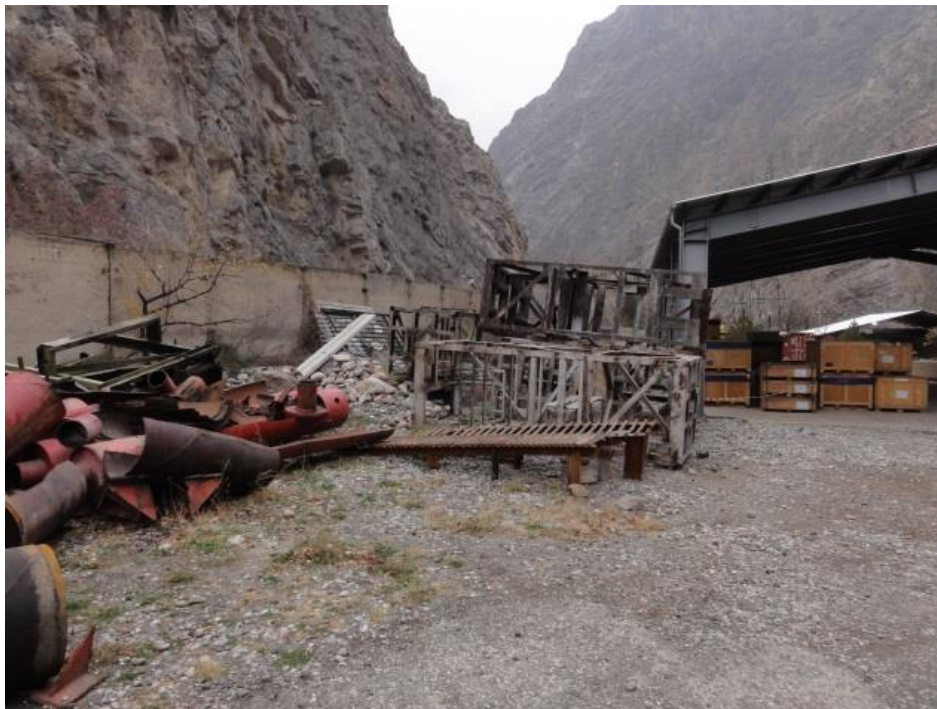
78. Metallic waste is also stored outside the scrap metal area near the oil storage site (*Picture 28*).

Picture 28: Scrap metal stored temporarily kept at the storage area - Status for December 2017.

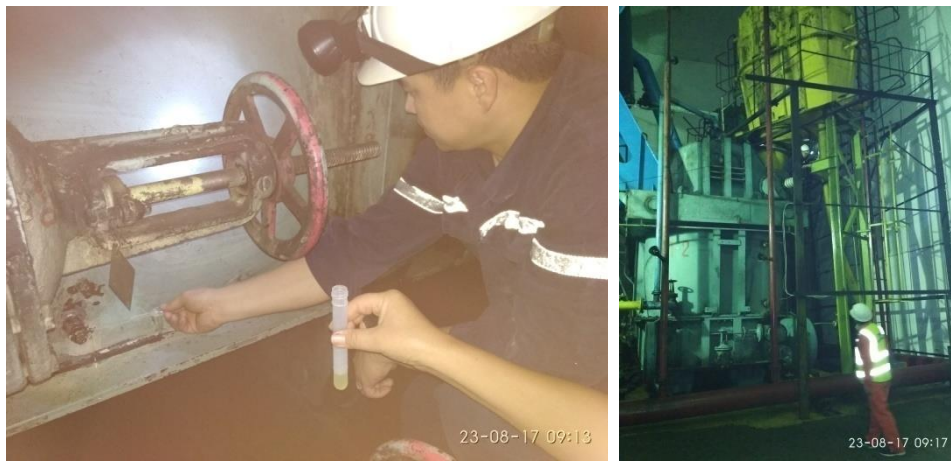
80. During sampling the cable and transformer oil, the Cascade of Toktogul HPP Chemical laboratory personnel jointly with Ms Jyldyz Moldosanova took 8 samples from different points and equipment: four samples from Unit 2 main transformer (*Picture 29*) and four samples from Unit 2 cable line 500kV (*Picture 30*). Oil testing for PCB was made by L2000DX Analyzer (*Picture 32*).

Picture 29. Oil sampling from Unit 2 main transformer of Toktogul HPP

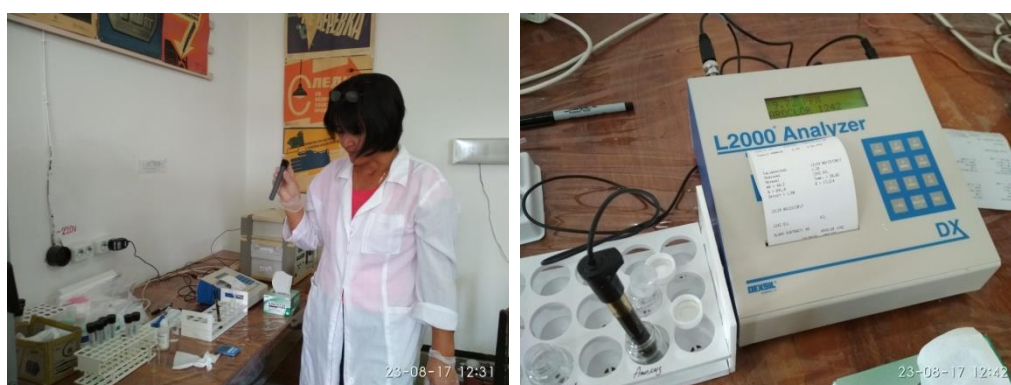
82. All 8 samples were analyzed for PCB by the Chemical Laboratory of Cascade of Toktogul HPP personnel. Results (see below Table 5) confirmed the previous analyses made in 2014 presented in IEE set up to the Project.

Picture 32. Performing of oil test for PCBs by Toktogul HPP personnel.

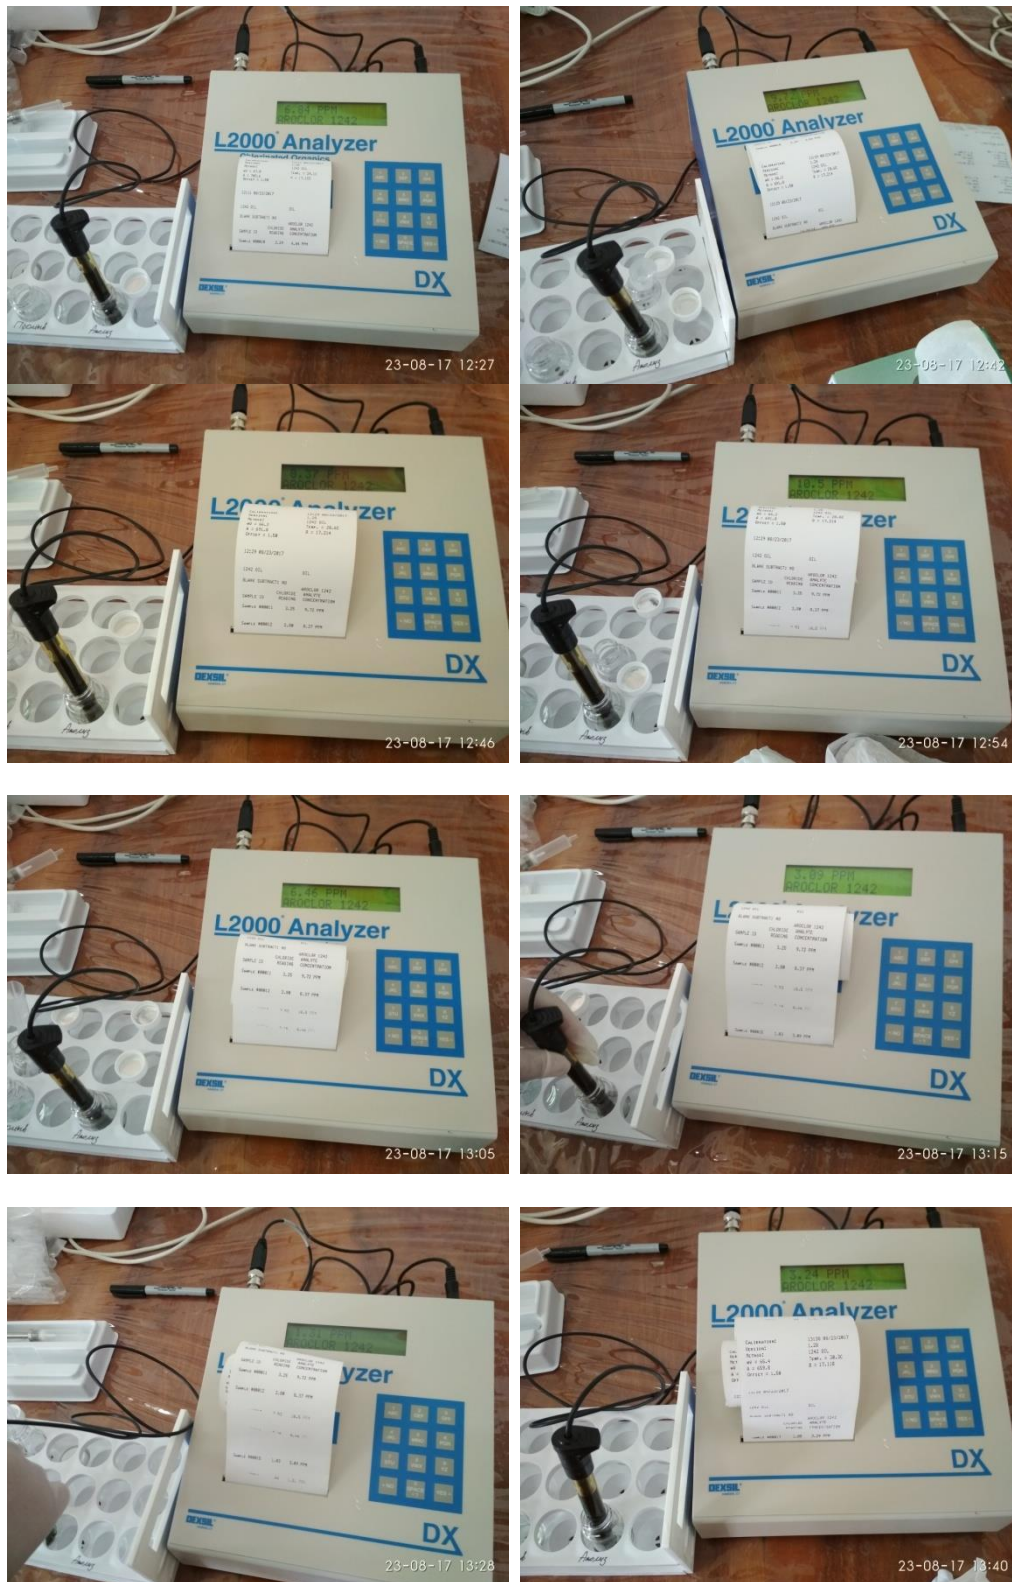
Picture 33. The automatically generated reports of the analyses made by L2000DX.

83. The PCB concentrations in all samples were below 50 µg/kg. Thus, these **oils can be considered to be free of PCB** and no specific measures in handling or disposing them are needed. The consolidated automatically generated report is attached in Annex 4.

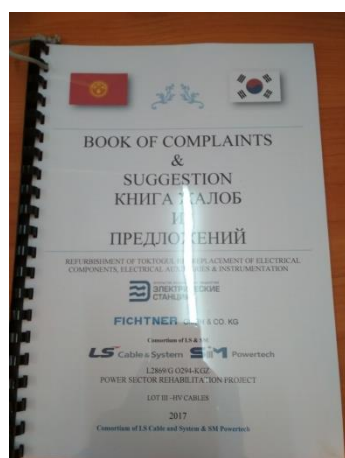
92. Both Korean and Chinese Construction Contractors have GRM Log Books at sites (*Picture 34*). There have no complaints been raised so far, neither by workers nor by the population. GRM log books are filled up appropriately.

Picture 34. Compliance Books in the field offices of the Construction Contractors and are easily accessible.
