Bi-annual Environmental Monitoring Report
January 2014

PAK: Flood Emergency Reconstruction Project

Flood Emergency Reconstruction Projects (FERP)

Reconstruction and Rehabilitation of Roads

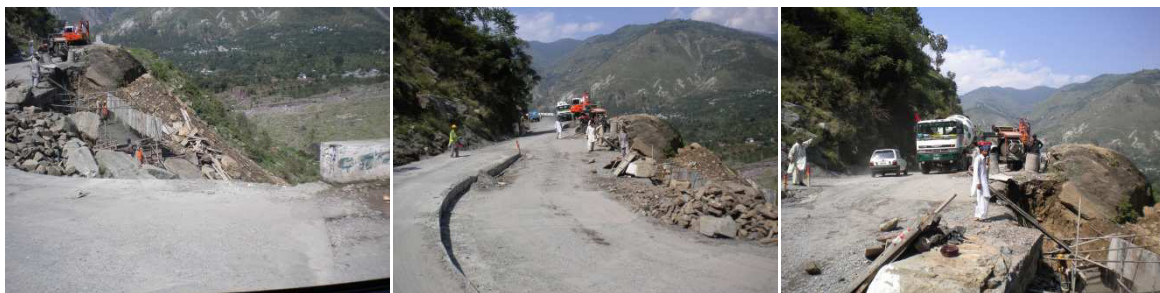
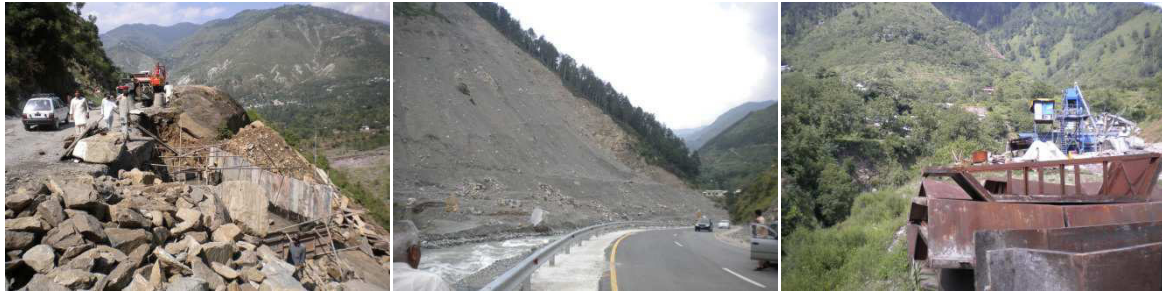
Pictorial Profile of N-15

1. Initially there is no communication for the people who travel on the road about the work in progress and the dangers was observed but the contractor was arranging the communication system during our visit.
2. Proper sign and signage were displayed at the site.
3. The construction material of the retaining wall was scattered on the road, creating hurdles for the passengers, which was being removed from the site by the workers.
4. There is no cordoning of the dangerous area, places where work is in progress and places where heavy machines are kept on the road. Whereas, the contractor agreed to do the cordoning in 2 to 3 days.
5. Blind turns were marked along the blind ends of the road.
6. The people who were made to stand at later stages were in bright colored jacket and flag sand they were wearing hard hats. This was the good practice observed at the site.

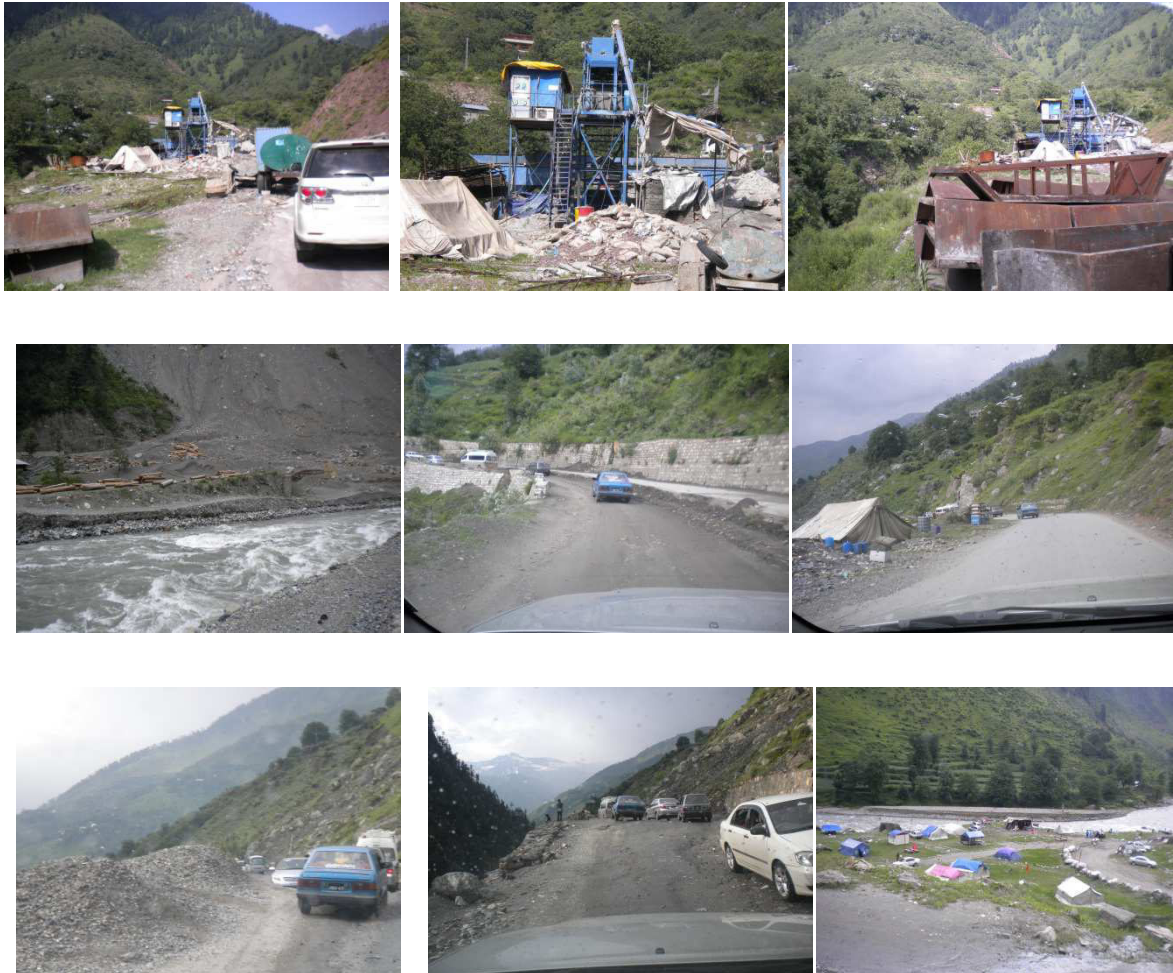
Site: 24 KM away from Naran

1. Similar problems were observed as in 1st one
2. Rustam JV Batching plant site.

1. The heavy loads and old machinery was observed to be on the road sides, whereas, the workers were removing them from the site.
2. Safety signs at blind end mirrors were present.
3. No fire extinguishers were available.
4. There was proper arrangement done for the loose electrical wires..
5. The safety measures were adopted for the diesel tanks.

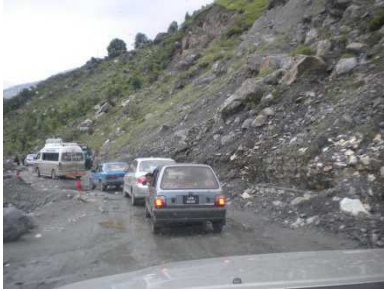
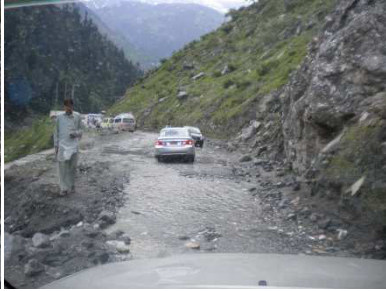
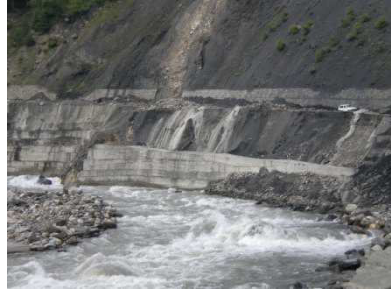
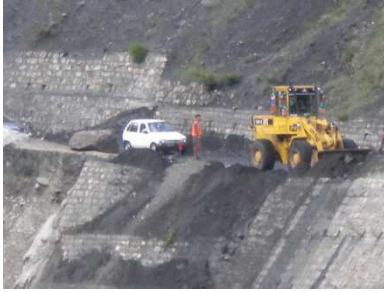
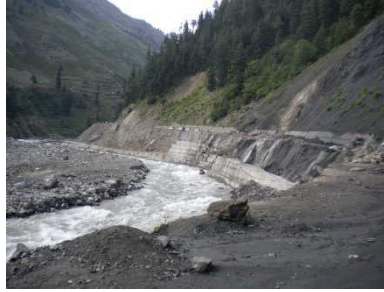
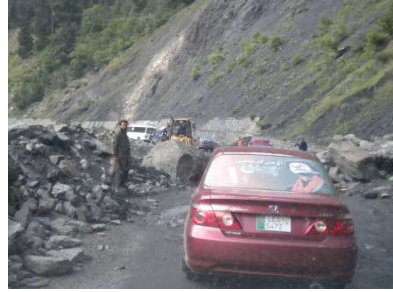
Observing the overall condition of the construction site

5. Safety signs were displayed along the road and on the area of quarrying and landslides.
6. There was a proper place assigned for the workers accommodation.
7. The waste construction material was left to slide along the mountain down to the river.
8. The site is on the bank of the river and the site management was ensured that no remains , rubbish or waste is thrown or mixed in the river

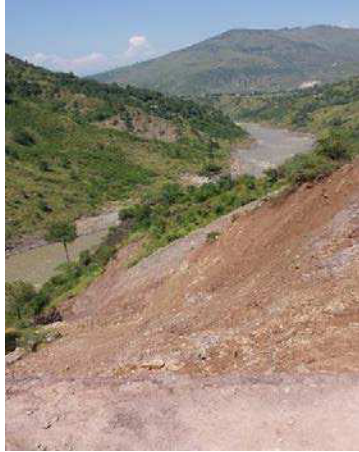
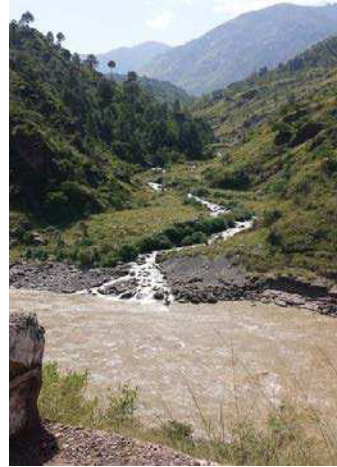
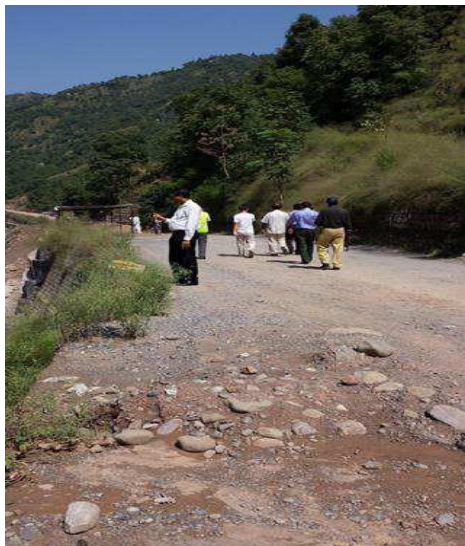
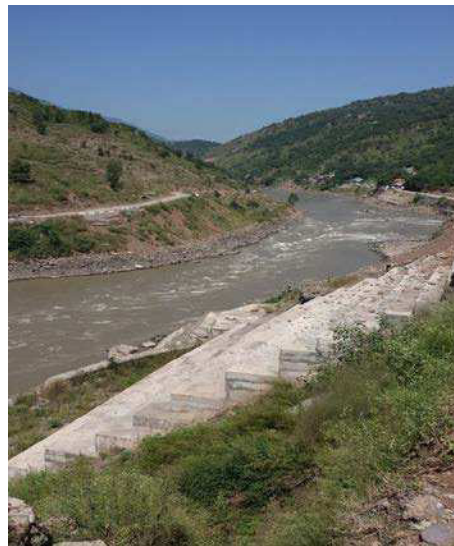
Pictorial Profile of S-2

1. There is no communication with the people who travel on the road about the work in progress and the dangers. The road has eroded due to land slide and any mishap can result. The contractor agreed to arrange the fore said system in periods of 4 days.
2. Proper sign and signage were placed on all entrance points to warn people about the hazards of the area.
3. The sign & signage was in proper native language, so that the people could easily understand them.
4. There is no person to facilitate or guide the incoming and outgoing traffic. Whereas, the contractor agreed to make arrangement immediately.
5. The people who were made to stand at later stages were in proper shoes, with bright colored jackets and flags and they were also wearing hard hats.
6. In short we could see construction safety standards even to the minimum being followed.

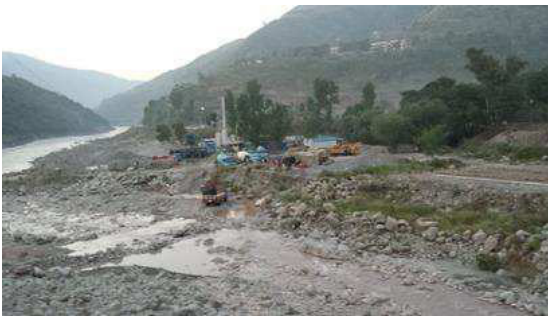
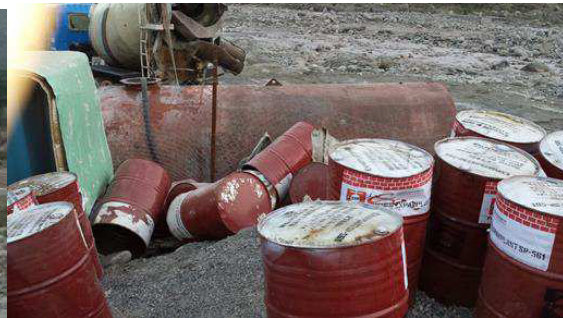
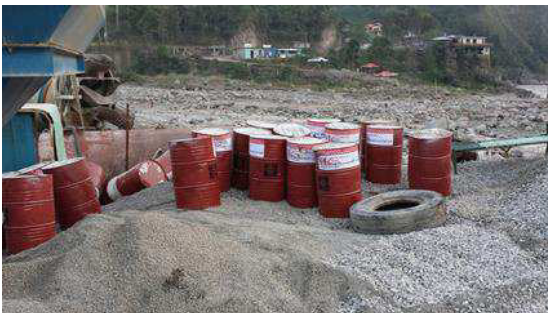
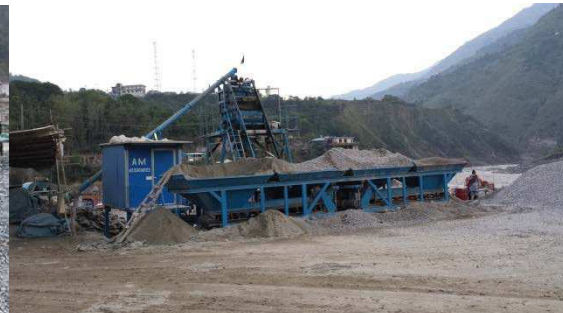
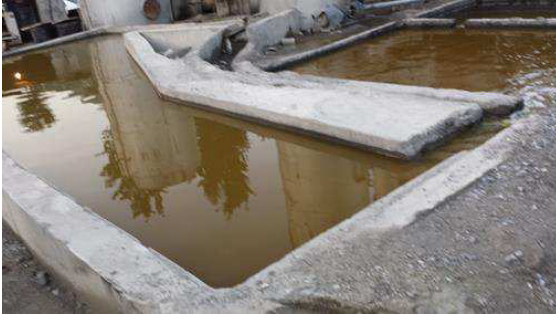
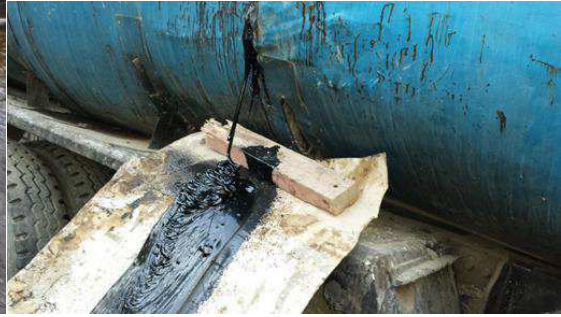
Observation of Overall Health Safety Conditions of S-2

1. Not very professionally done, yet the traffic was being regulated at work sites. The working staff was wearing bright jackets with flags. However, there was communication problem between the two to synchronise the traffic, which would be managed by the contractor on immediate basis.
2. The bitumen boiler was in bad shape, and some were leaking. The contractor managed to avoid its leakage problem efficiently.
3. Signs & signage were missing in all work area, whereas, the contractor agreed to arrange the signage in 3-4 days.
4. Safety was seen in practice and many belts and chains were running with guards. So the cause of accident is negligible.

5. Similarly the electric cable was in a bad shape and should have been discarded due serious electrical hazard; whereas, the contractor agreed to dispose them off on immediate basis.

6. The truck that was used to transport the bitumen was leaking from all side, creating problems where it was falling. After this observation, the contractor agreed to remove such hazardous trucks.

9. The site is on the bank of the river and the site management had ensured us that no remains, rubbish or waste would be thrown or mixed in the river.
