Environmental Monitoring Report

Project number: 44458–013

Period covered: July–December 2018

UZB: Amu Bukhara Irrigation System Rehabilitation Project

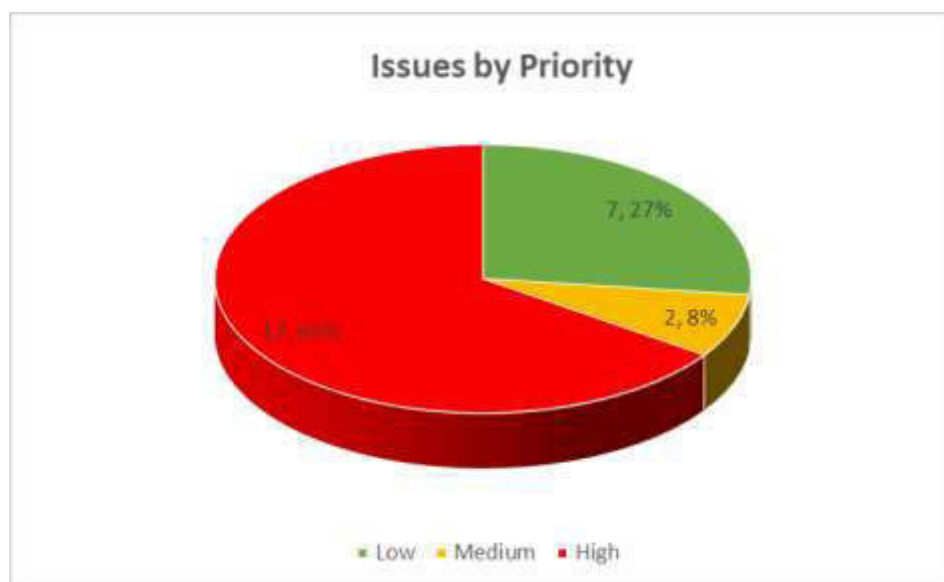
Figure 3-1 Summary of Issues by Priority

41. The distribution of Non-Conformance issues based on priority is shown at the Figure 3-1 and non-conformance level at the Figure 3-2.

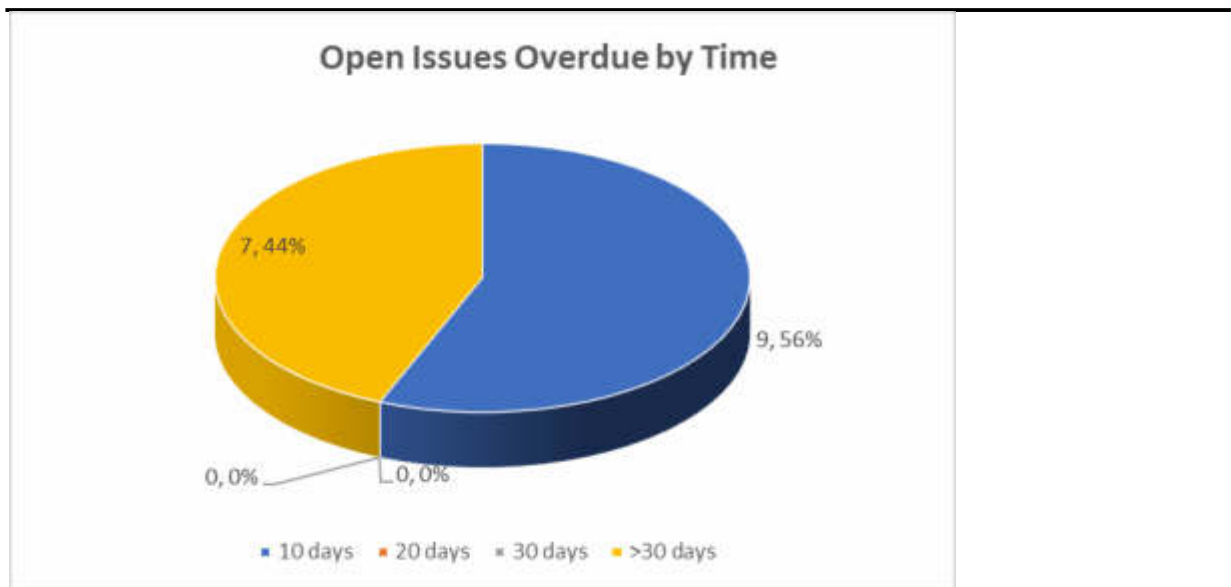
Figure 3-3 Open Issues Overdue by Time

42. Duration to close any issue takes approximately 4 months. The distribution of days required to close any issue has been shown in Figure 3-3.

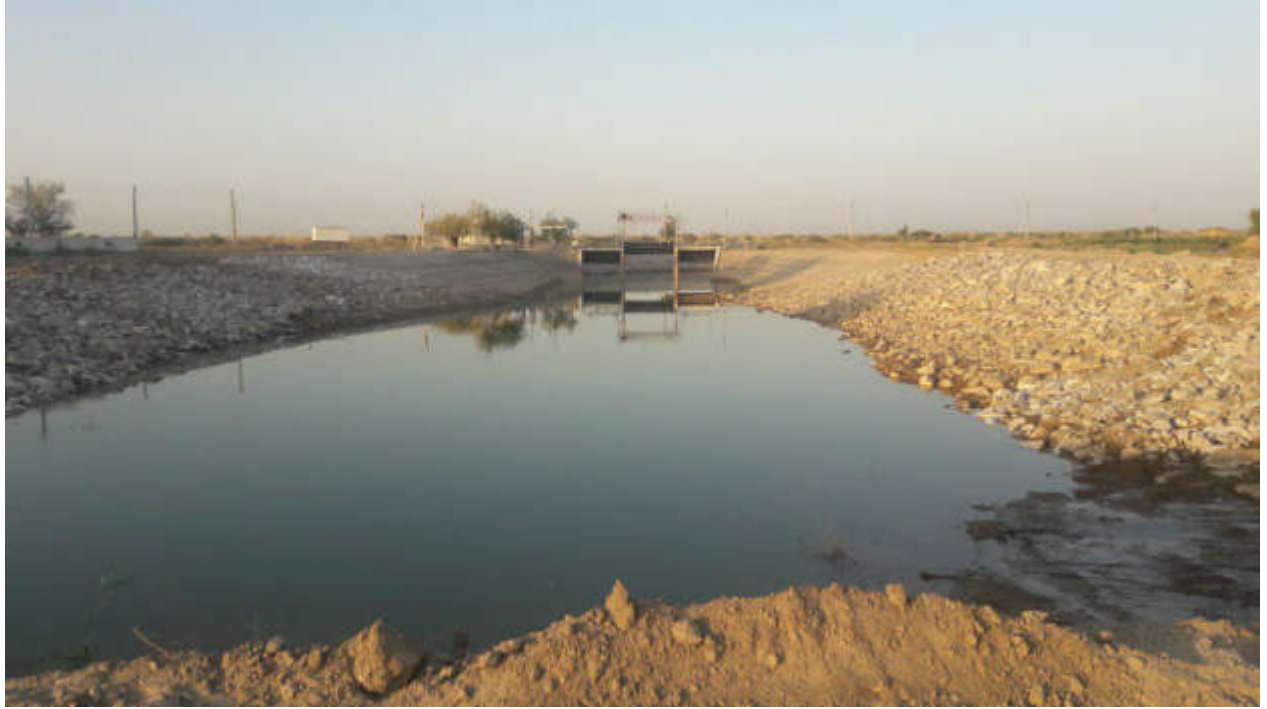
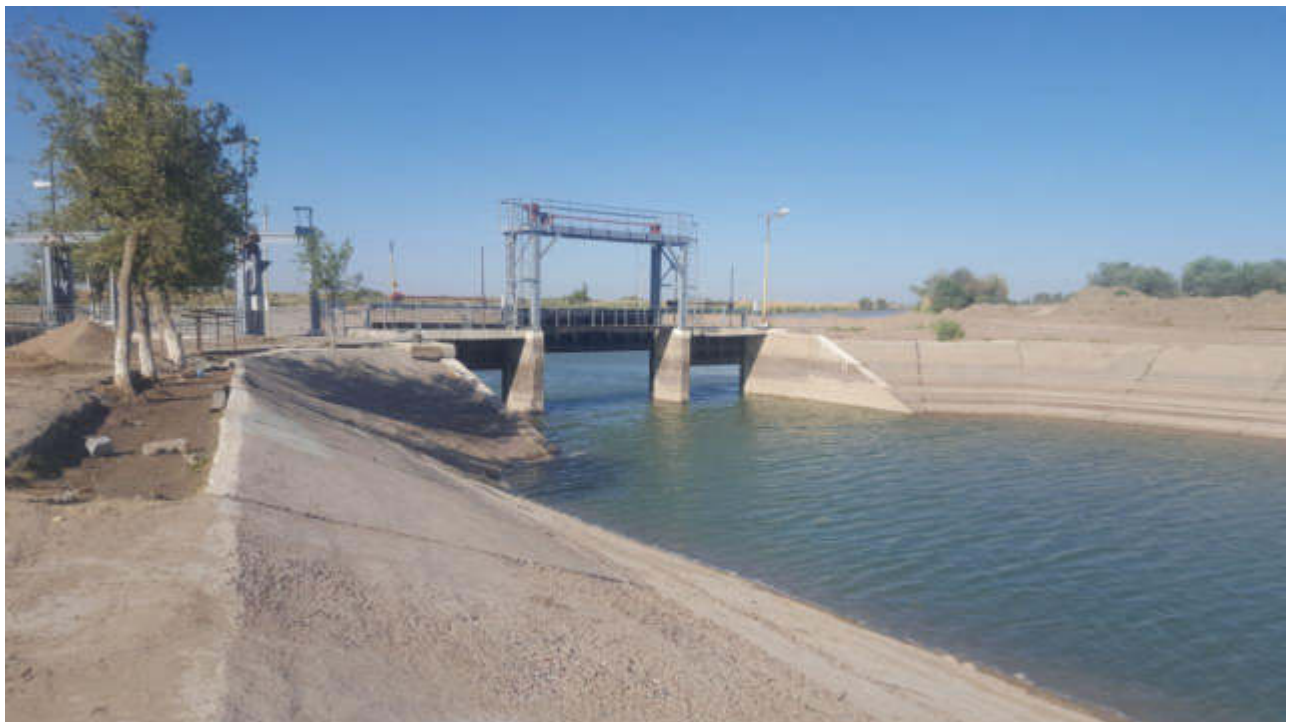
Works on installation of equipment are performed. The primary test is performed. The stone outline along the channel slopes and the bottom of the channel is completed. Water is passed through a new channel channel.

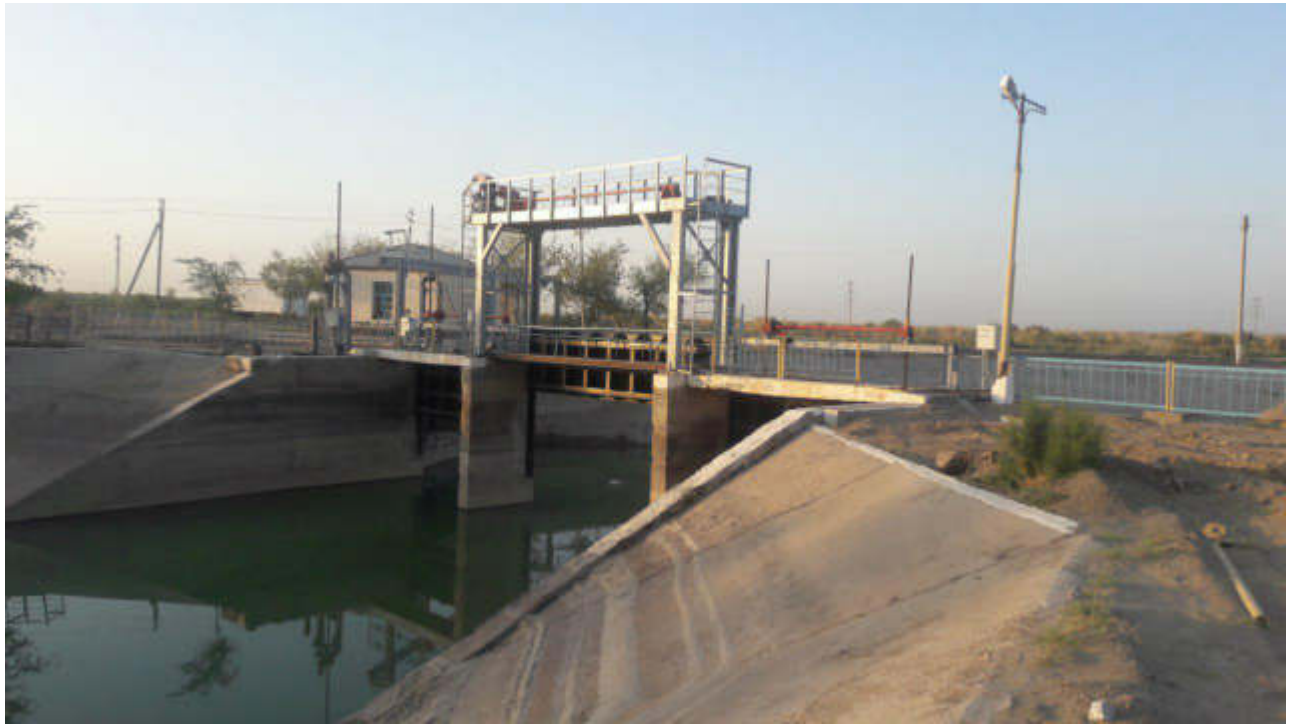
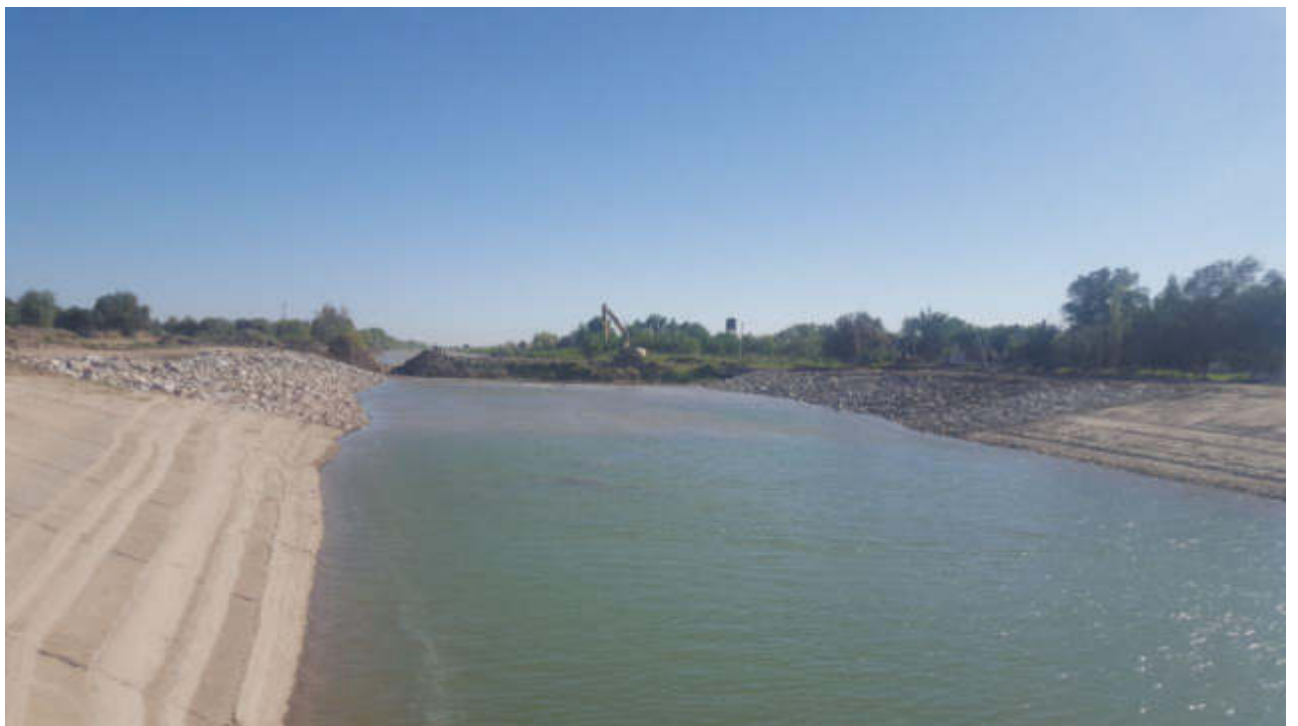
Stone outline along the slopes of the canal and at the bottom of the channel is completed.

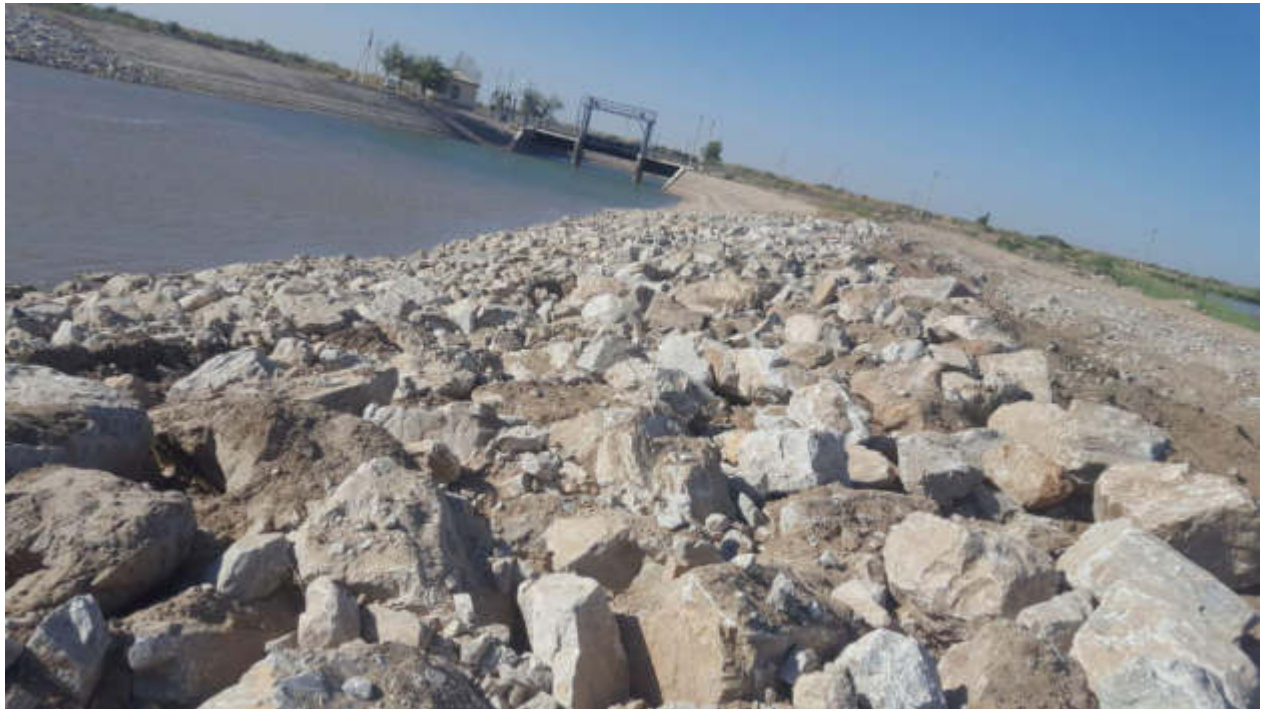
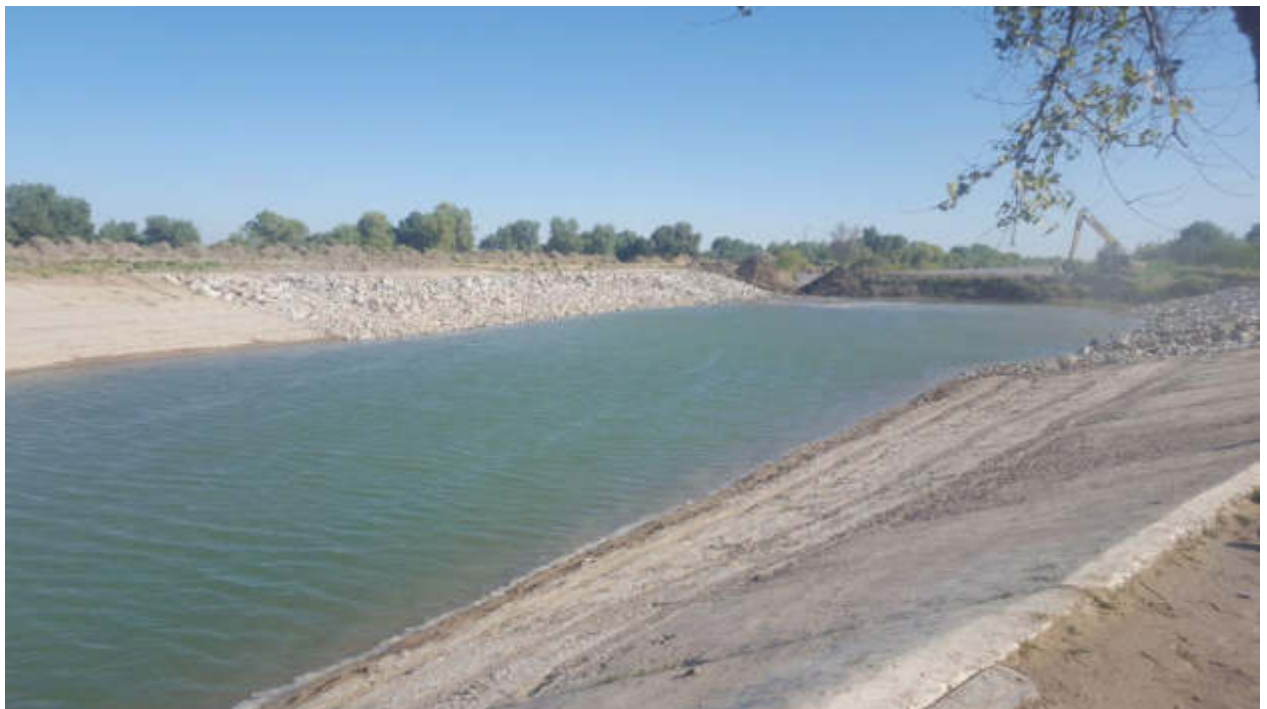
(Disassembly) The jumpers on the upper and lower channels of the channel have been removed.

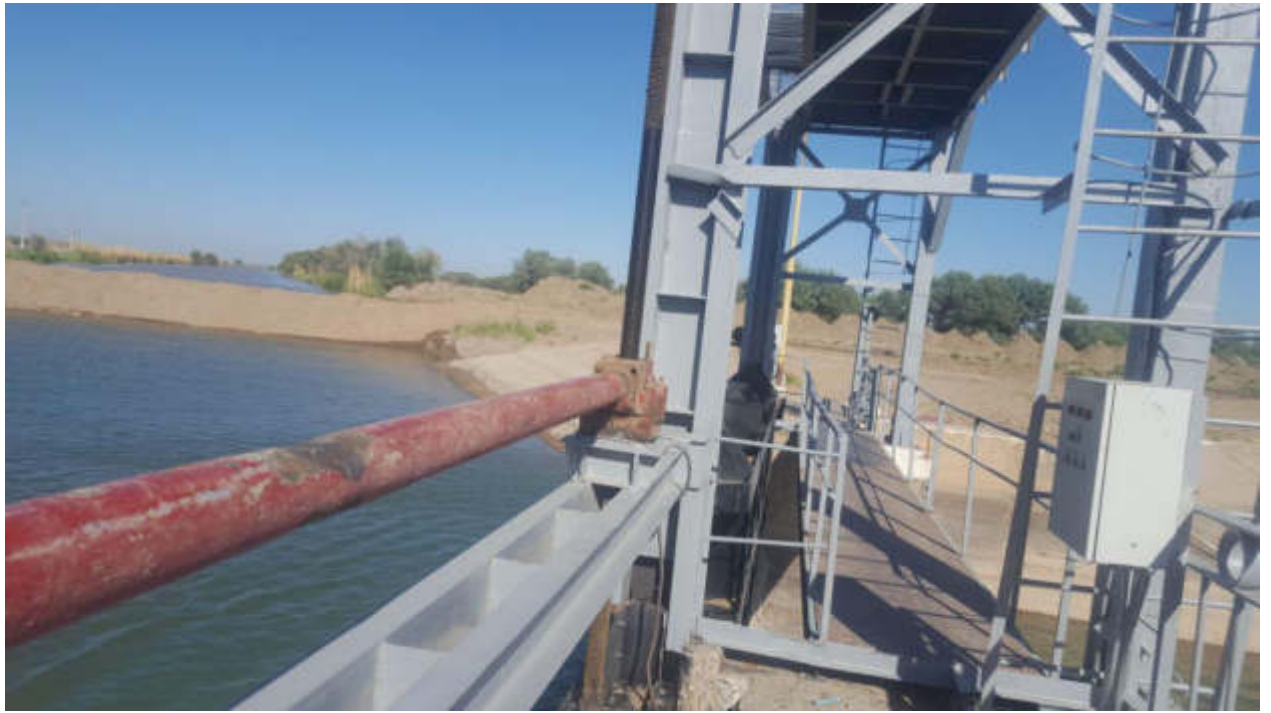
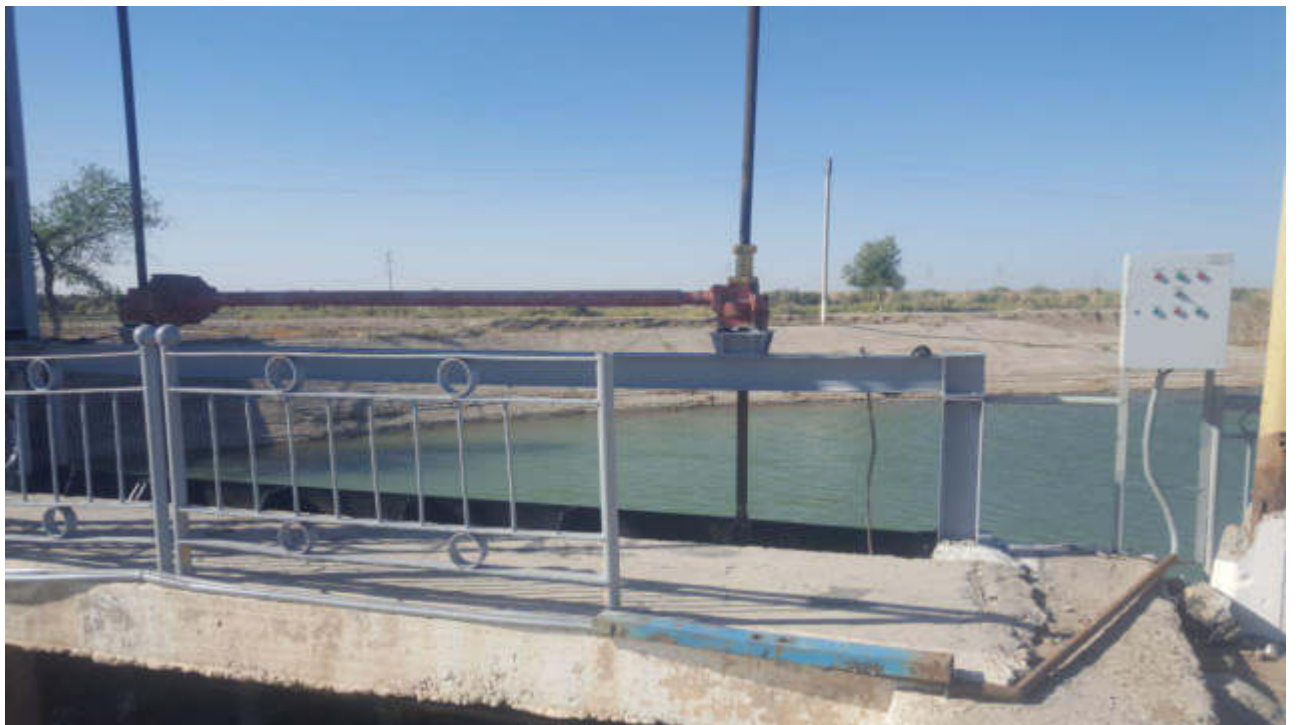
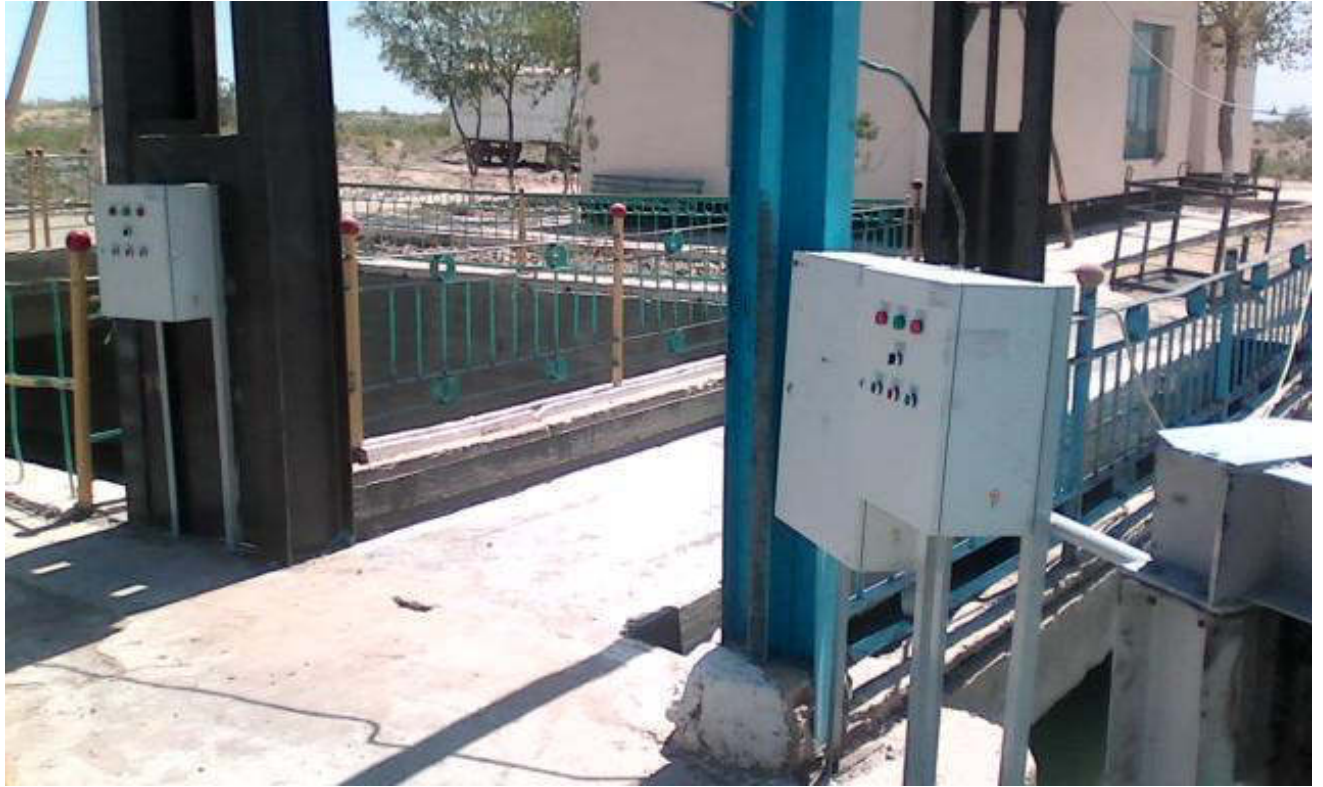
Work is underway on the installation and installation of electrical cable lines and installation of a transformer.

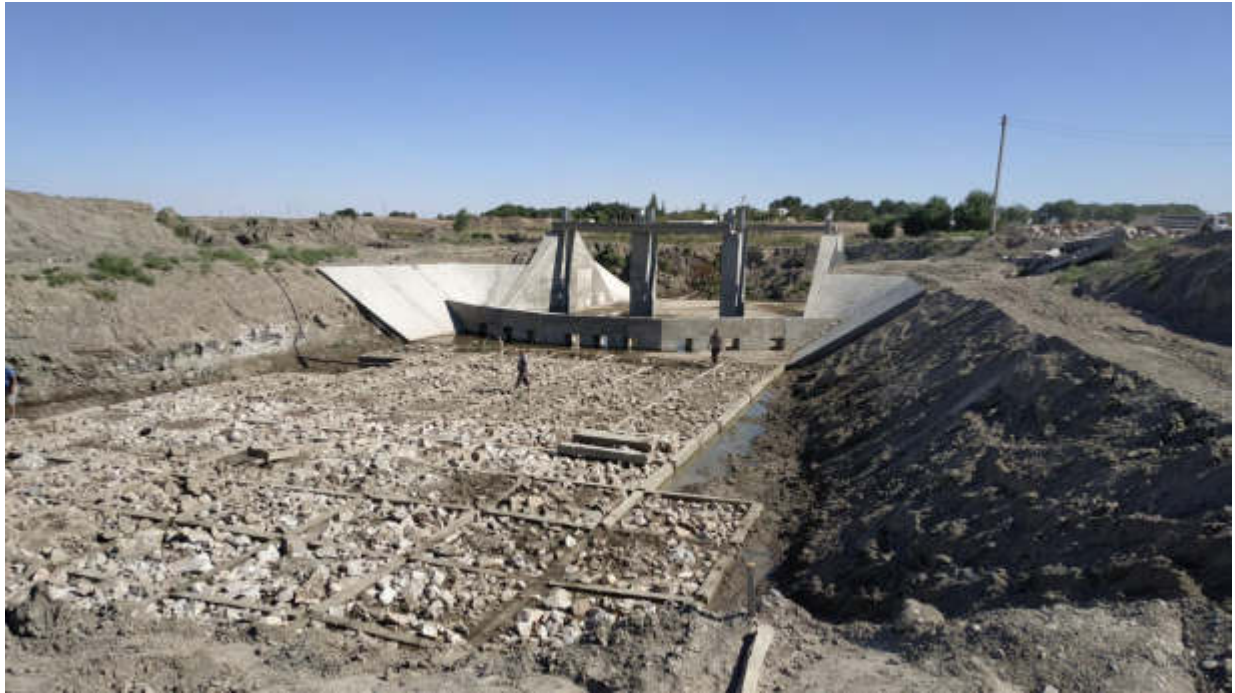
Access roads have been constructed for the transportation of building materials. Electric lines are connected and the channel slopes are being strengthened.

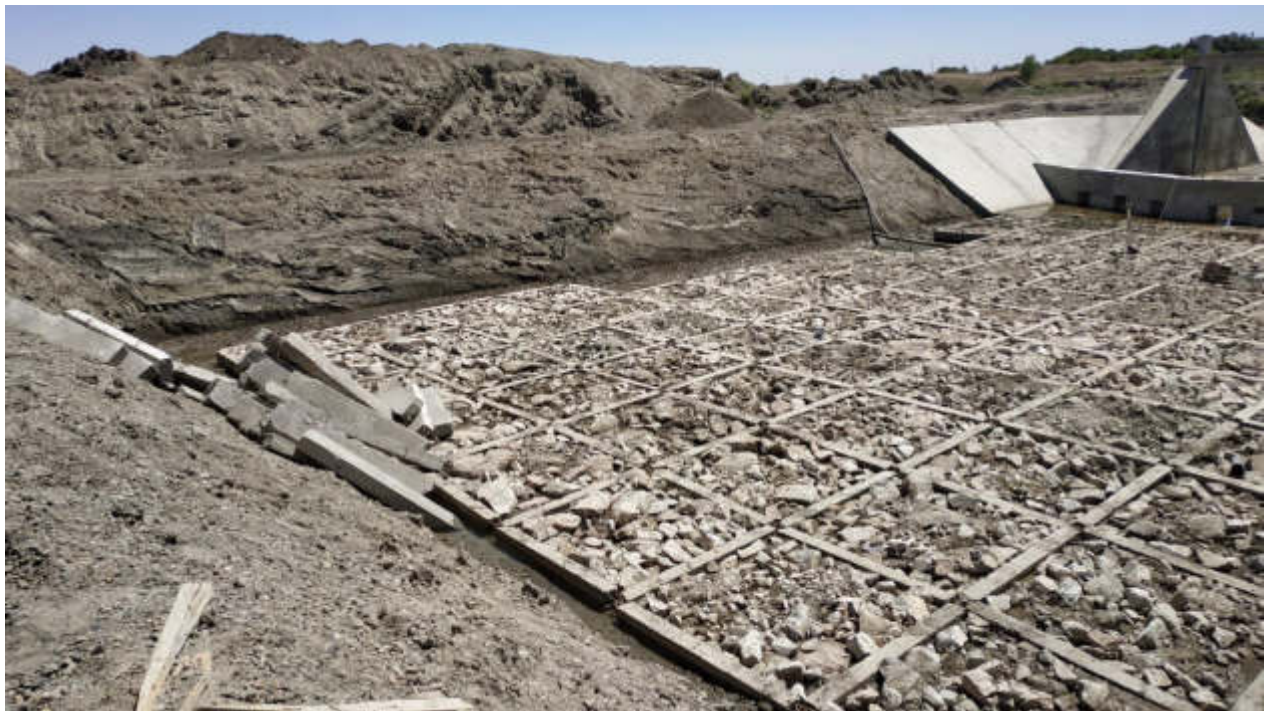
Round-the-clock duty for the subsoil water pumping facility was organized.

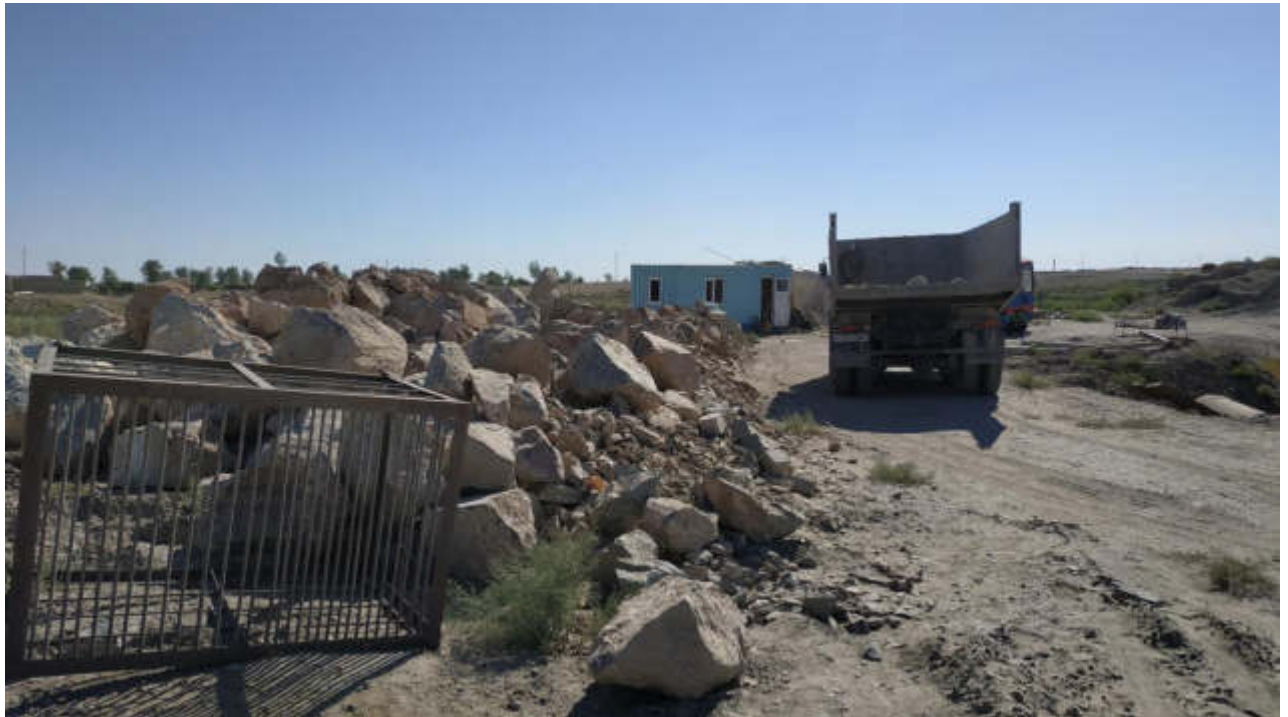
A special place for storage of quartz stone is allocated.

There are open areas for acceptance and storage of incoming materials.

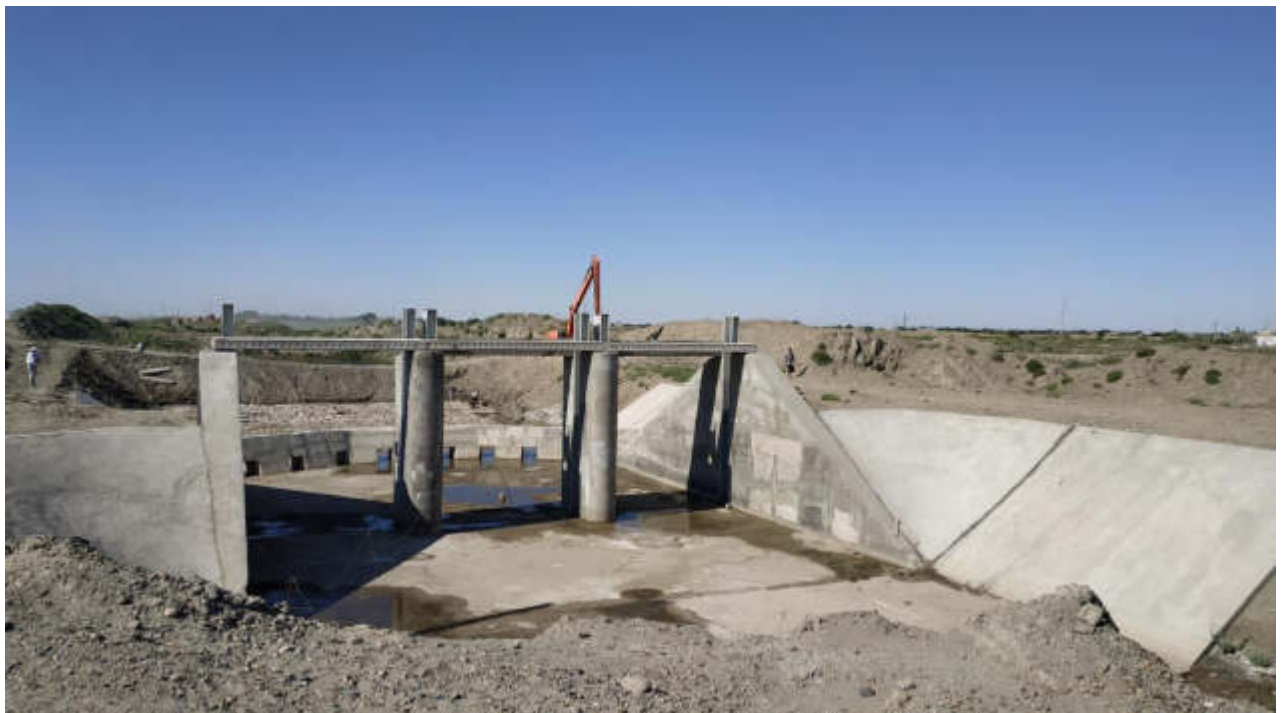
The area for the construction site is clean and leveled. On this site there were no trees and various plantations.

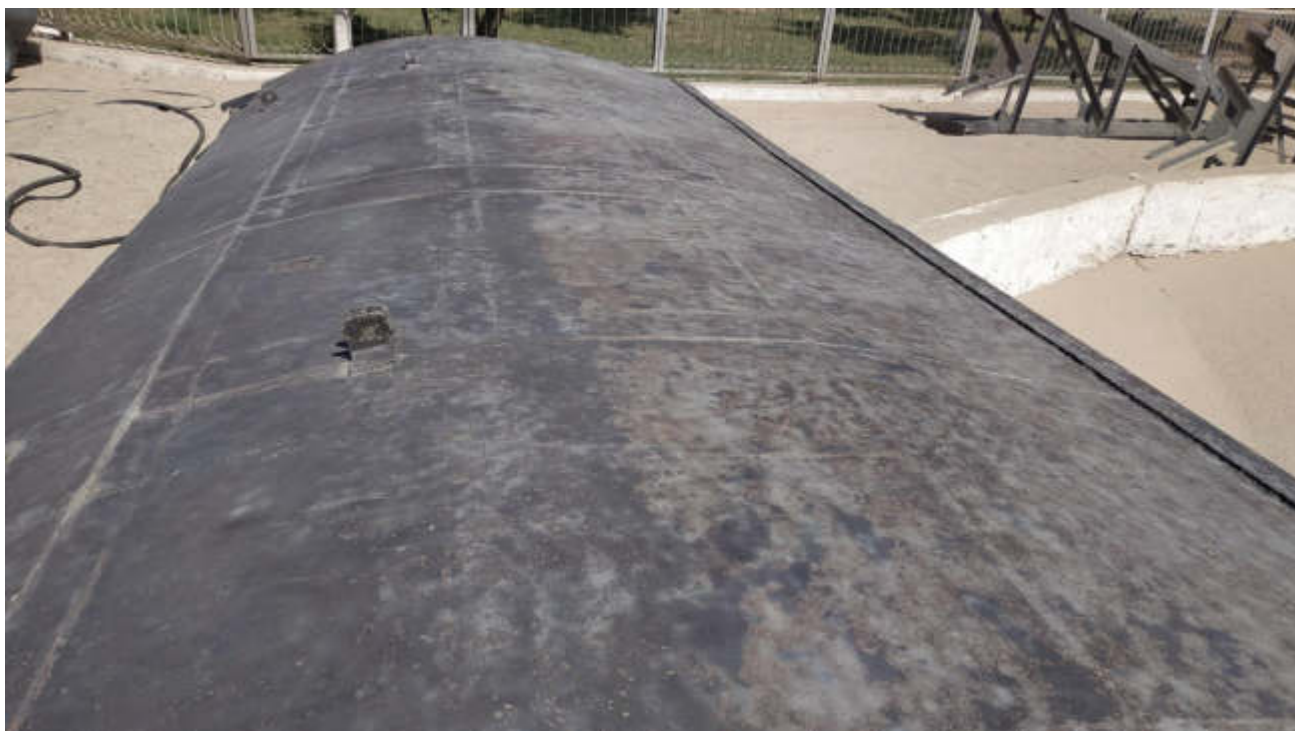
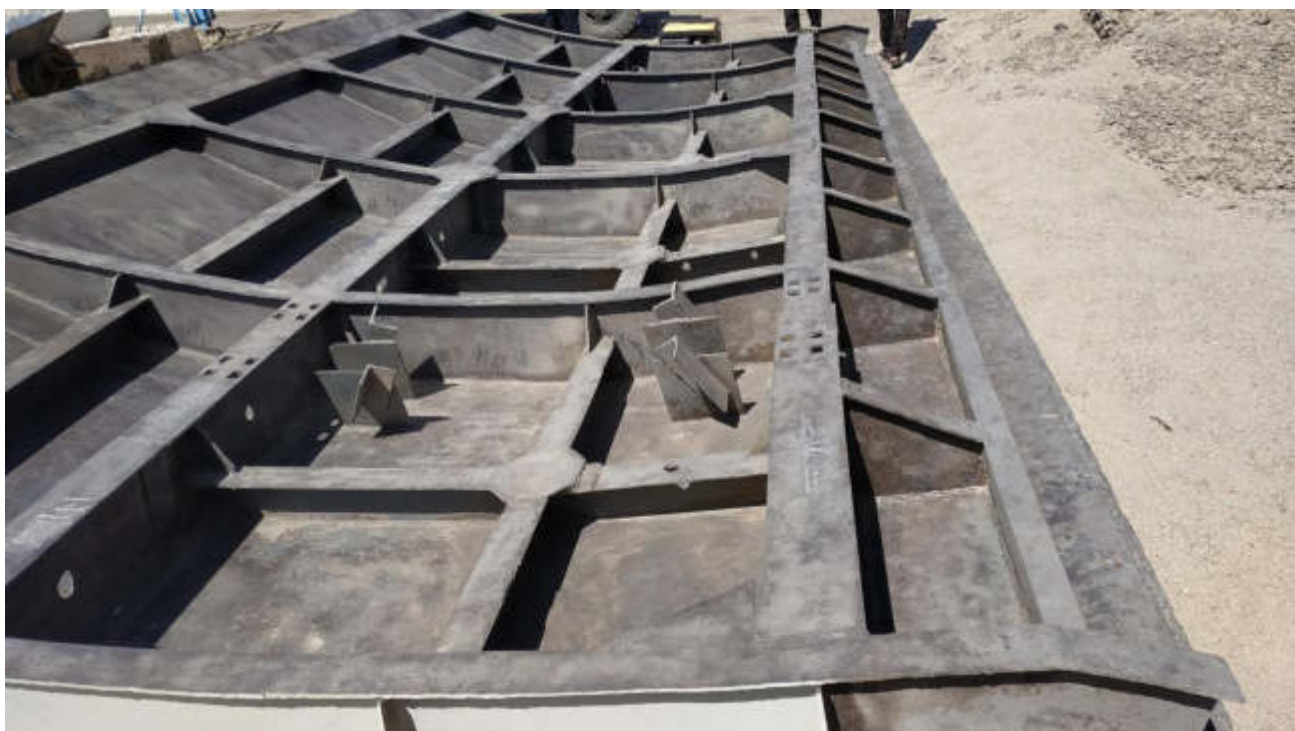
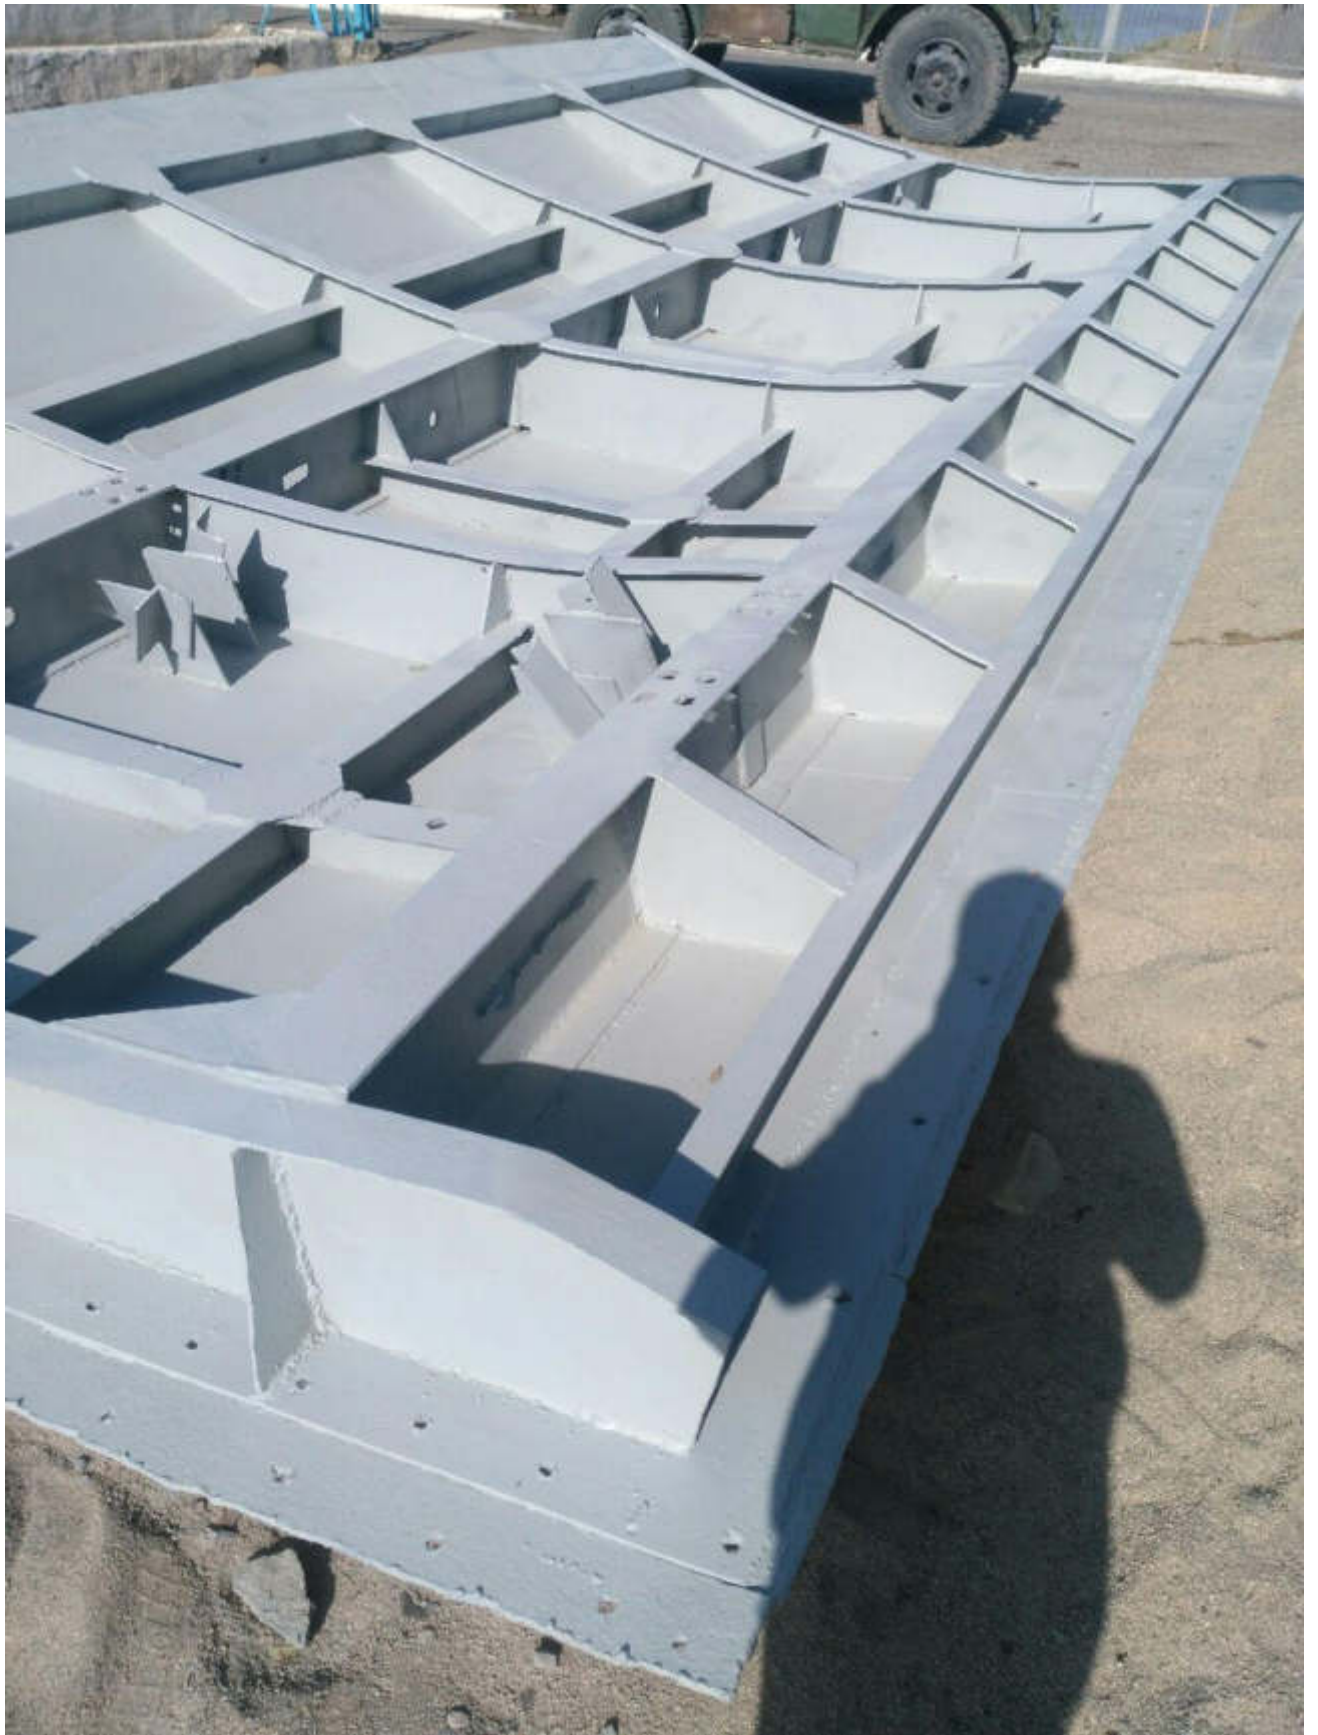
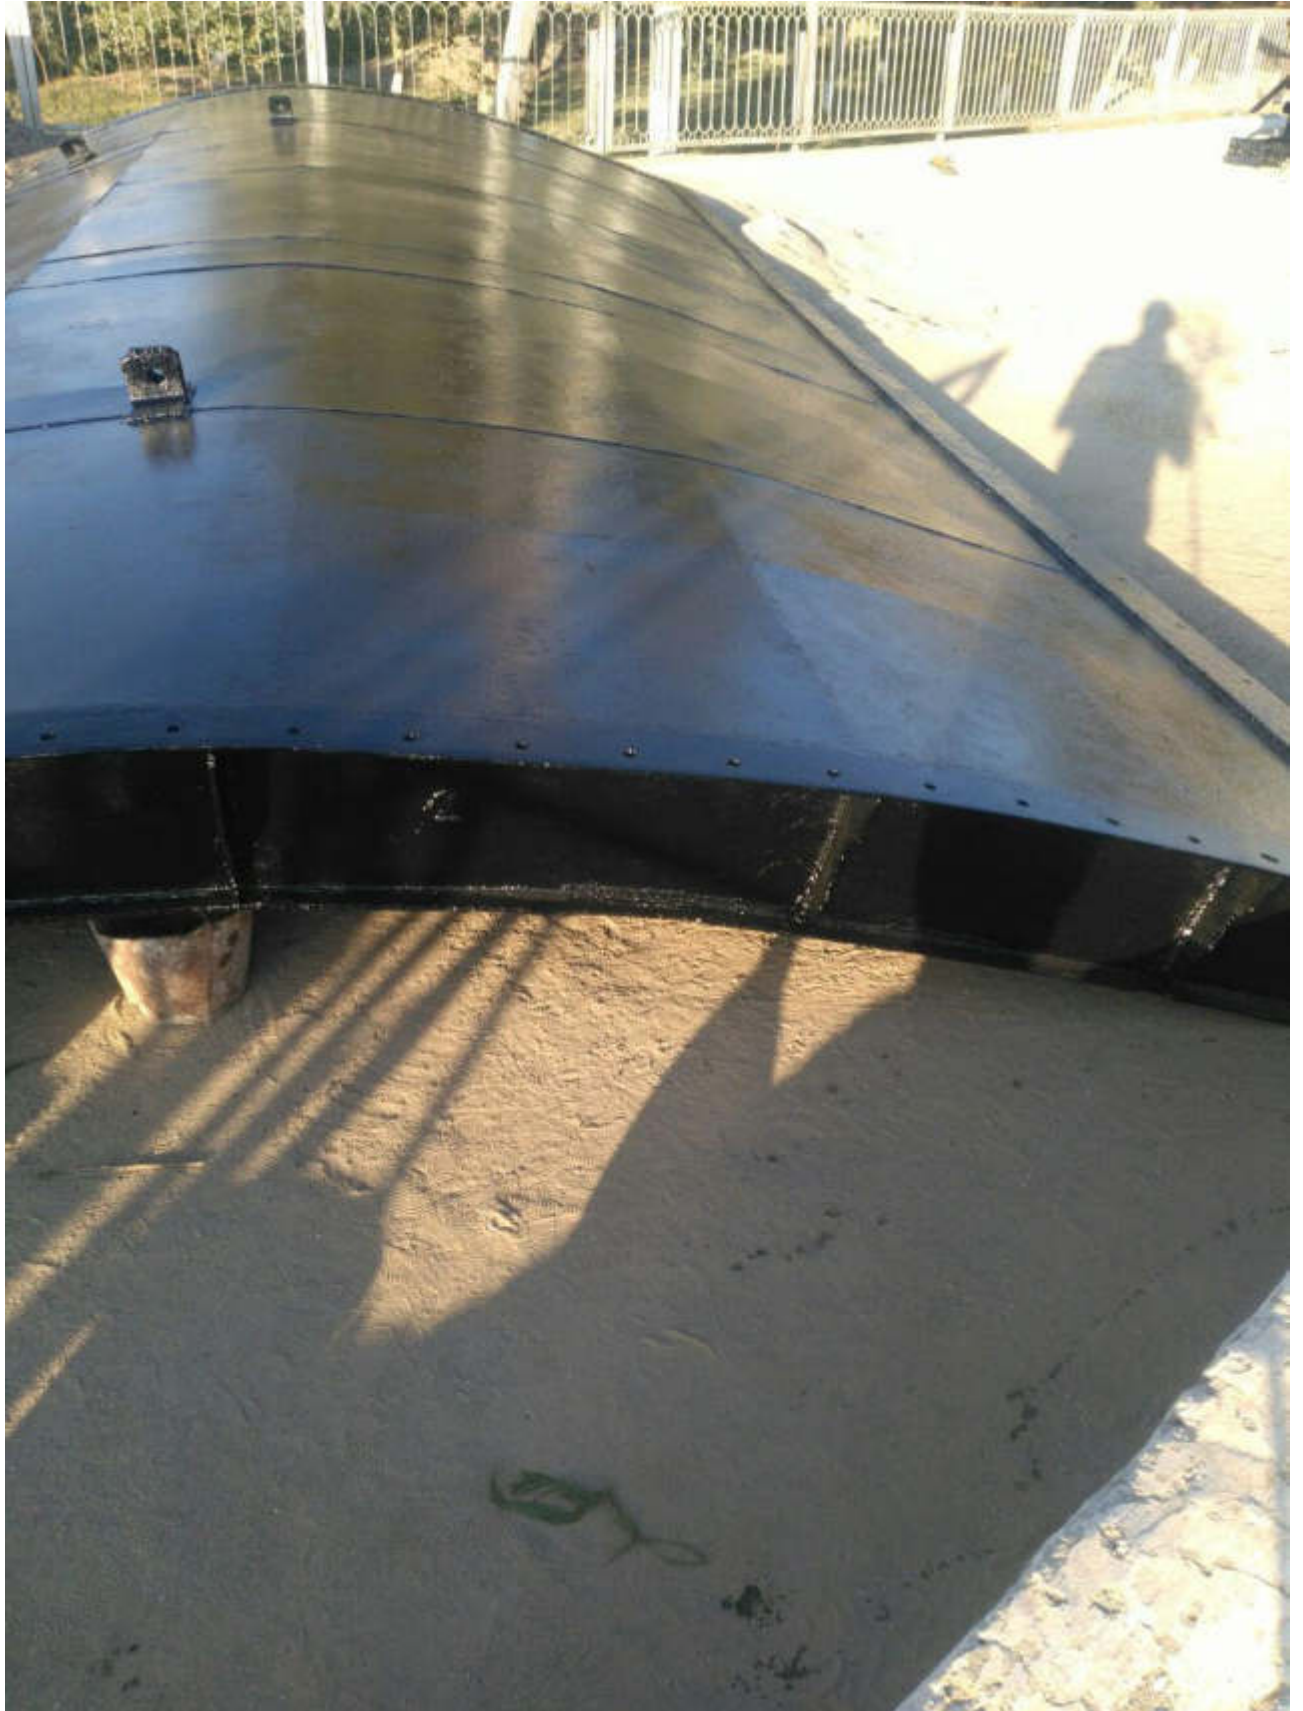
To repair the hydrounit Tashrabad structure Shafirkan, work is underway on sand blasting and painting of the gates. For the installation and repair of the corresponding closures work 5 people, 3 units of equipment. This month 1 item was repaired. gate. In addition, another 5 pcs. The donors were brought to the contractor's base for repair.

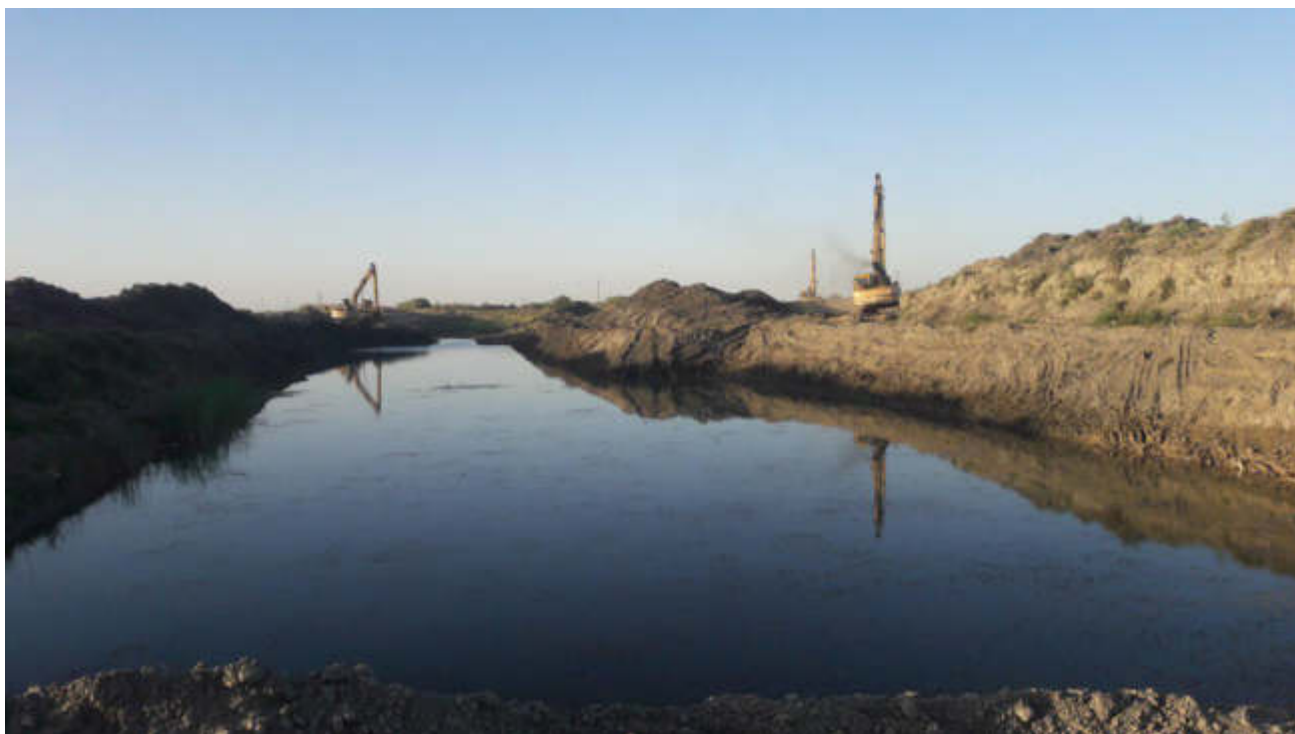
Work is underway to clean the emergency waste channel "Agitma"

Over the course of 500m, work has been developed to clean the channel that has been filled in, to hold it at its original condition and according to the design mark.

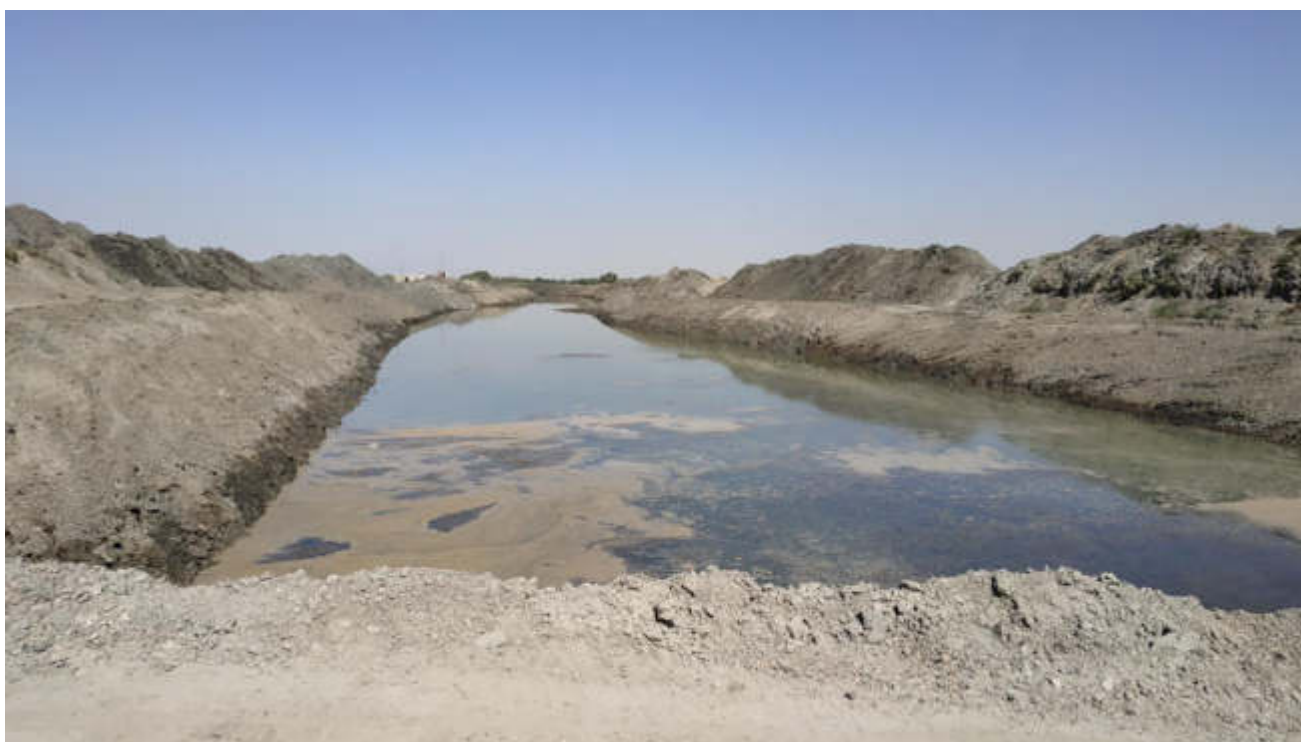
Cleaning and removal of sediment from the supply and discharge channels is planned at a distance of 500m.

The excavation of the developed soil with a bulldozer is regularly conducted and space is allocated for placement.
