Environmental Monitoring Report

Project number: 44458–013

Period covered: July–December 2018

UZB: Amu Bukhara Irrigation System Rehabilitation Project

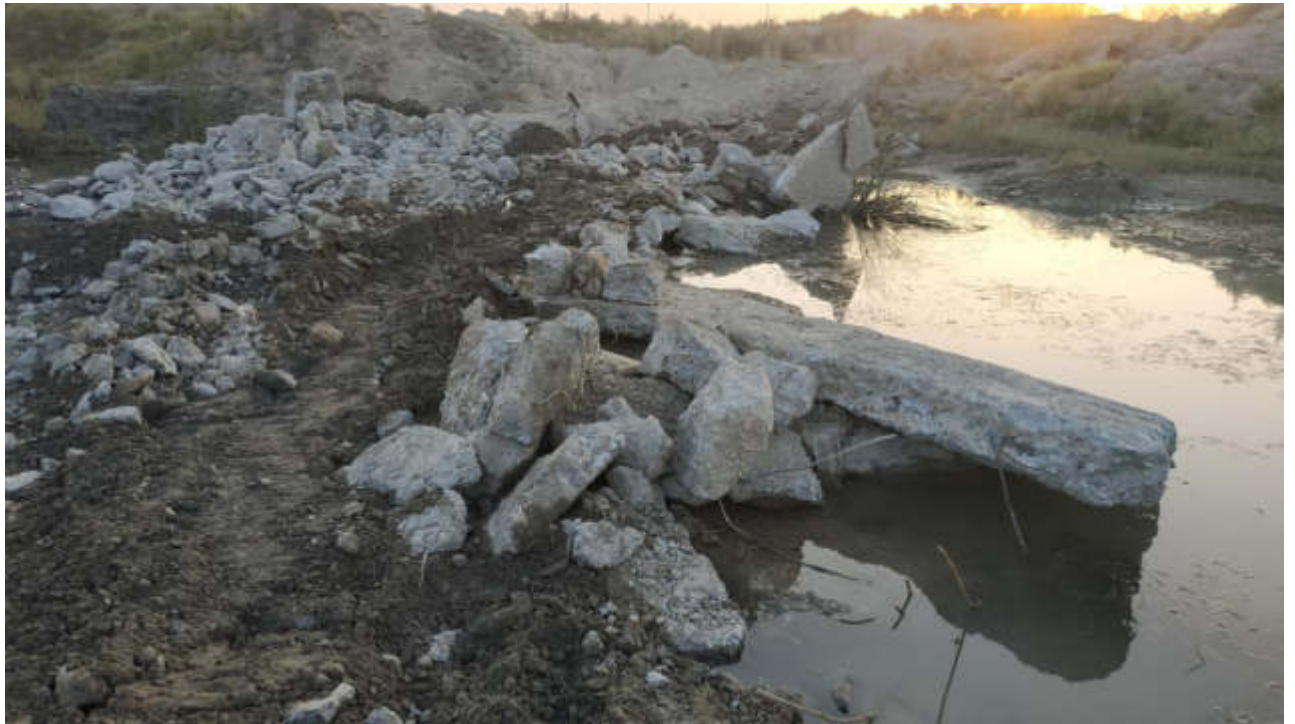
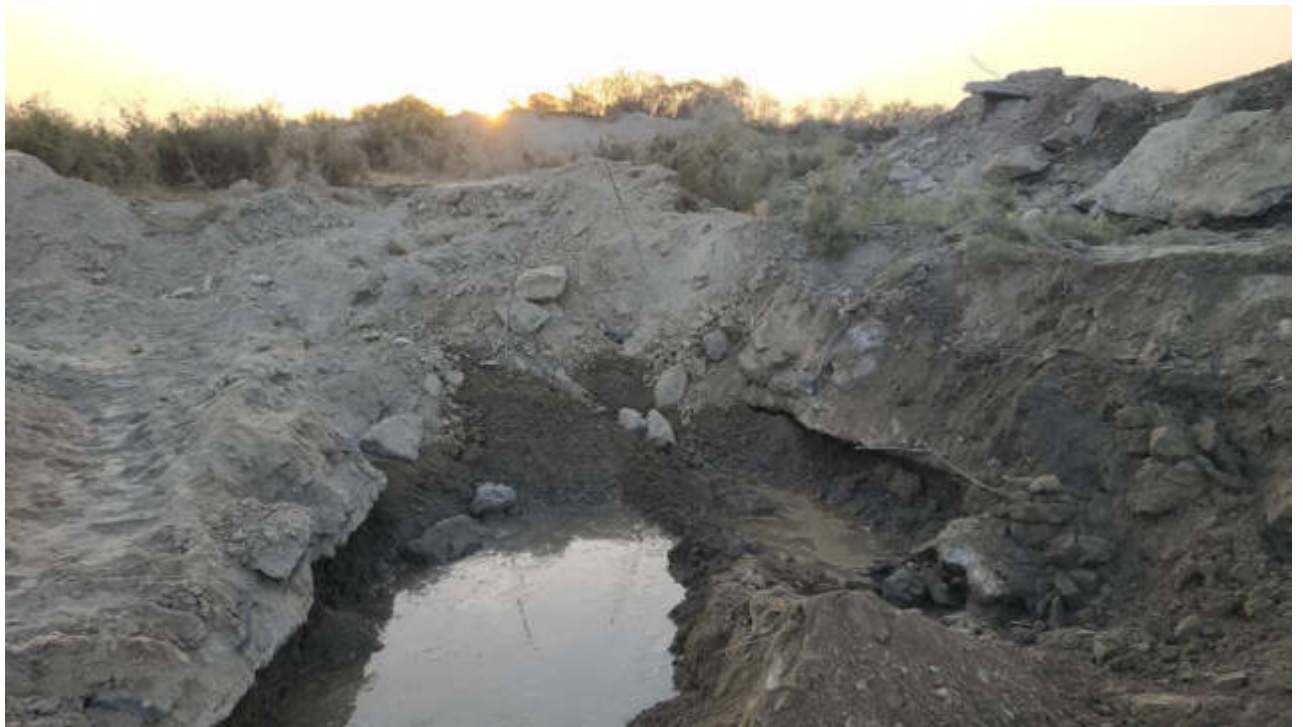
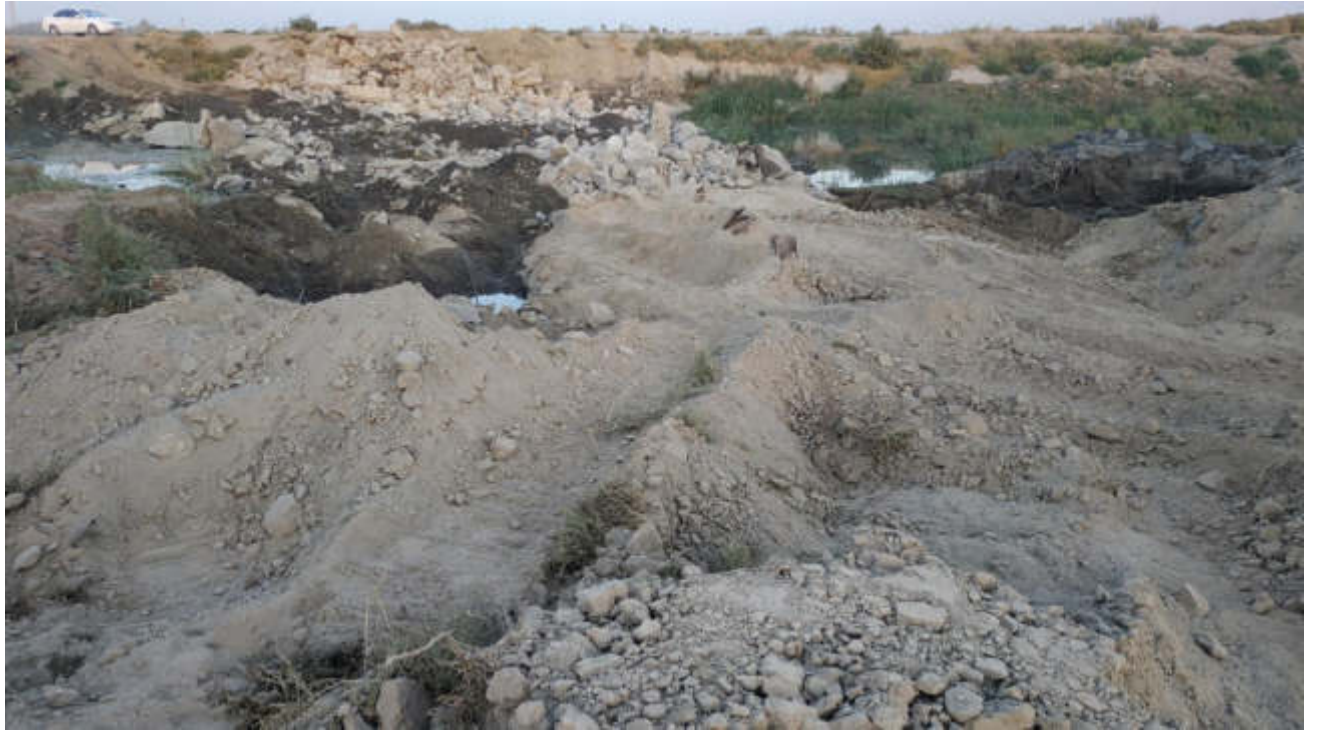
Removed the existing concrete threshold by the method of hydraulic splitting of rocks.

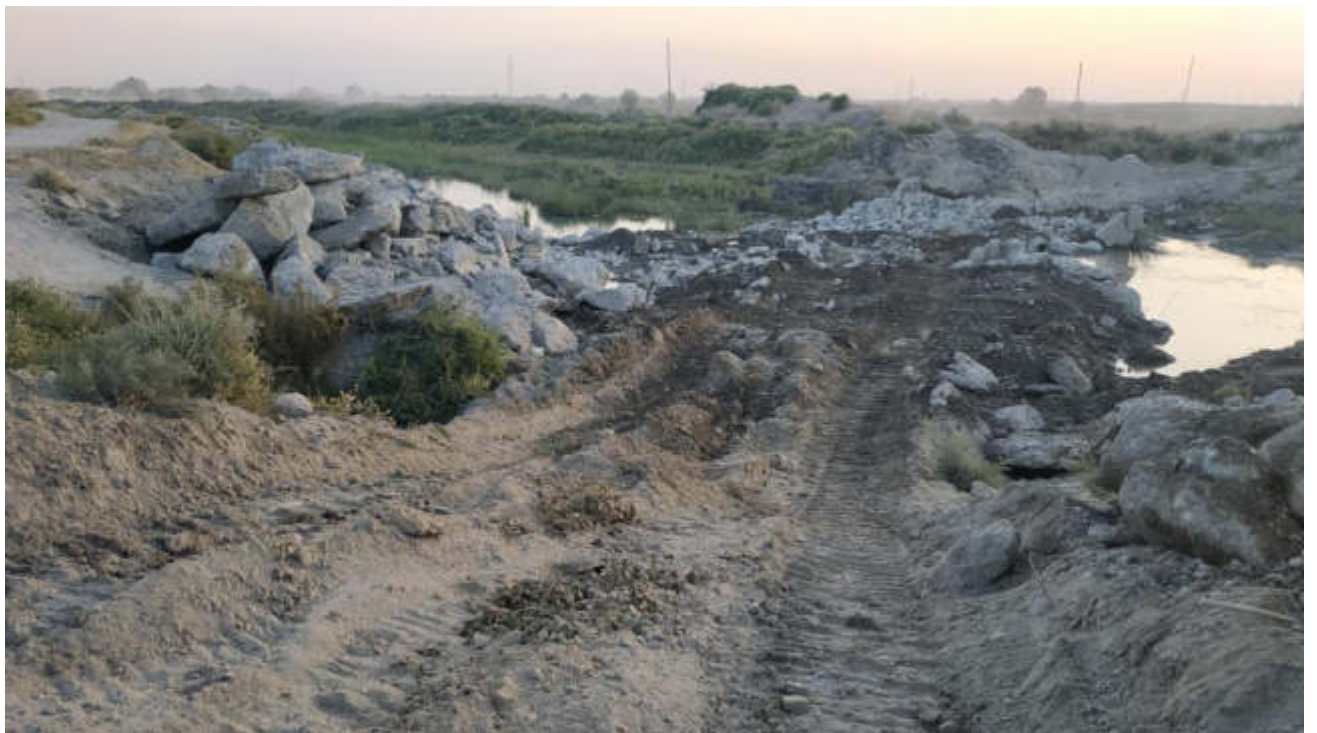
Organized sites for unloading building materials, concrete products.

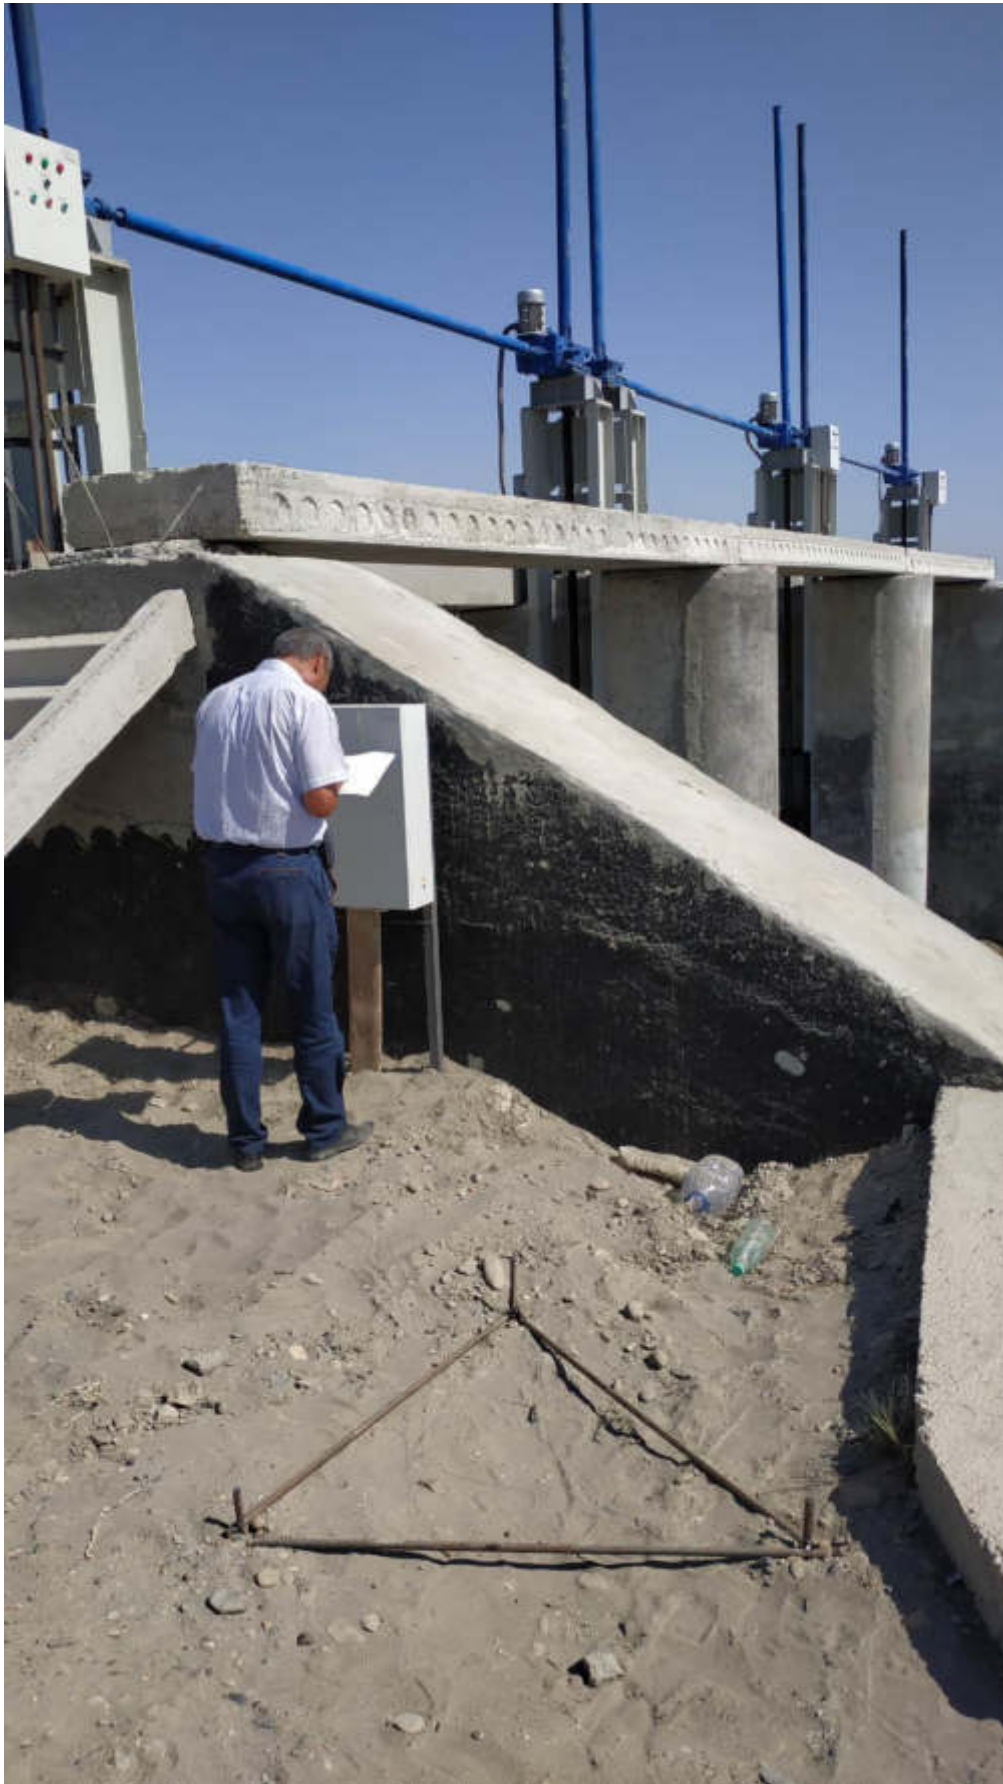
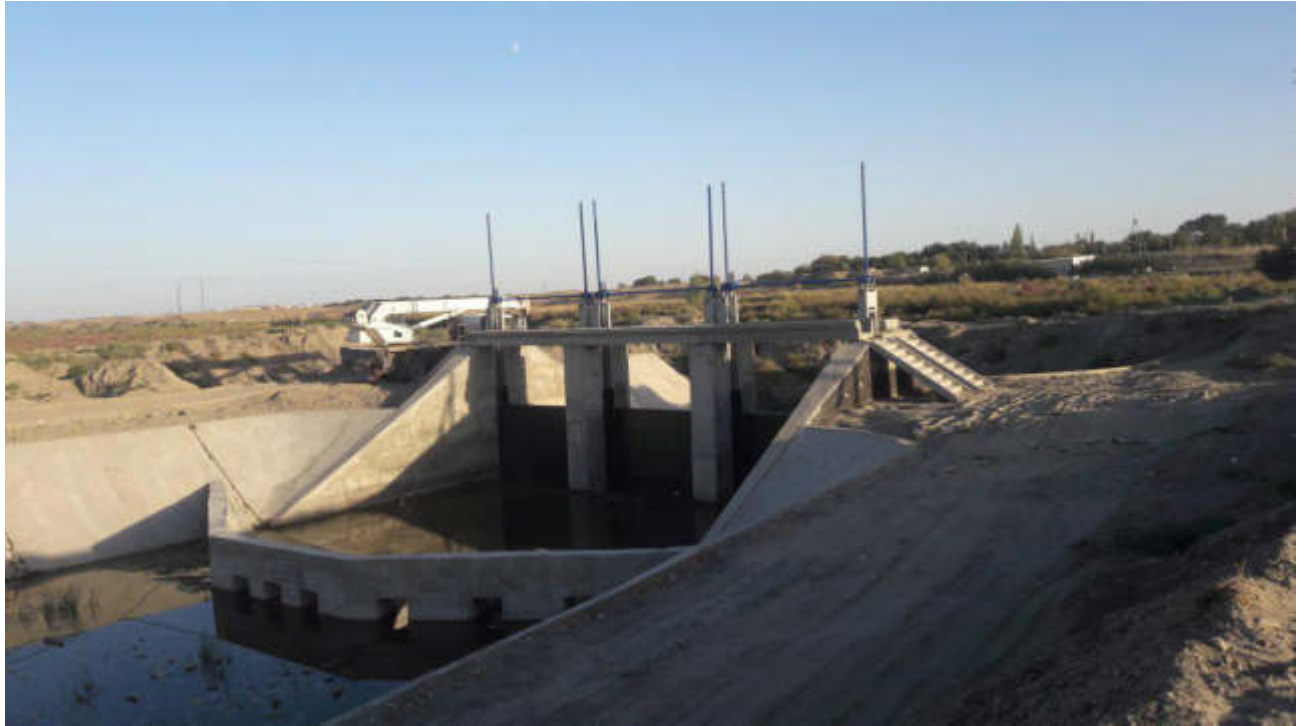
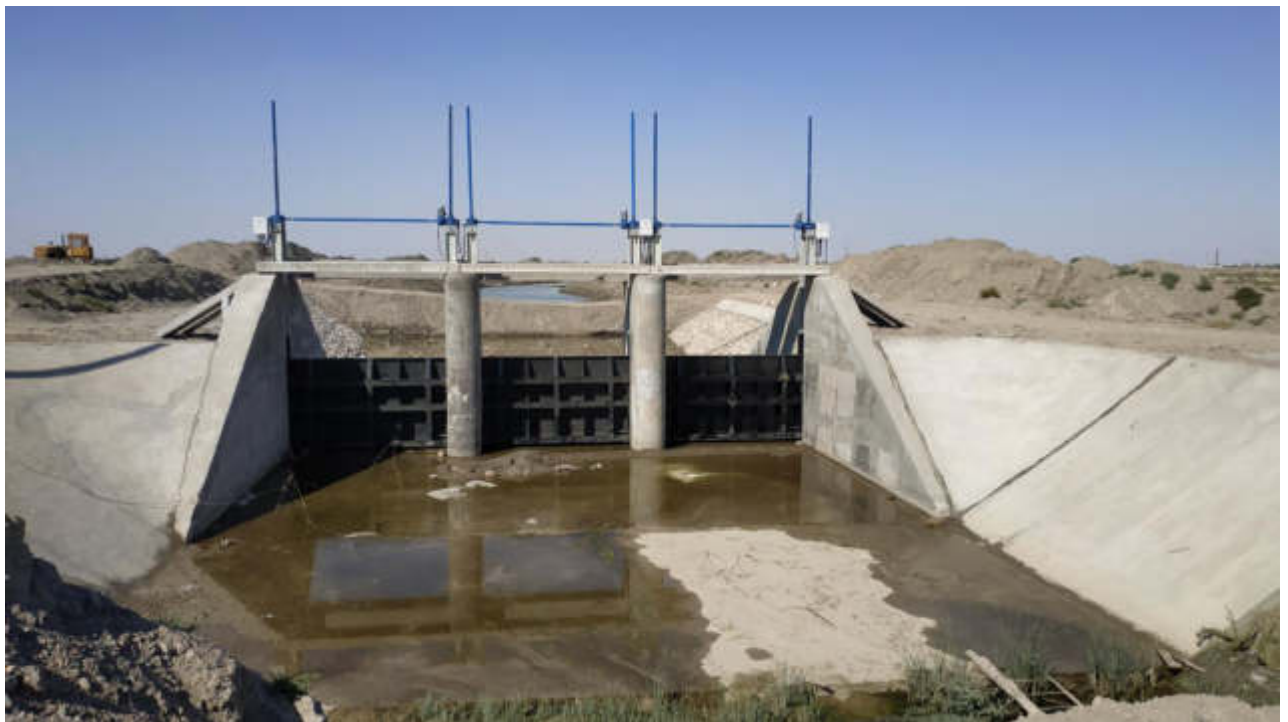
B In the current month, installation of ladders, cable channels, plates, gates, lifts and electrical equipment was carried out at the “Agitma” facility.

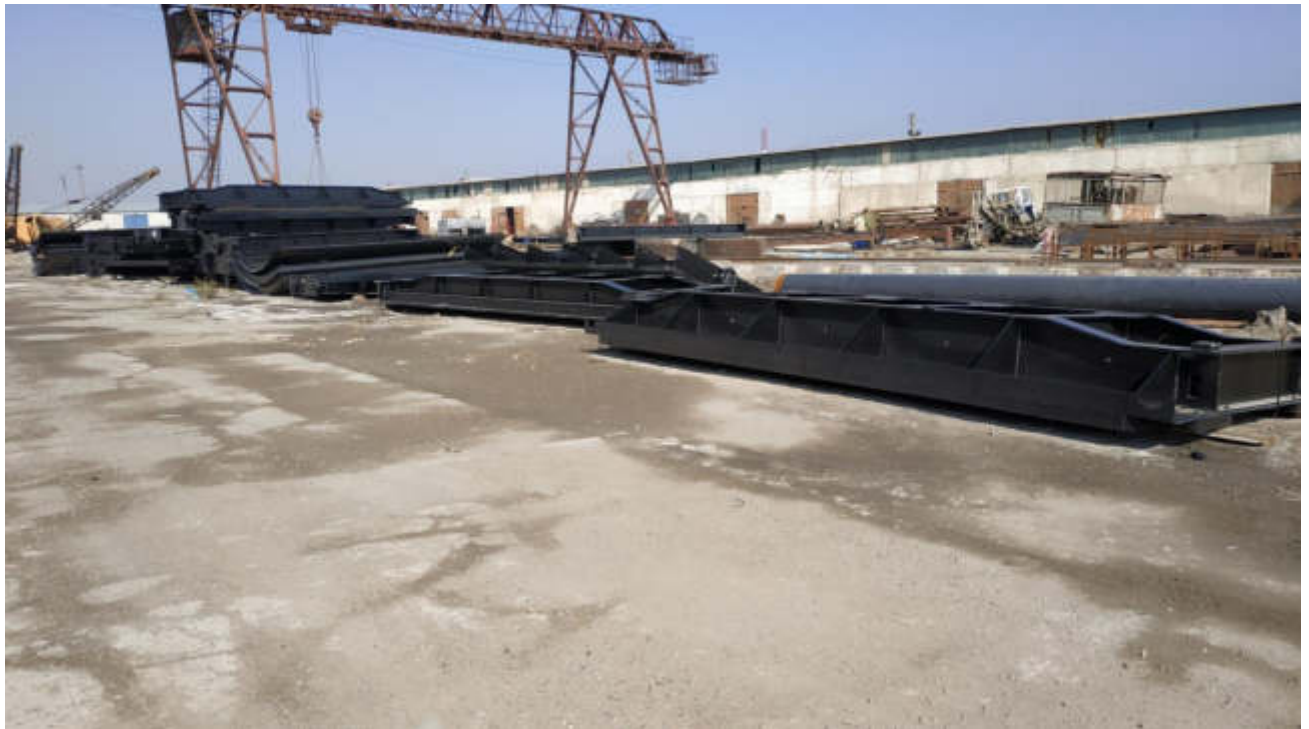
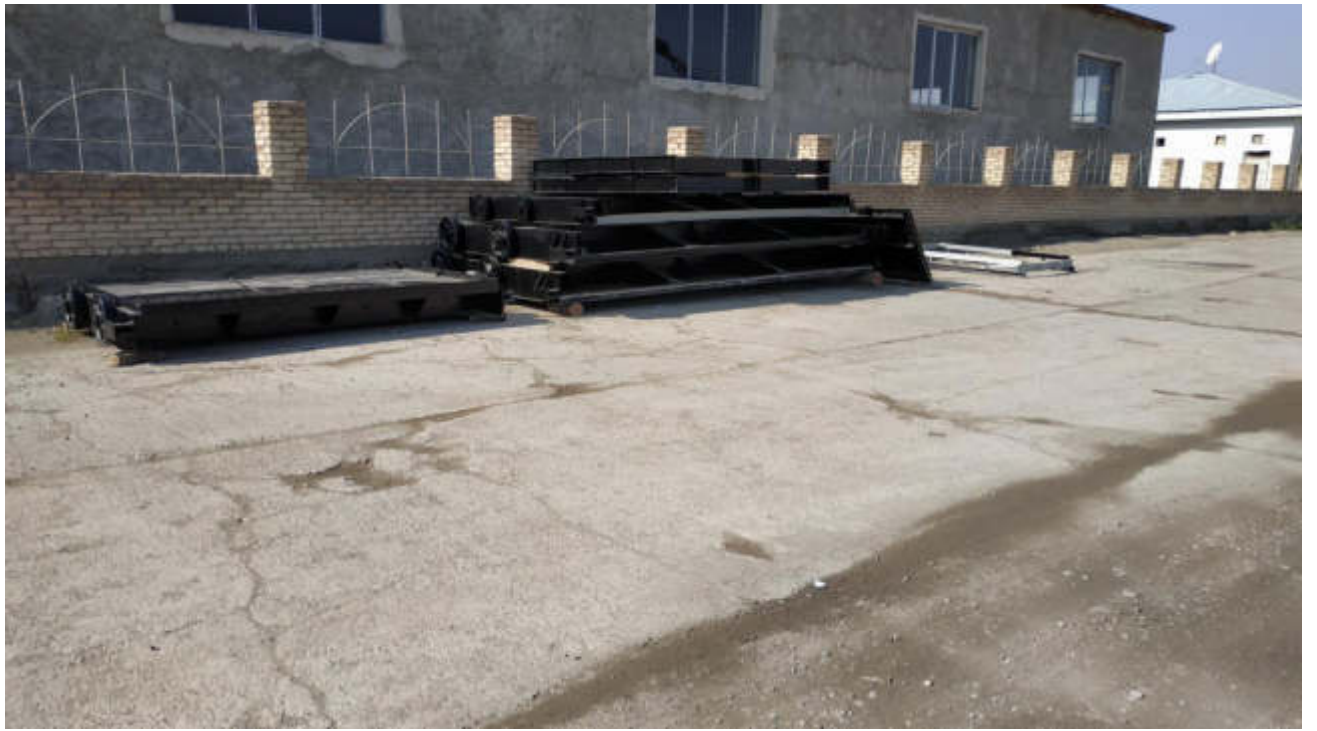
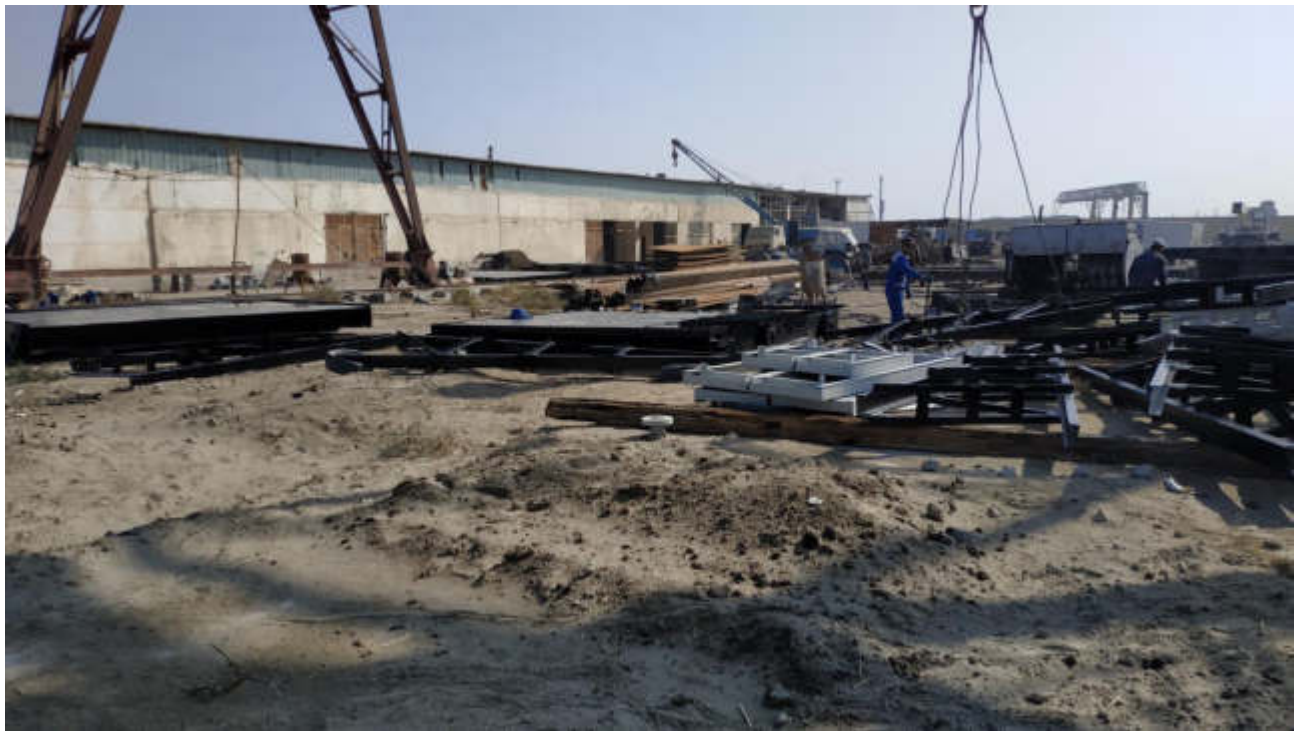
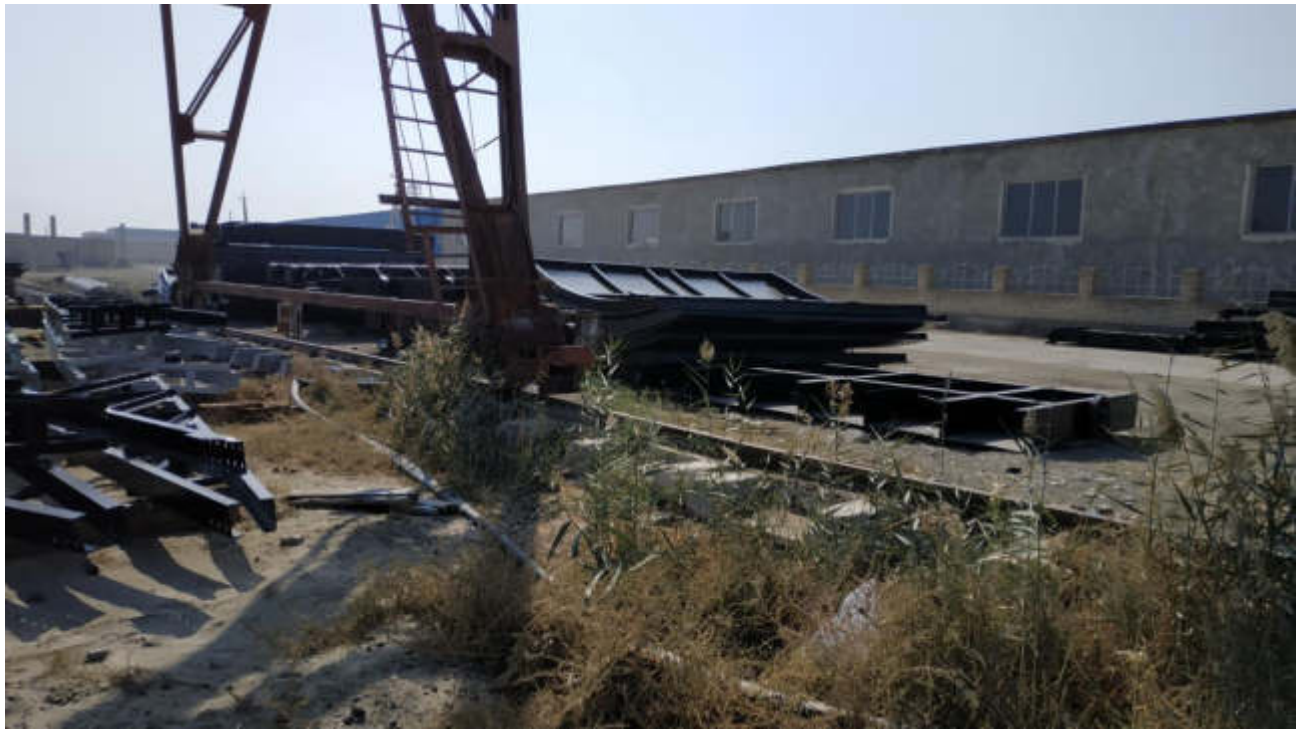
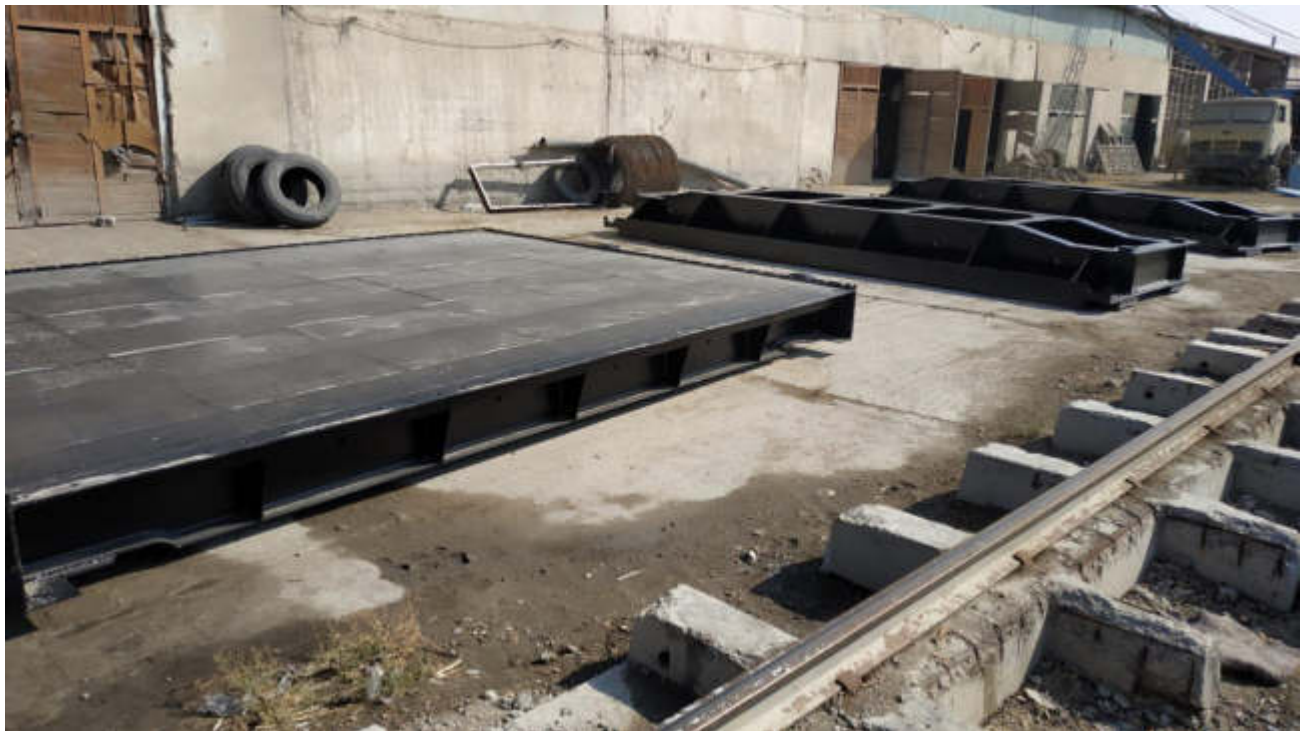
In addition, the contractor created its own paint crew at the base consisting of 10 employees, and the relevant team performed sandblasting, priming and painting the shutters delivered to the contractor's warehouse.
