Environmental Monitoring Report

Semestral Report: July – December 2020
June 2021

Uzbekistan: Amu Bukhara Irrigation System Rehabilitation Project

Reporting period: July – December 2020

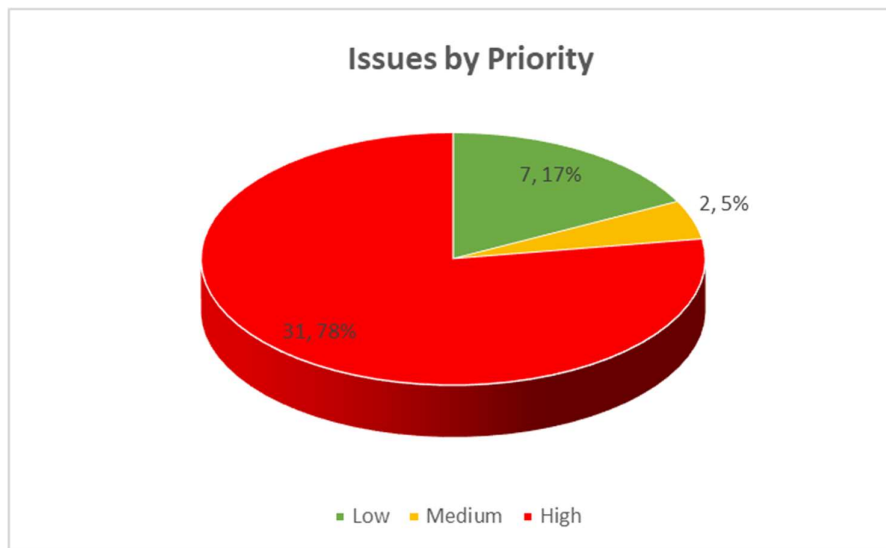
Figure 3-1: Summary of Issues by Priority

53. Figure 3-1 and non-conformance level at the Figure 3-2.

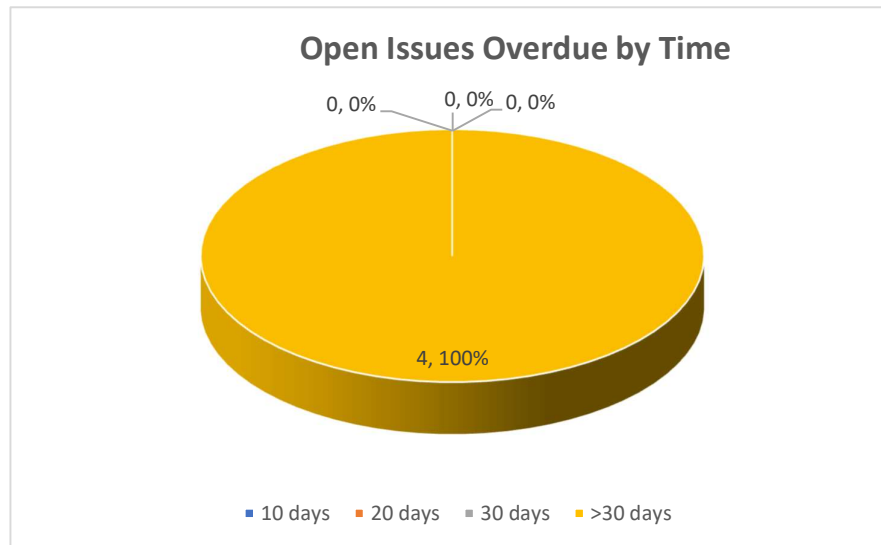
Figure 3-3: Open Issues Overdue by Time

54. Duration to close any issue takes approximately 5.2 months. The distribution of days required to close any issue has been shown in Figure 3-3.

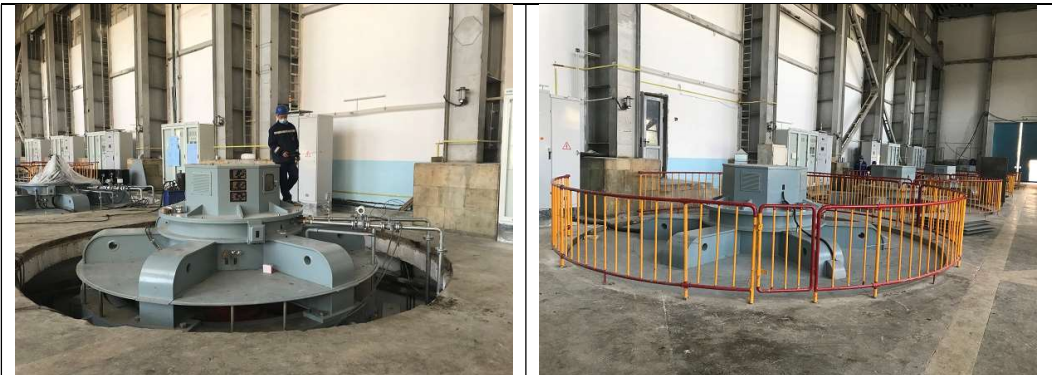
Kuyumazar Pumping Station Pumping and Electrical Installations

77. Within the scope of the Modernization and Rehabilitation of Kuyu Mazar Pump Station (ABISRP 03.1) the dismantling of old electrical equipment was carried out in July 2020. During the dismantling relevant nation authority has supervised the dismantling of the old electrical equipment. The staff who is responsible in the pump station took over the dismantled electrical equipment, and kept them in the warehouse of regional department of Amu Bukhara main canal system.

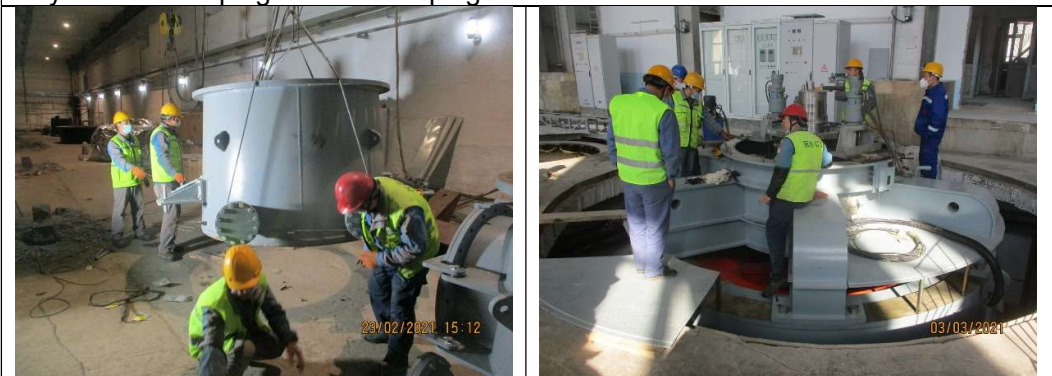
Kiziltepa Pumping Station Pumping and Electrical Installations

78. Within the scope of the Modernization and Rehabilitation of Kizil Tepa Pump Station (ABISRP 03.2) the dismantling of old electrical equipment was carried out in September 2020. During the dismantling relevant nation authority has supervised the dismantling of the old electrical equipment. The staff who is responsible in the pump station took over the dismantled electrical equipment, and kept them in the warehouse of regional department of Amu Bukhara main canal system.

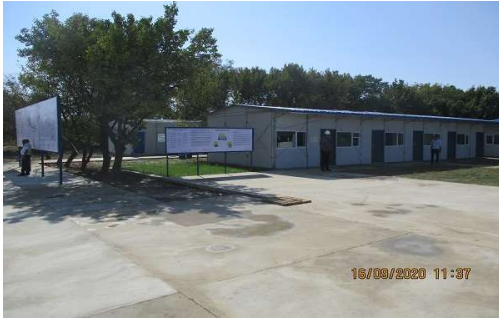
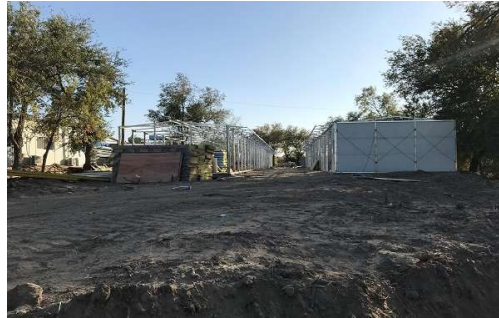
Construction of Working Camps

65. The Contractor of Construction of Amu Bukhara 1 NEW Pump Station (ABISRP 01) is constructing the working camp area with septic tanks and toilet facilities. Temporary toilets exist in the field.
66. The toilet facilities for Contract ABISRP 02 exist in the Prokor regulator area. But their conditions are poor. Since the number of workers are less in number, the wastewater produced during the daily activities have been directly filtered to the ground. The contamination risk of these effluents to the canals are low.
67. Closed septic tanks exist both for Kuyu Mazar Pump Station (ABISRP 03.1) and Modernization and Rehabilitation of Kizil Tepa Pump Station (ABISRP 03.2) camp sites. The collected sewage has been transferred by septic tank trucks to disposal site. In the working field workers use toilets located at the existing pump stations.

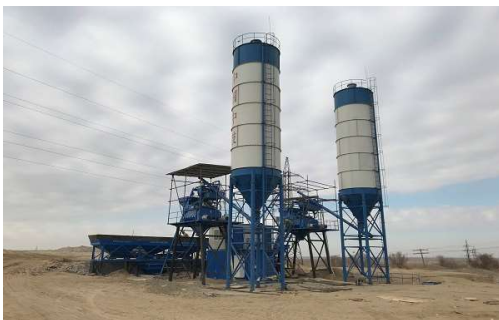
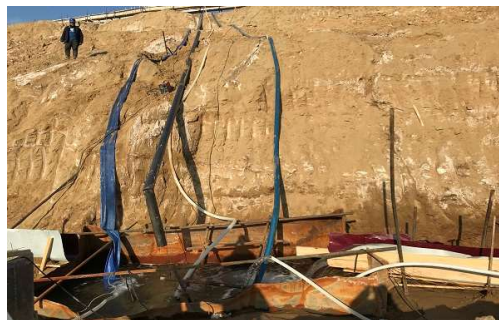
Concrete Plant and dewatering works

<p>Construction of Amu Bukhara 1 NEW Pump Station (ABISRP 01) Dewatering works</p>	<p>Amu Bukhara Main Canal Regulating Structure (ABISRP 02) Construction Works at Peresechenie Regulator</p>

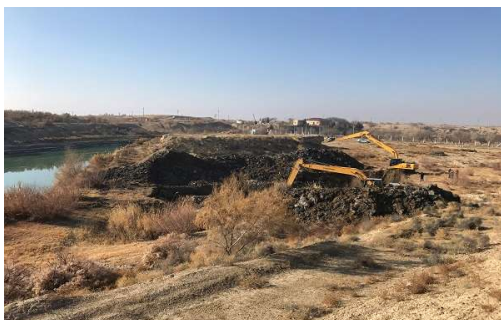
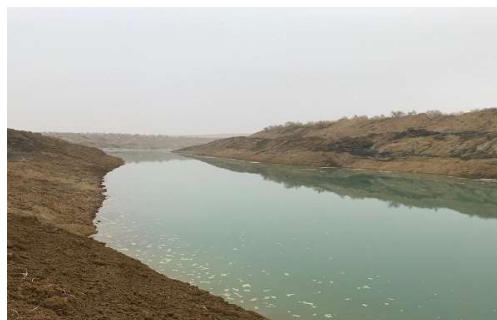
Construction Works at Prokor Area

40. Environmental progress of the Modernization and Rehabilitation of Amu Bukhara Main Canal Regulating Structure (ABISRP 02) Contractor considered to be minor. See performance evaluation form at the Annex I. The construction activities in Agitma Regulator, Dvoynik Regulator, Rostguy, Djilvan, Peresechenie Regulator has been completed. Construction works in the, Prokop regulator area in progress. (See Annex II).

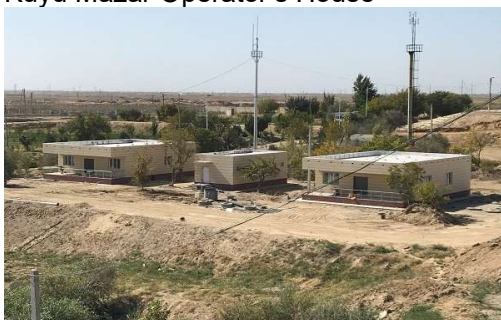
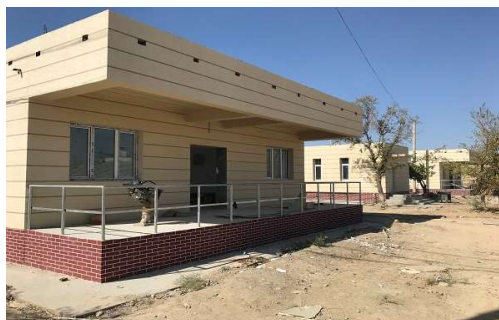
Kuyu Mazar Operator's House

19. **Kuyu Mazar PS:** The works have been substantially completed except some minor repair works in and around the PS building. As soon as the preparation works are completed, inspection and test procedures for completion of the facilities will be implemented.

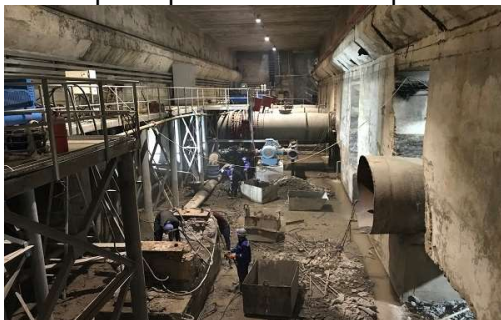
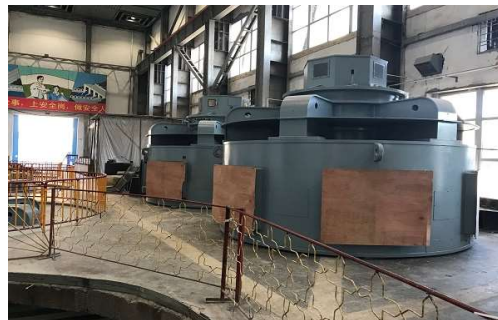
Kizil Tapa Replacement of Pumps

20. **Kizil Tepa PS:** The Contractor mainly engaged with some civil repair works until end of August 2020. As of the end of August 2020, the remaining 2 pump units (units # 6 and 7) have been delivered to the Contractor for replacement, relevant replacement works are in progress. Proceedings were continued through the Employer for approval of the change orders including the additional works, mainly for surge protection measures, and procurement of additional spare parts.
