Environmental & Social Monitoring Report (April to June 2014)

PAK: Patrind Hydropower Project

147 MW PATRIND HYDRO POWER PROJECT

ENVIRONMENTAL & SOCIAL MONITORING REPORT

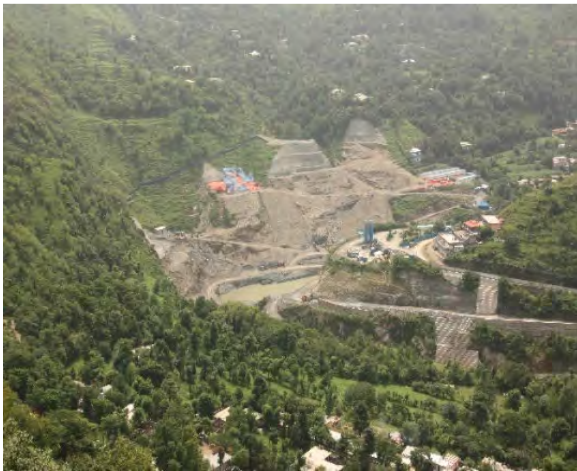
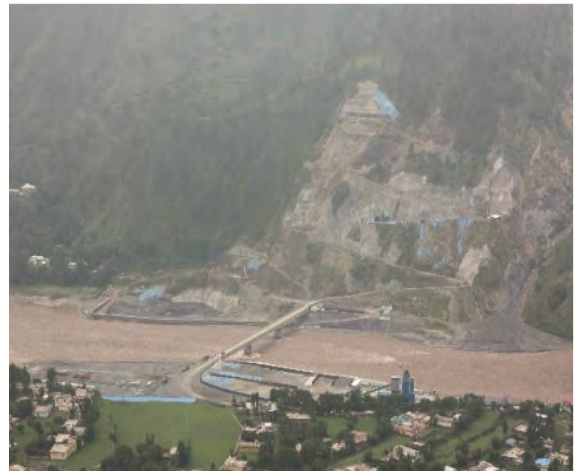
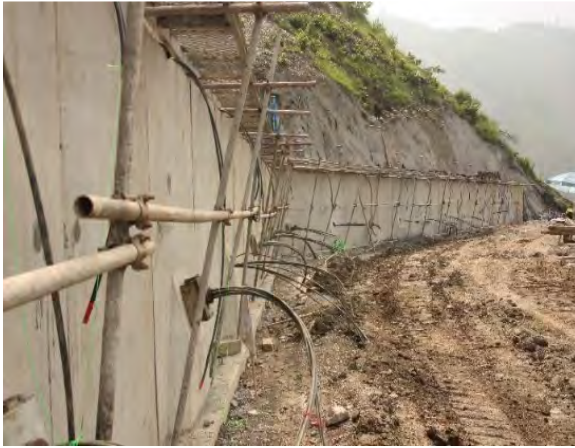
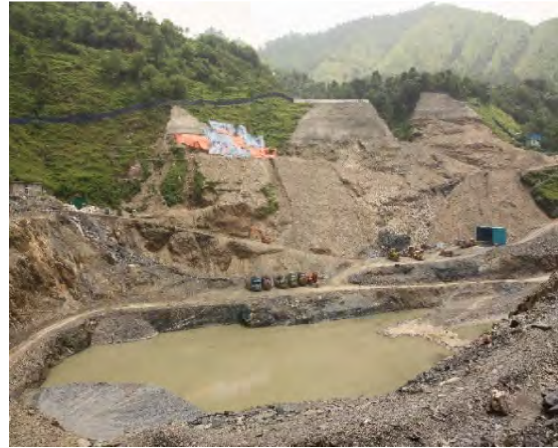
Slope protection works on both sites

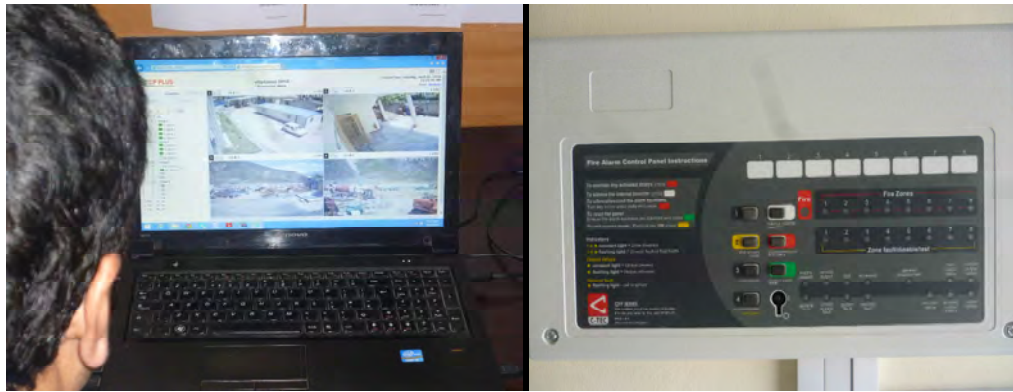
1. Fire alarm system and smoke detectors have been installed on camp offices, sites and accommodations after OE's recommendation

Monitoring through CCTV

Fire Alarm system installed

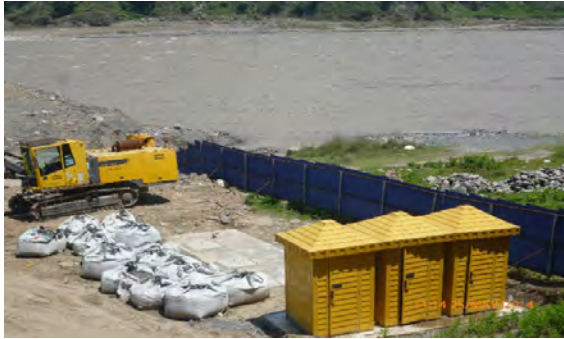
Erection of portable toilets with septic tank

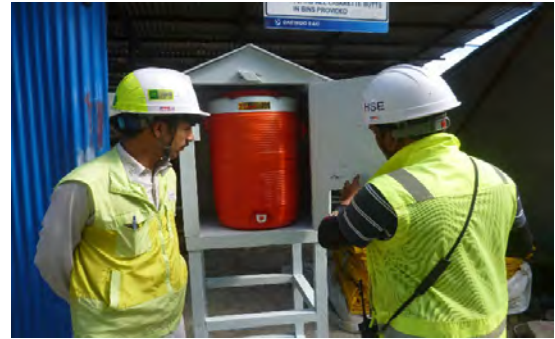
Placement of water coolers on site

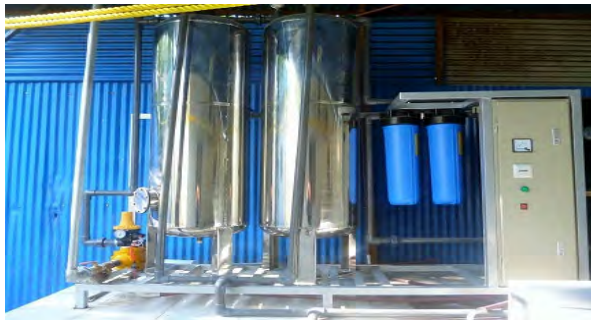
Filtration plants & ice makers installed

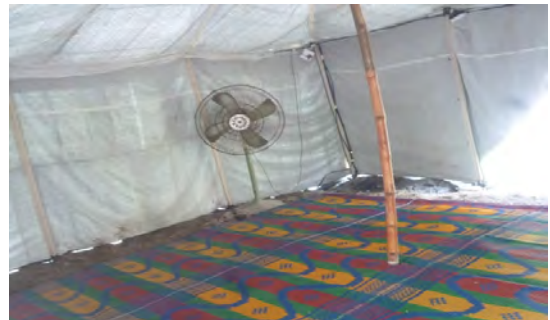
Workers rest areas

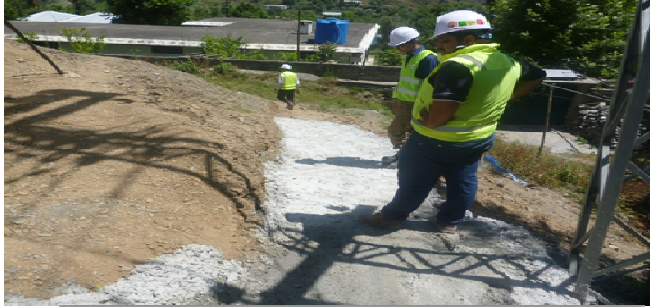
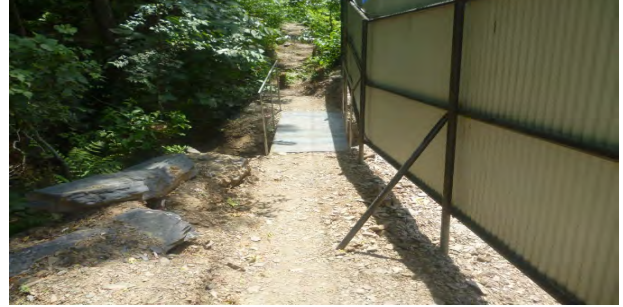
Pathway towards adjacent spring should be restored or constructed to facilitate locals' access to the water source:

A monitoring team from EPA Khyber Pakhtunkhwa visited upper site new batching plant area on 30th April 2014. Following corrective actions were undertaken as per EPA's recommendation:

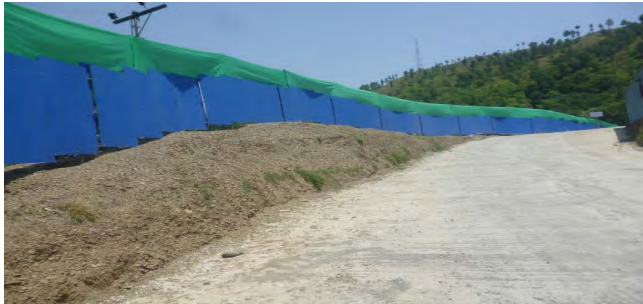
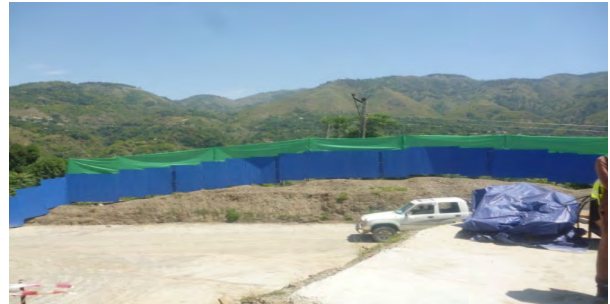
Height of already installed fence (GI sheets) between residential houses and batching plant should be raised at a level to ensure the privacy of local residents:

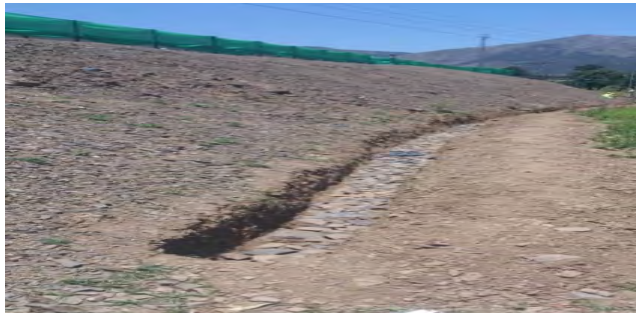
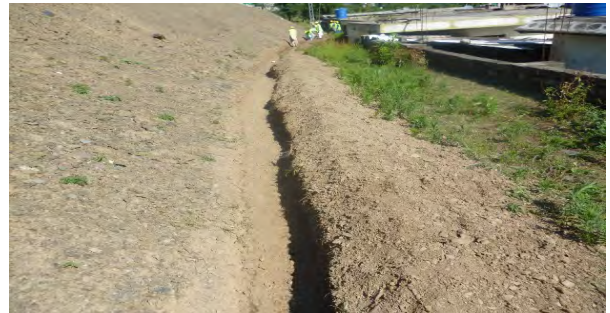
A cut-off drain should be constructed backside of houses to prevent water seepage:

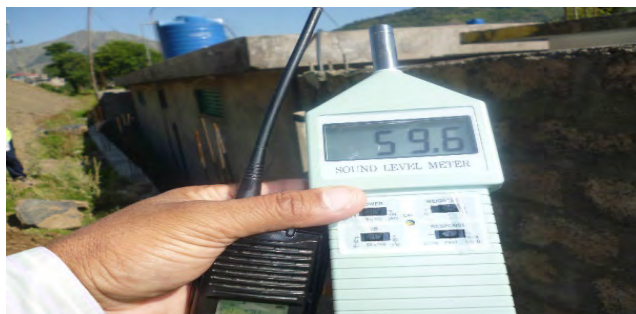
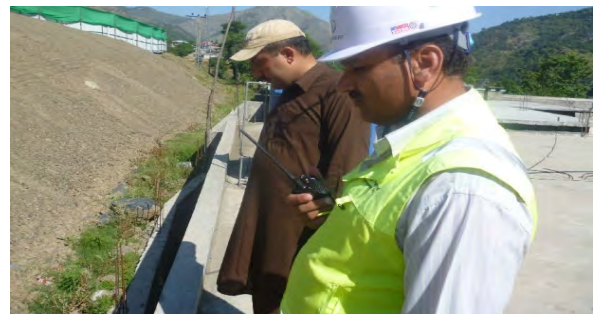
Batching plant generator with appropriate noise reduction measures was placed away from houses. Later on the generator was replaced by small size generator as it was required only during installation of plant.

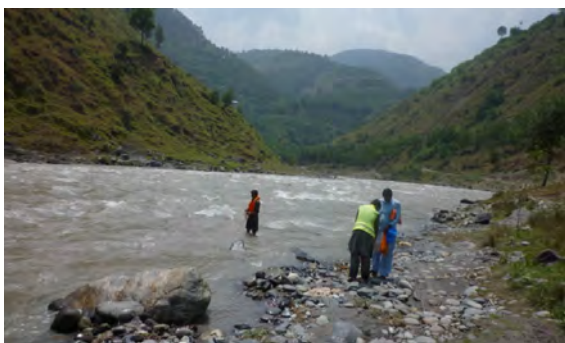
Point-I: (Boi)

This is the point situated at 34° 18/ 19" N, 73° 26/ 44" E at 723 meters of elevation above sea level. The water flow is high and turbid. Water depth varies in the stretch of about 500 meters. The fish at this part

of year has come to the sides as the catching concentration is quite significant. Five fish were caught of two species, *Schizothorax plagiostomus* and *S. Curvifrons* this shows that the fish catch during June-August remains high. No fish was caught last time in March 2014 at this point. The size of the fish was 9 centimeters to 24 centimeters.

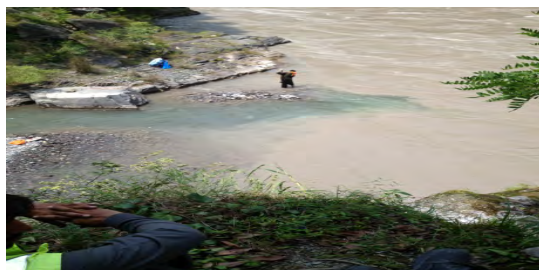
Point-II: (Domel Boi)

This is the point situated at $34^{\circ} 18' 36''$ N, $73^{\circ} 26' 43''$ E at 736 meters of elevation above sea level. This is the point where fish can migrate upstream in the Boi Nallah during the spawning period and can have little impact of low river flow when tunneling of the water starts. According to a local, Mr. Muzhar Hussain Shah, the fish was poisoned by some visitors in May 2014 in the Nallah and large number of juvenile and large fish died because of that. The party could catch some but others were taken down by the current of water. According to him this is not the first occasion of this sort, every year people kill the fish using explosives, poisons and electric current. Seven fish could be caught by the two fishermen. No fish could be netted during the last time trial in March 2014. Seven fish caught were again of 2 species but the evidences of existence of *Glyptothorax spp* and common carp (*Cyprinus carpio*) were found in the Boi Nallah, with the interview of the locals. Four of the fish caught were above 20 cm.

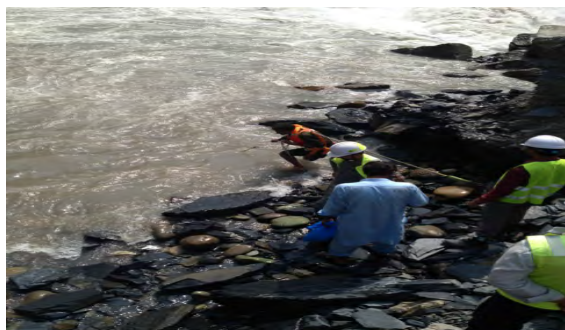
Point IV: (Outlet of river diversion)

This is the point situated at $34^{\circ} 18' 19''$ N, $73^{\circ} 26' 44''$ E at 766 meters of elevation above sea level. This is the outlet of the diversion tunnel. Again no fish, as expected, could be caught as the flow of the river water is very fast. This diversion tunnel has a definite impact on the fish production but to maximum of 800 meters downstream. Then the river makes pools to provide breeding ground to the fish.

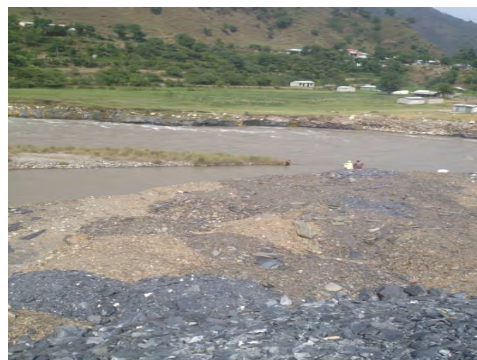
Point-V: Excavated Material Disposal Site:

This is the point situated at $34^{\circ}20' 16''$ N, $73^{\circ} 25' 26''$ E at 772 meters of elevation above sea level. This is near to the inlet of the diversion tunnel, which is a better alternate study of inlet point last time studied. The inlet point has been closed to access because of increase in the water flow and blockage of the possible path leading to the point. Still the impact on aquatic life is not very high as the lake has not developed and course and flow of water has not changed here. When the lake will grow after construction of Patrind weir, this can harbor the Rainbow and Brown trout. If carefully planned, this can become commercial activity but needs expert input. Three small sized fish was caught from here of 14-16 cm length.

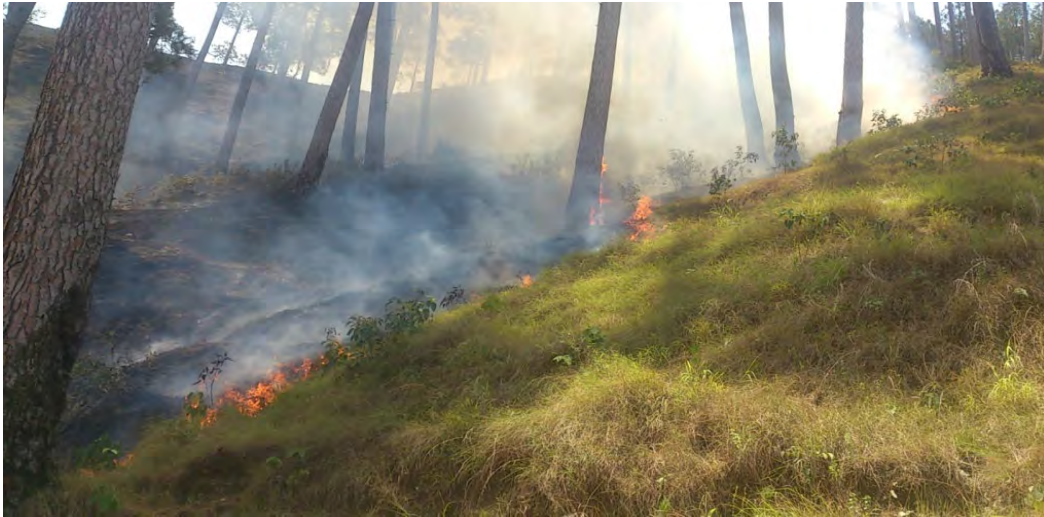
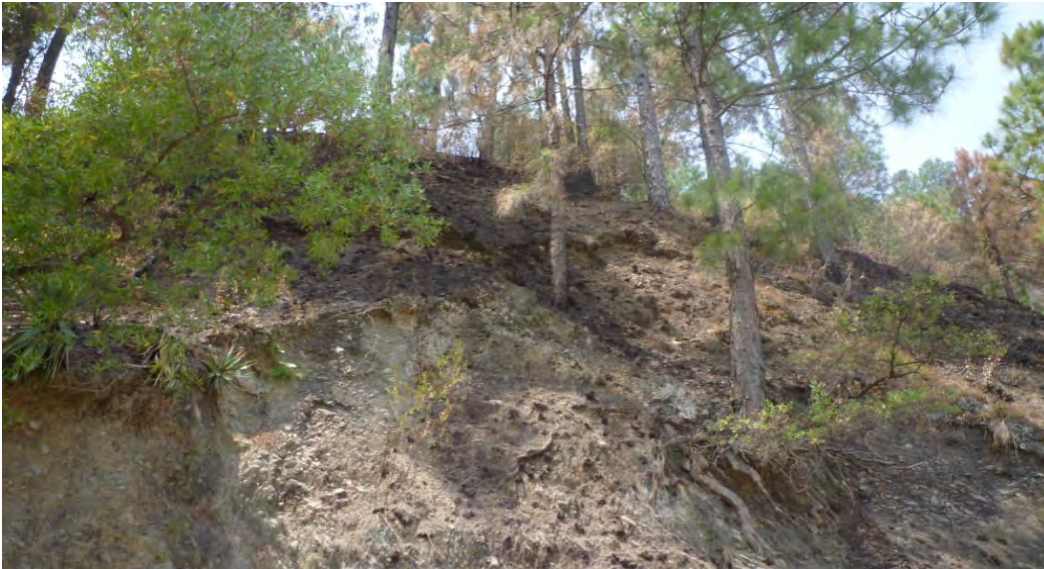
Area affected by fire hazard completely lacking the undergrowth

The intention of burning the area was to give better chances of growing the grasses of nutritional value and eliminating the domination of unwanted grass species but, this ground fire became the crown fire damaging almost all the undergrowth of the tall tree species. Following are the plant species which are damaged to an extent of 90% in the fire affected area:

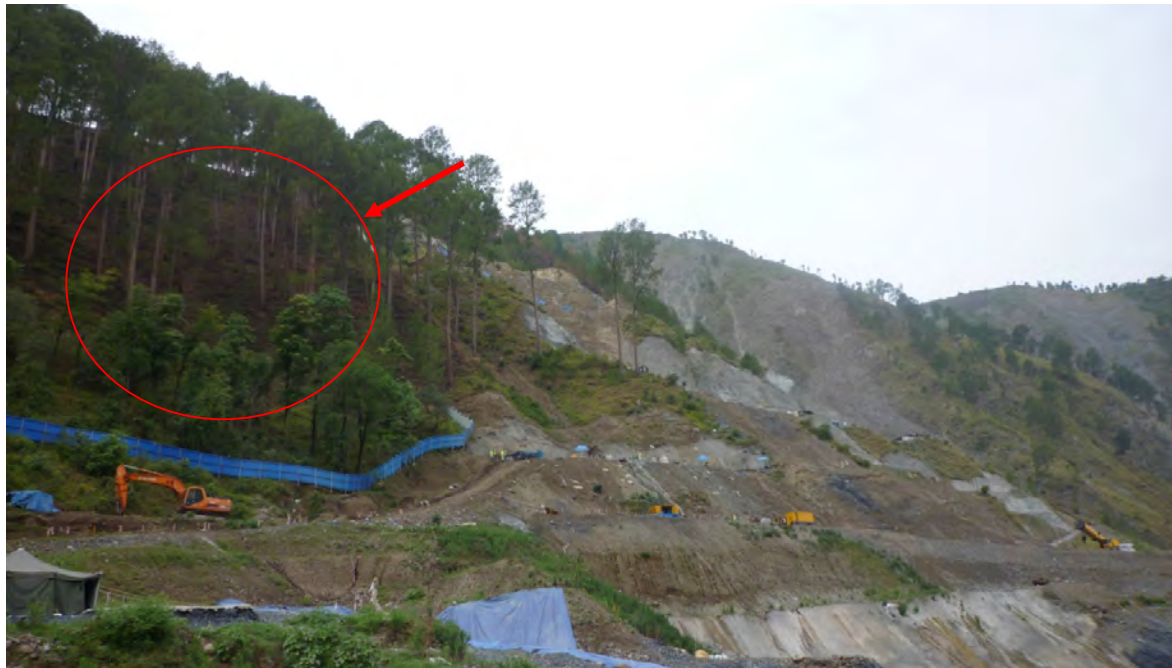
Area Affected by forest fire at Alda

The fire caught at Alda forest on 22nd of June 2014 was a crown fire. Somebody deliberately put the area under fire most probably for getting a better quality of grass. It could have come into the project area of Hydropower station and damaged the property but, the staff at the station efficiently extinguished the fire. The soil outside the Project area is exposed to direct hit of the rain drops which can lead to the gully erosion and Project area may come under the threat of landslide. Similar type of fire has affected the Patrind site of the Project. Staff there has also controlled the fire using fire extinguishers and throwing water on the outer boundary of the area. Both sites are now in the danger of soil erosion and if proper measures are not taken, the area may get huge damage in the future.

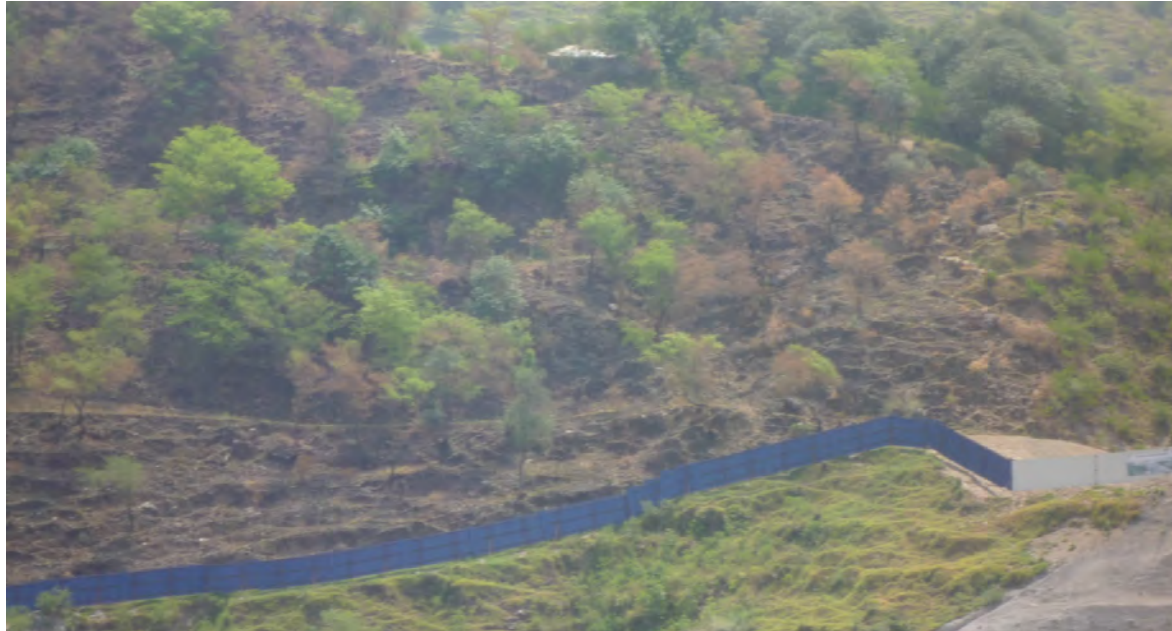
Area affected by forest fire at Patrind

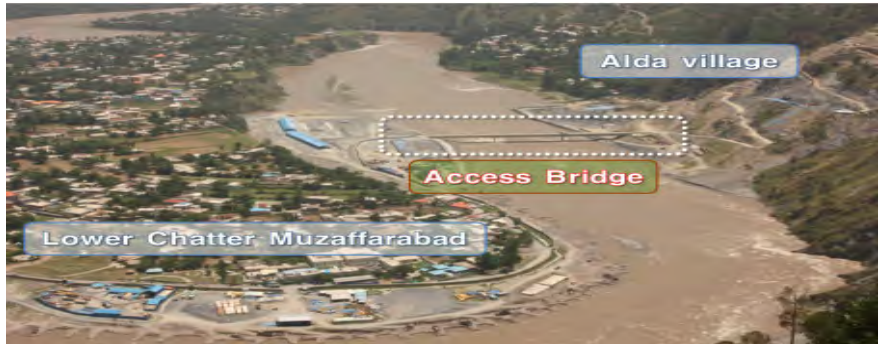
SR.	PROPOSED ACTIVITY	STATUS
1.	BRIDGE ACROSS JHELUM RIVER	<p>✓ The construction of bridge was completed on 31st August 2012. The bridge has been connected Lower Chatter Muzaffarabad to Alda village on the right bank of Jhelum river. Now, vehicular traffic access is</p>

<p>available for the locals to across the river.</p>
2.	CONNECTS SARATI VILLAGE (KP) TO PATRIND VILLAGES (AJK)	<p>✓ Downstream cofferdam is being used temporary access bridge and after the completion of the construction there will be a permanent bridge on the weir deck which will be used by the locals to cross the Kunhar river between both the sides (by December 31, 2016)</p>

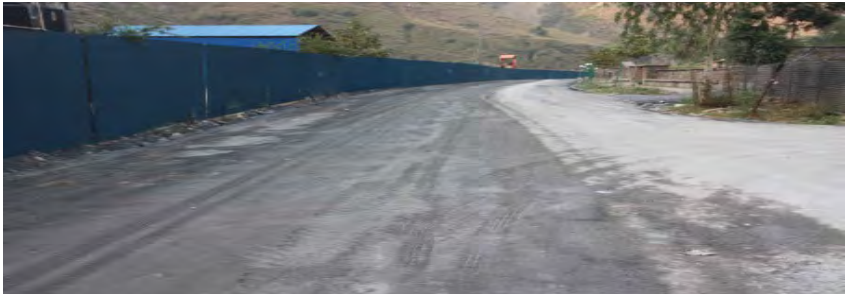
SR.	PROPOSED ACTIVITY	STATUS
3.	IMPROVEMENT OF EXISTING ROAD	<p>✓ The road from Supreme Court to Children Park will be improved and upgraded where possible.</p>

<p>Improvement is an ongoing activity which is carried out as and when needed.</p>
