Environmental and Social Monitoring Report

Project Number: 44914-014
Quarterly Report (July-September 2015)
September 2015

Pakistan: Patrind Hydropower Project

147 MW PATRIND HYDRO POWER PROJECT

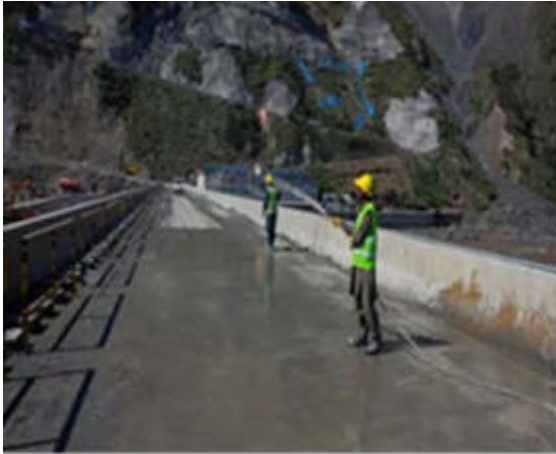
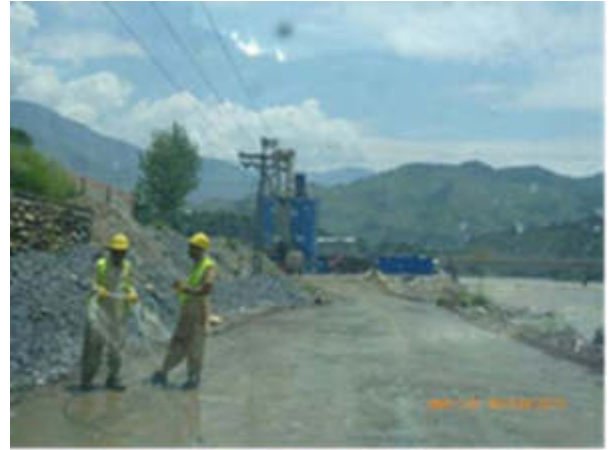
- Dust pollution had been a noticeable issue on the powerhouse site during the month of July due to irregular water sprinkling due to water sprinkling pump break down and the water bowsers were not available on time due to the tight schedule of construction activities. As a corrective action, it was ensured that water sprinkling is done on the site at least 5 times a day, meanwhile, new water tank, new water pump and new water sprinkling line were installed on the site and water sprinkling was ensured on the site on regular basis.

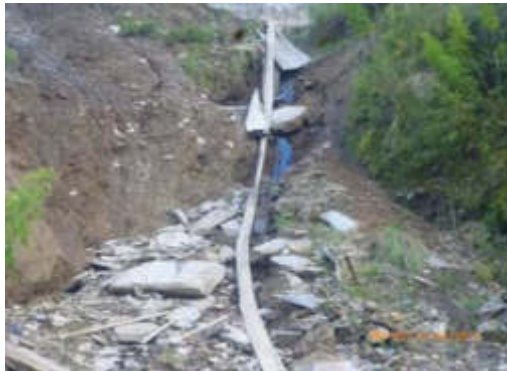
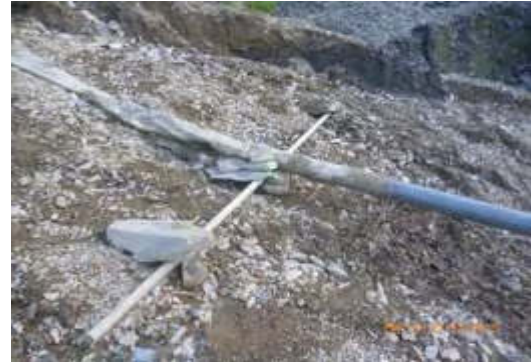
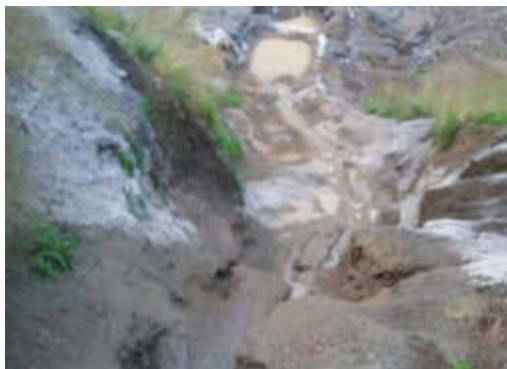
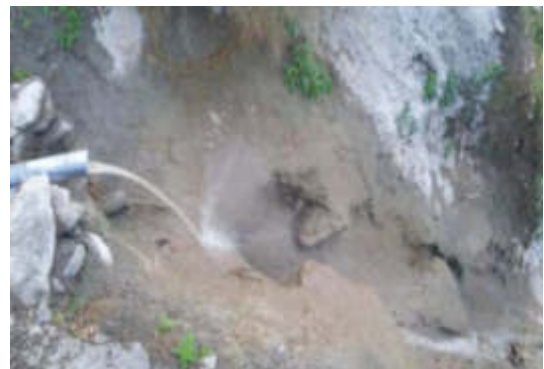
- The breakdown of the canvas pipe from the first corner tank towards last corner due to the torrential rainfall was observed during the month of July 2015, as a corrective action, the pipe was repaired and fixed properly into the tank to prevent the ground water contamination and to stop the sludge from going directly into the river. Later on, proper drainage was prepared in this location to avoid any further ground water contamination.

- The breakdown of the canvas pipe from the first corner tank towards last corner due to the torrential rainfall was observed during the month of July 2015, and was mitigated by fixing the Canvas Pipe and later on by preparing a concrete drainage for the waste water.

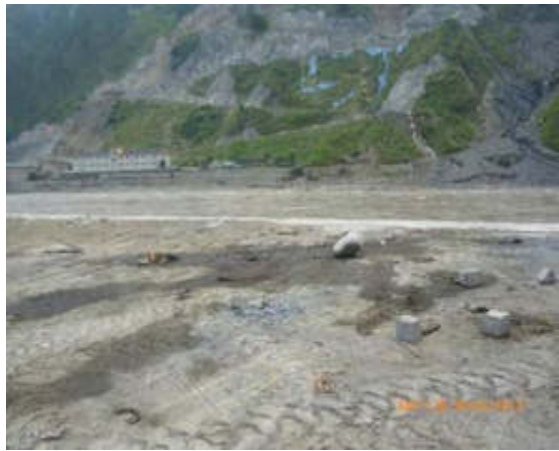
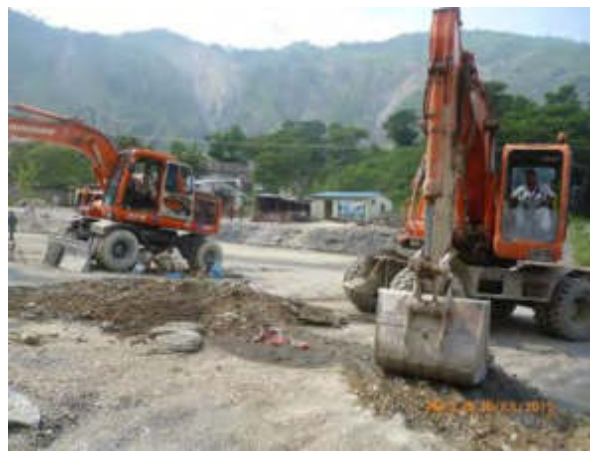
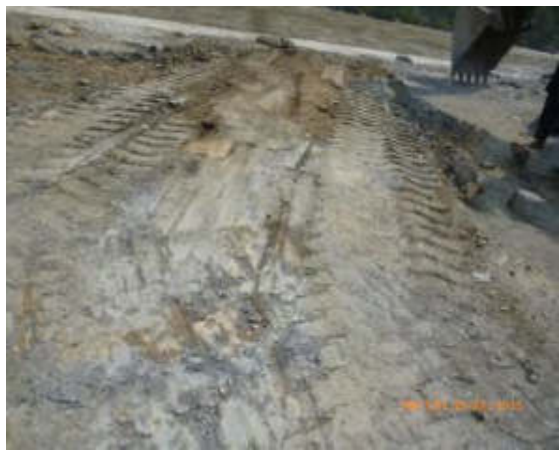
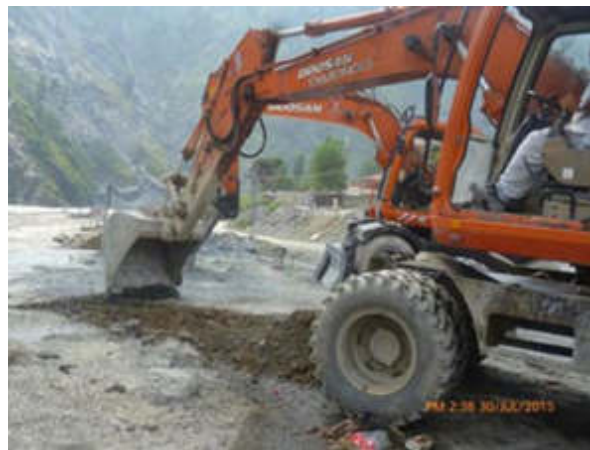
- During the month of July, oil spillage was observed in front of the batching plant due to the maintenance of the machinery and generators placed on the site. Corrective actions were taken immediately in this regard to stop oil spillage by

removing the contaminated soil by excavator and dumping into the concrete waste trench in the disposal area to prevent environmental degradation.

- Oil spillage was observed in front of the batching plant and was rectified by removing the contaminated soil. The contaminated soil was properly disposed-off in the concrete disposal trench.

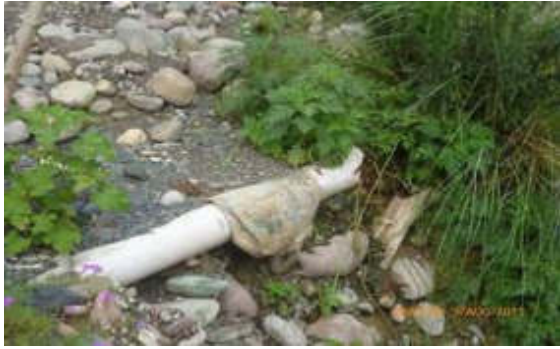
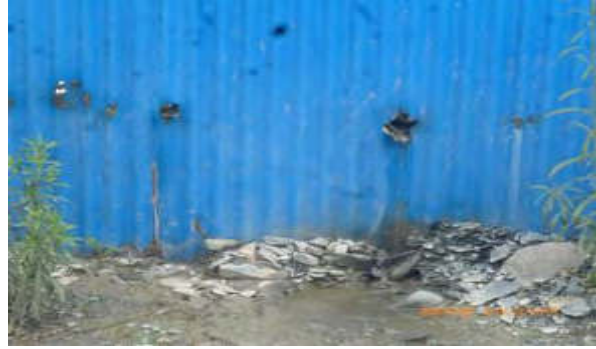
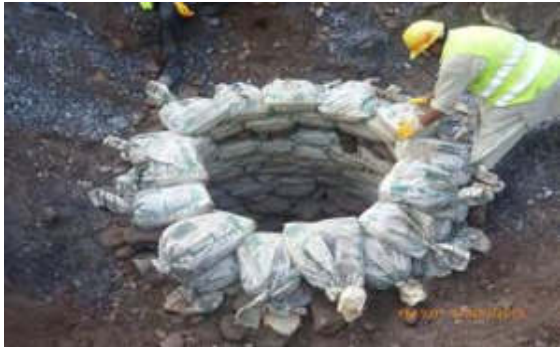
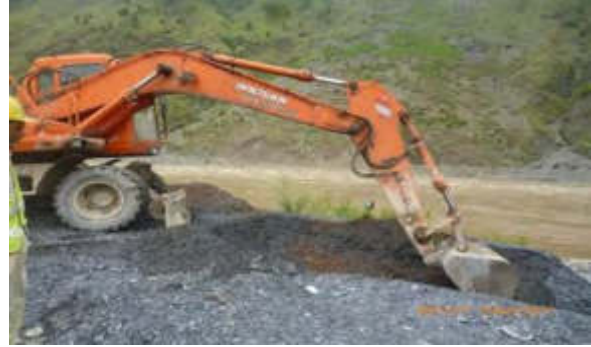
- During the month of August, sewerage water coming from the Daewoo workshop was observed going directly into the river without proper treatment as there were no main holes and drainage system properly prepared due to which people living nearby area were suffering by this. Corrective actions were suggested by SHPL and OE in this regard to prevent foul smell and water-borne diseases. Septic tank was made, layers of stone and sand bags were placed inside the pit to make a proper soakage pit. A pipe was installed inside pit from the inlet of sewage water that connects with the outlet and gives proper channel for the waste water to drain out. The septic tank was finally covered and soil to prevent environmental degradation in regard to the spread of diseases and ecosystem disturbance.

- Sewerage water coming from the Daewoo workshop was observed going directly into the river without proper treatment, as a corrective action, proper septic tank was made.

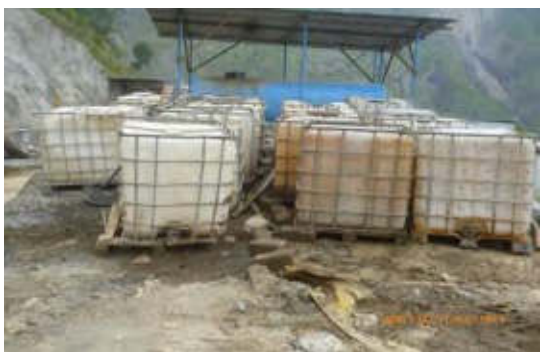
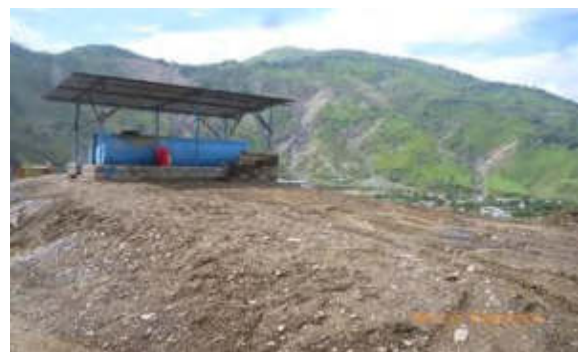
- During the month of August, spillage of fuel was observed at third corner due to the fuel tankers that were placed directly on the loose soil. Thus, inadequate fuel storage and inappropriate spill containment lead towards the soil contamination. As a corrective action, all the fuel from tanks was shifted into the metal tank at fuel storage area and remaining empty tanks were removed from the ground and transferred to the workshop. After that contaminated loose soil was got cleaned up and compacted with the help of excavator to prevent land degradation.

- During the month of August, spillage of fuel was observed at third corner due to the fuel tankers that were placed directly on the loose soil, as a corrective action the tanks

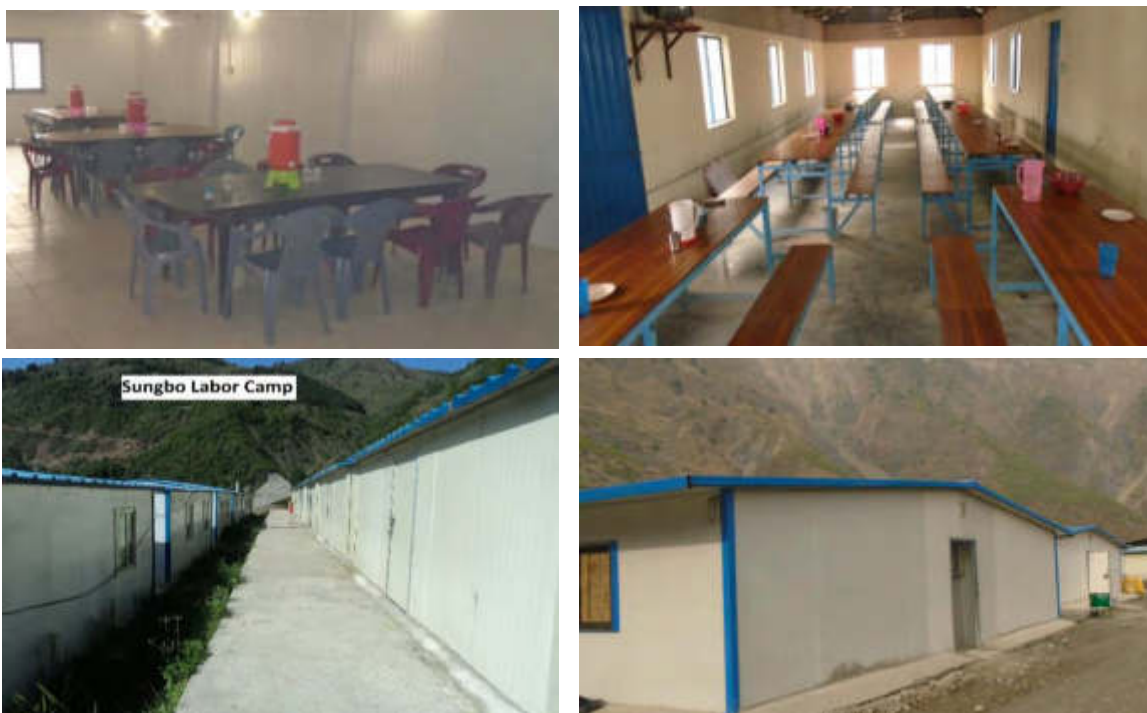
Prefabricated accommodations labour at upper & lower Sites

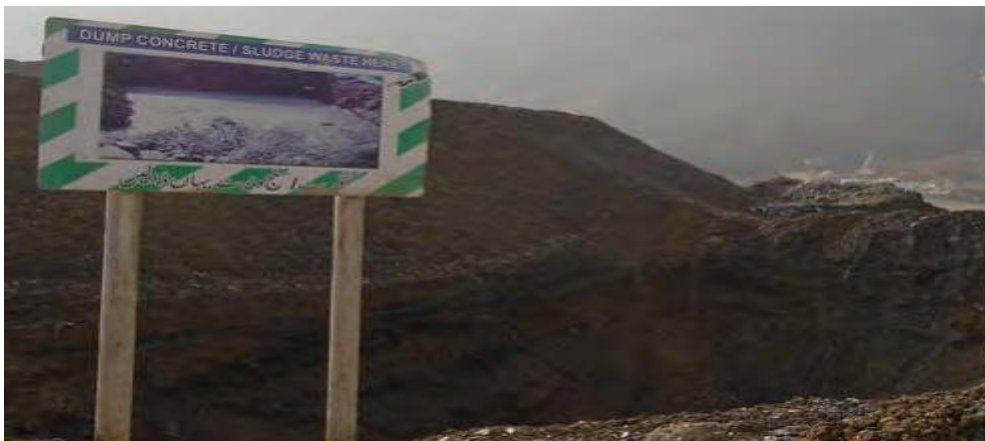
Waste segregation and collection system has considerably been improved on both the sites. EPC and sub-contractors have waste collectors placed on both sites to maintain housekeeping and timely segregation /collection of waste. It is being ensured that landfill is carried out in such a manner that it does not cause harm to the environment. For instance a geo-membrane, concrete and clay lined This can be done by ensuring that landfills are located, designed, constructed, operated and restored so as to ensure that ground and surface waters are not contaminated.

All waste generated in all operation at sites is being managed in accordance with EMP & Waste Management Plan. All the recyclable Waste has been carried and transferred to the scrap dealer by HSE vehicle.

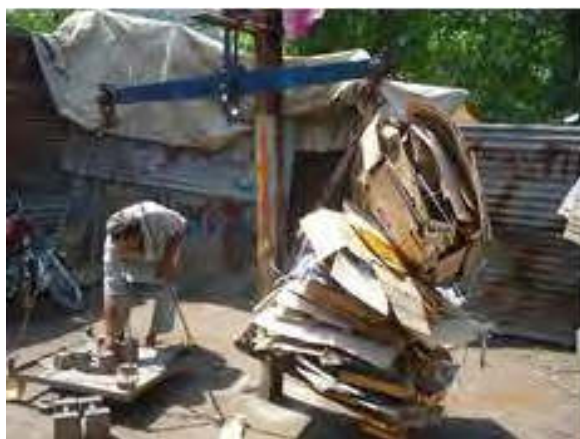
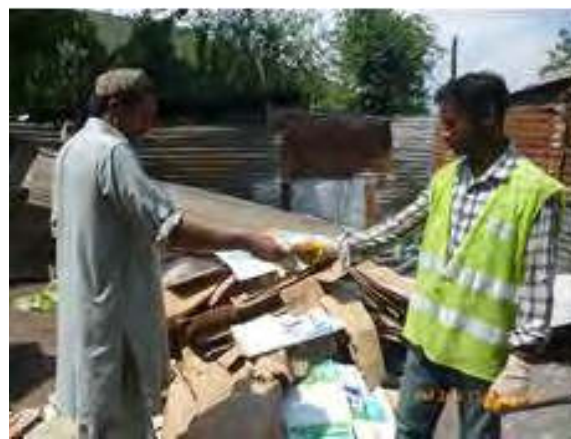
Paper, plastic, cardboard and few iron bars have been properly measured by the scrap dealer, the quantity of which has been noted down on the waste consignment note. Daily environmental Performance regarding potential environmental impacts has been made and monitored at site regularly by direct observation and inspection. These impacts include the monitoring of air emissions, water consumption and discharge, waste management, housekeeping, noise impact, hazardous waste management at the project site. Comments have been noted down In case of any improvement or any corrective action regarding any environmental activity if required.

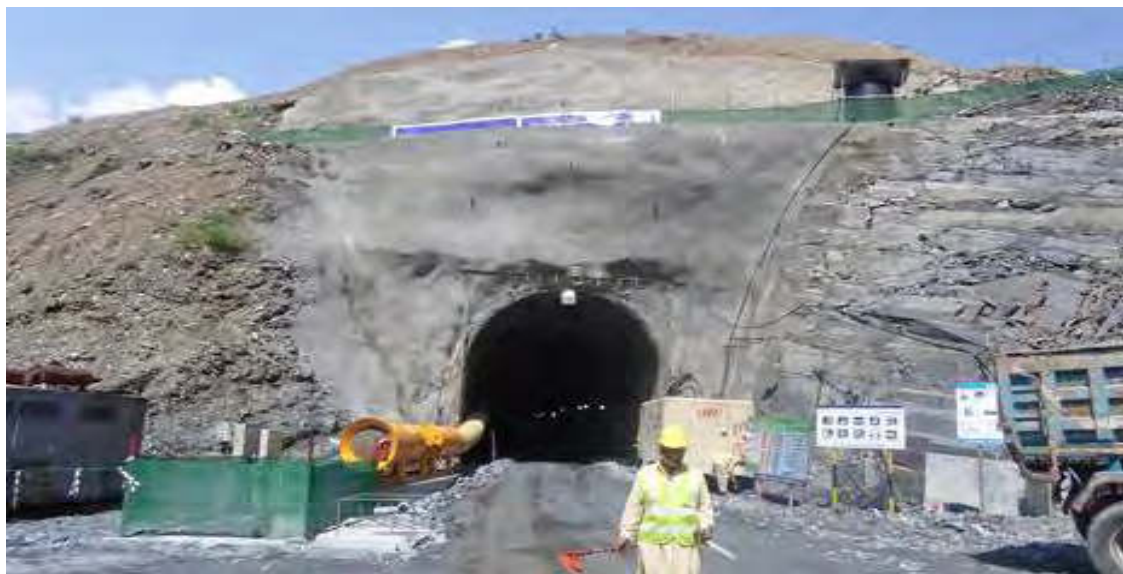
Description

Bypass Adit Tunnel Entrance

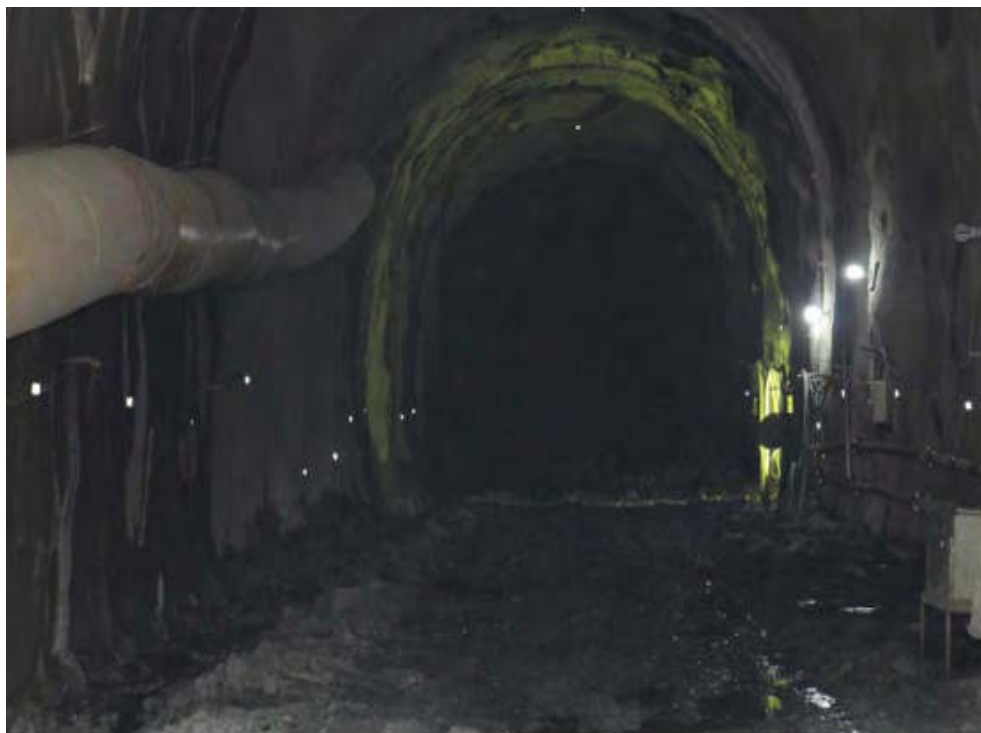
Description

Inside the Bypass Adit Tunnel

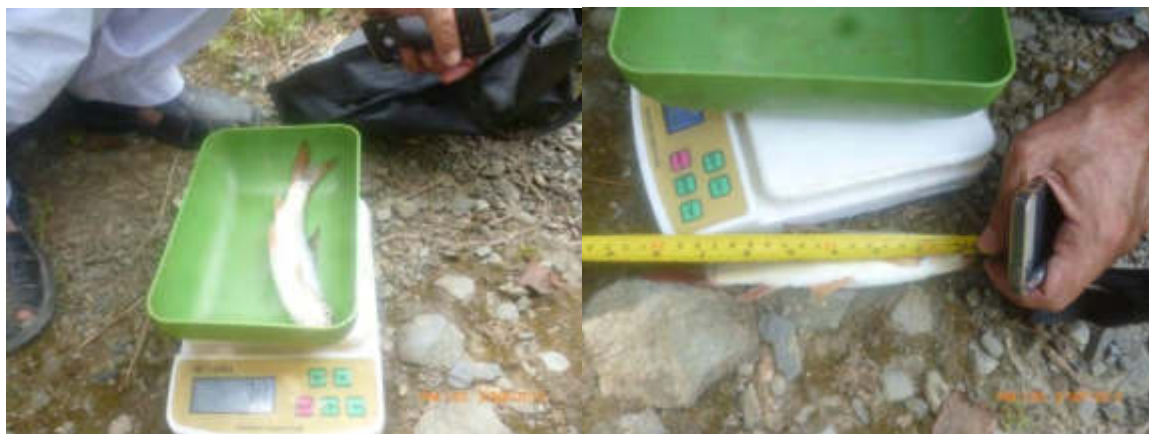
First sampling point of the study is situated at $34^{\circ} 18' 19''$ N, $73^{\circ} 26' 44''$ E at 2422 ft of elevation above sea level. The water level is moderate and it is greyish. The water level has gone down as compared to the study during June 2015. The fish caught with their details is given in the following table below. No fish of *Schizothorax curvifrons* could be netted here.

Sampling at point-I

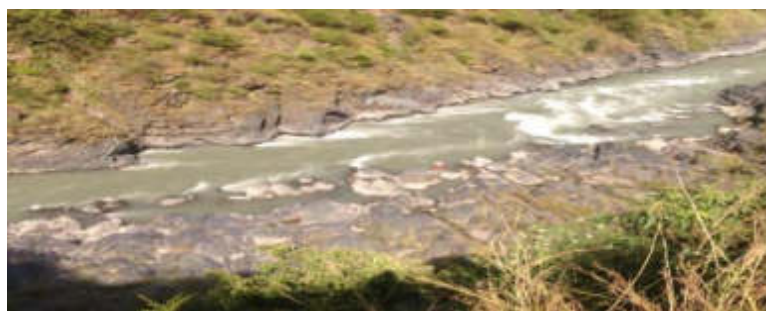
This sampling point is situated at $34^{\circ} 19' 47''$ N, $73^{\circ} 25' 35''$ E at 2475 ft of elevation above sea level. The river is turbid at this time of the year due to rain. A small creek joins the river here and possibility of suitable breeding ground of the fish could be expected here. One fish could be caught here. Detail is given in the table below.

Sampling at point-III, Parri

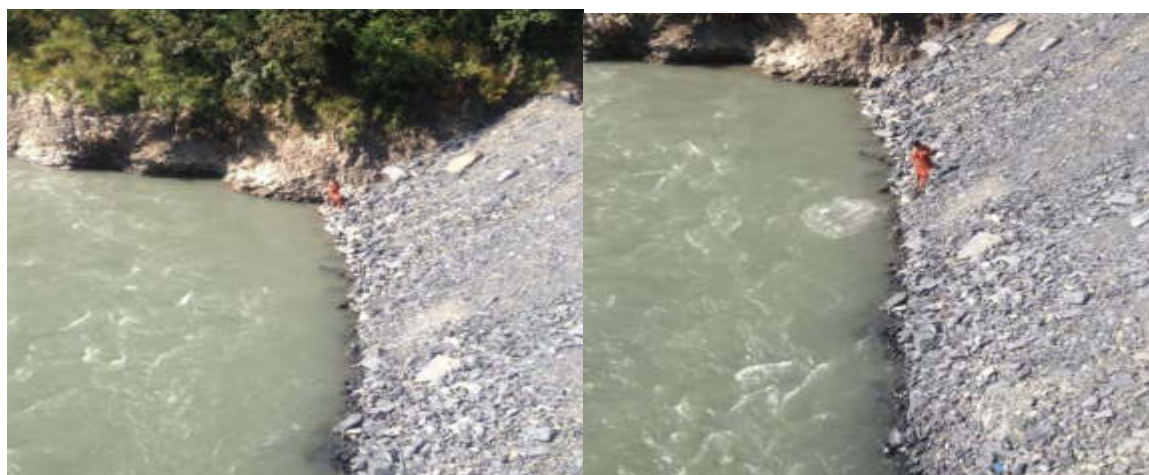
This is the point situated at $34^{\circ} 20' 36''$ N, $73^{\circ} 25' 08''$ E at 2615 ft of elevation above sea level. This is the inlet of the diversion tunnel. Although a small pool do exists even then the water flow velocity is quite high at this time as compared to the last sampling time. No fish could be caught here. Possibly due to coming breeding season the migration has taken place. The impact on aquatic life is not very high as the lake has not developed to its expected level and course and flow of water has not changed here. When the lake will grow after construction of Patrind weir, this can harbor the Rainbow and Brown trout. If carefully planned, this can become commercial activity but needs expert inputs.

Sampling at inlet of water diversion tunnel

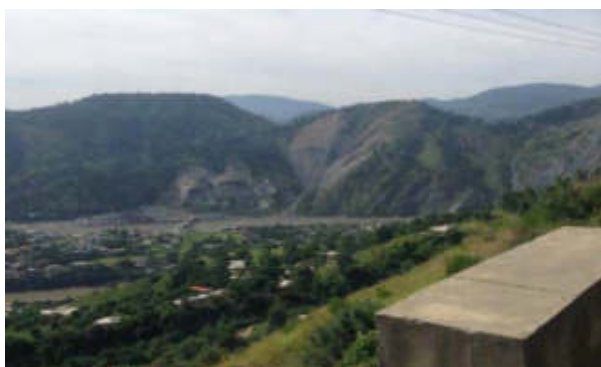
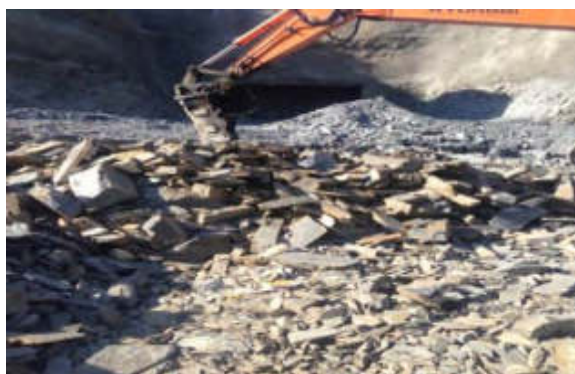
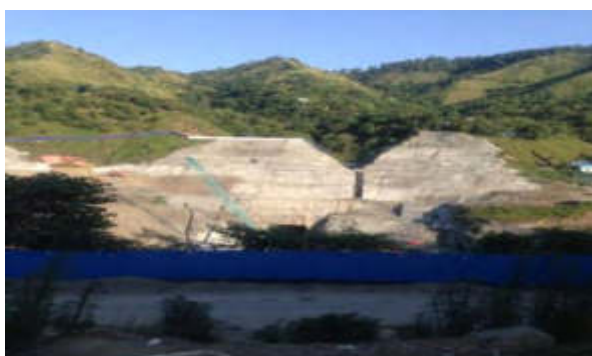
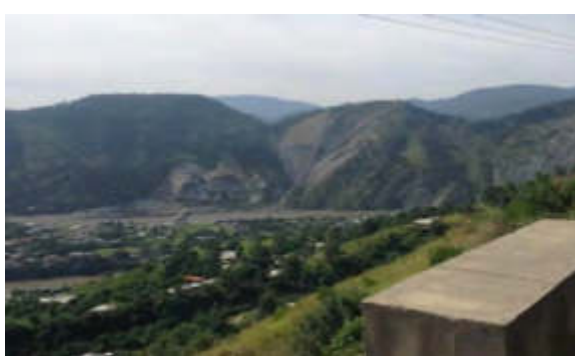
Another serious impact is the landslide disaster of the fragile mountains due to mining and tunneling. This impact can easily be observed in and around the working area of Project sites.

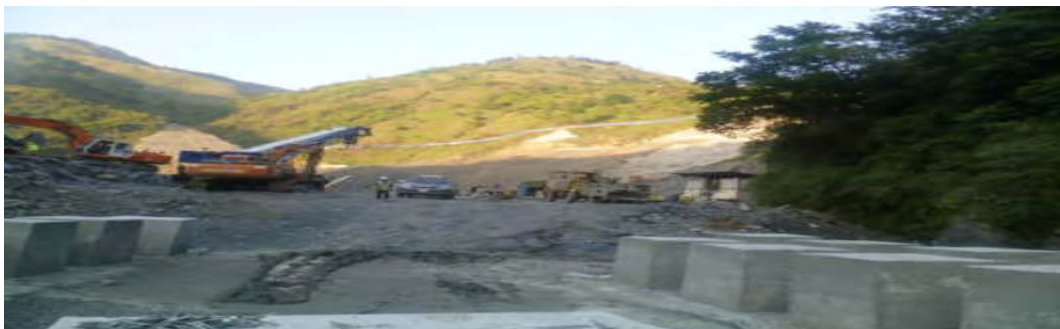
Expanding landslides at powerhouse site Lower Chatter Alda)

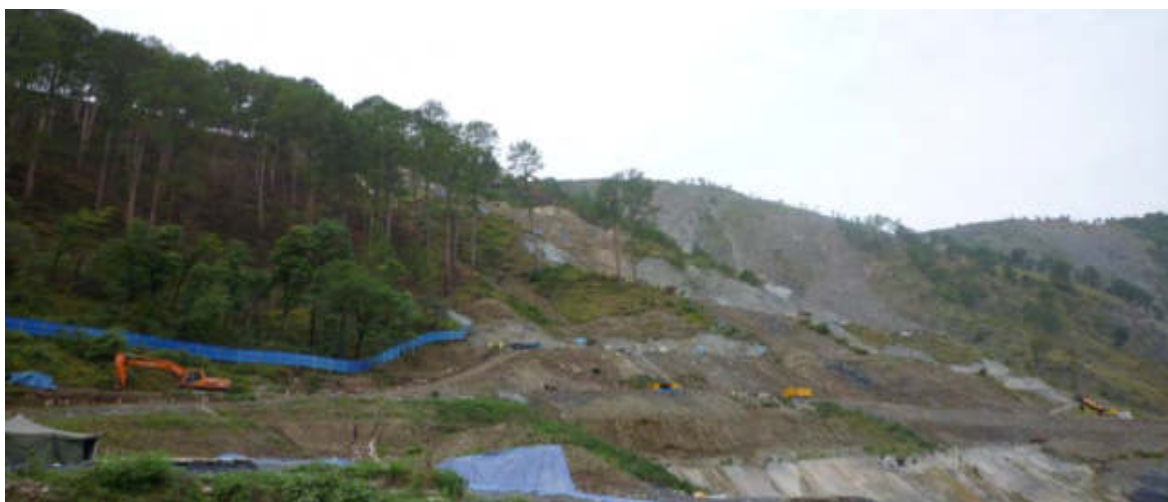
Chir pine trees on the powerhouse site and land deterioration can be seen

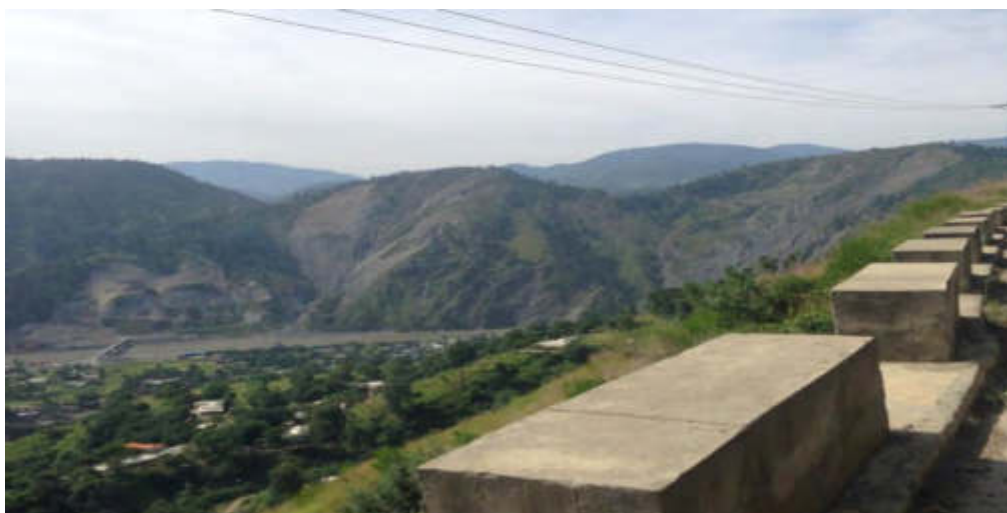
Some more trees have been observed fallen on the site with several more leaning towards one side. They will also fall down in the near future. No replacement plan of trees has been shown to make the area green.

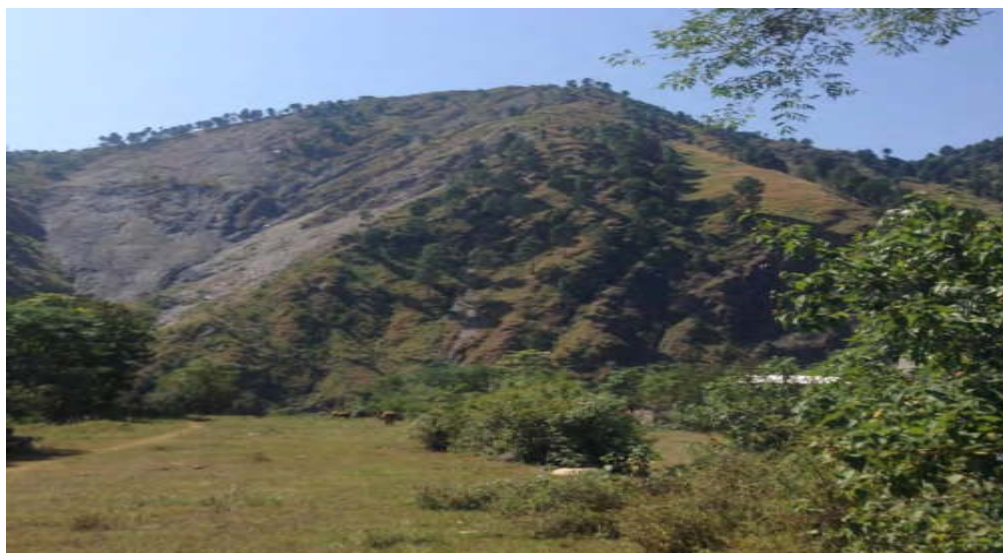
9. Another small slide has appeared at Lohar gali adjacent to the existing big slide. This slide needs to be stabilized without any delay otherwise this will also create a big havoc.
10. Slides inside the project area and adjacent to it are expanding with an alarming speed. These slides have accelerated due to mining in the tunnel. The mountains are very fragile and cannot bear the thrill of mining activity. Once they are destabilized, then there is no end to it. Immediate attention is required by the project to control and stabilize these slides as recommended above.
