Environmental and Social Monitoring Report

Project Number: 44914-014
Quarterly Report (January-March 2019)
March 2019

Pakistan: Patrind Hydropower Project

147 MW PATRIND HYDRO POWER PROJECT

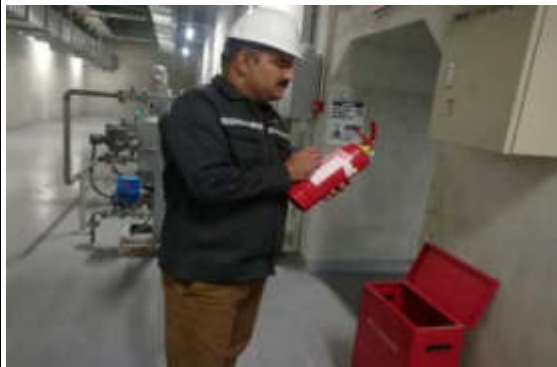
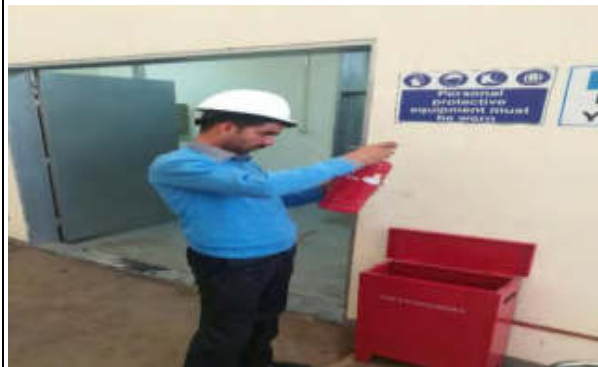
Fire Extinguisher Inspection

- All the fire extinguishers of powerhouse were inspected. Discharged cylinders were replaced with new fire extinguishers.
- Three (03) HSE inspections of operation conducted. Overall HSE compliance was satisfactory and no major HSE issues were recorded.

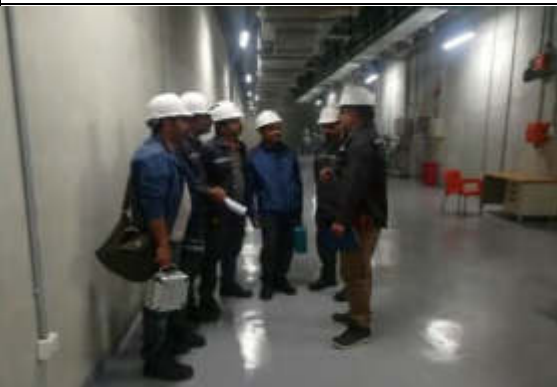
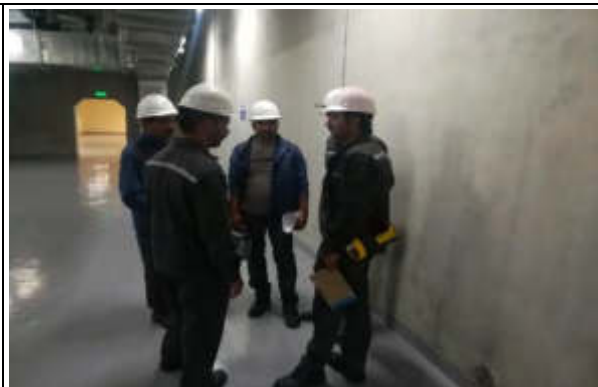
Noise Monitoring

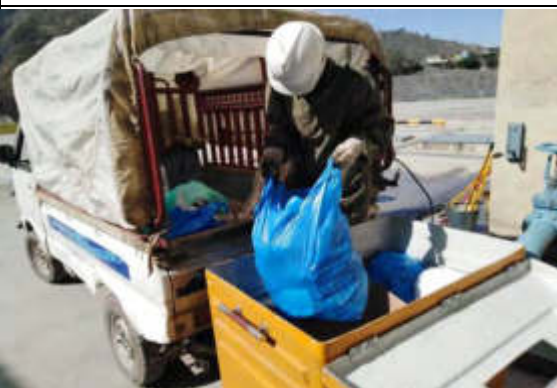
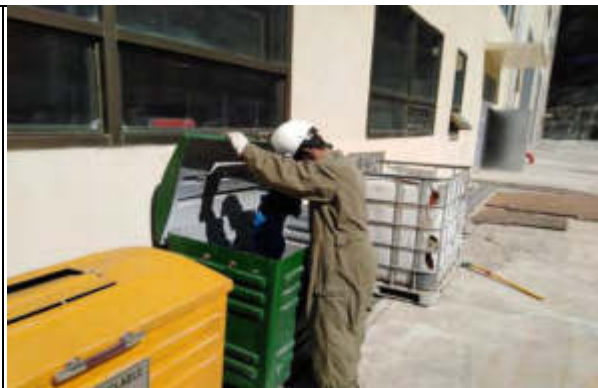
Powerhouse Inspection

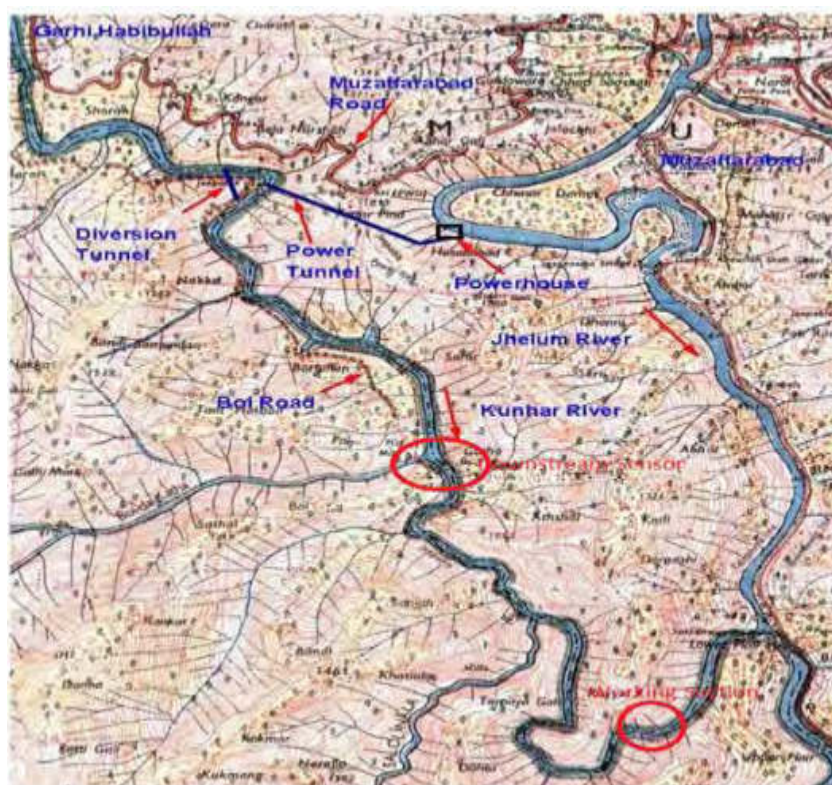
3. Site selection

After visiting to several locations, one site i.e. Bella (Boi) has been selected for discharge measurement at weir downstream considering the following aspects.

- The site should be safely accessible and should be in a section of the stream that is free flowing.
- Stream should be straight enough to have uniform form.
- The flow should not be affected by tributaries or tides.
- There should not be any side channels so that all the water flows through the main channel.

- Areas where there are large boulders, logs, or thick brush which can create eddies, slack water, turbulence or disturbed flow should be avoided.

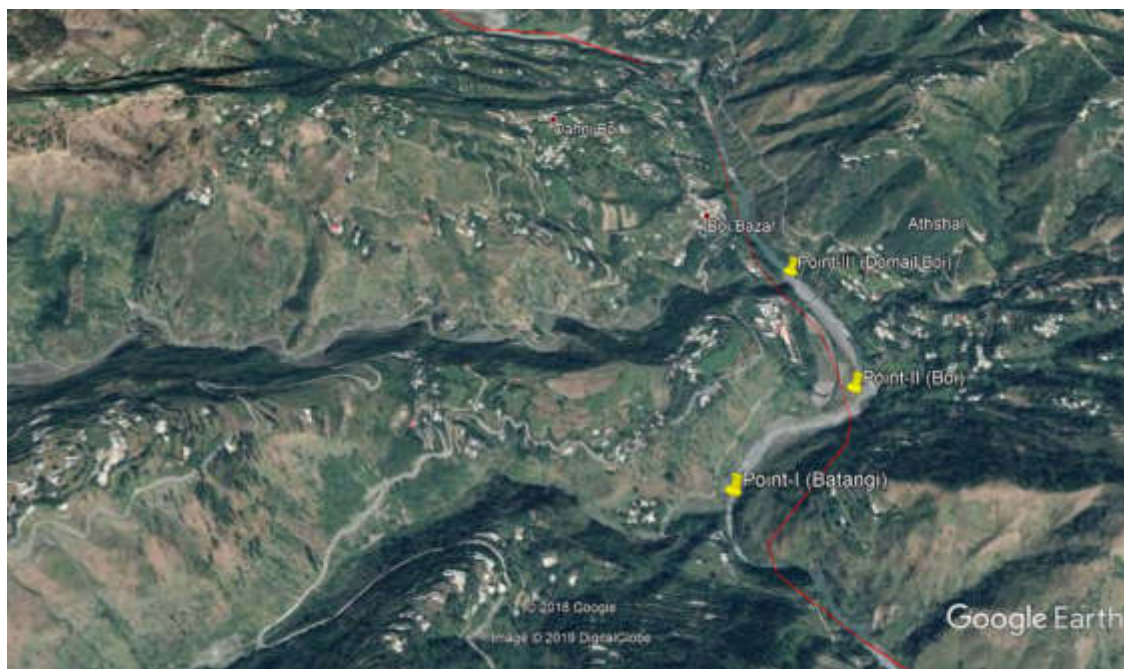
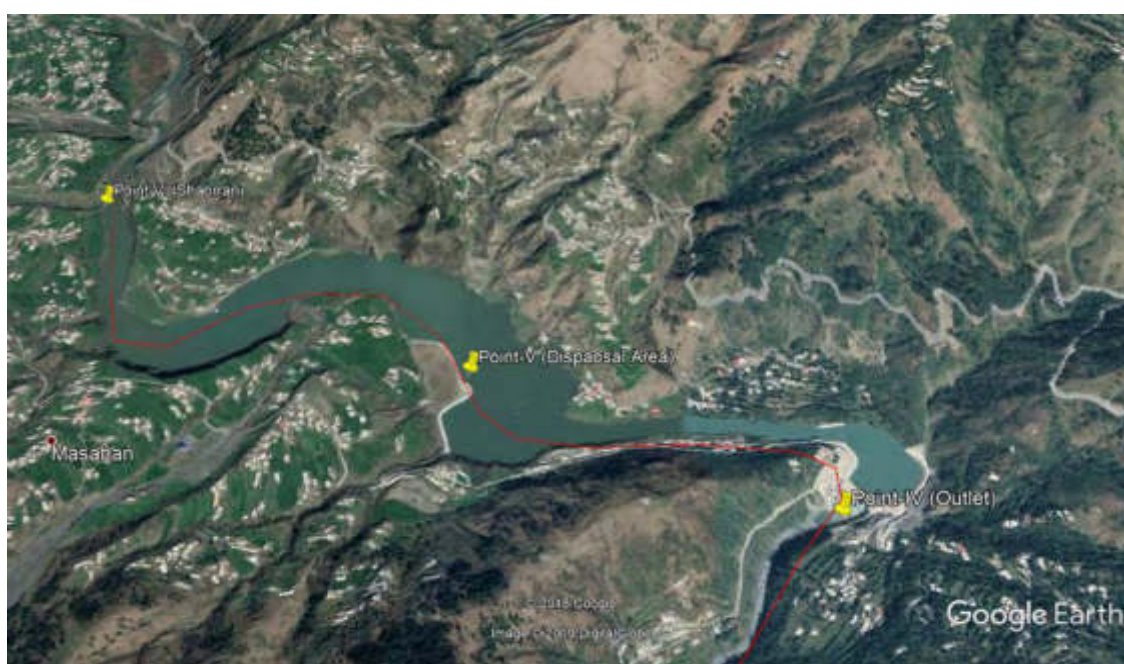
The study area has been divided into six sampling points for comparative impact assessment at a stretch of about 12 km down and upstream, the points selected were based on the potential of existence of the fish on the basis of their breeding ground, abundance of food ingredients, confluence of side streams and migration possibility of the fish. The points were selected during the pre-construction phase of the dam and sampled during the construction and now during the operational phase. There are two points where sampling has now become impossible; one at Parri (Point-III) where water flow has become centralized and large boulders have made it impossible for casting or erecting any type of net there and second is Point-V at disposal area where casing of net in the reservoir is of no use because of the absence of the fish catch and depth of the reservoir water. During this study, an alternate sampling point has been selected downstream at Batangi Village where a small stream joins the river Kunhar. Another sampling point will be selected upstream beyond Shorran on the next sampling time after June 2019.

Study Area showing location of points

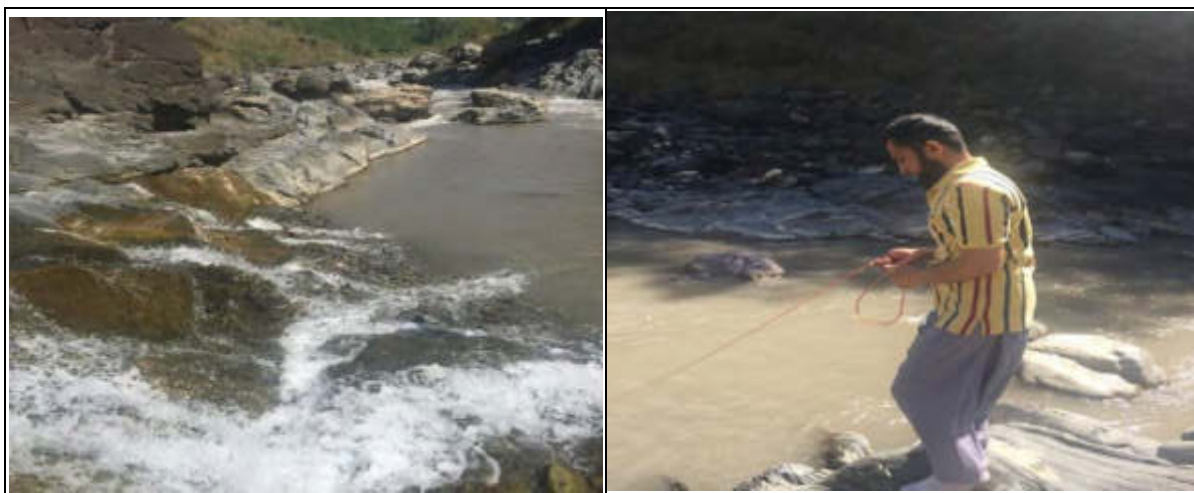
This is a new selected point for sampling as the point 3 at Parri is no more suitable for the fishing because large boulders and centered river water. The selection of this new point at Batangi was based on a small creek joining river Kunhar and it has the possibility of potential of fish concentration on the basis of food availability coming in the creek. This is situated at 34°18' 8.12" N 73°26' 32.79" E with an altitude from sea level is 2371 feet. The creek has brought some gravels and sand and making the bed suitable for possible breeding of the fish. Water flow is slow and river water is greyish muddy while the stream water is clear. Water temperature is 16°C and pH is 6.5. One fish of 125 grams and 15 cm long has been caught here.

Fishing at Point-1 Batangi

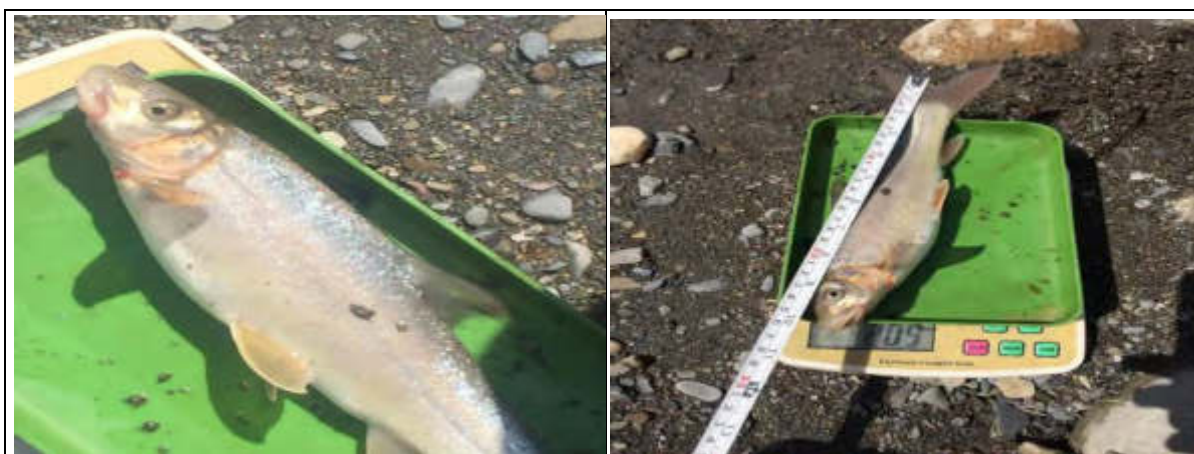
This second sampling point of the study is situated at $34^{\circ} 18' 19''$ N, $73^{\circ} 26' 44''$ E at an elevation of 2422 ft above mean sea level. The water flow is slow, air temperature at this point is 32°C , water temperature 16°C and pH 6.5. River guards are placed by the project authorities here to control the pedestrian movement along the riverside to take care of any sudden flooding in the river. The river water was flodded by opening the gates on 7th of April and sign of inundation is visible at the sides. One fish (*shizothorax plagiostomus*) could be caught here with a weight of 211 grams with 26 cm length.

Fish caught at point-2

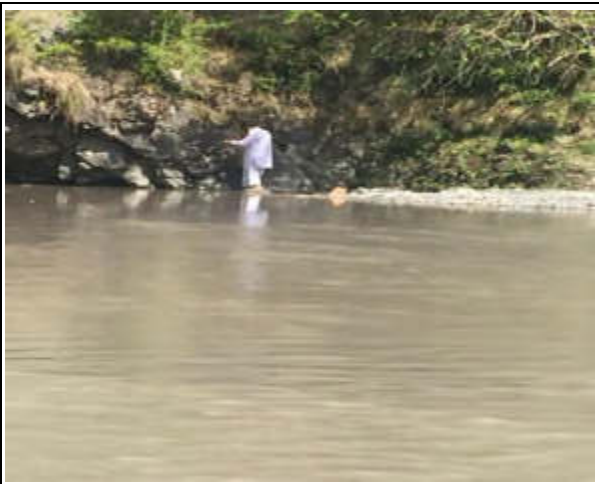
The third point of sampling is Domail at the junction of Nallah Boi with River Kunhar. This point is situated at $34^{\circ} 18' 36''$ N, $73^{\circ} 26' 43''$ E at an elevation of 2398 ft above sea level. The river water is muddy and very slow but nallah water is clear. Air temperature 32°C and water temperature 16°C . The water quantity is low and nallah water has pushed the river more towards the left bank. This is the only bigger source of water contributing in the river Kunhar down the Boi to Domeshi up to the confluence of River Kunhar with River Jhelum. No fish could be caught here. One angler was erecting the line with bat on the left bank of the river and there was no body from the Fisheries department to check him. River Guard of the Hydropower project accessed him to forbid him from coming close to the river but he did not seem to listen to him. During the study for management plan development, the department of Fisheries, KPK Government should be asked to place at least one Fisheries watcher on this area to control illegal fishing and avoid any incident of life danger because of sudden river flooding or they should authorize the project guard to exercise the law on their behalf.

<p>An angler fixing the line for catching fish</p>	<p>Nallah Boi joining River Kunhar</p>

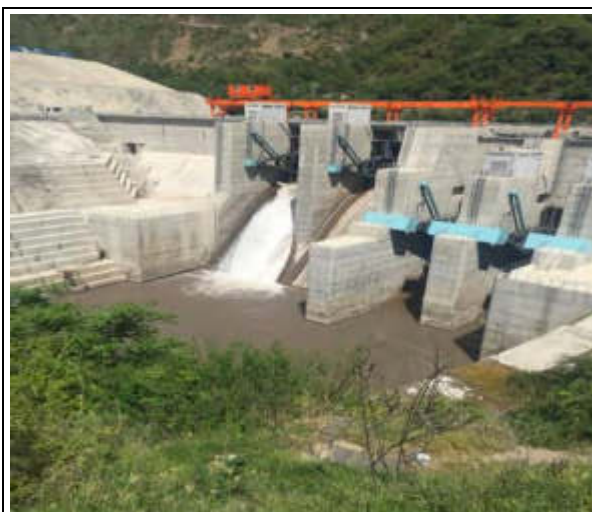
Water flow from the gate

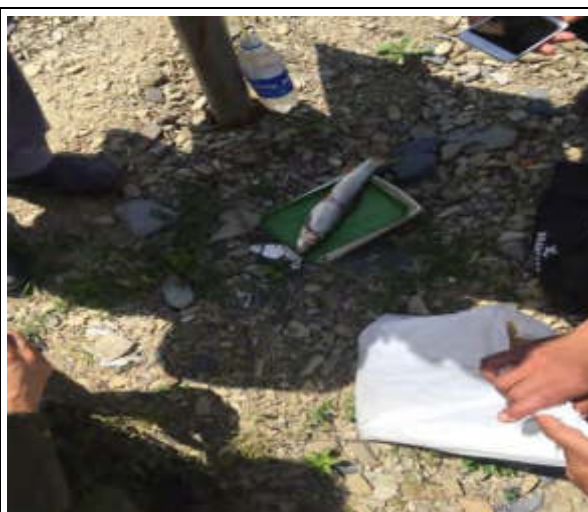
Fish caught here

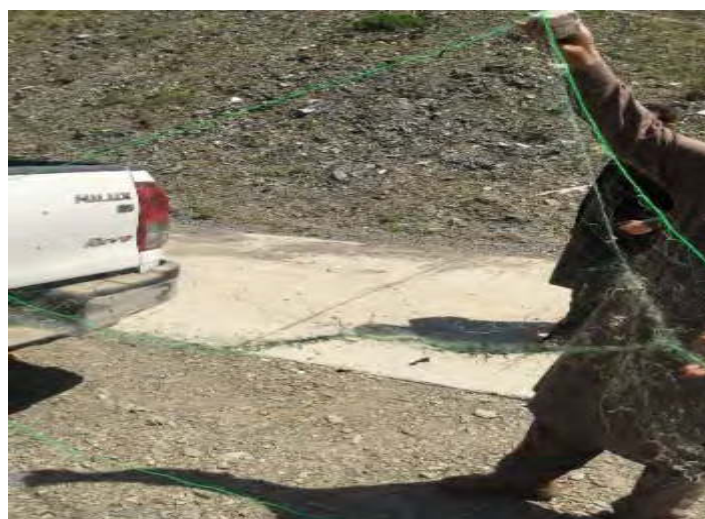
Cast net of 2x2 inch mesh size with a weight of 6 kg has been used and gill net of 1.5x1.5-inch mesh size was used at Point-IV (Weir) to catch fish. A professional fisherman, Mr. Sajid Mehmood was engaged for catching the fish at the sample points of the river Kunhar. Electronic balance was used to weigh the caught fish and normal tap to measure the length. PH paper was used to measure the hardness and TDS meter was used to measure the total dissolved solid and DO meter for the dissolved oxygen in the stream water. Water samples were collected for other parameters of the river water.

Gill net placed at Point IV

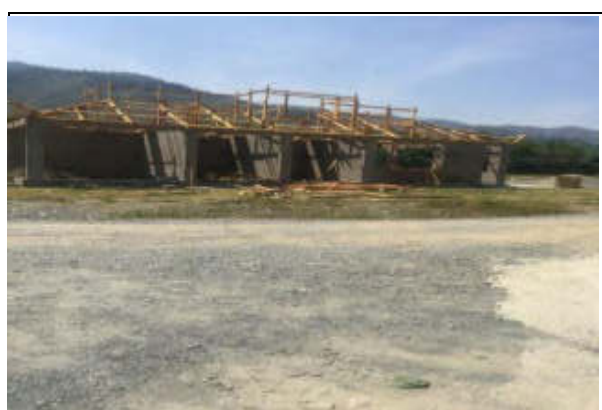
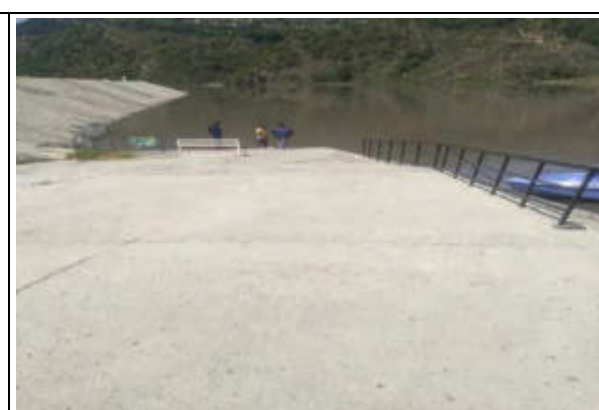
This point lies at 34° 20' 43" N and 73° 25' 01" E with an elevation of 2471 ft above mean sea level. The water flow is almost dead here. Air temperature is 30°C and water temperature 16°C. The water temperature indicates that the winter and summer both impact the reservoir. Only hardy fish, *Gyptothrax* or loaches can survive in this reservoir. Mosquitos and other crustaceans are present at the top surface of the reservoir. No fish could be caught. There is no possibility of fish catch here so it is decided to have another sampling point upstream during the next study for establishing baseline for Fisheries Management Plan. A building is under construction of the park but no proper site selection has been carried out. The Government of KPK has allowed the contractor to construct this building without observing the loss of aesthetic value.

Building construction at Park	Park beside the lake

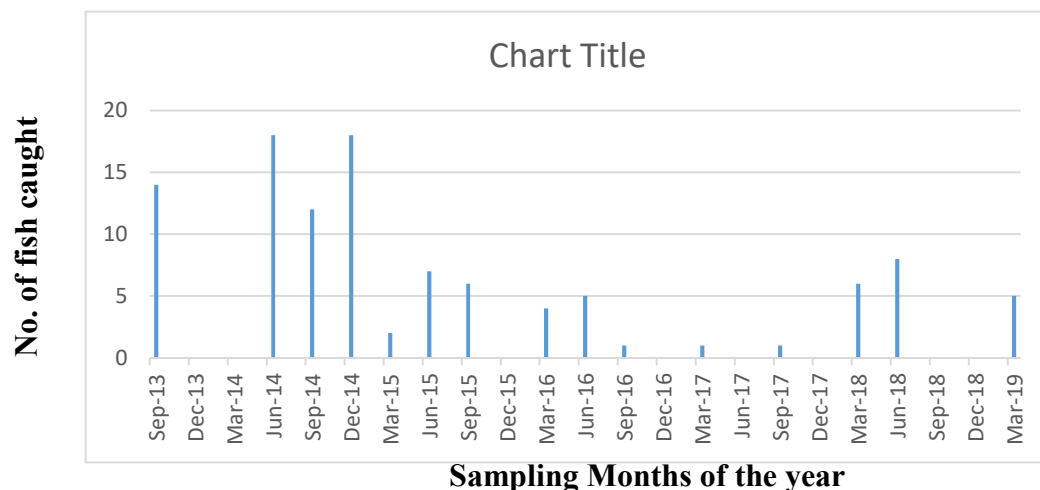
The graph below shows the trend of fish catch over the study period of September 2013 to March 2019

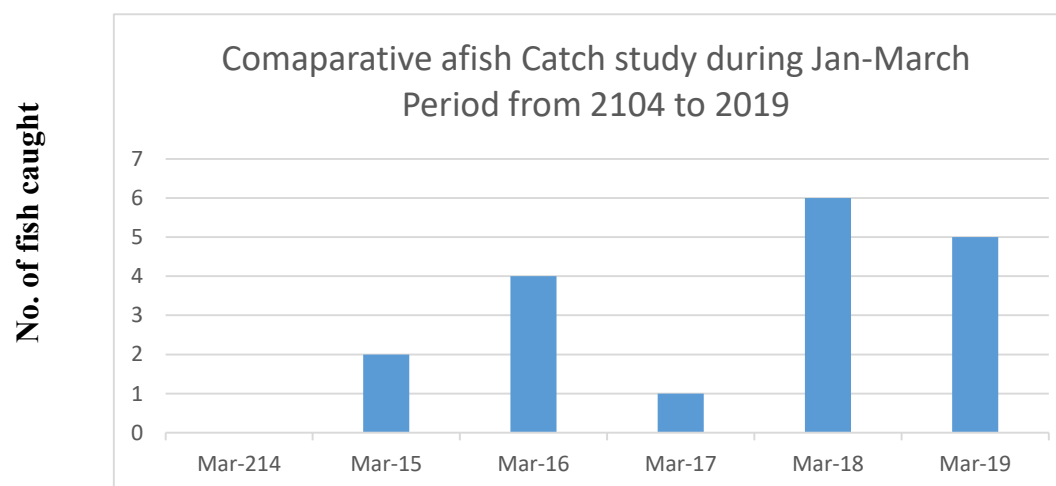
The graph produced below shows the trend of fish catch during the month of march/April covering whole study period, shows that the catch remains almost the same. This is the breeding time of the fish and Schizothrax species migrate from the tail of the river towards up and this migration stops at weir due to obstruction. The bigger size fish is found here during the breeding months (April and October).

Low water flow (2.25 m³/s) in the river has changed the ecology and breeding grounds of the fish. The water is more centered and its quality downstream and, in the reservoir, has changed which has affected the fisheries. A ‘Fisheries Management Plan’ is the process of development which, hopefully, will cater all the aspects of fisheries rehabilitation in the project area of the River Kunhar.

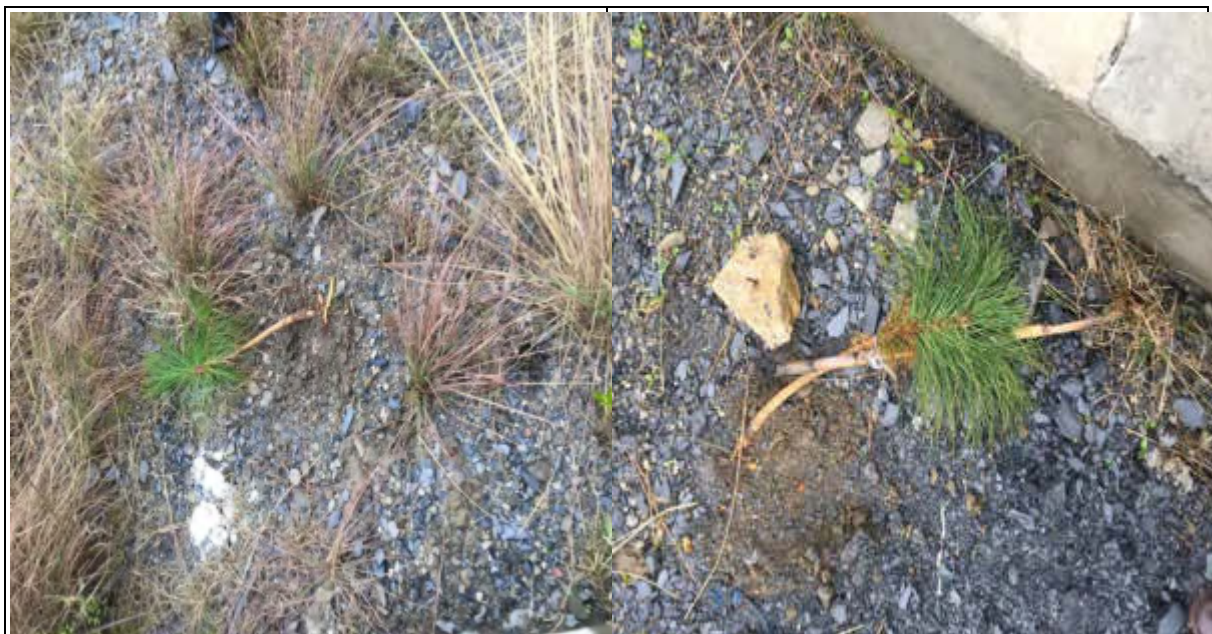
The landslide behind the powerhouse has been treated with some bioengineering works and excellent plantation of suitable species has been carried out. The deep rooted species of Walnut (*Juglans regia*), soil binder species of Injeer (*Ficus caraca*), native species of Chipine (*Pinus roxburghii*), early sprouting species of Mulberry (*Morus alba*) and other soil binder species have been planted on both sides of the project area i.e., powerhouse and weir sides. Inspection on the success percentage has been carried out during the study and it was found that the porcupine has damaged Chirpine saplings along the roadside towards corner 2 and 4 behind powerhouse.

Porcupine damage to Chir Pine trees along the road

EDA facilitated the project by requesting the relevant experts of the University of AJK in seeking their support for controlling the attack of the Porcupine on the newly planted saplings of Chir Pine. Four Scholars headed by Mrs. Nuzhat Shafi, Head of the Zoology Department of the University of AJK has very kindly, visited the area and they assured their full assistance in controlling the porcupine attack on the saplings. They visited the area and promised to carry on the appropriate action in stopping the attack of the vermin.

- ii) The slope area of the weir side has also been planted with selected plants and their success seems to be higher than 60%, which is a good sign.
- iii) Fresh plantation of Chir pine along the road behind the powerhouse has been damaged by the porcupine. University scholars of AJK have committed to control the vermin attack. This area needs to be re-planted either by Chir pine or deodar saplings can also be tried as they are not attacked by the porcupine.

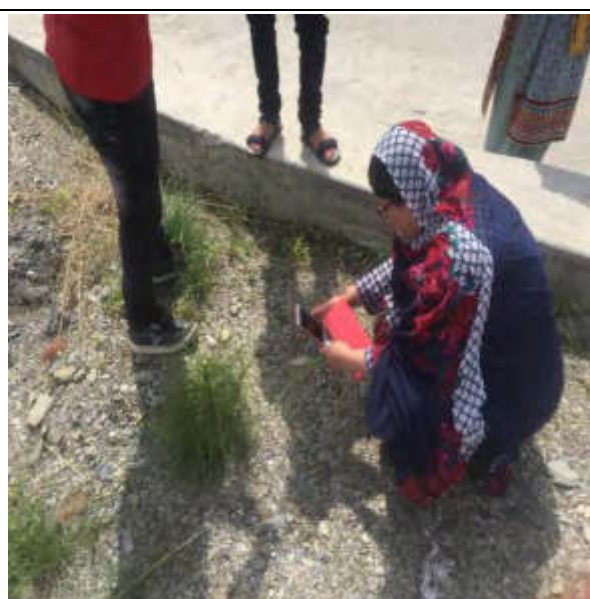
Head of Zoology Department of AJK university assistance in controlling the porcupine attack on the saplings

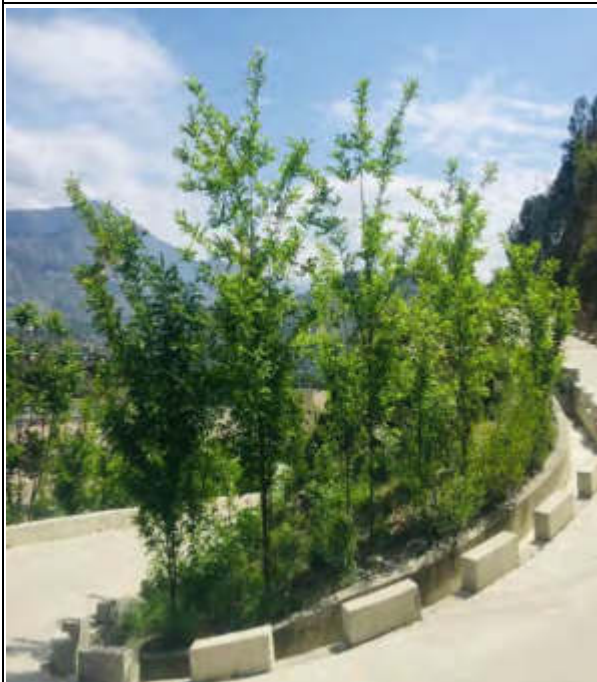
Lush green view of plantation of last year

- v) Plantation carried out two years back have shown a good result and plants are grown up and established their root system in the soil.
- vi) Dieback of the species is no more a problem and the plant species growing on both sides of the impoundment are in a good health condition.

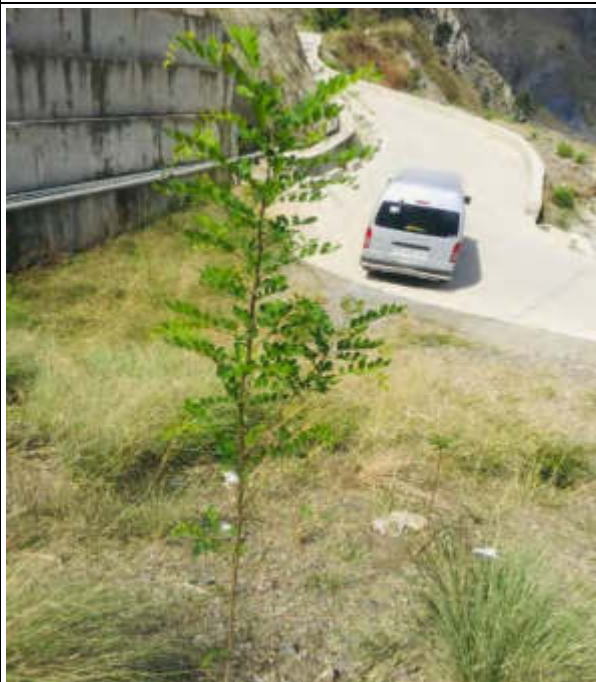
A good view of sprouted plant planted this year

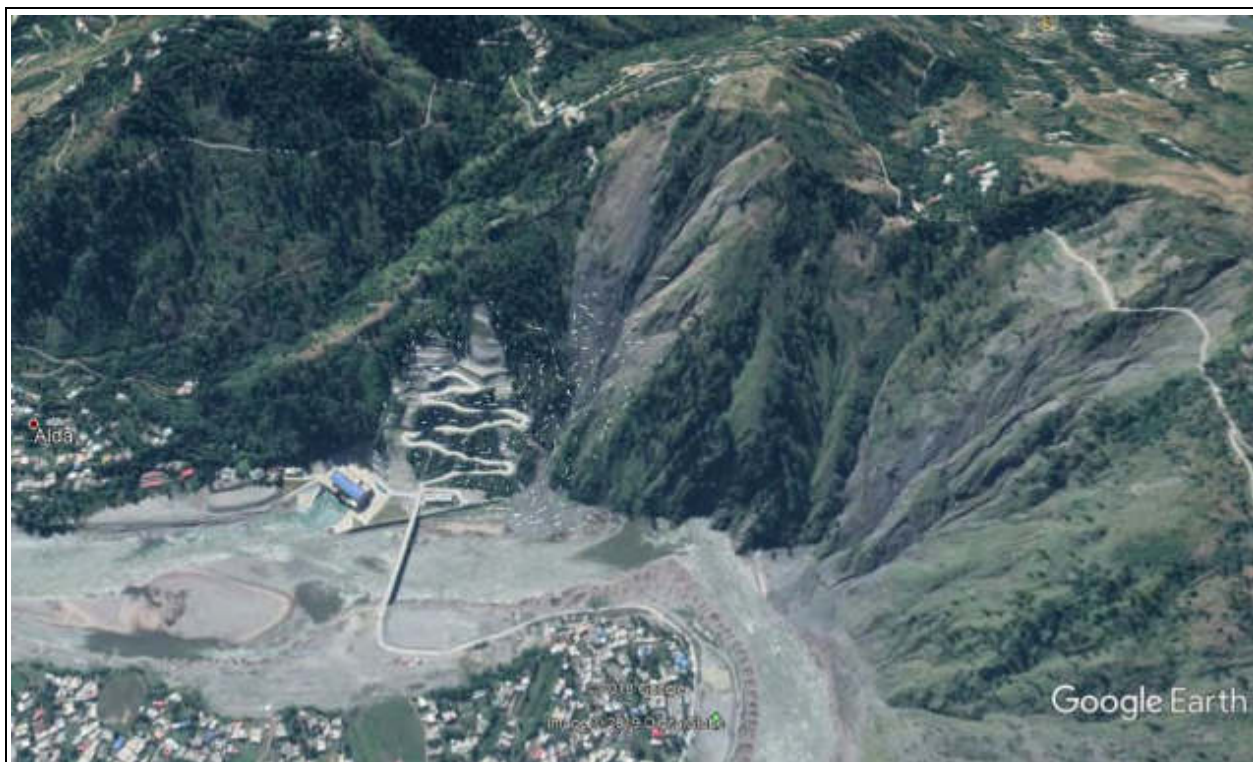
The slide area was also planted by the project authority and some area was taken up by the Forest Department of AJK. The plantation carried out by the forest department in the live slide area has been damaged by erosion. They have also constructed gabion check walls of dry stone masonry to control the soil movement in the slide area.

Image showing the fresh planted and gabion check walls fixed area behind the powerhouse

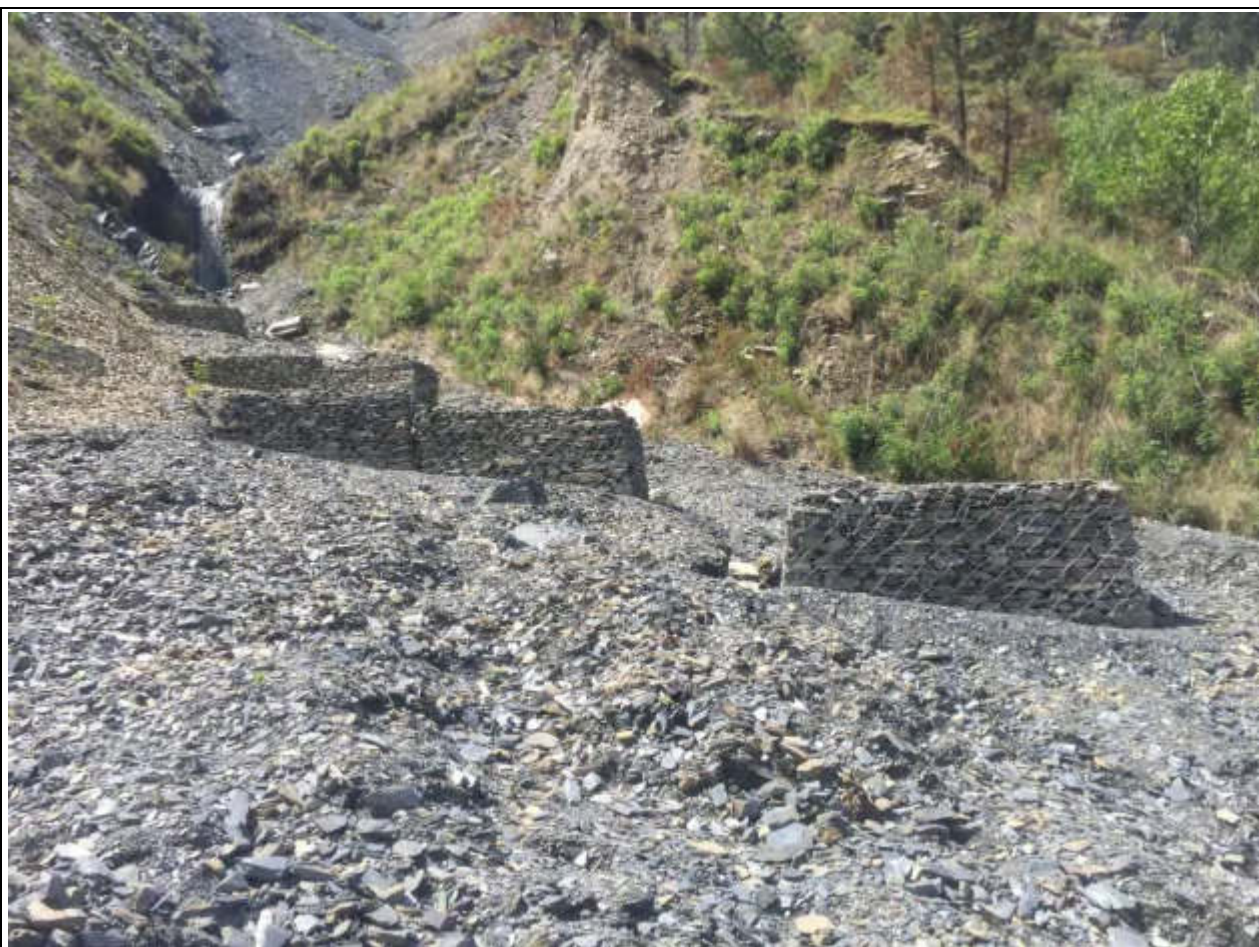
Picture showing project plantation at the base of the slide and gabion work by Forest Department

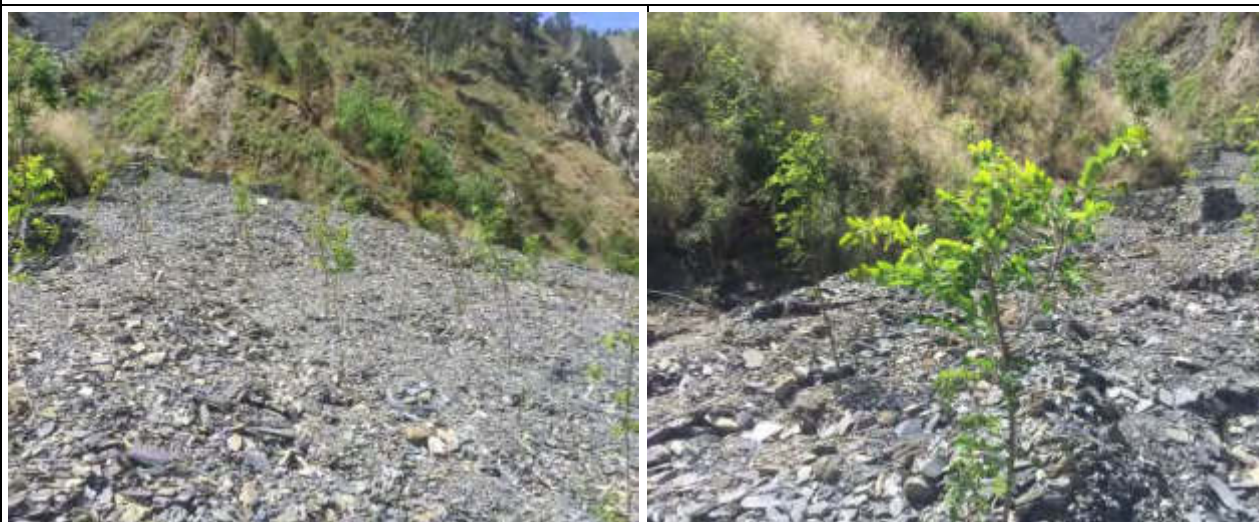
Plantation along the river bed to stabilize the area

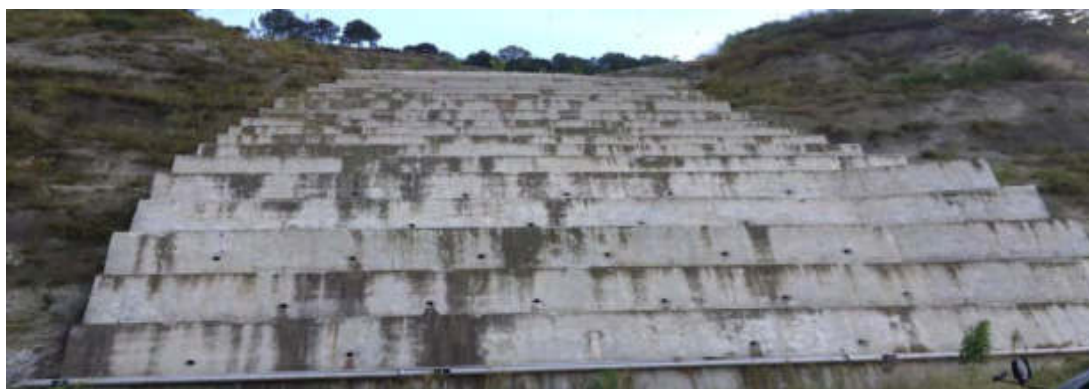
- viii) The dense cover of weed (*Benthium* species) observed last time has been removed and this shows the action on the recommendations.
- ix) The concrete area behind the powerhouse has many steps. Floral earthen pots of larger size should be placed here with plant climbers and creepers. This will make good green look of the area.

Pic: Concrete beds ideal for putting earthen pots with bails, creepers, and climbers

5. The concreted area have provision of steps which can be used for placing earthen pots with some creepers so that it cloud look green and represent a pleasant view

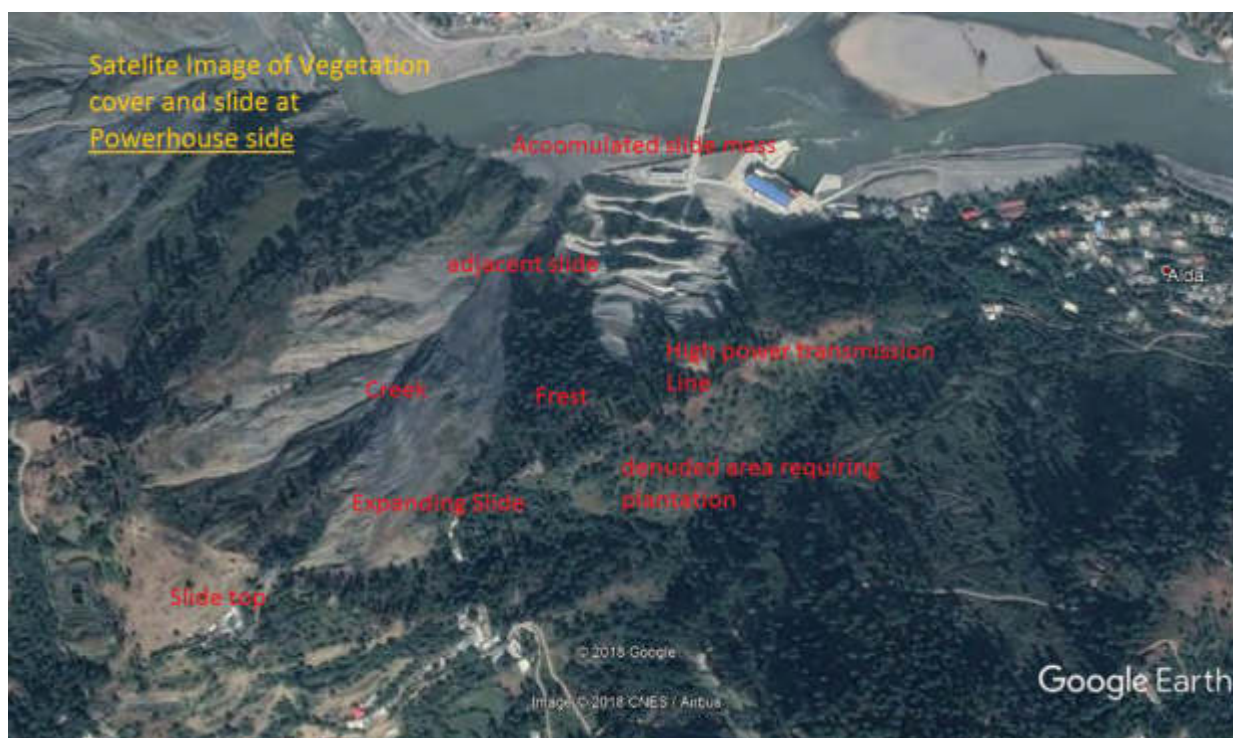
Pic: Satellite image of landslide area with marked details
