## Pakistan: Patrind Hydropower Project

Prepared by Star Hydro Power Limited for the Asian Development Bank.

# **147 MW PATRIND HYDRO POWER PROJECT**

## **Environmental & Social Monitoring Report April 2019 to June 2019**

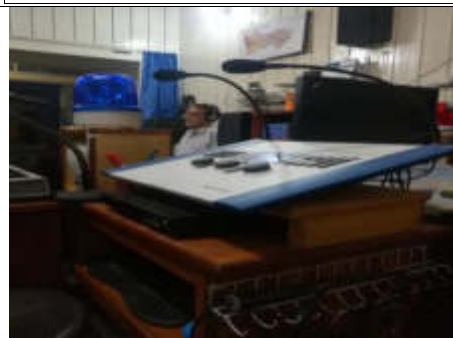
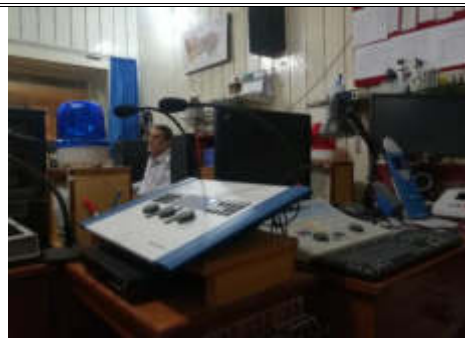
Employees Hearing Tests

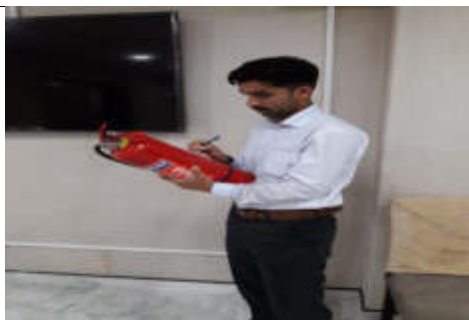
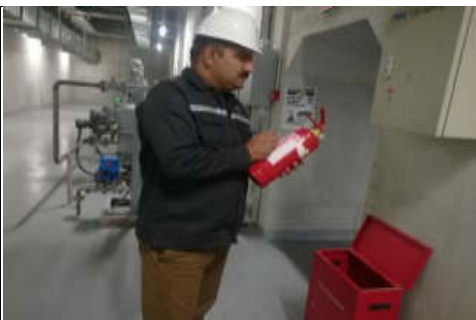
Fire Extinguishers Inspection

- All the fire extinguishers of powerhouse were inspected. Discharged cylinders were replaced with new fire extinguishers.
- Three (03) monthly noise monitoring surveys were conducted by HSE in power complex and nearby community. The result findings were in compliance with NEQS.

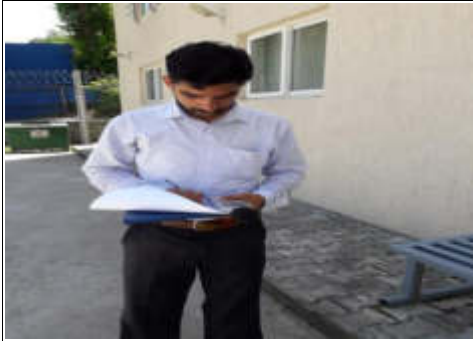
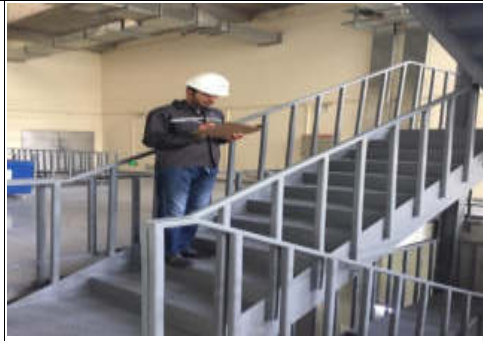
Noise Monitoring

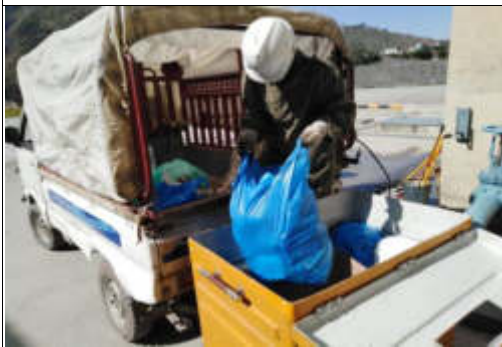
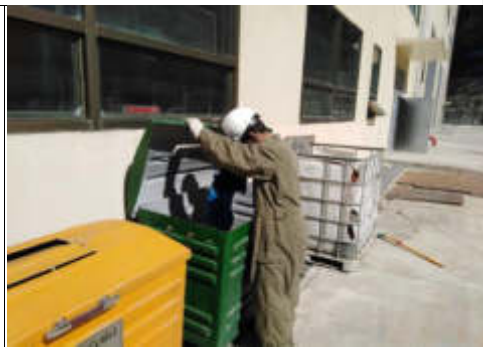
Waste Management

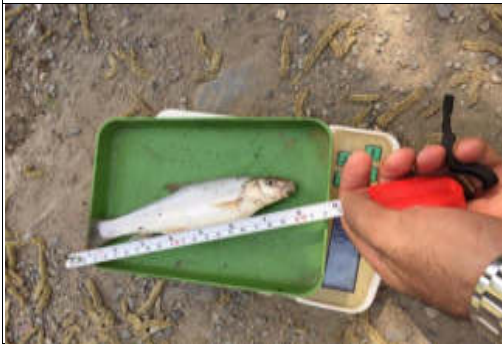
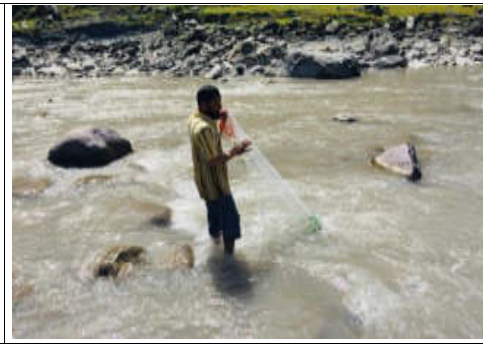
Fish Monitoring Study

- Quarterly fish fauna study/monitoring was undertaken in Kunhar River (Up & downstream of weir site) in the reporting quarter. Sampling was carried out at six (06) study points. Some insignificant changes in the fish catch and quality of water observed during the study; that is only due to the irregular seasonal changes and pattern of water turbidity due to the intensity of rain or drought.

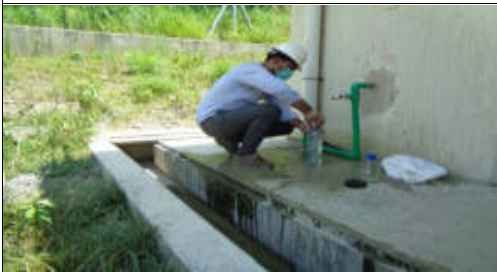
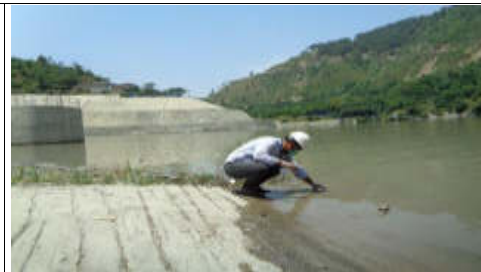
Visit of HSE Team at Kaghan Gauging Station

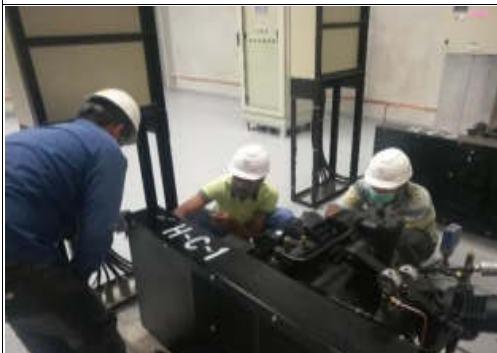
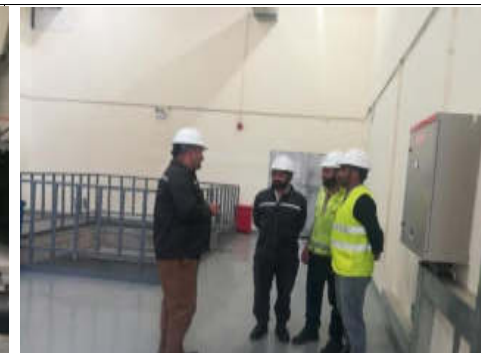
Power House HSE Inspection

issues observed include exposed conductor / panel at weir site; discharged fire extinguishers at some places; stairs sharp edges in B3 area (Powerhouse); and littering around the O&M building etc. All these issues were rectified by the relevant departments.

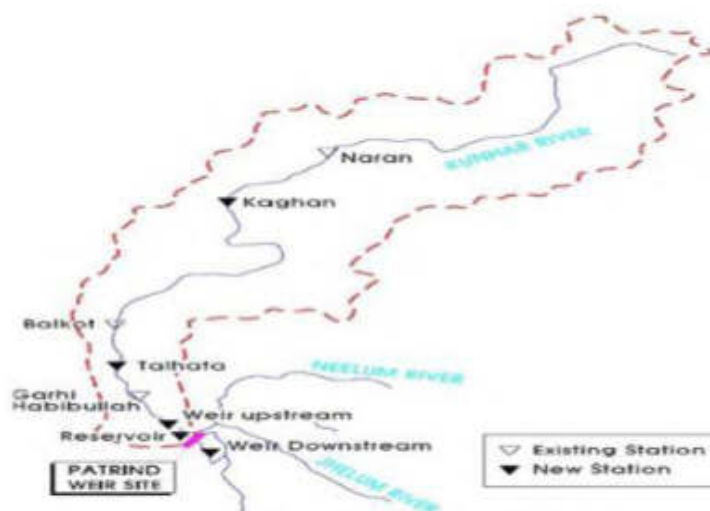
Gauging stations and the reason for selection is given in below table.

Location	Purpose	Installed gauges	Calibration
Kaghan station	Forecasting of floods	Rainfall, Water Level, Temperature	Calibration of each sensor will be on annual basis by third party
Talhata station	Forecasting of floods	Rain & Water Level	
Weir upstream	Monitoring Water flow into reservoir	Water Level	
Reservoir	Monitoring Water flow into reservoir	Rainfall, Water flow, Temp & Humidity, Wind Speed & Direction	
Weir downstream	environmental flow	Rain & Level and e-flow

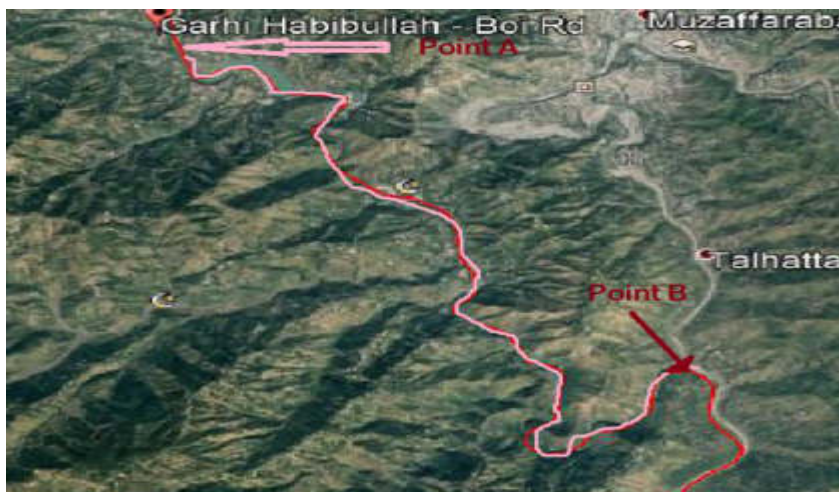
The study area has been divided into six sampling points for comparative impact assessment at a stretch of about 14 km down and upstream. The points selected were based on the potential of existence of the fish, their breeding ground, abundance of food ingredients, confluence of side streams and migration possibility of the fish. Four points were selected during the pre-construction phase of the dam and sampled during the construction and now 02 new sampling points have been set as the fish catch had become impossible at previous Point III (Parri) and Point V (Disposal area). One point towards down side near village Batangi and one at upstream near village Dalola have been set for further assessment. There are two points where sampling has now become impossible; one at Parri (Point-III) where water flow has become centralized and large boulders have made it impossible for casting or erecting any type of net and second is Point-V at disposal area where casting of net in the reservoir is of no use because of the absence of the fish catch and depth of the reservoir water.

River stretch of Kunhar River from Gahri Habibullah (Point A) to the confluence at Rarra (Point B)

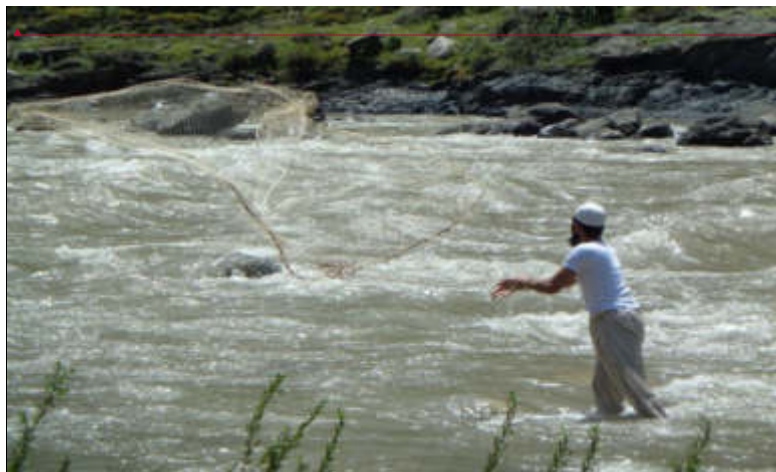
This second sampling point of the study is situated at 34° 18' 19" N, 73° 26' 44" E at an elevation of 2422 ft above mean sea level. Color of the river is muddy greyish and water flow is slow, air temperature at this point is 32°C, water temperature 12.5°C and pH 6.5. Four number of fish (*shizothorax plagiostomus*) could be caught here with a weight of 104 grams with 23 cm length, 153 gms with 25 cm length, 81 gms with 20 cm length, 62 grams with 19 cm length.

*Fishing at Point-2*

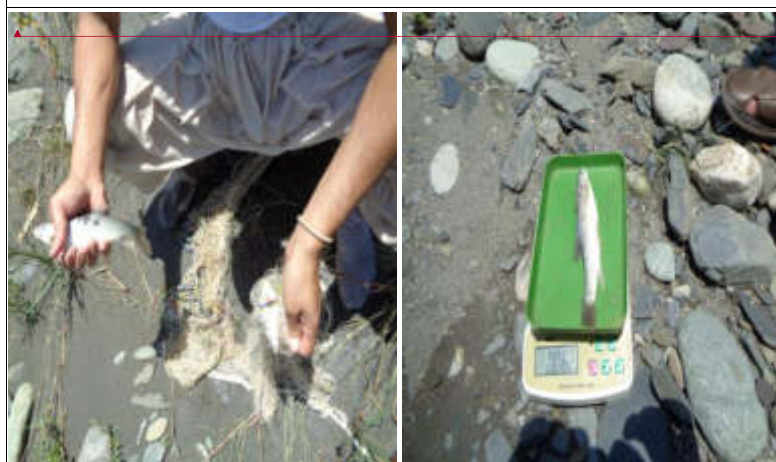
*Fish caught at sampling point 2*

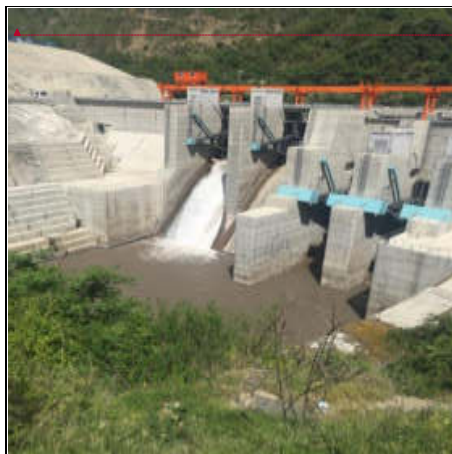
The fourth point of sampling is situated at 34° 20' 30" N and 73° 25' 43" E. with an elevation of 2519 ft above mean sea level. A Gill net of 60 ft by 4 ft size had been placed here one day before the sampling day to catch the fish for assessment. No fish could be caught here this time. During the possible breeding time, a good catch of fish was caught during April and September. The months of April and September-October are the migratory months of the Schizothorax species (*Schizothora plagiostomus*, *S. curvifrons*, *S. dilatate*). The migration is blocked here because of the weir constructed at this point. The water flow is higher (about 60cumecs) because of high water level in the upstream. The pH value of the water is 6.5 and temperature 12°C.

Point IV outlet

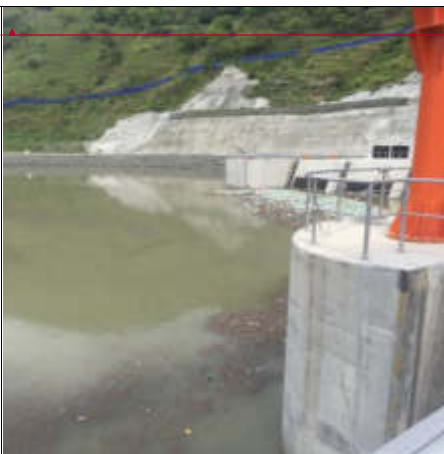
Solid waste accumulation at Weir Point

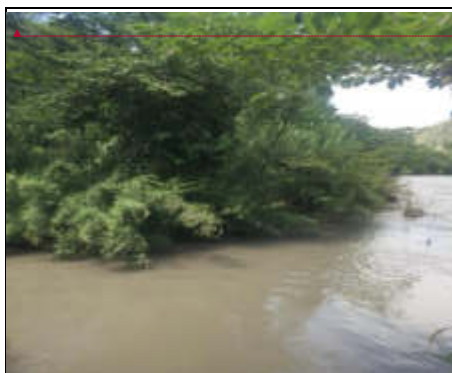
This sampling point is at the tail of the reservoir and is situated at 34° 21' 09" N and 73° 24' 1" E with an elevation of 2556 ft above mean sea level. The flow of water is faster as compared to the last time 25 km/hr. most probably the reservoir water was low because of the release of water during 7<sup>th</sup> of April 2019. The sides of the river are rich and thick in vegetation. The air temperature is 31°C and the water temperature was 12°C with pH 6.5. The area has become a good ground for the mosquitos and mollusks. Ono small juvenile fish (*S. plagiosomus*) was caught here.

Thick vegetation cover at Shorran

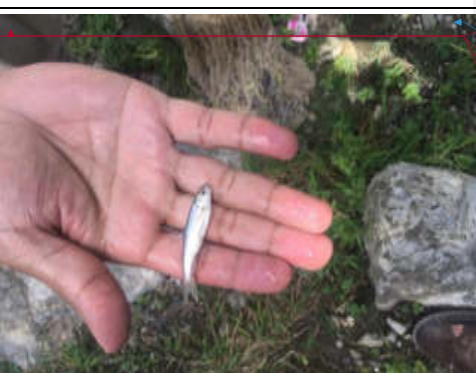
Small juvenile *S. plagiosomus* fish caught at point-V

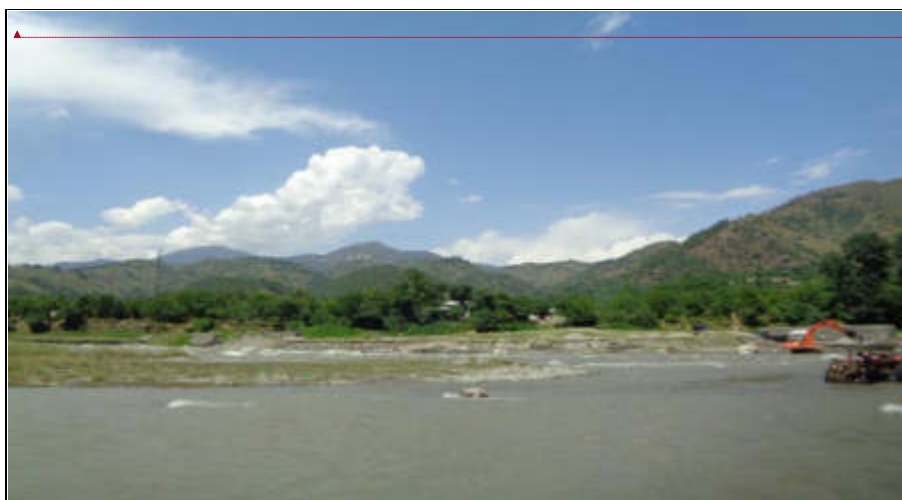
This is a new set sampling point for comparative study. It is situated at 34° 22' E // N and 73° 23' 34" with an elevation of 780 meters. The river flow is quite fast here 35km/h. water temperature is 13°C and ph. 12. TDS 520. There is a stone crusher placed beside the river and many trucks and tractor trolleys visit to transport sand and crush for the market.

▲ View of point-VI

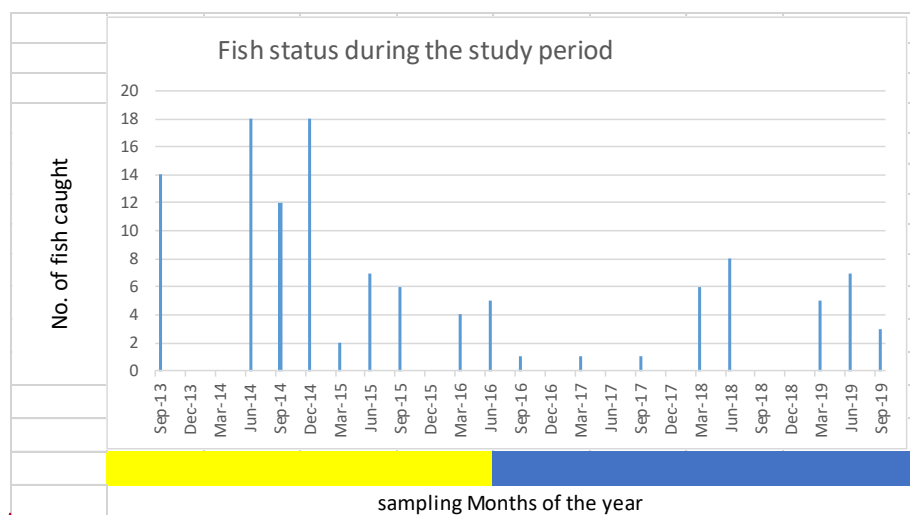
The graph below shows the trend of fish caught over the study period of September 2013 to March 2019

The line graph above shows the changes in the fish catch. After December 14, the fish catch has reduced as the construction of the dam completed during December 2017. After that, the population of fish is re-establishing but improvement can come if breeding grounds are made available to the fish downstream.

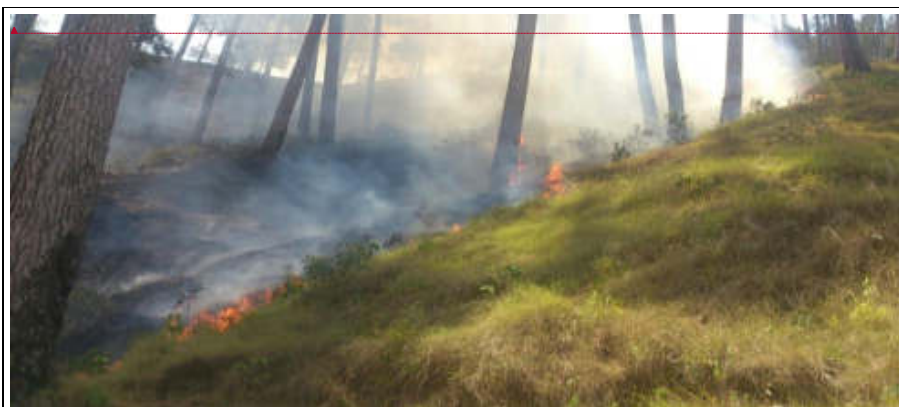
The surrounding area of the powerhouse has badly been disturbed due to forest fire. The area is outside the project but the danger was there for the land under the chirpine species cover as the dry needles on the area are highly combustible to fire.

Picture showing Forest Fire

Manual labor has been engaged by the project to clear the land from grasses as a precautionary measure for fire control. This is wonderful work carried out by the project authorities and should be continued every year.

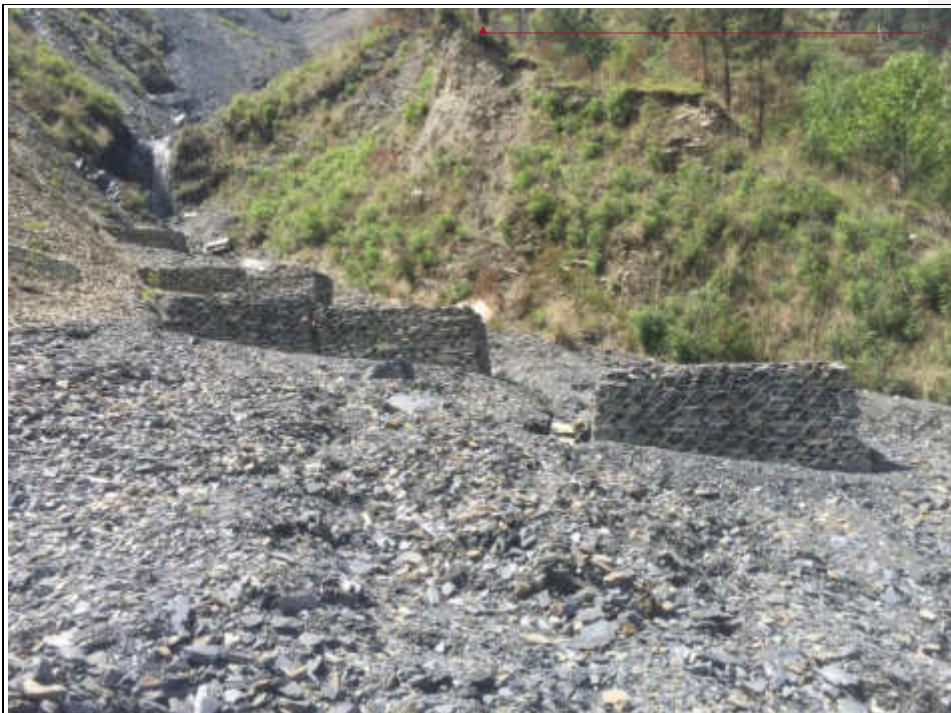
The slide area around Alladra is spreading continuously and needs more intensive effort by the provision of Bio-engineering works and more biological steps during the coming season in January-February 2020. Engineering structures alone cannot control the slides and again this will require a huge amount of funds for engineering structures. The loss of biomass quantum is not so significant as there has been a low vegetative cover in these areas.

Picture showing project plantation at the base of the slide and gabion work by Forest Department during the last quarter

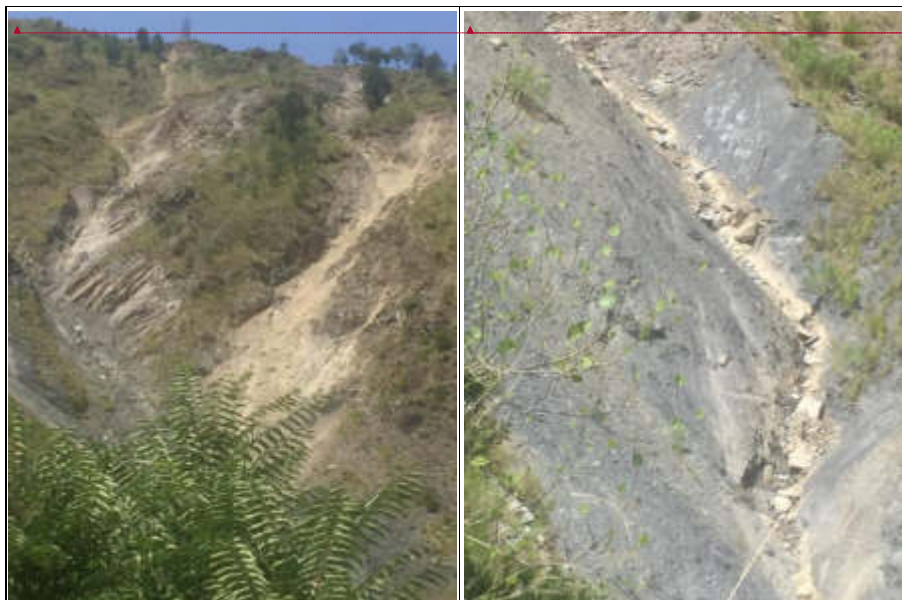
*The expanding slide behind the powerhouse*

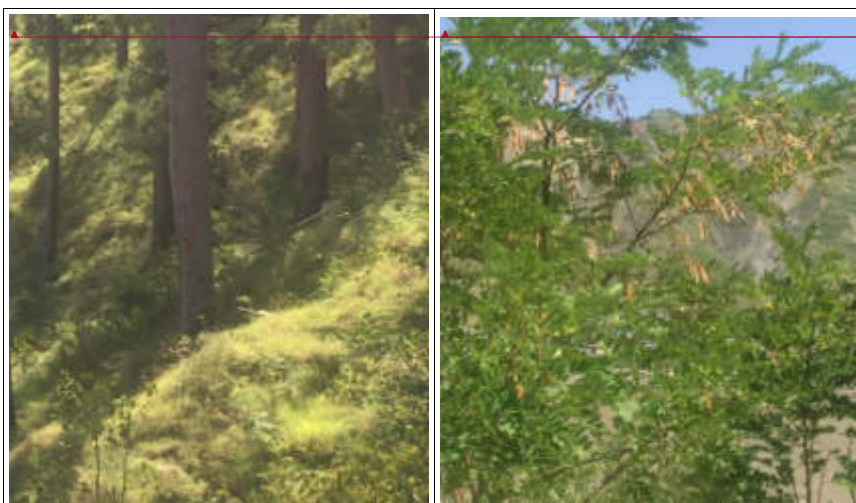
*A fallen tree*

The leaning trees have been removed in light of the recommendations. The pace of compliance of the recommendations is very satisfactory and needs to be continued in the future for controlling the environmental and physical hazards.
