# Environmental and Social Monitoring Report

Project Number: 44914-014  
Quarterly Report (July-September 2019)  
September 2019

## Pakistan: Patrind Hydropower Project

# 147 MW PATRIND HYDROPOWER PROJECT

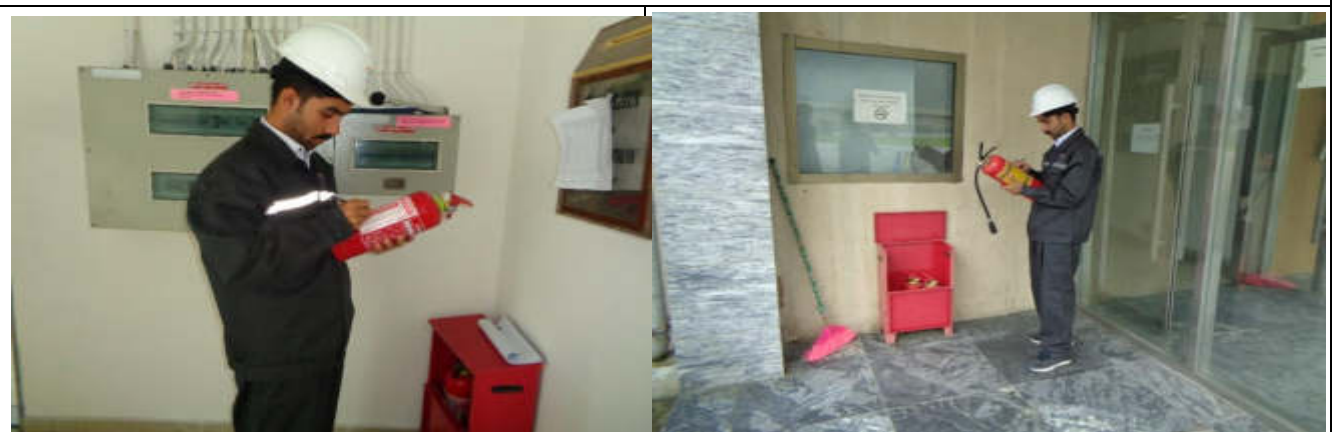
Fire Extinguishers Inspection

- All the fire extinguishers of powerhouse were inspected. Discharged cylinders were replaced with new fire extinguishers.
- Three (03) monthly noise monitoring surveys were conducted by HSE in power complex and nearby community. The result findings were in compliance with NEQS.

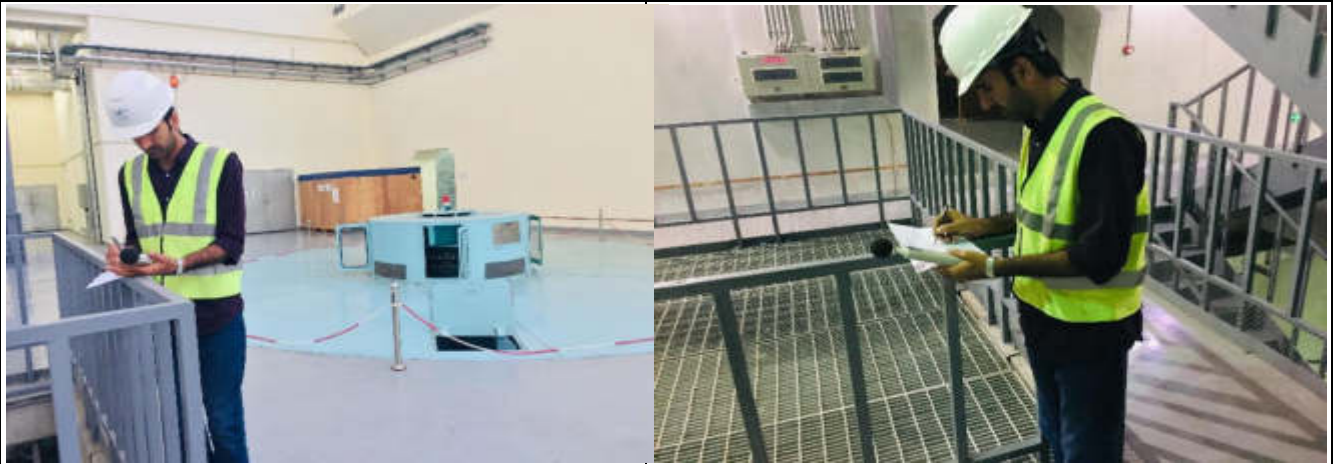
Noise Monitoring

<p>Please refer to <b>Annex-6</b> for the noise monitoring reports.</p> <p>Turbine units are installed at Basement areas 1, 2 &amp; 3. The noise level exceeds in the area depending on the unit operation. Keeping in view the noise level, necessary instructions are communicated to the staff working in that area and proper PPEs are ensured. Noise level in rest of the areas is within the limits.</p> <p>During the reporting period, company procured four (04) hearing muffs on test basis.</p>
	Environmentally-friendly disposal of solid waste	Yes	<p>Waste generated on both sites is being disposed of in an environmentally friendly manner through a third-party waste contractor.</p> <p>Please refer to <b>Annex-7</b> waste transfer notes.</p>
	Development and implementation of CSR Plan and procedure /Community Development Programs	Yes	Please refer to <b>Row XII of Table 2, Section 2.</b>
	Labors / Employees management as per applicable regulations and standards.	Yes	<p>Labors / Employees are being managed as per applicable regulations and standards.</p> <p>An internal grievance redressal mechanism is also in place. Internal GRC has been formed and the complaint box has been installed. A total of six (06) internal complaints received in the reporting period. For details, please refer to <b>Annex-8.</b></p>

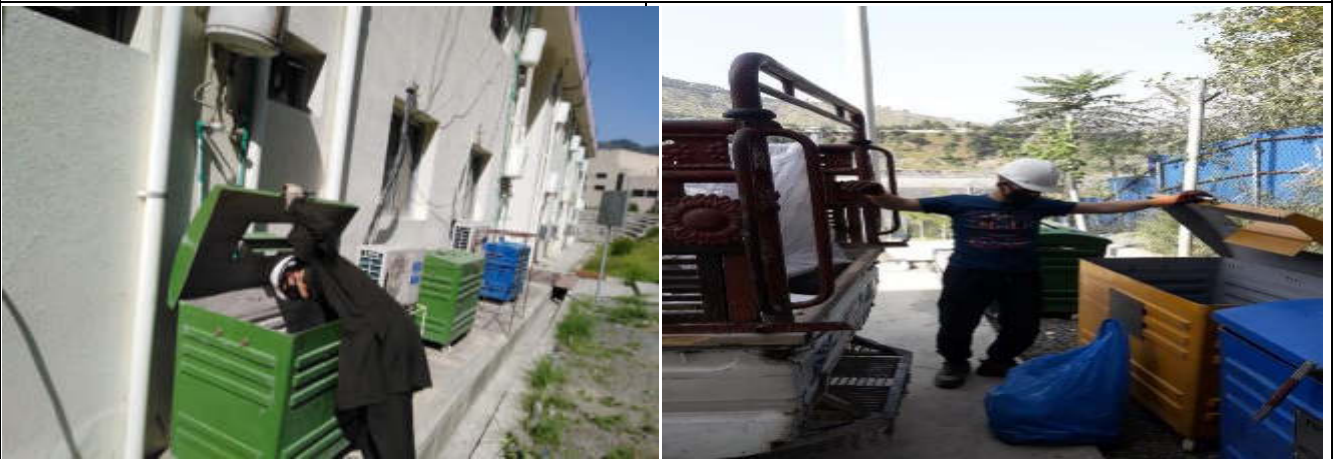
Waste Management

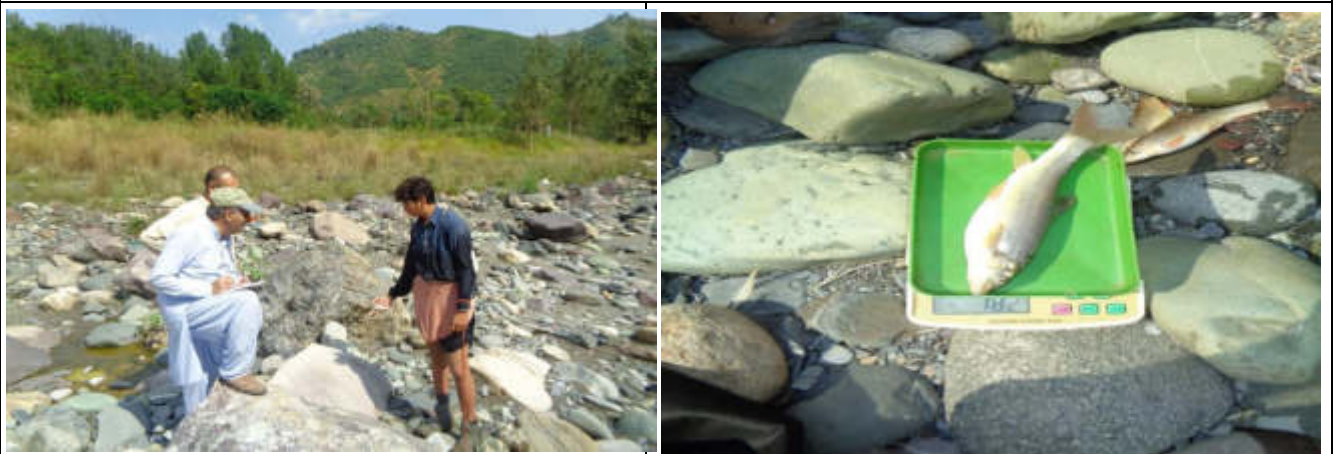
- Quarterly fish fauna study/monitoring was undertaken in Kunhar River (Up & downstream of weir site) in the reporting quarter. Sampling was carried out at six (06) study points. Some insignificant changes in the fish catch and quality of water observed during the study; that is only due to the irregular seasonal changes and pattern of water turbidity due to the intensity of rain or drought.
- Quarterly flora study/monitoring was undertaken at both (Powerhouse & weir) sites in the 3<sup>rd</sup> quarter. Overall there is no significant negative impact of operational activities however due to annual plantation campaigns and presence company security guard's vegetation cover on both sites has been improved significantly.

Fish Monitoring Study

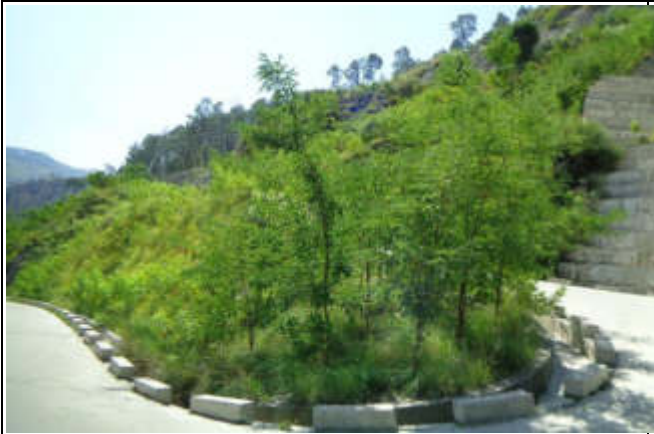
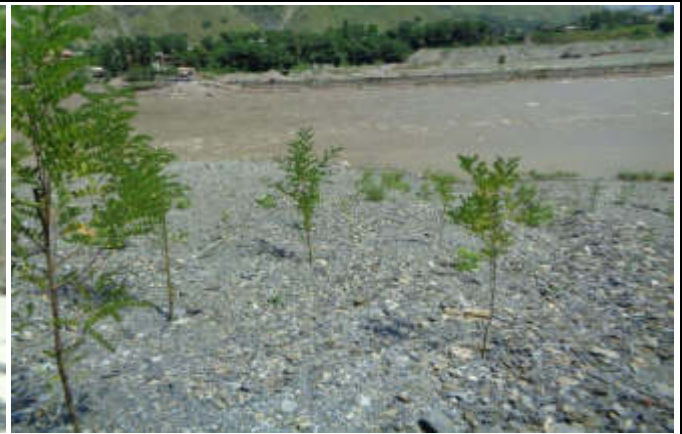
Vegetation Monitoring Study

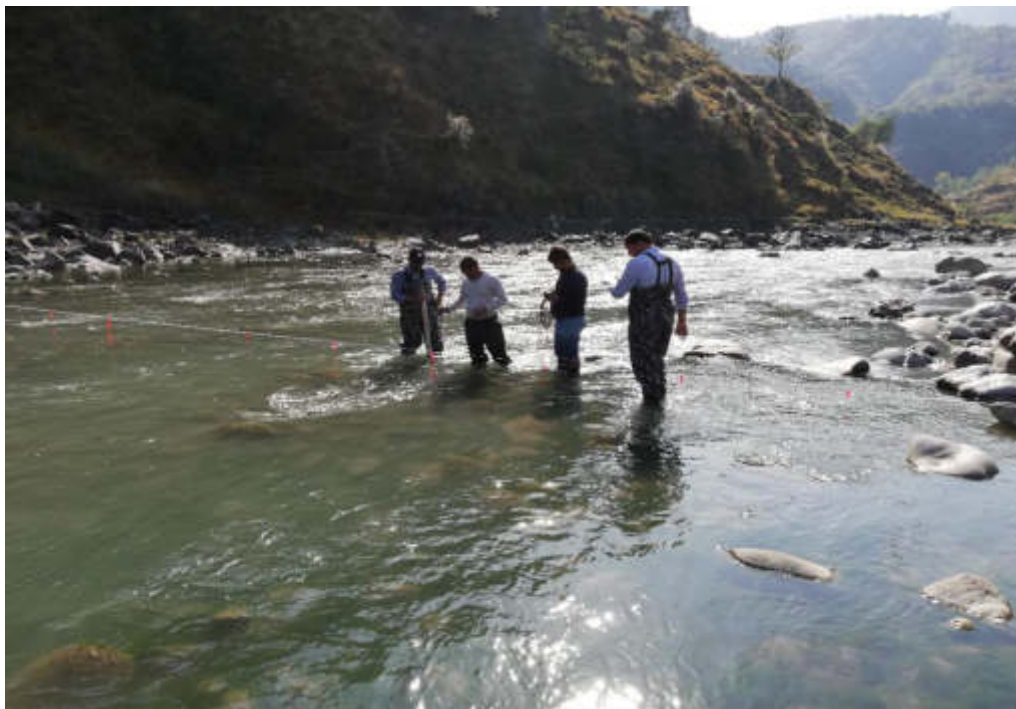
### Weir Downstream

The main purpose of discharge measurement at Bella (Boi) downstream of weir structure is to verify that enough environmental flow is being released by Patrind hydropower project.

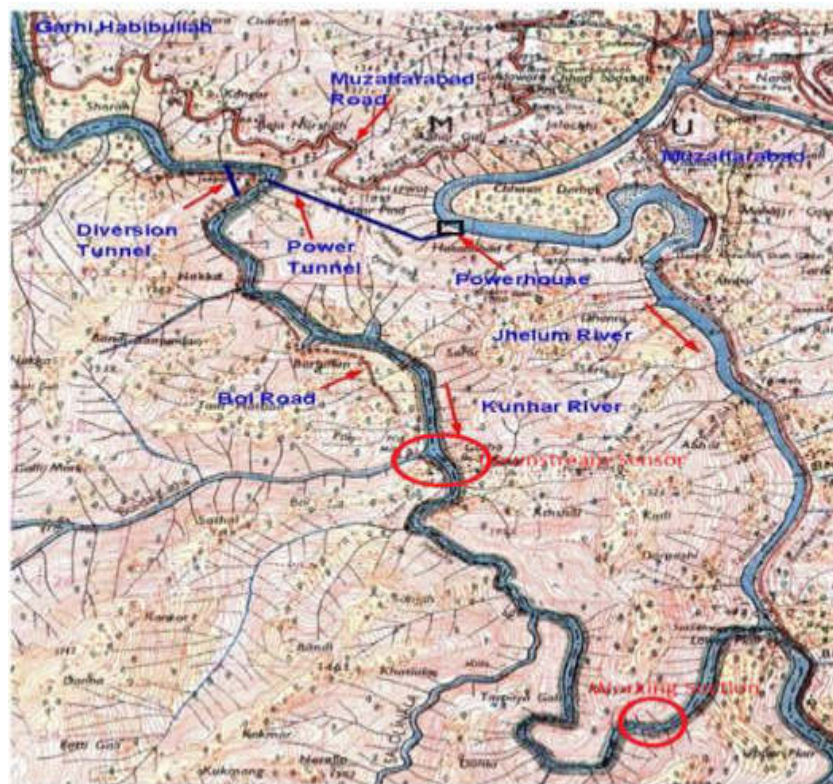
## 3. Site selection

After visiting to several locations, one site i.e. Bella (Boi) has been selected for discharge measurement at weir downstream considering the following aspects.

- The site should be safely accessible and should be in a section of the stream that is free flowing.
- Stream should be straight enough to have uniform form.
- The flow should not be affected by tributaries or tides.
- There should not be any side channels so that all the water flows through the main channel.

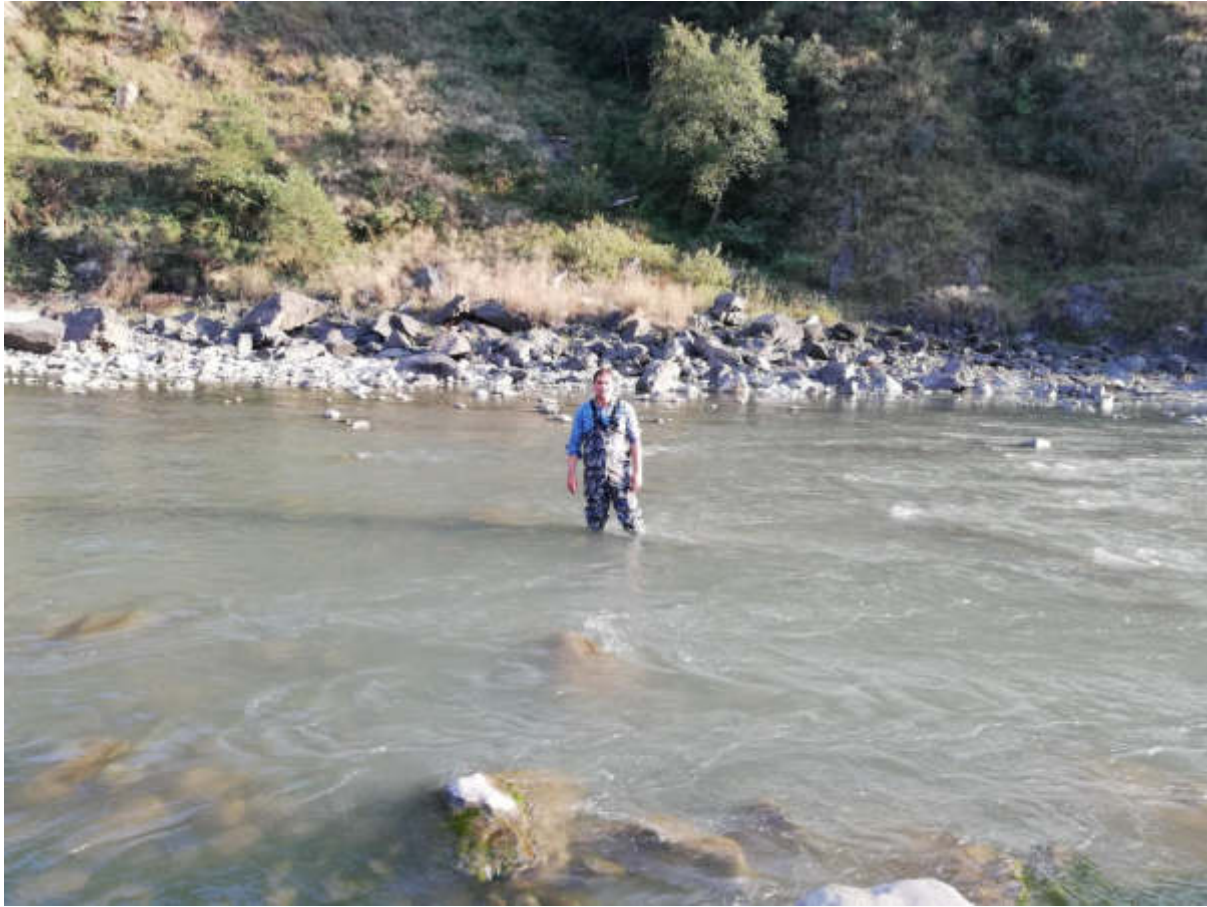
- Areas, where there are large boulders, logs, or thick brush which can create eddies, slack water, turbulence or disturbed flow, should be avoided.

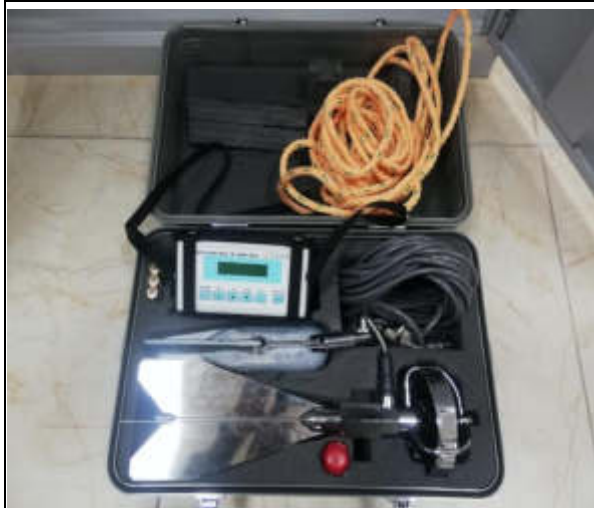
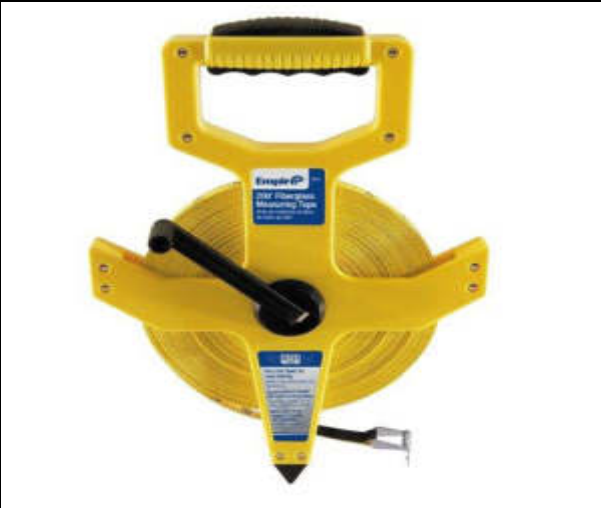
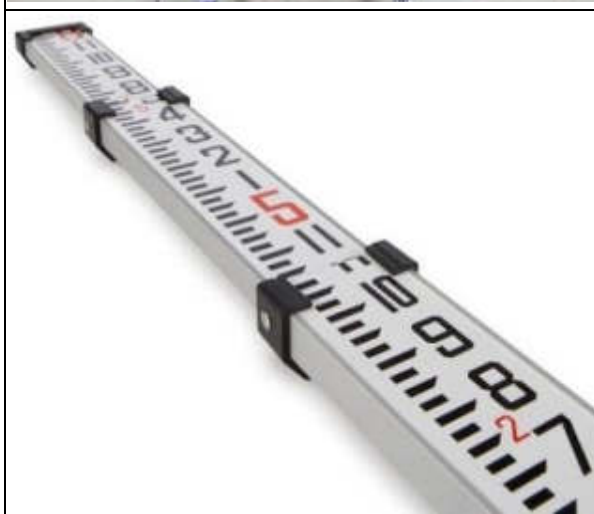
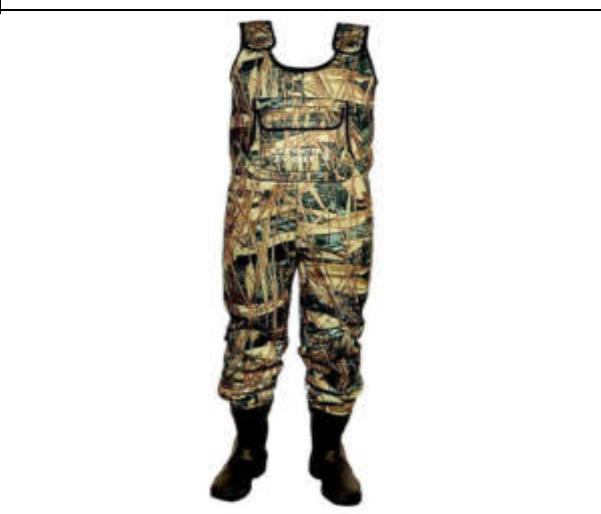
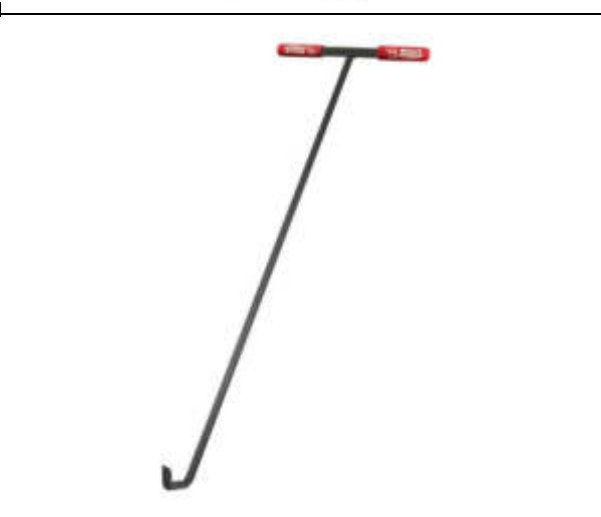
#### **4. Equipment**

- Measuring tape
- Digital Current Meter
- Top-setting rod (if available) or measuring stick
- Paper and pencil for record keeping
- Waders (waterproof garment)

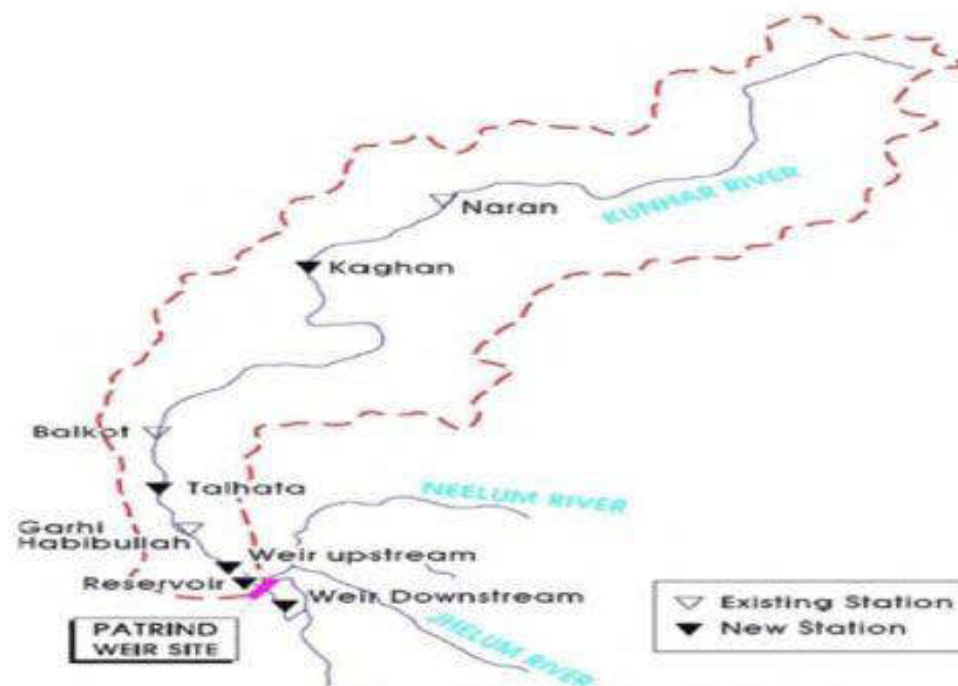
### **Water Sensors Location**

✚ Gauging stations and the reason for selection is given in below table.

Location	Purpose	Installed gauges	Calibration
Kaghan station	Forecasting of floods	Rainfall, Water Level, Temperature	Calibration of each sensor will be on annual basis by third party
Talhata station	Forecasting of floods	Rain & Water Level	
Weir upstream	Monitoring Water flow into reservoir	Water Level	
Reservoir	Monitoring Water flow into reservoir	Rainfall, Water flow, Temp & Humidity, Wind Speed & Direction	
Weir downstream	environmental flow	Rain & Level and e-flow

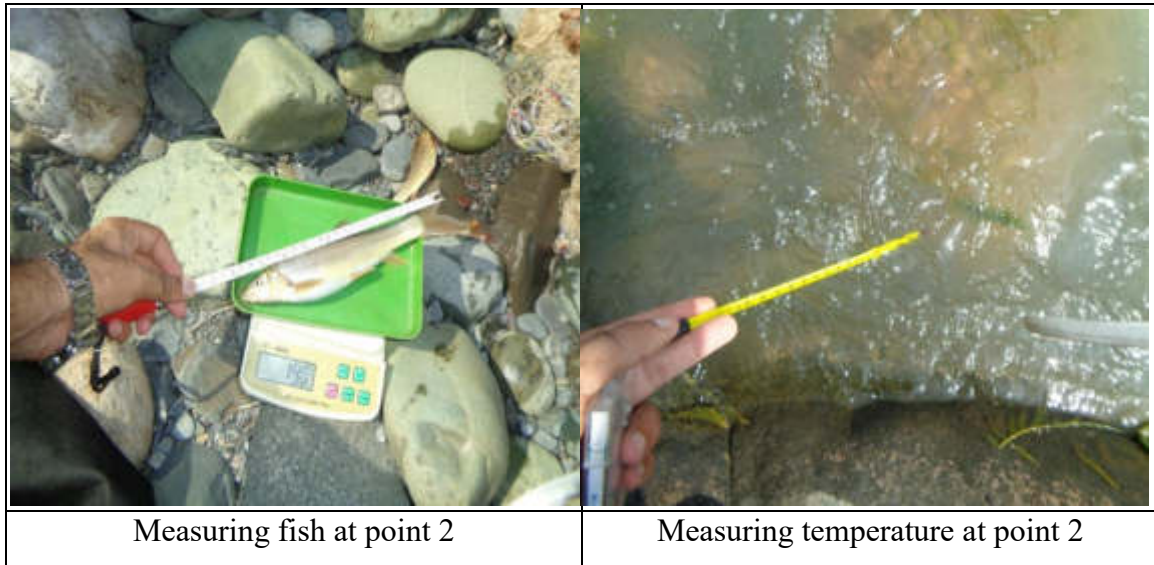
This second sampling point of the study is situated at 34° 18' 19" N, 73° 26' 44" E at an elevation of 2422 ft above mean sea level. Color of the river water is clear and water flow is slow, air temperature at this point is 22°C, water temperature 19°C and pH 6.5. Three number of fish (shizothorax plagiostomus) could be caught here with a weight of 20 grams with 11 cm length, 25 gram with 11 cm length, 25 grams with 13 cm length.

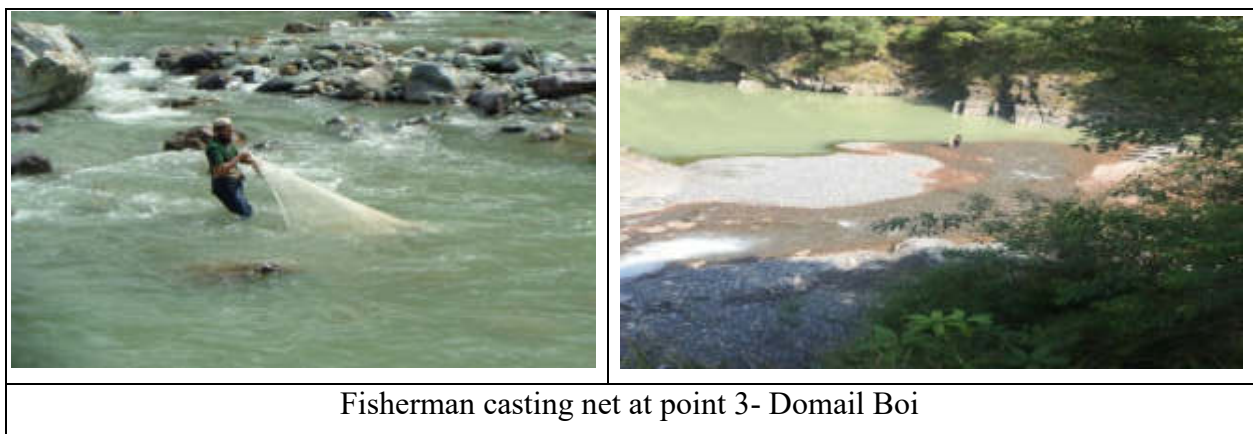
The third point of sampling is Domail at the junction of Nallah Boi with River Kunhar. This point is situated at 34° 18' 36" N, 73° 26' 43" E at an elevation of 2398 ft above sea level. The river and nallah water are clear and very slow. Air temperature is 22°C and water temperature 19.°C. This is the only bigger source of water contributing in the river Kunhar down the Boi to Domeshi up to the confluence of River Kunhar with River Jhelum. No fish could be caught here.

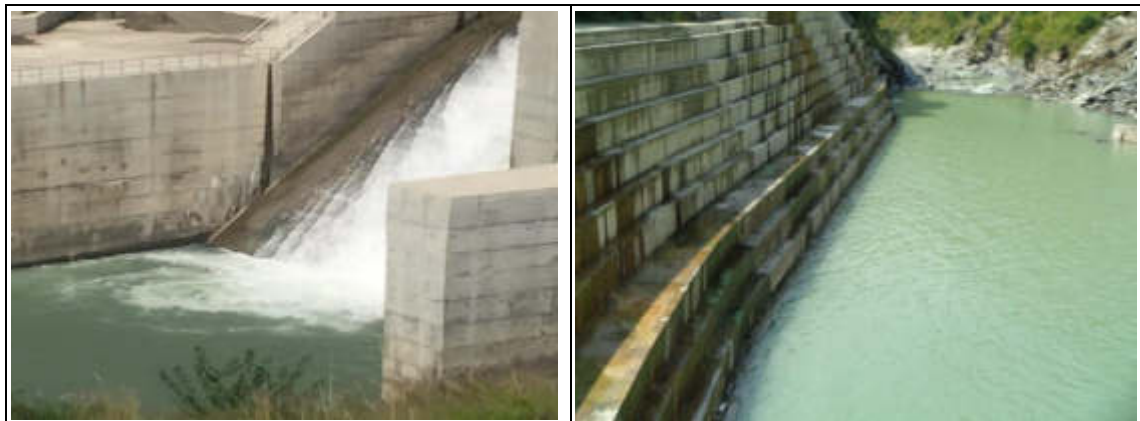
Point 3- Weir Outlet

Fourth point of sampling is situated at 34° 20' 30" N and 73° 25' 43" E. with an elevation of 2519 ft above mean sea level. A Gill net of 15-meter length and 1-meter width had been placed here one day before the sampling day to catch the fish for assessment. No fish could be caught here this time. During the possible breeding time, a good catch of fish was caught during April. The probability of fish migration is possible in September. Further migration is hampered here due to the weir construction. The migration is blocked here because of the weir constructed at this point. The E-flow of the water is maintained as 2.25 m<sup>3</sup>/s. The pH value of the water is 6.5 and temperature 19°C.

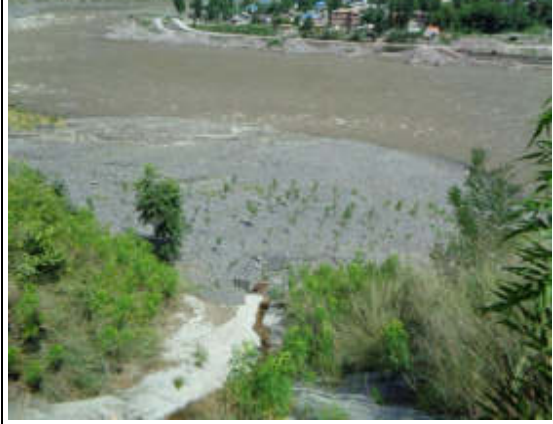
<p><i>Plantation at the base of Alda landslide</i></p>	<p><i>New Chirrpine saplings behind the residential area</i></p>

The plantation carried out last time is showing good results except the chirpine saplings planted towards the corner 3 and 4. This has been fully damaged by the Porcupine and need to be replanted with taking measures to control the porcupine attack.

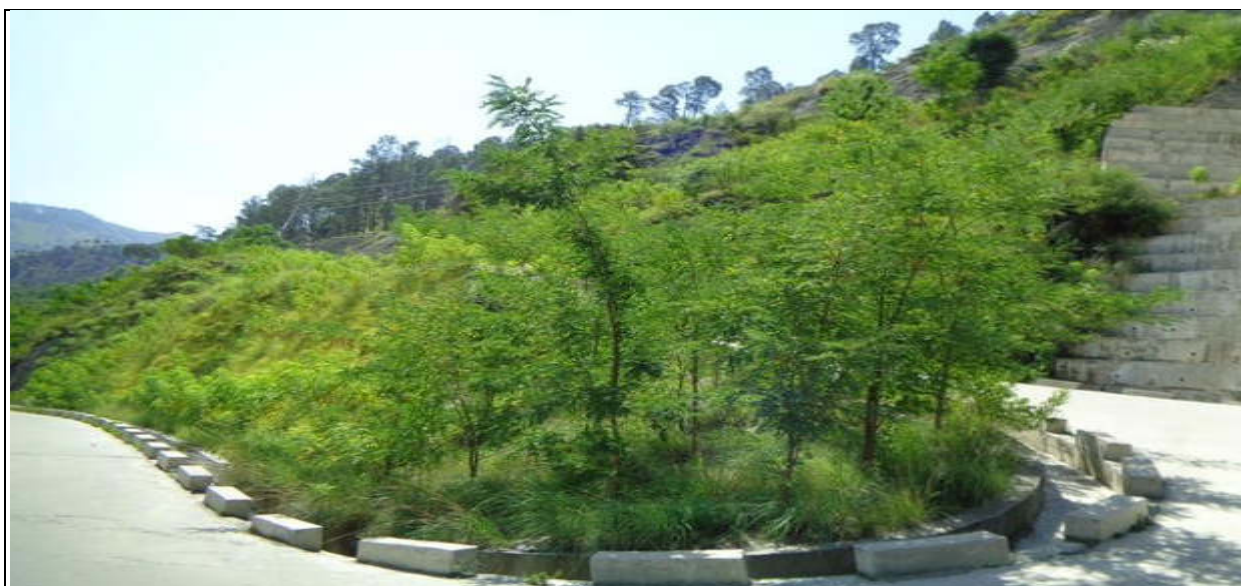
Three years plantation at Corner-1 of the back of the powerhouse

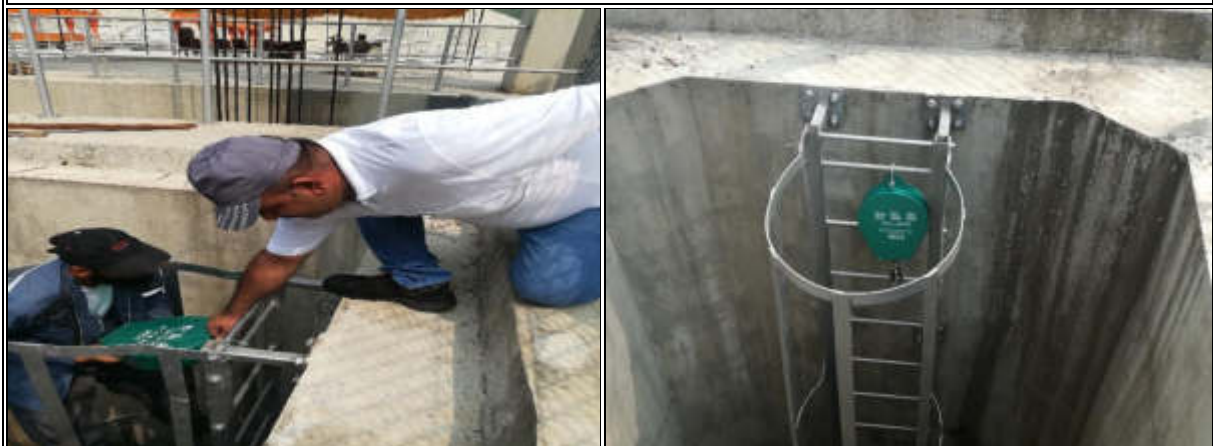
Installation of Fall Arresting Device at HRT Access

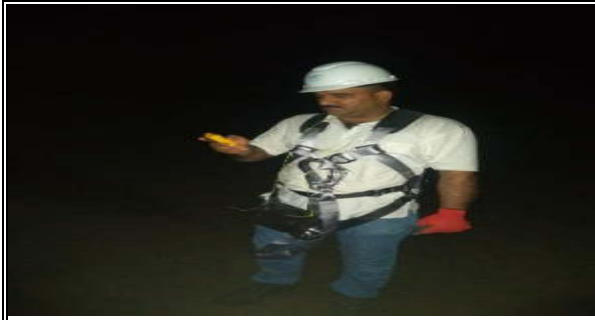
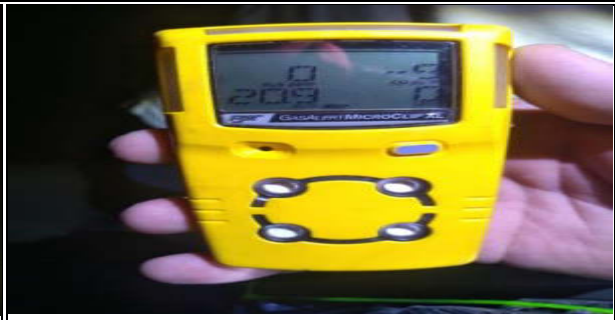
**Gas testing inside HRT**

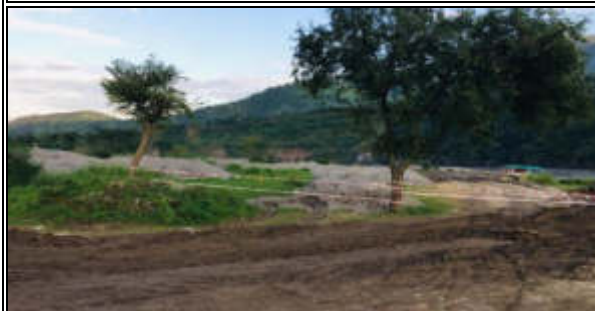
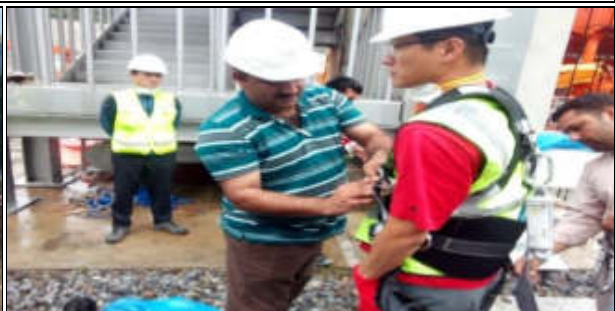
**Barricading the Area to Stop Vehicle Movement**

**Wearing Body Harness with Double Lanyard**
