Project Number: 44914-014  
Quarterly Report (January-March 2020)  
March 2020

## Pakistan: Patrind Hydropower Project

# **147 MW PATRIND HYDROPOWER PROJECT**

## **Environmental & Social Monitoring Report January 2020 to March 2020**

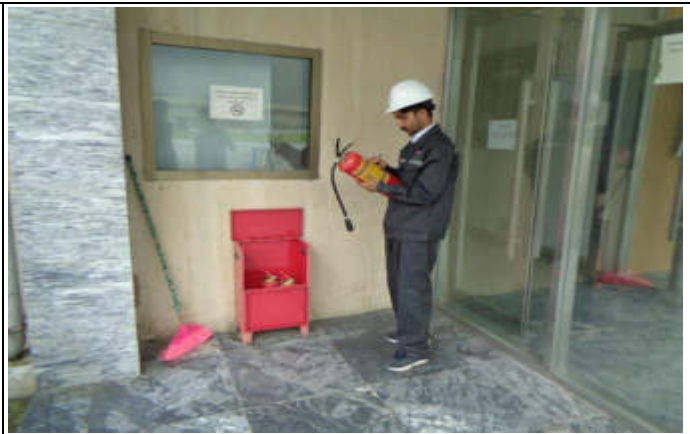
Fire Extinguishers Inspection

2.	<u>Fire Extinguisher inspection</u>	<u>Empty fire extinguishers found at police check post at power house</u>	<u>Refilled fire extinguishers were placed with the empty one.</u> <u>Empty fire extinguishers were sent for the refill.</u>

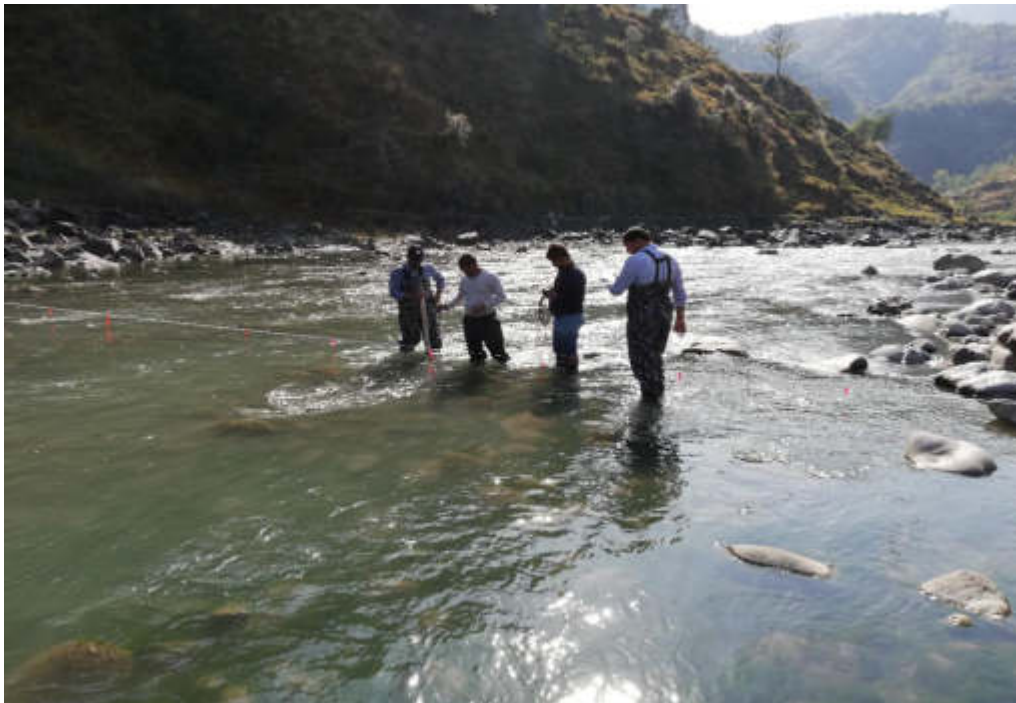
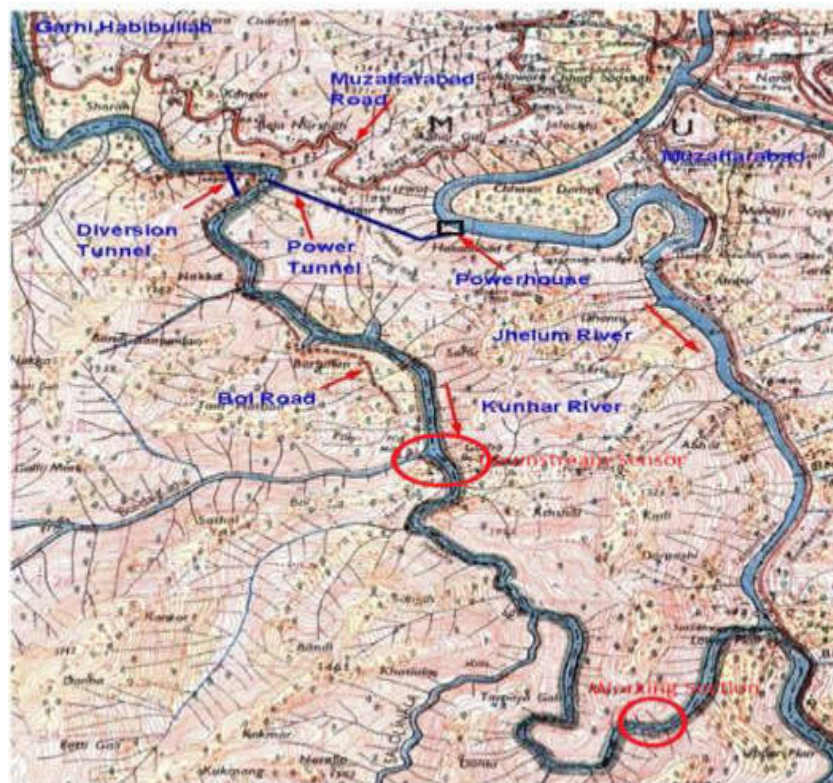
The main purpose of discharge measurement at Bella (Boi) downstream of weir structure is to verify that enough environmental flow is being released by Patrind hydropower project.

After visiting to several locations, one site i.e. Bella (Boi) has been selected for discharge measurement at weir downstream considering the following aspects.

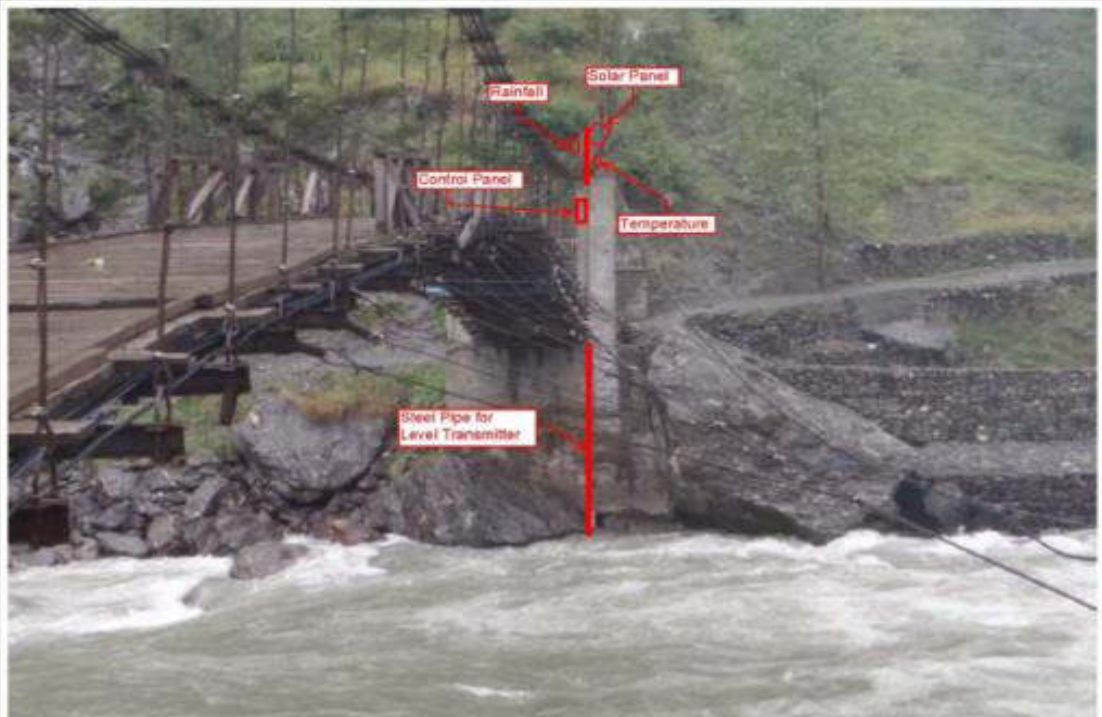
❑ Assumption Diagram

Kaghan measuring station will be located at 74km upstream side of the weir. The flood from the Kagan station comes into the weir site after 4.5 hours later. Therefore it will provide necessary precaution time against floods situation from upstream of Kunhar river.

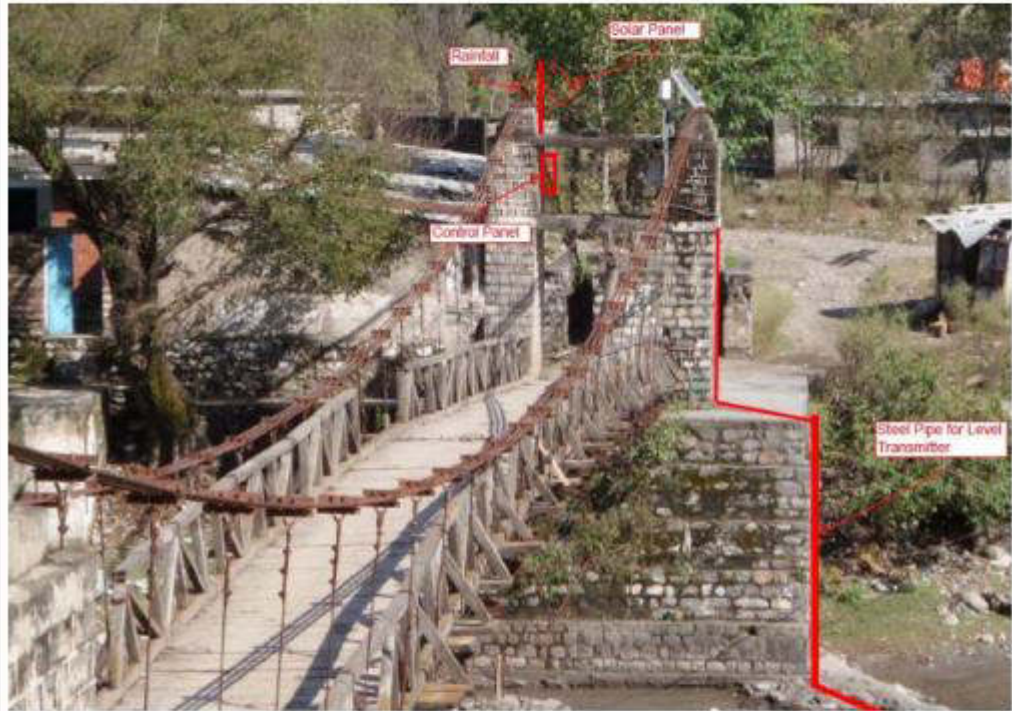
### ❑ Assumption Diagram

Talhata measuring station is located at 13km upstream side of the weir. More accurate water flow data can be achieved from this station.

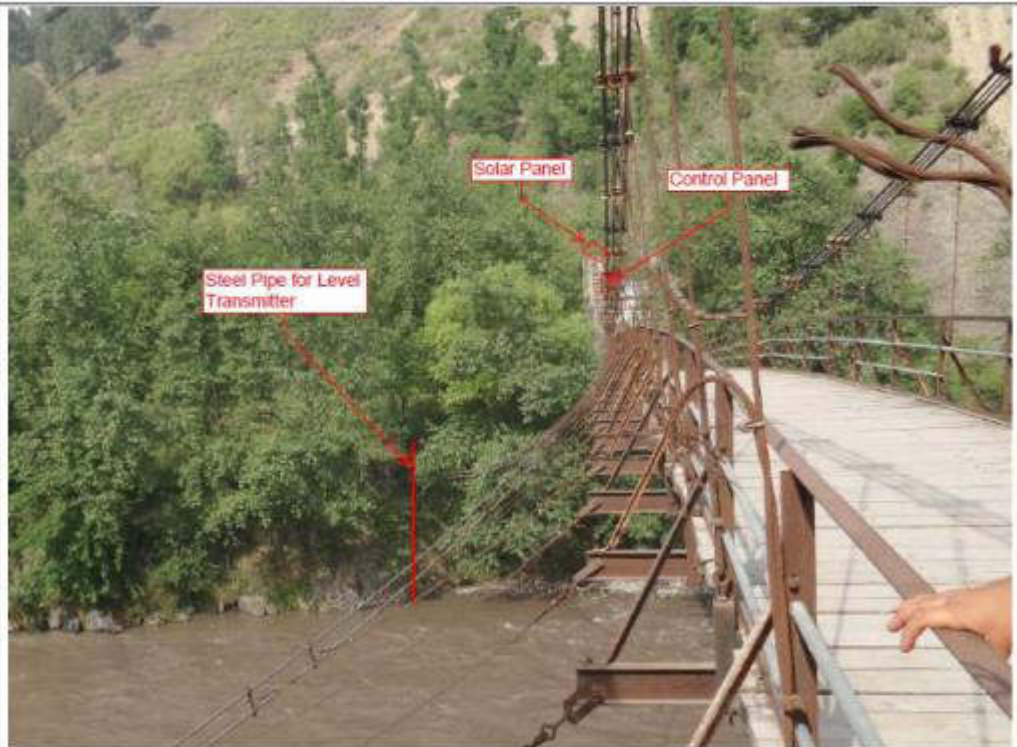
### ☐ Assumption Diagram

Weir upstream measuring station will be located at the reservoir inlet. The water level signal from pressure type level transmitter would be converted into flow rate.

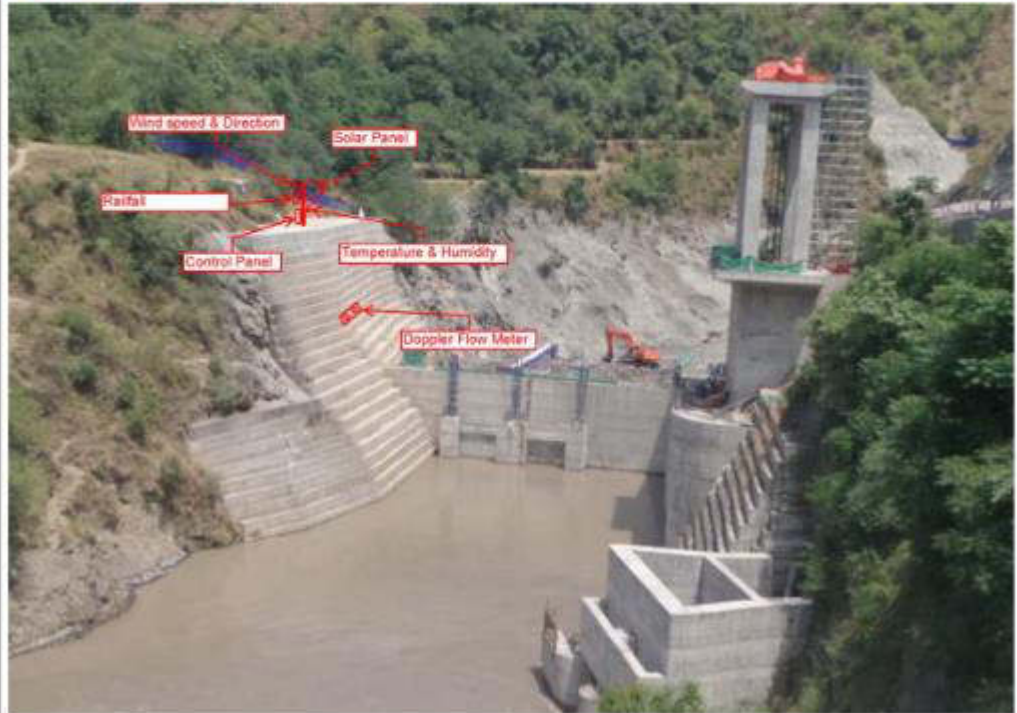
### Assumption Diagram

The flow rate into the reservoir will be measured by the flow meter. Doppler type flow meter will be installed at the cofferdam as the section of the upstream cofferdam is a concrete structure and it will not be affected against sedimentation. Although the station is located in the reservoir, the shape is similar to the canal so no turbulence will occurred during the normal operation. Thus, it provides stable measurement.

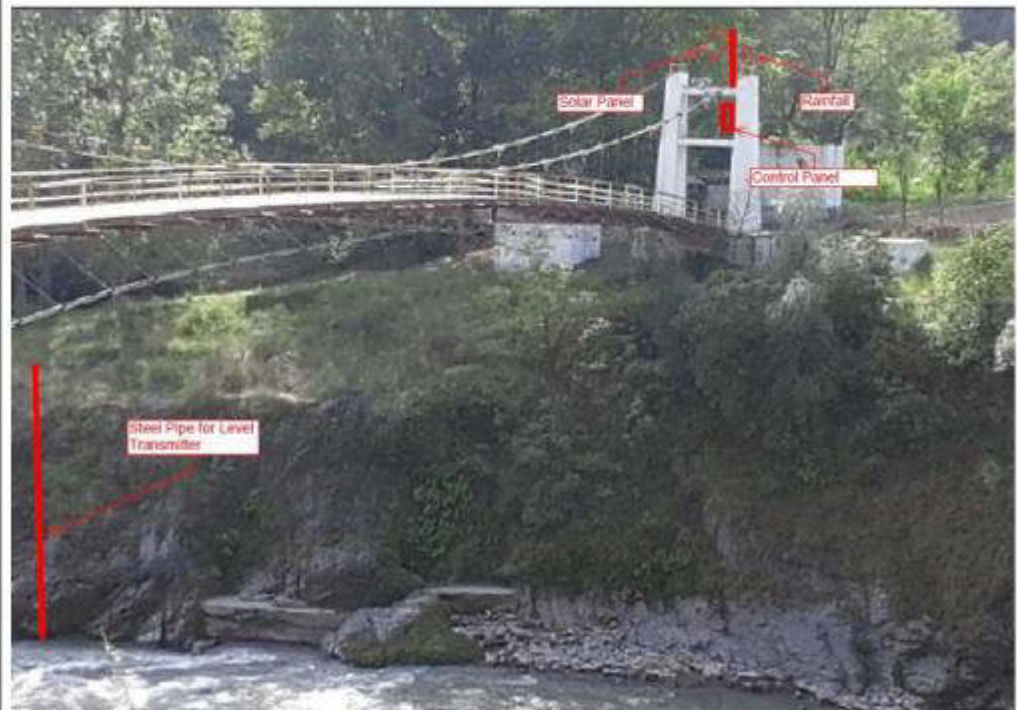
### ☐ Assumption Diagram

Weir downstream measuring station is located at 4km downstream of the weir for the measurement of environmental flow of 2.2 m<sup>3</sup>/s. As this flow rate is too small for measurement, the water level signal from pressure type level transmitter need to be converted into flow rate. It can be achieved comparing with gate opening rate. The location was decided considering of security against thief.

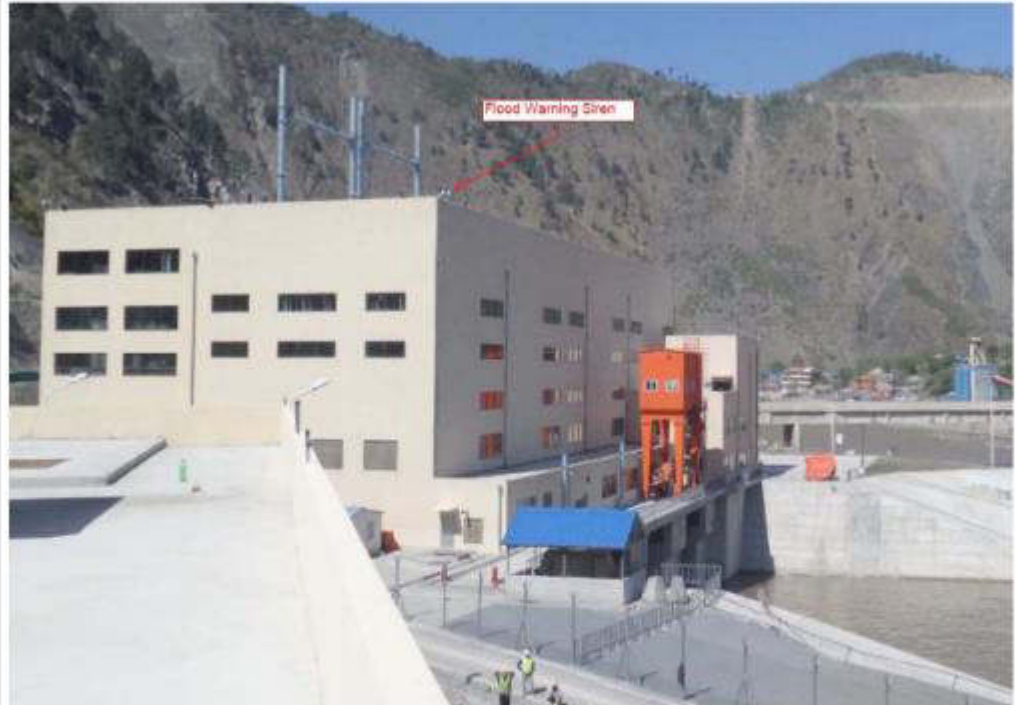
### ☐ Assumption Diagram

Issue a warning alarm for residents to prevent flood damage. Air raid siren will be manually operated by operator before power generation.

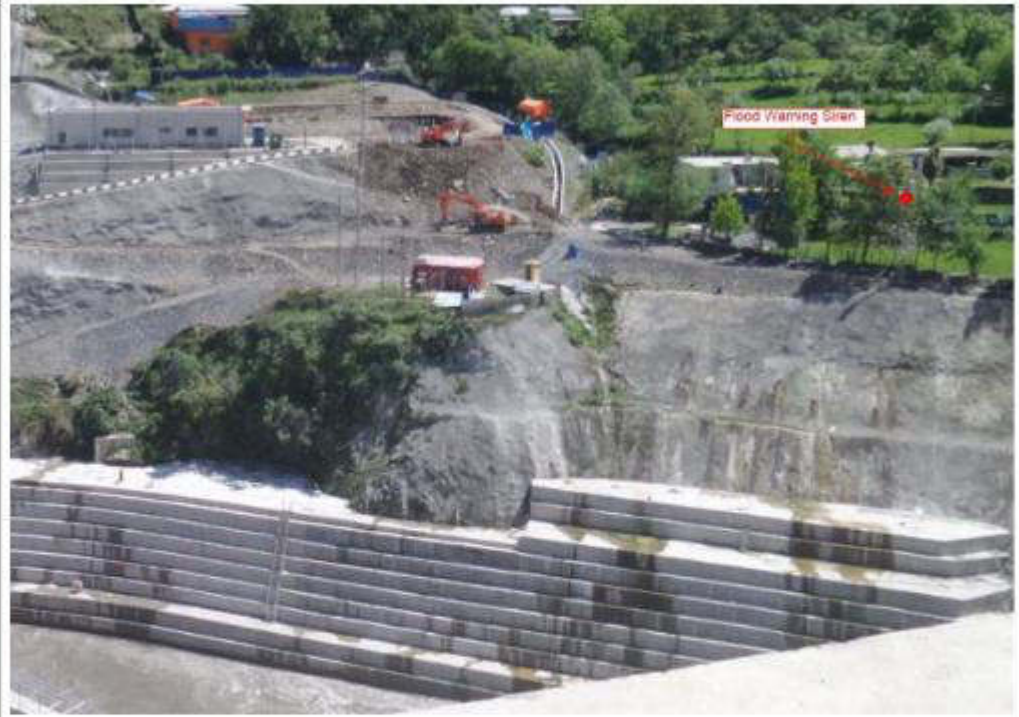
### ☐ Assumption Diagram

Issue a warning alarm for residents to prevent flood damage. The air raid siren will be manually operated by operator before gate operation.

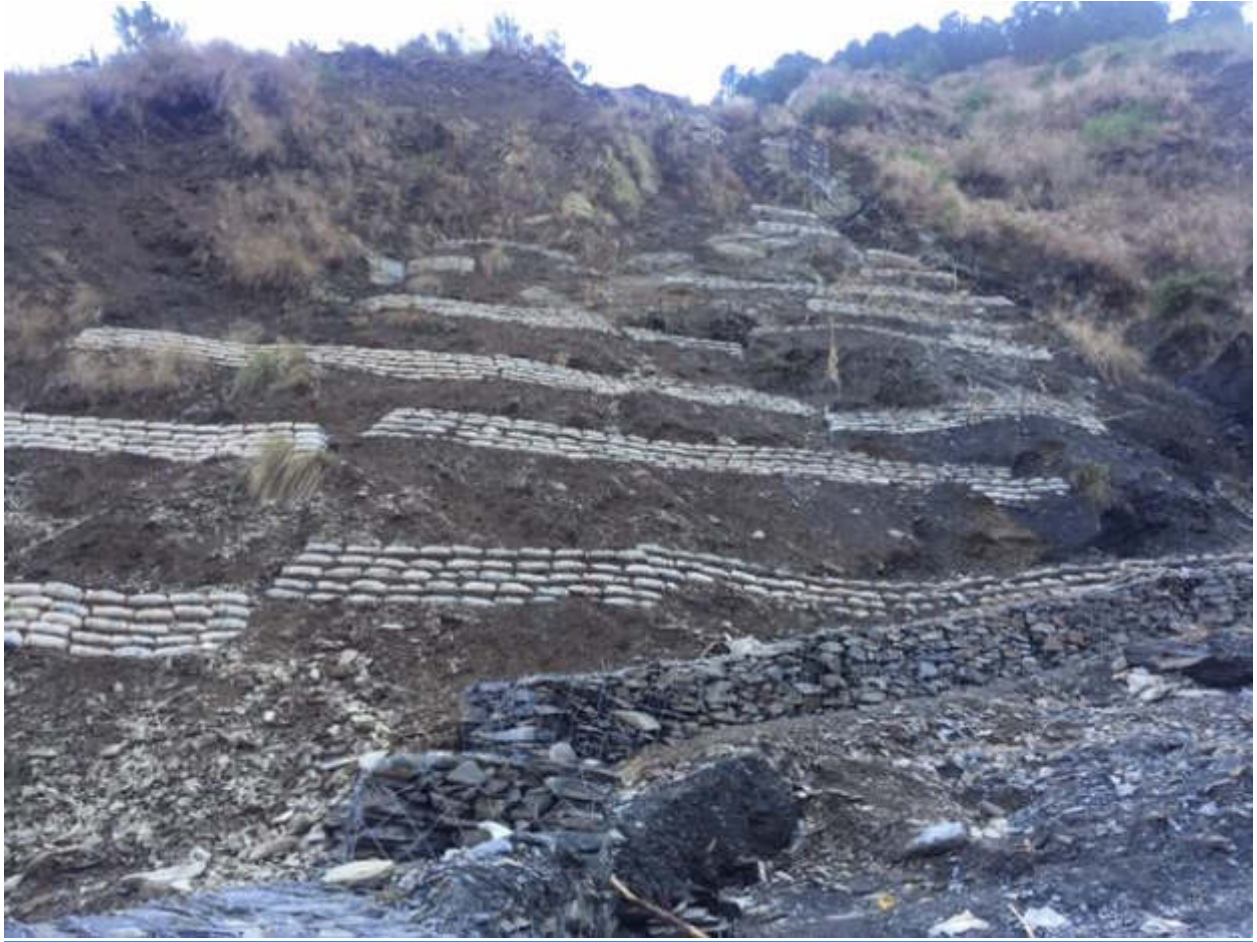
Picture showing bioengineering works with plantation and sowing before the sprout and germination (December-February 2020)

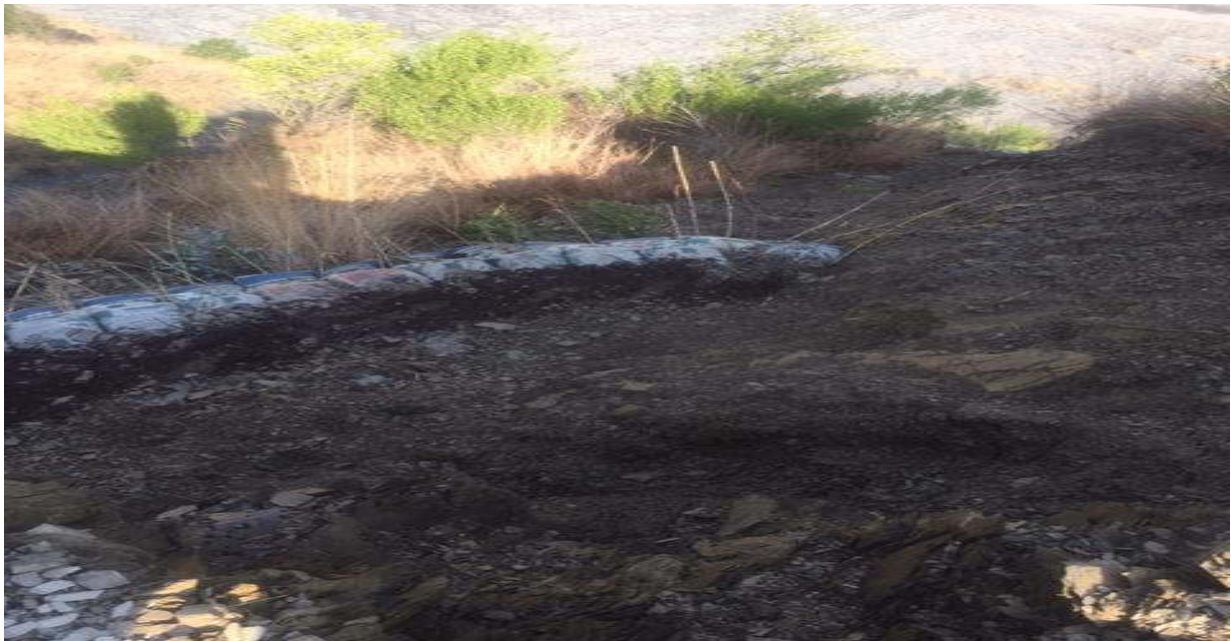
*Pic: Soft gabions placed in the slide*

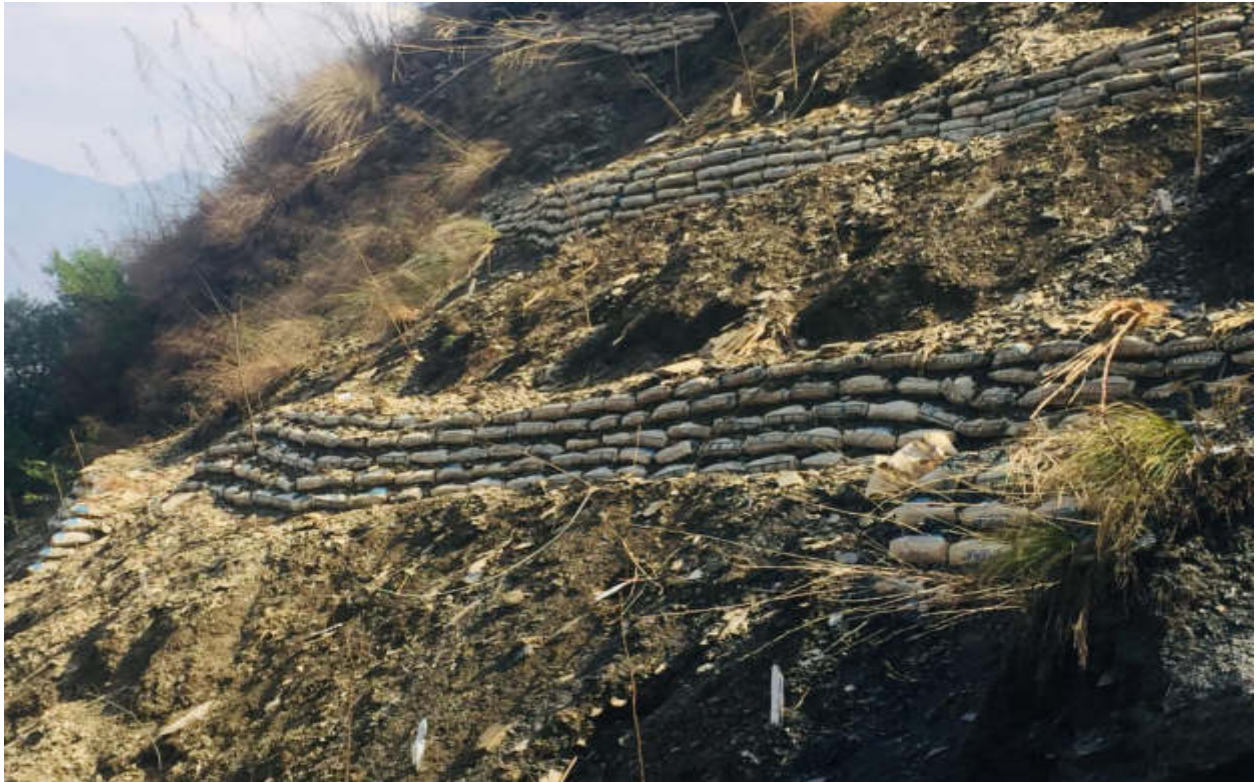
Soft gabions and plantation between and behind the rows of soft gabions

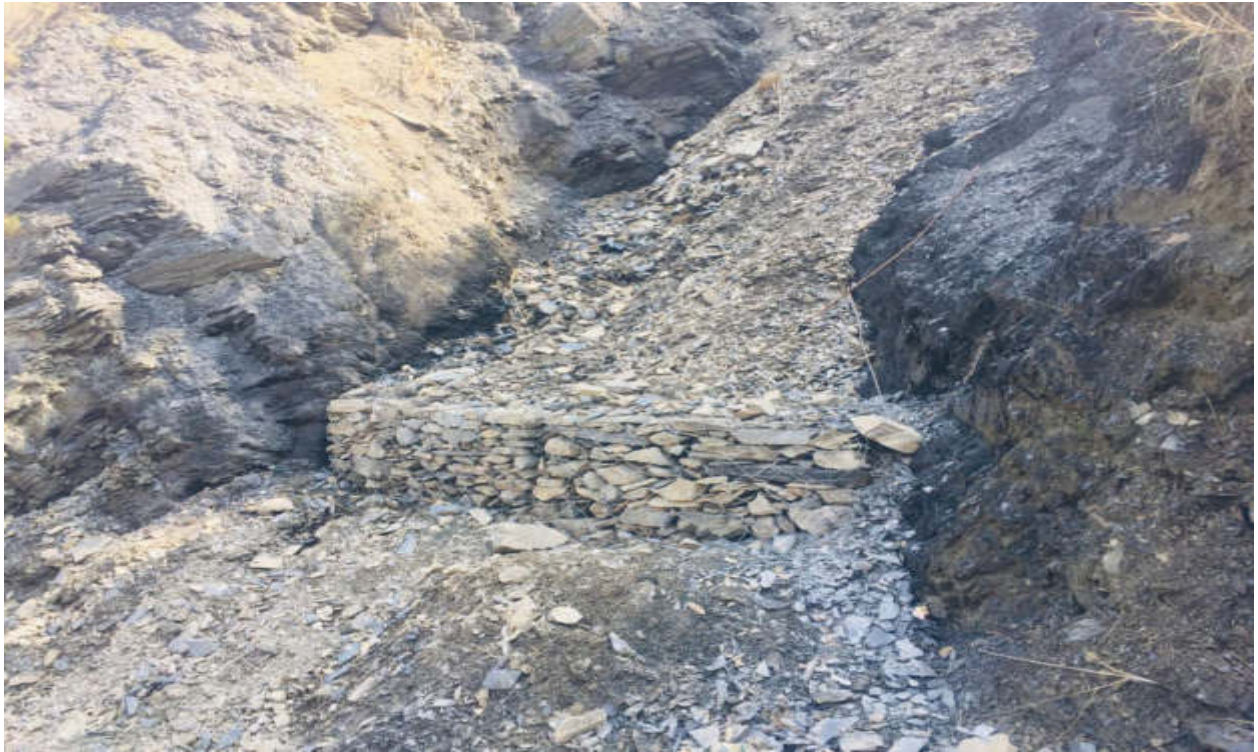
*Pic: Wire stone gabion work under the slide*

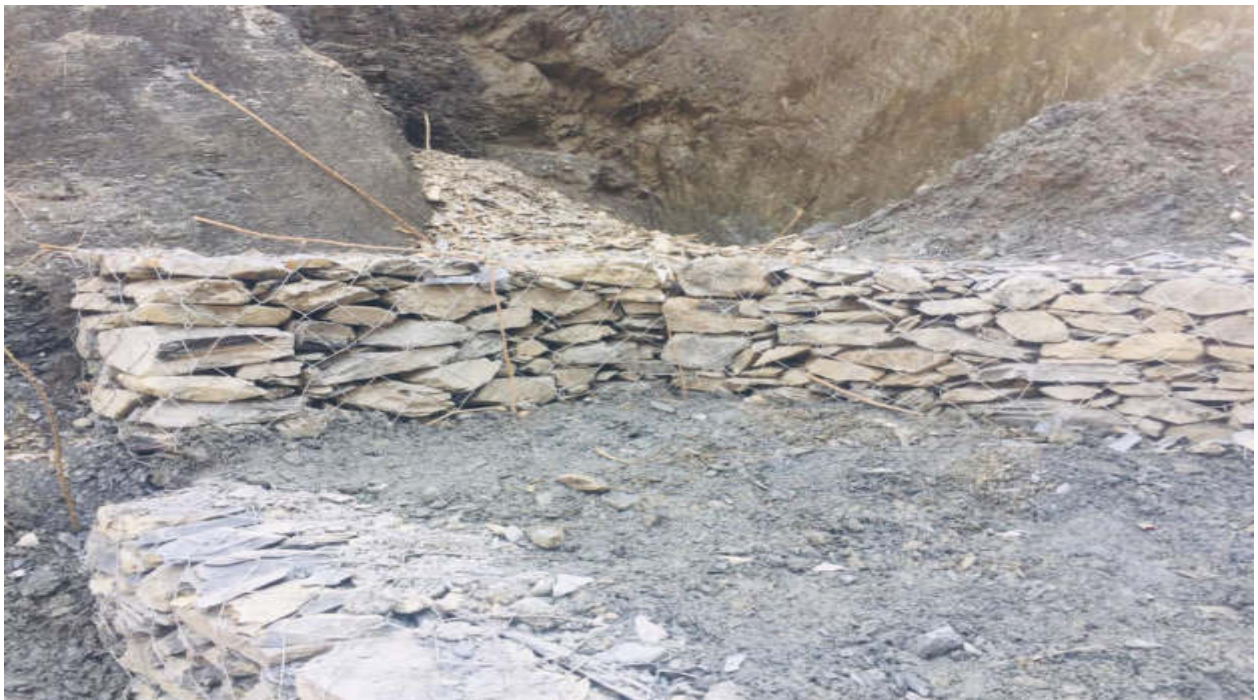
Pic: Wire stone gabion under the waterfall to reduce the thrust of the fall

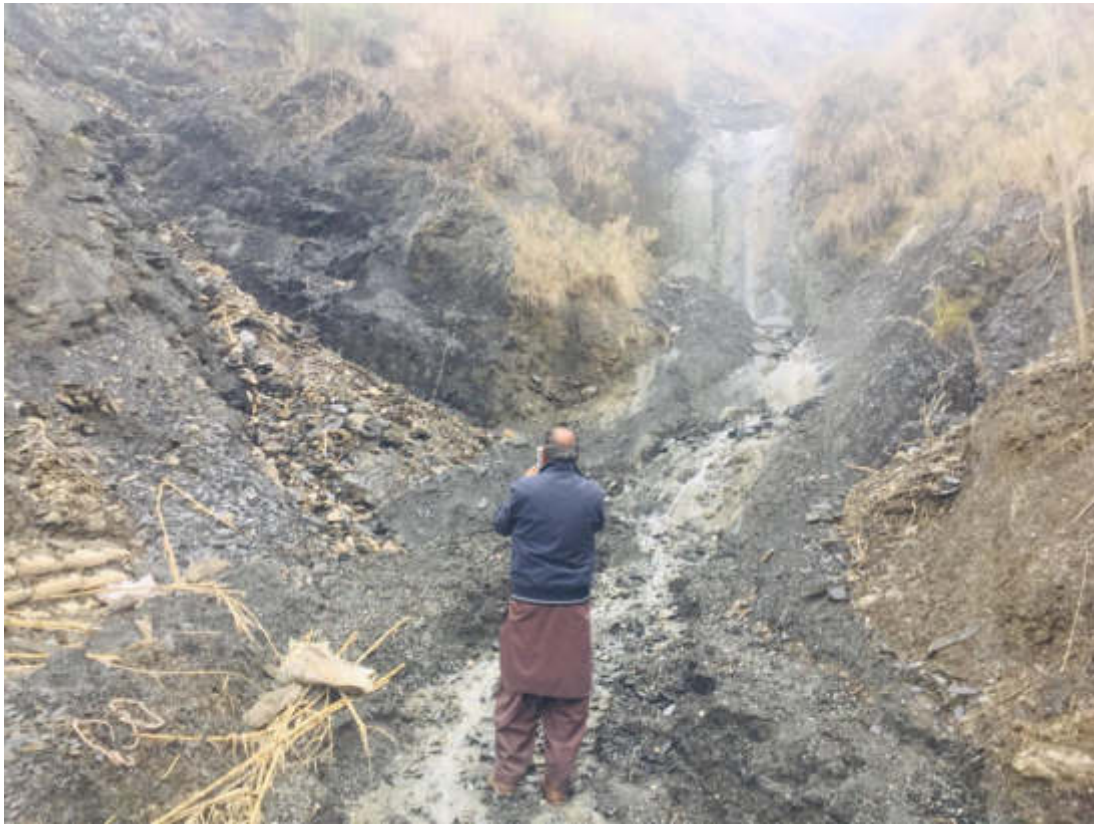
Pic: view of the waterfall before the placement of wire stone gabions

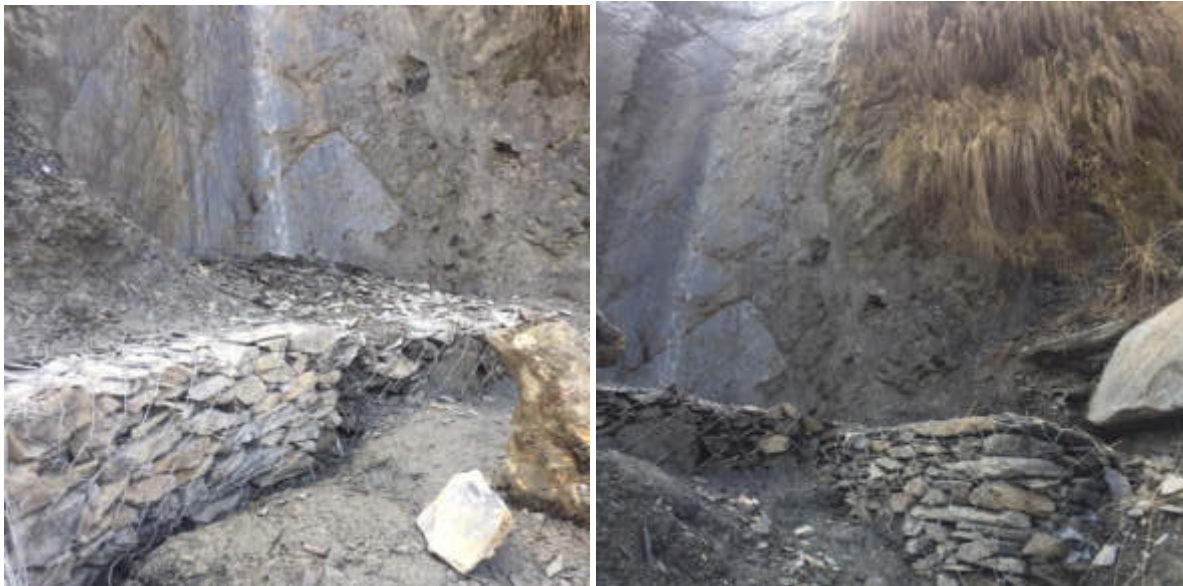
Pic: Waterfall after the placement of wire stone gabions

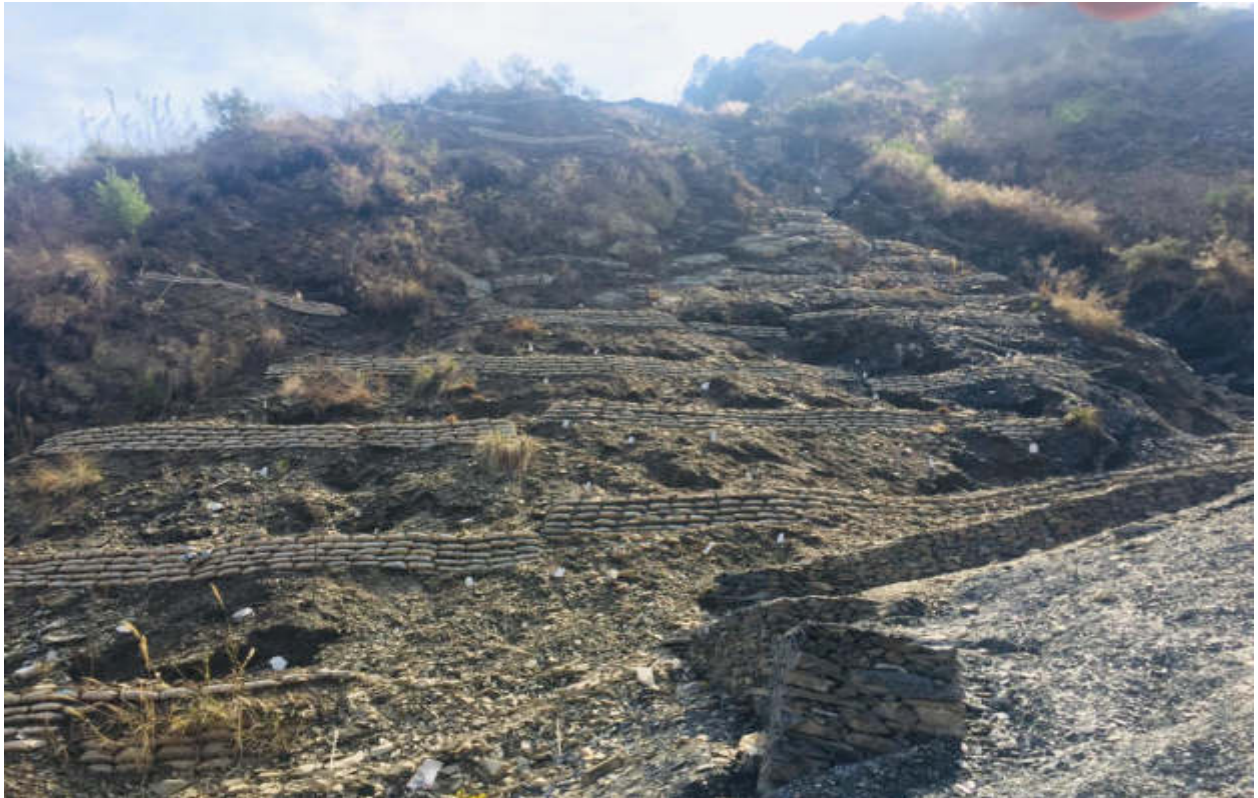
Pic: View of combination of old and new work

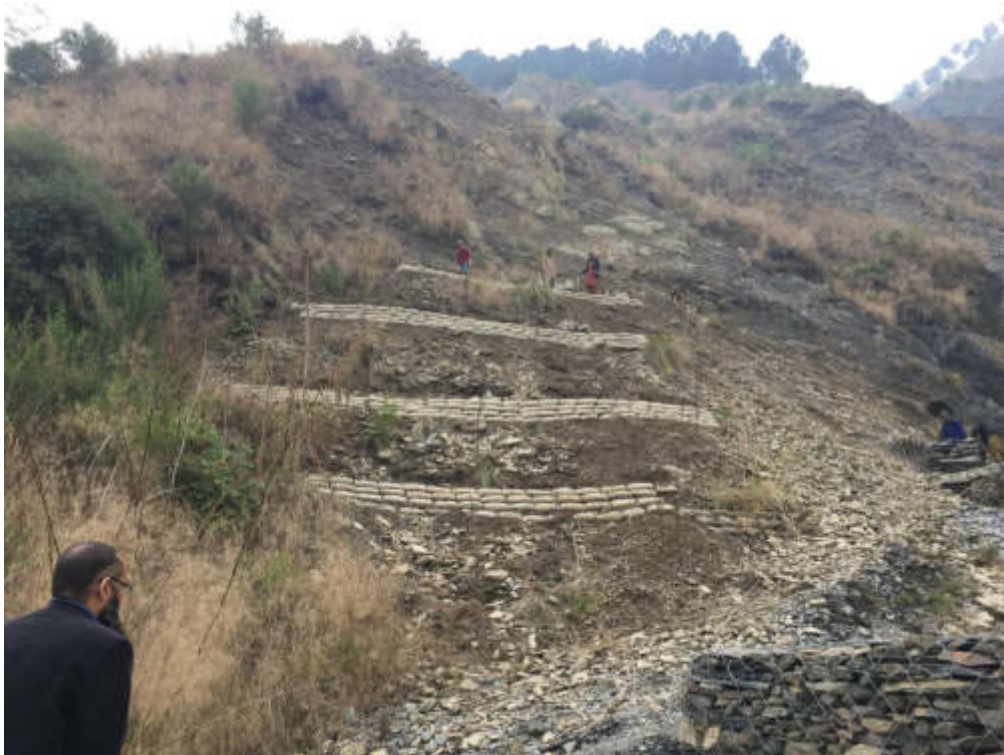
Pic: A view of soft gabions from the top with thick plantation carried out
