Environmental and Social Monitoring Report

Project Number: 44914-014
Quarterly Report (January-March 2016)
March 2016

Pakistan: Patrind Hydropower Project

ENVIRONMENTAL & SOCIAL MONITORING REPORT

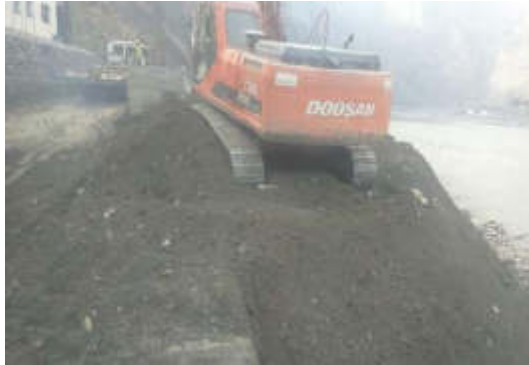
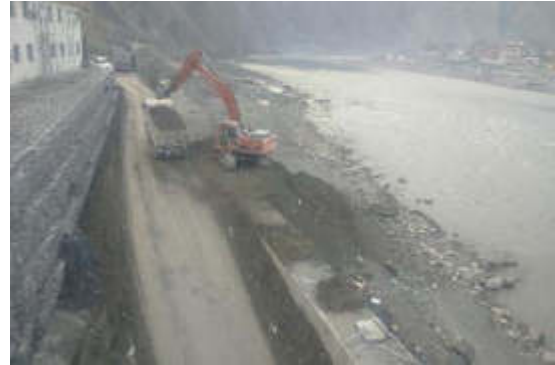
- In January, penstock road was being prepared for the shifting of steel lining. Construction team has dumped all the soil nearby river so corrective action was taken and removed all the soil from that site with the help of excavator and dump truck and discarded into the disposal area.

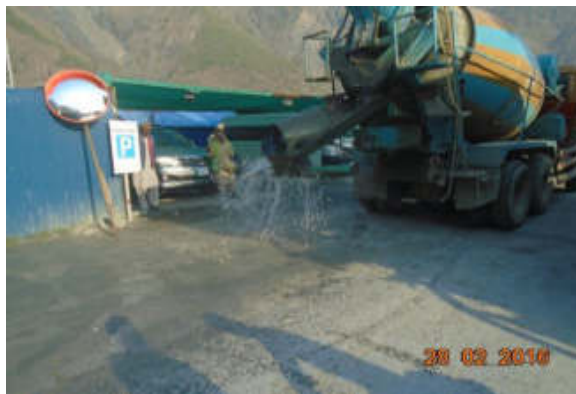
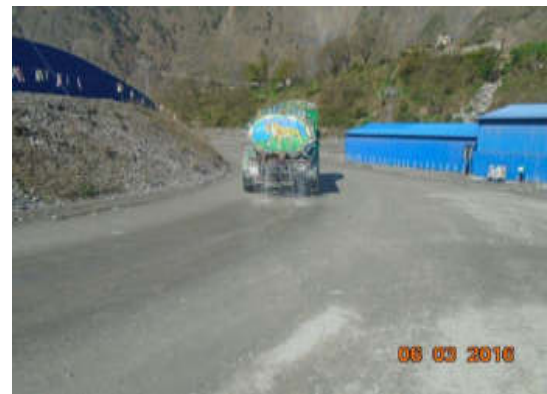
- During the month of February it has been observed that the ratio of dust generation has been increased due to the changing of weather. So, corrective action was taken by issuing water sprinkling schedule to the batching plant supervisor and asked him to follow the schedule to overcome the dust issues.

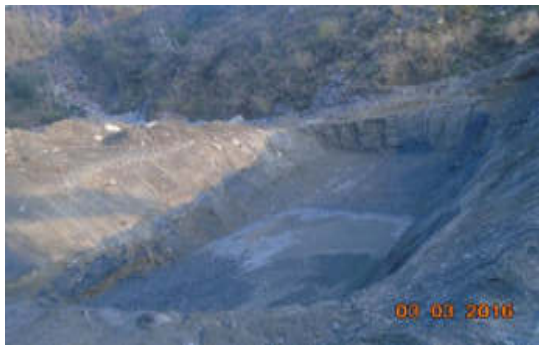
Excavated Waste trench

- In the month of March, new waste trench has been constructed to ensure the proper disposal of waste. Trench is constructed according to the method statement with liners including concrete, clay and geo membrane that will make a barrier between the waste and the environment. It is prepared with a typical depth of 8m and length of 15m. It has 20cm concrete layer, 6 inches of clay liner then 1 mm thickness of geo membrane liner having tear resistance of 6.5. The primary purpose of the lining is to isolate the landfill contents from the environment and, therefore, to protect the soil and ground water from pollution originating in the landfill. Furthermore, soft barrication is placed

around the trench with proper dyke and access for the waste collector to dispose the waste.

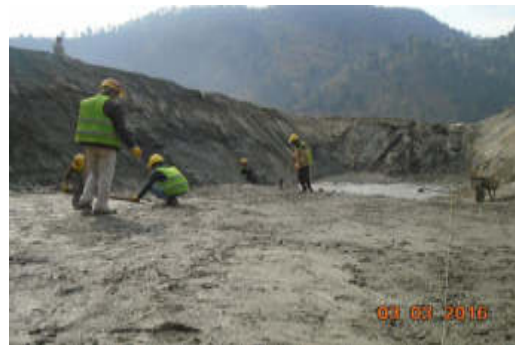
Concrete lining of 6cm

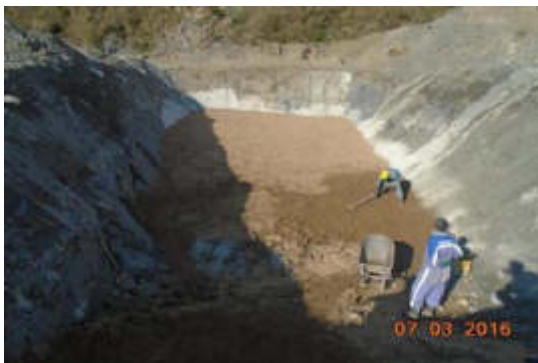
Clay lining of 6 cm

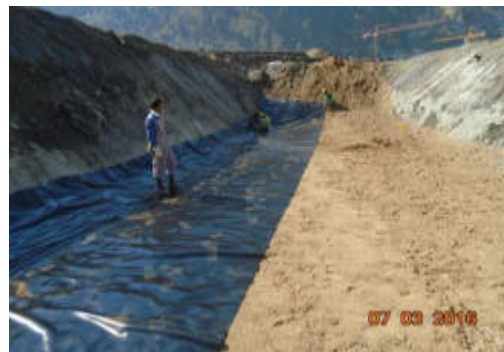
Installation of Geo-Membrane Sheet (1mm)

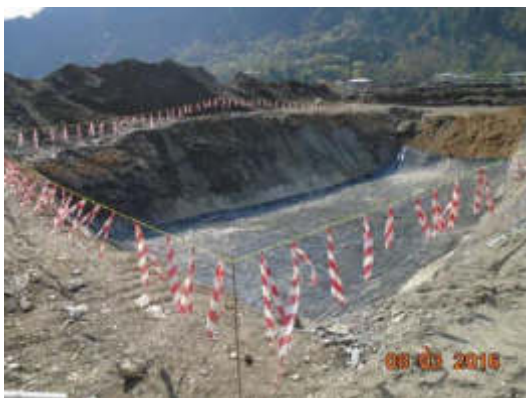
Complete installation of Geomembrane

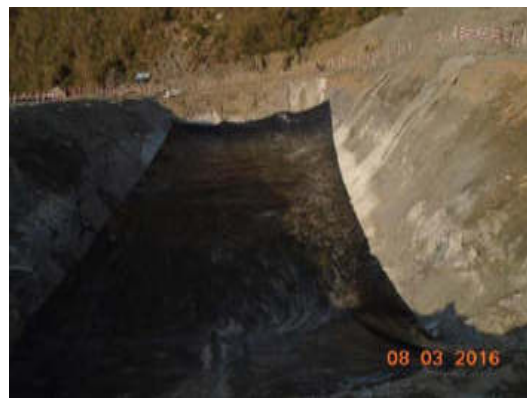
Soft Barrication around the trench

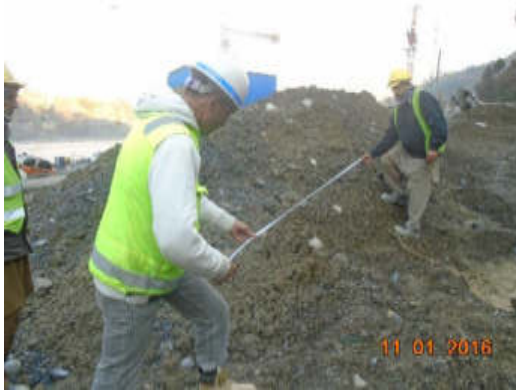
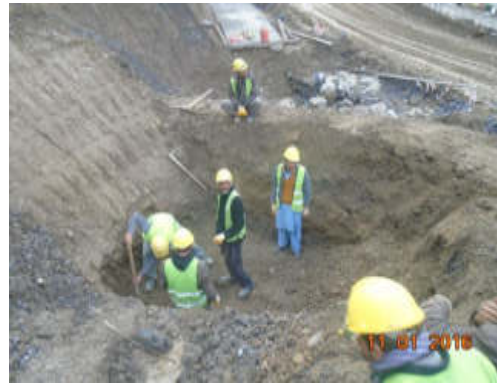
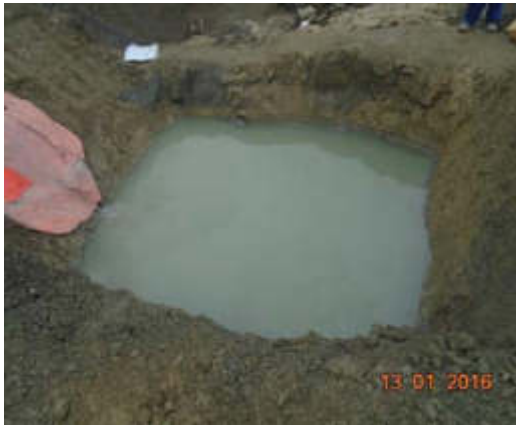
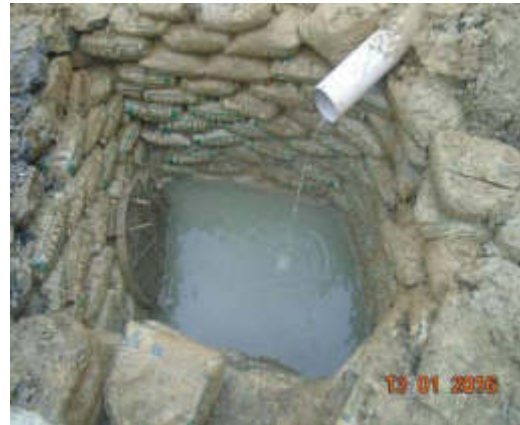
- Due to the construction of drainage system the sedimentation tank process affected because construction team have diverted sedimentation tanks water from its original path towards O & M building so corrective action was taken and made new sedimentation tank in front of O & M building in order to avoid release of contaminated water into the river.

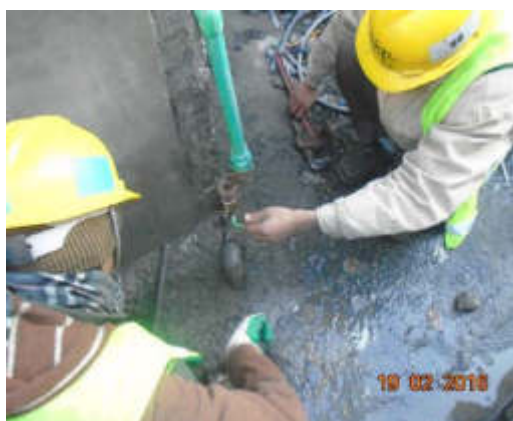
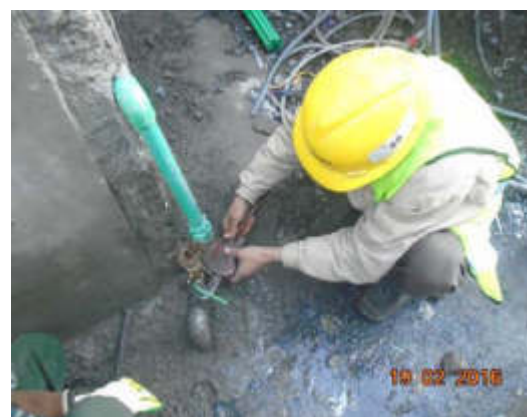
- In Kyung dong accommodation there are some taps, valves and regulators which are not properly fixed so water impending from those valves was going into the containers, creating problems for the labors living in the Kyungdong camp. HSE department asked Kyung Dong management to repair them or change in order to avoid the depletion of water resources.

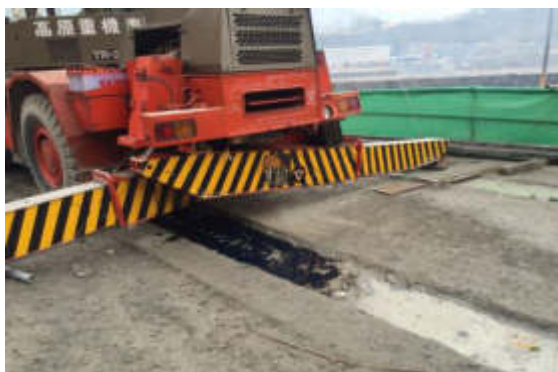
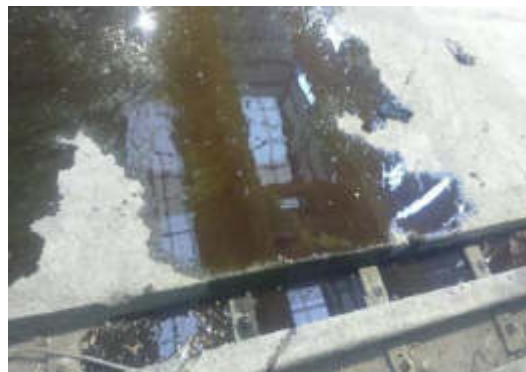
- During the quarter, minor oil spillage was observed in front of the batching plant, power house and in workshop area due to the maintenance of the machinery and generators placed on the site. Corrective actions were taken immediately in this regard to stop oil spillage by removing the top layer of contaminated soil and dumping into the concrete waste trench in the disposal area to prevent environmental degradation.

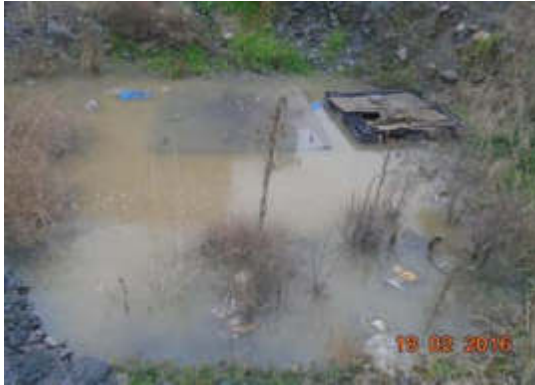
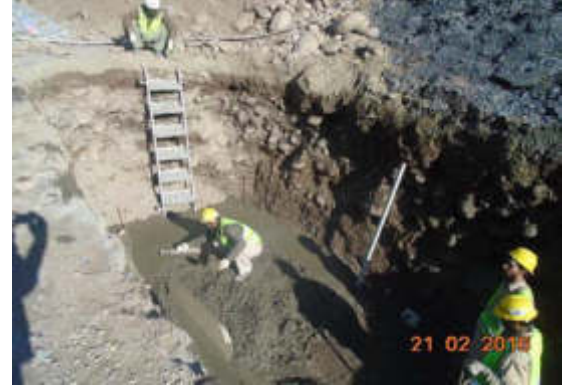
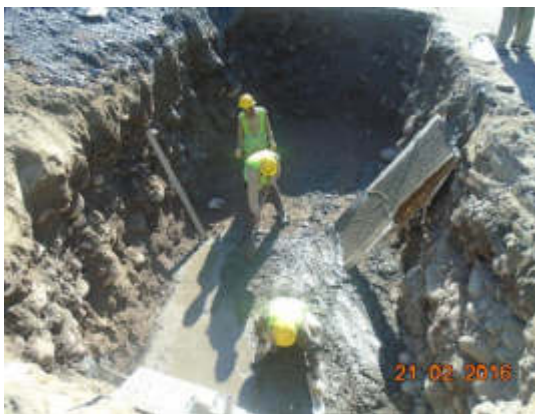
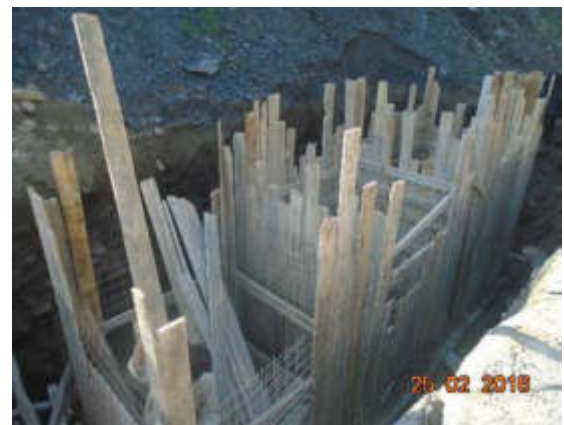
- Beside Kyung dong accommodation sewage lines were impassable due to which all of the sewage water was curving on the road by creating foul smell which is directly affecting the populates living around and degrading surroundings environment. In this regard corrective action was taken by making another settling tank with soak pit to avoid environmental degradation.

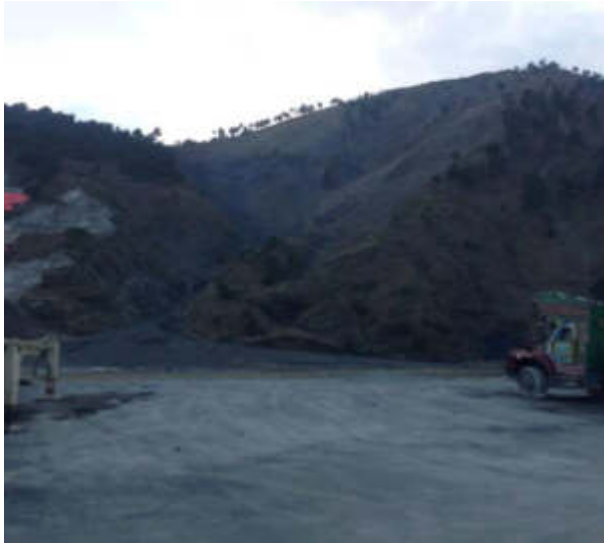
Some Remedial actions were taken to control these landslides. If this area is planted with some useful plants with the involvement of the custodian communities and they are made responsible for the protection of these plants then the danger of fire could be reduced to minimum level. The fire in the area has caused damaged about one year before. There is a need to address this issue and fire control measure should be taken before the dry season starts in June.

The recent picture of March 2016

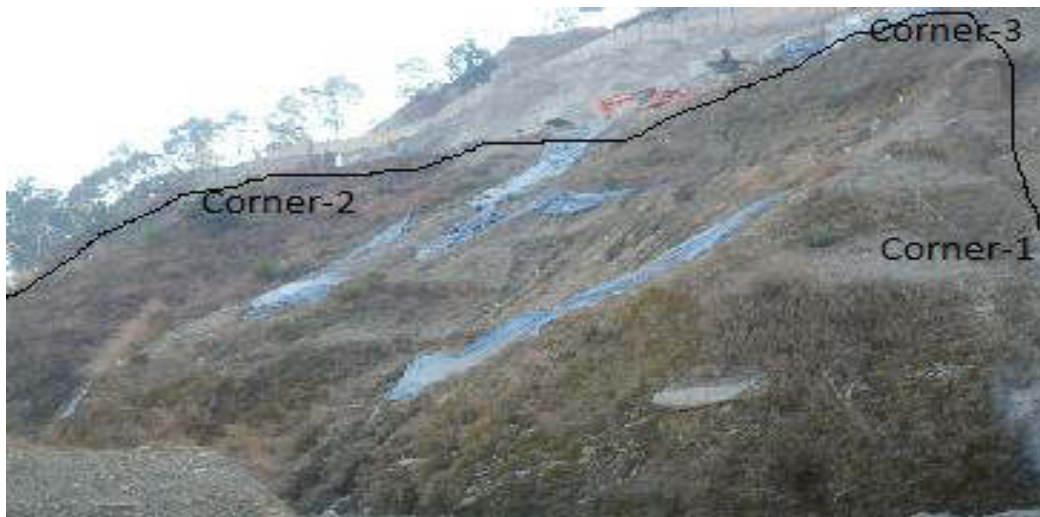
The design of the outlet of the power plant has been changed and the location has also been shifted most probably due to the instability of the hillside. The site so left between the **First Corner** and the **Second Corner** below the **Third Corner** seems to be under the danger of land erosion/ sliding and needs immediate attention. The planting season is not confined to February only. If potted plants are planted here they will have positive impact though not that much as would have been with the combination of bioengineering works.

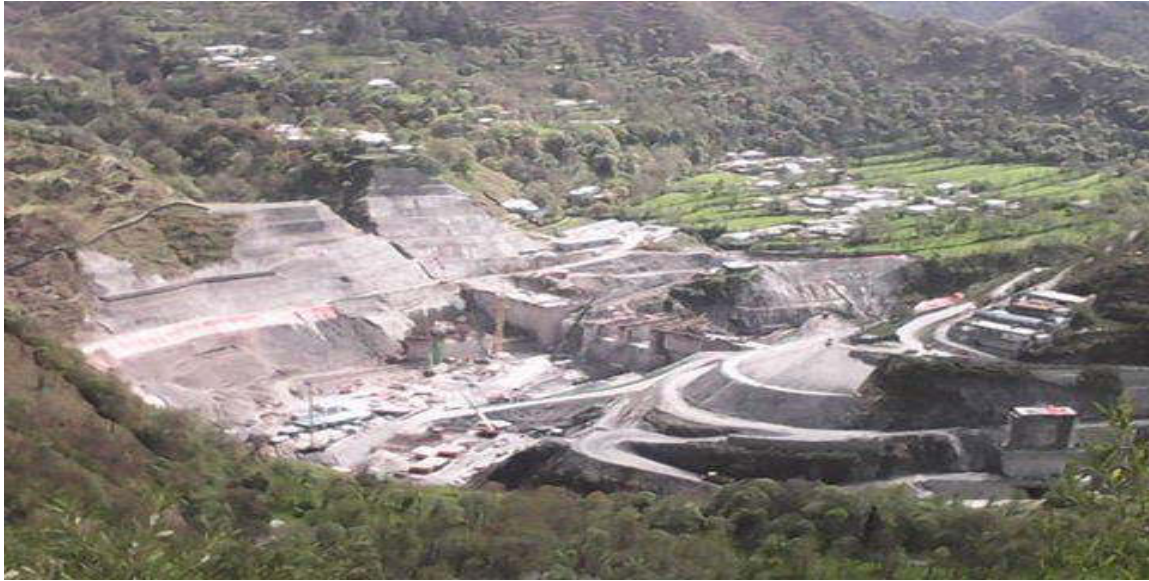
The area affected on the weir site due to inundation is 57.2 ha and on the powerhouse site is 5.5 ha which will come under construction.

Latest position (March 2016) of Patrind side of the project area.

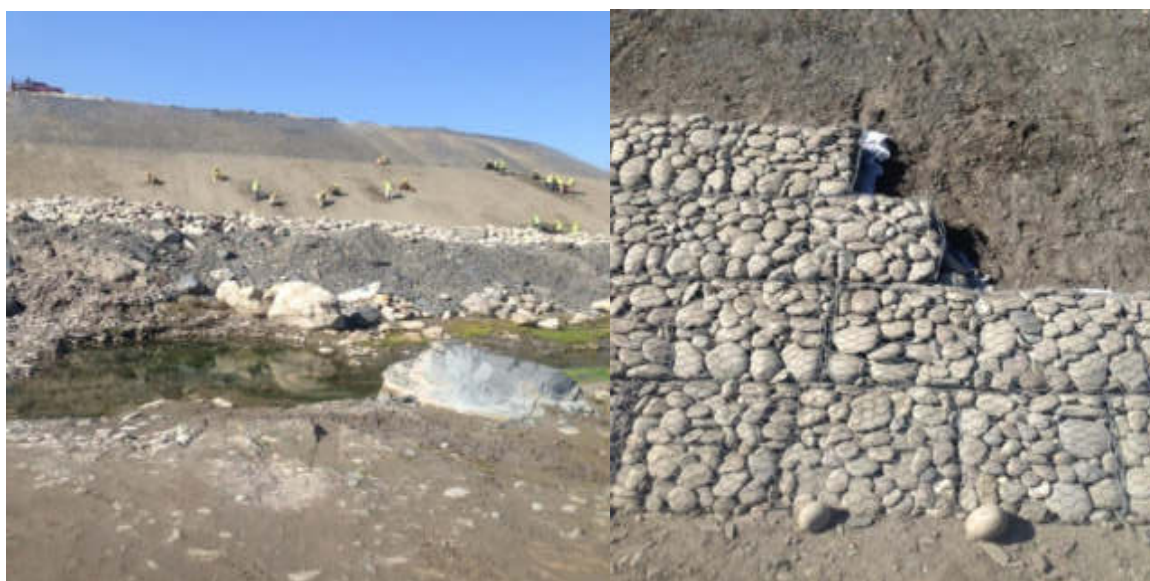
Fig 1&2: Gabion fixing and stone pitching at dumping site.

Another factor of ecosystem disturbance is the disposal of dug material into the river Kunhar and dumping place near Patrind. The material was mixing with river water especially during the rain. Now the loose soil has been strengthened by stone pitching and iron wire gabions. This will definitely improve the condition and during the rise in water more erosion will not take place and whatsoever the ecosystem condition is today will remain intact in the future.

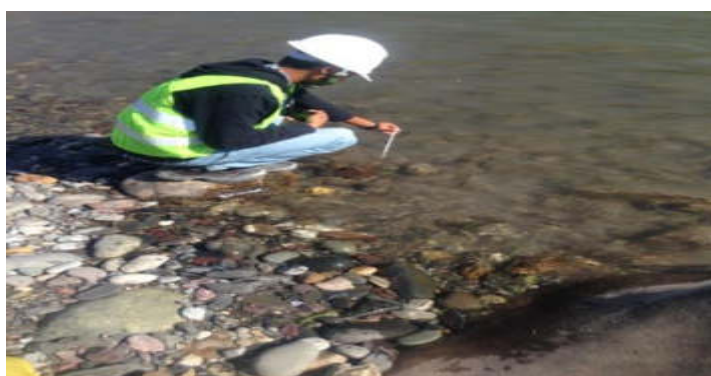
First sampling point of the study is situated at $34^{\circ} 18' 19''$ N, $73^{\circ} 26' 44''$ E at 2422 ft of elevation above sea level. The water level is moderate and it is more or less clear because of no rain for the last few days. No fish could be caught in the cast net by both the fishermen. This is the same result as was during the last study during December 2015.

Fig 6: Sampling at point-I

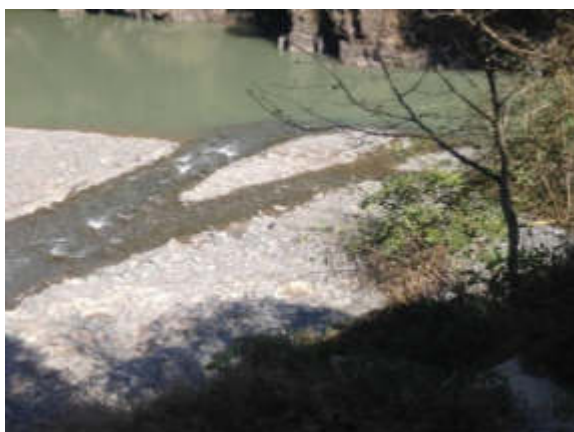
This sampling point is situated at $34^{\circ} 18' 36''$ N, $73^{\circ} 26' 43''$ E at 2398 ft of elevation above sea level. This is the point where fish can migrate upstream in the Boi Nallah during the spawning period and can have little impact of low river flow when tunneling of the water starts. Unlike before, the nallah water was very clear as compared to the relatively turbid water of river Kunhar. No fish could be caught here at this point. According to the locals, evidences of existence of *Glyptothorax spp* and common carp (*Cyprinus carpio*) were found in the Boi nallah.

Fig 7: Sampling at Point of confluence of nallah

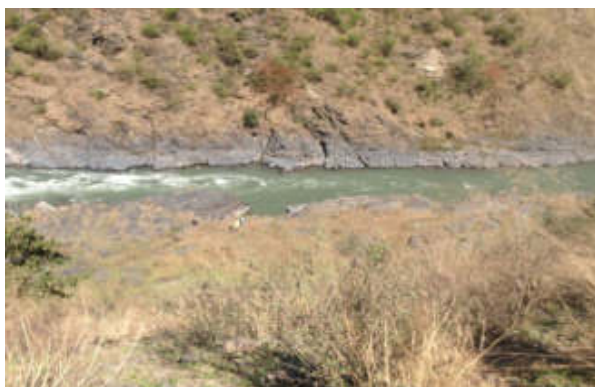
This sampling point is situated at $34^{\circ} 19' 47''$ N, $73^{\circ} 25' 35''$ E at 2475 ft of elevation above sea level. The river water is almost clear at this time of the year. The small creek joining the river is also clear. Chance of fish catch was expected here and proved correct. Three fish could be caught here and all of them were *Schizothorax plagiostomus*. Water temperature and pH is given in the table below

Fig 9: Sampling at point-III, Parri

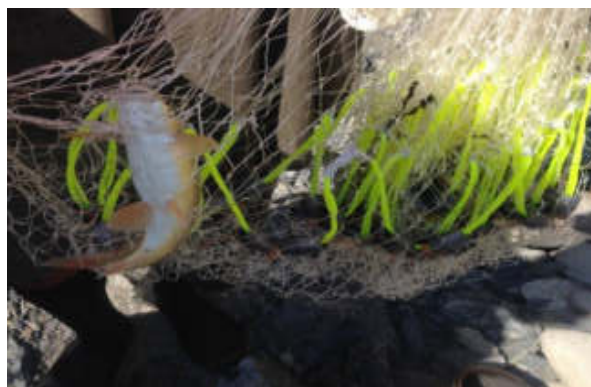
Fig 10. Fish in Net at Parri

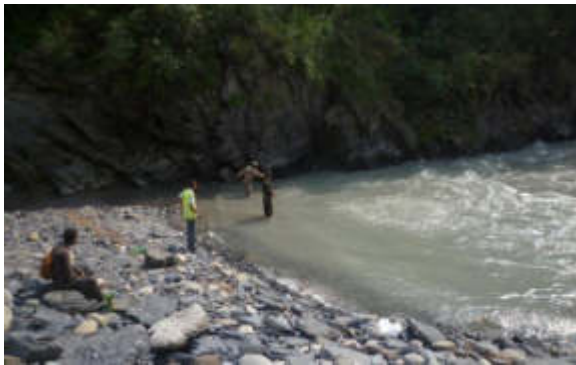
The point is situated at $34^{\circ} 18' 19''$ N, $73^{\circ} 26' 44''$ E at 766 meters of elevation above sea level. The pool existing here last time has disappeared due to new construction and enforcement of the embankment. Difficult access was possible to the river and general observation shows that there is no chance of existence of live fish as the water flow speed

was very high. This diversion tunnel has a definite impact on the fish production but to a maximum of 800 meters downstream.

Fig9: Sampling Point at outlet before

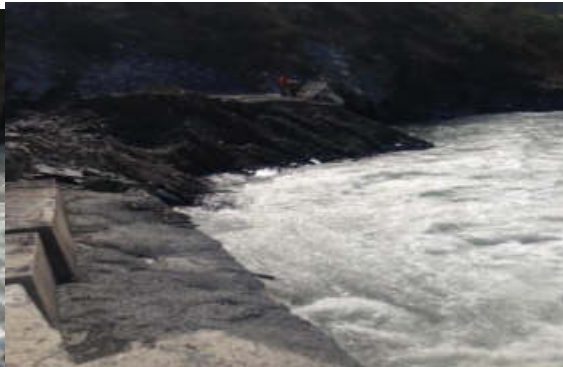
Fig 10:Rapid water flow at Outlet

- During this study it was observed that another concrete pond is being constructed at the outlet to control the rapid flow of water through the overhead flow tunnel. There will be complete check on the migration of the fish. This pond will make another base for the culture of trout as this will have no impact on the other river fish because of its stagnant condition. Survival of local fish in this pond is near to impossible.

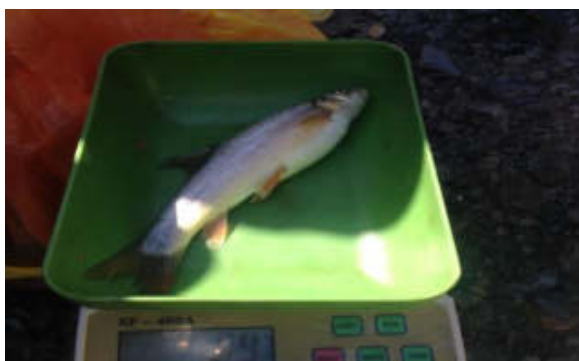
This is the point situated at $34^{\circ} 20' 36''$ N, $73^{\circ} 25' 08''$ E at 2615 ft of elevation above sea level. This is the inlet of the diversion tunnel. One small sized fish, *Schizothorax curvifrons* could be caught here. Still the impact on aquatic life is not very high as the lake has not developed and course and flow of water has not changed here. When the lake will grow after construction of Patrind weir, this can harbour the Rainbow and Brown trout. If carefully planned, this can become commercial activity but needs expert inputs. There is another tunnel is almost completed which will carry through the overflow or released water. A concrete pond construction is underway at this place which is supposed to hold the water and control the speed of water to avoid any side damage. This means upward migration of fish will not be possible, hence, the impact on the survival and spawning of the fish will be very high during the operational stage of the project.

Fig11: Sampling at inlet of water diversion tunnel Fig 12: Inlet position

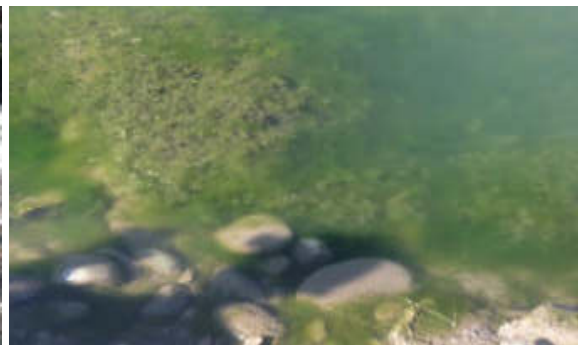
Fig 13: Rich algae at the side water of the river

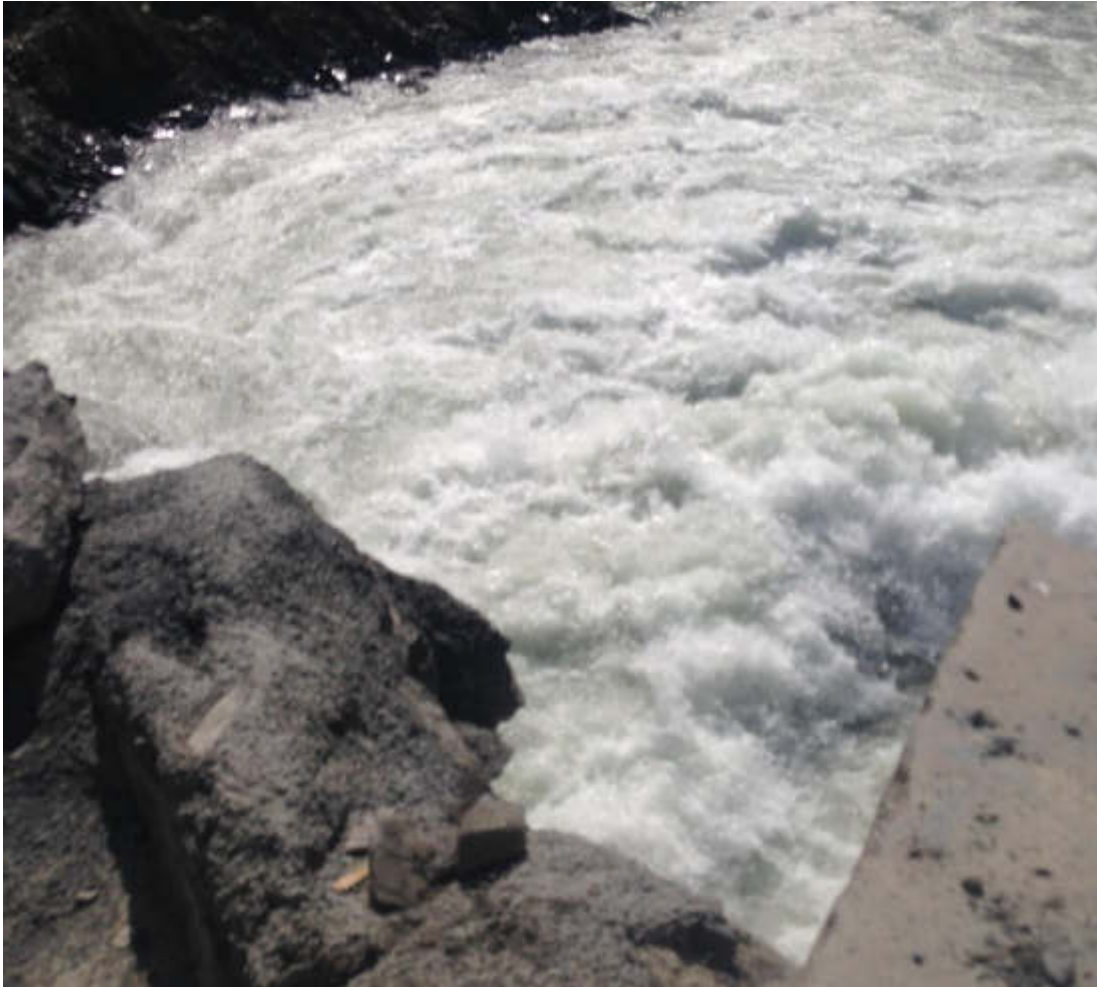
Fig:15: Roaring water coming out of the diversion tunnel

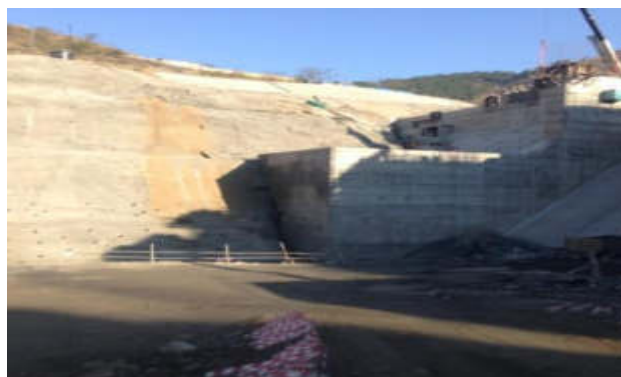
Fig 16: Weir construction in progress

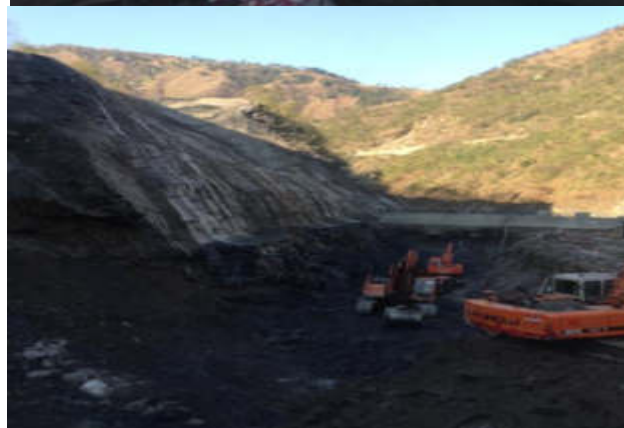
Fig 17: Excavation of the pond for released water

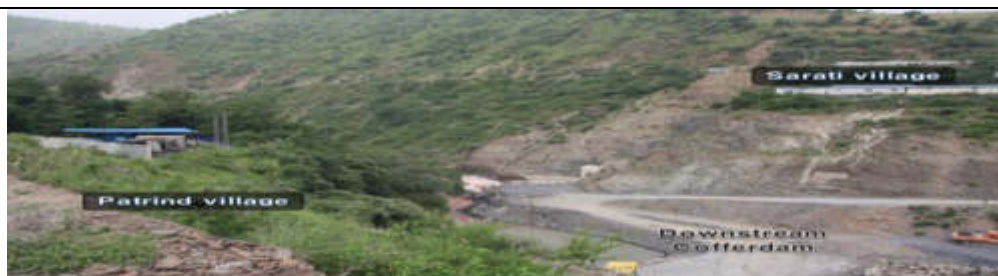
(Additional): This pedestrian bridge was used until the downstream Cofferdam was constructed.

Downstream cofferdam was constructed in 2013 and has been used as Access Bridge.

d. Future Plan: As the permanent access route, Spillway Bridge of weir will be installed in October 2016.

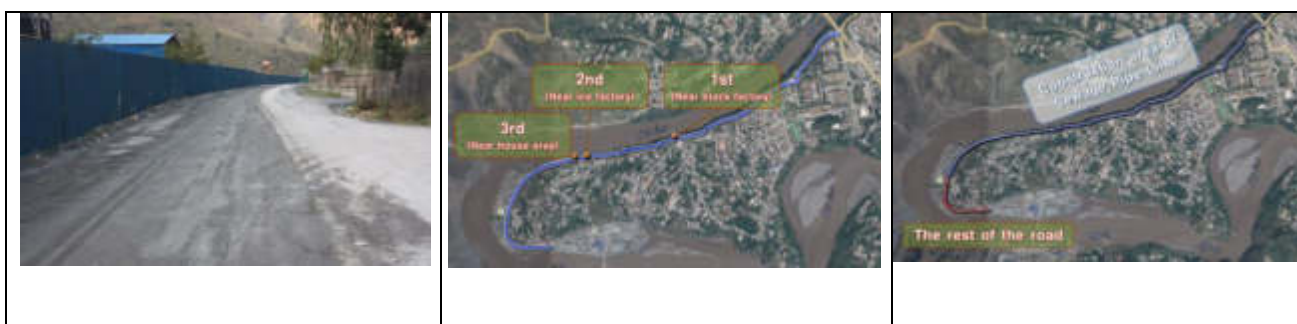
To improve the road conditions for ongoing traffic, EPCC has been maintaining the road regularly using grader and road sprinkler.

- 1st: 18th April 2013: Construction of retaining wall near Awan Block Factory.
- 2nd: 18th April 2013: Construction of retaining wall near Ice Factory.
- 3rd: 25th Sep 2013: Re-Constructing of damaged retaining wall near house.
- EPCC subcontracted on 25 May 2015 to Abbaseen Associates for the rehabilitation of thuri road collapsed area.
- EPCC subcontracted to AJK Developers 3 times for following works:
 - 25th May 2015: Construction of retaining wall near fruit shop.
 - 25th May 2015: Construction of retaining wall near ice factory.
 - 29th Oct 2015: Construction of retaining wall near lala G block Factory.

Major portion of the road has already paved under Muzaffarabad Development Project (MCDP) and rest part of that road will be improved in the same way by EPCC with the finalization of construction activities, until then regular maintenance work will be carried out as and when required.
