## Pakistan: Patrind Hydropower Project

## **147 MW PATRIND HYDRO POWER PROJECT**

### **ENVIRONMENTAL & SOCIAL MONITORING REPORT**

**(JANUARY-MARCH 2015)**

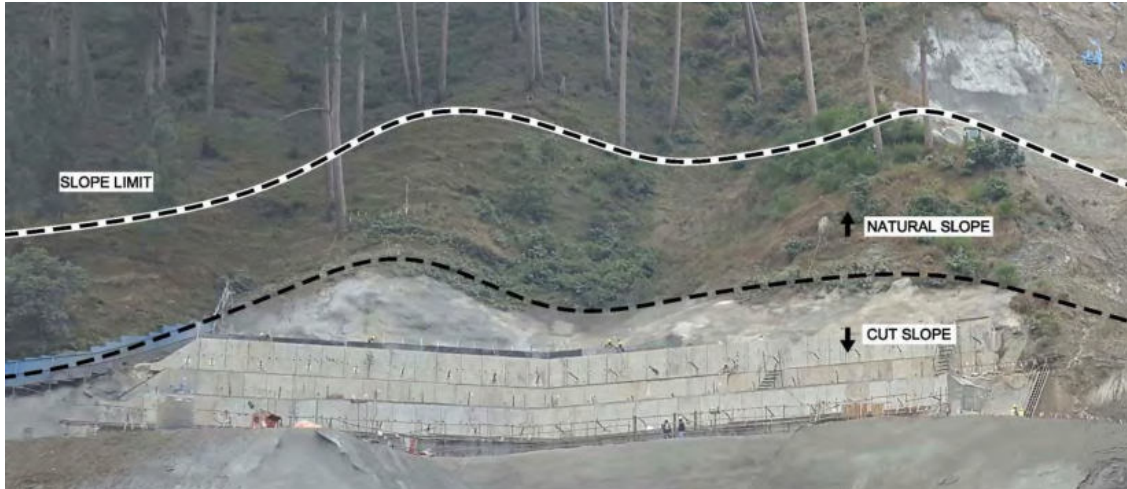
- Shotcrete activities have been undertaken to stabilize slopes and to mitigate risk of erosion and to minimize landslide risk.

Slope protection works on power house site

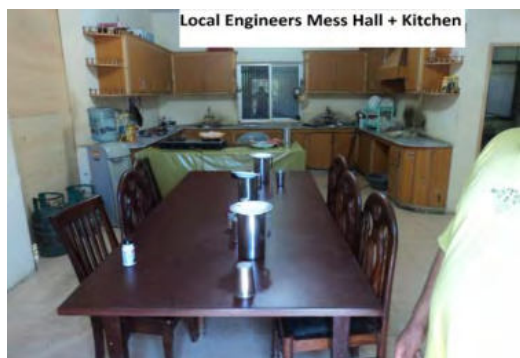
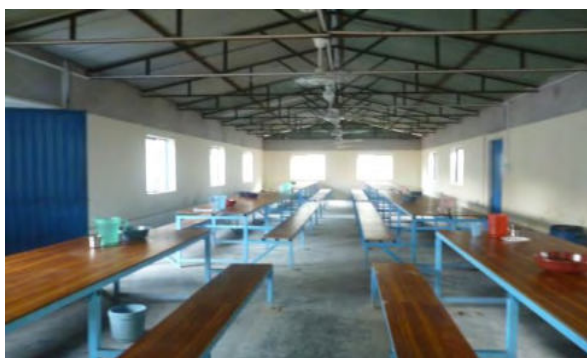
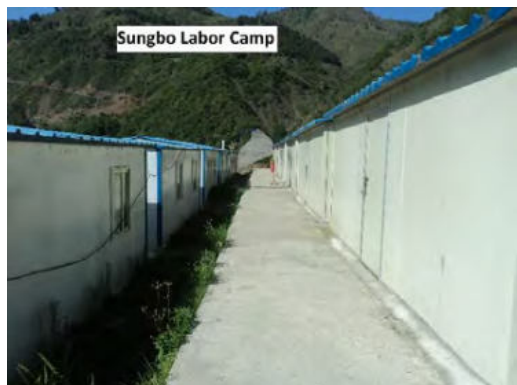
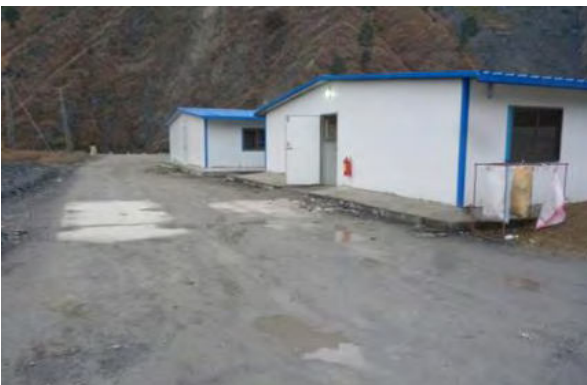
Prefabricated accommodations labour at upper & lower Sites

All staff/workers before induction have been educated to respect local norms and never involve in any conflict with locals. Furthermore, community liaison officer / coordinator who have been employed from local area, assist in managing these accommodations. Basic services like electricity, water and gas have been provided. Safety measures such as fire extinguishers and emergency contact numbers have been placed on main locations. Fire alarm system has been installed on main campus lower site and will be installed on new accommodations as well. Ambulance drivers are aware of all accommodations to have prompt access in case of any emergency.

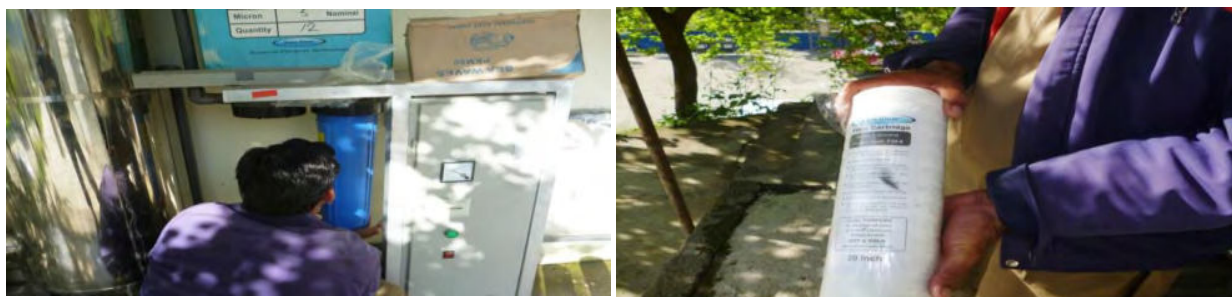
New cartridges being installed at the filter Plant

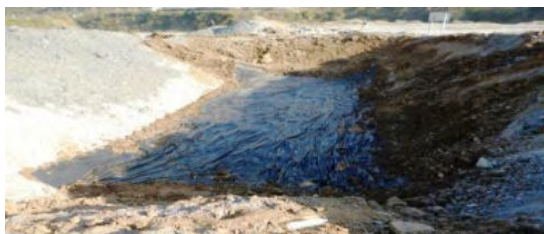
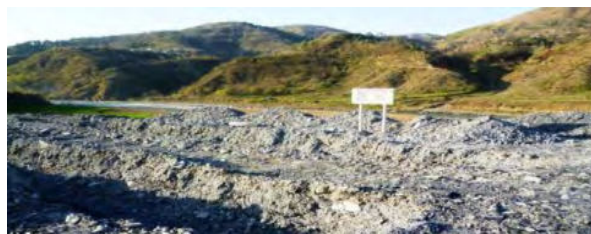
Waste segregation and collection system has considerably been improved on both the sites. EPC and sub-contractors have waste collectors placed on both sites to maintain housekeeping and timely segregation /collection of waste. It is being ensured that landfill is carried out in such a manner that it does not cause harm to the environment. For instance a geo-membrane, concrete and clay lined This can be done by ensuring that landfills are located, designed, constructed, operated and restored so as to ensure that ground and surface waters are not contaminated.

All waste generated in all operation at sites is being managed in accordance with EMP & Waste Management Plan. All the recyclable Waste has been carried and transferred to the scrap dealer by HSE vehicle.

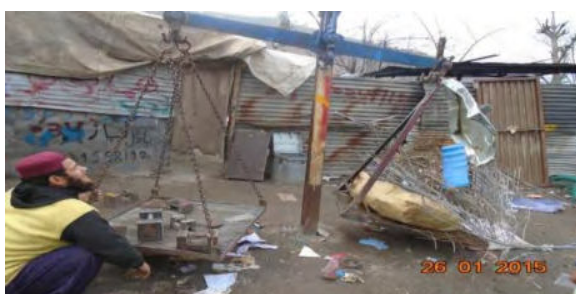
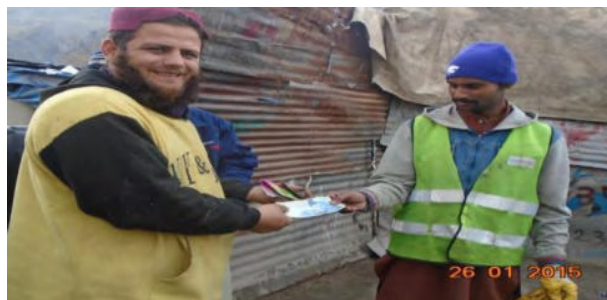
Paper, plastic, cardboard and few iron bars have been properly measured by the scrap dealer, the quantity of which has been noted down on the waste consignment note. Daily environmental Performa regarding potential environmental impacts has been made and monitored at site regularly by direct observation and inspection. These impacts include the monitoring of air emissions, water consumption and discharge, waste management, housekeeping, noise impact, hazardous waste management at the project site. Comments have been noted down In case of any improvement or any corrective action regarding any environmental activity if required.

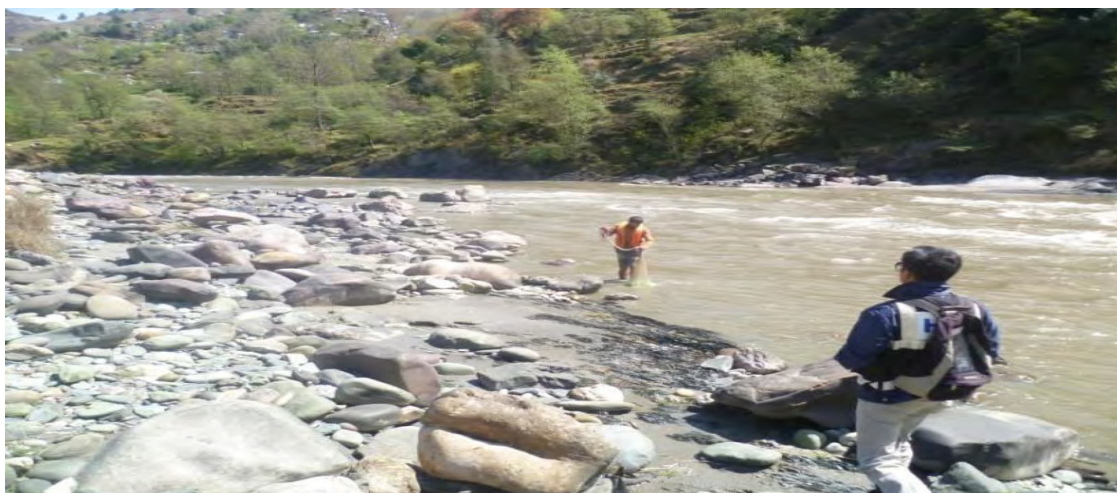
4. Sampling at point-I

First sampling point off the study is situated at  $34^{\circ} 18' 19''$  N,  $73^{\circ} 26' 44''$  E at 2422 ft of elevation above sea level. The water level is moderate and it is turbid due to rains for the last two days. Two fish could be caught in the cast net. Both the fish caught were *Schizothorax plagiostomus* with a length of 7.5" weight 57 grams and length 8.4" and weight 89 grams respectively.

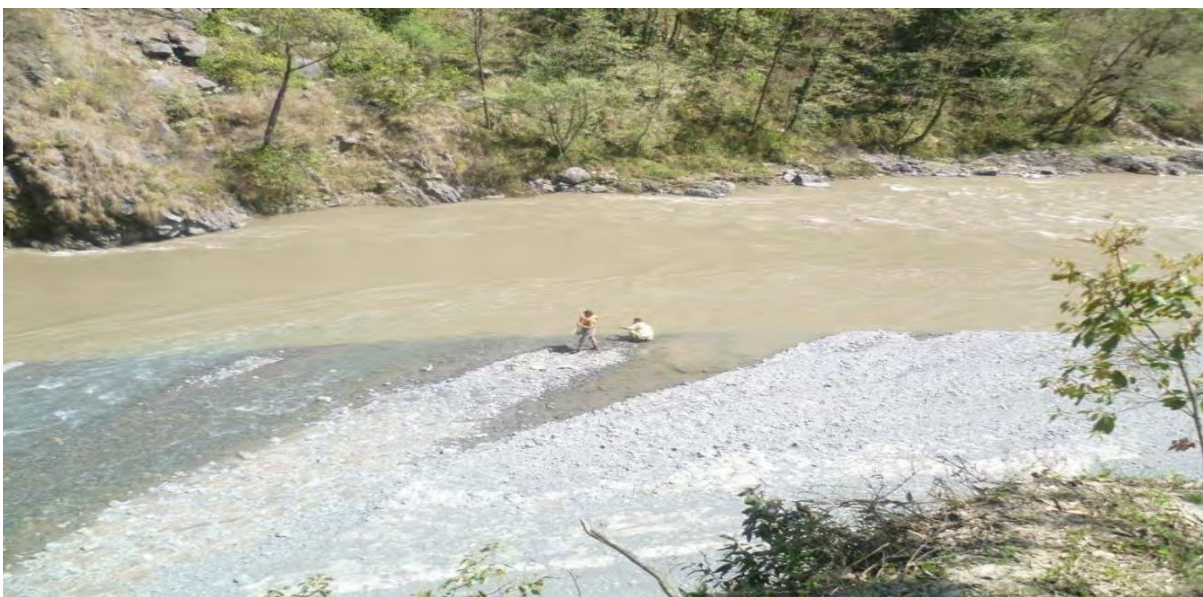
6. Sampling at Point of confluence of nallah Boi with River Kunhar

This sampling point is situated at  $34^{\circ} 18' 36''$  N,  $73^{\circ} 26' 43''$  E at 2398 ft of elevation above sea level. This is the point where fish can migrate upstream in the Boi Nallah during the spawning period and can have little impact of low river flow when tunneling of the water starts. Unlike before, the nallah water was very clear as compared to the highly turbid water of river Kunhar. No fish could be caught here at this point. According to the locals, evidences of existence of *Glyptothorax spp* and common carp (*Cyprinus carpio*) were found in the Boi nallah.

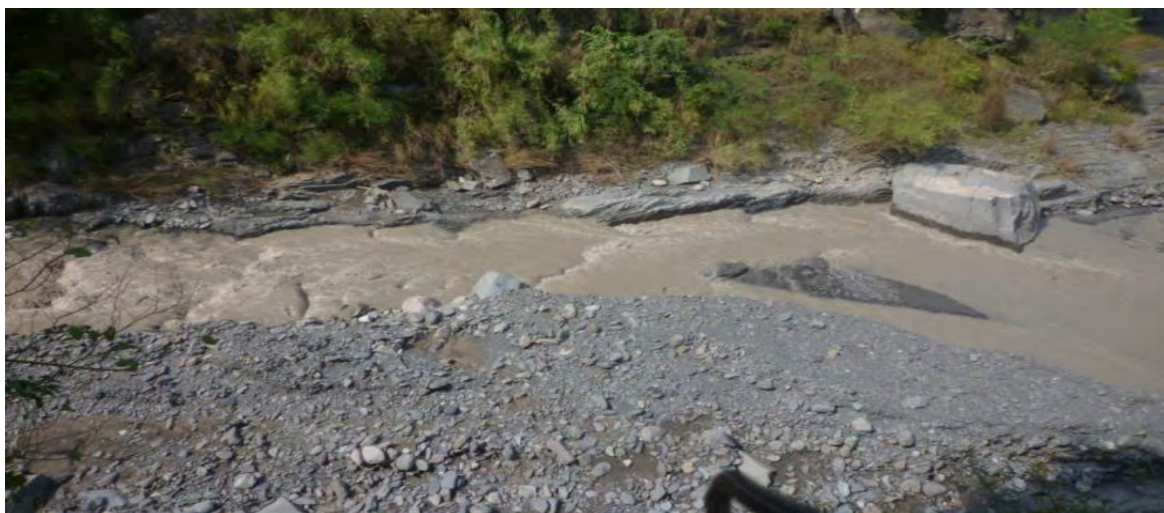
*7. Turbid water of Nallah Boi during last study*

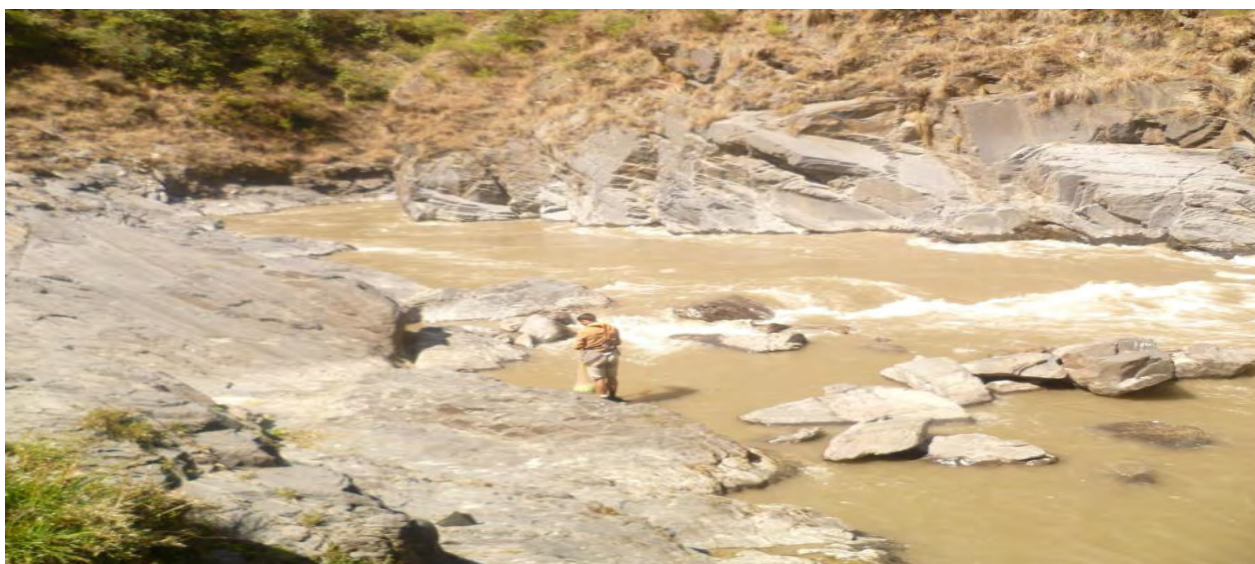
*8. Sampling at point-III, Parri*

This sampling point is situated at  $34^{\circ} 19' 47''$  N,  $73^{\circ} 25' 35''$  E at 2475 ft of elevation above sea level. The river is turbid at this time of the year due to rain. The small creek joining the river is also muddy. Chance of fish catch was expected to be very low and proved correct. No fish could be caught here. Water temperature was  $12^{\circ}$  C and pH 6.5.

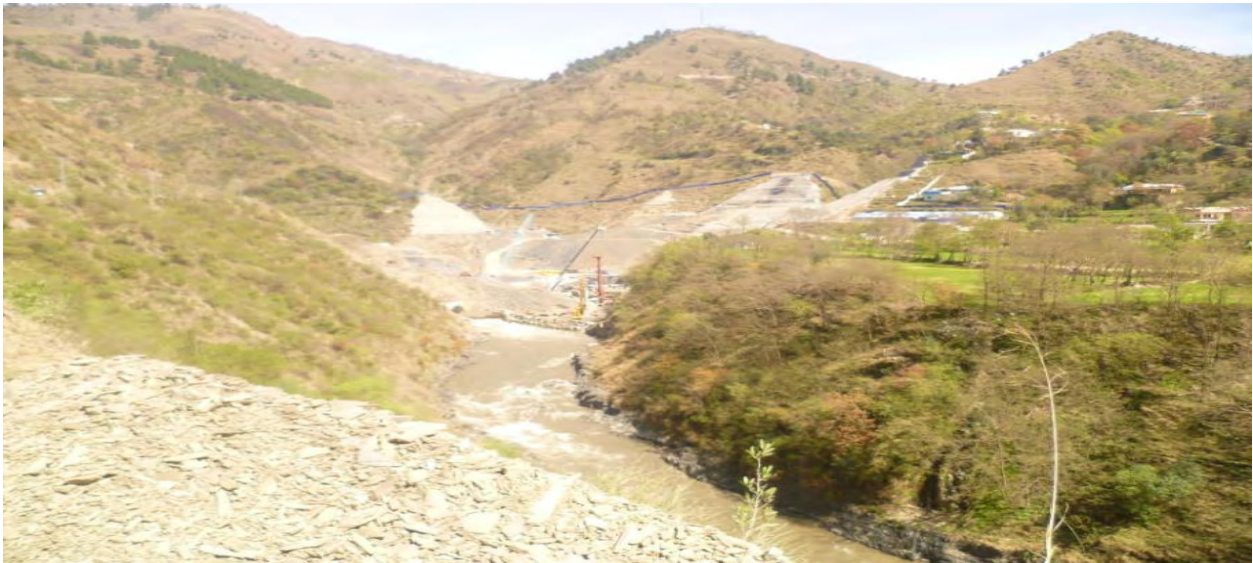
The point is situated at  $34^{\circ} 18' 19''$  N,  $73^{\circ} 26' 44''$  E at 766 meters of elevation above sea level. The pool existing here last time has disappeared due to new construction and enforcement of the embankment. No access was possible to the river but general observation shows that there is no chance of existence of live fish as the water flow speed was very high. The fish caught last time was cylindrical showing the low consumption of food.

*9. Sampling Point at outlet now*

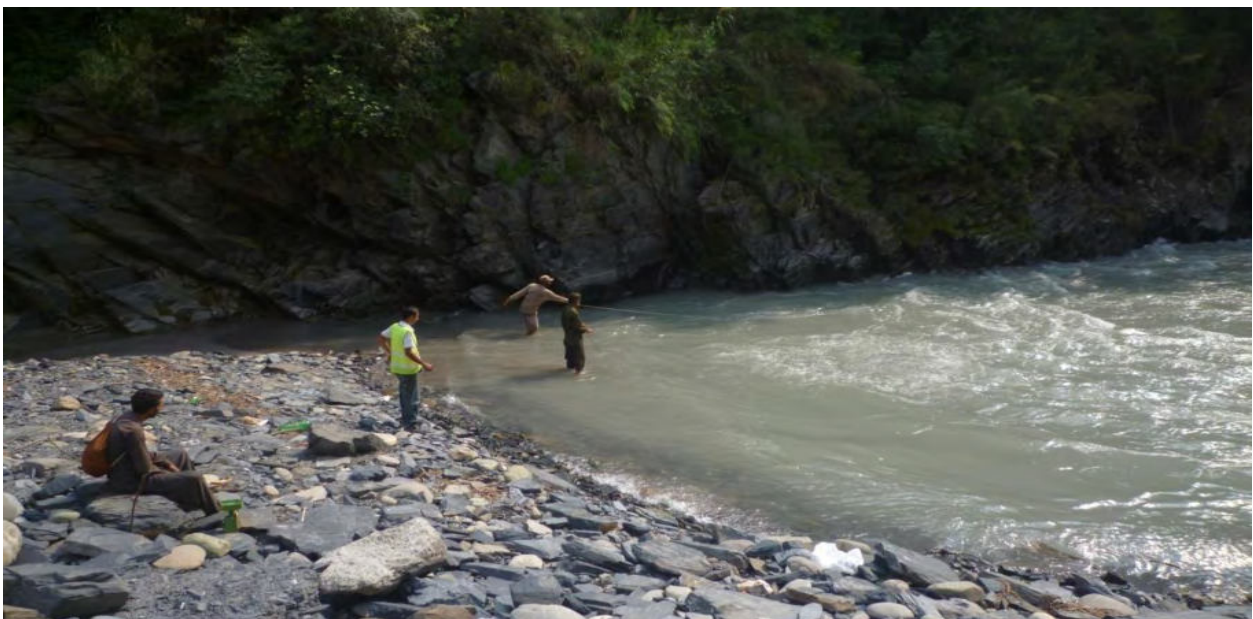
*10. Outlet of Diversion Channel at Patrind during last sampling*

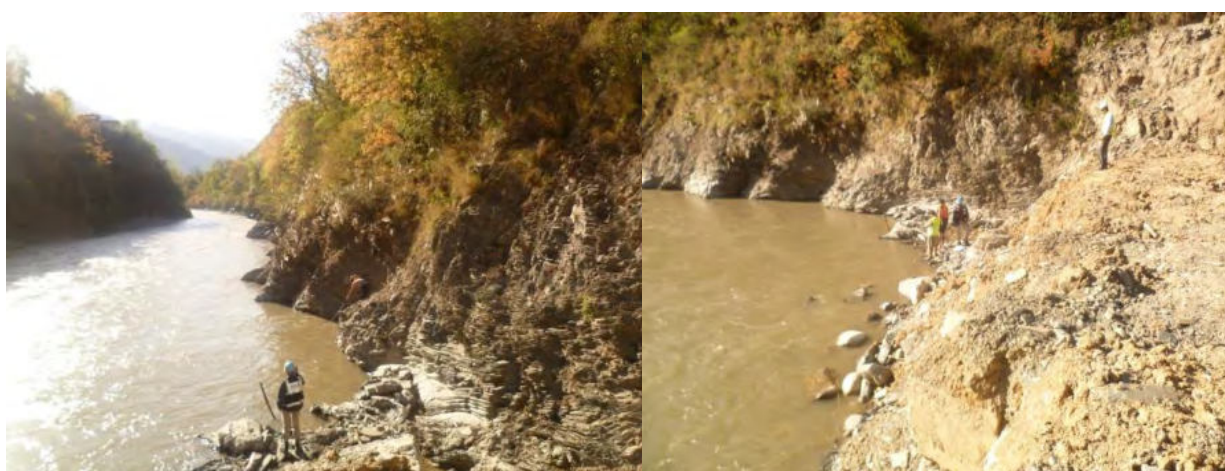
11. Sampling at inlet of water diversion tunnel

This is the point situated at  $34^{\circ} 20'36''$  N,  $73^{\circ} 25'08''$  E, at 2615 ft of elevation above sea level. This is the inlet of the diversion tunnel. Last time the inlet point was not accessible because of the increase in the water flow and blockage of the possible path leading to the point. No fish could be caught here. Still the impact on aquatic life is not very high as the lake has not developed and course and flow of water has not changed here. When the lake will grow after construction of Patrind weir, this can harbour the Rainbow and Brown trout. If carefully planned, this can become commercial activity but needs expert inputs.

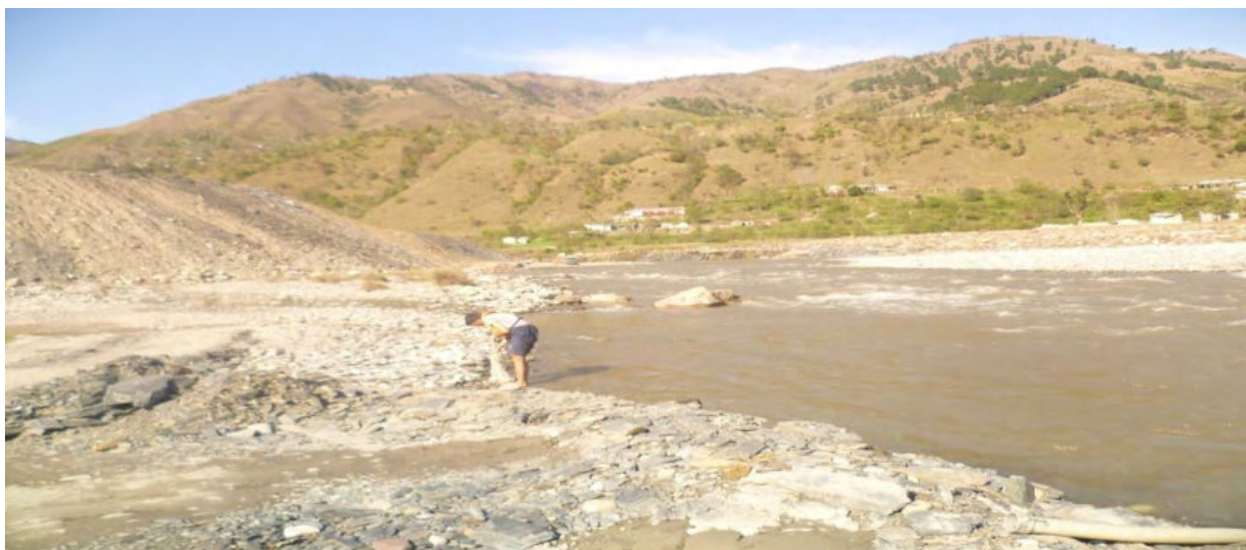
12. Sampling at point VI

This is the point situated at  $34^{\circ} 18' 19''$  N,  $73^{\circ} 26' 44''$  E at 776 meters of elevation above sea level. This is the dumping site of the disposal from the tunnel. This a potential site of the lake emerging due to damming on the river at Patrind. Two fish could be caught here one *Scizithorax plagiostomus* and the other *Scizithorax curvifrons*. The size of the fish *Scizithorax curvifrons* was 5.8'' with a weight of 34 grams and the other *Scizithorax plagiostomus* was 7.5'' with a weight of 97 grams.

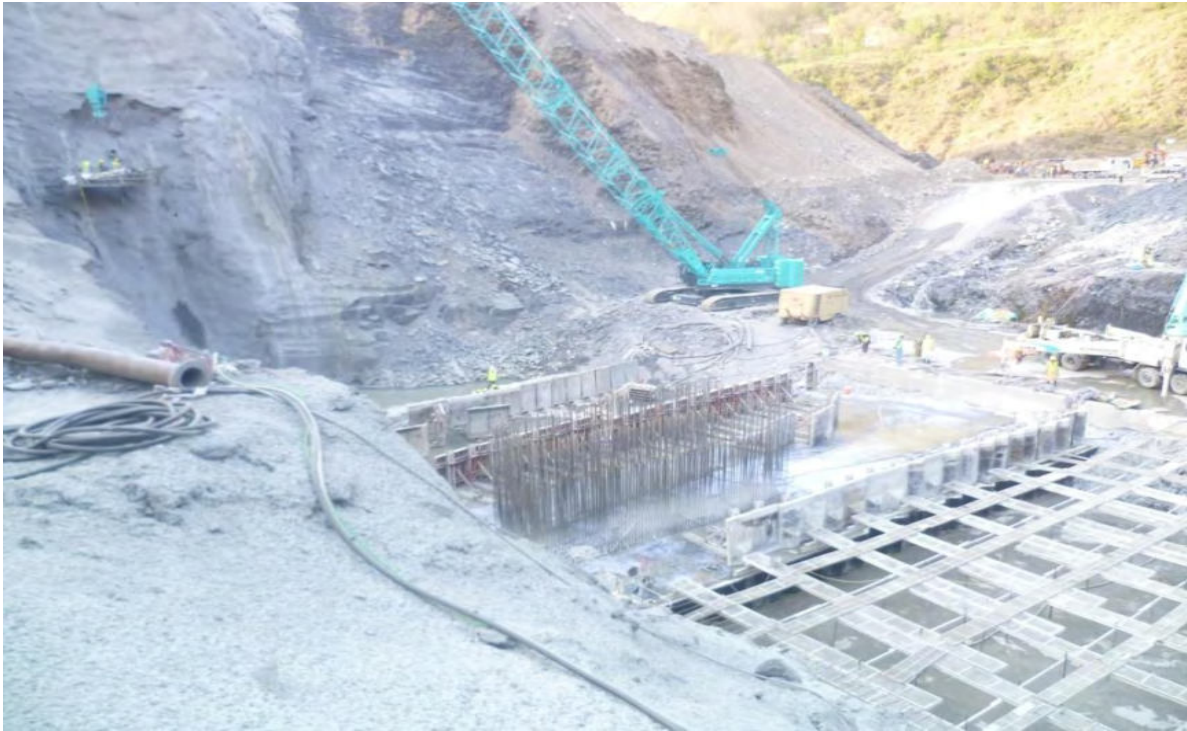
No plantation and bio-engineering work have been undertaken on the site for controlling the erosion and giving it a good looking shape.

*Picture: Showing landslide and new short creating at Patrind*

Engineering structures alone cannot control the slides and again this will require a huge amount of funds for engineering structures. Treating with short creating instead of treating it with plantation and bio engineering will not be a permanent solution to it. The project is mostly looked after by the Engineers and to them, short creating is the easiest and permanent solution for treating the slides. The loss of biomass quantum is not as significant as there has been a low vegetative cover in this area.

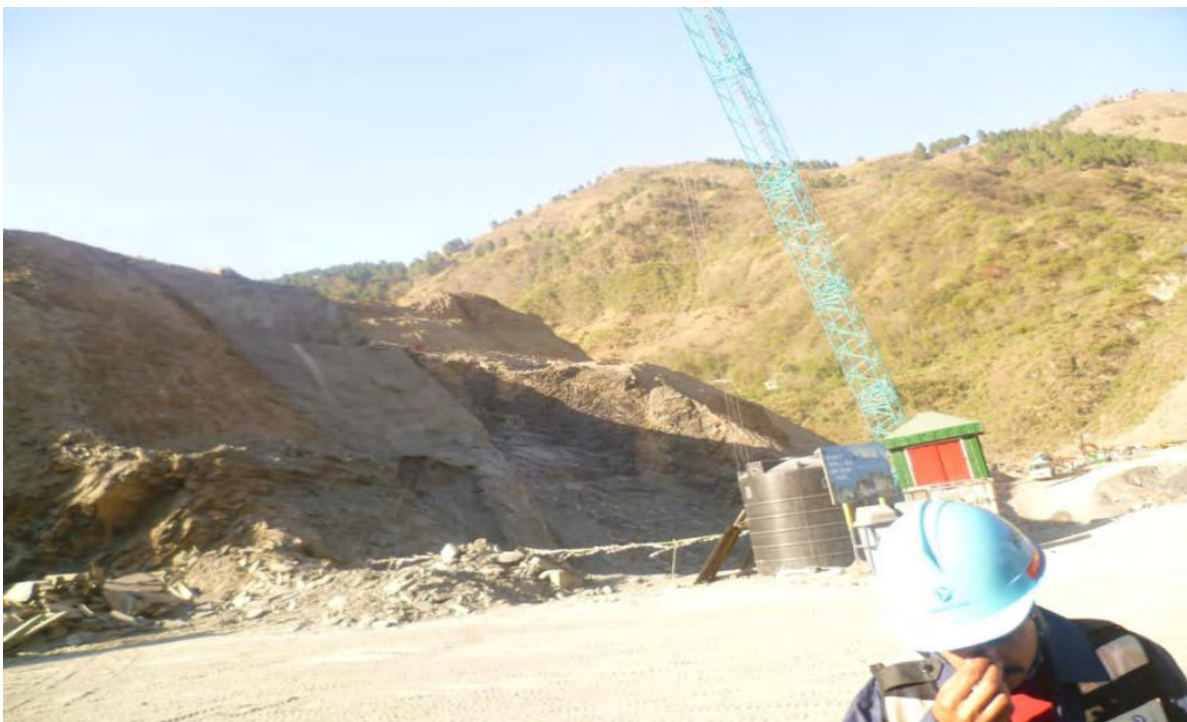
The area has been very badly affected by the landslide on both the sides. Short creating was done in the intake area above the right bank of the river Kunhar at the site of dam construction. The concrete work has again been started with the reinforcement of iron bars. The picture below shows the condition of the area. It also shows the bad look of the site as if it is a desert.

2.. Areas of high working concentration (in-let and outlet of the tunnel) are facing the problem of soil erosion and these have been treated by concreting. It was suggested in the first study to initiate the Bio-engineering technology to control these slides effectively which include vegetated soft gabions, vegetated loose stone walls, gabion check dams, live brush wood check dams, planting, sowing and tufting, dry seeding, hydro seeding, hay seeding, grass sodding, sowing with geo- textile sheets, brush wattles, brush layering, hedge layering, semi-dead fences with live hedges. Total engineering treatment has caused a loss for growing vegetative cover. This will also contribute in the process of global warming and environmental degradation which is not acceptable globally. This adverse effect should be compensated by treating the adjacent slides with Bio-engineering measures which will not only treat the soil but will also improve the environmental status.

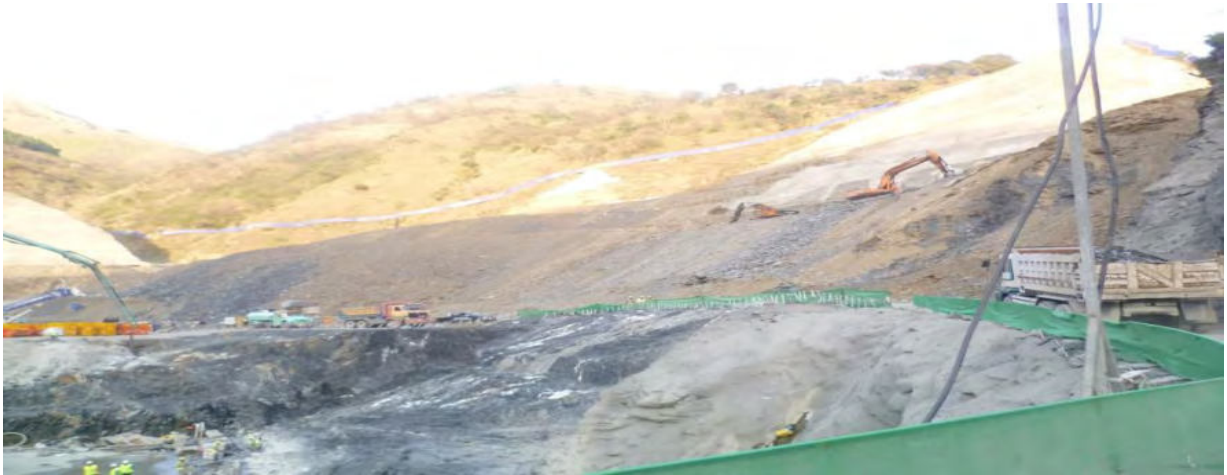
Other left side above the river Kunhar is also not very much different than the right bank as seen in the photograph below. The site outside the project area also shows the need of plantation which has not been done so far in spite of strong recommendations under the previous studies.

Note: The area should be treated with biological means along with engineering works, the otherwise position will further deteriorate. It is very important to start working in the light of this report.

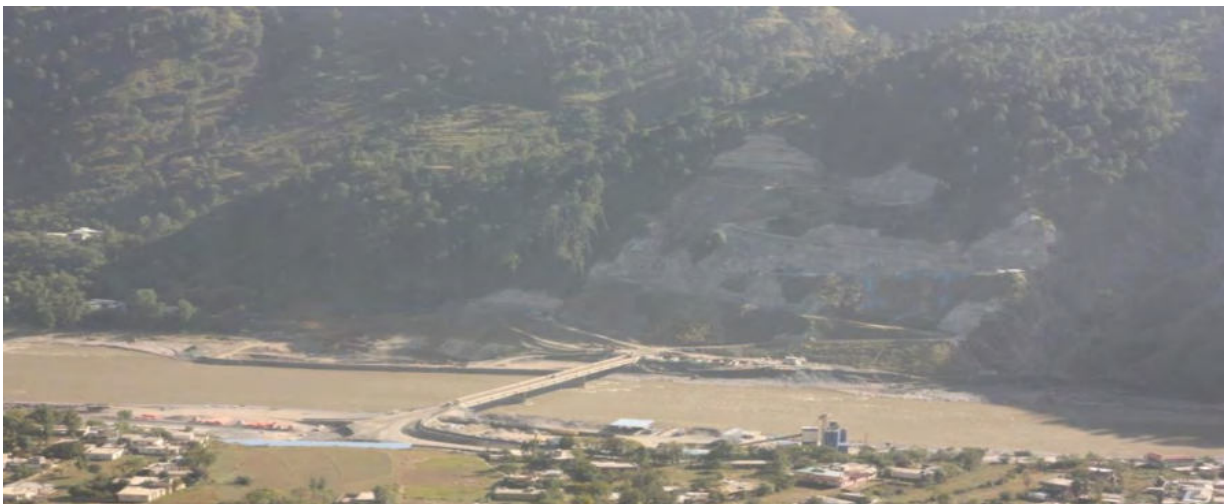
The site at Alda even shows the worst position. The slide area inside and outside the project site has been damaged very badly. New land slide at the point of outlet has appeared resulting in the change of outlet position. The slide has covered more area at the upper side. Pictures of the previous and current study are given below for comparison purposes.

*Picture: Showing position of landslide during December 2014*

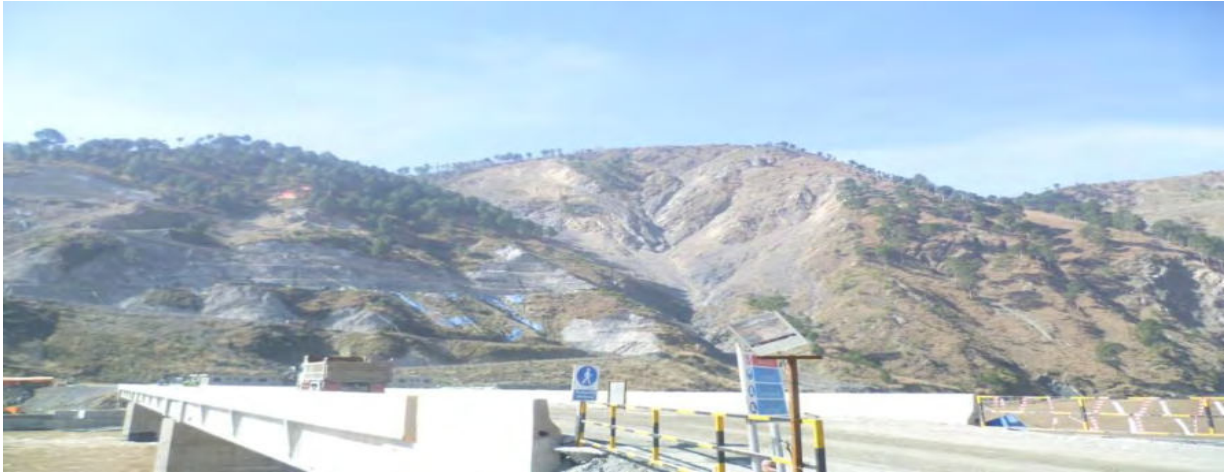
*Picture: showing the present position of the site*

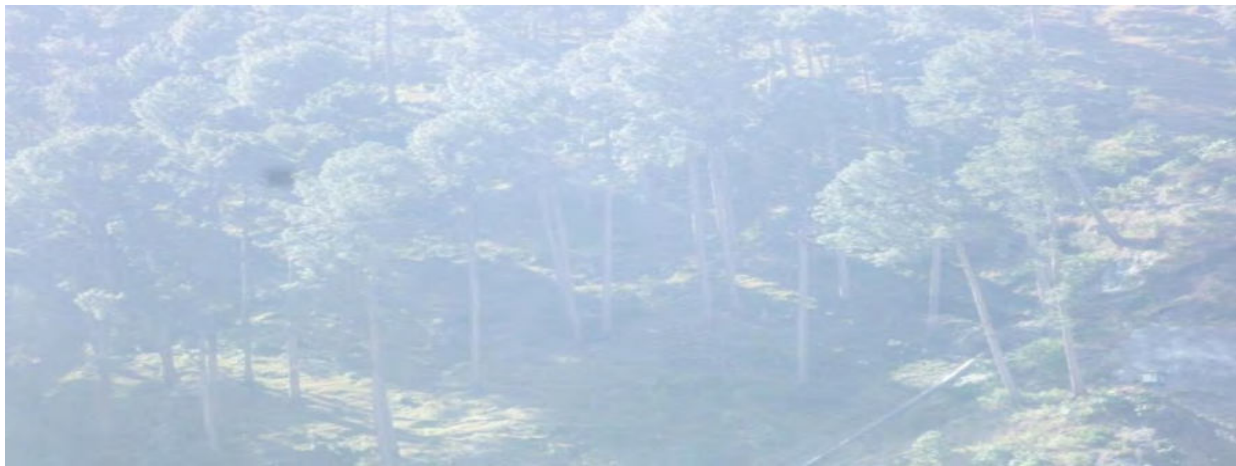
Many Chirpine trees outside the project area are leaning on one side and they are susceptible to fall down by a strong wind at any time. No new sapling plants are coming up and area has been left to the mercy of nature. One fallen tree can be seen in this picture below:

*Picture: Showing a fallen tree and some leaning trees at Alda*
