Environmental and Social Monitoring Report

Project Number: 44914-014
Quarterly Report 2017 (January – March 2017)
March 2017

Pakistan: Patrind Hydropower Project

147 MW PATRIND HYDRO POWER PROJECT

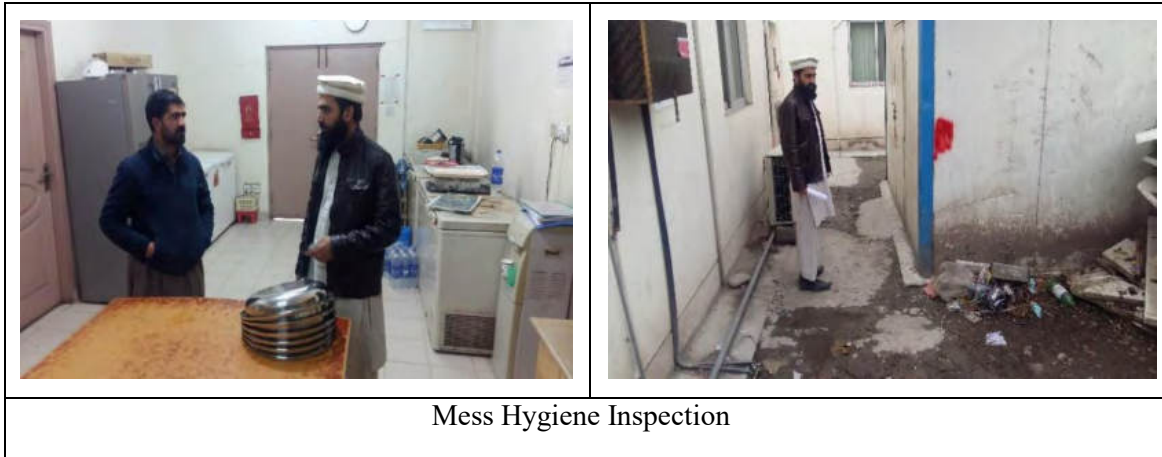
- In the month of Jan-17, mess hygiene inspection was conducted. HSE doctor along with Environmentalist visited the camp vicinity and Mess to inspect the surrounding areas.

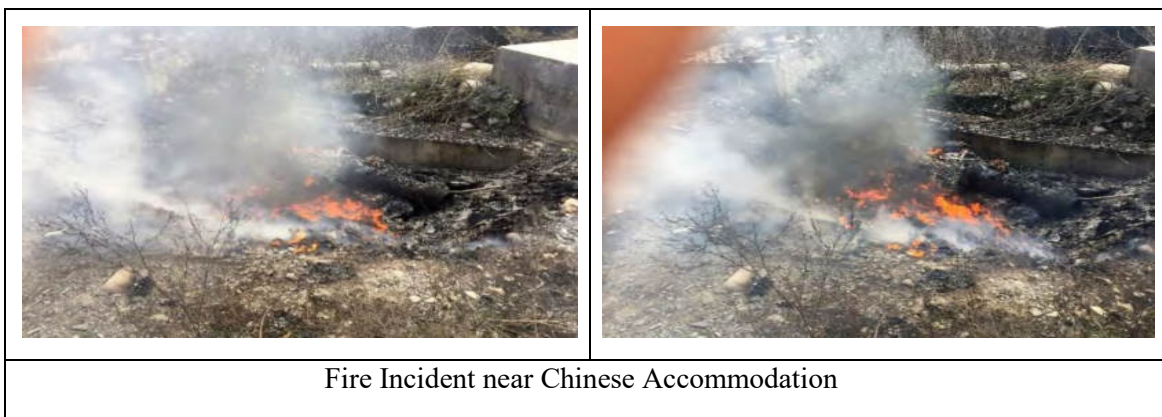
- In the month of Feb-17, minor fire incident occurred near Chinese labor accommodation no serious damage had been occurred and corrective action was taken in this regard by removing the fire and informed the local community not to fire anything inside the project territory.

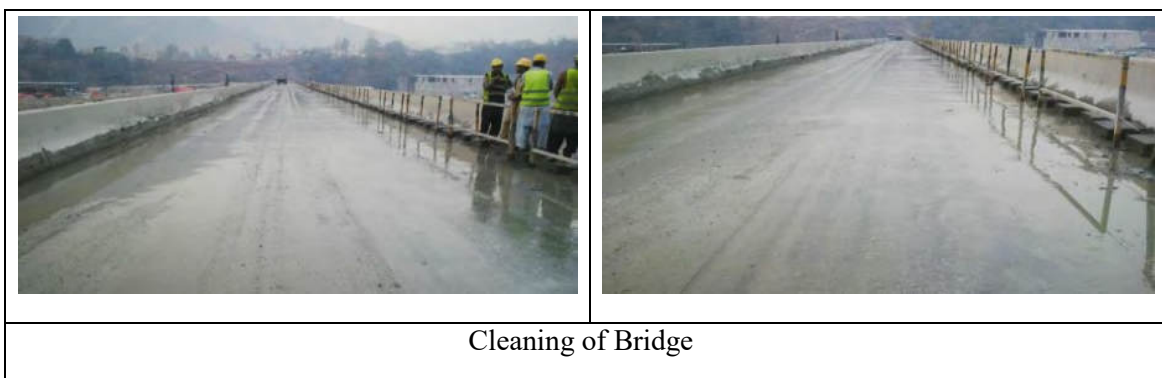
- Mud was accumulated on bridge due to precipitation in the month of Feb-17 & most of the workers faced problem while walking through pedestrian access. Accumulated mud was removed from the location.

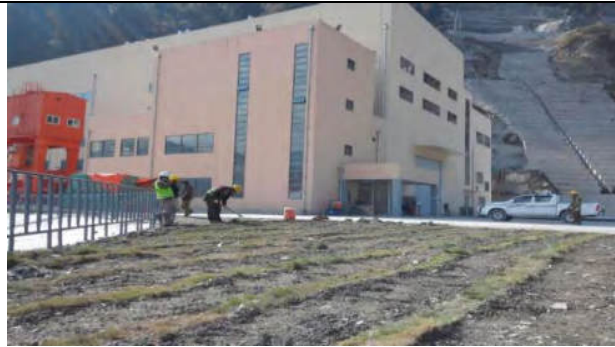
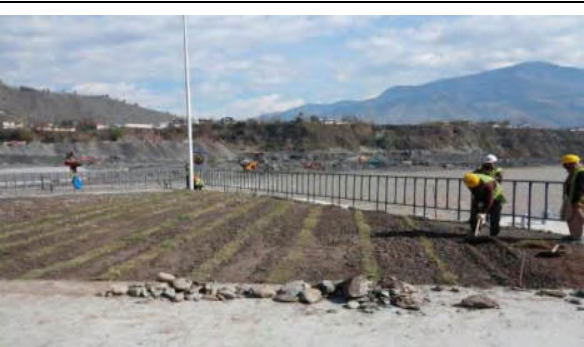
<p align="center">Grass Tufting at Powerhouse site</p>	<p align="center">Grass Tufting at Powerhouse site</p>

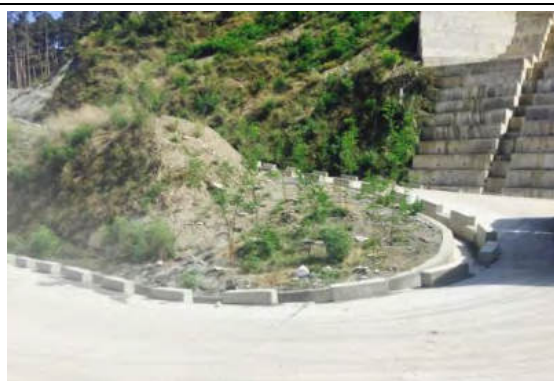
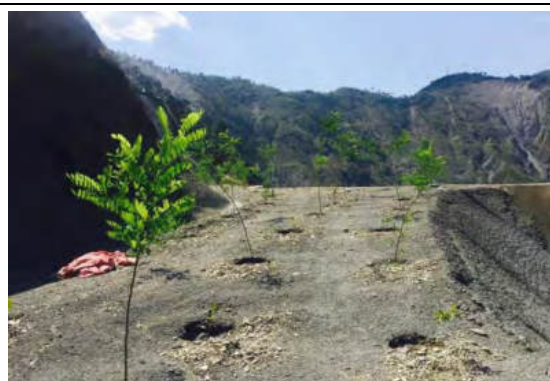
The monitoring report recommends the bio-engineering works for the treatment of unstable slopes and stabilization of landslides to retain the good looks and better environment; detailed report is annexed as **Annex-9**.

Vegetation Monitoring During the First Quarter, 2017

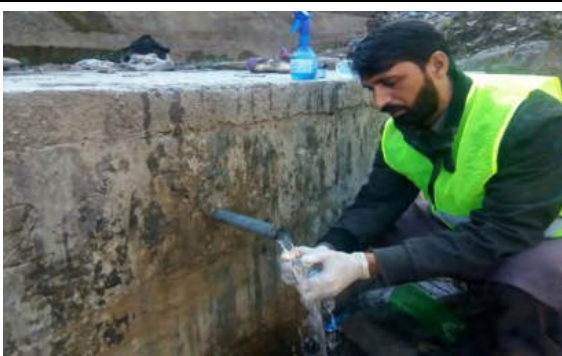
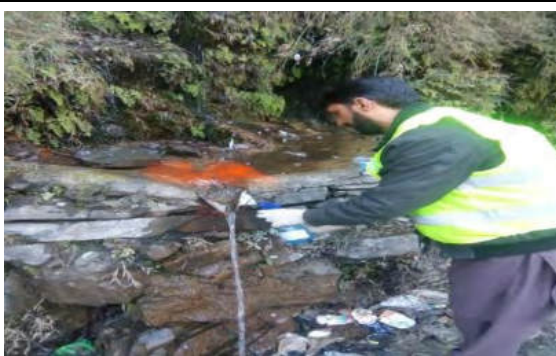
A team comprising of technical experts from PCRWR officials and Patrind hydropower project staff was assigned in order to carry out field survey and collect water samples from identified water sources being used by the local community and for drinking purpose and other domestic needs. Officials from PCRWR with the assistance of project staff collected the samples from identified site according to the standard procedure. The detailed report is attached as **Annex-12**.

Water Quality Analysis during the First Quarter, 2017 by PCRWR

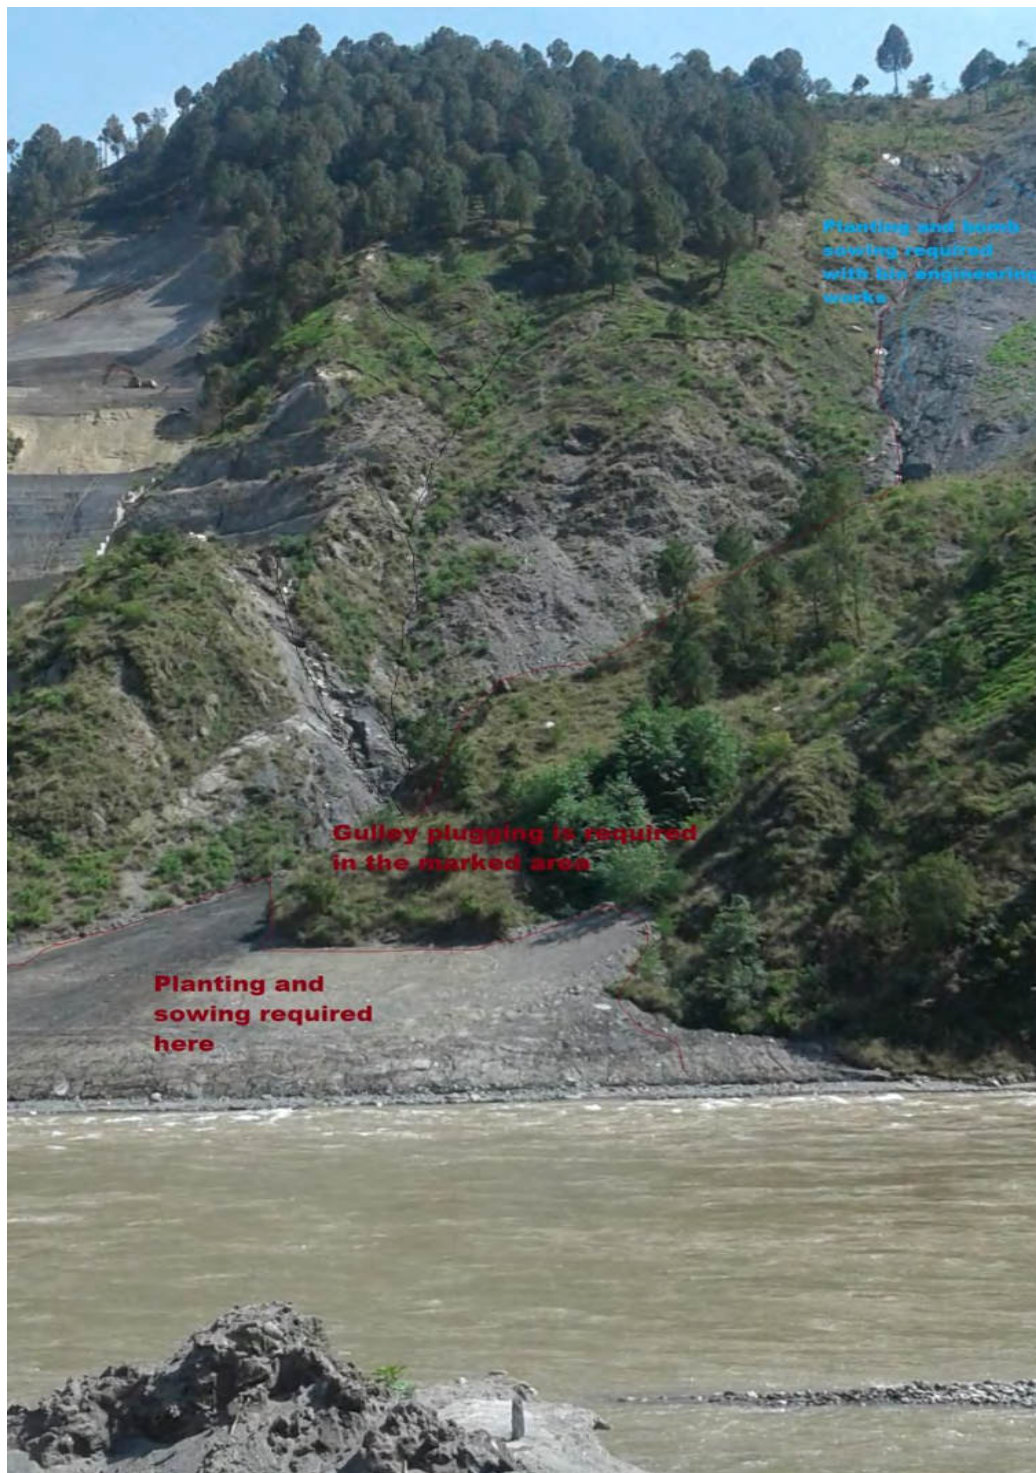
The area affected by the project on the Patrind side has been protected by concrete work on both sides of the weir and reinforced on the right bank of the lake appeared by stone pitching and wire gabions. Left side of the lake has not been reinforced as most of the area has a solid rock but one point seems to be susceptible to sinking which needs attention. The vegetative cover of the lake area has come under the water which was marked before.

Fig: marked areas for different interventions to be carried out seriously

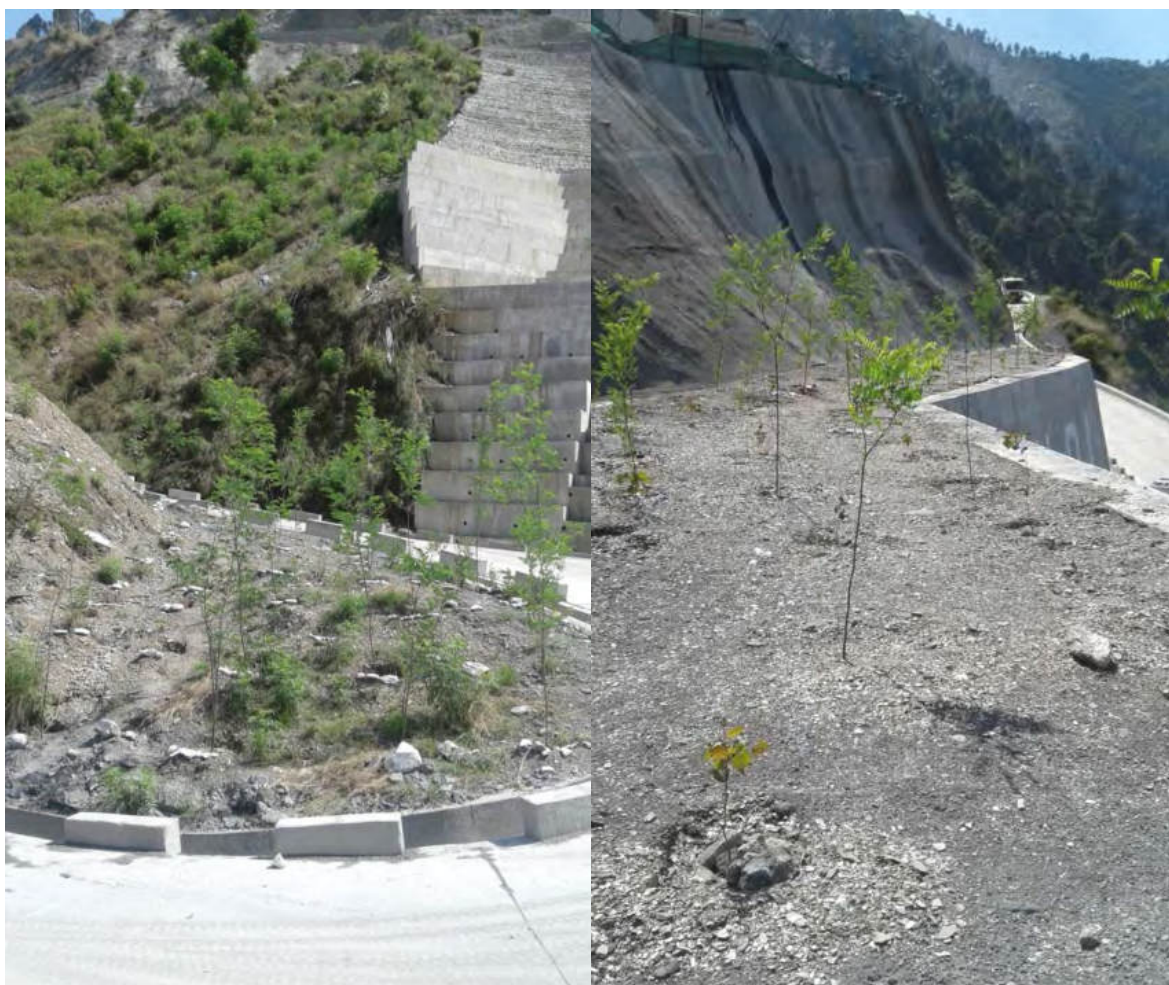
Fig: View of plantation of Robinnea and Ailanthas plants with few euphorbia plants

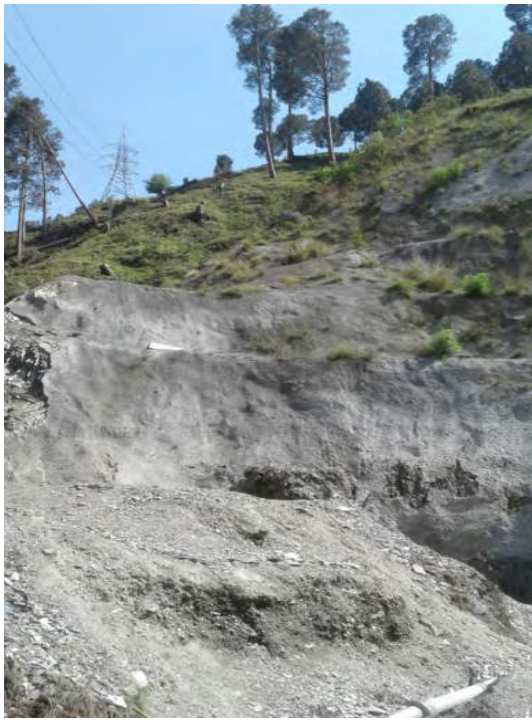
Fig: Area exposed due to Pine tree cutting and damaged house by the landslide and more houses nearby

The area exposed by cutting the mature Chir Pine trees must be planted with native low level plants like *Ficus palmate* (Phagwar), *Celtus australis* butculd) and some bush species.

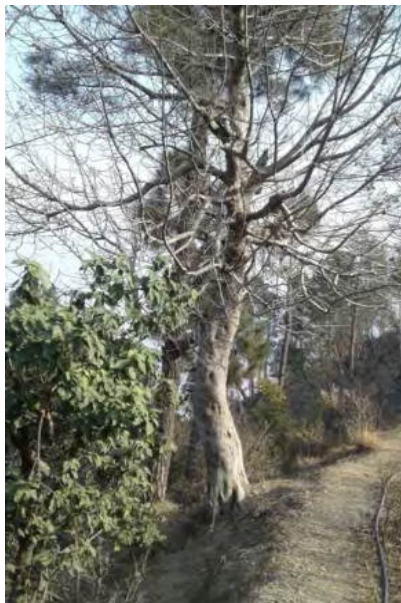
Some local tree and bush species were found near the top which are excellent soil binders and they need to be planted in the affected area as well.

A Phagwarr tree (excellent soil binder)

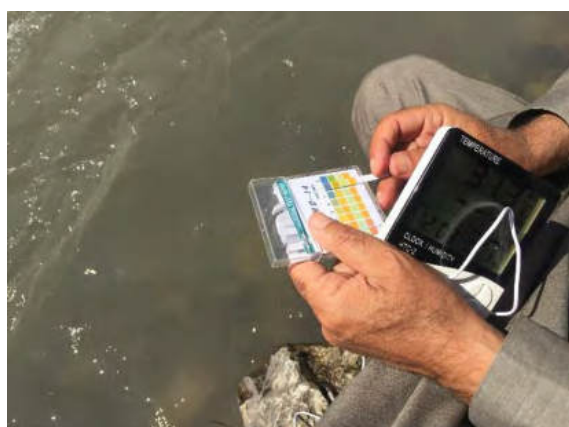
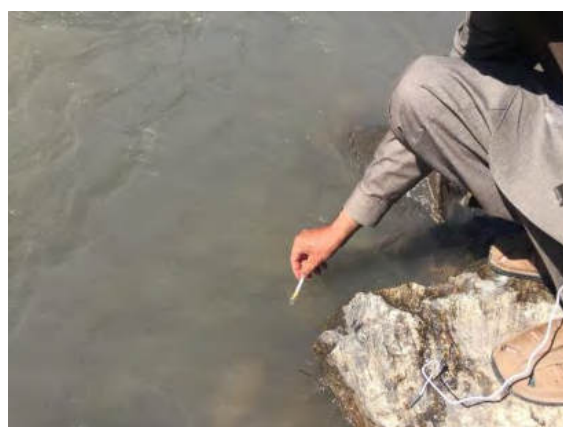
S No	Point	Dissolved Oxygen (ppm)	pH	Temperature °C	Transparency
1	Boi	8.1	6.5	11.54	1
2	NallahBoi	8	6.5	12	1
3	Parri	8.1	6.5	11.5	1
4	Turchilla	9	7	13.4	1
5	Dalola-1	9	7	13.4	1
6	Dalola -2	9	7	13.4	1

Checking PH and Temperature of Kunhar River at Point No. 1 (Boi)

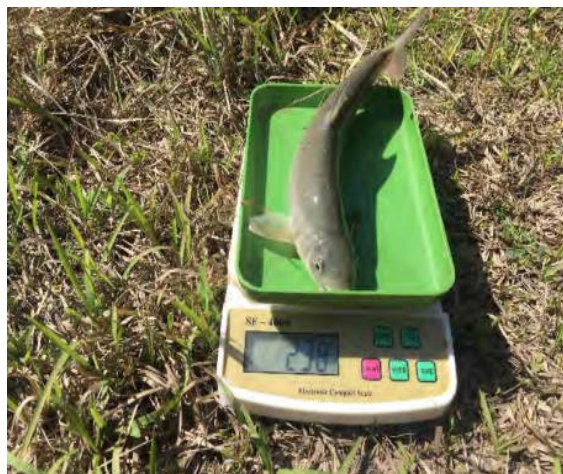
Fish Caught at Sampling Point 1

Catch in the deep lake behind the weir has become impossible due to the depth of the lake and fish survival probability has also become near to impossible as the river ecology has changed altogether. The fish caught at sampling Point-I was very healthy and it shows the survival of fish in any pool water.

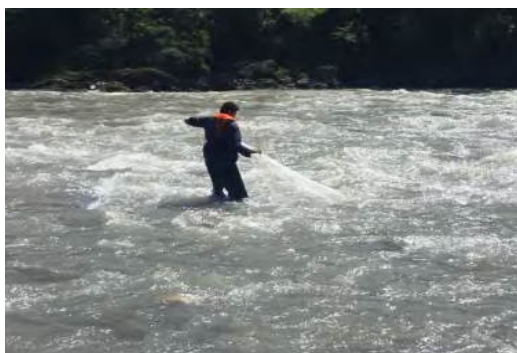
First sampling point of the study is situated at 34° 18' 19" N, 73° 26' 44" E at 2422 ft of elevation above sea level. The water level is normal as compared to the last study in December 2016. The water has not been stopped at the weir due to some technicalities. One fish species, *Schizothorax plagiostomus* was caught here with a weight of 240 grams. The fish was very healthy and it can be predicted that the food is abundant but the population has decreased. The water is clear; change in flow has been noticed. More water depth is in the middle while shallow sides are limited.

Fig: River water in May 2016

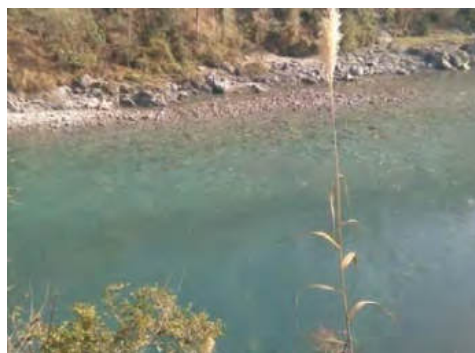
River water in December 2016.

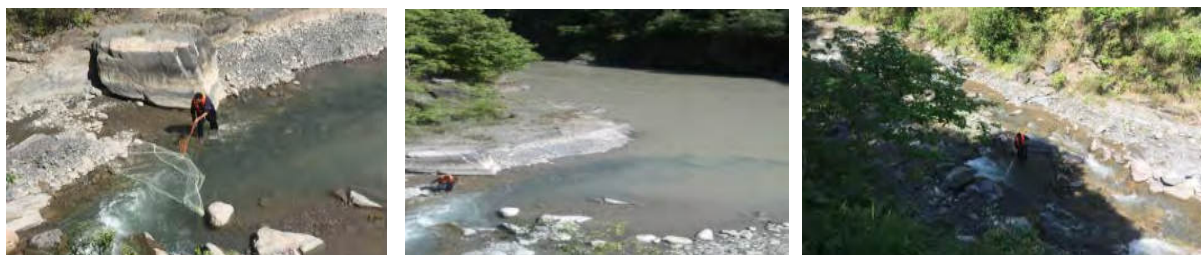
This sampling point is situated at $34^{\circ} 18' 36''$ N, $73^{\circ} 26' 43''$ E at 2398 ft of elevation above sea level. The nallah water was very clear as compared to the river water. The river flow is more centered at this time. No fish could be caught here even in the nallah. This is the only source of water contributing in the river Kunhar down the Boi to Domeshi.

Pic: Nallah boi confluencing with river Neelum during May 2017

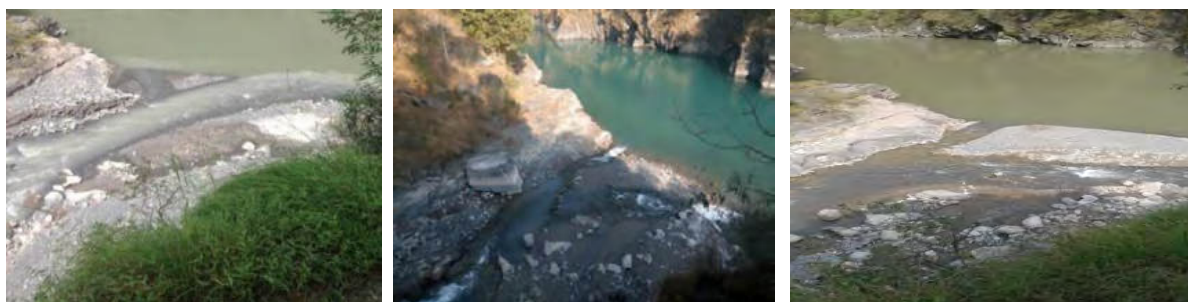
Fig: Confluence of Boi Nallah Pictures in Sep. 2016, September 2015 and Dec. 2016.

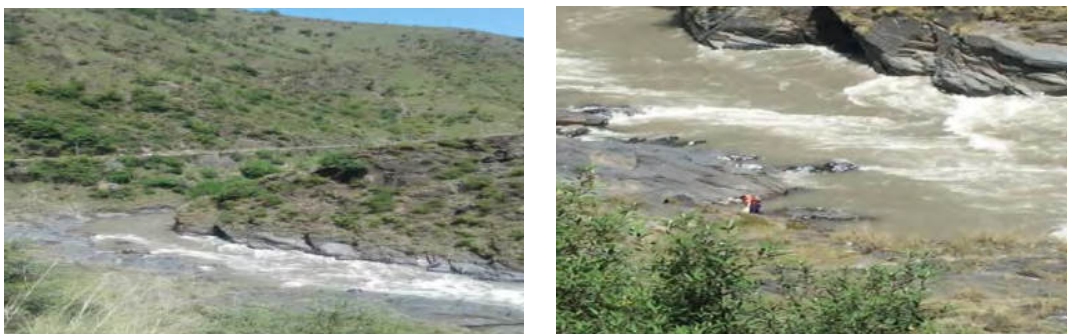
This sampling point is situated at $34^{\circ} 19' 47''$ N, $73^{\circ} 25' 35''$ E at 2475 ft of elevation above sea level. The small creek joins the river here. No fish could be caught here. The river flow is high and centered.

Fig: Sampling at point-III, Parri during May. 2017 and December 2016.

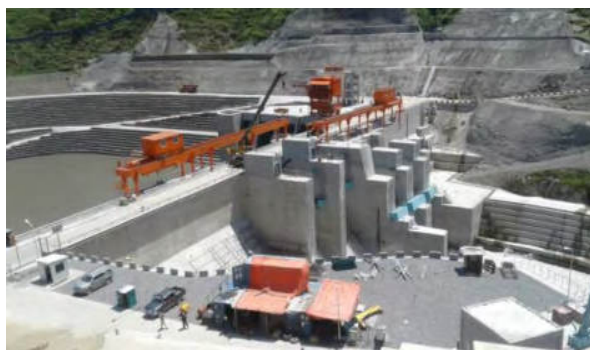
This point has become inaccessible and now there is no use to sample at this point because the water over flowing from the spillway will have no fish or such larger aquatic life as the lake behind the spillway is very deep. Instead of this point a point near Tarcheela was sampled but again no fish was found. Here it is important to mention that the agreed minimum quantity of water must be released regularly so that impact on aquatic life can be kept to a compromising level. As it has been done on December 26, 2016 by completely stopping the water for raising the water level in the lake, then the fish life cannot be guaranteed below this point. The point sampled at Tarchella also had no fish.

Fig: The weir point in May 2017

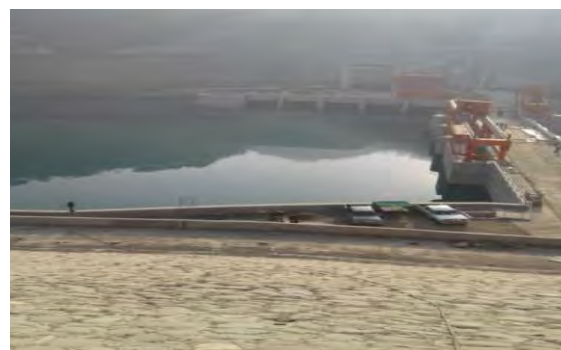
Fig: The weir point in December 2016

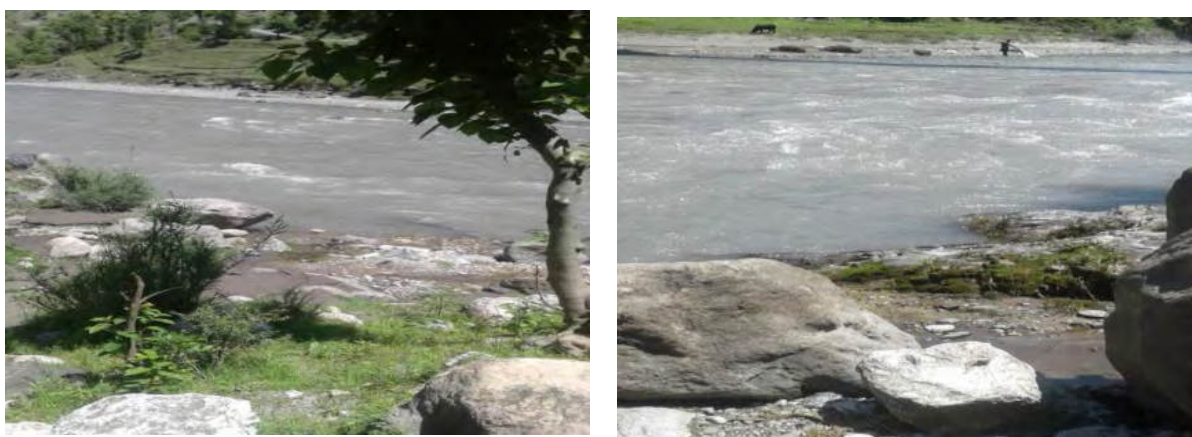
This is the point from where the water enters into the lake. According to the fisherman, a group of *Glyptothorax kasmiriensis* was seen here on December 2016 but now they have disappeared. I requested him to catch the fish whenever he can find it so that impact of change in ecology could be ascertained. No fish was found here.

Fig: point-VI Shorran in May 2017

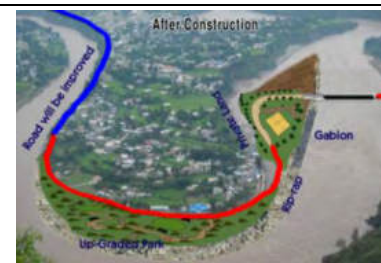
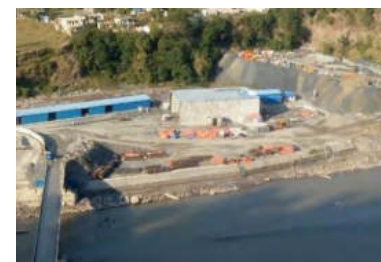
3	Embank protection	<ul style="list-style-type: none"> Slope protection and embankment against the risk of encroachment and inundation during heavy rainy season - Rip-rap protection Gabion protection 	<ul style="list-style-type: none"> Completed in 2015 	<ul style="list-style-type: none"> Permanent protection measure with concrete works have been taken (Up & downstream the access bridge) along the river bank at batching plant area and M&E fabrication workshop area Same measures have been undertaken on power house site in front of O&M building and powerhouse structure site.

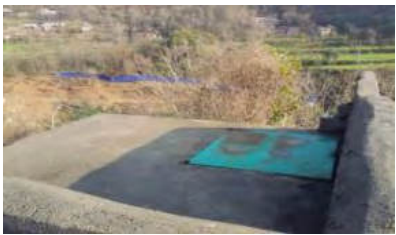
No.	Classification	Description of Plan	Time Schedule	Status	Photos
				- Pvc pipe line : 1,500m	
5-0	Water supply for Weir site	<ul style="list-style-type: none"> Initially water supply were planned for Tarcheela, Patrind, Taitree(Sarati) because Tarcheela and Patrind, were designated as camp area However acquisition of Tarcheela and Patrind land turned down by villagers Eventually our current camp was built in Taitree adjacent to Sarati Developing water supply for Tarcheela and Patrind cancelled 			
5-1	Water supply for Weir site	Water supply to the Sarati village after developing and using the well in weir camp	<ul style="list-style-type: none"> Water tank completed In 2012 Handed over 	<ul style="list-style-type: none"> Water resistivity survey was carried out but no ground water was found. Currently Sarati village is using weir camp water source after making branch pipe

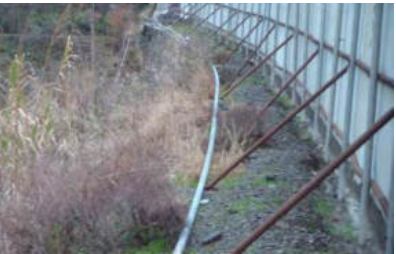
5-2	Water supply for Weir site	<ul style="list-style-type: none"> Connection of water pipe line to the water tank at Sarati village Installation of surface drainage line at Sarati village 	<ul style="list-style-type: none"> Completed In 2013 Handed over 	<ul style="list-style-type: none"> Water pipe line was developed from existing water tank to Sarati village in 2013. - GI pipe(D50mm) : 230m - Installation of fence and protection wall for water source were installed and access road was also repaired. Surface drainage line was developed at Sarati village in 2013. <ul style="list-style-type: none"> - RCC pipe(D450mm) : 87m - 3 Manholes and block masonry

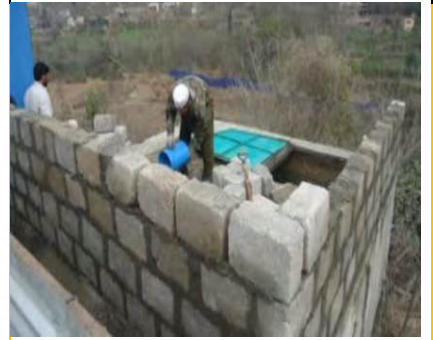
No.	Classification	Description of Plan	Time Schedule	Status	Photos
5-3	Water supply for Weir site	<ul style="list-style-type: none"> Repairing water tank at Sarati village with proper top covering 	<ul style="list-style-type: none"> During construction phase 	<ul style="list-style-type: none"> Water tank for Sarati village was repaired and has been made dirt free - Top cover is installed surrounded by a concrete protection wall

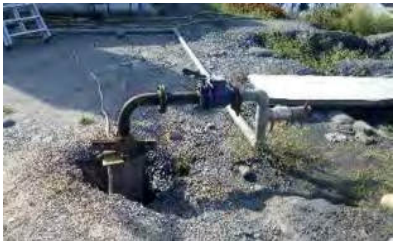
No.	Classification	Description of plan	Time Schedule	Status	Photos
1	Water supply for Power House Site	<ul style="list-style-type: none"> Water supply to the Lower Chatter and Alda villagers using the well in labor camp area 	<ul style="list-style-type: none"> Completed in 2014 The local community will have access to this water well after construction phase 	This well is currently being used to supply water to CNEEC and Kyungdong workers who are engaged in Powerhouse construction during construction phase.

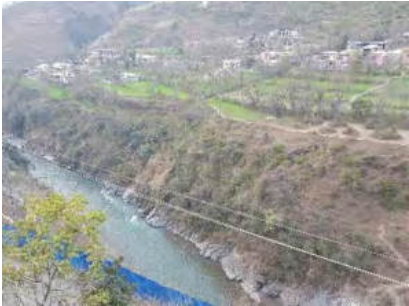
2	Water supply for Weir Site (Tarcheela)	<ul style="list-style-type: none"> Cash support on tubular well construction for Tarcheela village 	<ul style="list-style-type: none"> Tarcheela find spot for tubular well and EPCC paid Rs.150,000/- on 21st Mar,2017 they will complete building the tubular well April in 2017(time line is subject to change) 	<ul style="list-style-type: none"> As agreed EPCC paid half payment Rs.150,000/- to Tarcheela village. Tubular Well construction work is progress and hopefully complete on 30th April 2017

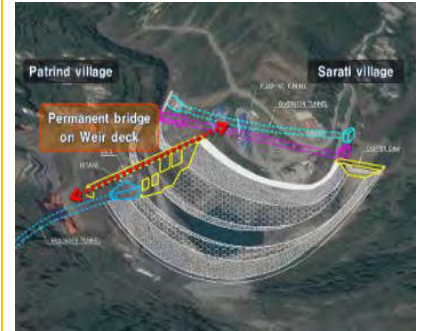
No.	Classification	Description of plan	Time Schedule	Status	Photos
3-1	Improvement on access to isolated villages (Weir Site)	<ul style="list-style-type: none"> Provision of Link between KP and AJK regions to local people As the permanent link route, Spillway bridge of Weir will be allowed to the locals. 	<ul style="list-style-type: none"> After construction phase in March 2017 Time line is subject to change according to progress 	<ul style="list-style-type: none"> Cofferdam was constructed in 2013 and used to be an access for Tarcheela villagers Currently, road passing through the weir site is being used by the locals as access between AJK & KP Site.

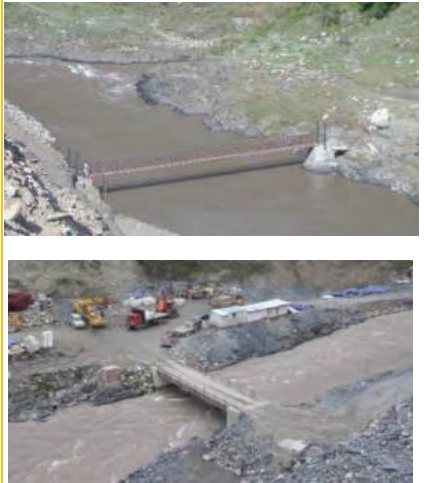
<p>[Bridges installed in 2012 & 2013]</p>

3-2	Improvement on access to isolated villages (Weir Site)	<ul style="list-style-type: none"> Installation of pedestrian bridge for Patrind villagers. 	<ul style="list-style-type: none"> Pedestrian bridge installed in 2012 and 2013 	<ul style="list-style-type: none"> The villagers used to go across the river by cable trolley but it was washed away by flood in May 2005. As part of corporate social contribution, EPCC built the pedestrian bridge temporarily.

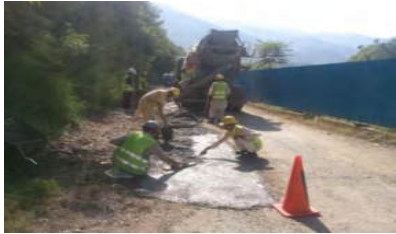
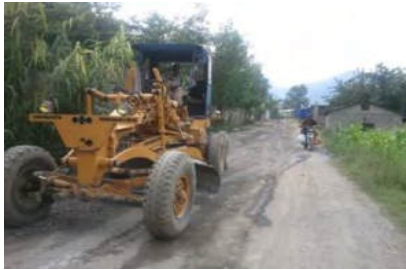
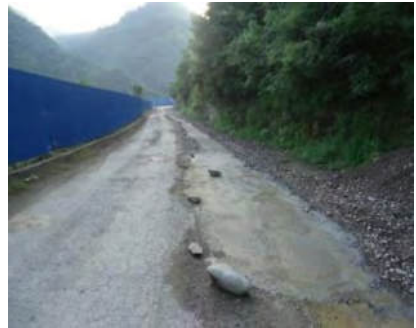
No.	Classification	Description of plan	Time Schedule	Status	Photos
4-1	Improvement on existing road (Weir Site)	<ul style="list-style-type: none"> 1st improvement for Boi road between sarati village and batching plant completed

<ul style="list-style-type: none"> After maintenance passing by is improved.

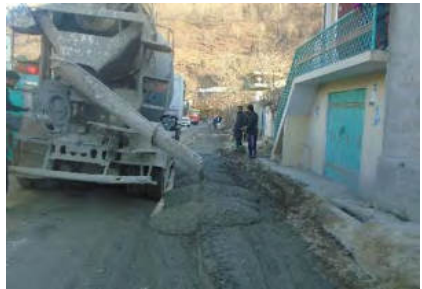
4-2	Improvement on existing road (Weir Site)	<ul style="list-style-type: none"> Final improvement for Boi road between sarati village and batching plant (Hoondi). 	<ul style="list-style-type: none"> After construction phase in April 2017 Time line is subject to change according to progress 	<ul style="list-style-type: none"> From Hoondi (batching plant) to Sarati Village (Weir Offices) area around 1600m is finally paved on 15th April 2017.

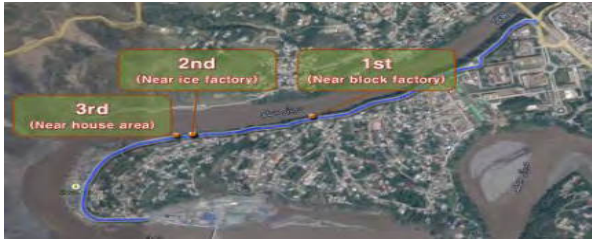
5-1	Improvement on existing road (Power House)	<ul style="list-style-type: none"> 1st~3rd improvement done EPCC have done several restoration works for the sliding section of the road until now.

<ul style="list-style-type: none"> EPCC subcontracted to DAM (Development Authority of Muzaffarabad) 3 times for that work. 1st : : Construction of road and barrier near Awan Block Factory. 2nd :

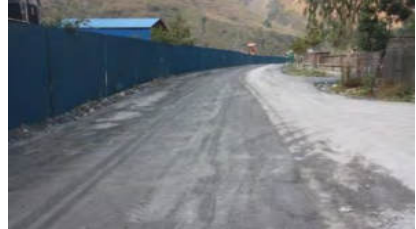
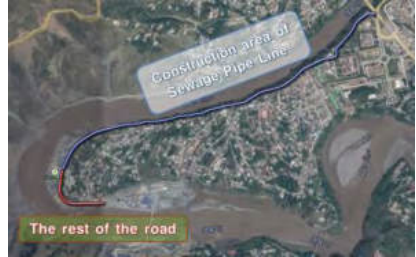
No.	Classification	Description of plan	Time Schedule	Status	Photos
				<p>: Construction of barrier near Ice Factory.</p> <p>- 3rd :</p> <p>: Re-construction of damaged retaining wall near house</p>	
5-2	Improvement on existing road (Power House)	<ul style="list-style-type: none"> • Final improvement • The rest part of road from labor camp area to Jhelum River bridge will be improved 	<ul style="list-style-type: none"> • Road Pavement is completed from Ice Factory to Jhelum River Bridge. 	<ul style="list-style-type: none"> • To improve the road condition for ongoing traffic, EPCC has been completed concrete road pavement from Ice Factory to Jhelum River Bridge and from Bridge to Alda Village.

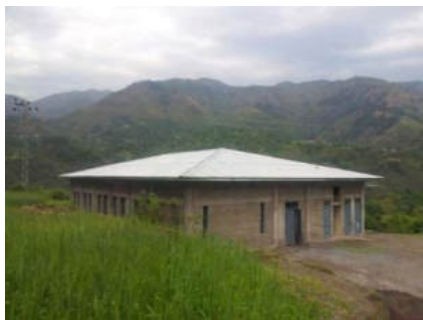
2-1	School support (Wier Site)	<ul style="list-style-type: none">Deedal Meera school was badly damaged due to earthquake in 2005

<ul style="list-style-type: none">Completed in 2013	<ul style="list-style-type: none">EPCC installed the entire roof, doors and windows in 2013.
