Environmental and Social Monitoring Report

Project Number: 44914-014
Quarterly Report (July – September 2020)
September 2020

Pakistan: Patrind Hydropower Project

147 MW PATRIND HYDROPOWER PROJECT

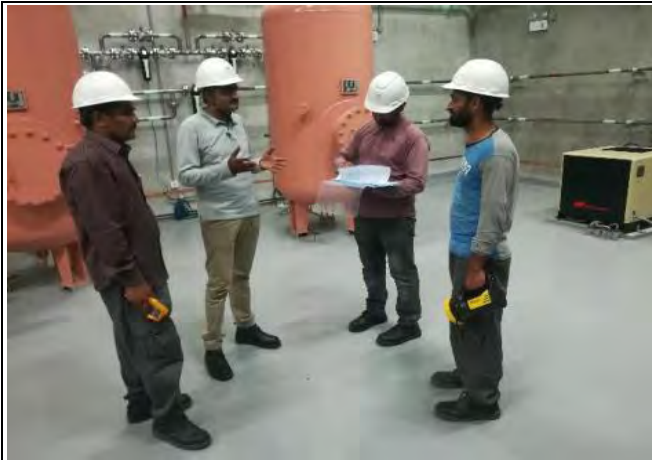
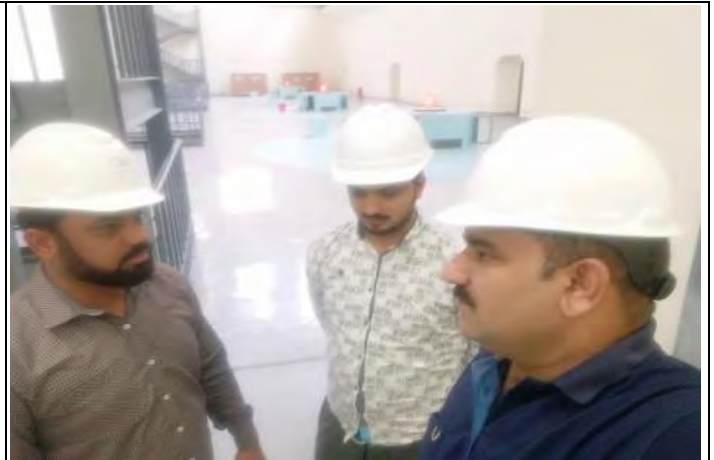
Powerhouse Area Inspection

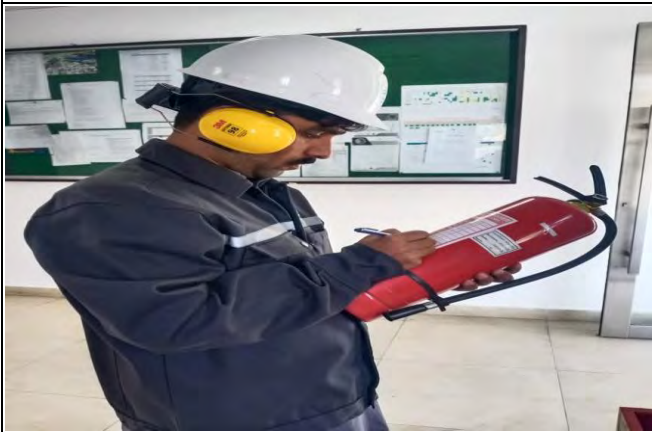
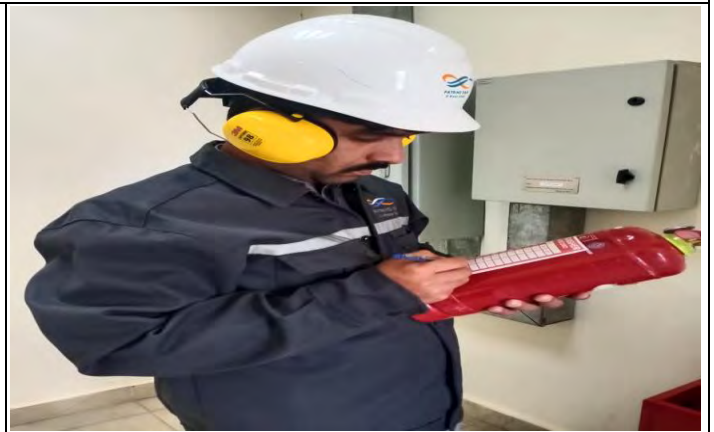
Fire Extinguishers Inspection

Sr. No	Inspection	Observation	Corrective Action
1.	Fire Extinguisher Inspection	Empty fire extinguishers found at power house site	Refilled fire extinguishers were placed with the empty one. Empty fire extinguishers were sent for the refill.
2.	General Hygiene Inspection	Littering observed around O&M residency	Cleaned the surrounding area of O&M residency, Powerhouse and Korean accommodation
3.	General Hygiene Inspection	Growing weeds observed at powerhouse site residency	Extra weeds were cut down by the civil department.
4.	Electrical Inspection	Some electrical cords found with damaged insulation	Damage cables were replaced with new one
5.	PPEs Inspection at powerhouse	Some staff working without proper PPEs	Given verbal warning and asked them to wear PPEs before entering in the operational area

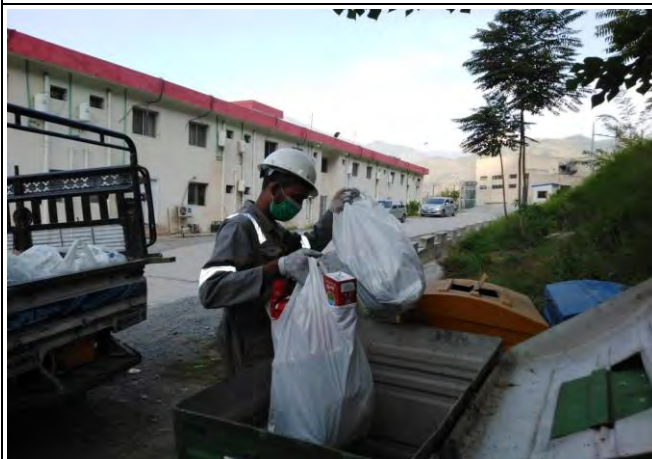
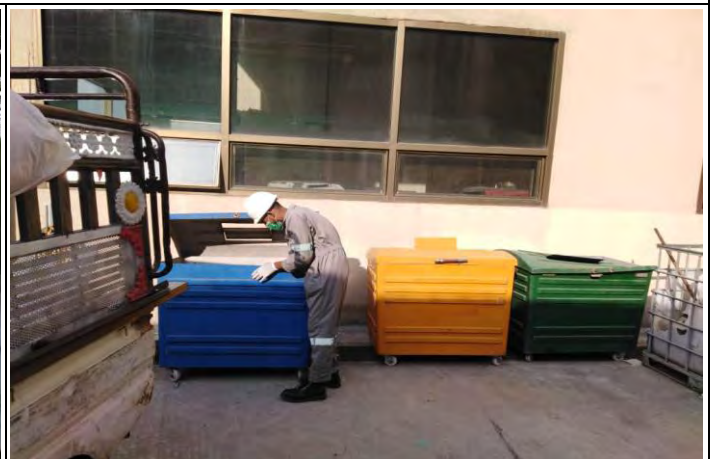
Waste Management

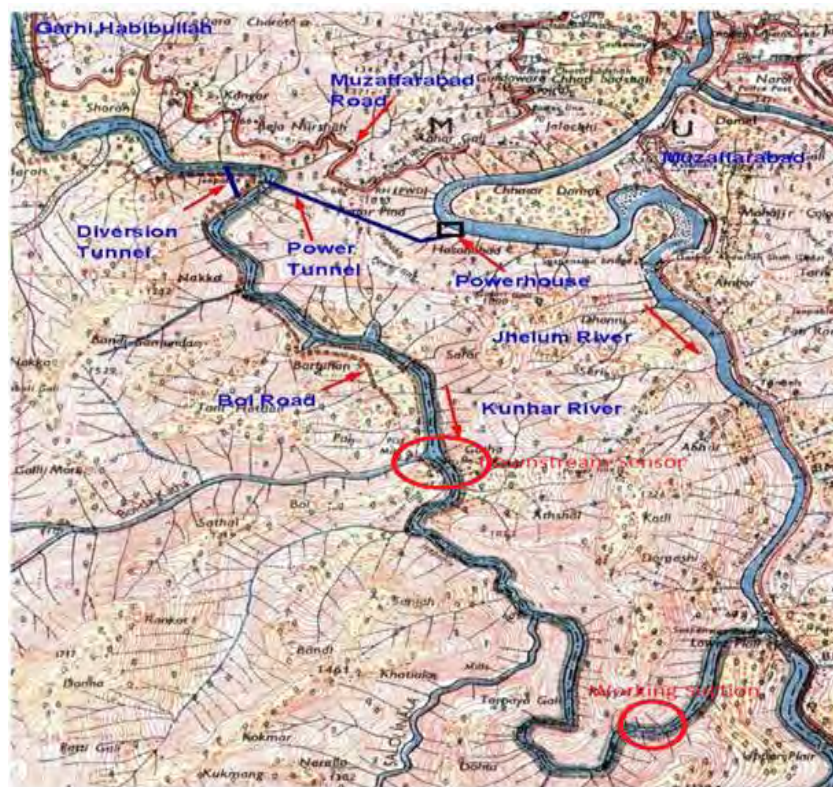
3. Site selection

After visiting to several locations, one site i.e. Bella (Boi) has been selected for discharge measurement at weir downstream considering the following aspects.

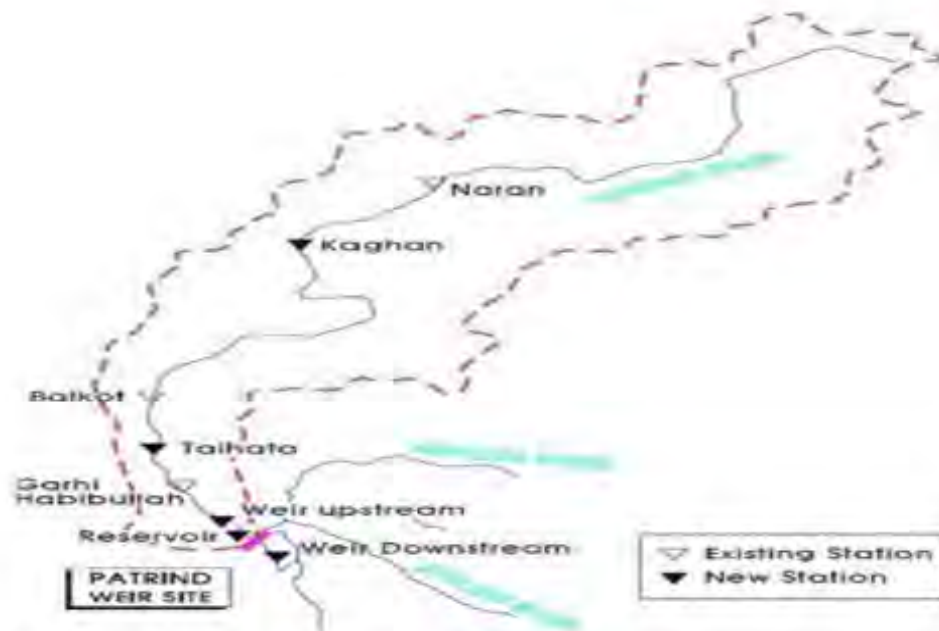
Sensors Location, Photographs and Calibration Certificates

⊕ Gauging stations and the reason for selection is given in below table.

Location	Purpose	Installed gauges	Calibration
Kaghan station	Forecasting of floods	Rainfall, Water Level, Temperature	Calibration of each sensor will be on annual basis by third party
Talhata station	Forecasting of floods	Rain & Water Level	
Weir upstream	Monitoring Water flow into reservoir	Water Level	
Reservoir	Monitoring Water flow into reservoir	Rainfall, Water flow, Temp & Humidity, Wind Speed & Direction	
Weir downstream	environmental flow	Rain & Level and e-flow

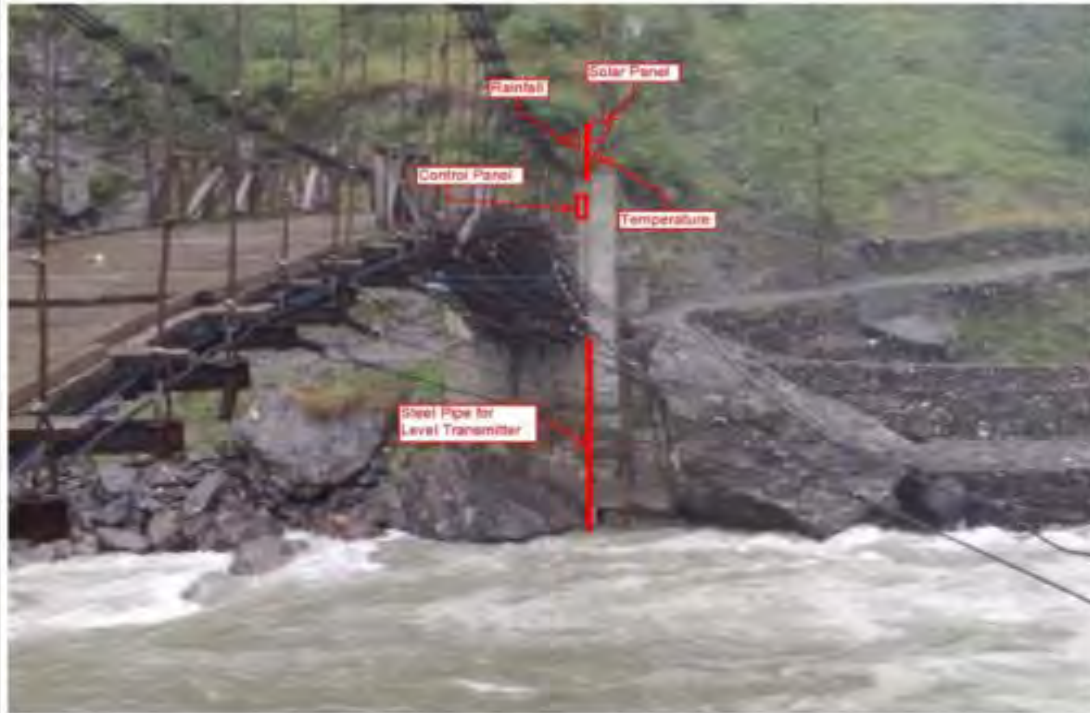
Kaghan measuring station will be located at 74km upstream side of the weir. The flood from the Kagan station comes into the weir site after 4.5 hours later. Therefore it will provide necessary precaution time against floods situation from upstream of Kunhar river.

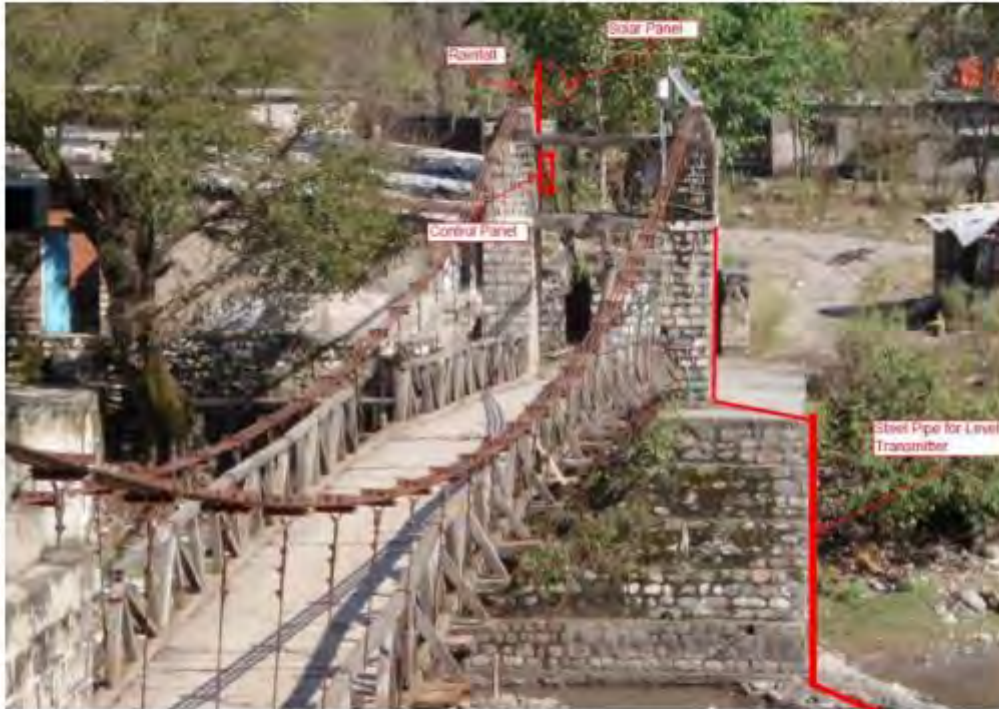
Talhata measuring station is located at 13km upstream side of the weir. More accurate water flow data can be achieved from this station.

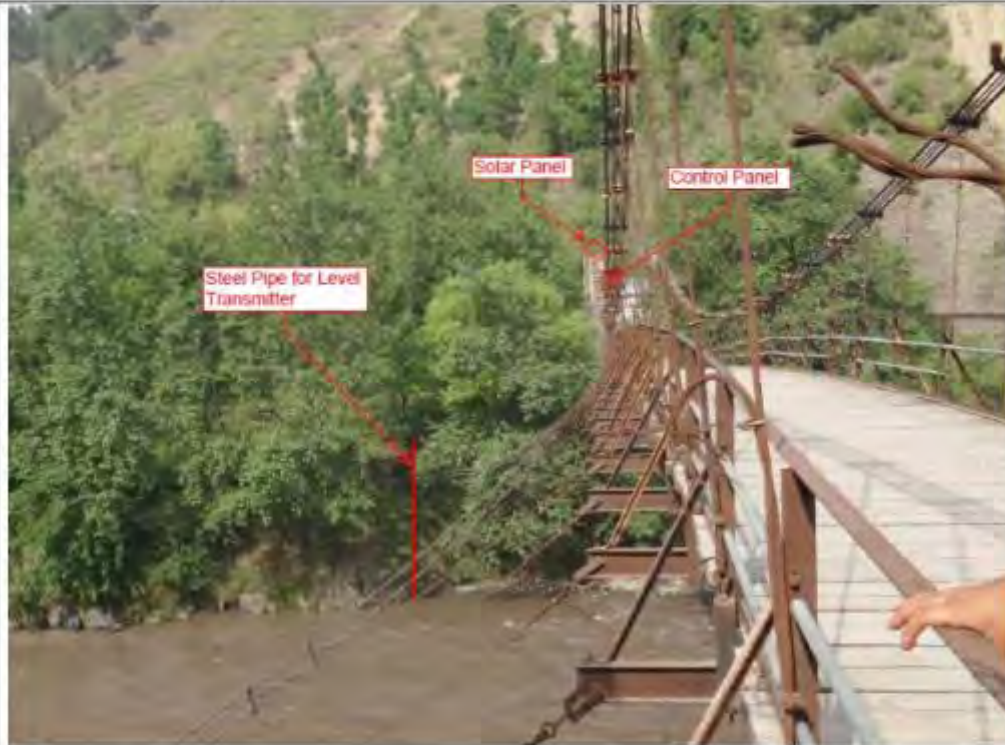
Weir upstream measuring station will be located at the reservoir inlet. The water level signal from pressure type level transmitter would be converted into flow rate.

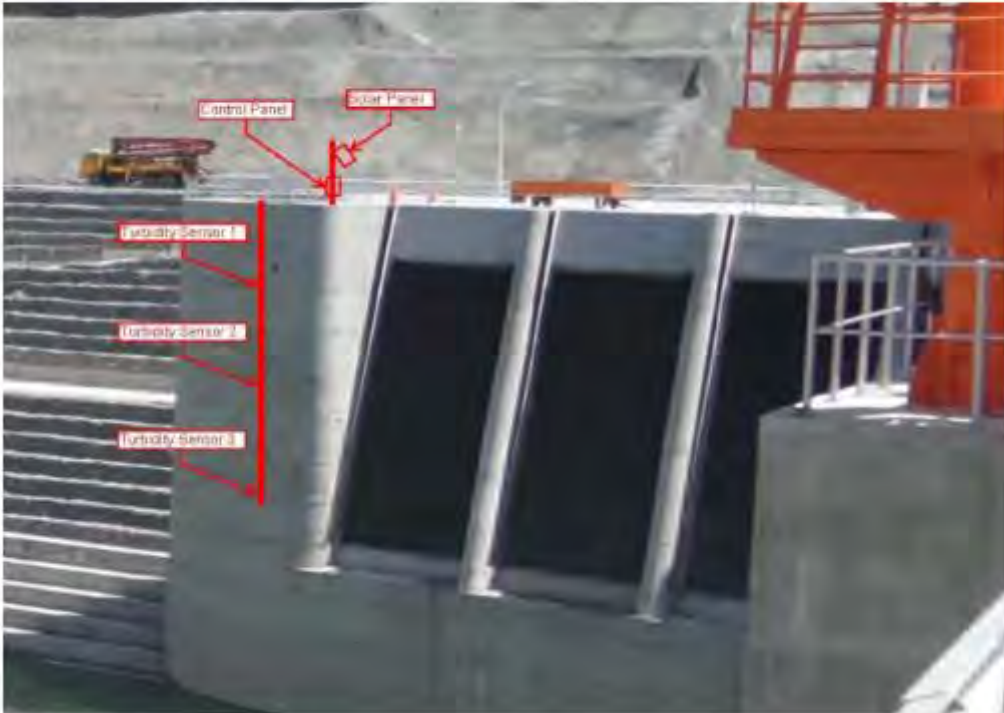
<p><input type="checkbox"/> Purpose</p> <p>Weir intake measuring station is located at the weir intake. Total three (3) turbidity sensors measure the turbidity of water into the HRT (Head Race Tunnel). Turbidity sensors are positioned at the high, middle and low points of the intake screen respectively.</p>
<p><input type="checkbox"/> Measurement Item</p> <p>(1) Turbidity (High, Middle, Low Points)</p>

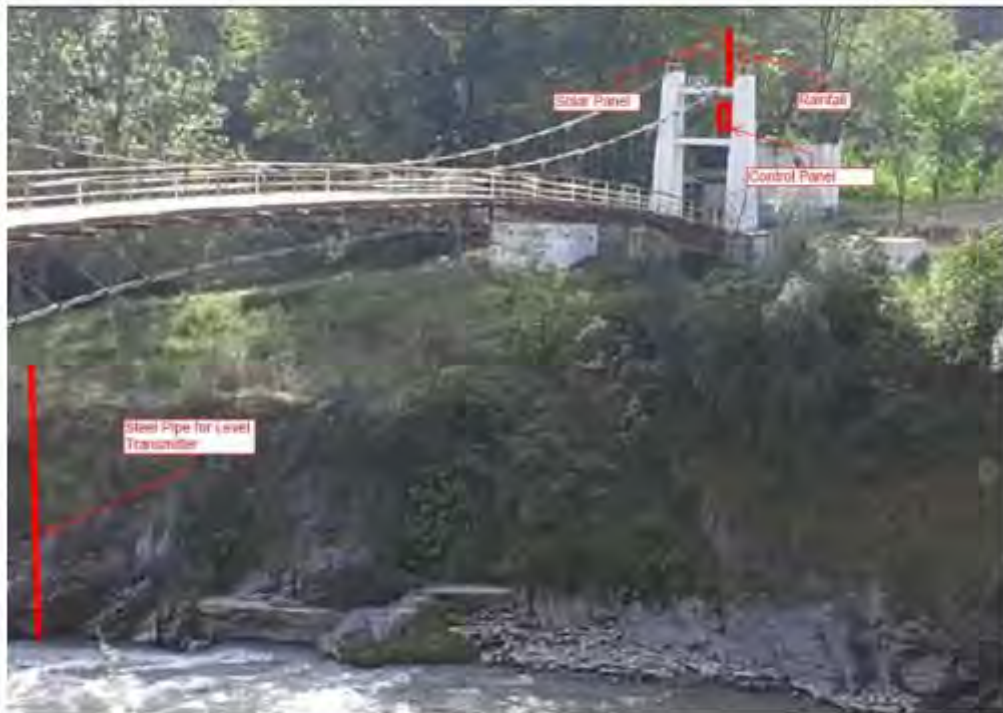
9. Weir Downstream Measuring Station

Weir downstream measuring station is located at 4km downstream of the weir for the measurement of environmental flow of 2.2 m³/s. As this flow rate is too small for measurement, the water level signal from pressure type level transmitter need to be converted into flow rate. It can be achieved comparing with gate opening rate. The location was decided considering of security against thief.

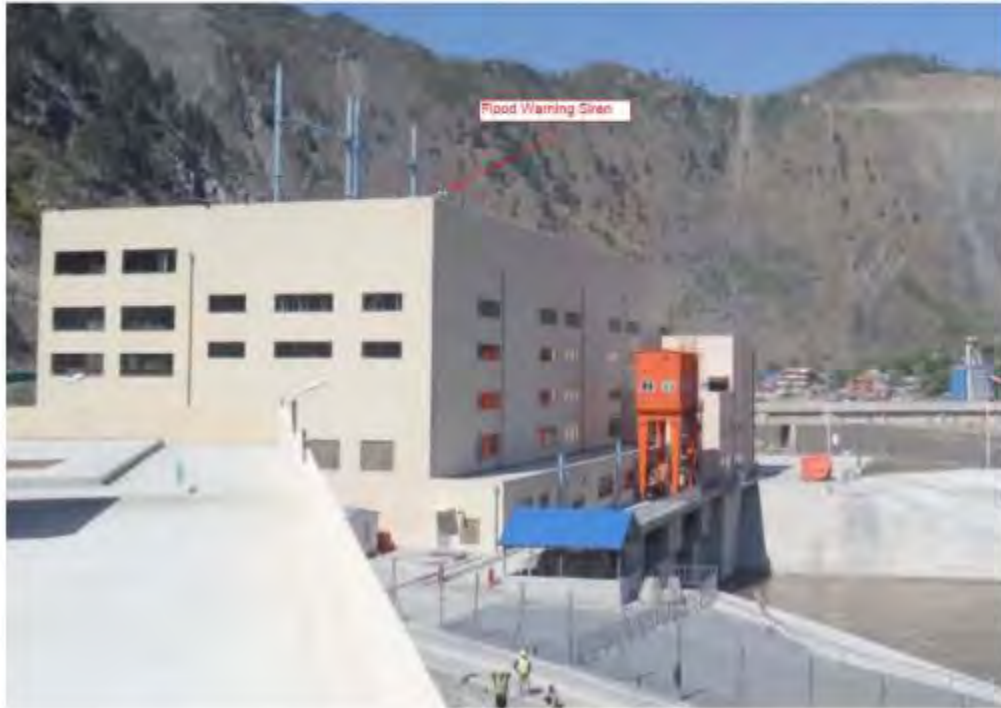
Issue a warning alarm for residents to prevent flood damage. Air raid siren will be manually operated by operator before power generation.

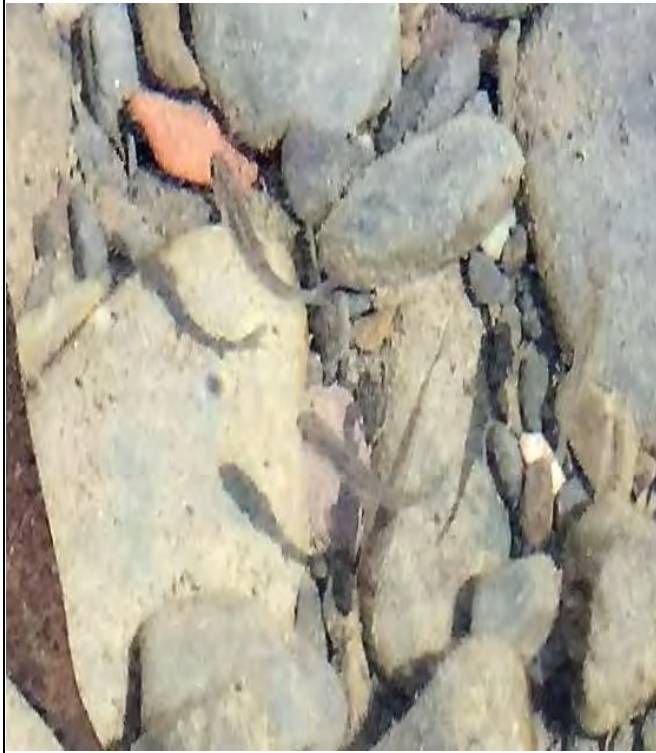
During sampling, it was noticed that the fish has already breed during the first and 2nd week of September. The catch was very low which shows the downstream migration of the fish and concentration in the middle under the boulders. Juvenile fish was examined at the sides of the breeding ground established during the month of March 2020 which shows a very encouraging result of the construction of breeding points. Breeding point one and two were examined and young fish was found on the side stream in shallow water.

Juvenile fish of *Schithorax plagiostomus* found in the shallow water part of the side stream

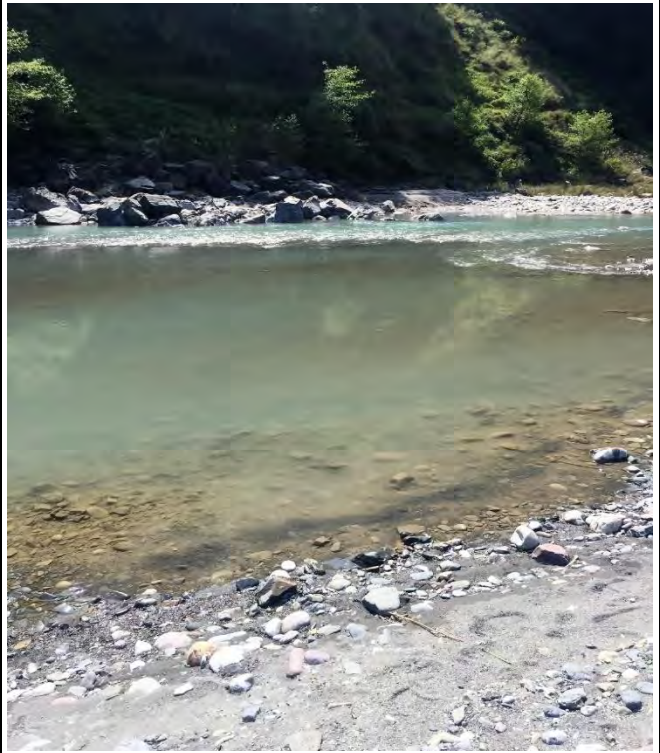
The breeding grounds are partially damaged by the high flood during the month of March and water level has risen to the maximum. The stones pitched by the labor are washed away but the boulders are still there. The breeding grounds have served their function as witnessed by the presence of young fish on the sides, which were never seen before.

Fish breeding ground -1 still intact with large boulders

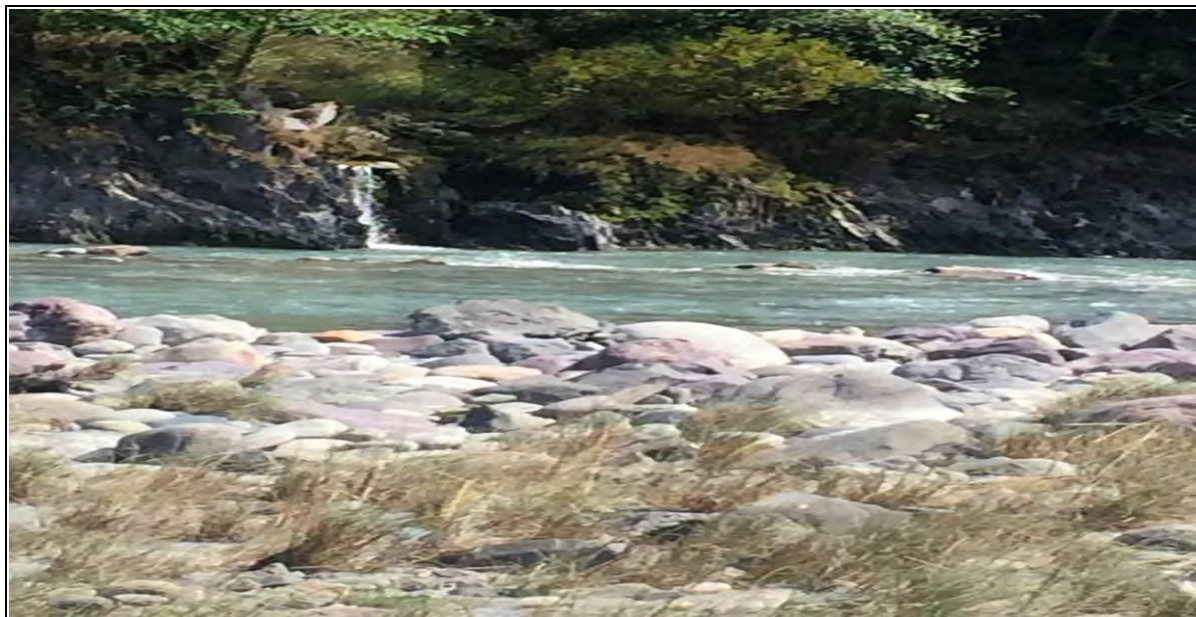
View of Breeding spot-2 with visible water flow obstacle of large boulders

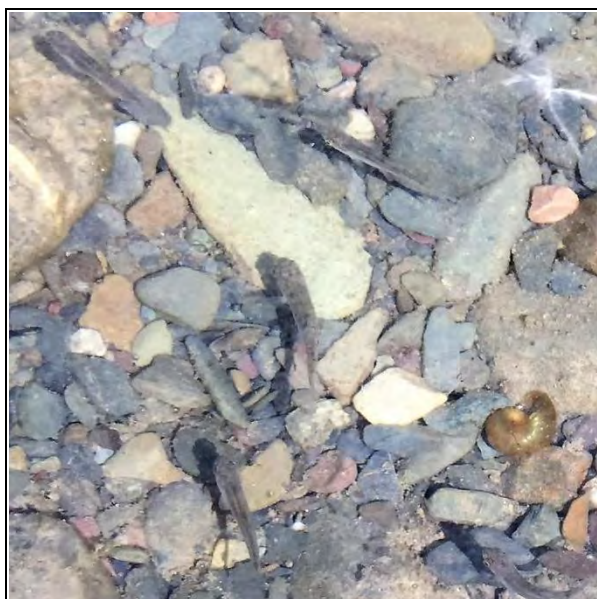
This second sampling point of the study is situated at 34° 18' 19" N, 73° 26' 44" E at an elevation of 2422 ft above mean sea level. The first and second breeding points are lying near to this point. New juvenile fish was found in the side small shallow water of the river Kunhar proving the success of the establishment of the breeding grounds for *Shizothorax* species. The breeding season was early to mid of September as per the size of the young fish. Watercolor is Transparent with air temperature of 28°C and water temperature 16°C with pH 7. No fish could be caught here for the reason quoted above.

Young fish found at the breeding ground-2

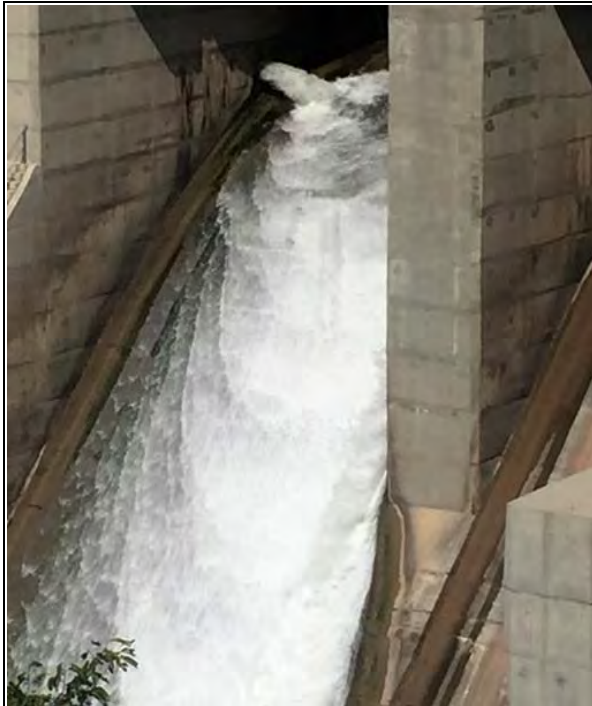
Controlled E-flow of water at weir

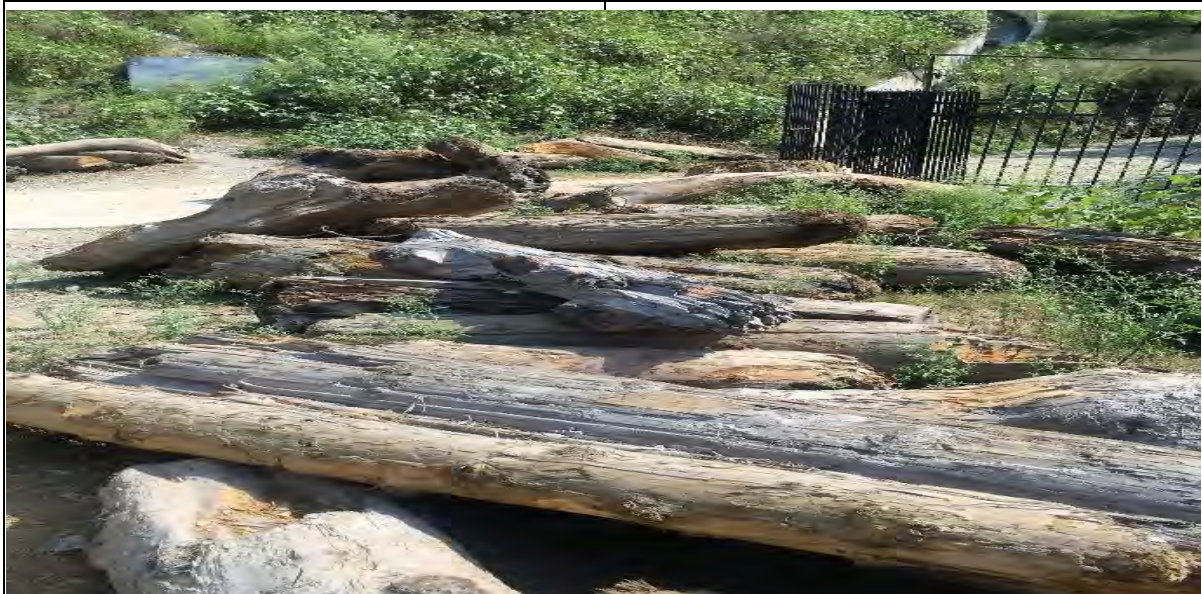
Wood logs collected from the reservoir in August

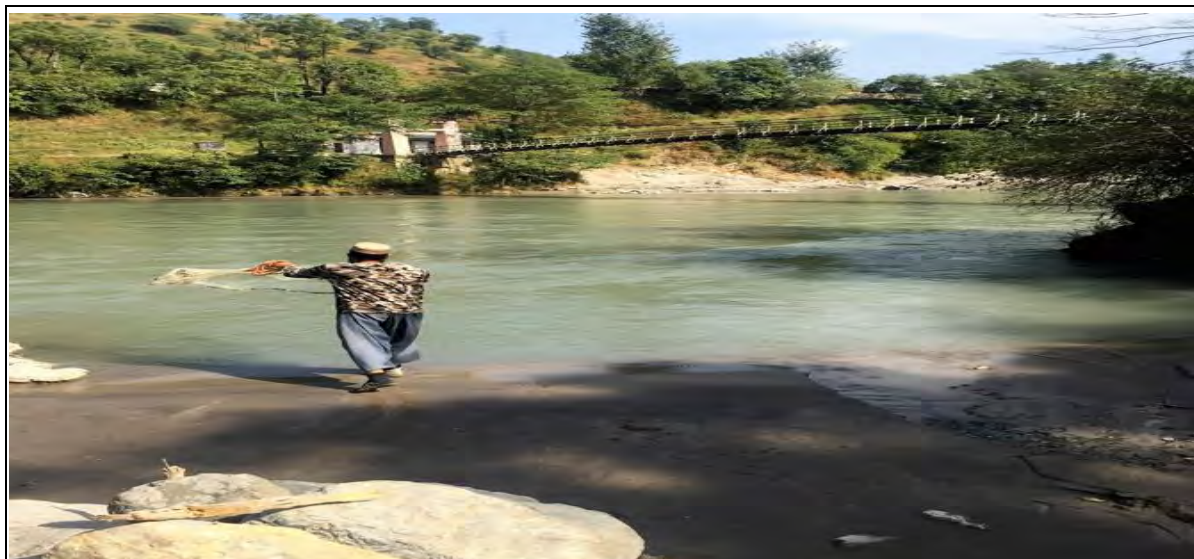
This sampling point is at the tail of the reservoir and is situated at $34^{\circ} 21' 09''$ N and $73^{\circ} 24' 1''$ E with an elevation of 2556 ft above mean sea level. The side vegetation has been mostly being cleared by the locals and a road has been constructed for trucks to get loads of sand from here. The air temperature is 28°C and water temperature was 16°C with pH 7. No fish could be caught here.

Fish Sampling at point-5

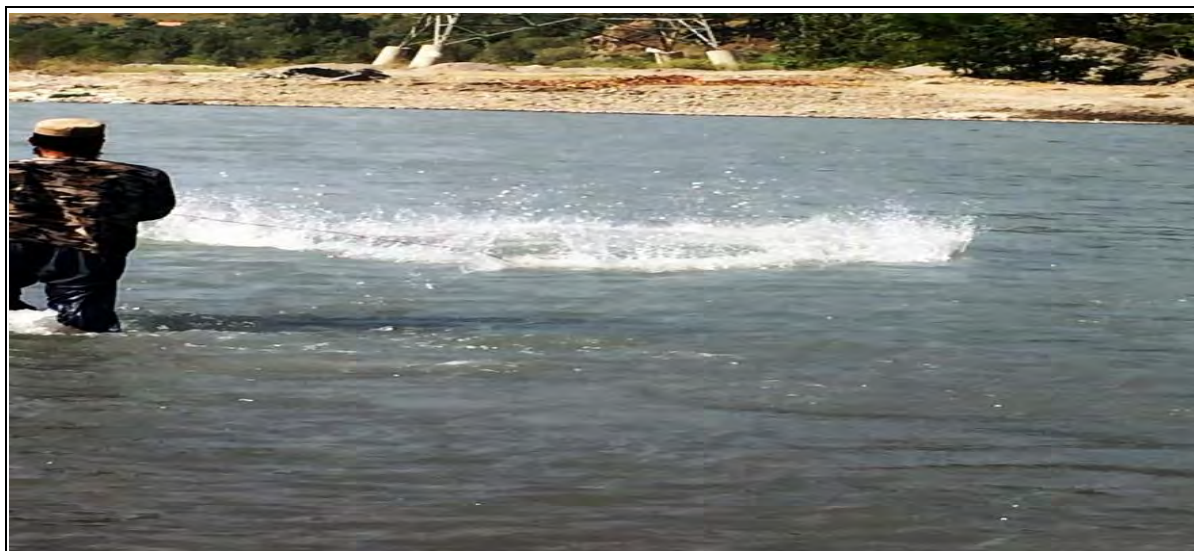
This sampling point is situated at 34° 22' 27" N and 73° 23' 34" E with an elevation of 780 meters. water temperature is 16°C and pH 7. TDS 376. No fish could be caught here.

Fish Sampling at point-6

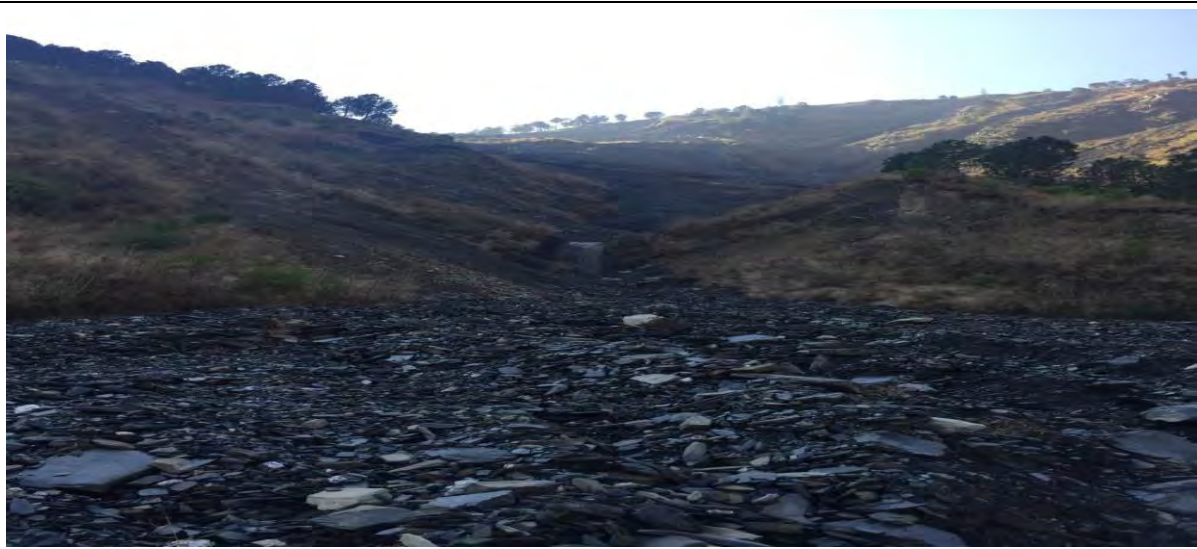
Initial position of the slide behind the powerhouse

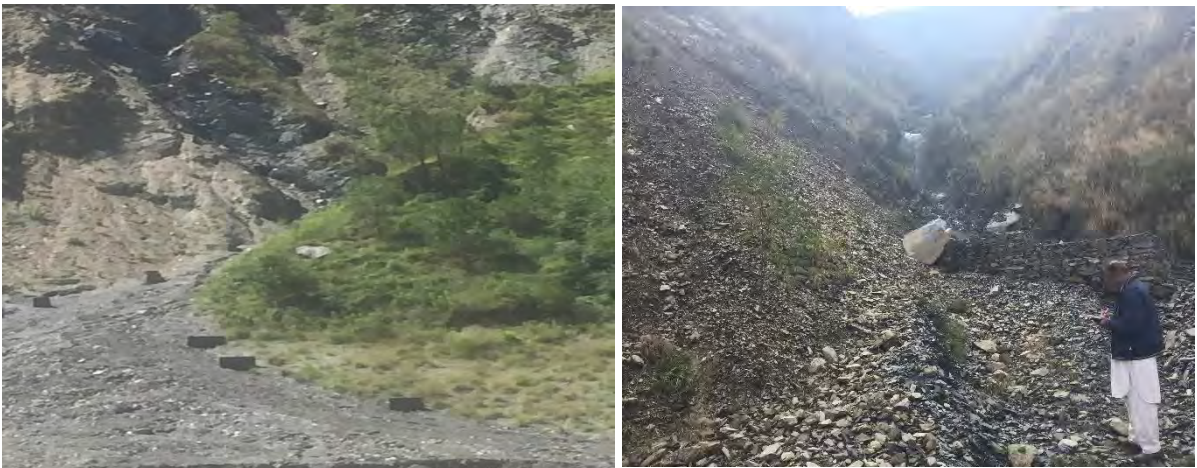
Land position before bioengineering works in the slide

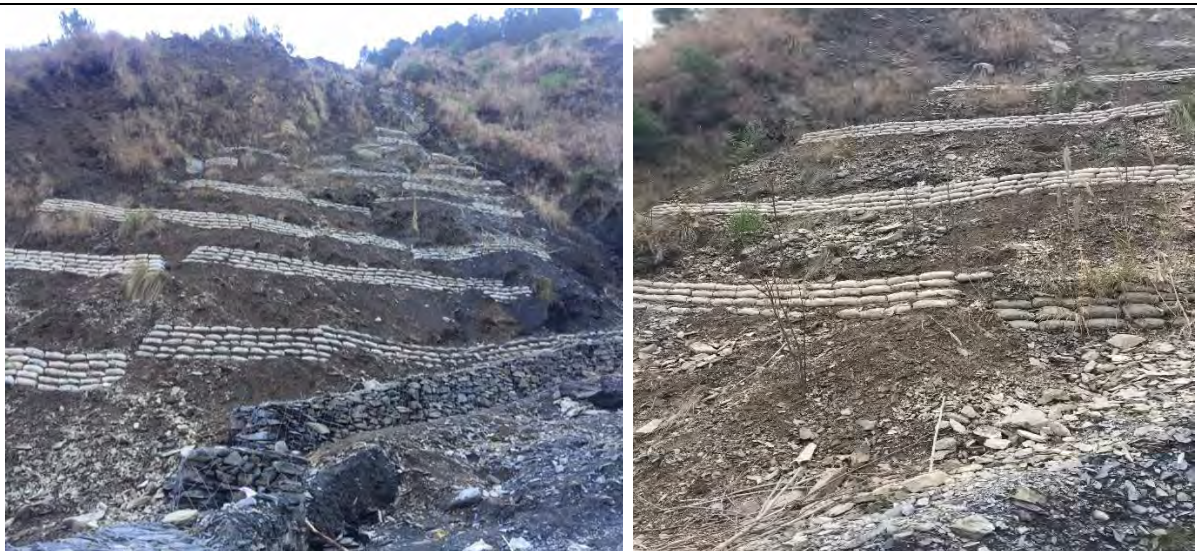
Landslide position after the Bioengineering works in December 2019

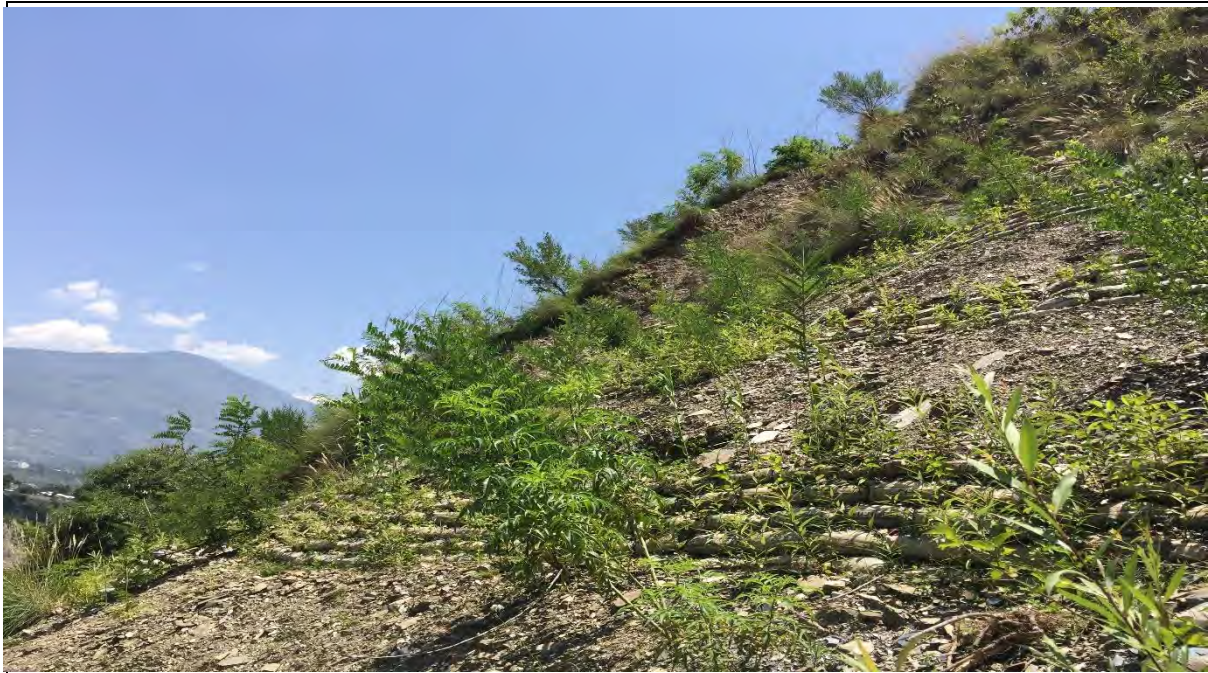
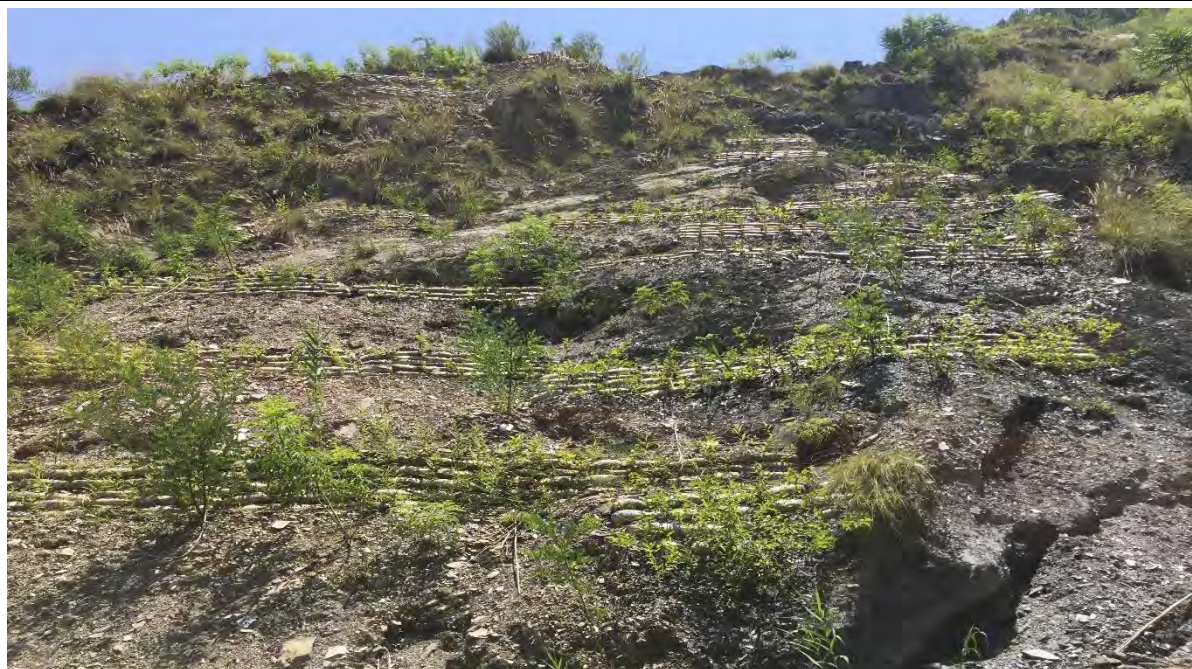
Same slide in June 2020 after the growth of vegetation planted, and germination of sown seeds

The area above the treated part is difficult because of its terrain and steep slope. Working will have to be done in this area as well during December 2020 to February 2021. Early works during this year have produced wonderful results and same has to be replicated in the coming season of the works.

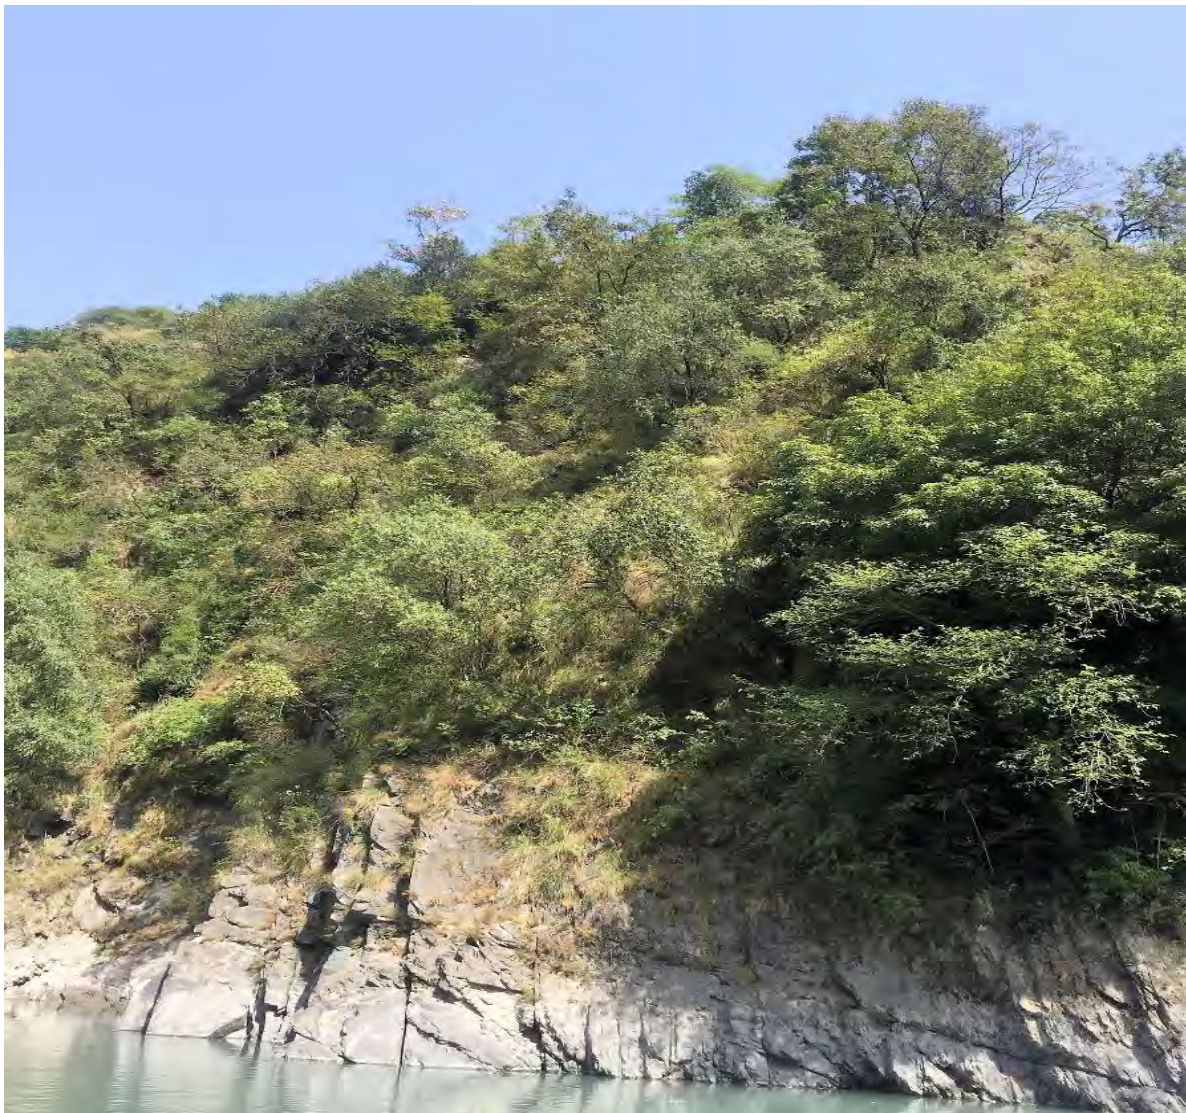
The reservoir side of the project has got established with many green belts. Riversides are mostly stabilized and river cut on the sides is seldom seen. The plants germinated at the sides of the river Kunhar are washed away with the increase in the current of water. This August of 2020 has brought a flood and eroded all new germinated plants.

Dense vegetative cover on the side of the River Kunhar

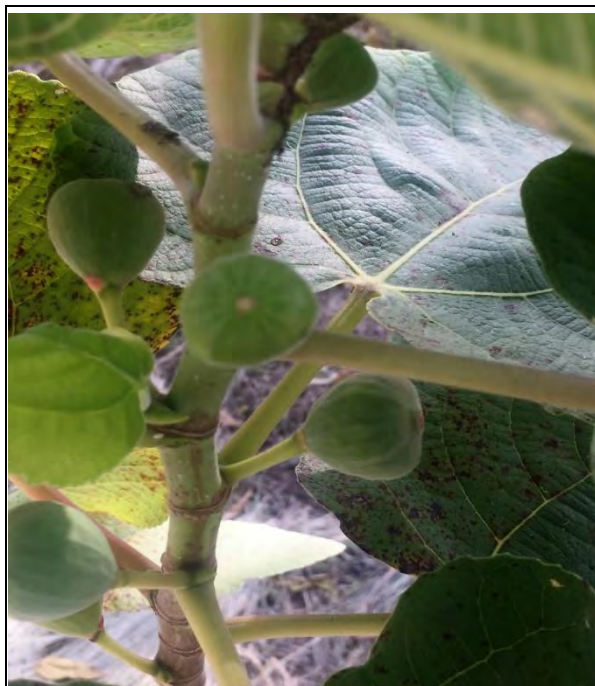
Fruits on 2 years of Anjeer Plant at powerhouse

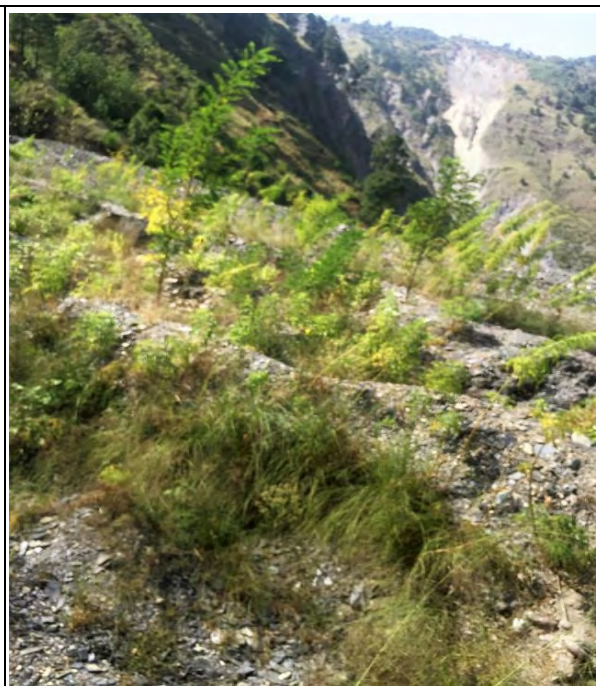
Powerhouse side has a little difficulty of success in plantation as the base is mostly gravel and dolomite rock type. Fertile soil has already been eroded away in the slide area but the plantation carried out with addition of fertile soil in the pits has given good results and drying up or dying back percentage is low. The erosion process generates when the angle of repose of the hill is disturbed either by human activity or by nature. Control of this erosion needs an early treatment with strengthening the base and giving support to the inclination of the hillside.

Success in the plantation at powerhouse site

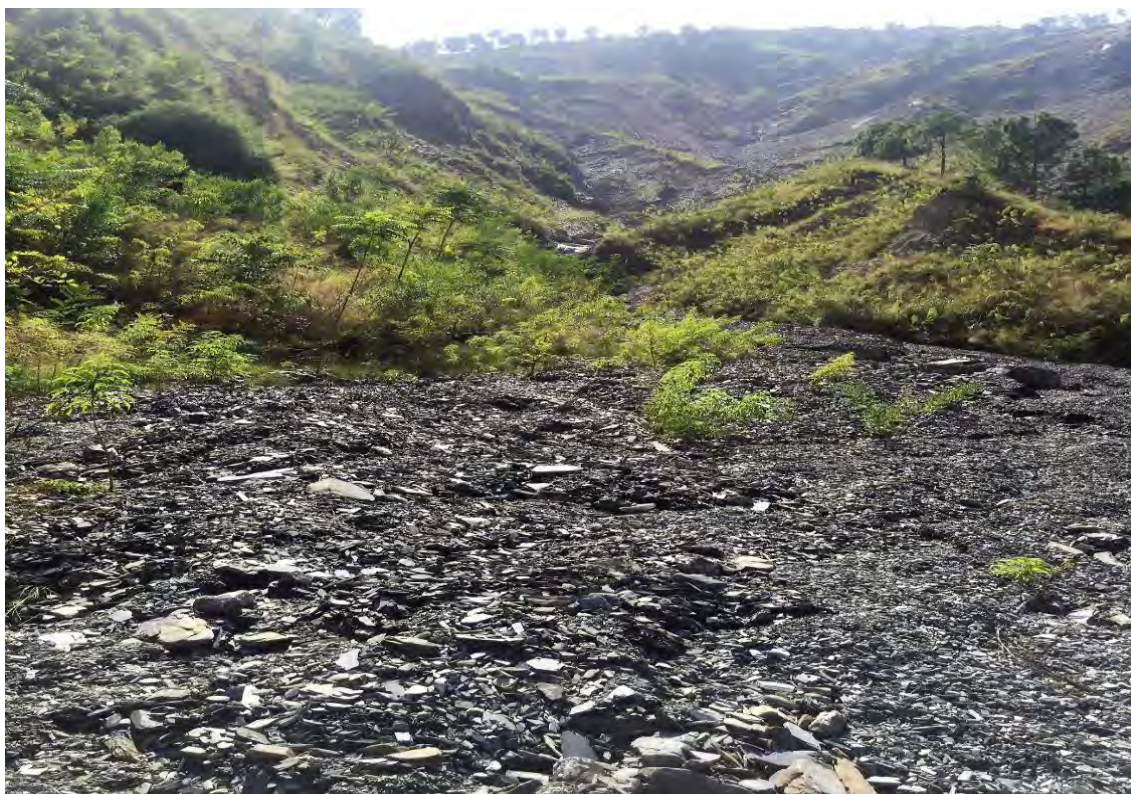
The bioengineering work carried out is producing good results. The area has been taken in a gradual process for treatment against the erosion.

A wonderful result of the landslide stabilization on right side of the nallah

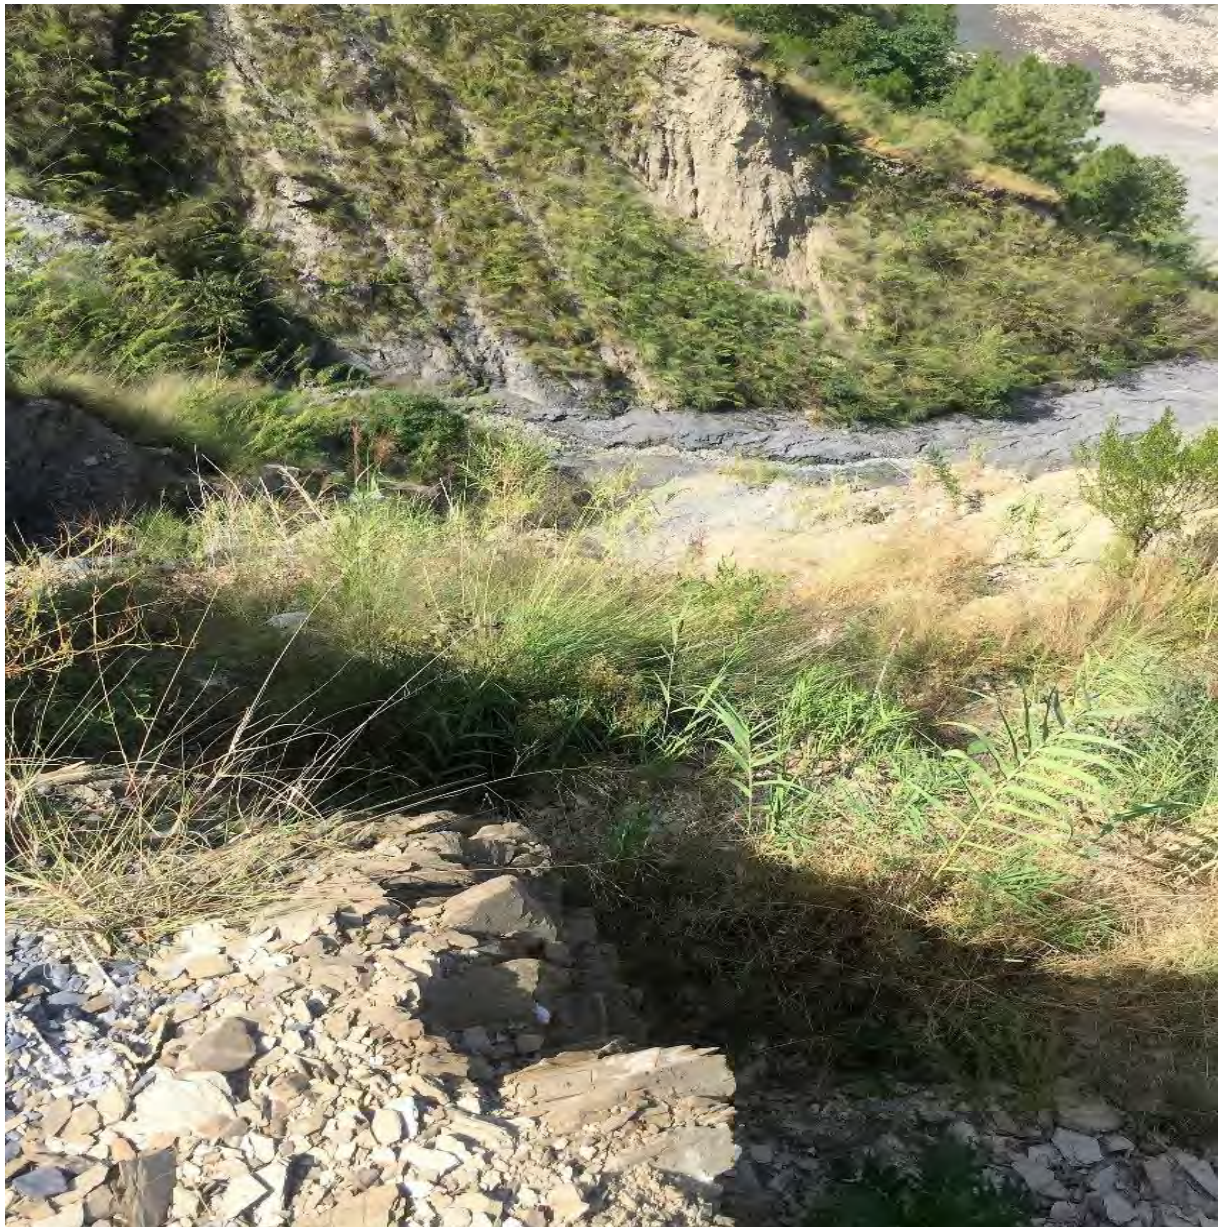
Narri (*Arunda donax*) has grown to a better size and developed a hedge, which will further grow and its root system will bind the loose soil to firm green strengthened slope. The bioengineering works were carried out in a gradual process for treatment against the erosion. It needs further intervention during the season of December this year. Another attempt on the right part of the slide will bring safety against the sliding of the hill on powerhouse part of the area. Then left side of the slide should be treated as the finances allow.

Arunda donax (Narri) growing in the slide area
