Environmental and Social Monitoring Report

Project Number: 44914-014
Quarterly Report (July – September 2020)
September 2020

Pakistan: Patrind Hydropower Project

147 MW PATRIND HYDROPOWER PROJECT

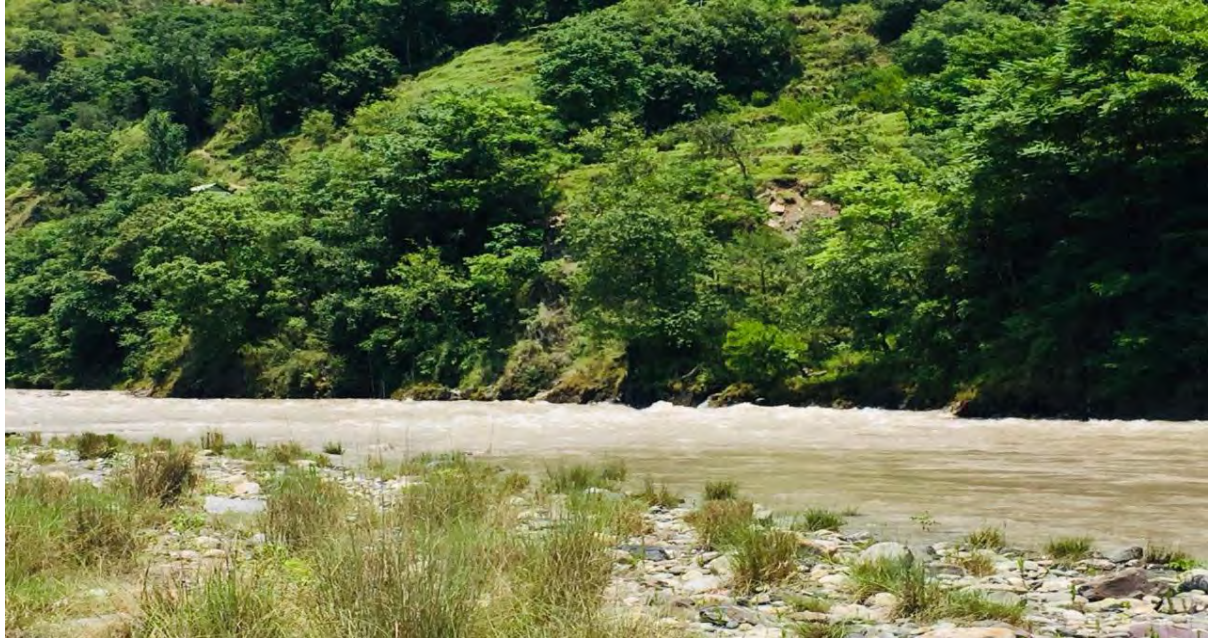
Green patch of the vegetation along the river Kunhar

Downstream of the weir point, riparian plant species change their pattern of growth with the change in water level. Flooding due to seasonal change or flushing of the reservoir wash away all new established vegetation at the immediate side of the river. This flooding also changes the species combination pattern as the roots or seeds of different plants are drifted down by the floods and gets established every time with the water level change.

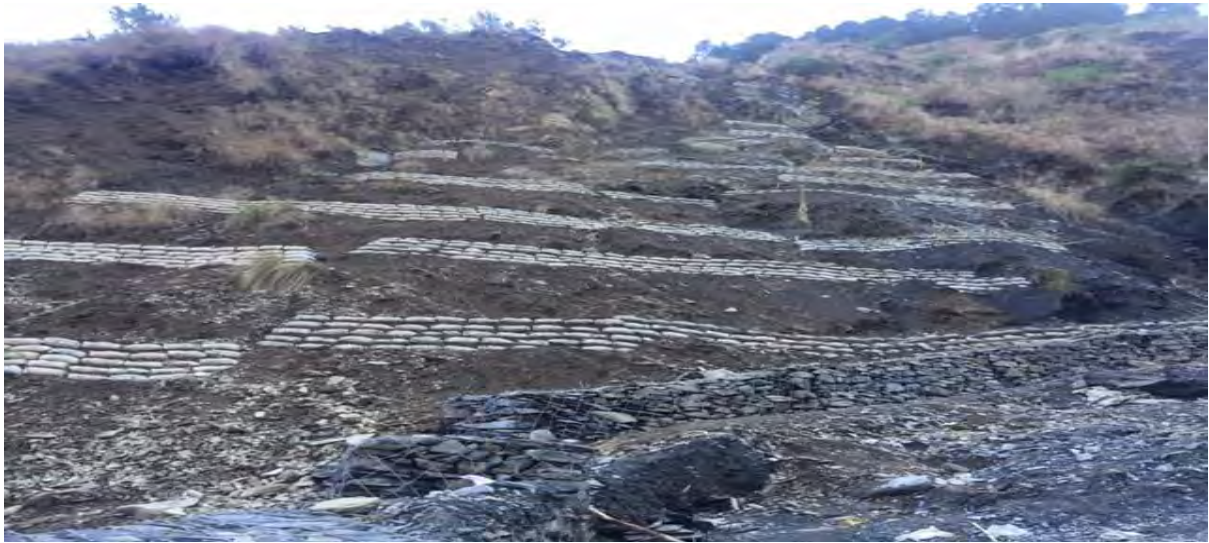
Slide treatment with wire gabion check dam and soft gabions with sowing and planting before germination

Different interventions have to be carried out for the rest of the big landslide patches behind the treated one. A cut of drain construction has to be carried out to collect the slide water and drain it into the main channel. Retaining walls, check dams, soft gabions, sodding tufting, sowing planting etc., are the some of the biological and bioengineering techniques to be applied in the entire slide to stabilize it effectively.

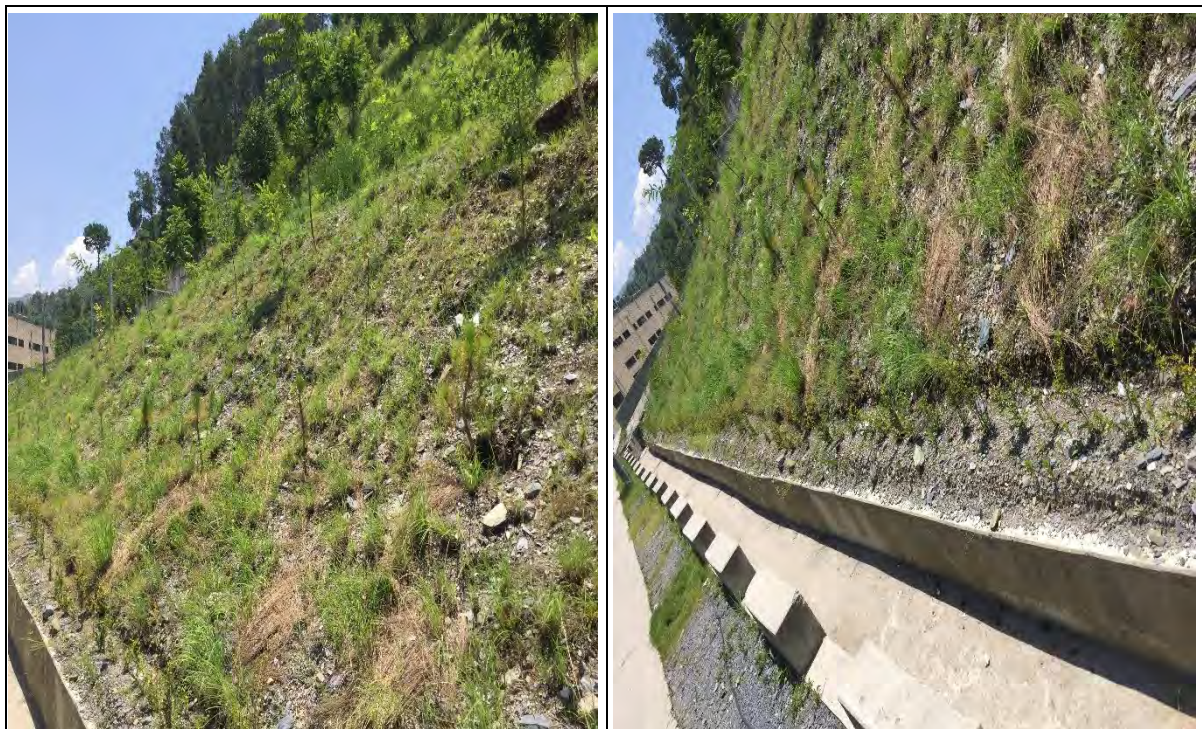
Successful Plantation carried out by SHPL around O&M building

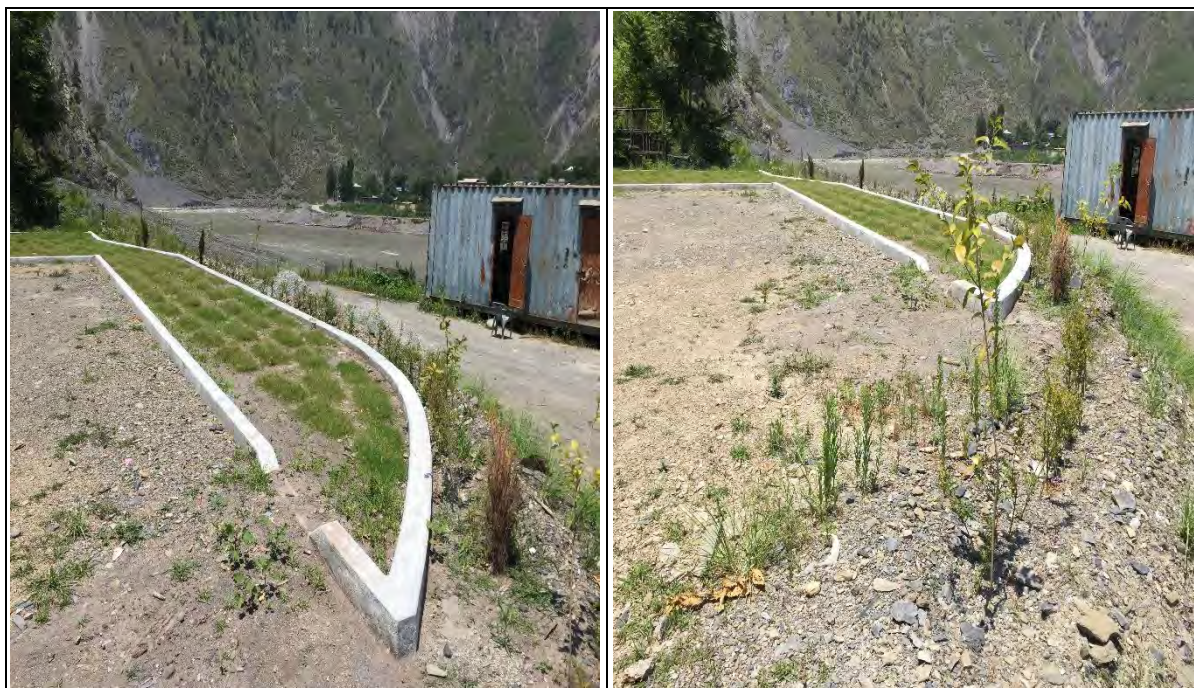
Green patches and plantation in front of O&M building
