Environmental and Social Monitoring Report

Project Number: 44914-014
Quarterly Report (July-September 2018)
September 2018

Pakistan: Patrind Hydropower Project

Environmental & Social Monitoring Report July to September 2018

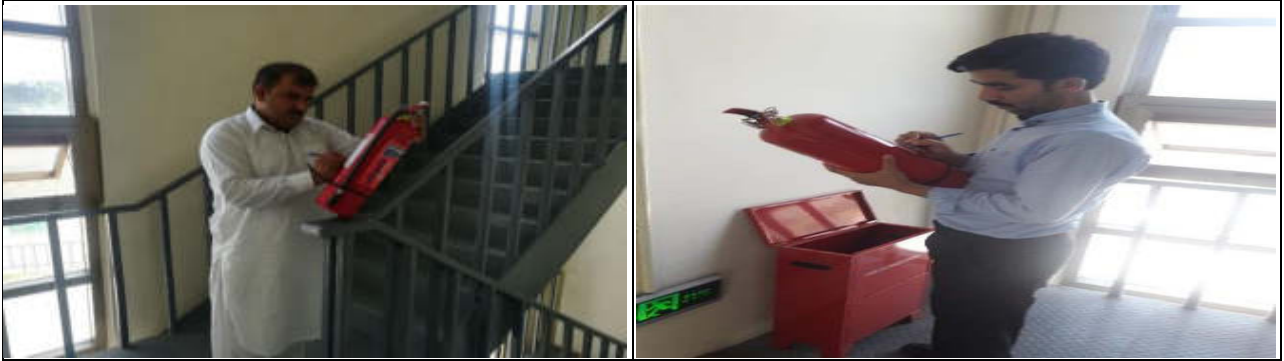
Fire Extinguishers inspection during 3rd quarter, 2018

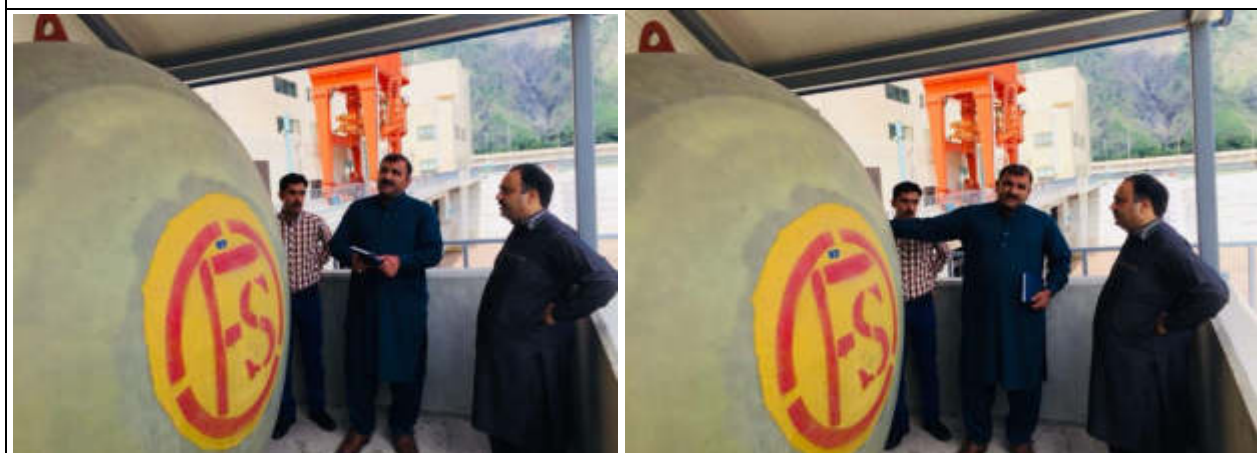
Assistant commissioner visited power house to inspect fuel storage

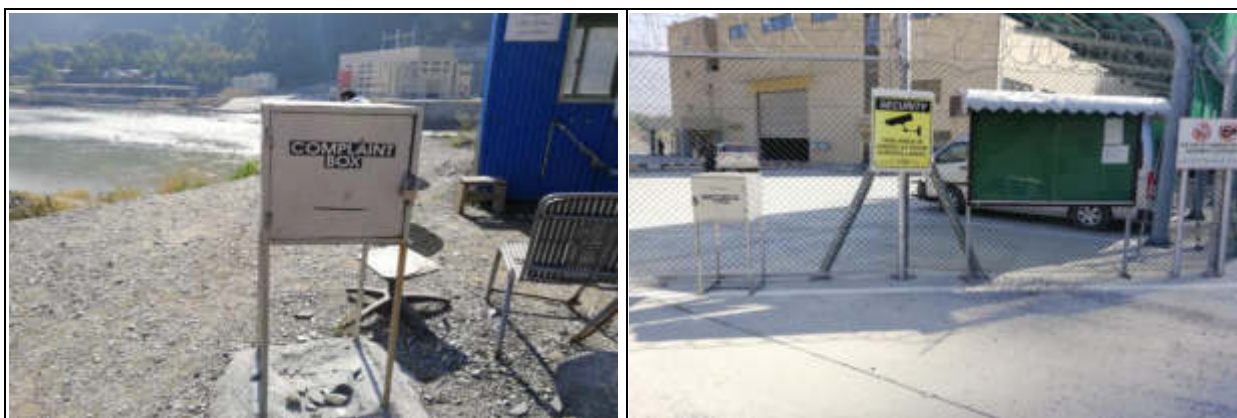
- Three (03) complaint boxes, two (02) complainant registers and one (01) notice-board at power-house
- Two (02) complaint boxes, one (01) complainant register and one (01) notice-board at weir-site

Complaint Boxes placed on both sites

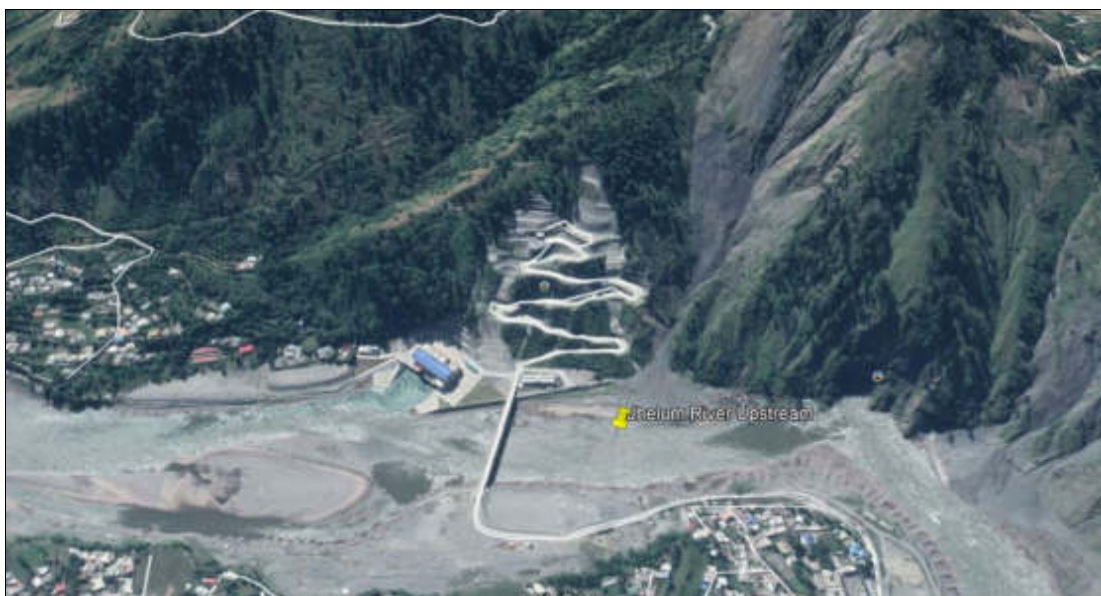
View of Powerhouse Site Patrind Hydropower project- Unstable soil around the surge shaft area

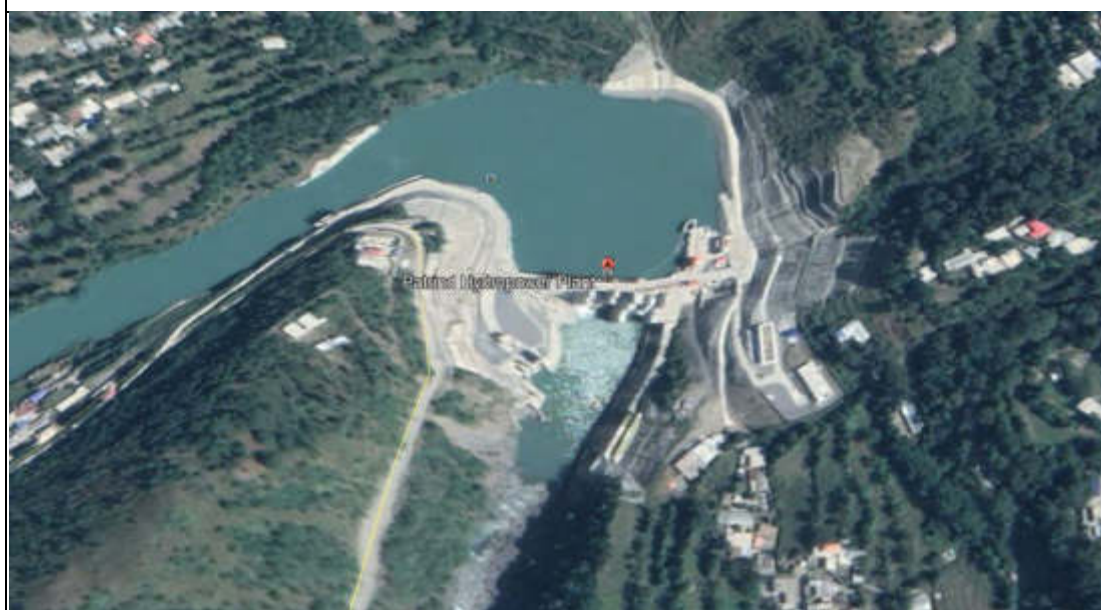
View of Weir Site Patrind Hydropower Project- Slopes are well Protected and dense vegetation at powerhouse

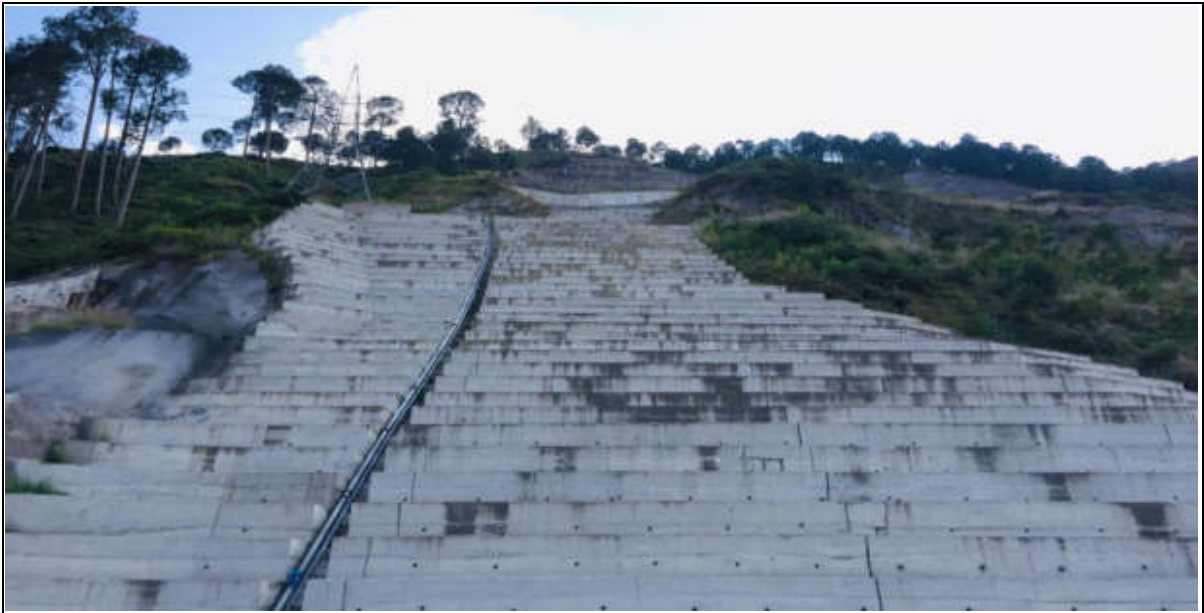
The site of the tunnel outlet has been strengthened with shotcreting but it also has lost the green belt.

Step wall at Powerhouse site to protect the soil erosion and land sliding

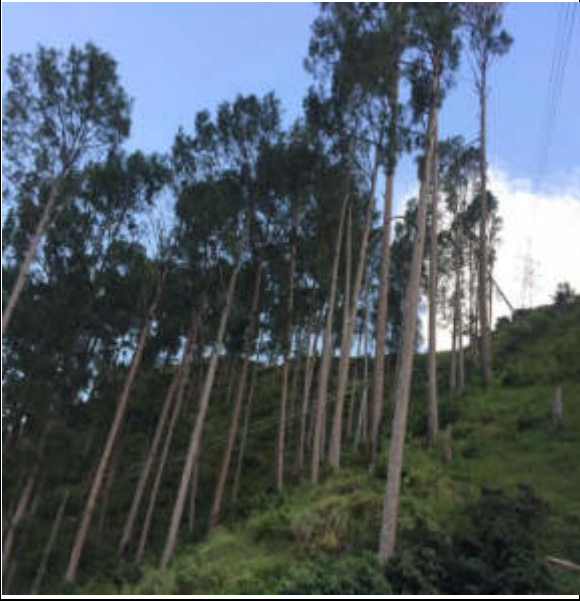
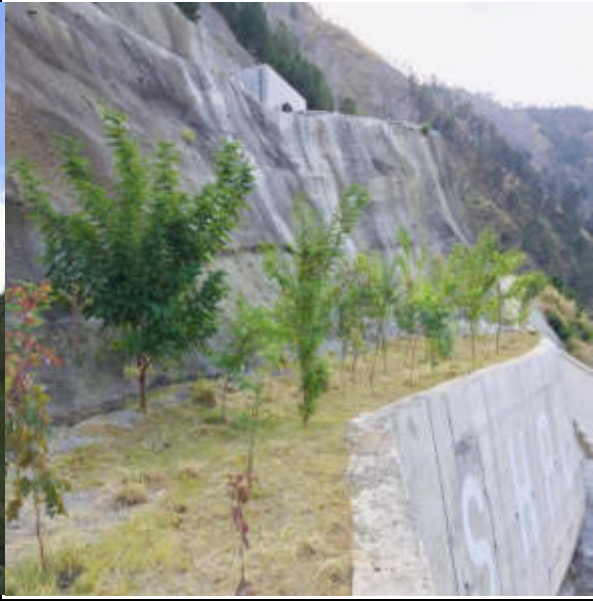
Plantation cover beside powerhouse between transmission lines	Plantation cover at 4 th corner. These are planted during the construction phase

- v)** The area around the power house is mostly shortcrested but some soil beds are planted with mixture of species. Dieback of Chir pine plantation under the high power transmission line and on the side slopes has been observed.

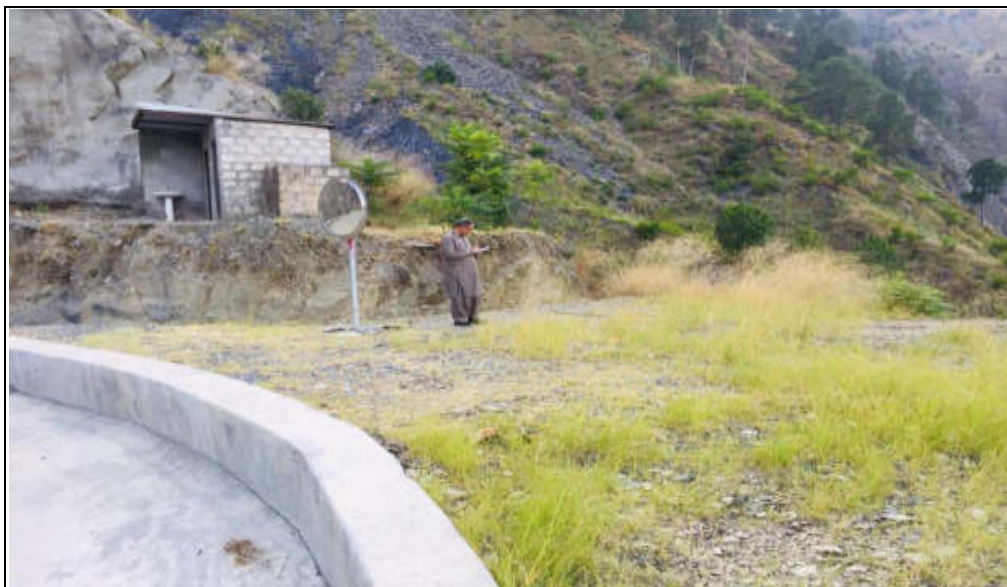
Survey during the study at powerhouse site for site identification for
Plantation

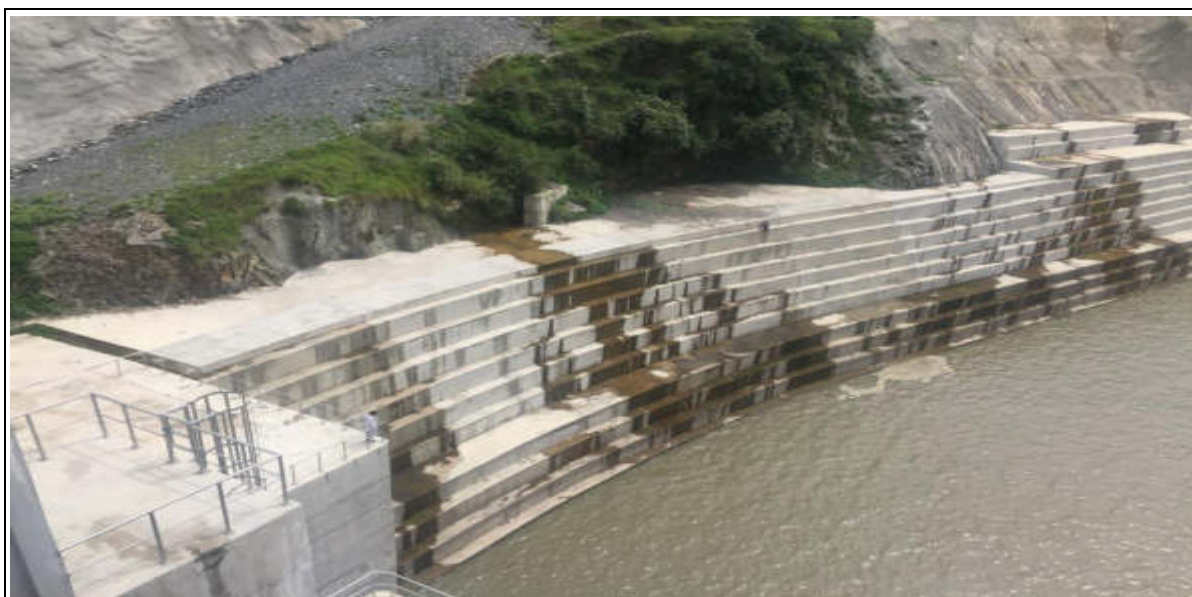
- ii) The area around the weir and the steep slopes behind the obstruction have been concreted to control the soil merger or slump. The right bank has been strengthened with wire stone gabion provision at this place.

Walls at weir site to avoid soil erosion

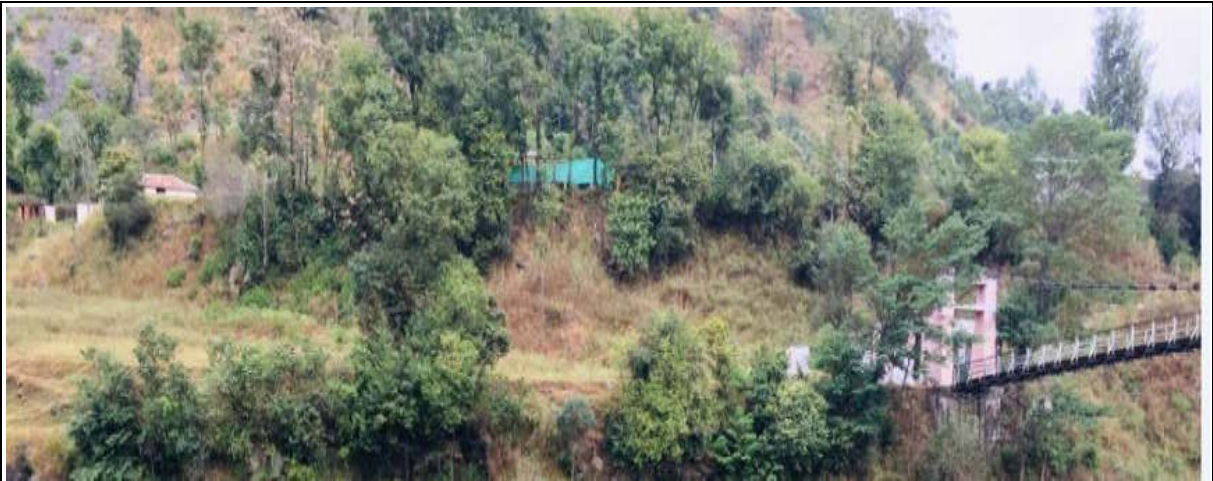
- iii)** Dieback of the species is no more a problem and the plant species growing on both sides of the impoundment are in a good health condition.
- iv)** The tail area of the impoundment is very rich in species population. Although the moisture loving plants are dominating here but the green patches show a good look near the bridge of Shoran village.

Green patches show a good look near the bridge of Shoran village.

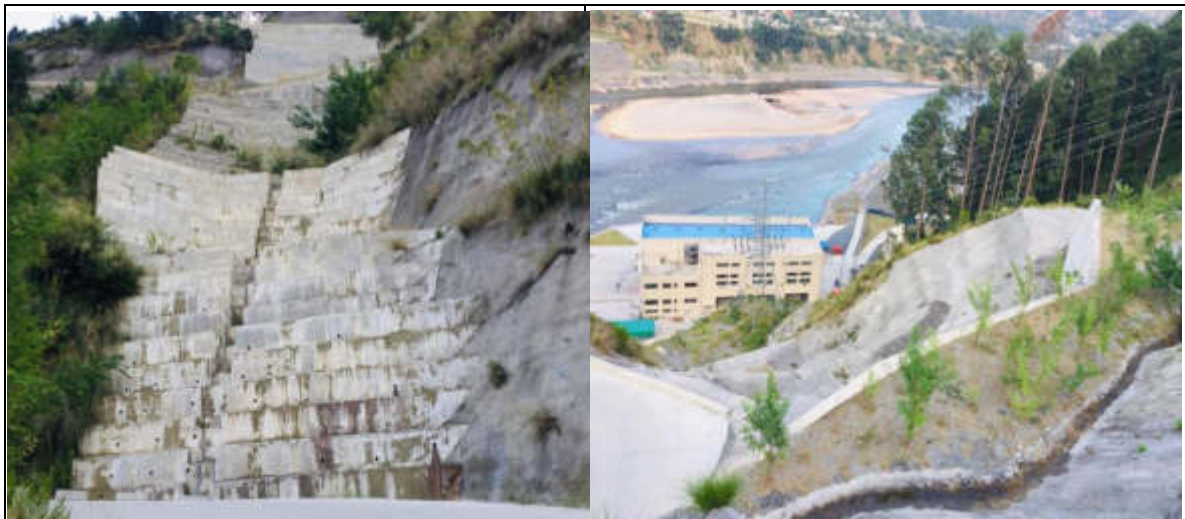
Area at powerhouse site showing step walls and plantation

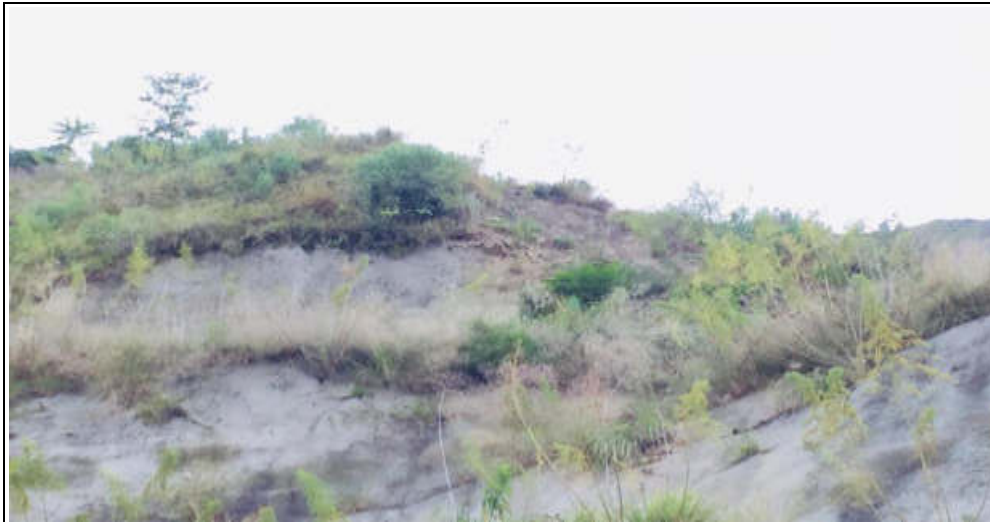
- vi)** One small slide has appeared this time behind the powerhouse at Corner number 1. This needs attention. December is the ideal month to treat this slide and will give a good reputation to the project authority by stabilizing the slide and making it green. Biological, engineering, and bioengineering treatment is required to establish this land slide for making it green. December and January is the right season for these activities. The area treatment plan should become the part of the vegetation Management Plan. Portion wise detail mentioned in that plan is needed.

Area eroded due to rainfalls at powerhouse site

- Grass sowing and tufting is better on the loose soil of the slide. Native grasses should be selected for that and their seed can be collected in October-November.

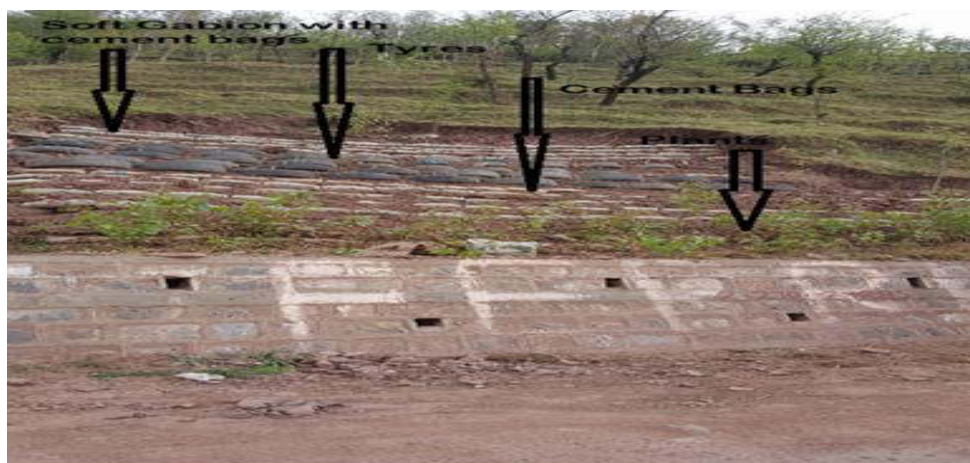
- Retaining walls: vegetated crib walls, vegetated concrete block walls, vegetated soft gabion walls, live brush wood wall
- Check dams: Single row post live brush wood check dams, double row post live, brush wood check dams, palisades
- Barriers on loose soil slopes: brush wattles, brush layering, hedge layering, brush-hedge layering, rush fence, sodding

Pic: Bio-engineering work at Kohala road

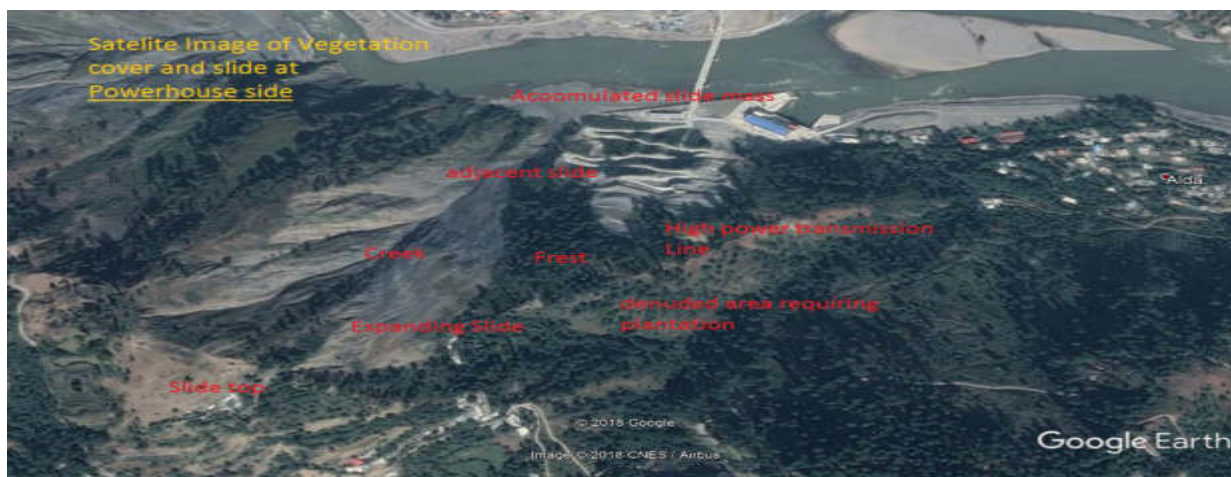
Pic: Satellite image of landslide area with marked details

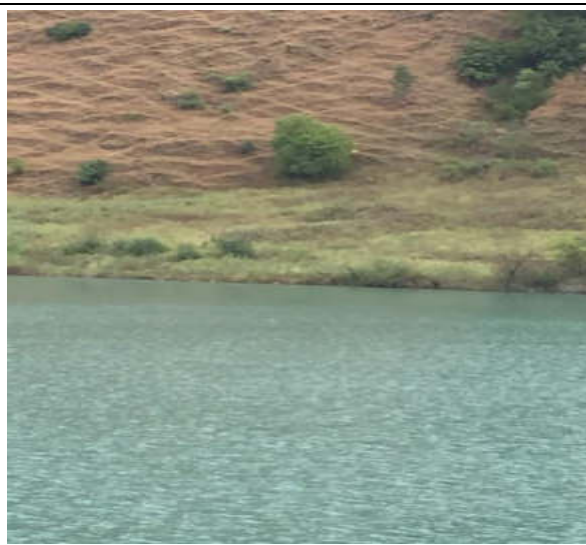
Reservoir banks' stability is susceptible to change as it has not been strengthened at the left bank of the reservoir and bank is more likely to slump in the future.

Pic 3: Left side of the reservoir needs strengthening

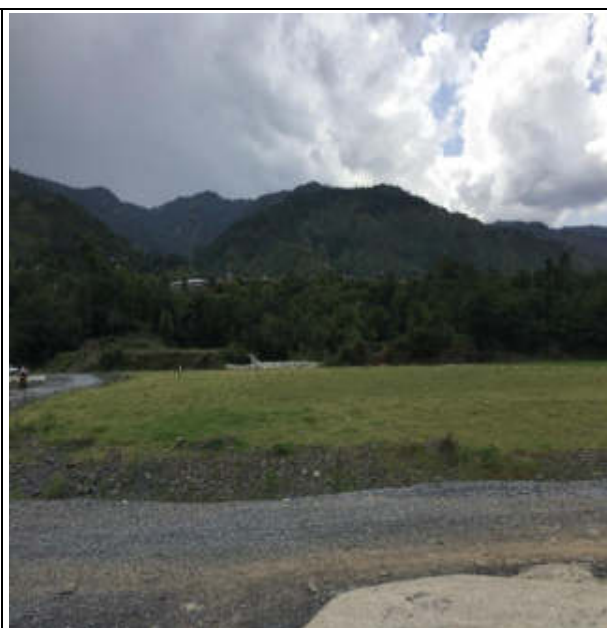
Some of the natural landscape and heritage has submerged, destroyed or disturbed by the dam and reservoir meanwhile, the reservoir has added the new landscape. The landscape at the disposal point has been enriched by developing a children playground by putting forward the better measures for further utilizing heritage landscape. Another very positive impact of dam has appeared as recreational and entertainment activities have started upstream in and around the lake. The recreational park developed at the disposal point has become a good place for families to visit. Before, there were two colorful water boats introduced but now the number has increased in the lake near the village Shorran and at side of the recreational park at Disposal point. According to the operator, Mr. Hamad, he has paid an amount of Rs. 600,000 for one year to KP Local Government for operating these boats but none on the AJK side.

Pic 6: Disposal area converted into Park after construction

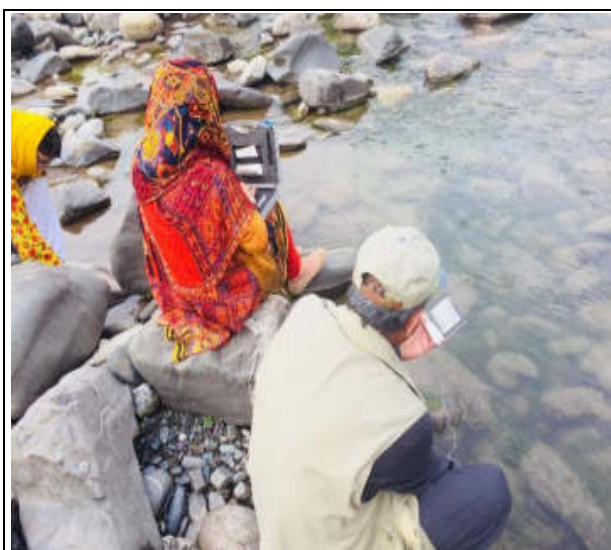
Pic 8: Water sampling at point-1.

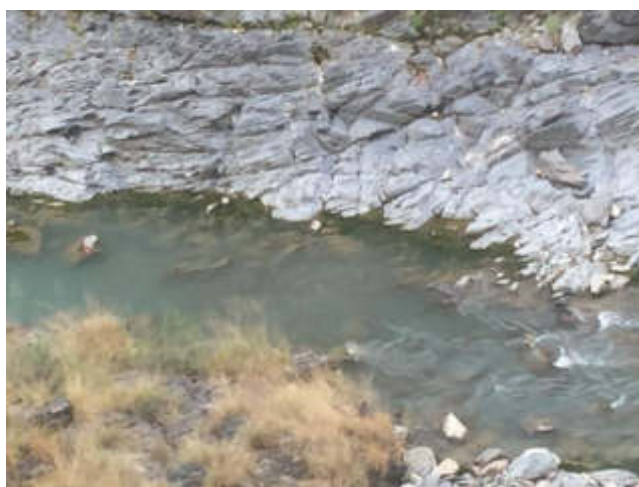
Pic 10: River Water level at its lowest level at point 3.

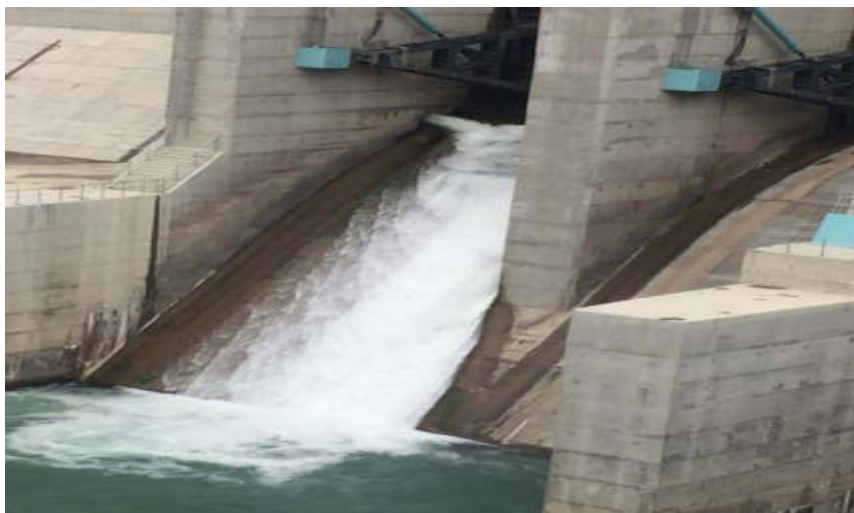
The garbage last time seen accumulated behind the walls of the weir are released in the river downstream. There is no mechanism of accumulating and properly disposing this garbage, mostly the plastic material.

Pic 11: E-flow

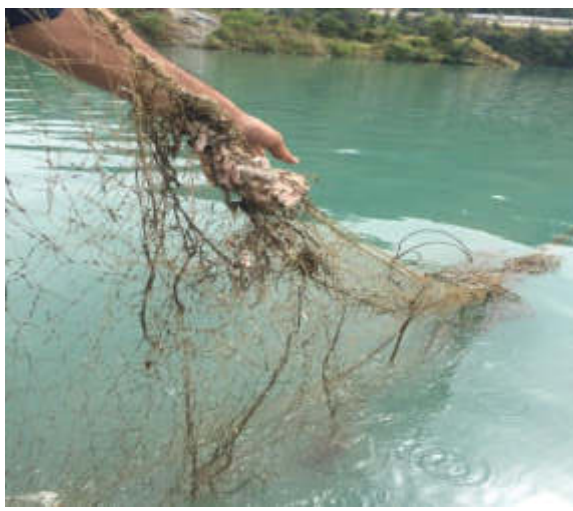
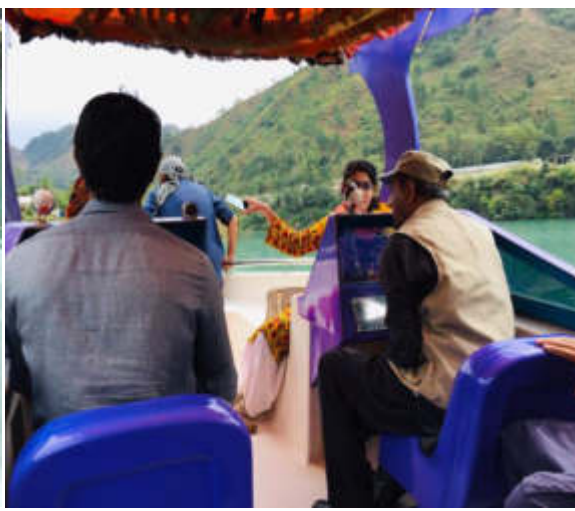
This point lies at 34° 20' 43" N and 73° 25' 01" E with an elevation of 2471 ft above mean sea level. The water flow is almost dead here. Air temperature is 28°C and water temperature 19°C. There are many tourists enjoying the facilities of the recreational provided by the hydropower project authority here. The sailing boats are now operational here as they were only at Shorran before. There was a Gill net fixed at the right side in the reservoir. All team members went by the boat to examine the gill net but there was no fish and according to the locals, they have left erecting the nets as no fish could come in the net after December 2017. This is just because of the change in the ecology of the water body. There is no possibility of fish survival now. Mosquitos and other crustaceans are present at the top surface of the reservoir.

<p>Pic 12: Gill net erected on the left bank of the reservoir</p>	<p>Pic 13: Reservoir crossing on motor baot</p>

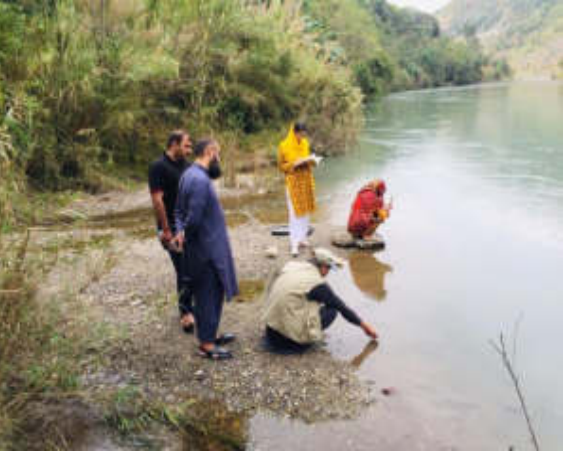
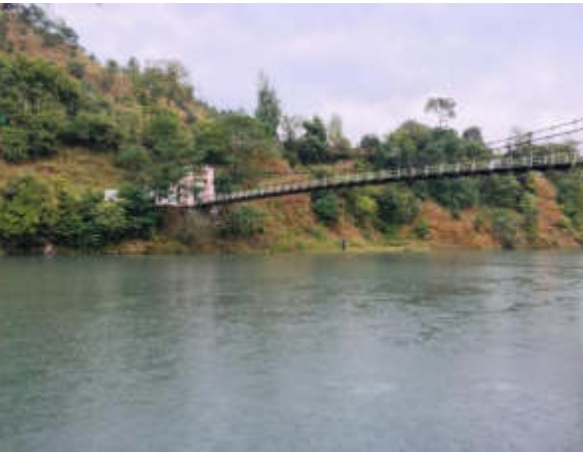
This sampling point is at the tail of the reservoir and is situated at 34° 21' 09" N and 73° 24' 12" E with an elevation of 2556 ft above mean sea level. Flow of water is very low with an average speed of 5 km/hr. Eutrophication can be observed here but it changes with the changing speed of water. No fish could be caught here. The sides of the river are rich in vegetation. The air temperature is 28°C and water temperature was 19°C and pH 6.5. The area has become a good ground for the mosquitos and mollusks.

<p>Pic 14: Water parameter testing using the gadgets with thick vegetative cover behind</p>	<p>Pic 15: Shorran Bridge</p>
