Semi-annual Environmental Monitoring Report
October 2020

TIM: Road Network Upgrading Project

July 2018 – December 2018

ROAD NETWORK DEVELOPMENT SECTOR PROJECT (RNDSP): GRANT 0180 TIM

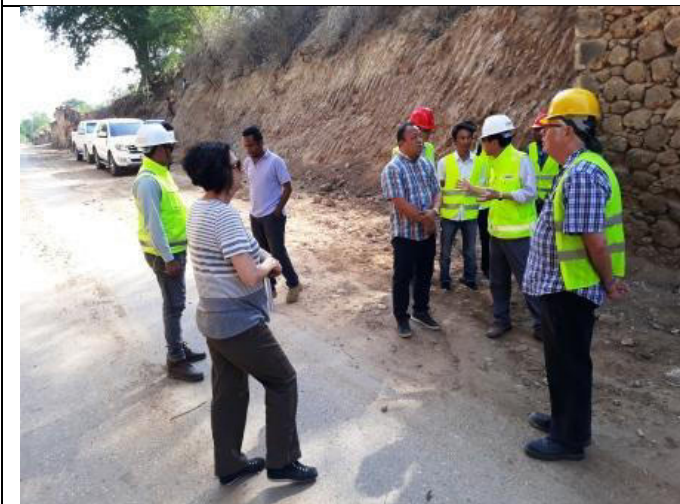
5 July 2018 Joint site inspection observing the Lautem Fort to be preserved as historical site.

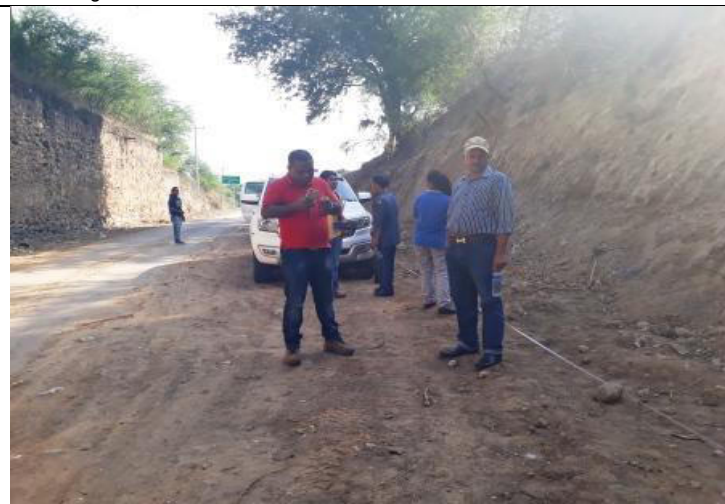
5 July 2018 Ministry of Art and Culture Investigated the Lautem Fort and requested the contractor to temporarily stockpile the removed fort stone to be reused again for The rehabilitation of the fort.

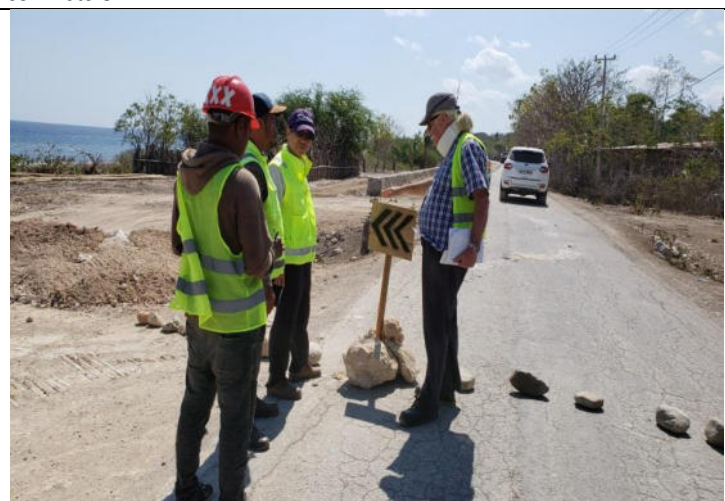
September 2018 instruction given to the PISC and contractor on site during the joint inspection to install the warning signs properly to warn the commuters.

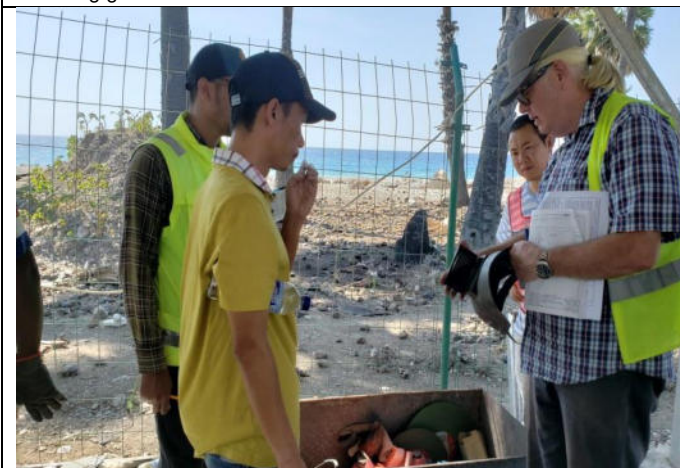
September 2018. Contractor camp. Contractor to provide a proper welding glasses for workers to do the work.

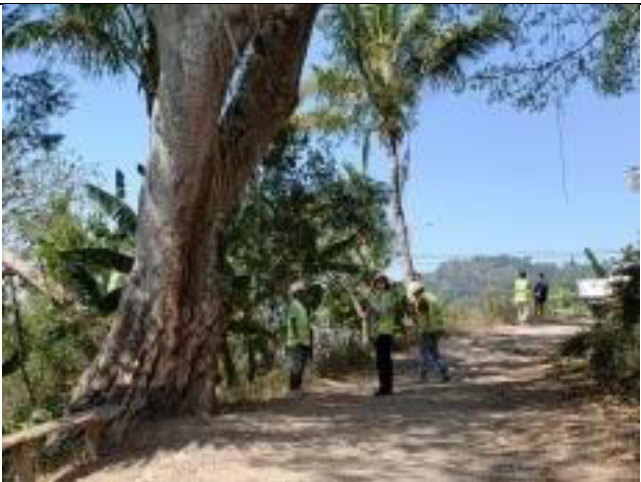
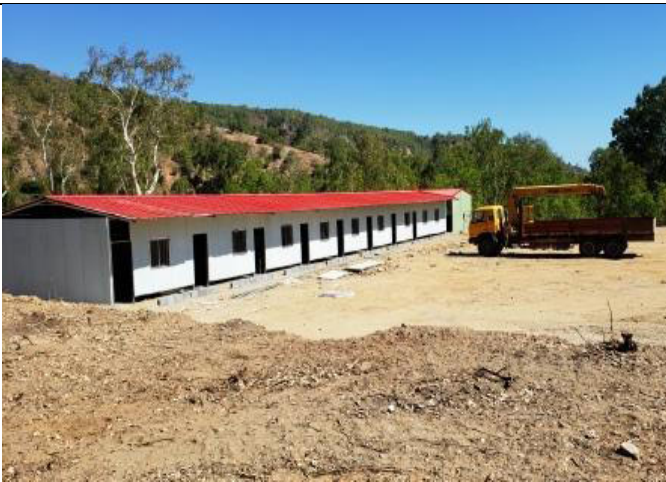
<p>9 July 2018 Joint site inspection for C16/17 Package 1 Aipelu – Bazartete</p>	<p>9 July 2018 Ongoing construction of contractor's camp at Km 1+800 RS</p>

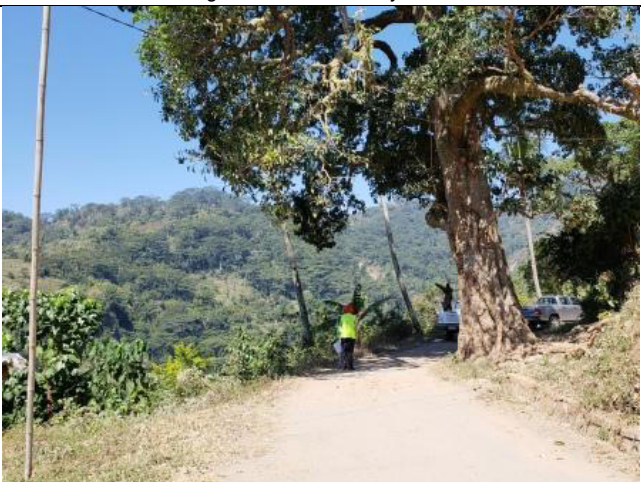
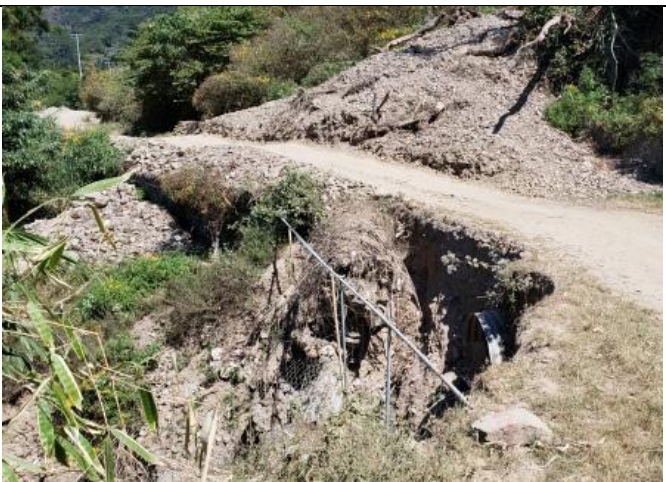
<p>9 July 2018 identified tree at Km 7+900 to be removed as the tree is in the work limit and dangerous for the safety of the traffic.</p>	<p>Land slide section at Km 11+200 RS</p>

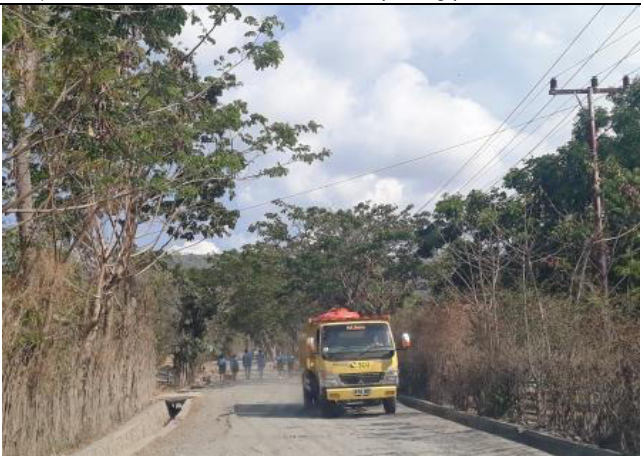
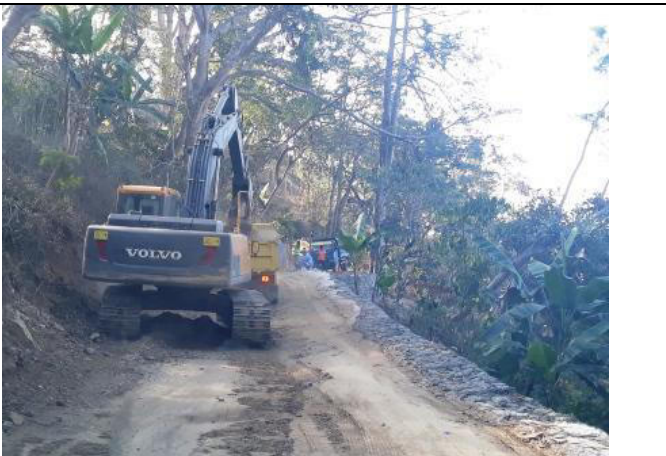
<p>8 November 2018 Audit on dust control found out that Contractor's truck distributing water for the work activities (not dedicated to water the road). CPAR will be issued in the next reporting period</p>	<p>8 November 2018 No flagmen assigned to control the traffic at the heavy equipment operation area.</p>
