Environmental Monitoring Report

Bi-annual Report
June 2015

AZE: Second Road Network Development Investment Program – Project 1

Republic of Azerbaijan:
Second Road Network Programme, Tranche 1:
Construction Supervision for the Alat-Astara Motorway –
Masalli to Jalilabad Intersection

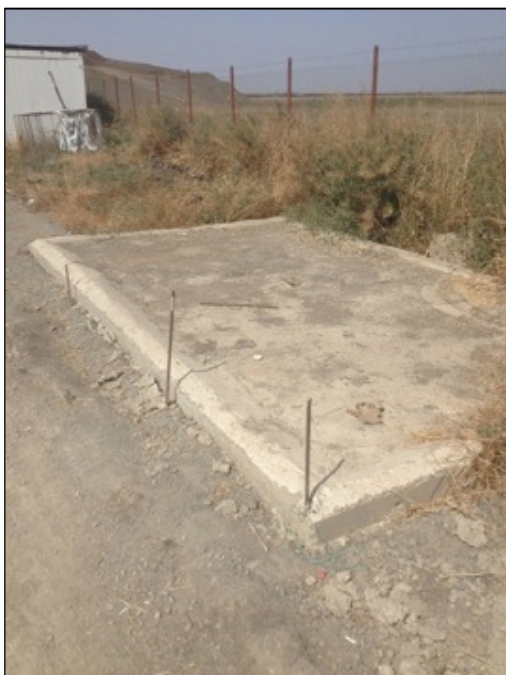
Figure 1: Concrete area for storage of hazardous liquid waste. The bunding is not sufficient size to prevent a spill from a 200 litre drum escaping from this area.

- 31. Bunding – Although concrete bunding has been installed for all of the fuel tanks and also for liquid storage areas, it was noted that some of the bunds are an inadequate size, or have had holes installed to drain water. This, in effect, renders the bunds useless and will not prevent any spill or leak of fuel or hazardous liquid entering the surrounding soils and groundwater. Figure 1 & 3 illustrate examples of these issues. The Contractors EHS team were notified of all of the bunds which needed repairing and upgrading.

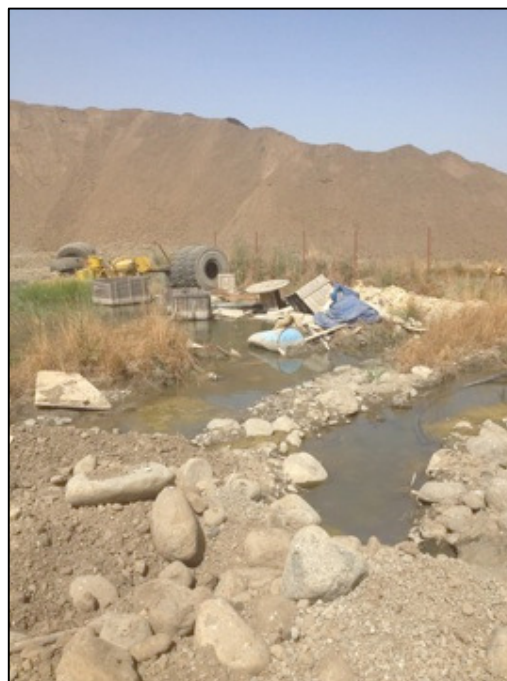
Figure 2: Poor waste management to the rear of the water treatment area.

- 32. Waste Management – In general waste is managed well across the site. Bins are provided for storage of both domestic waste as hazardous waste (e.g. at the re-fuelling area and maintenance yard). However, certain portions of the construction camp need to be cleared of waste, including the area behind the water treatment plant identified in Figure 2. The Contractors EHS was notified of the issue and was informed that the Engineers Environmental Manager will be undertaking regular spot checks around the camp to identify areas of poor waste management.

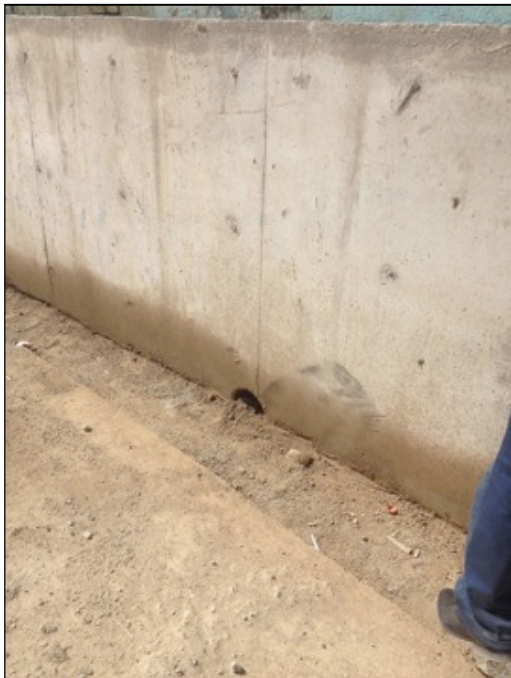
- 33. Re-fuelling – As noted above, the bunding around the refuelling area now has holes in its base for drainage of water (Figure 3). Accumulated rainwater maybe contaminated, and should not be released, except to a drainage sump where oil and grease can be separated from the rainwater. An example of how bulk fuel storage should be designed is provided by **Annex E**. In addition, the original re-fuelling area which comprised a concrete area for waiting trucks and a concrete lip to prevent spills leaving the area, has gradually deteriorated (Figure 4). The Contractors EHS team was told that this area needed to be rehabilitated and ideally connected to a sump to collect oily and greasy water during periods of high rainfall.

Figure 3: Bund with a hole for drainage at the re-fuelling area.

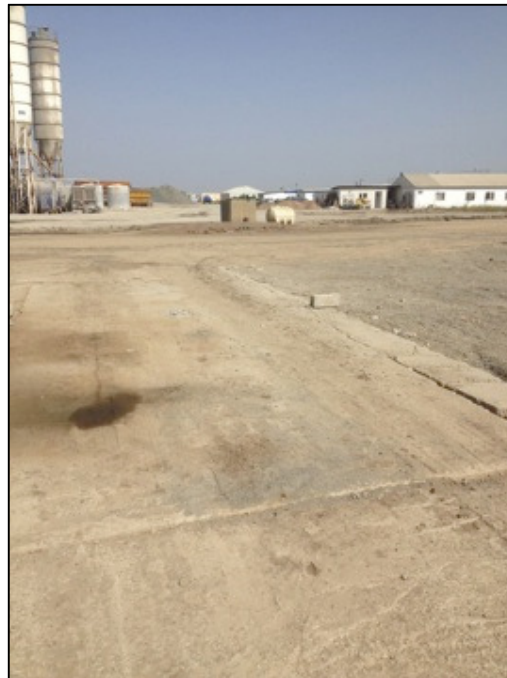
Figure 4: No drainage channel for run-off from the vehicle re-fuelling area.

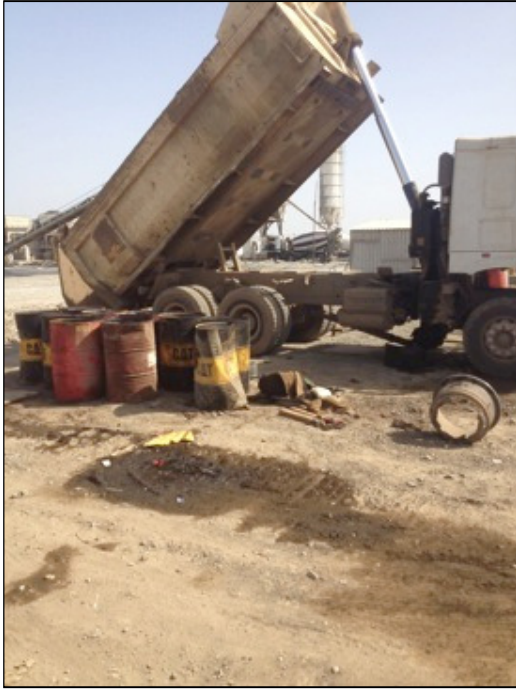
34. Maintenance Area – The maintenance yard poses the most significant environmental issue at the Contractors camp. Even though there is an adequately sized covered area for maintenance, the Contractors staff continue to perform vehicle maintenance on open ground outside of the maintenance yard (Figure 5). This is leading to contamination of soils and potentially groundwater. In addition, waste oils and other contaminated materials are stored haphazardly in this area, and may also be resulting in contamination of soils and pollution of groundwater. The Contractors EHS team stated that they would inform the manager of the maintenance area of these issues and that all maintenance should be undertaken in the correct areas.

Figure 5: Vehicle maintenance on open ground next to the maintenance yard.

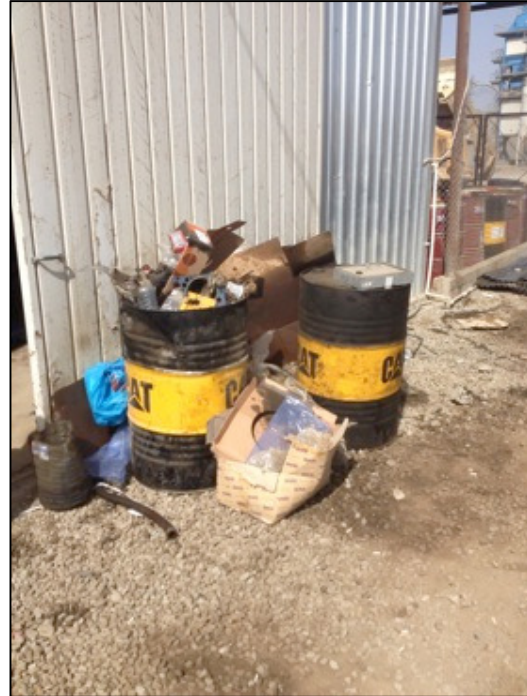
Figure 6: Storage of hazardous waste on open ground outside the maintenance yard.

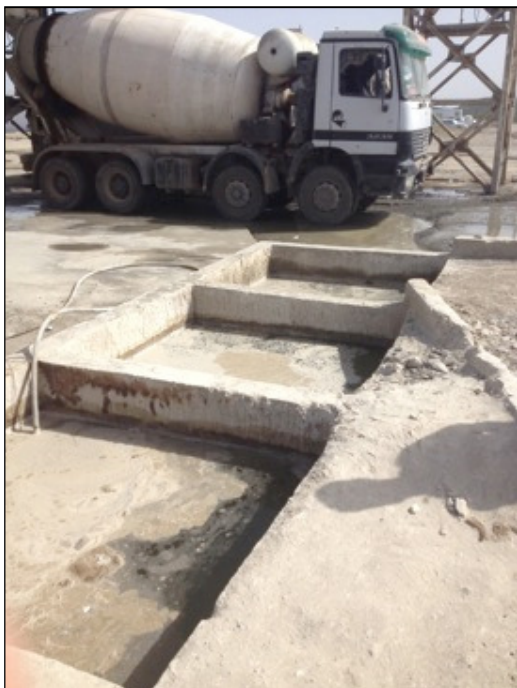
35. Wash Bays – The vehicle washing bay (Figure 7) has not been designed correctly and is not functioning properly. The Contractors EHS team said that they would review the design and make the necessary changes.

Figure 7: Poorly designed vehicle washing bay.

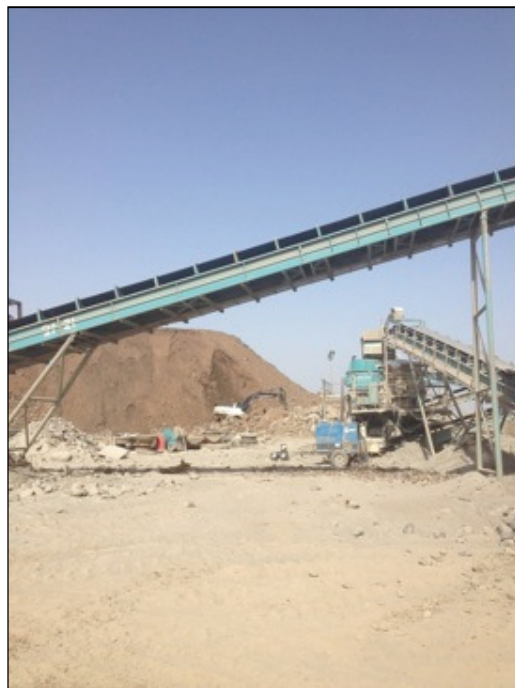
36. Conveyor Belts – In the rock crushing area of the Contractors camp a conveyor belt moving rocks (approximately 10cm in diameter) was noted without any side boards (Figure 8). Walking beneath the conveyor belt should be prohibited in case of rocks falling off the conveyor belt. The Contractor was informed to place signs in this area to prevent staff walking in this area.

Figure 8: Small rocks were being transported up this open-sided conveyor belt, presenting a risk to anyone walking under the conveyor.

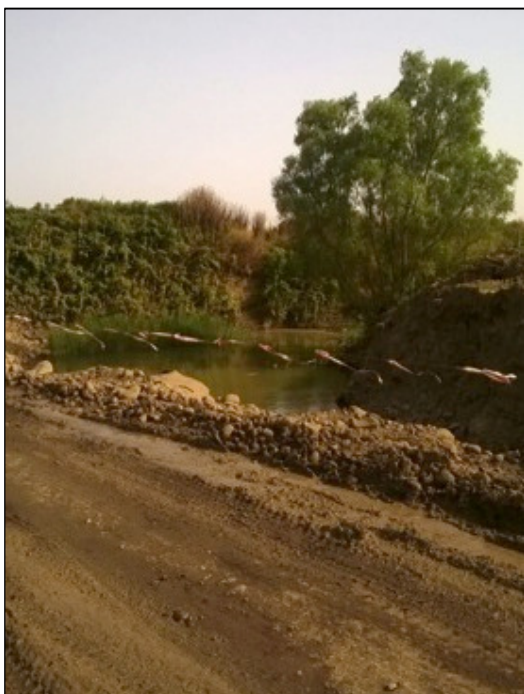
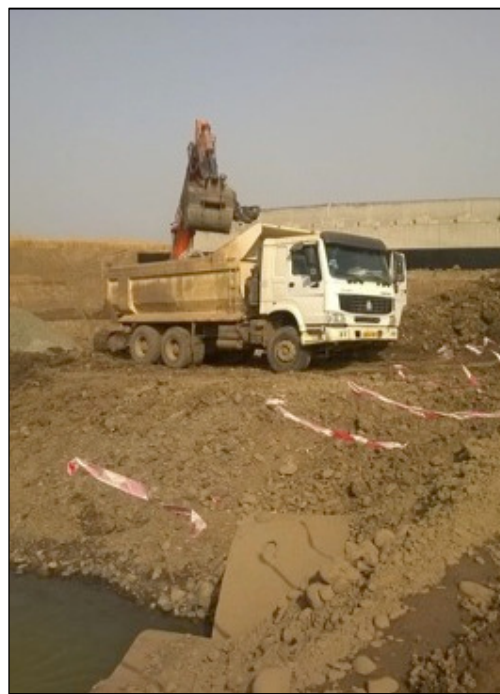
39. Vilash River – Bridge works are currently in progress at the Vilash River. Figure 9 & 10 illustrate the lack of appropriate safety barriers at the river crossing. In theory this crossing should only be used by contractors vehicles. However, locals are using the Project access roads as shortcuts and they can be seen crossing the river at this point. As such, the Contractor needs to place safety barriers in this area to ensure that Contractors vehicles and other non contractor vehicles do not fall into the river.

Figure 9: Lack of safety barriers at Vilash River

Figure 10: Lack of safety barriers at Vilash River.
