Environmental Monitoring Report

AZE: Second Road Network Development Investment Program, Project 1

Republic of Azerbaijan:
Second Road Network Programme, Tranche 1:
Construction Supervision for the Alat-Astara Motorway –
Masalli to Jalilabad Intersection.

Report 6: 1st January – 30th June, 2017

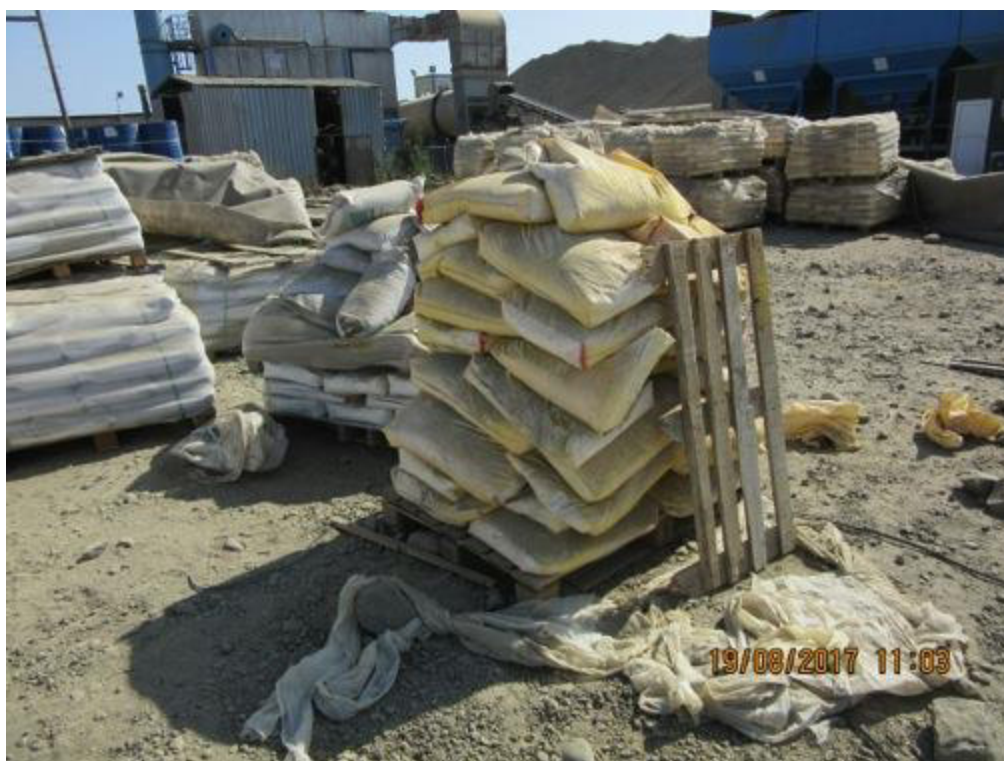
Item	Comment	Action	Responsibility	Schedule
1. Explosive material (see Appendix D, Photo D-1)	Despite being told numerous times the Contractor still does not have any control over the Kraton material. This represents a health and safety risk to workers on site.	As per table 2.	Kolin HSE Team	01/08/17

Photo D-1 – Poorly Managed Kraton

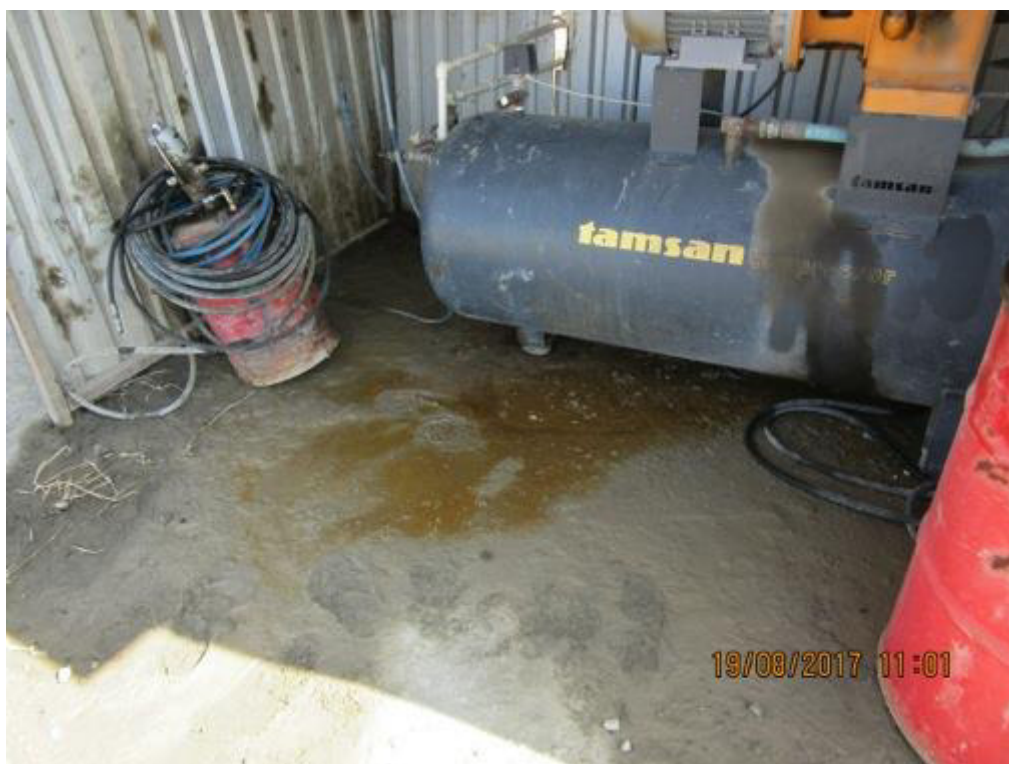
2. Leaks of fuel and oil (see Appendix D, Photo D-2)	Leaks of fuel and oil were noted around the site, including the maintenance yard.	Contractor to clean and remove all spills, which maybe more difficult given that his spill kits have mysteriously disappeared from the camp.	Kolin HSE Team	01/08/17

Photo D-2 – Leaking Fuel, Maintenance Yard

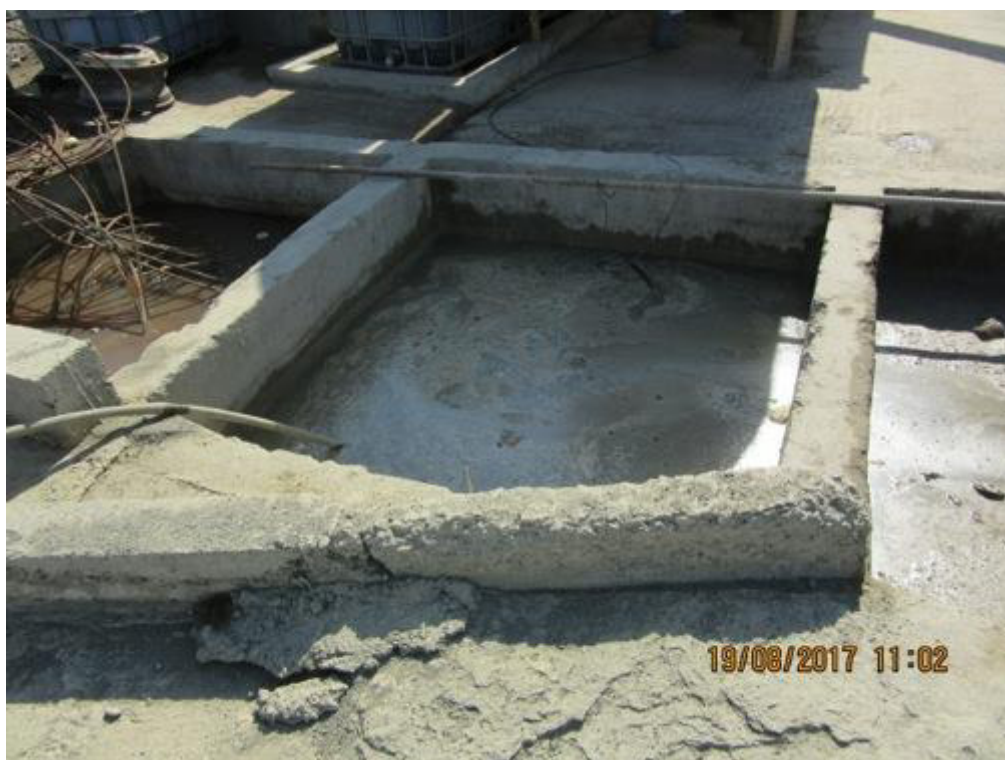
3. Concrete mixer washout area (see Appendix D, Photo D-3)	The wash out area is full of scrap metal.	The scrap metal should be removed and recycled.	Kolin HSE Team	01/08/17

Photo D-3 – Concrete Mixer Wash out pit, filled with scrap metal

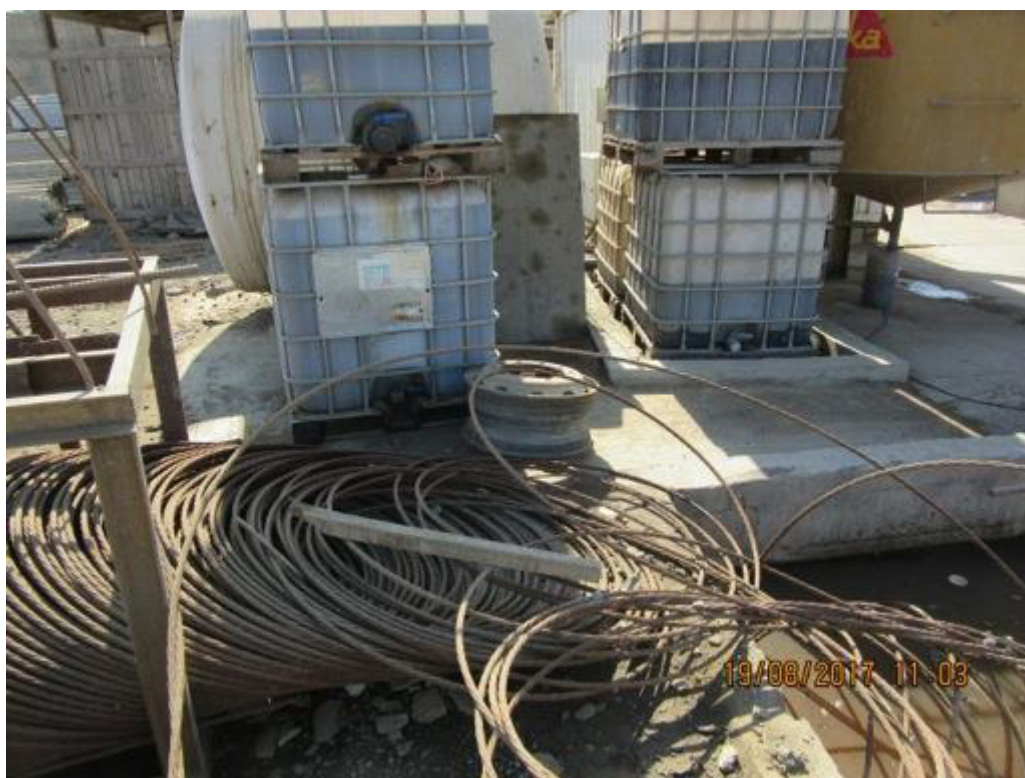
4. Plasticizers (see Appendix D, Photo D-4)	Plasticizers are still not stored in correct sized bunds.	Contractor to ensure all materials are stored in correct sized bunds until they are removed from site.	Kolin HSE Team	01/08/17

Photo D-4 – Plasticizers not in a bund

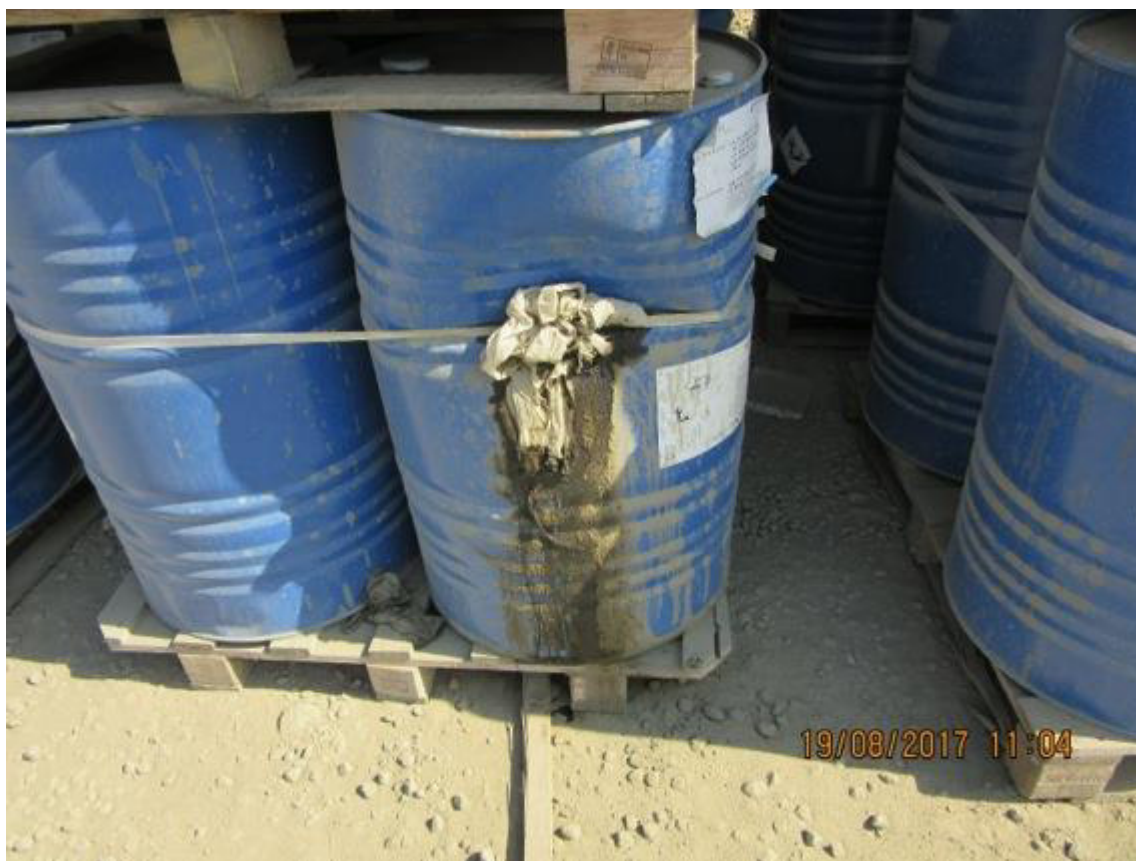
5. Leaking liquid containers (see Appendix D, Photo D-5)	Some drums of hazardous liquids are leaking onto bare soils.	Contractor to ensure all materials are stored in correct sized bunds until they are removed from site.	Kolin HSE Team	01/08/17

Photo D-5 – Leaking Chemical drum

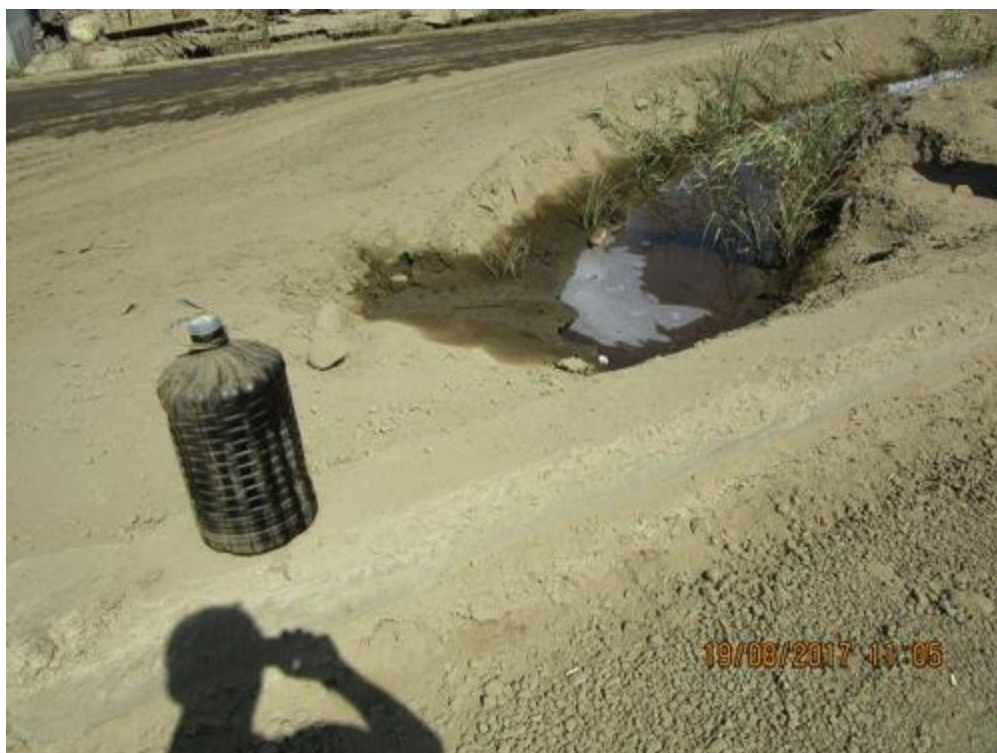
6. Wrong storage containers (see Appendix D,	Oils and fuel are still being stored in the wrong types of container (e.g. used water bottles)	Contractor to ensure that all fuels are stored in correct	Kolin HSE Team	01/08/17

Photo D-6 – Fuel stored in wrong type of container

Photo D-6)		containers.		
7. Holes in bunds (see Appendix D, Photo D-7)	Gaps are still present in the bunds in the asphalt plant.	Unless the asphalt plant no longer contains hazardous liquids this bund should be repaired.	Kolin HSE Team	01/08/17

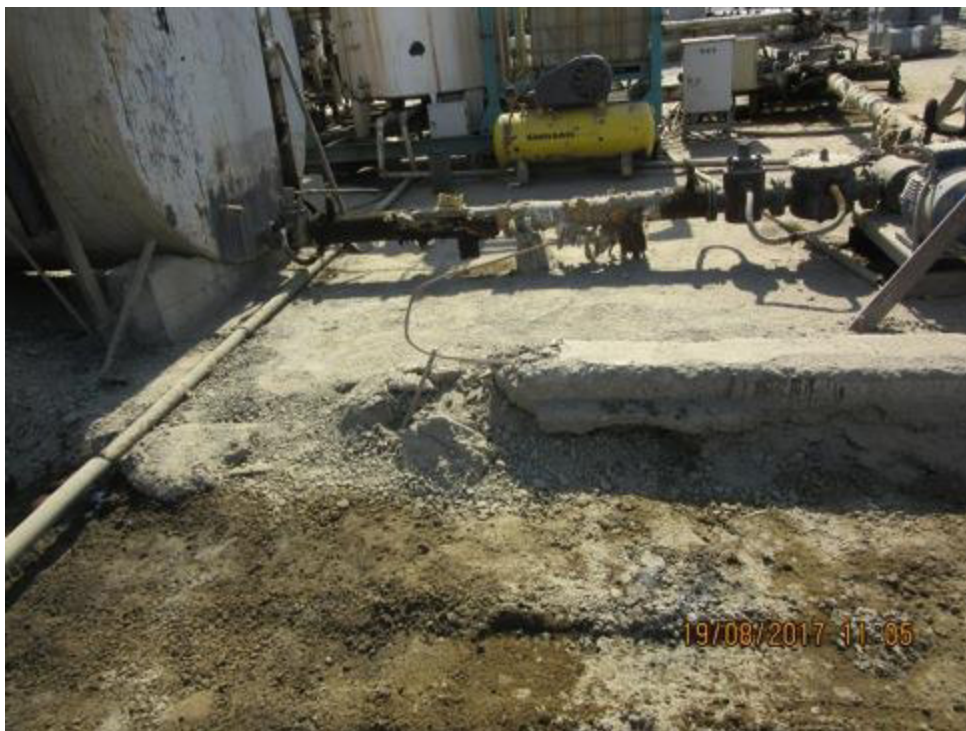
Photo D-7 – Missing bund in Asphalt plant area

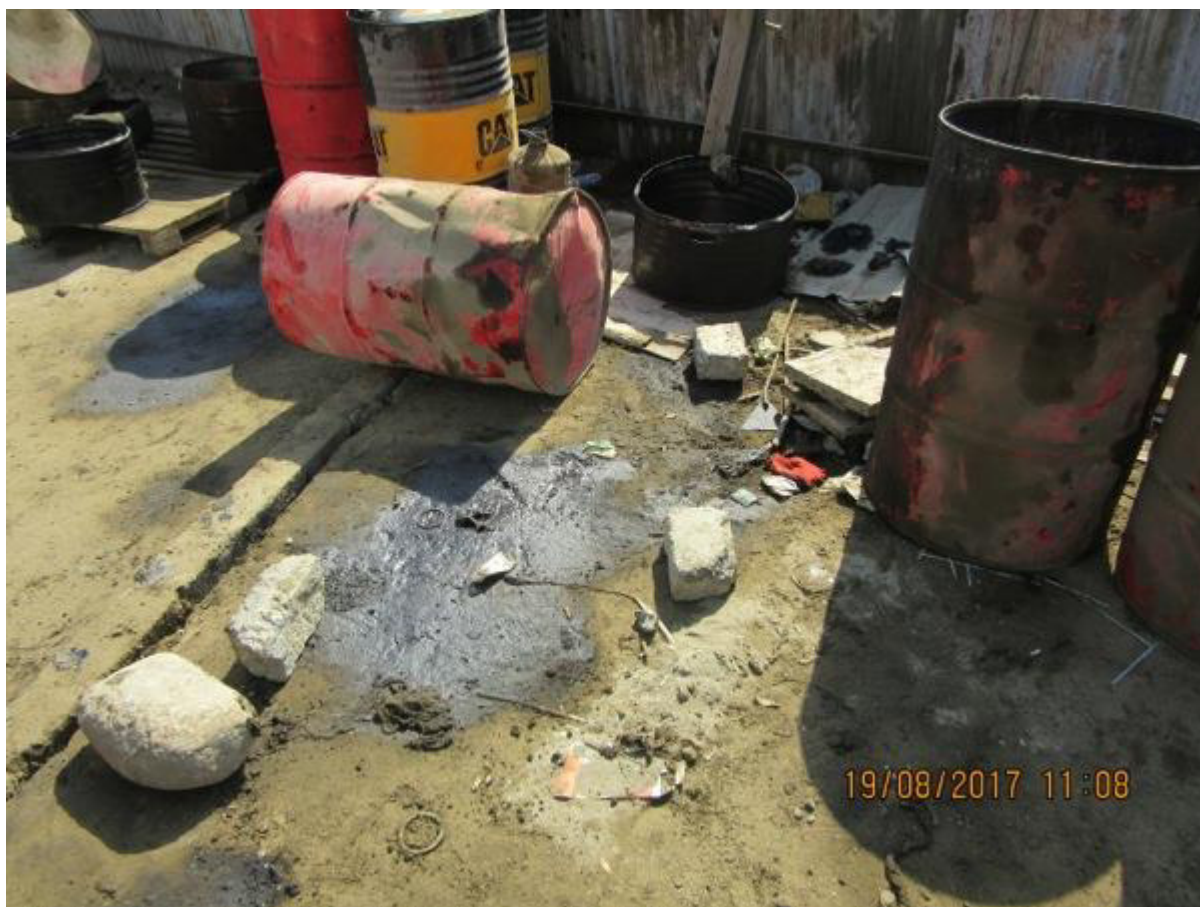
8. Poor storage of hazardous materials (see Appendix D, Photo D-8)	Hazardous materials in the maintenance yard are not stored correctly.	The Contractors HSE manager should examine these areas and assess if he thinks the storage methods are suitable. Then he should fix the problem.	Kolin HSE Team	01/08/17

Photo D-8 - Hazardous material management outside of the maintenance yard

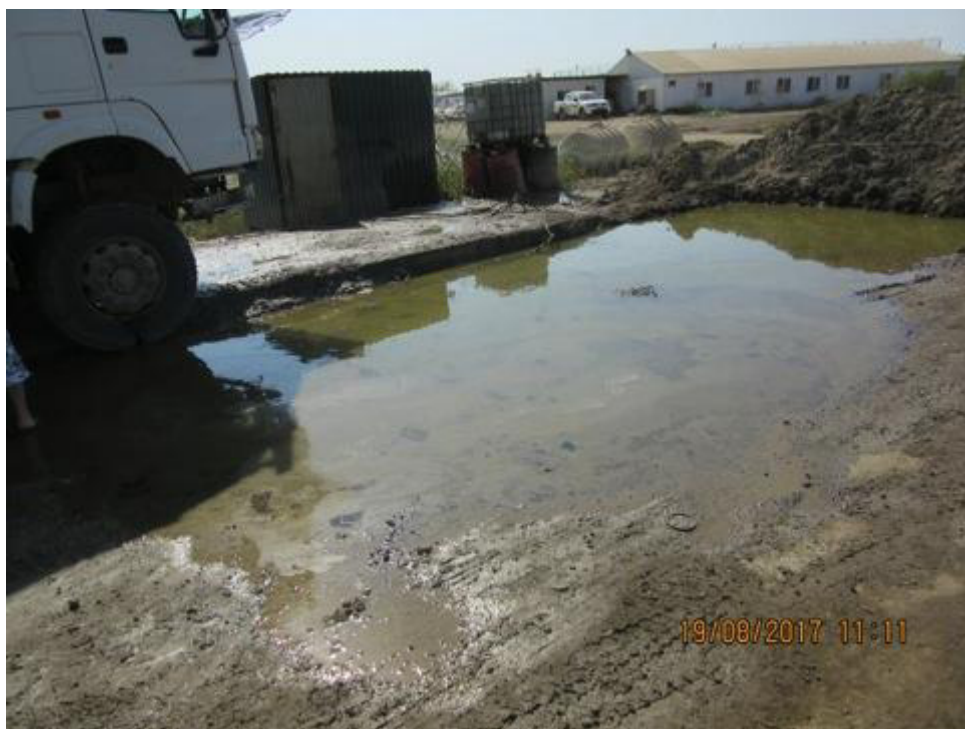
9. Vehicle washing bay (see Appendix D, Photo D-9)	The Contractor has been asked six or seven times over the course of the Project to rehabilitate this area so that it functions correctly. Each time the Contractor does a useless job and the wash bay turns back into a mud bath.	Despite the fact that the Contractor has failed multiple times with this task, it is not recommended that any further actions are undertaken in this area as the Project is almost completed and the Contractor would only fail in this task again anyway.	N/A	None

Photo D-9 – Useless vehicle washing facility

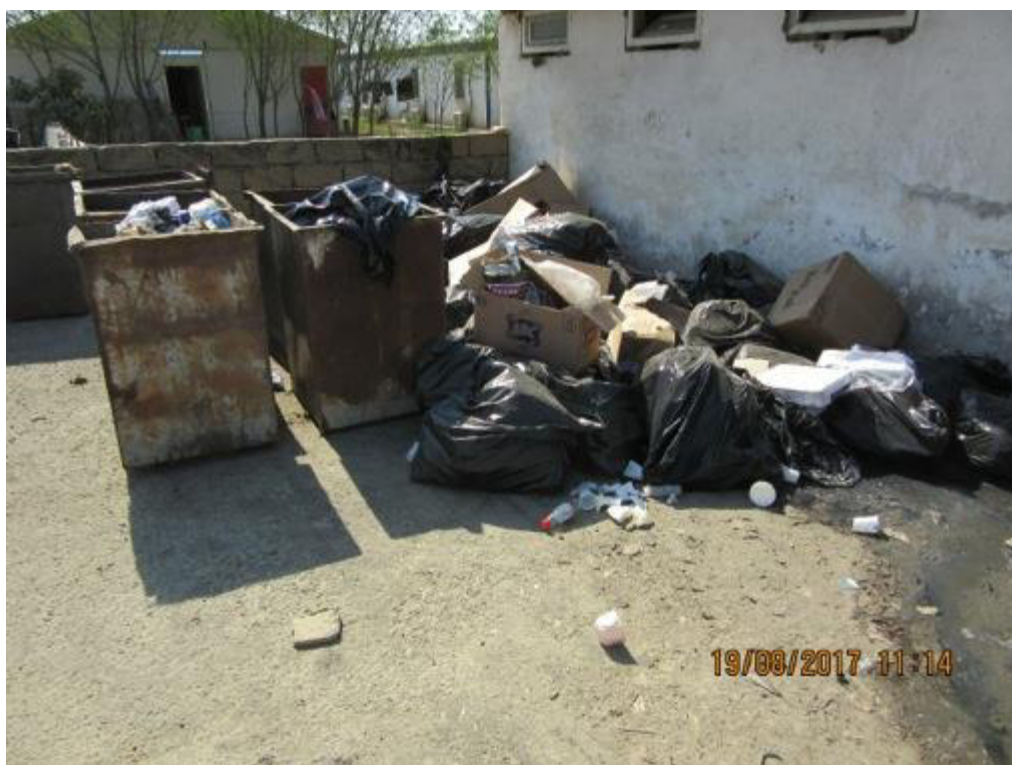
10. Domestic waste (see Appendix D, Photo D-10)	Domestic waste is not stored correctly.	All domestic waste should be stored according to the waste management plan prepared by the Contractor until the last member of staff leaves the site upon completion of the Project.	Kolin HSE Team	01/08/17

Photo D-10 – Poor management of domestic waste

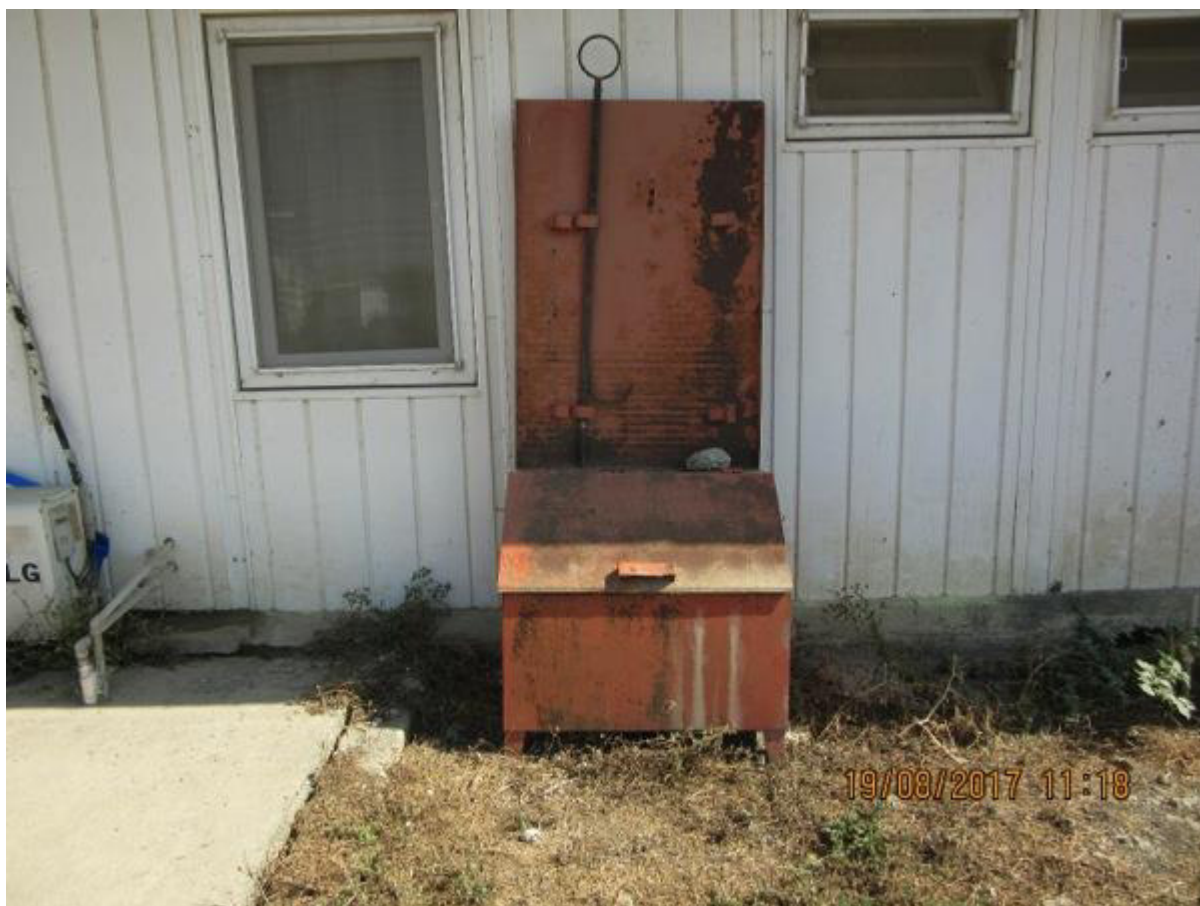
11. Firefighting equipment (or lack of it) (see Appendix D, Photo D-11)	Firefighting equipment is missing in some locations, or is not in the right pressure range. This represents and safety risk.	Adequate firefighting equipment shall be provided on site by the Contractor until the last member of staff leaves the site upon completion of the Project.	Kolin HSE Team	01/08/17
---	--	--	----------------	-----------------

Photo D-11 – Missing firefighting equipment at accommodation blocks
