Bi-annual Environmental Monitoring Report

Second Road Network Development Investment Program, Tranche 2 under Multitranche Financing Facility 2

Lot 1. Construction Supervision of Civil Works Contracts for Reconstruction of Ujar-Zardab-Agjabadi Section of R32 (70.50 Km)
– Ujar-Zardab, Km 0+000 – Km 37+000

Reporting Period: 01 July 2019 to 31 December 2019 (Report 2)

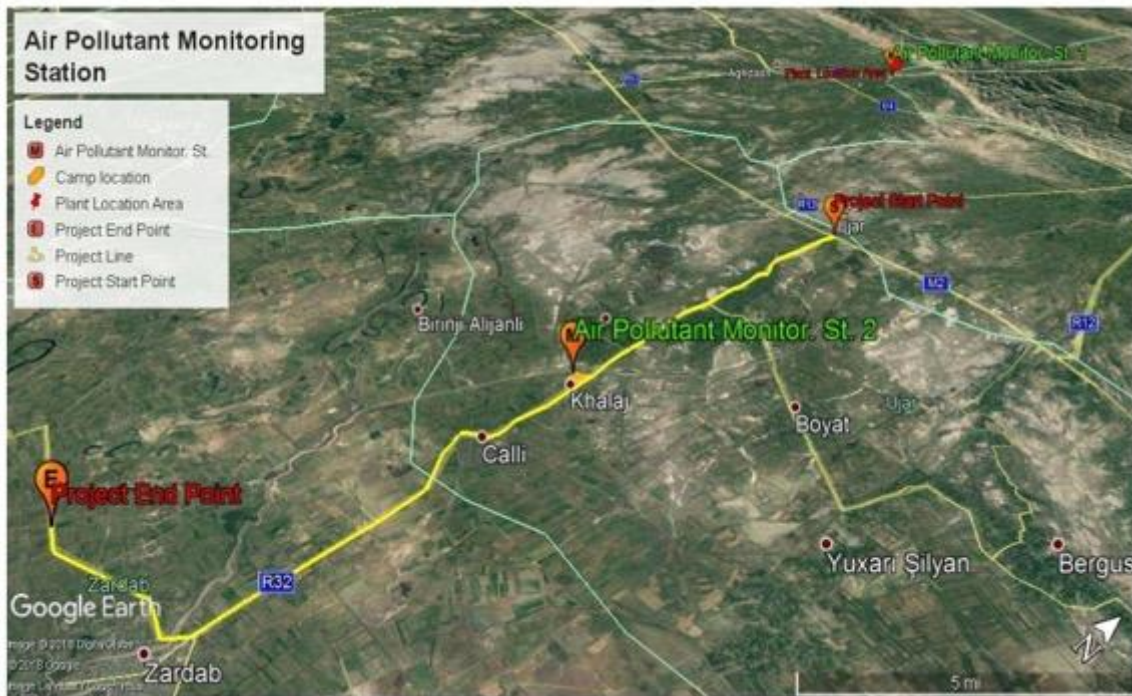
Figure 3 Air monitoring points

43. **Air quality monitoring:** 2 air monitoring stations have been located within the Project's start and end points (figure 2). Air quality monitoring results for all determinants and all monitoring stations were below Azerbaijan standards.

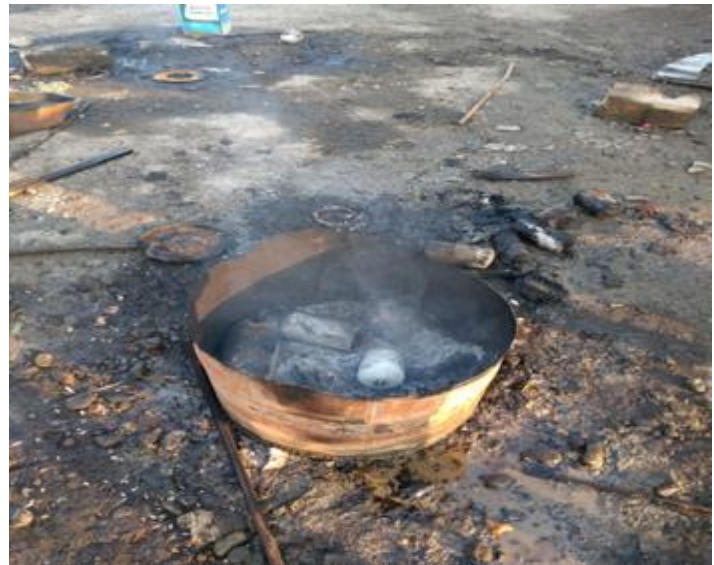
4. Burning waste (construction and from vehicles repair) prohibited; open fire is also prohibited, however, some personnel allowed these.

69. **Open fire in the workshop area.** Burning the construction waste like oil tubes and cans and open fire in the workshops area was observed which is prohibited. All staff and workers should be warned not to burn any waste and not to make any fire in the camp, workshops and other construction sites (see photos).

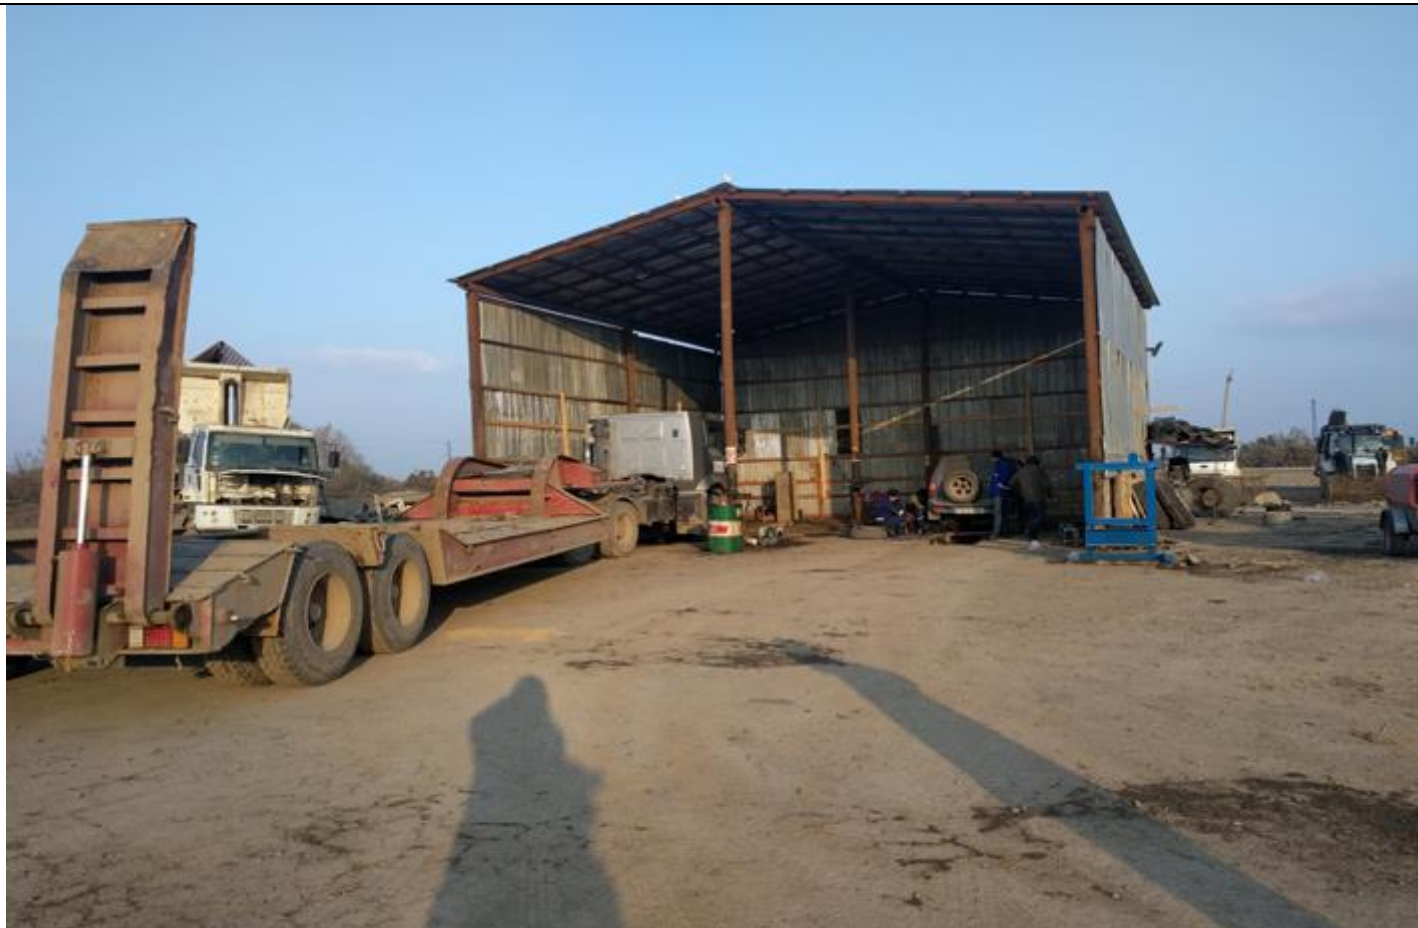
7. Camp workshop area: (a) small to fit the Contractor's vehicles, and (b) man without PPE and reflective garments is hardly visible though there is construction vehicles traffic in the worksite and workshop/camp area.

89. **Workshop for vehicles maintenance and repairing.** The Contractor has built a workshop for maintenance and repairing of vehicles to avoid the vehicles' oil spills in undesignated areas. However, the built workshop seems to be not big enough to meet the maintenance and repairing needs of number of vehicles the Contractor has. It was noticed that occasionally the vehicles' maintenance and repair took place outside the workshop in the camps territory and resulted in spills of vehicles oils' in soil. The Contractor should ensure:

- (i) Prohibit vehicles maintenance and repairing outside the workshop premise;
- (ii) Train all personnel to follow queuing in vehicles' maintenance and repair in the existing workshop or build additional workshop for vehicles repairing if this space is not enough.

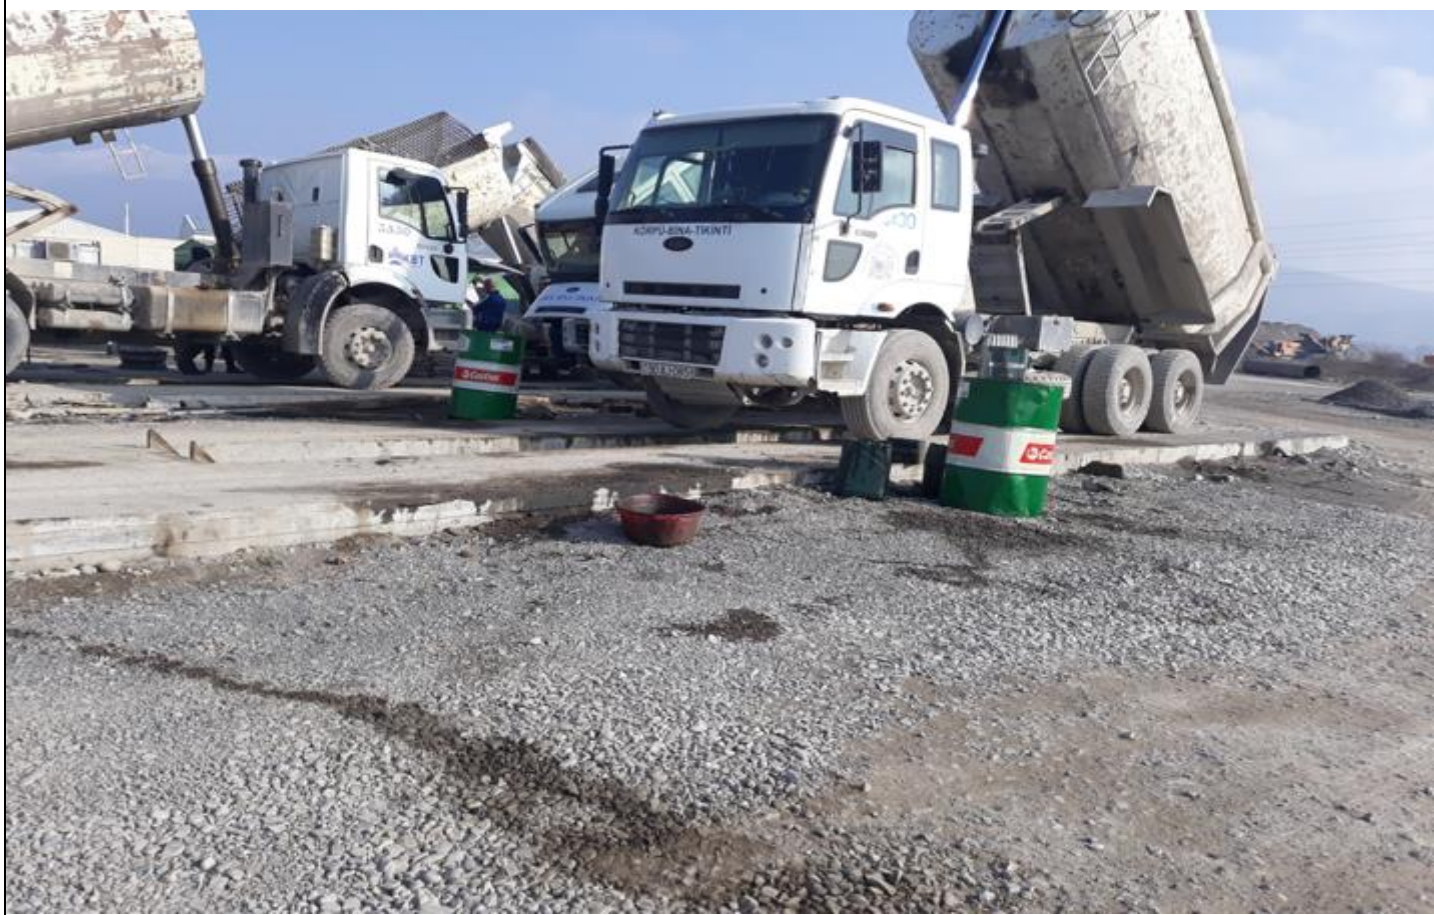
8. Man without PPE and reflective garments is hardly visible

91. **Personal Protective Equipment (PPE)** shortcomings are observed. Workers lack of the PPE. The Contractor should ensure all workers are supplied with and wear the complete set of PPE. It was observed in some cases, while wearing the reflective jackets, the workers lacked helmets, gloves, working jackets and trousers, or other specially required PPE such as respiratory masks when needed). The following corrective actions are required:

- (i) The Contractor should order and supply enough and full set of the PPE to every single worker as their jobs require, regardless of their formal positions (it was observed that mostly the management and the foremen have complete working clothes, helmets and warm jackets, etc. while the workers lack of it);
- (ii) Provide training and awareness raising to workers about OHS, health and life importance of PPE;

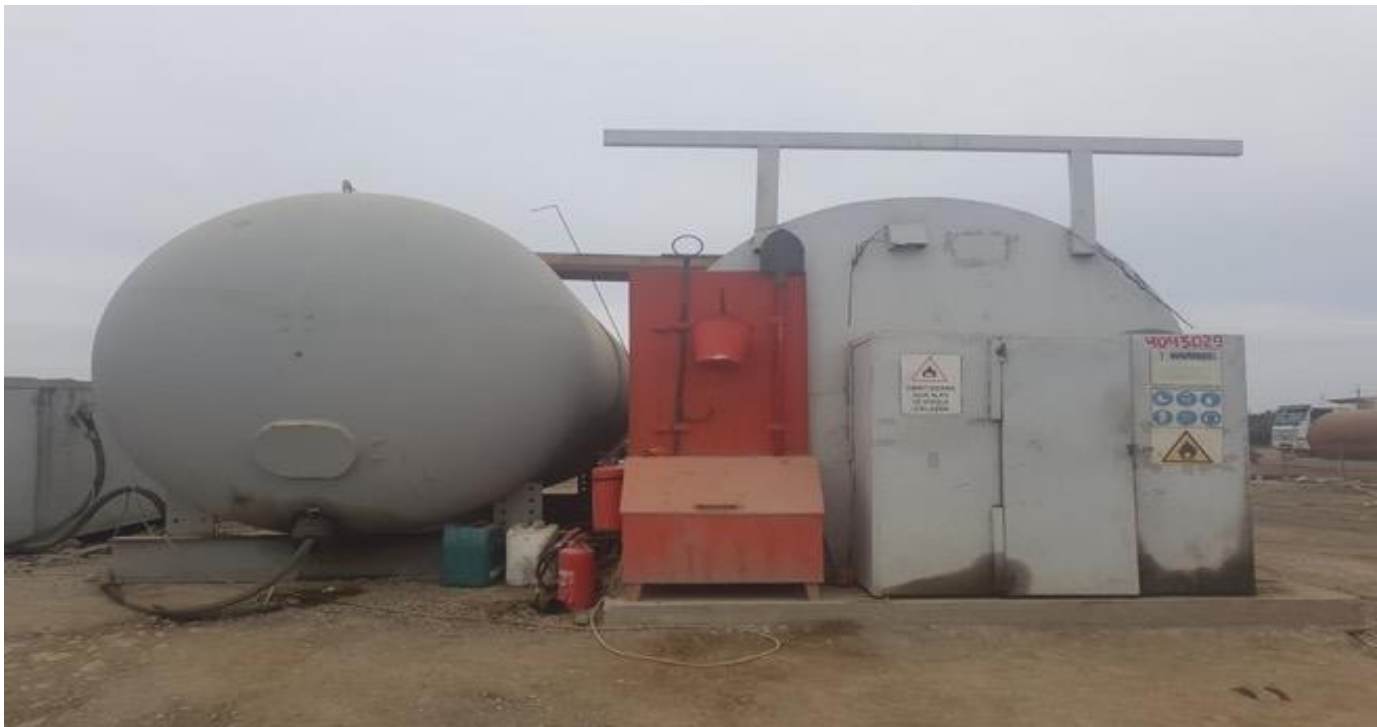
13.Camp Fuel Satation. The Engineer instructed the Contractor the fuel tanks should be placed in bunded enclosures of 110% capacity of the fuel tank and after the fuel tanks have been placed in bunded enclosures of 110% capacity of the fuel tank. The photoes will be submitted.

70. **Fuel and oil spills.** Oil and fuel were kept in the covered containers at the concrete surface area. However, in some location all over the workshop area, oil and fuel spills on the ground (soil) were observed because the vehicles' repairing and maintenance are carried out outside the designated workshop area, though this should not be allowed. Fuel spills are also observed at the fuel filling station.

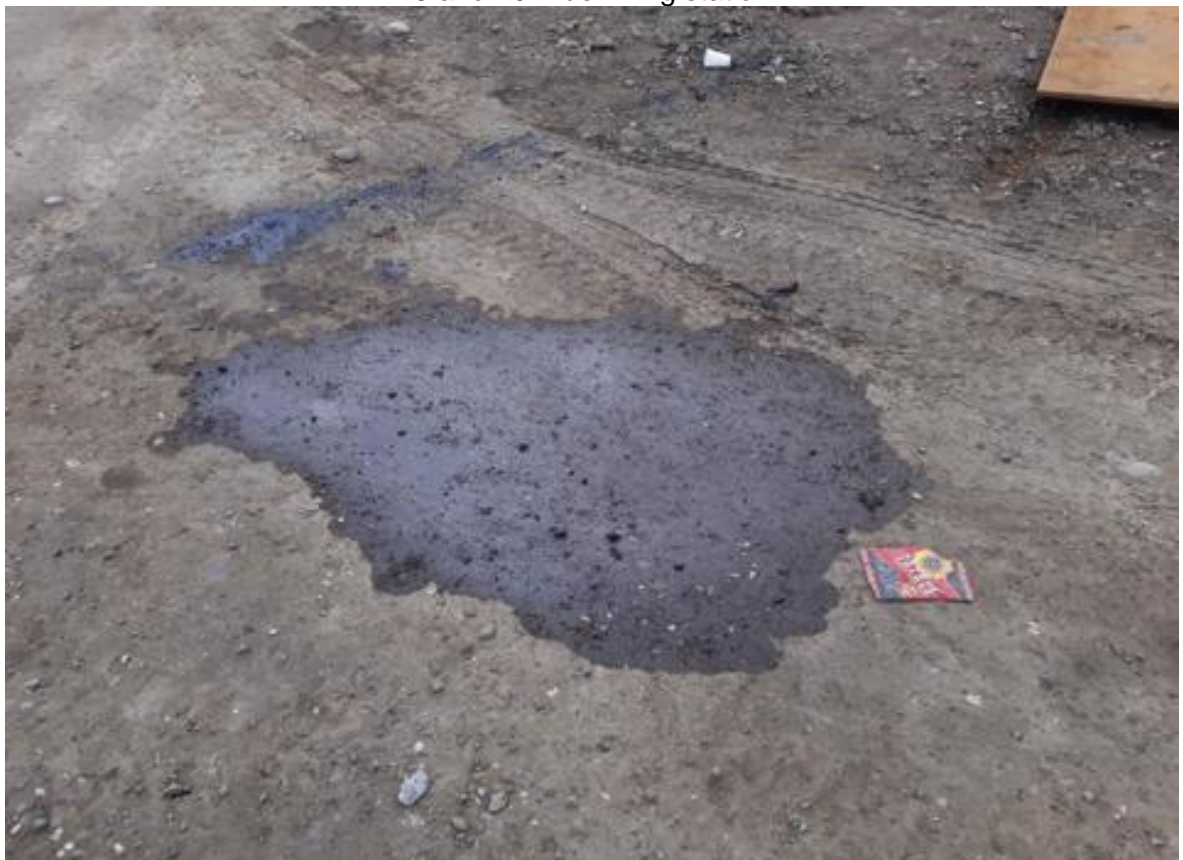
11. Oil/fuel spill

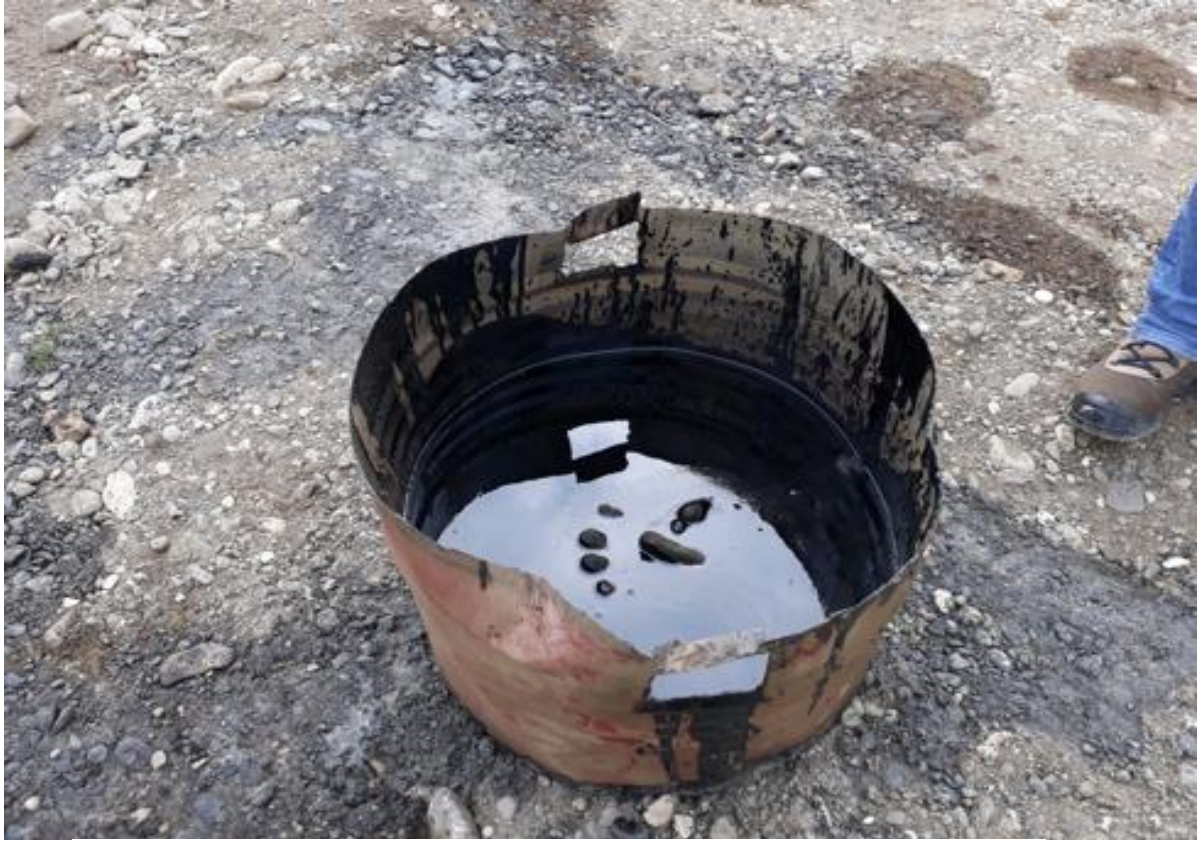
12. Oil tank left uncovered and with no roof

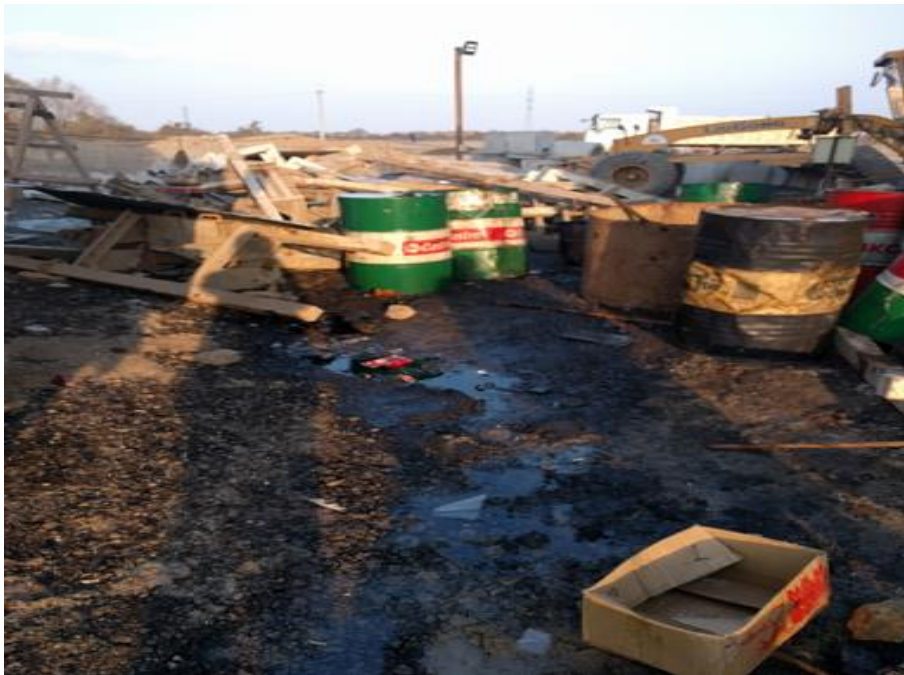
13. Improper waste management also observed

78. Similar to Lot 1, more training shall be provided to site staff to raise awareness on waste management and to train workers to separate hazardous and domestic waste in different

containers, construction sites and keep working places clean. Both construction waste (big plastic packages, pipes and metal materials) and domestic waste (cigarettes, papers, aluminum beverage cans) have been observed in the camp and workshop areas of the Contractor for Lot 2 too.

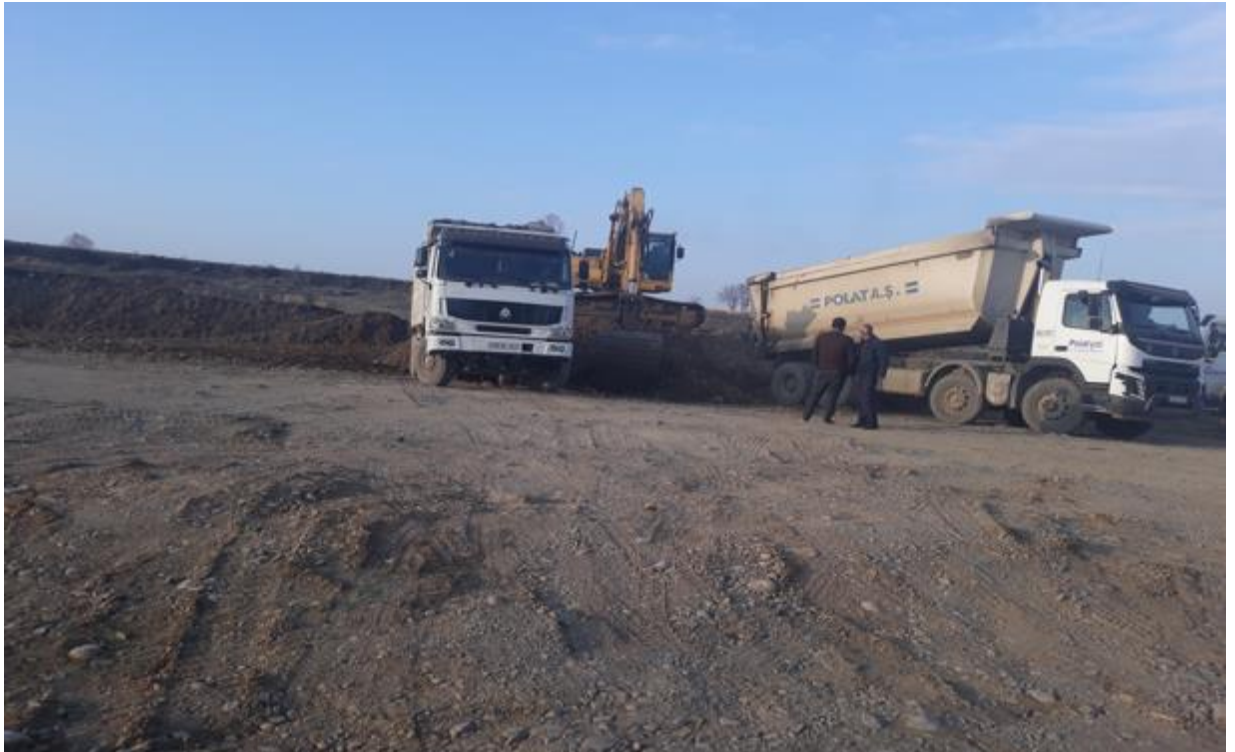
14. Men lack PPE and reflective garments

96. **PPE.** The Contractor has provided PPE to workers and the OHS Manager put efforts to ensure that all the workers wear the PPE. However, it was observed that not all the workers wear the PPE and the lack of complete set of PPE has been observed too (e.g. while wearing reflective vest, they missed helmets, gloves, trousers and jackets, or other specially required PPE as jobs requires (e.g. laboratory workers did not have respiratory masks). The following corrective actions are required:

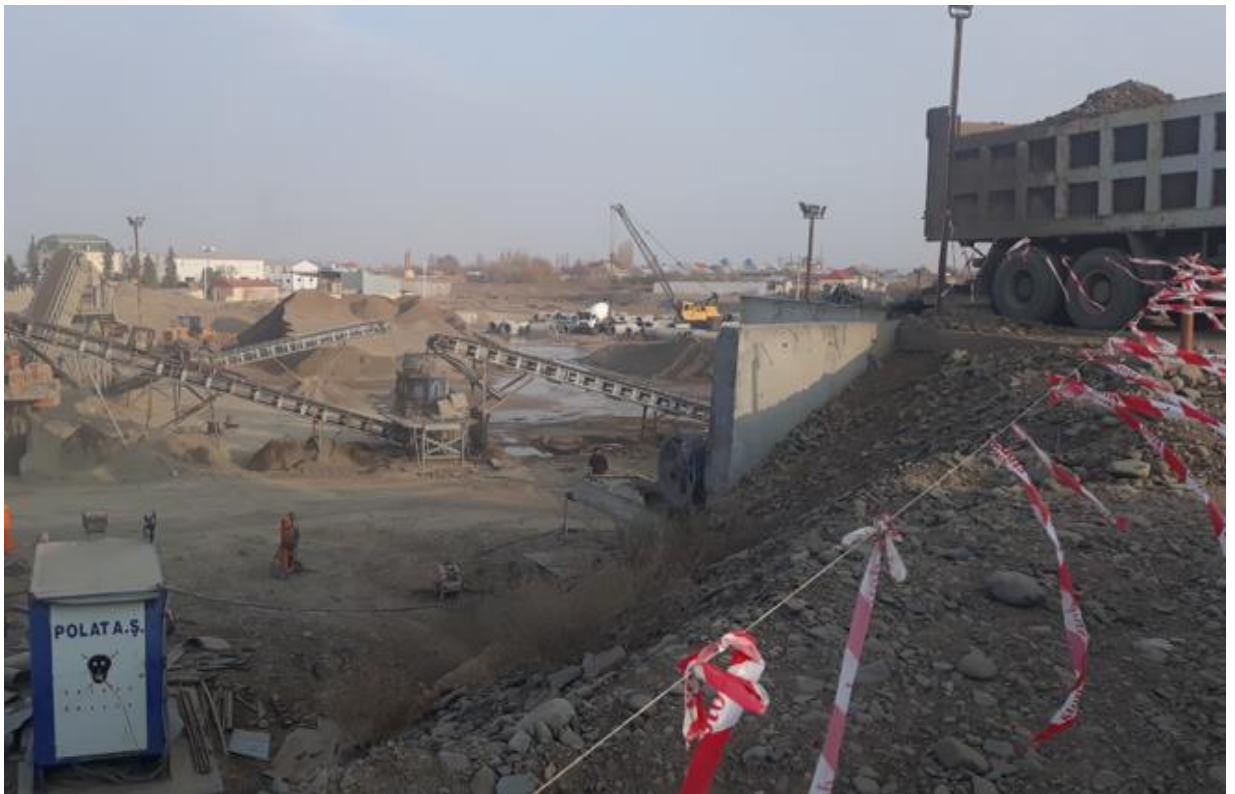
Figure 15. Man lacks PPE and reflective garments (hardly visible that increases safety risk)

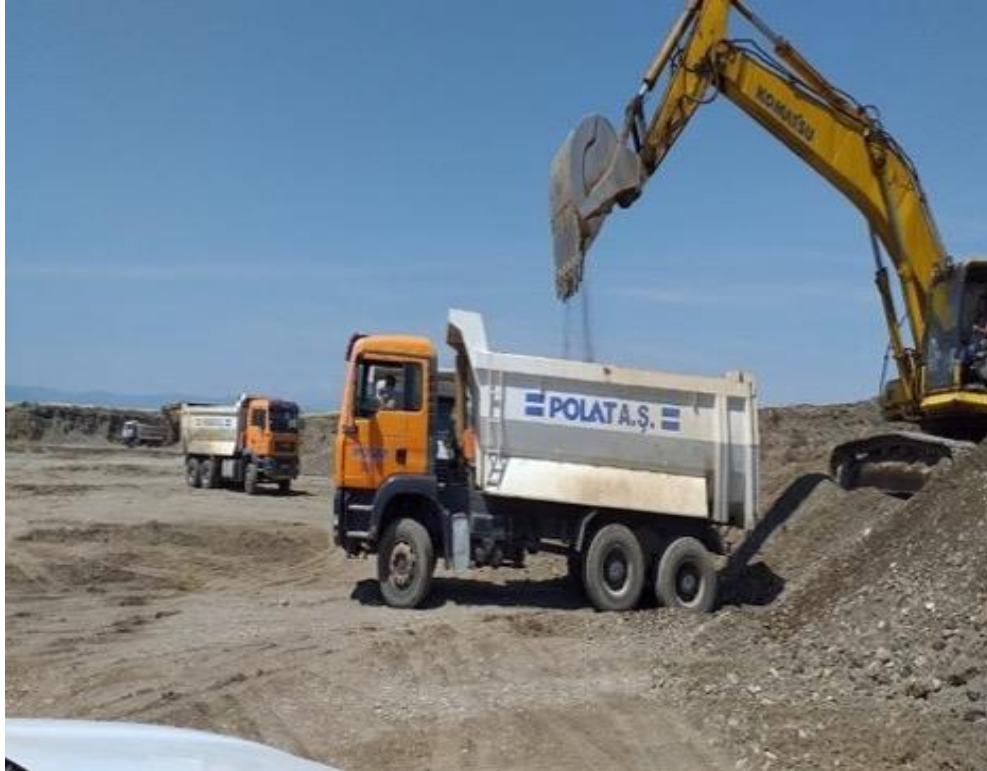
32.Kahrizli Borrow Pit. The drivers have no PPE
