Bi-Annual Environmental Monitoring Report

Project Number: 45389-004
January 2018

AZE: Second Road Network Development Investment Program, Tranche 2

Road Network Development Program, Project: Tranche 2
Construction Supervision of the Alat-Astara Highway
Jalilabad Intersection to Shorsulu Intersection

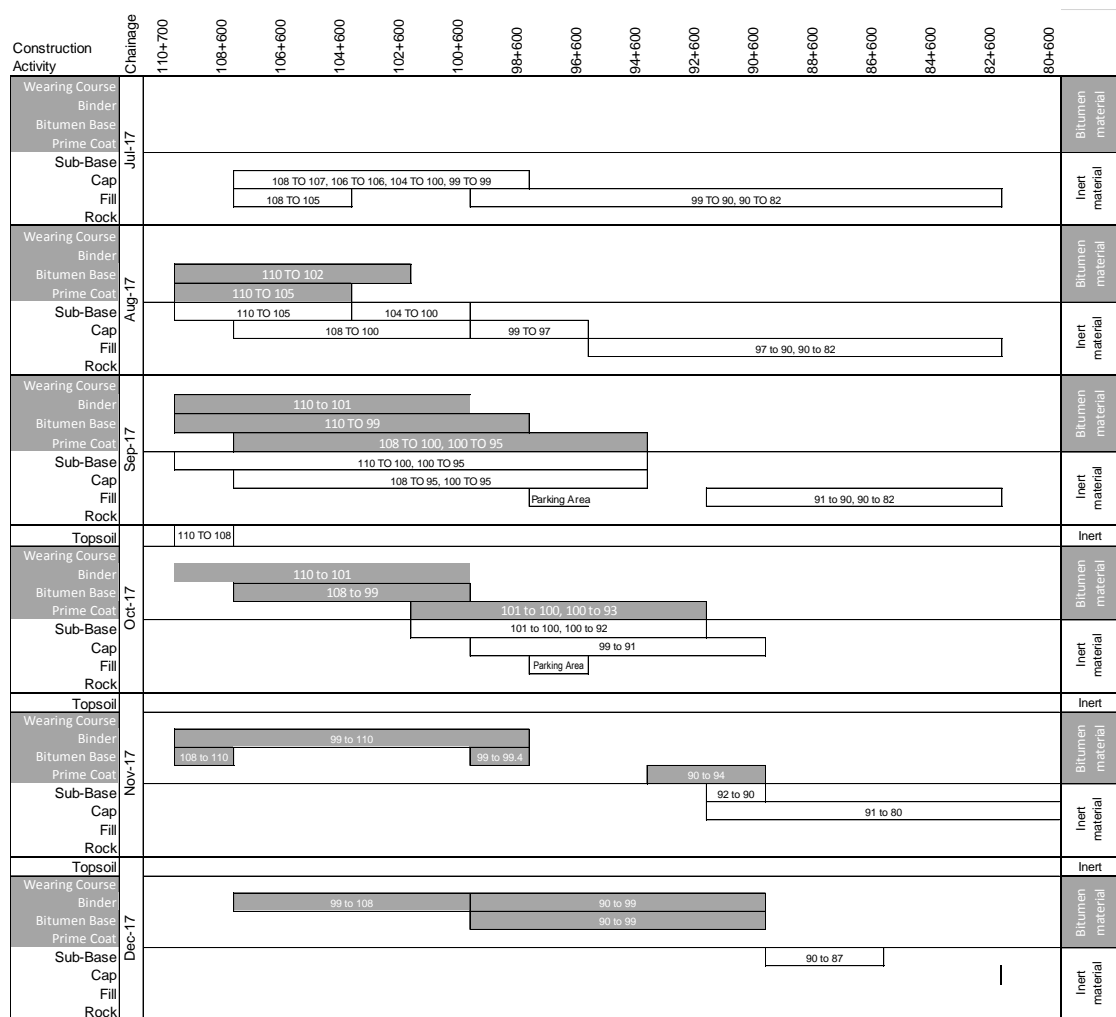
Figure 3: Embankment construction – Incorporating Inert and bitumen products into the works

8. In August 2017 the CC started to use bitumen products in the construction as: prime coat; bitumen base; and binder. Rather than develop an asphalt plant on site the CC has elected to source bitumen products and asphalt from an existing (approved and licensed) Kolin facility immediately to the south of this project. The construction of embankments and the incorporation of bitumen products into the permanent works are set out in Figure 3.

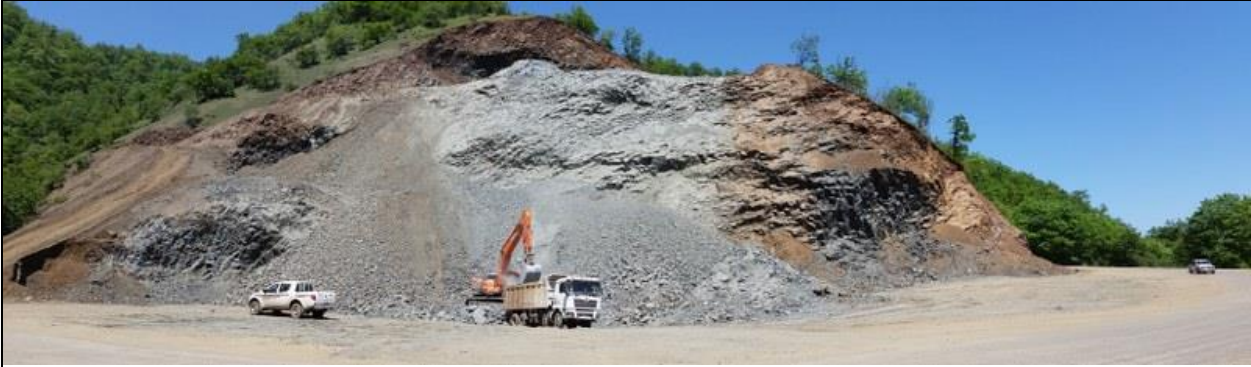
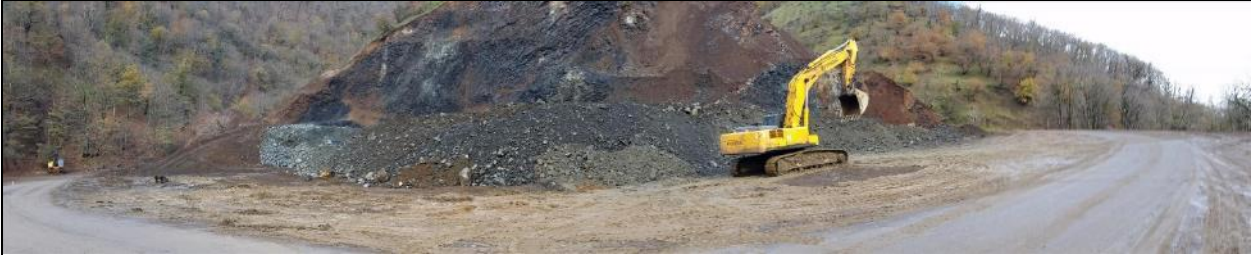
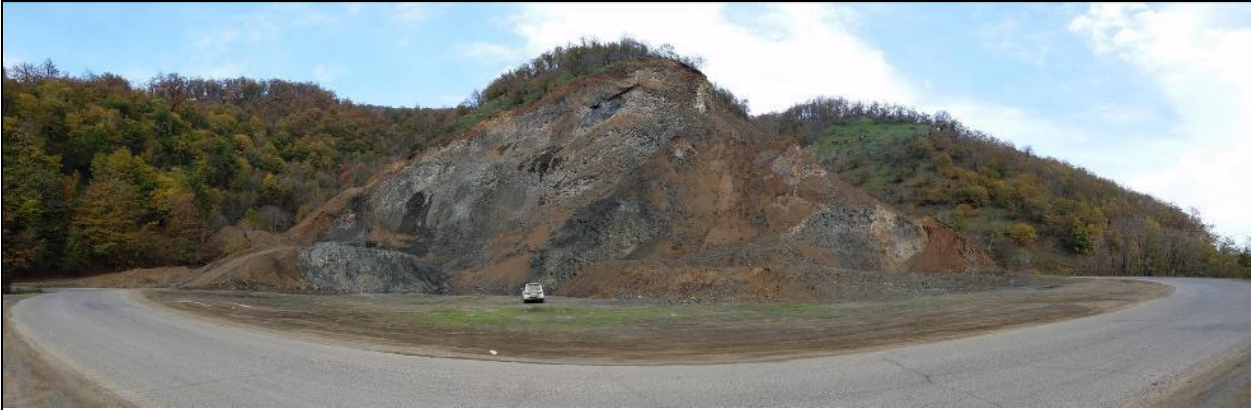
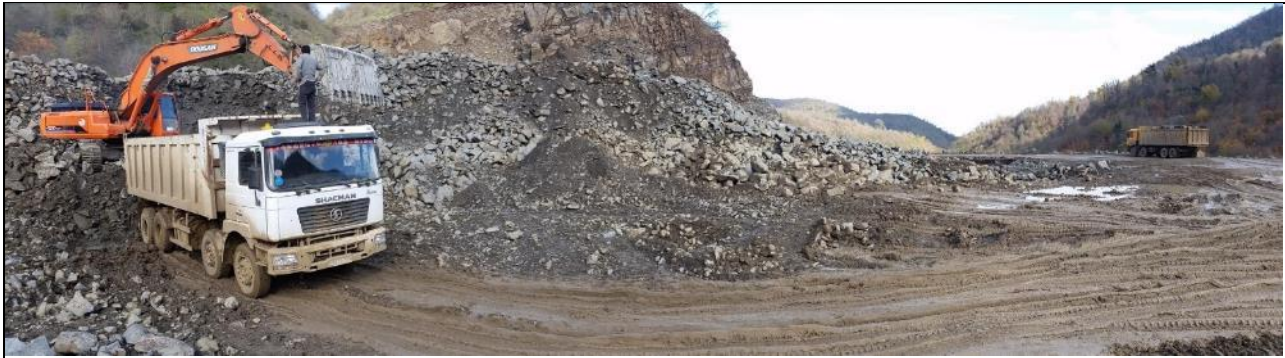
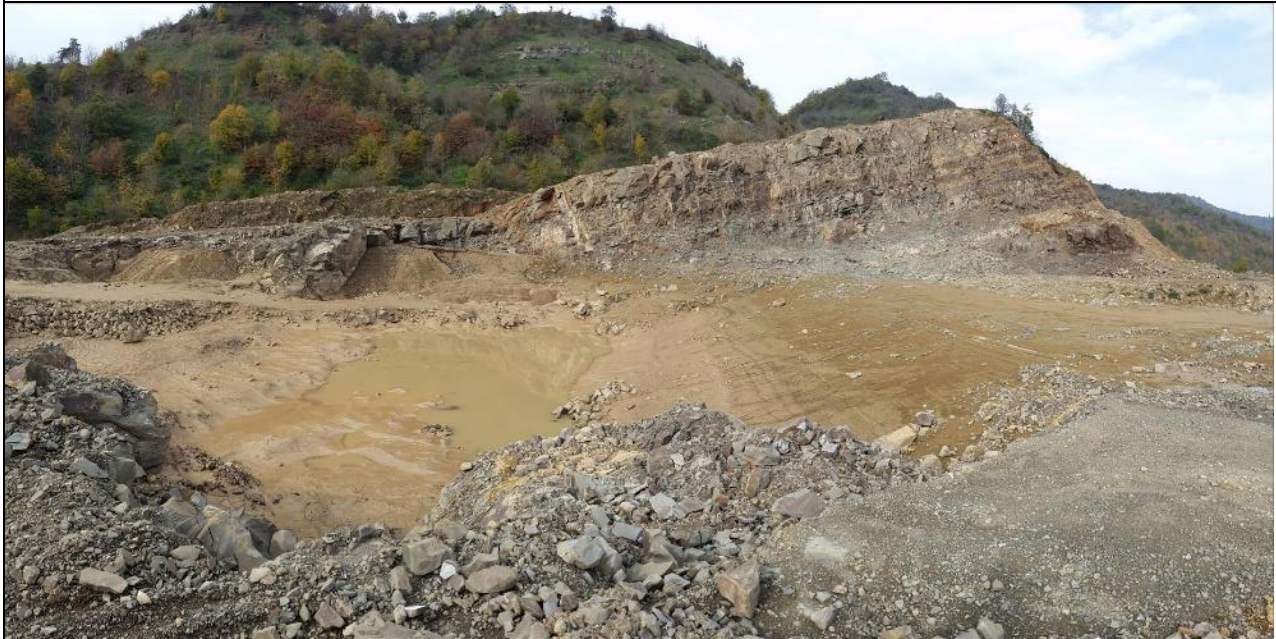
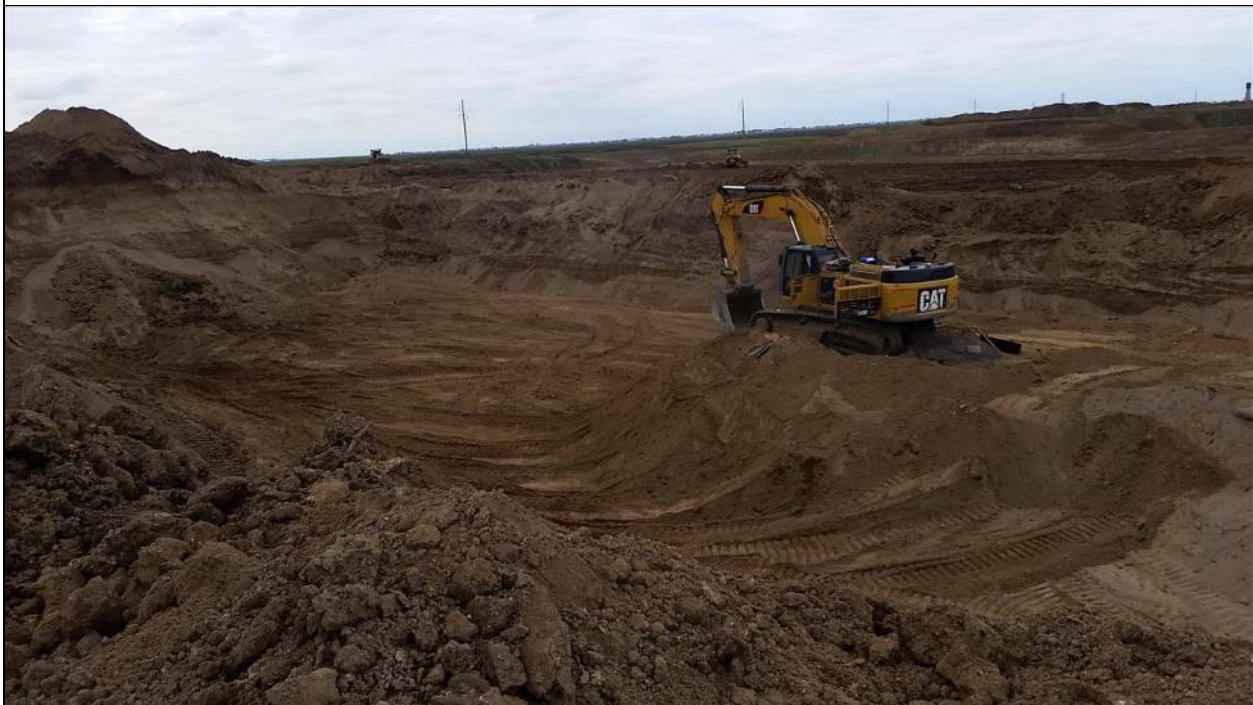
16. Kolin opened and operated quarries at Yardimli and Asurlu (rock), Alar and Sabirabad (Sand). These sites have now ceased operation and the following figure shows the historic and current status of the sites. Other sites at Lankaran (river stone) were used by multiple operators and the site at Behramtepe is a commercial quarry operation where the contractor is sourcing processed product.

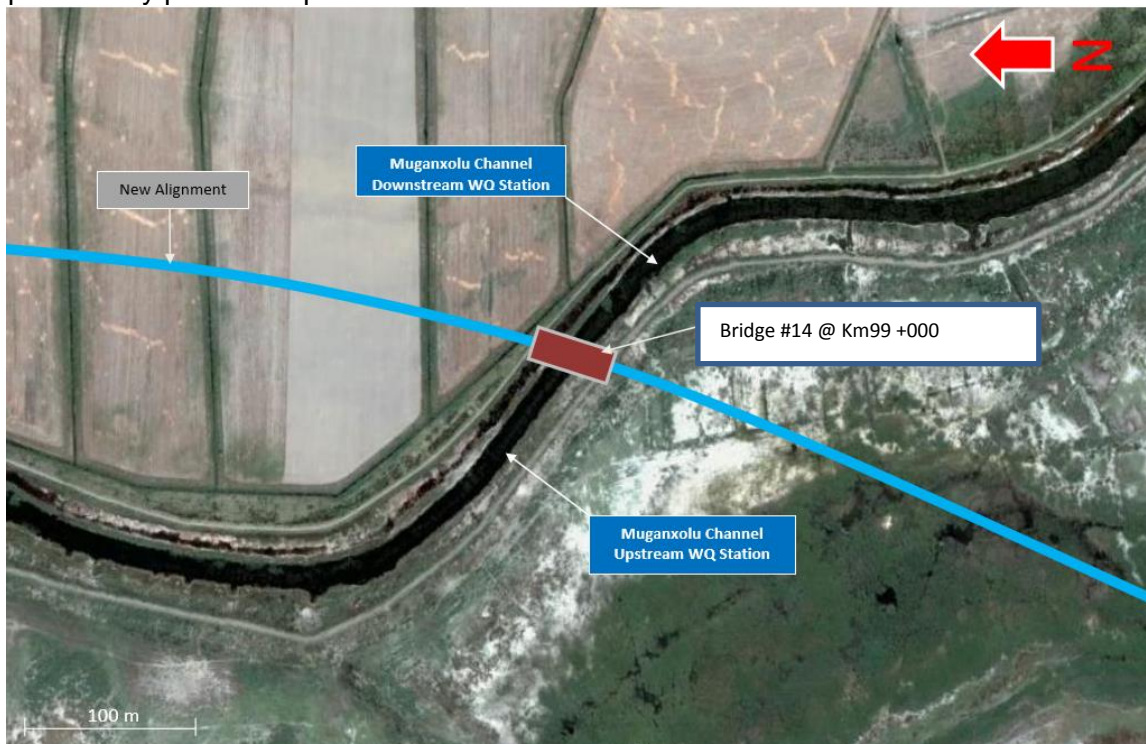
Figure 6: Water quality monitoring at the Muganxolu channel bridge crossing (Km 99+000)

21. In terms of water quality the construction of a bridge over the Muganxolu channel, a primary watercourse between the Mahmudchala and Akchala wetland areas, is identified as a potential water quality impact area and monitoring points were identified upstream and downstream from Bridge (Km 99+000). There is no specific requirement in the EIA for regular physical monitoring but pre construction and post construction monitoring will be carried out in addition the the weekly visual inspections by CC and SC. Figure 6 indicates the location of the water quality monitoring points. The pre-construction monitoring exercise was carried out in 2016 and post construction monitoring will be conducted in 2018. During works, the location was visually inspected on a daily basis to confirm that there were no incidents of silty runoff and identifiable pollution by petroleum products in the watercourse.

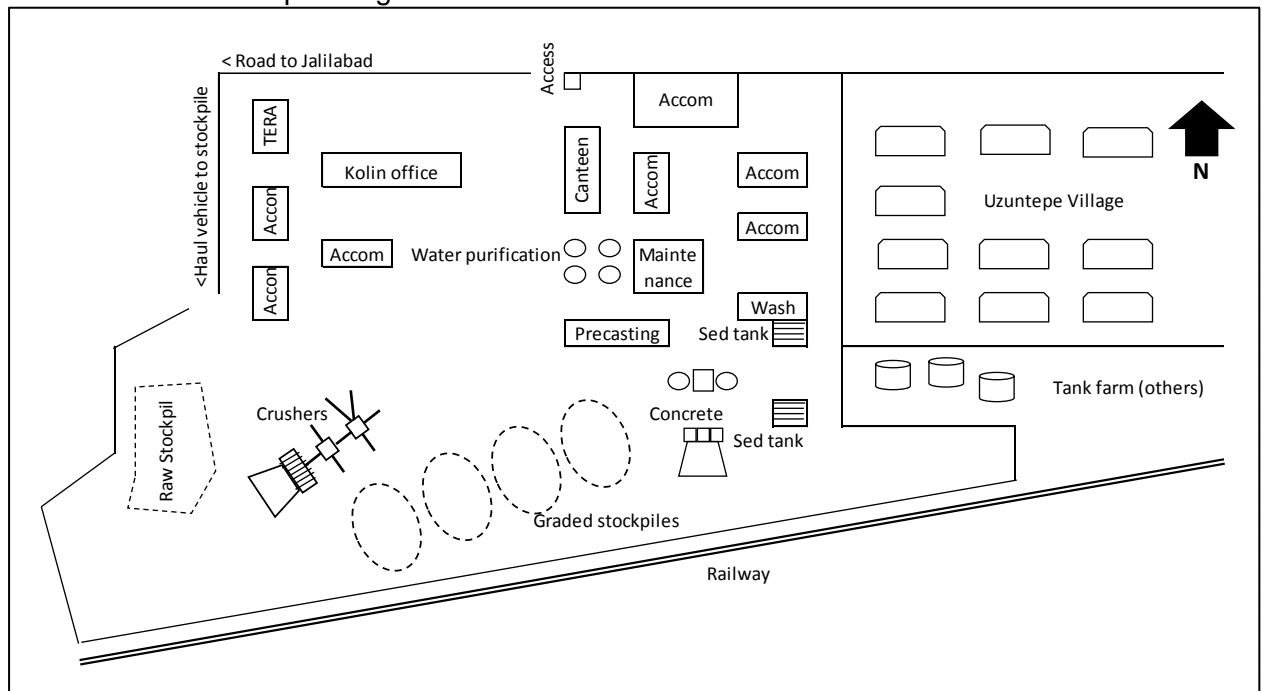
Figure 7: Schematic of Camp at Km 110+600 and proximity to Uzuntepe village

22. The camp is considered to be a potential source of noise and dust impact due to the presence of a large manufacturing area (rock stockpiling and processing and operation of a concrete batching plant). The manufacturing area includes rock crushing and grading, concrete batching, vehicle maintenance and a concentration of vehicle movements. The camp is located immediately to the west of Uzuntepe village and monitoring points are located at the closest sensitive receivers to the camp boundary. Figure 7 is a schematic of the camp showing its noise and dust generating activities in relation to Uzuntepe village.

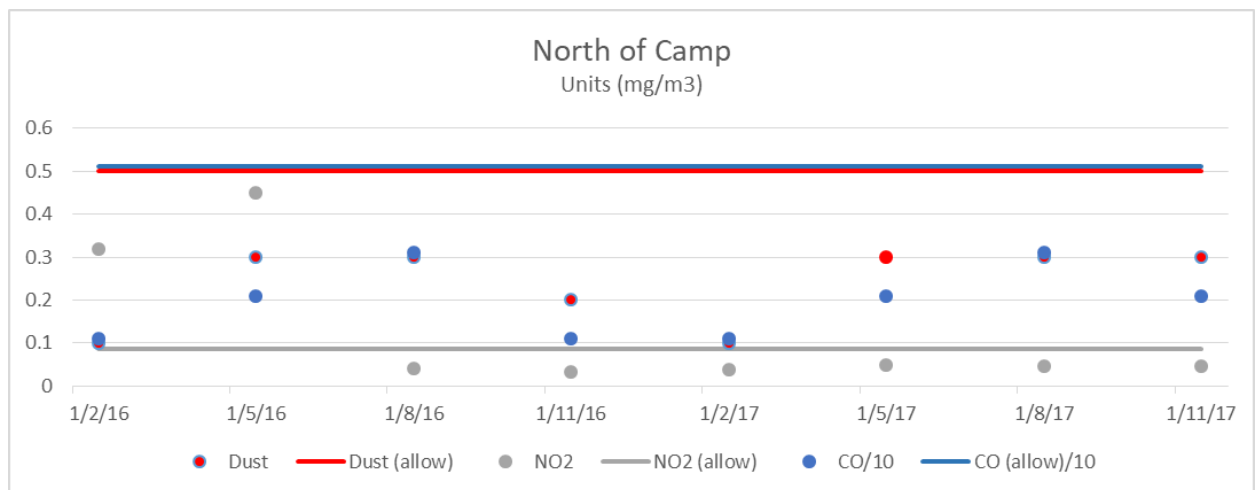
Figure 10: Air Quality Monitoring North of Camp – graphical representation

Note: For presentation purposes the Carbon Monoxide (CO) results have been reduced by a factor of 10

27. The air quality monitoring carried out in the reporting period indicates that construction dust and vehicle emissions (Nitrogen di-oxides [NO₂] and Carbon mon-oxide [CO]) emissions are within the allowable criteria.

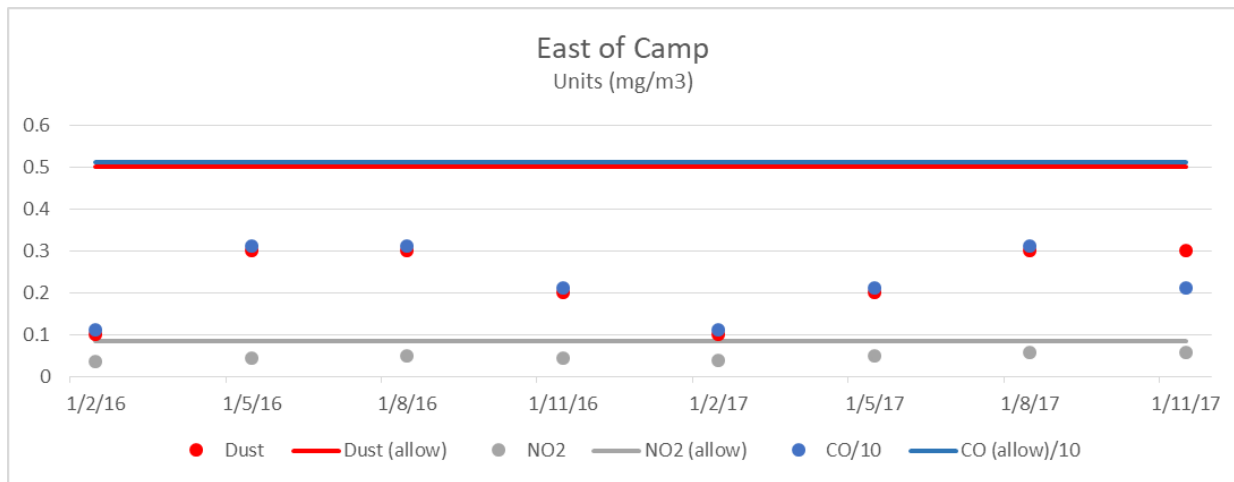
Figure 11: Air Quality Monitoring East of Camp – graphical representation

Note: For presentation purposes the Carbon Monoxide (CO) results have been reduced by a factor of 10

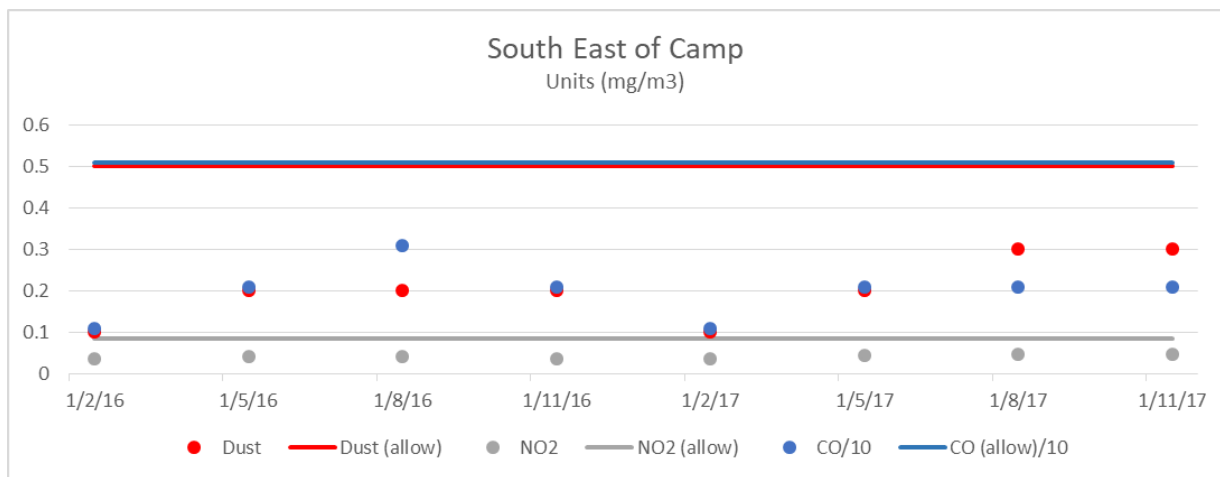
Figure 12: Air Quality Monitoring South East of Camp – graphical representation

Note: For presentation purposes the Carbon Monoxide (CO) results have been reduced by a factor of 10

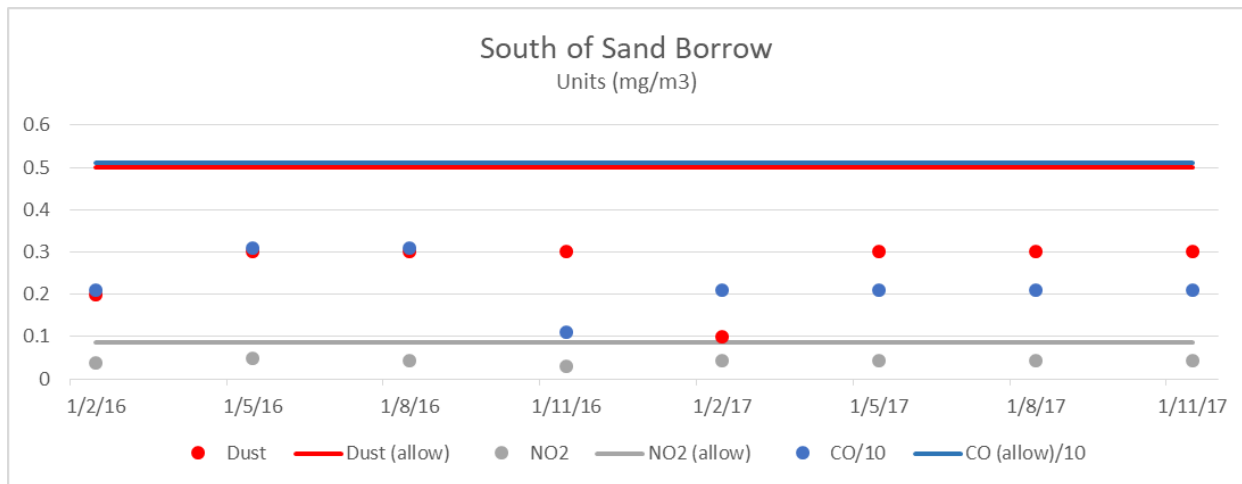
Figure 13: Air Quality Monitoring South of Sabirabad borrow area – graphical representation

Note: For presentation purposes the Carbon Monoxide (CO) results have been reduced by a factor of 10

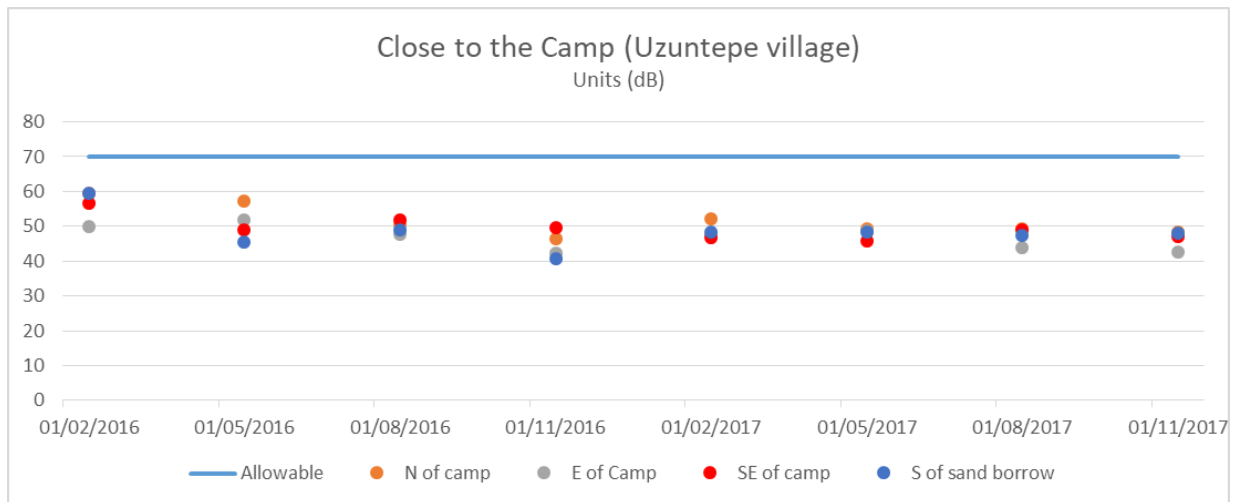
Figure 14: Noise Monitoring – graphical presentation

28. Noise monitoring carried out in the reporting period indicates that construction noise is being maintained within allowable criteria.

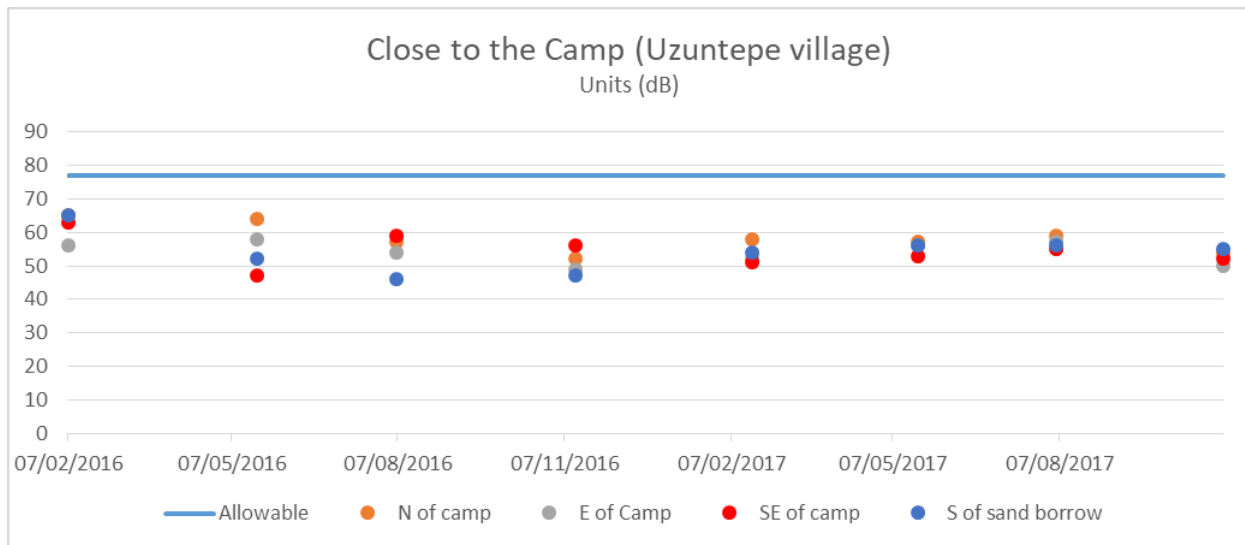
Figure 15: Vibration Monitoring – graphical representation

29. Vibration monitoring carried out in the reporting period indicates that vibration levels are being maintained within the allowable criteria.

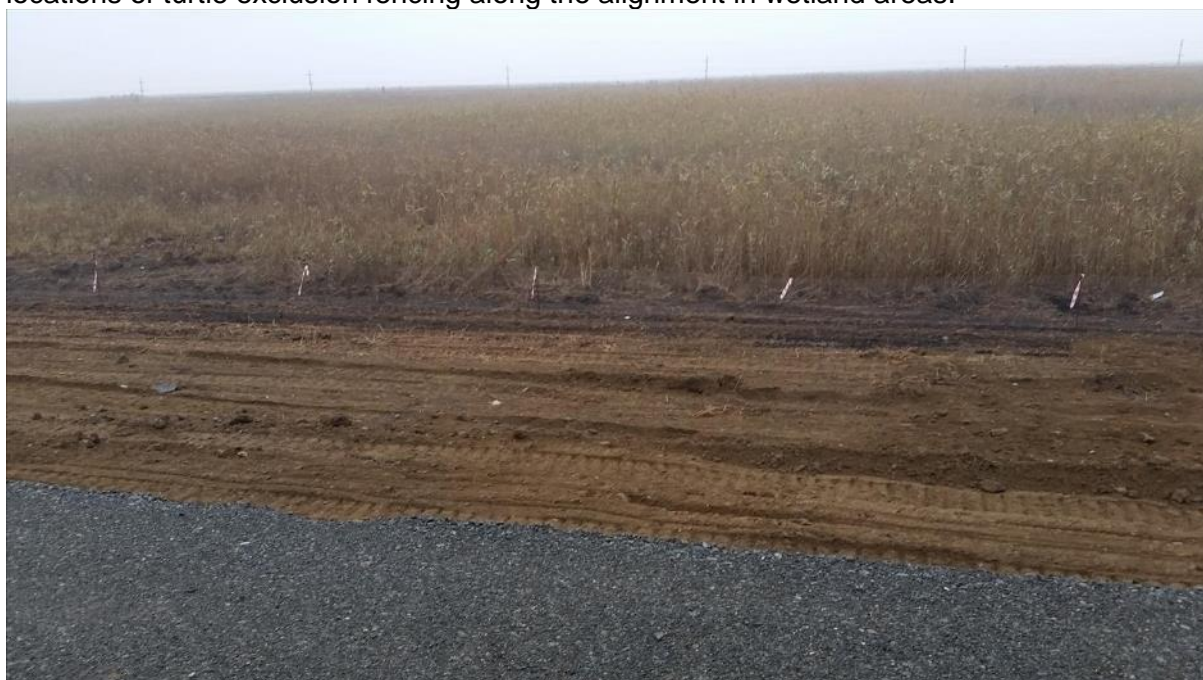
Figure 18: Example of turtle exclusion fencing erected alongside the alignment in wetland areas.

43. Turtle Management Plan –Dr. Luca Luiselli (Ecologist – Turtle Specialist) presented the Turtle Management Plan to members of the KOLIN site team on 05 May 2016. The main items covered were how to protect turtles from construction impacts. Both direct impact from construction activity (e.g. siltation, fatalities due to turtle plant interaction) and indirect actions (e.g. disruption of breeding activities) and the identification of locations of turtle exclusion fencing along the alignment in wetland areas.

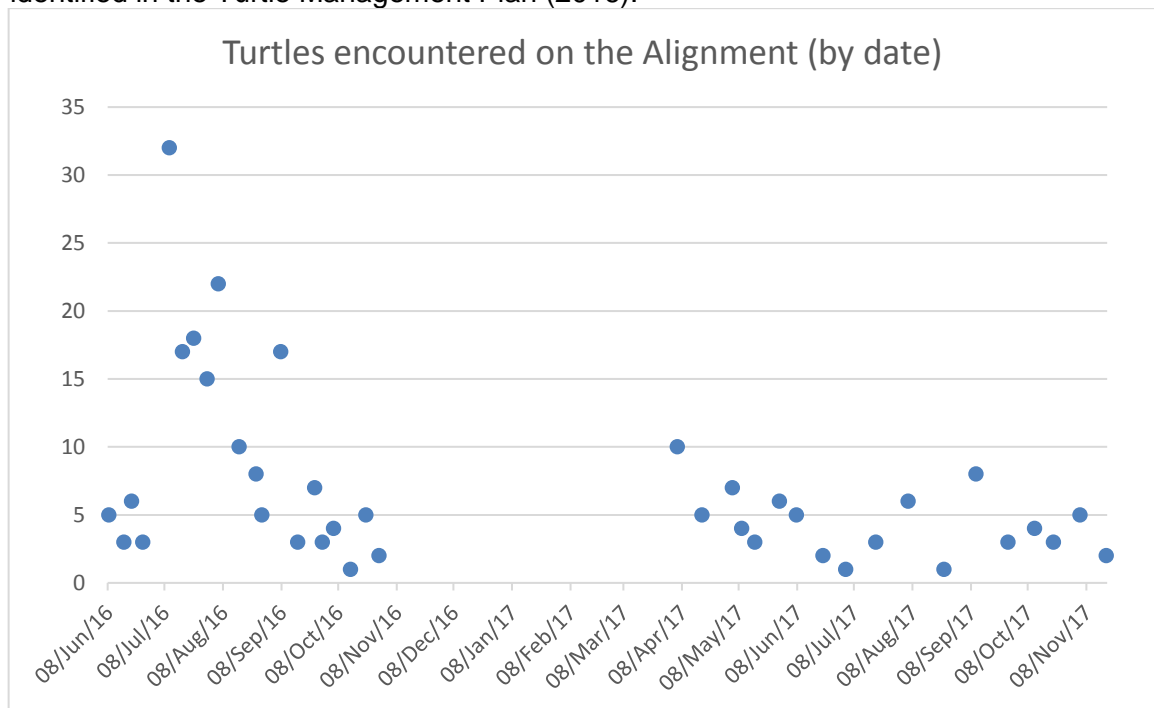
Figure 20: Turtle capture /release information (by date)

53. Figure 20 presents the number of turtles that have been captured and released since June 2016 and Figure 21 presents the same information by year showing how the capture / releases have been significantly reduced in 2017 due to the presence of physical barriers through wetland areas. Figure 23 shows the release capture information by location. The information broadly corresponds with the areas for fencing identified in the Turtle Management Plan (2016).

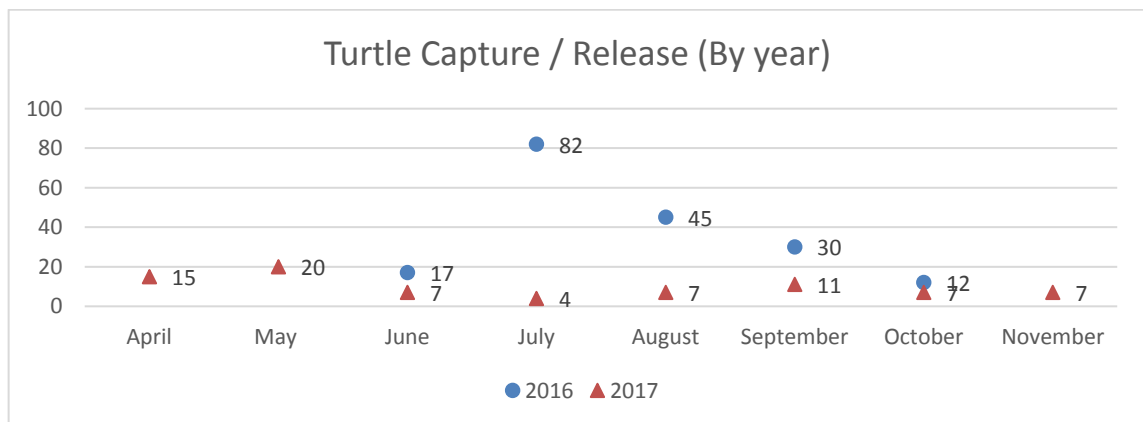
Figure 21: Turtle Capture release information (by year)

54. The Contractor installed fencing to prevent turtles straying onto the alignment in October 2016. Installation of these physical barriers appears to have significantly reduced the number of turtles straying onto the alignment. The temporary fencing will be replaced by permanent vertical concrete barriers at the edge of the alignment through wetland sections (82+700 to 83+600 [Mahmudchala] and 99+000 to 108+000 [Akchala]) see Figure 22. To allow turtle and other mammal access across the alignment there are 21 hydraulic culverts and vehicular access options through the two wetland areas.
