Cambodia: Flood Damage Emergency Reconstruction Project

Semi-Annual Environment Monitoring Report

Ministry of Economy and Finance
Flood Damage Emergency Reconstruction Project (FDERP)
ADB Loan No. 2852-CAM (SF) and Grant No. 0285-CAM (EF)

January-June 2013

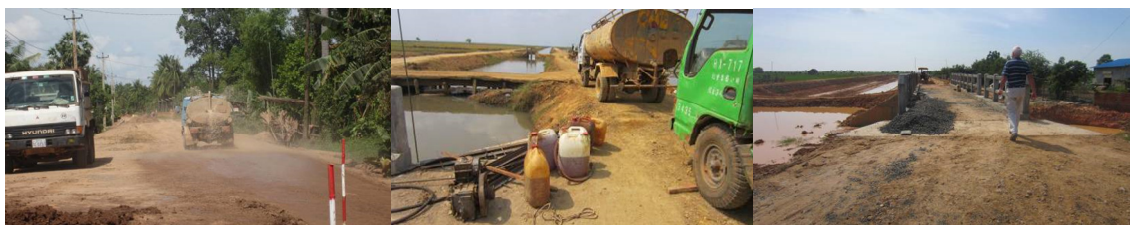
Caption for front cover:

Photo taken during field visit on 25 June 2013: MPWT-CW6a contractor applied water to control the dust :Provincial Road No.270 in Kampong Cham Province	Photo taken from MOWRAM, Hun Sen Baray during ADB mission in Kampong Thom province, site camp management still have to improve in terms of environmental aspect	Photo taken during field visits on 25 June 2013, Toul Skea MOWRAM in Prey Veng province: remaining works need to complete such as backfilling on both abutments and grass planting along the embankment of the canal.
---	---	---

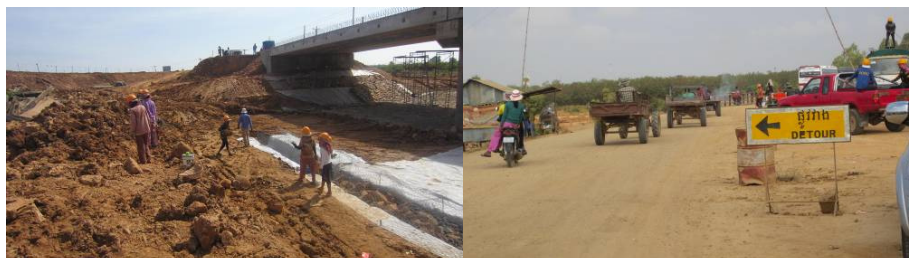
Photos: Baray Koeut bridge construction:

- Emergency repair of Baray Koeut Bridge in Prey Veng Province: It was observed that there is no potential impact on environmental issue. The EMPs had been followed under construction. It was also confirmed by local authorities that no complaint has been received regarding construction works.

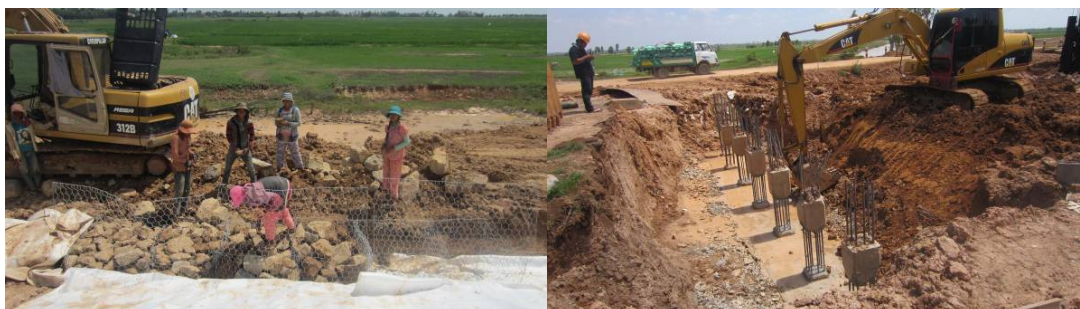
- Emergency reconstruction of Samputhor and Ampil Krao bridges: It was observed that there is no environmental impact for bridges constructions. It was also confirmed by local village chief that there has never been any complaint from the local people so far regarding the bridge constructions.

Photos: Employed F workers for basal

Photo: Trimming the head piles/worker with hammer.

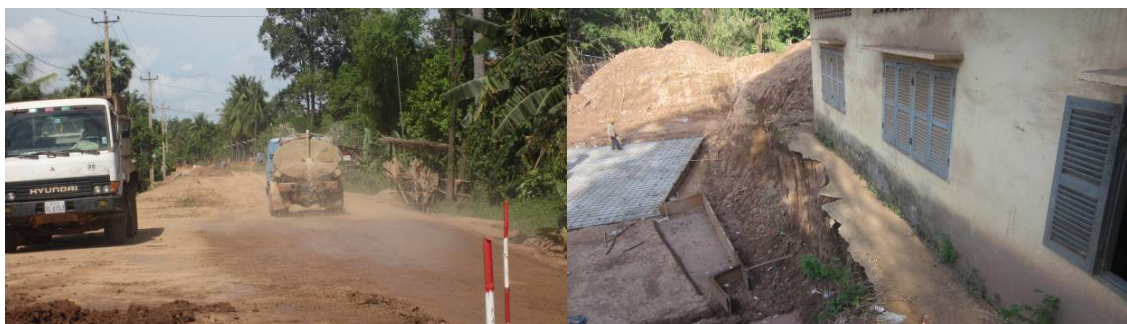
- Emergency reconstruction of DBST/CW6-a,b,c: It was observed there have been good dust control by applying the water, please see picture below during the field visits.

Photo: Dust control/water spraying

Photo: CW6c, the hole is so deep, no fence to prevent the pupil from school class falling down

Further investigations are needed with regard to developing a suitable design for the excavation and borrow pit, mainly MOWRAM and MPWT subprojects so that these may provide a range of multiple uses for the farmers whose land they will be excavated on and for MPWT/CW6b the hole so deep and close to classroom of one school so the contractor needs to construct the fence to prevent the pupil from falling down into hole.

The safeguard specialist immediately during his site visit on 25th June 2013 recommended to the contractor to build the fence to prevent the pupils from falling into the hole. One week later safeguards specialist followed up the progress of the work and found that the contractor has built the fence already to prevent pupil from falling down into the hole.
