Bi-Annual Environmental Monitoring Report

Project Number: 46145-001
Bi-annual Report
July 2015

Kazakhstan: CAREC Transport Corridor 3 (Shymkent–Tashkent Section) Road Improvement Project

Kazakhstan: CAREC Transport Corridor 3 (Shymkent – Tashkent Road) Rehabilitation Project (Road Section Km 705 – 742)

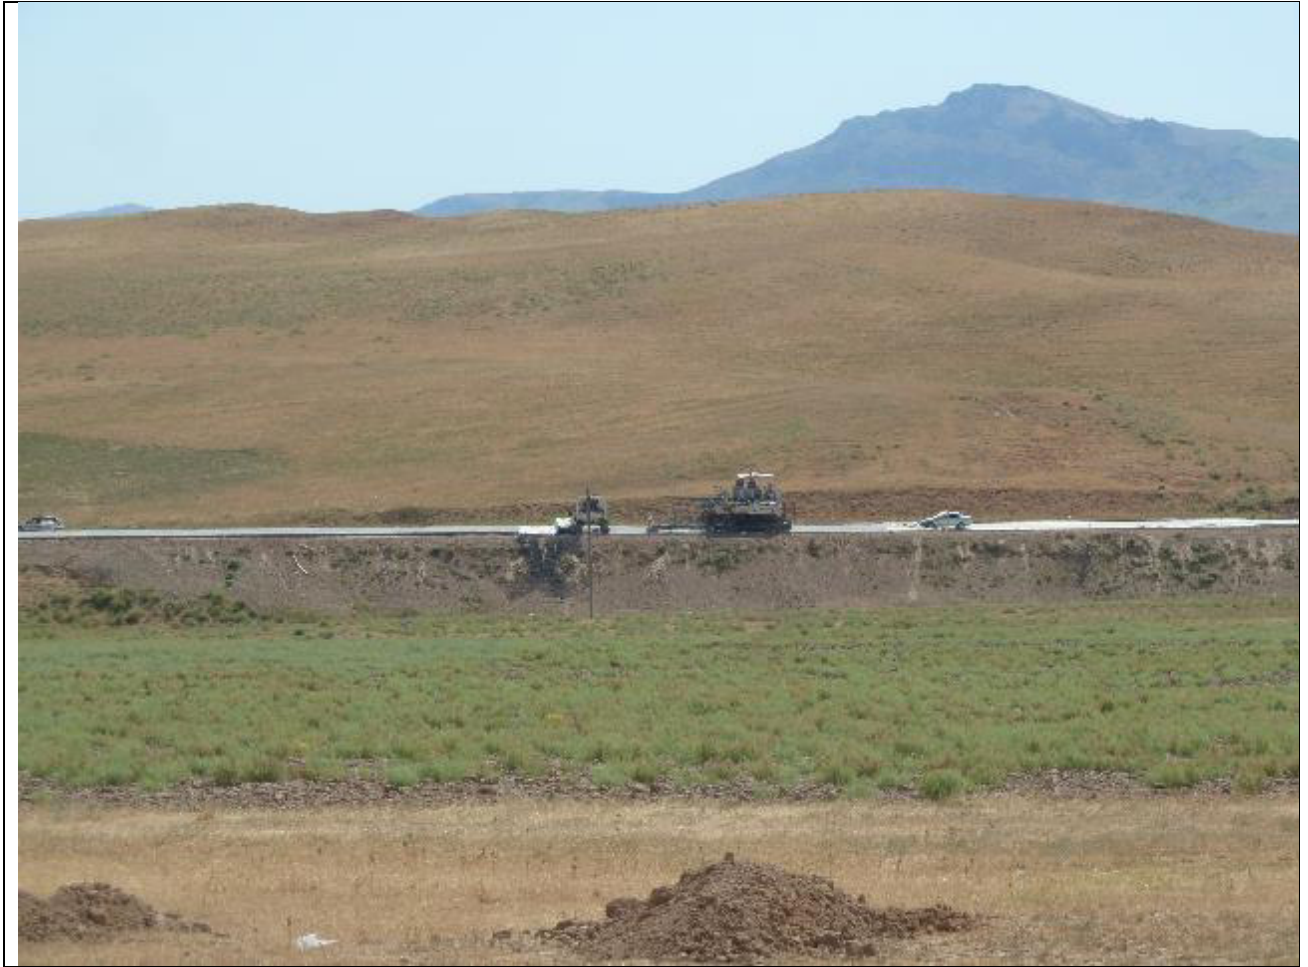
Road rehabilitation – through undulating landform – near Kilometer 27

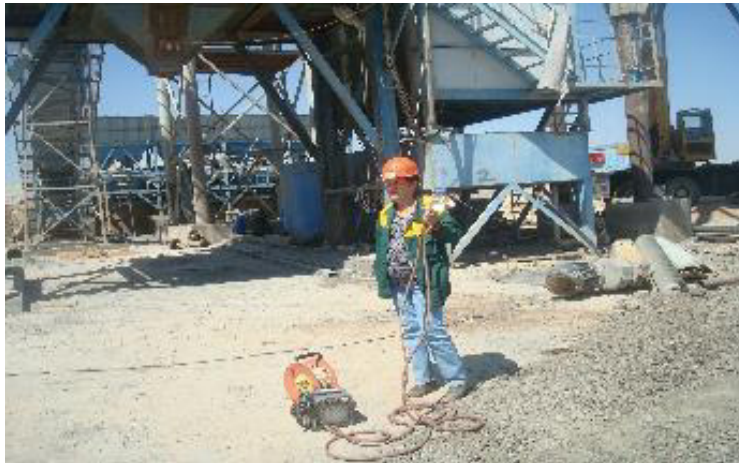
Air sampling at concrete plant

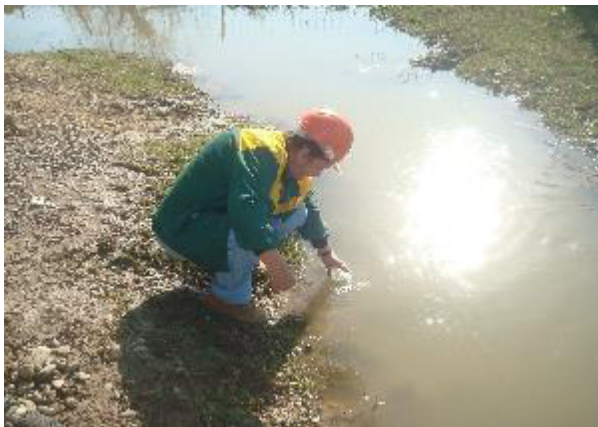
Water Sampling Km 9

The Contractor is monitoring water quality at Km 709, at the Aktas River location. Test results are given in Table 6.

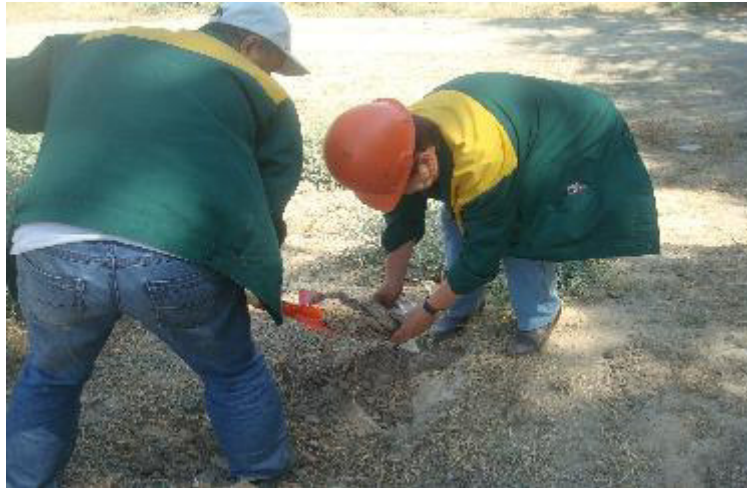
Soil Sampling

The Contractor has introduced regular monitoring points along the project road plus at the Concrete batching plant.

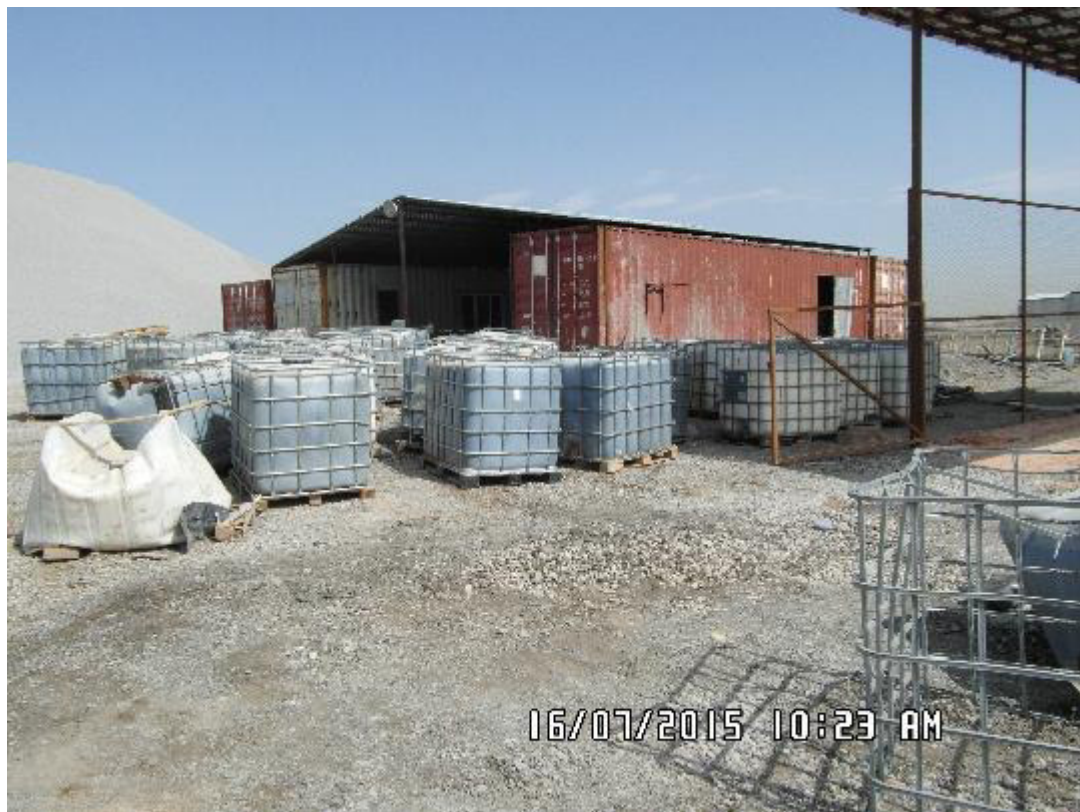
At the Km 708 Concrete Plant, there are three notable areas of non-compliance. Consideration must be given to the Plant area being earth and base course material, with almost no paved/concrete surfaces. Fuel storage tanks are located in a covered area, but spill containment devices were not evident on inspections. Specification requires a “Curing Agent” to be used with the concrete, when layed. The concrete plant stocks this agent in large plastic containers, some of which have metal guards to protect from damage, but some do not.

Curing Agent needs to be stored undercover, with spill containment of 110% capacity

The Consultant has provided recommendation to construct a covered, hard floored storage area for the curing agent to be stored, with full spill containment amounting to 110% of the proposed storage amount for both fuel and curing agent storage. By the end of this reporting period (in July), the batching plant were in process of preparing compliant structures, although not completed.
