Bi-annual Environmental Monitoring Report (July–December 2015)
Project Number: L2916
February 2016

KAZ: CAREC Transport Corridor 3 (Shymkent–Tashkent Road) Rehabilitation Project (Road Section Km 705–742)

PERIOD COVERED: JULY TO DECEMBER 2015

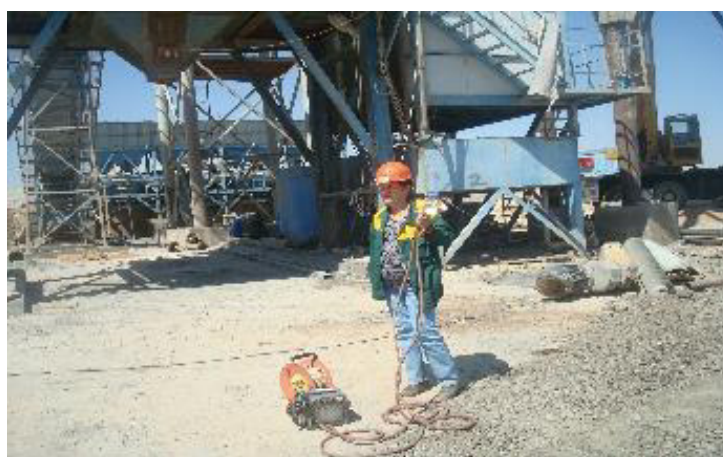
Air sampling at concrete plant

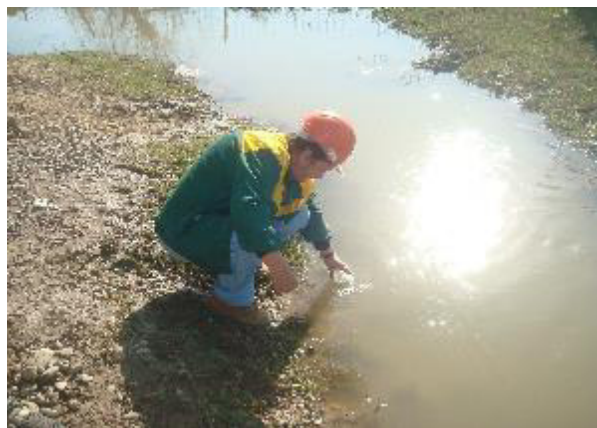
Water Sampling Km 9

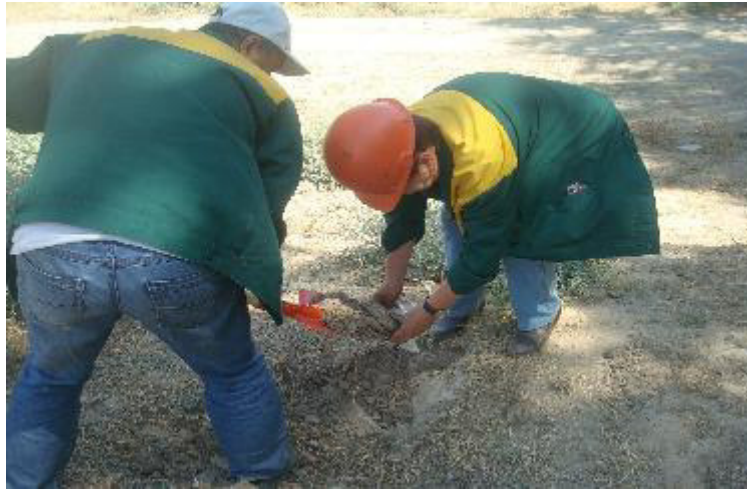
Soil Sampling

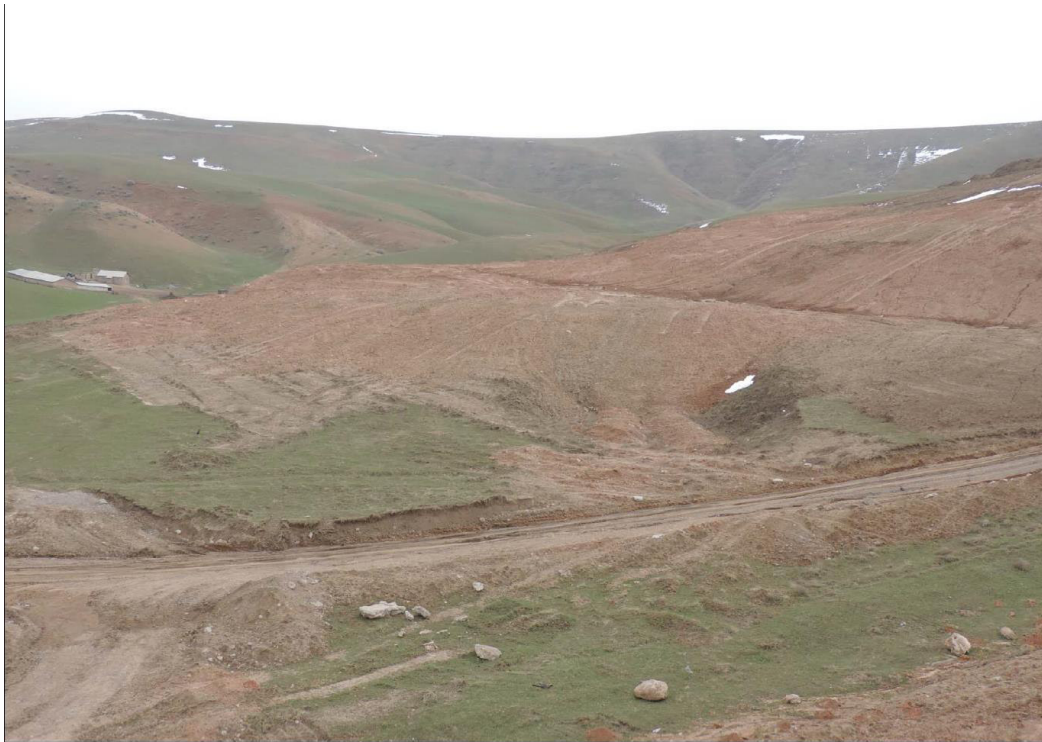
The borrow pit was at kilometre 27, from which compactable material, to specification was being used around culverts. Material was no longer being extracted from this area as at October 2015, but was being constructed as a community road. The engineer (refer to Table 10 (4)) on their request, was informed during the January-June reporting period that this observed borrow pit was part of a side road excavation under contract from the community, and which the contractor was able to show all relevant contracts and environmental responsibilities and documentation.

Below: Kazygurt Borrow Pit – rehabilitation is ongoing (December 2015)

Therefore, rehabilitation of this borrow-pit site is on-going and will be monitored. It is expected that full rehabilitation of site back to its original form, or to the land title holder's satisfaction, is completed prior to the final environmental inspections by the CSC when project is completed.

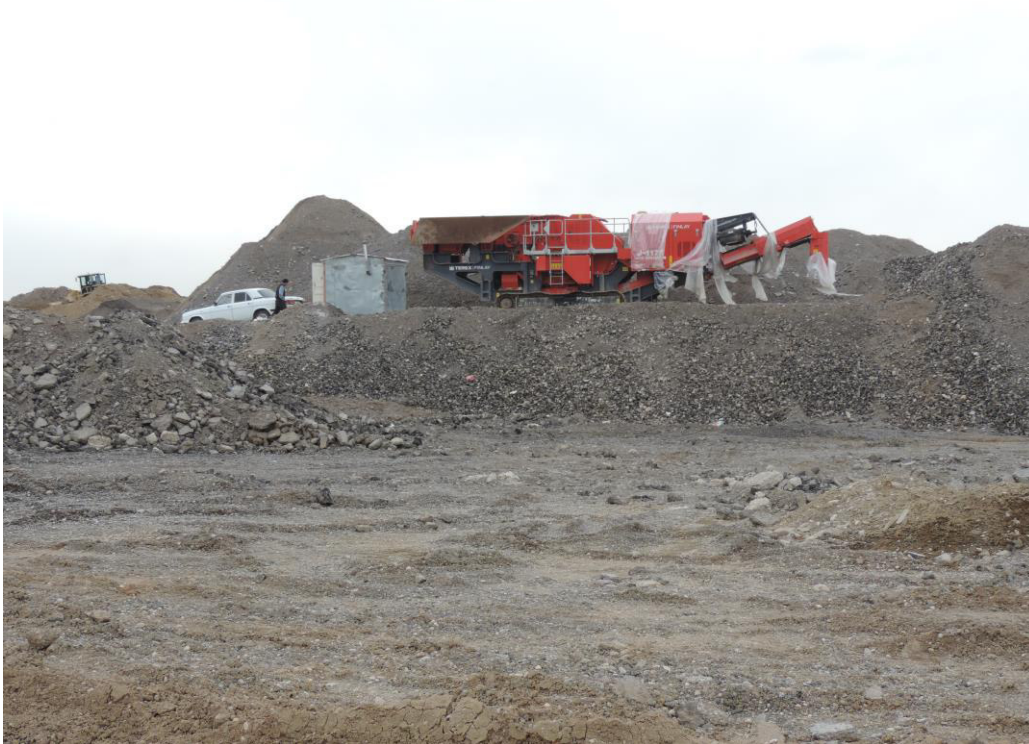
This is in a remote location, and understood to be on Akimat land. For this and all other stockpile locations, the agreement with the Akimat for using the land, and is documented in the Expanded EMP, is for these sites to be fully revegetated by the contractor after use and be set back into a condition similar or better than before the Project, or otherwise to the satisfaction of the land-use title holder.

Below: Crushing Plant Site – operations continue in 2016

The Engineer, on several occasions has requested revegetation and tree planting plans and proposals from the Contractor, in order to ensure that rehabilitation of stockpile, borrow-pit and crushing plant sites are conducted by the end of Project. By the end of this reporting period, no plans or programs have been submitted by the contractor, although the issue has been discussed with the Contractor' Environmental Specialist.

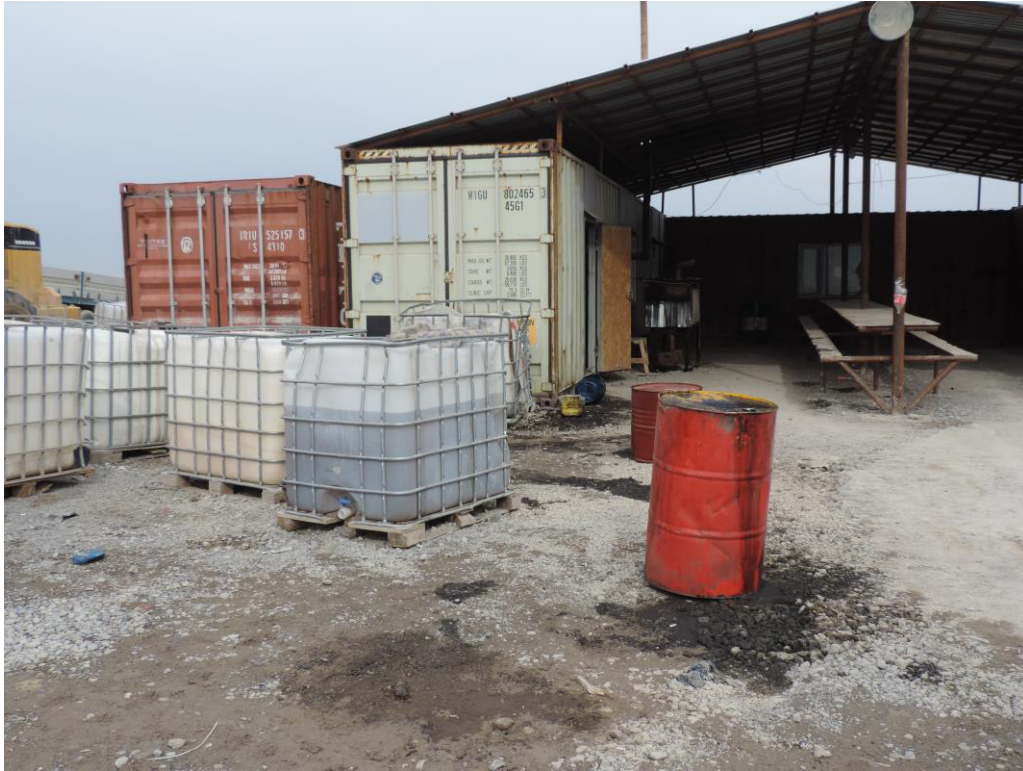
almost no paved/concrete surfaces. Fuel storage tanks are located in a covered area, but spill containment devices were not evident on inspections. Specification requires a "Curing Agent" to be used with the concrete, when laid. The concrete plant stocks this agent in large plastic containers, some of which have metal guards to protect from damage, but some do not.

Curing Agent needs to be stored undercover, with spill containment of 110% capacity. Also note the leaking drums and oil/substance spillages Contractor has been given sever corrective notices.

The contractor has been provided warning for corrective action (refer to January to June 2015 Environmental Monitoring report) through correspondence where the Consultant has recommended construction of a covered, hard floored storage area for the curing agent to be stored, with full spill containment amounting to 110% of the proposed storage amount for both fuel and curing agent storage. By the end of this reporting period (in July), the batching plant were in process of preparing compliant structures, although not completed. It appears that this is not being completed and utilized, with curing agent being kept near to staff rooms, and improperly stored (refer to photograph on next page).

As well as curing agents, the fuels and other potentially dangerous chemical storage can be viewed in close proximity of staff areas (refer to photographs). This was labelled already to the contractor as a health hazard and environmentally negative. Further correspondence was forwarded in 2016 for corrective actions to take place on an urgent basis.
