# Semi-annual Environmental Monitoring Report

Project Number: 47017-003  
Grant Number: 0417-TAJ  
Period covered: July - December 2018

## Republic of Tajikistan: Wholesale Metering and Transmission Reinforcement Project

Prepared by: AF MercadosEMI - Project Implementation Consultant

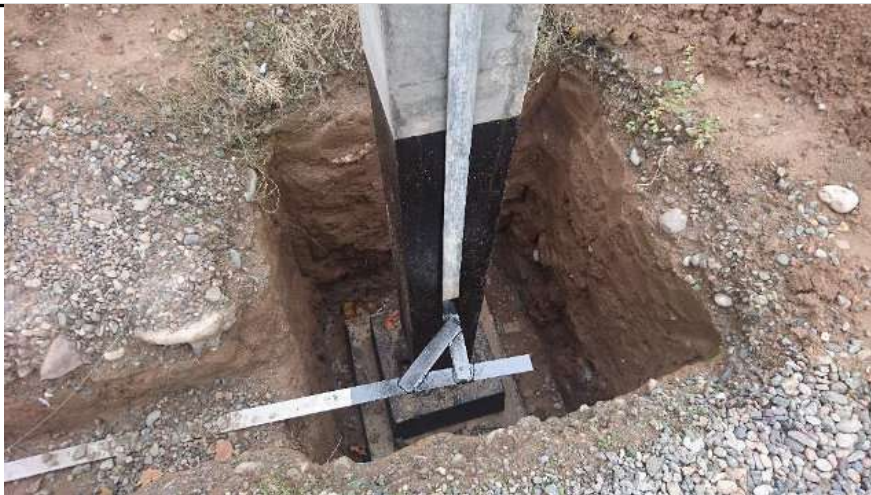
Figure 3. Picture showing the digging done for installing the new foundations for the installation of the new equipment at “Shahri” SS, Dushanbe, December 2018.

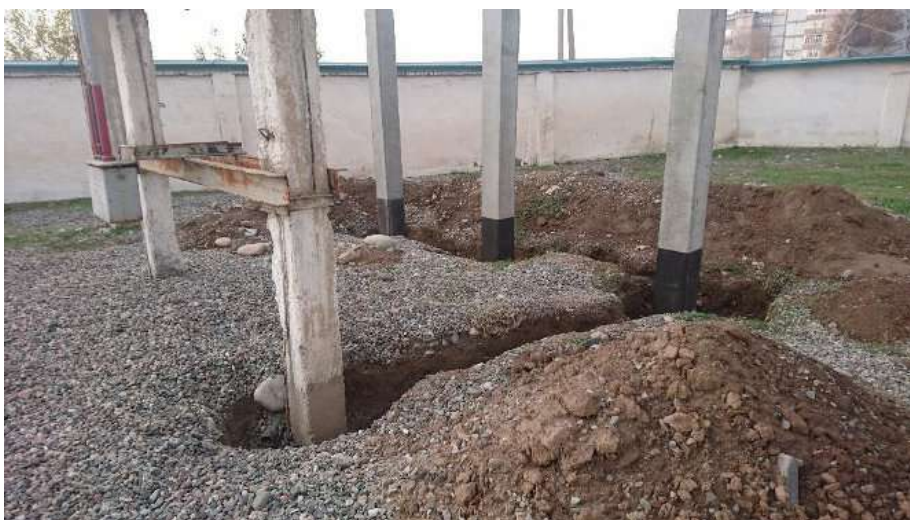
Figure 5. Picture showing the digging done for installing the new foundations for the installation of the new equipment at “Buston” SS, Dushanbe, December 2018.

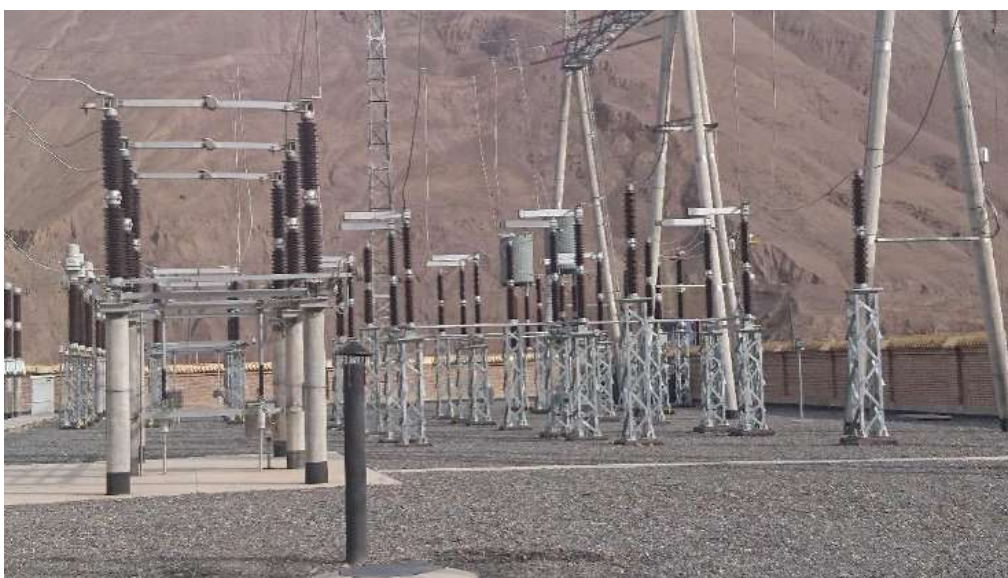
Figure 6. New bay built at Ayni SS, Panjakent Province. Completed at a previous reporting period. December 2018.

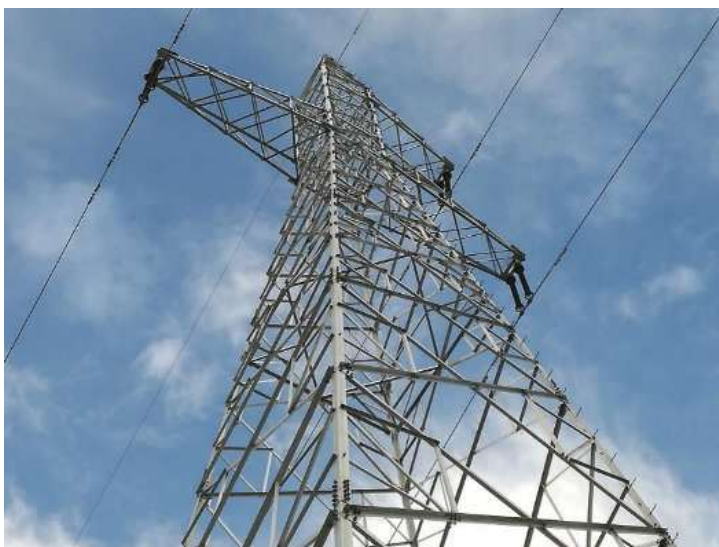
Figure 7. Tower that belongs to the constructed OHTL that was completed at a previous period. December 2018.

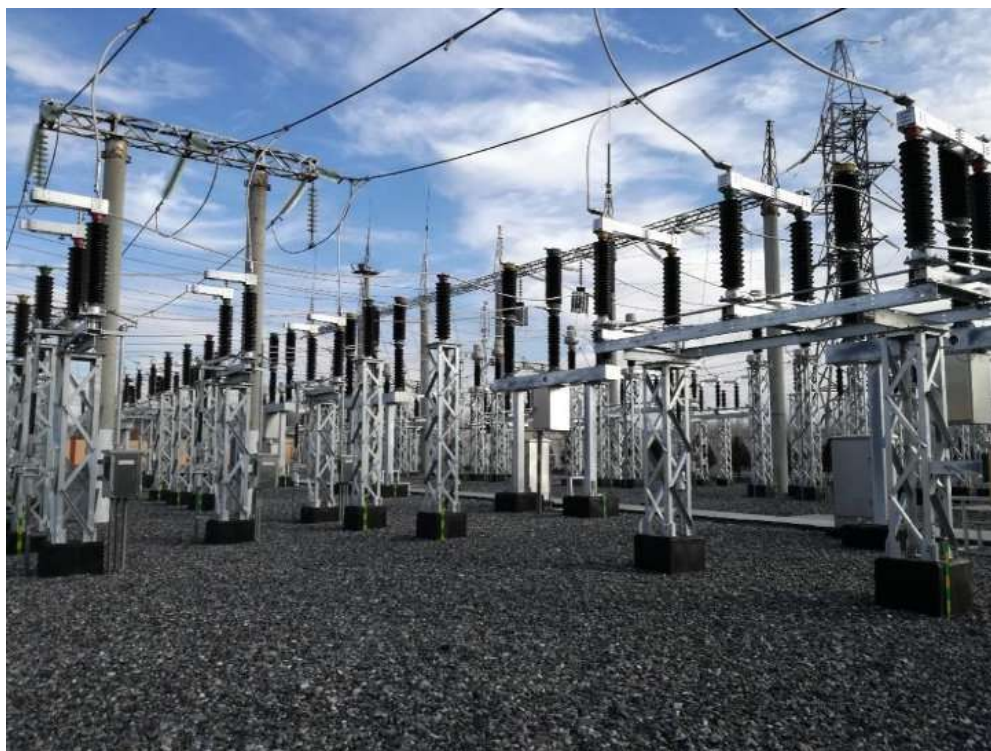
22. Regarding the Amendment 2 of Lot 2's work, which is the renovation of 110 kV switchyard at Rudaki Substation, it started in April 2018. Every activity was developed inside the plot of the Substation and on a working installation. TBEA completed most of the works for the variation order on 13 September 2018. It is pending to finalize setting concrete floors in the protections room, deliver one more training on maintenance and the final check on the equipment.

Figure 8. Renovation of 110 kV switchyard at Rudaki Substation, Panjakent Province. December 2018.

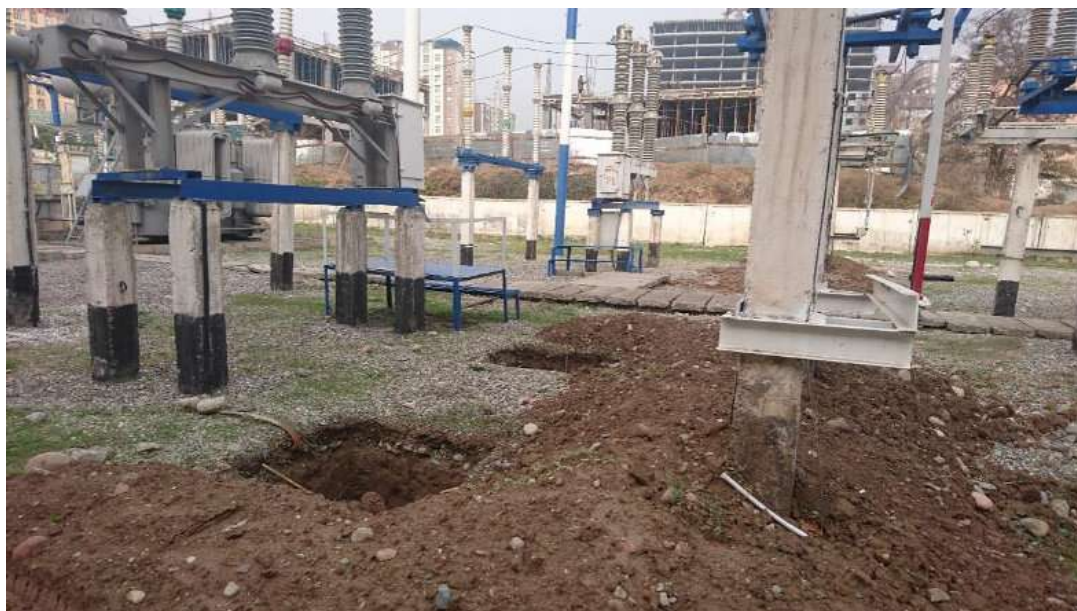
61. A good practice that will be implemented is using the same soil to refill the holes made for setting in the new foundations for the new equipment at the subject SSs under Lot 1.

Figure 11. Soil put aside will be used to refill the holes made for setting in the new foundations. Shahri SS, Dushanbe, December 2018.

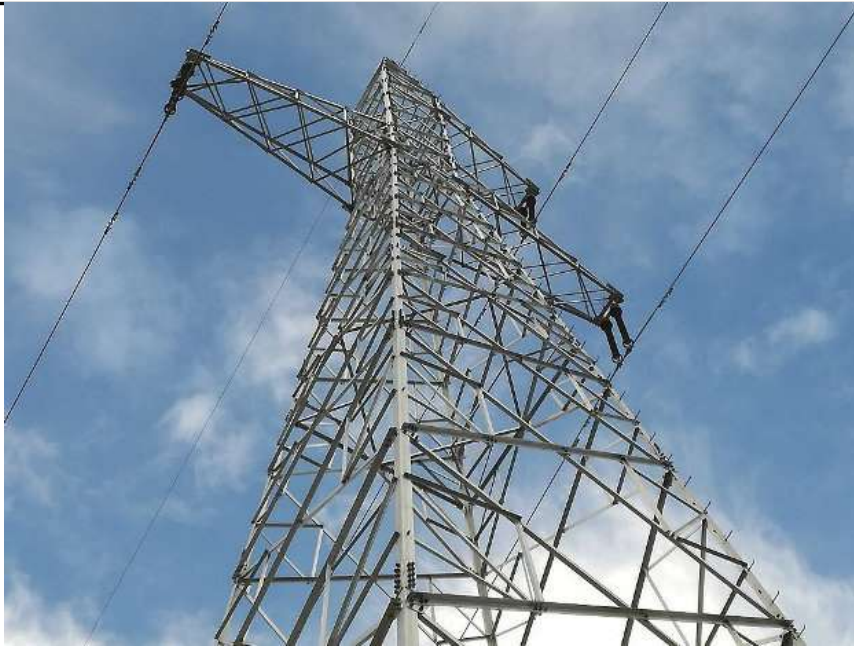
62. Another good practice is setting spikes at the towers of the OHTL in order to prevent birds setting on it and getting familiar with the towers. The less they are around the towers, the less probable it is they get electrocuted with the conductors.

Figure 12. Spikes set at the OHTL towers. Panjakent region. December 2018.

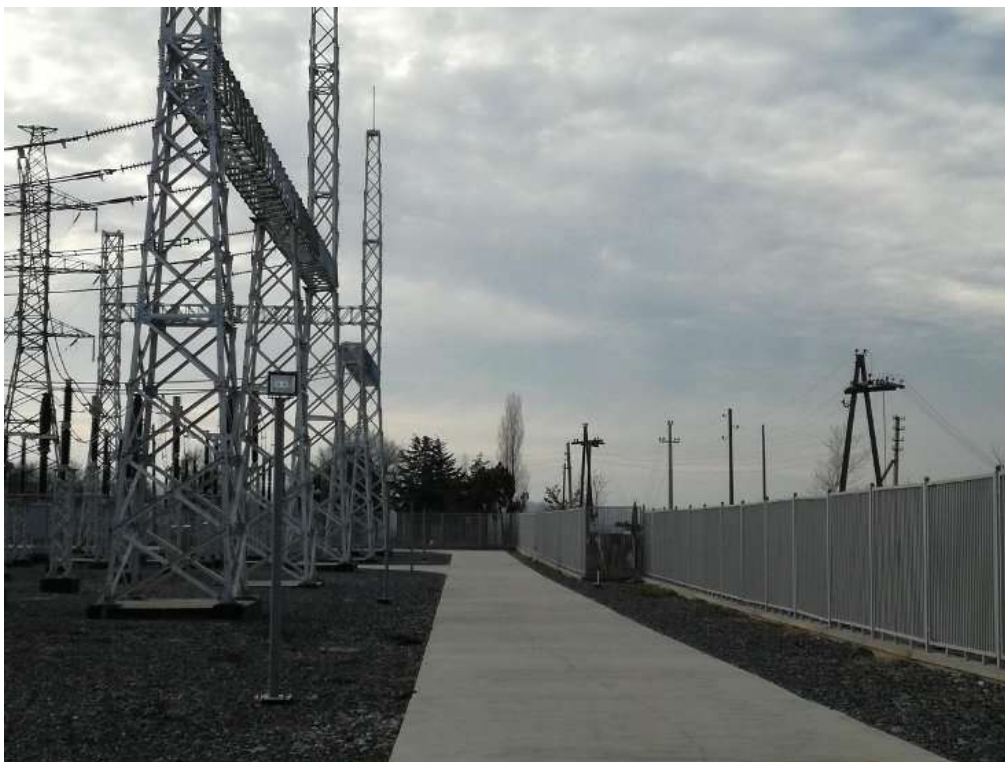
63. Counting with a new fence around the Rudaki SS that has been also funded by the Project is good from an environmental view since it prevents big and medium size mammals getting into the SS and being injured and it partially isolates the potential sources of pollution from the natural environment.

Figure 13. New fence at Rudaki SS. Panjakent region. December 2018.

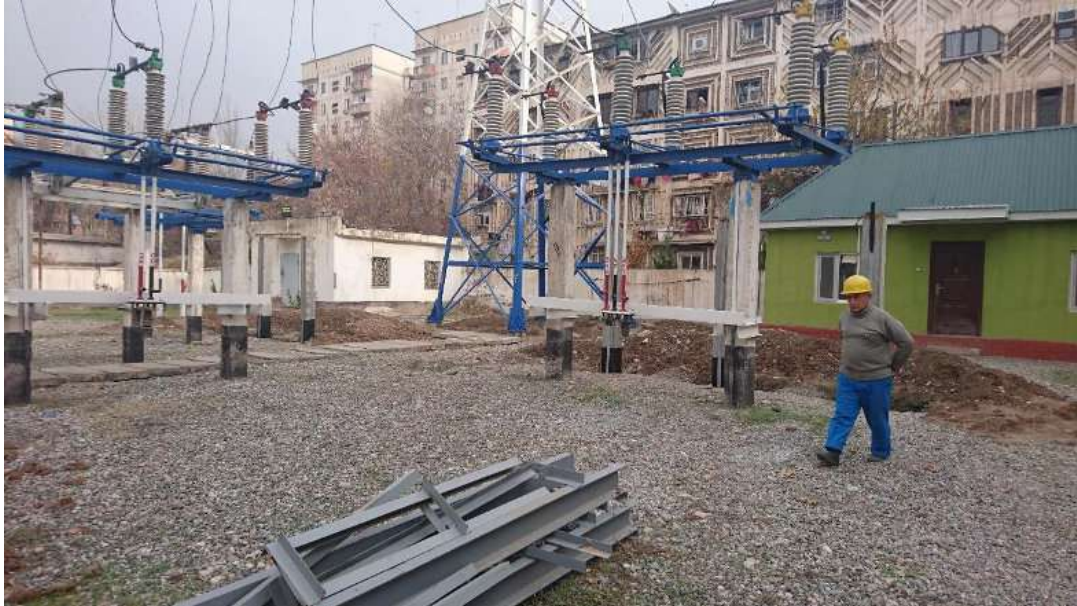
Figure 1. Digging works for building the new foundations for the new equipment that will be installed.

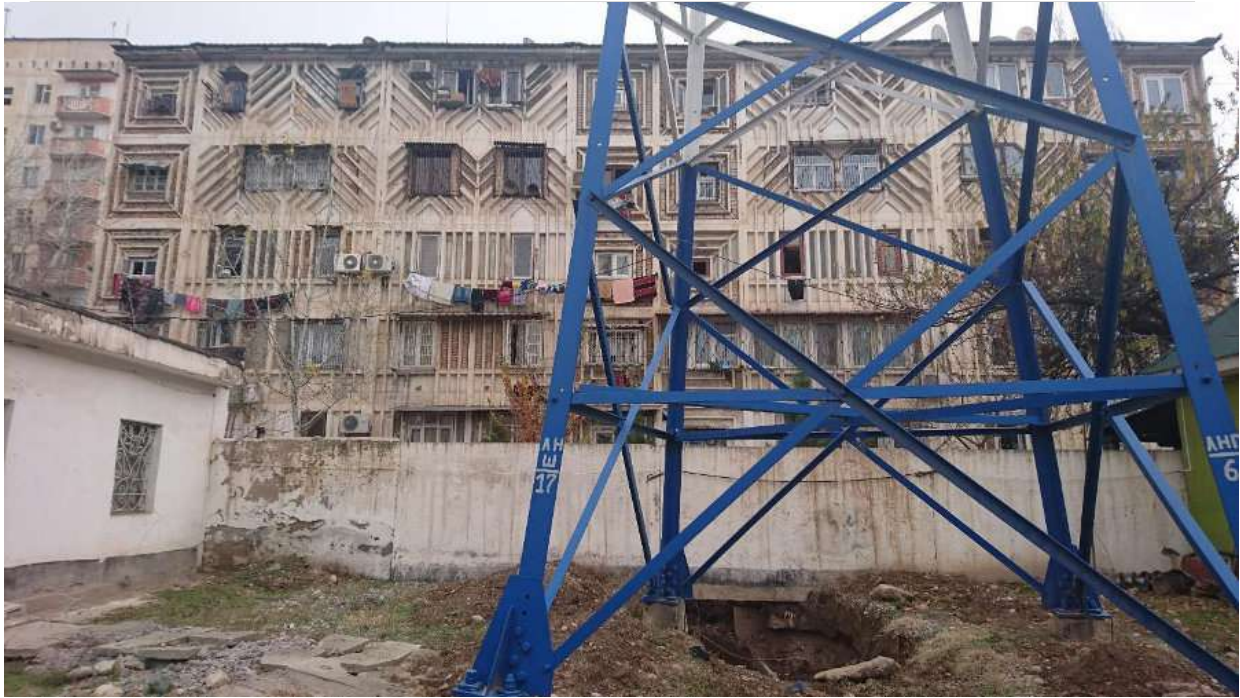
53. There are blocks of apartments located very close to the Shajari SS in Dushanbe. Workers doing the civil works work from 8AM to 5PM with a lunch break which it is good to avoid disruptions to the night sleep of the neighbors due to the noise.
54. The contractor EHS responsible for lot 1 pointed out that a briefing on H&S is provided to all the workers before they start to implement the activities. He said that the workers are using the required Personal Protective Equipment (PPE).

Figure 3. This picture shows the proximity of the apartments' building to the SS (potential annoyance because of the noise that is mitigated due to the adequate working hours).

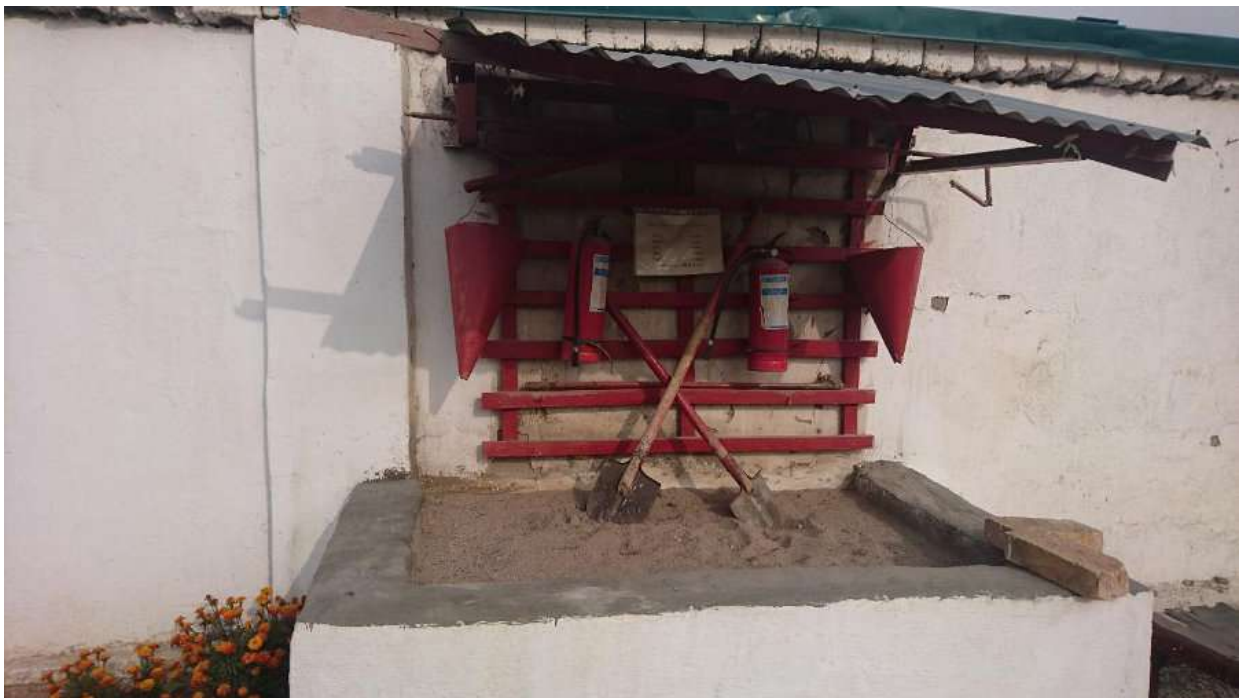
Figure 4: Complete set of fire safety equipment readily available.

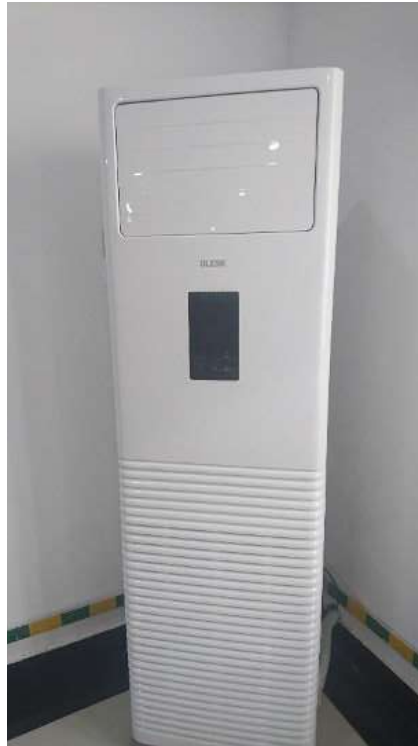
Figure 5: Temperature at the protections and communications room is kept optimum in order to avoid fires and enable the equipment to perform well. Good practice.

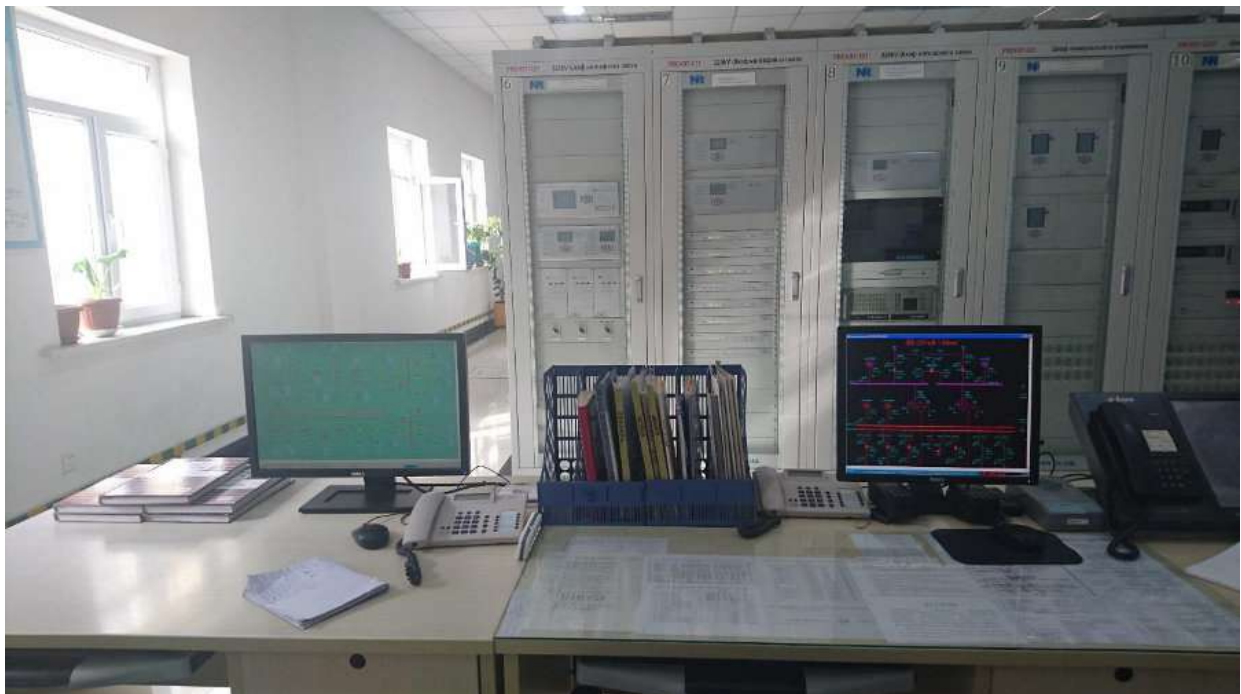
Figure 6: The control room is not separated by a wall of the communications and protections room where the temperature is kept stable at 20°C which is unpleasant for the control room workers and it makes it harder for them to focus. Bad practice.

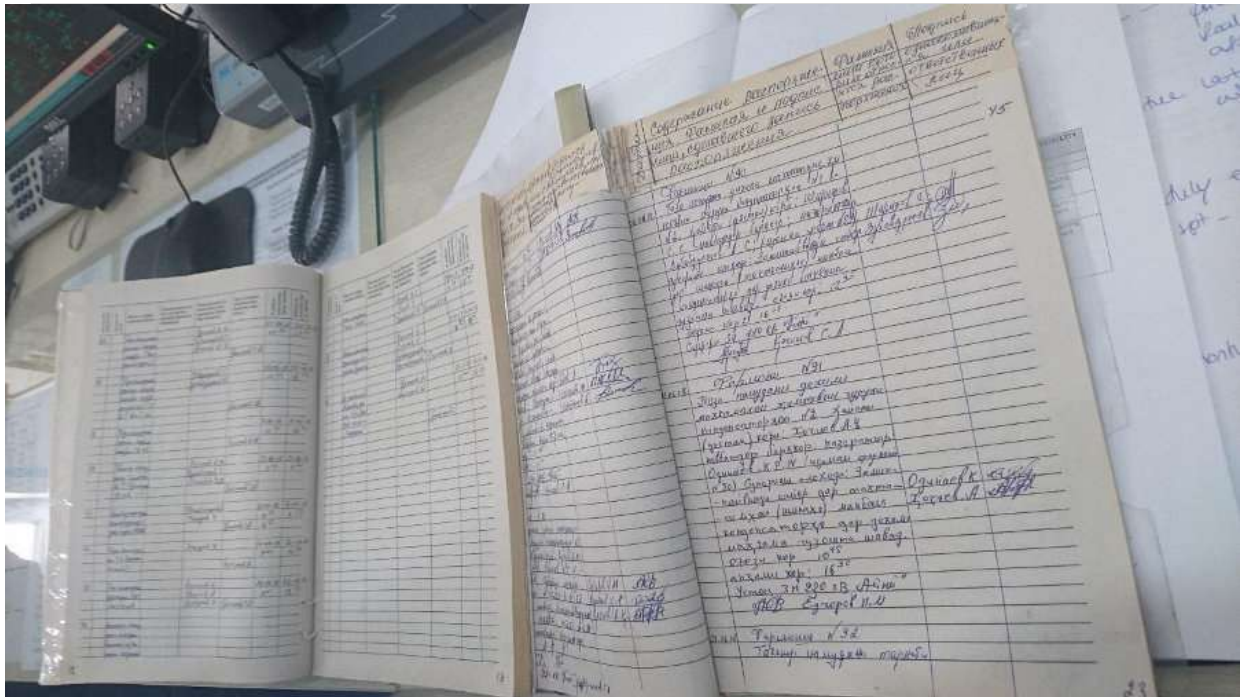
50. At the SSs, the BT staff fills in a daily journal where the performed activities and incidents if any are written down. The H&S issues and applied mitigation measures are also reported, but there is no reporting on environmental aspects.

Figure7: Journals that are filled daily with H&S aspects by the SS staff, but they do not cover the monitoring on environmental aspects.

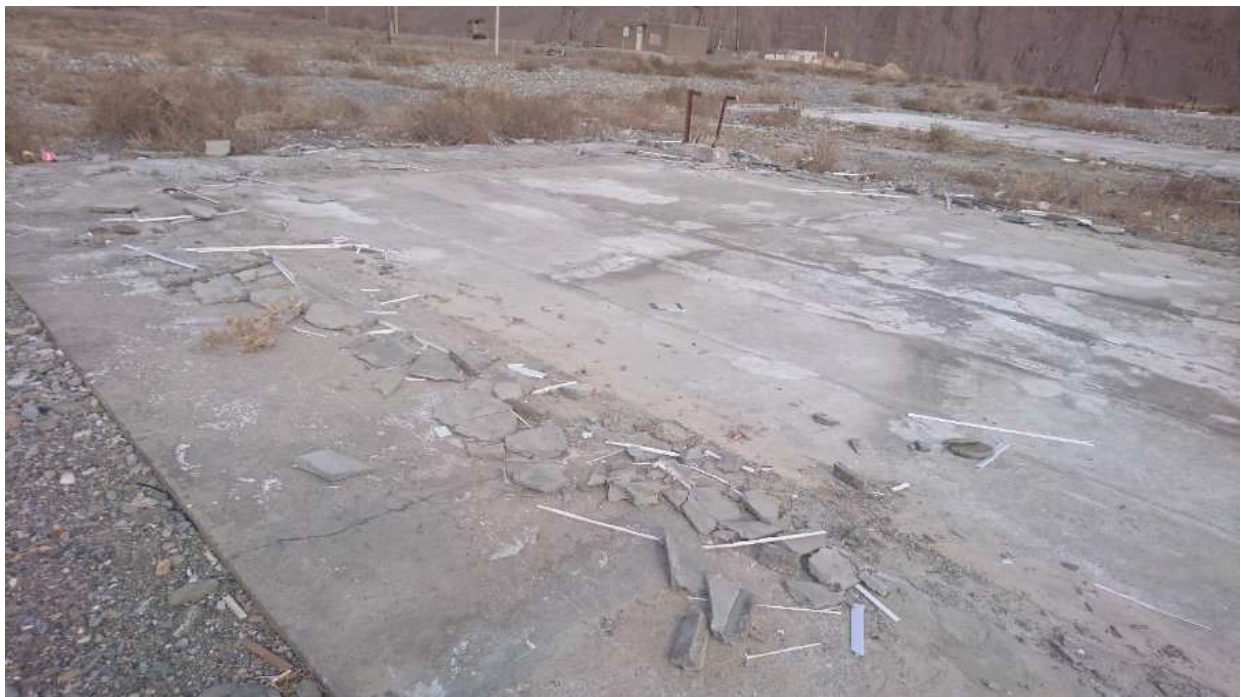
Figure 8: condition of the former workers' camp located near Ayni SS. Presence of concrete floors.

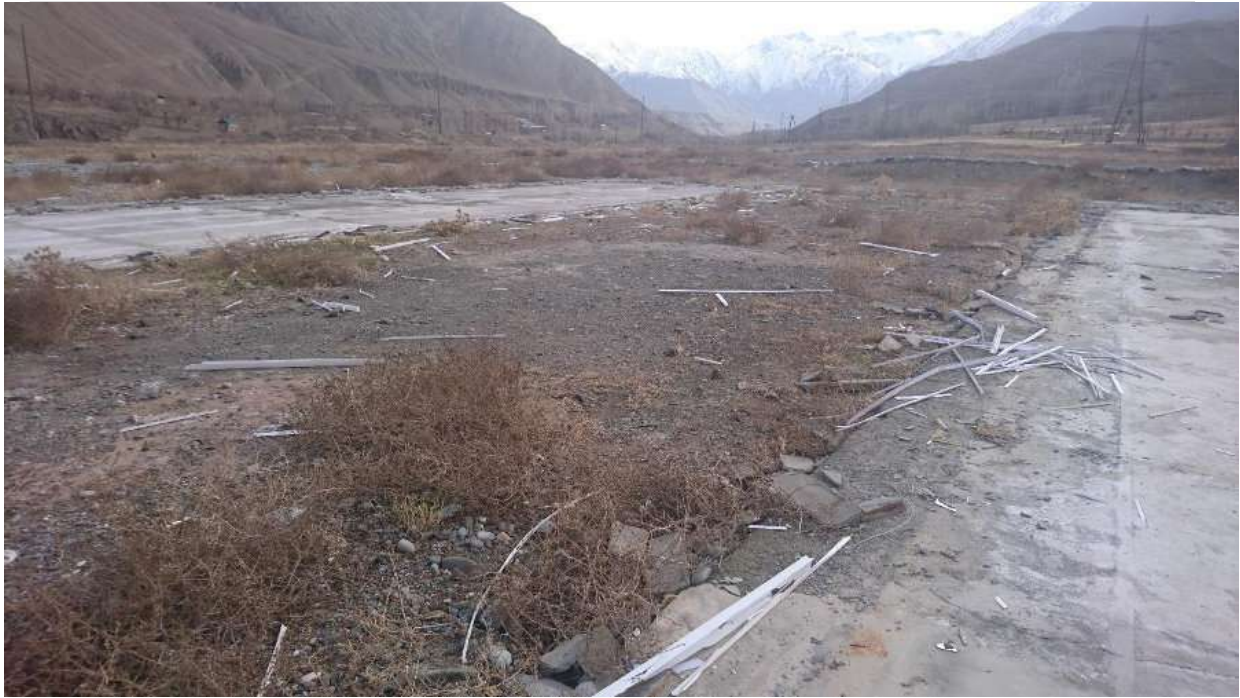
Figure 9: condition of the former workers' camp located near Ayni SS. Presence of construction material waste after dismantling the camp.

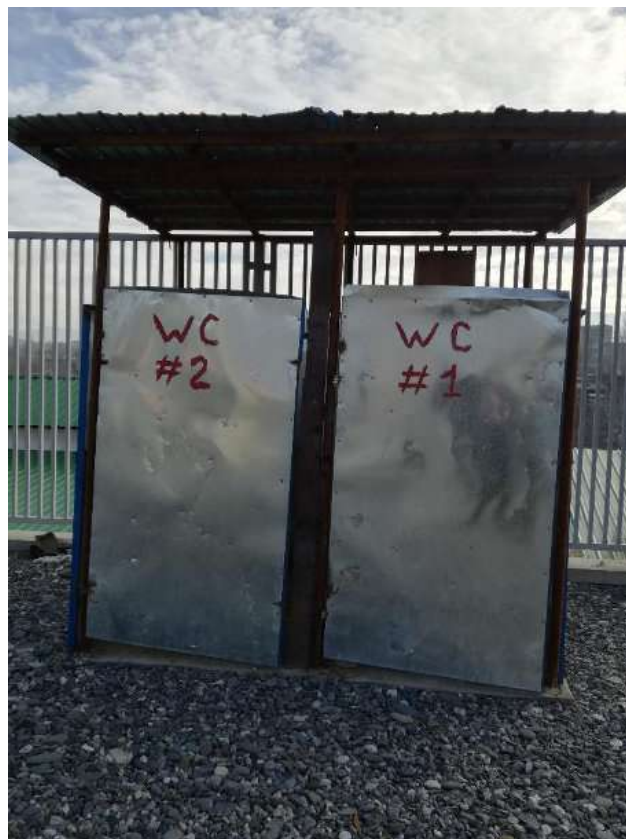
Figure 10: temporary toilets located next to the switchyard.

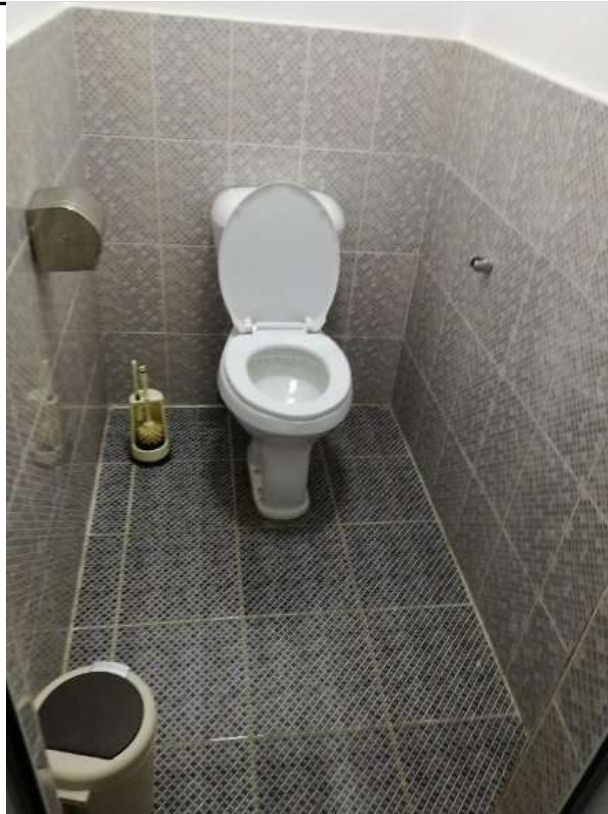
Figure 11: new toilet (2 in total) built under the Project.

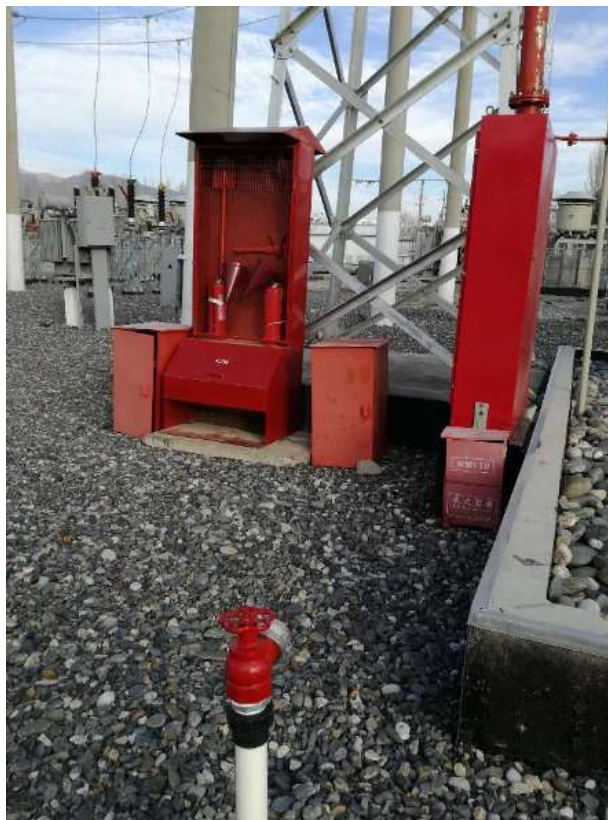
Figure 12: new fire safety equipment purchased under the Project that is located near a new auto transformer.

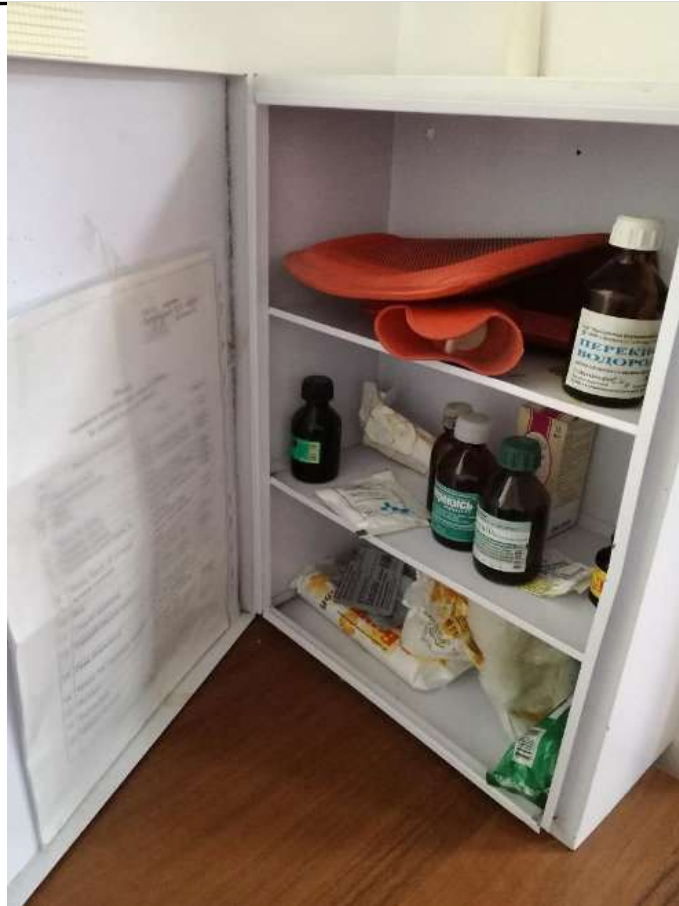
Figure 13: Safety box in full-set condition.

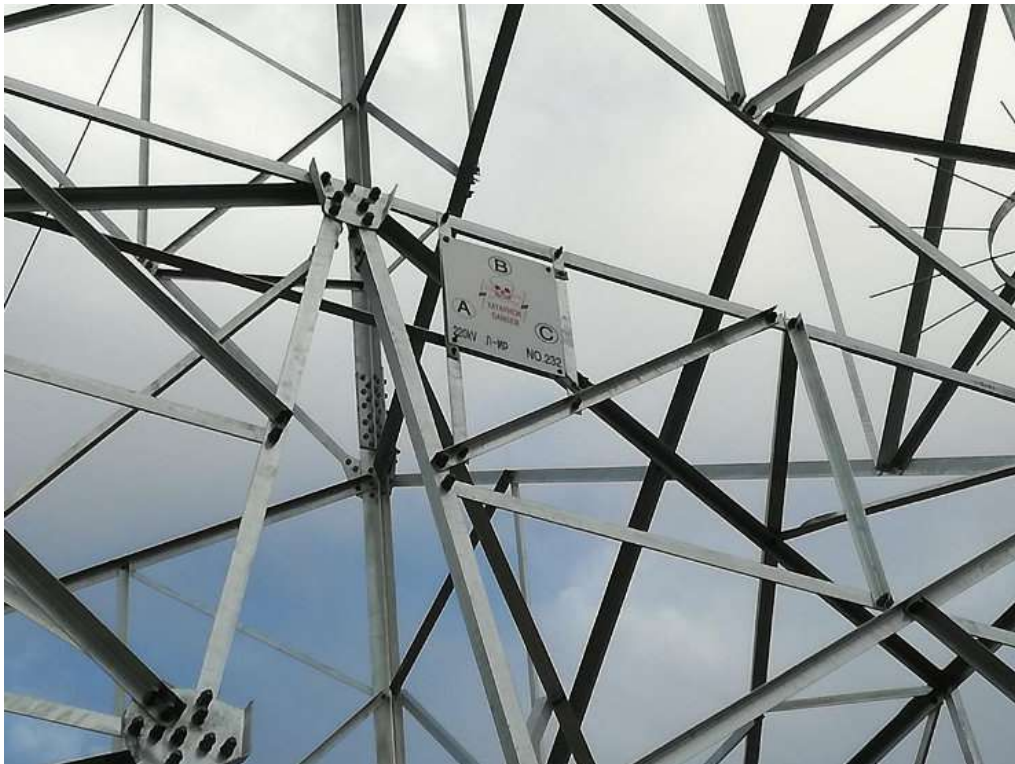
Figure 14: Safety notice located at every tower of the OHTL that informs on the risk of electrocution.
