# Semi-annual Environmental Monitoring Report

Project Number: 47017-003 G0417

Reporting period: July-December 2019

## Republic of Tajikistan: Wholesale Metering and Transmission Reinforcement Project (Financed by the Asian Development Bank)

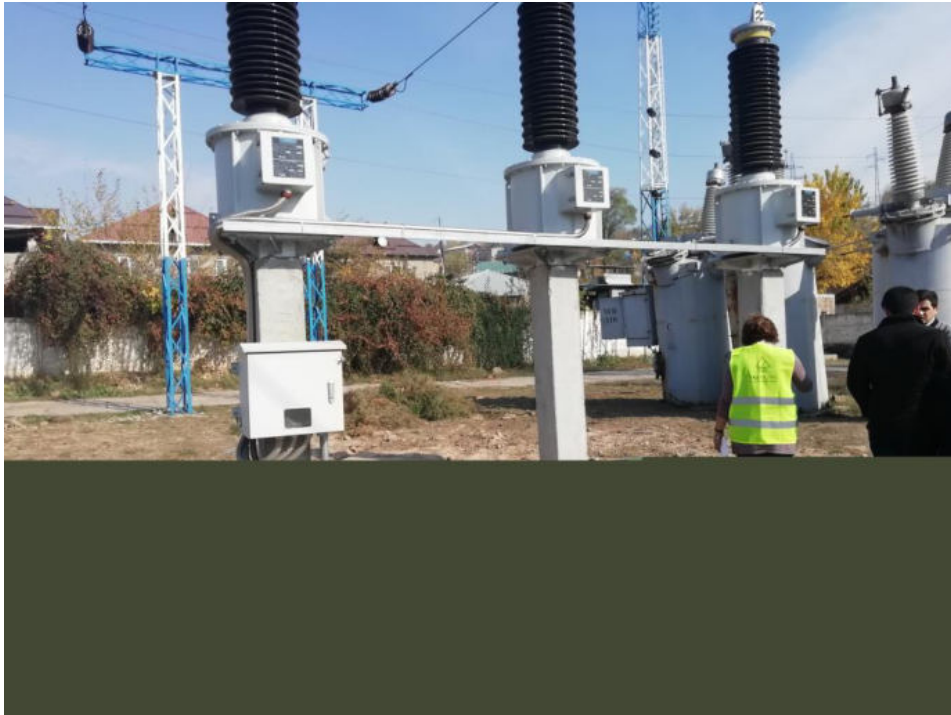
Figure 3. Picture taken at “Vostochmaya” SS (lot 1), Dushanbe city. No full reinstatement of the area done. November 2019

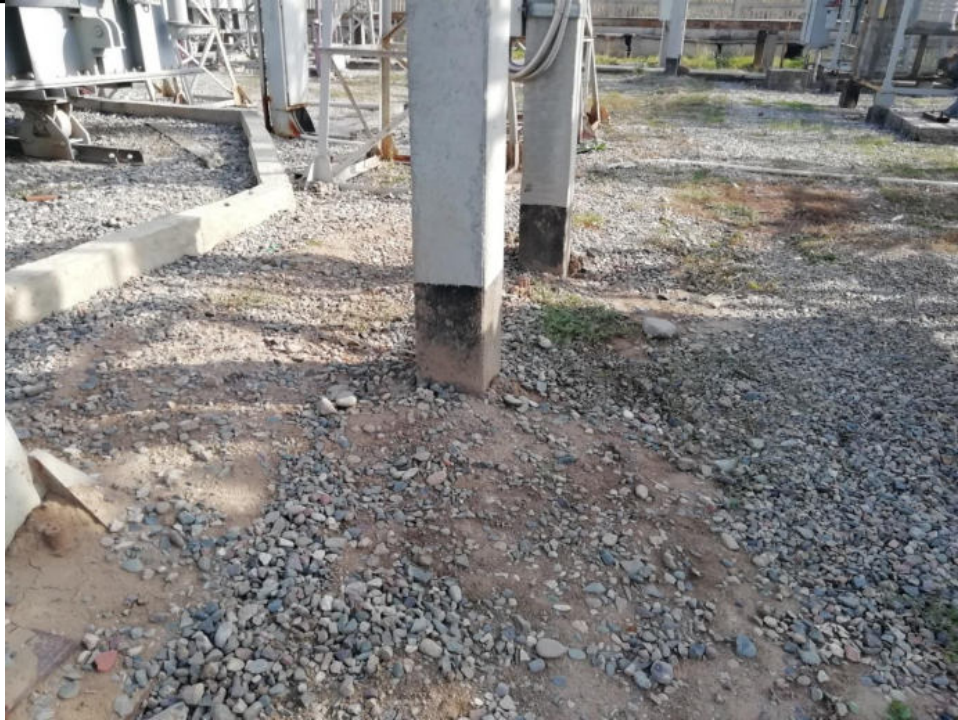
Figure 4. Installed CTs in “Academgorok” SS (lot 1), Dushanbe.  
November 2019.

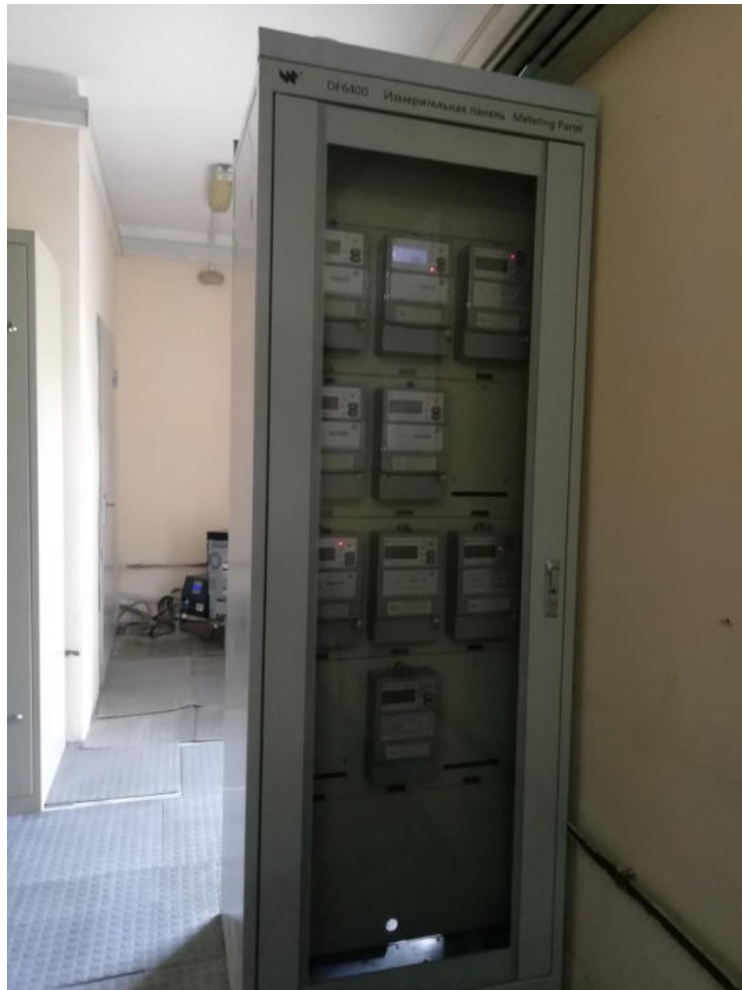
Figure 5. Installed wholesale meters in “Academgorok” SS (lot 1), Dushanbe.  
November 2019.

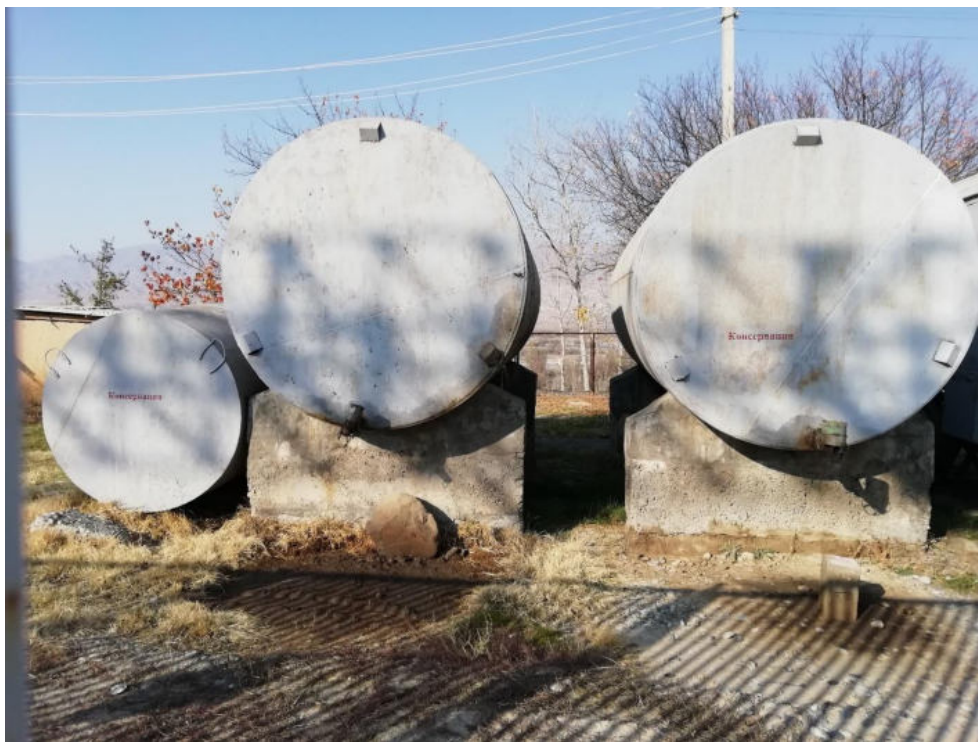
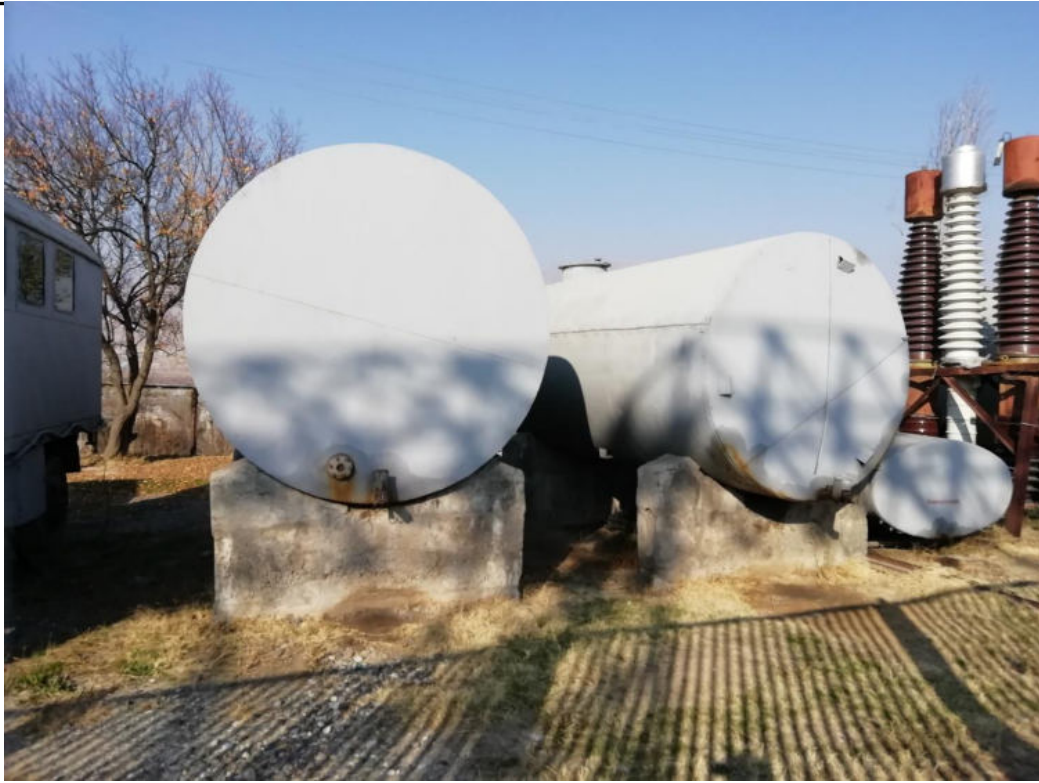
30. Soil got polluted with refrigeration oil from the uninstalled autotransformers in Rudaki Substation as shown on figures 10 and 11. The 7 metal tanks in the regional Panjakent Barki Tojik warehouse next to the substitution continue to drip oil. Barki Tojik has to perform/organize the safe pick-up and disposal of the soil polluted with refrigeration oil. Certificate from the hazardous waste dumping site will have to be submitted to the PIC Environmental and Social Specialist. It is also required that the 7 metal tanks get fixed (turners and seals) so the refrigeration oil does not get spilled. The metallic boxes for placing the polluted soil have already been manufactured by Barki Tojik. The remediation actions are pending since the soil is frozen at this time of the year. They will be performed in the next spring season.

Figure 10. Polluted soil with refrigeration oil in the BT's regional warehouse next door to Rudaki SS (Lot 2), Panjakent district, November 2019.

Figure 11. Polluted soil with refrigeration oil in the BT's regional warehouse next door to Rudaki SS (Lot 2), Panjakent city, November 2019.

| Main finding | Corrective actions applied or needed | Status |
|--|--|--|
| <u>Lot 2</u><br>Mayor: Soil polluted with refrigeration oil from the uninstalled autotransformers in Rudaki Substation. The 7 metal tanks in the regional BT warehouse next to the substitution continue to drip oil. | Barki Tojik has to perform/organize the safe pick-up and disposal of the soil polluted with refrigeration oil. Certificate from the hazardous waste dumping site will have to be submitted to the PIC safeguards Specialist. Fixing the 7 metal tanks (turners and seals) so the refrigeration oil does not get spilled. | Pending since the soil is frozen in this time of the year. It will be performed in the next spring season. |

| Issues, actions and responsible party | Criteria | Schedule |
|--|--|---|
| 6. Soil polluted with refrigeration oil from the uninstalled autotransformers in Rudaki Substation (Lot 2). The 7 metal tanks in the regional BT warehouse next to the substitution continue to drip oil. Barki Tojik has to perform/organize the safe pick-up and disposal of the soil polluted with refrigeration oil. Certificate from the hazardous waste dumping site will have to be submitted to the PIC Environmental and Social Specialist. Fixing the 7 metal tanks (turners and seals) so the refrigeration oil does not get spilled. | Best practice. Environmental and Social Management Plan. | By April 2020. The soil is frozen during wintertime. |

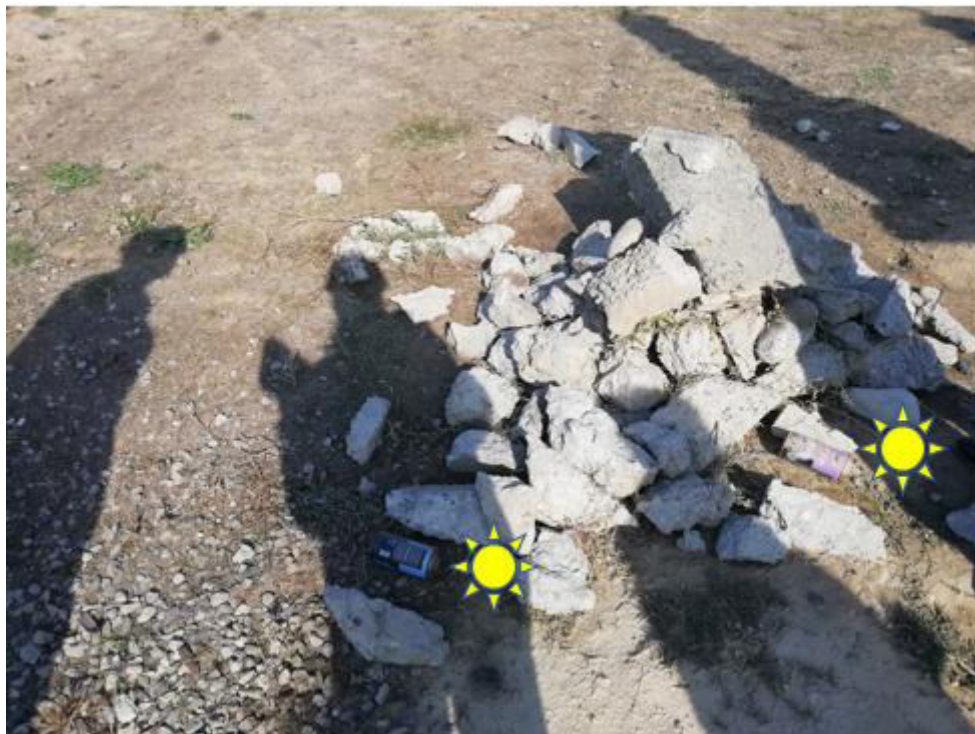
31. Some plastic waste, oily rags and empty paint cans were observed at Akademgorodok substation as shown on Figure 12. Waste has to be collected and disposed safely by the Contractor.

Figure 12. Waste observed in Akademgorodok substation, Dushanbe, November 2019.

| Main finding | Corrective actions applied or needed | Status |
|--|--|--|
| <u>Lot 1</u><br>Minor: Some plastic waste, oily rags and empty cans were observed at Akademgorodok substation. | Waste to be collected and disposed safely. | Pending. Shall be implemented by 14 February 2020. |

| Issues, actions and responsible party | Criteria | Schedule |
|--|--|---|
| 5. Some plastic waste, oily rags and empty cans were observed at Akademgorodok substation. Waste must be collected and disposed safely. | Environmental and Social Management Plan. | By February 14, 2020. |

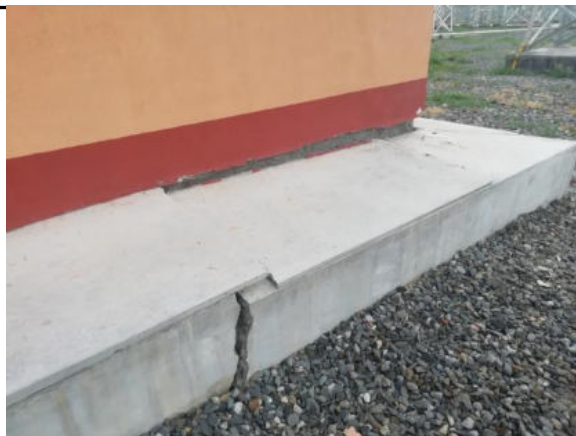
61. During the last inspection performed by the PIC Environmental and Social specialist in May 2019, they were identified risks to occupational health and safety in Rudaki SS since the lack of compaction of the floor during the construction had made it sink in the areas of the new rooms of the administration building, some of the electrical equipment that were no longer aligned and the grey water tanks. The cracks in the administration building could let the rainwater come in, which could had potentially generated dampness and sinking of that part of the building. The sinking of some areas of the new switchyards were posing trip hazards. The electrical equipment not being aligned, had the potential to generate technical problems. The sinking of the grey water tanks could had meant the lack of alignment with the pipes and potential bad odor and exposure to bacteria. All those compaction problems were solved by the contractor, as identified in the November 2019 inspection. Please see below the pictures that show case the previous problematic situation and the current situation free of health and safety risks.

Figure 16. Cracks in the external walls of the new rooms of the administration building. Rudaki SS (lot 2), Panjakent district, May 2019.

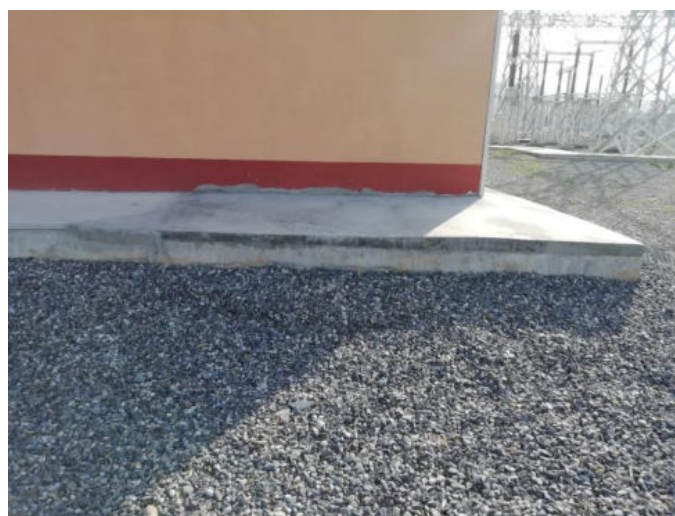
Figure 17. External walls of the new rooms of the administration building. Rudaki SS (lot 2), Panjakent district, November 2019.

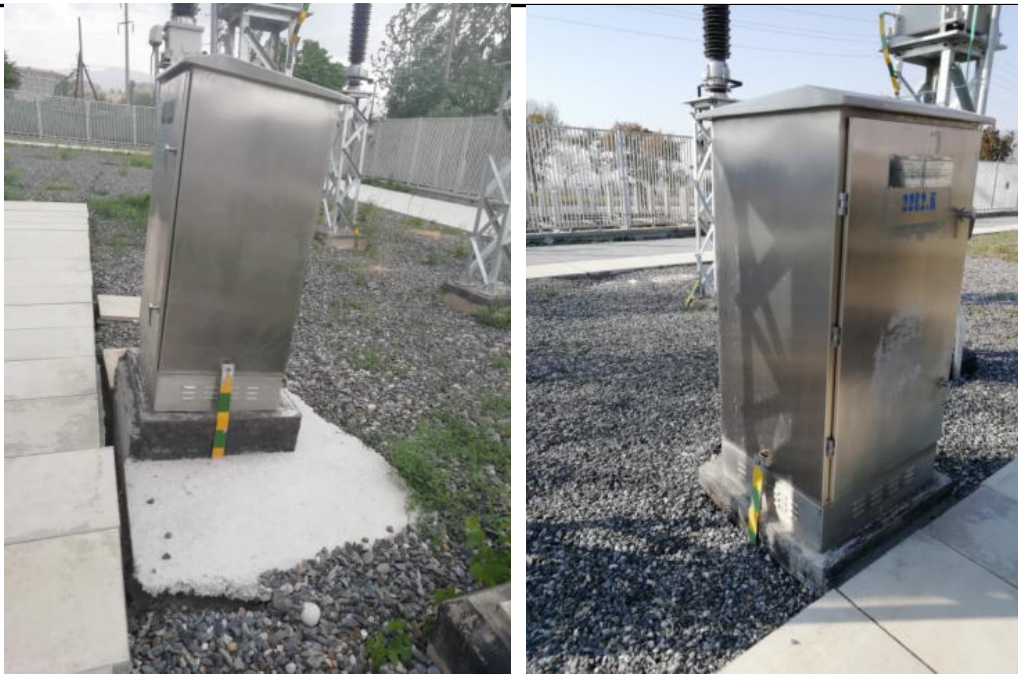
Figures 18 and 19. Condition of the concrete base of an electrical equipment box. Rudaki SS (lot 2), Panjakent district. May 2019 (Fig. 18) and November 2019 (Fig.19).

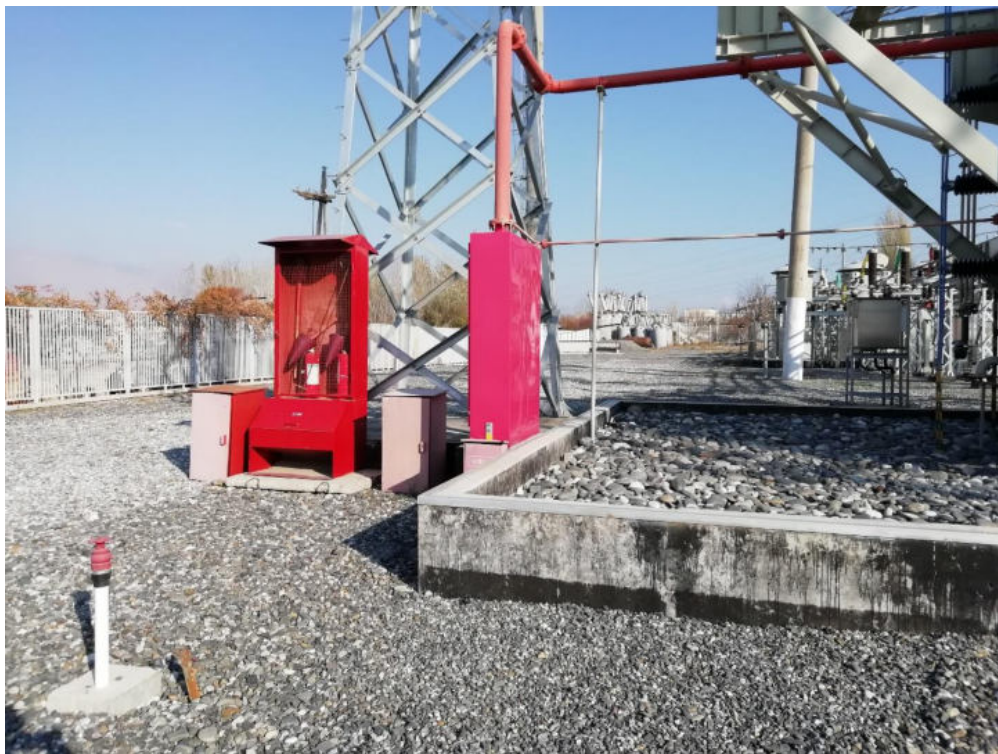
68. Regular maintenance of the anti-fire system in the new autotransformers installed in Rudaki SS.

Figure 21. Anti-fire system in one of the new autotransformers in Rudaki SS (Lot 2), Panjakent district. November 2019.

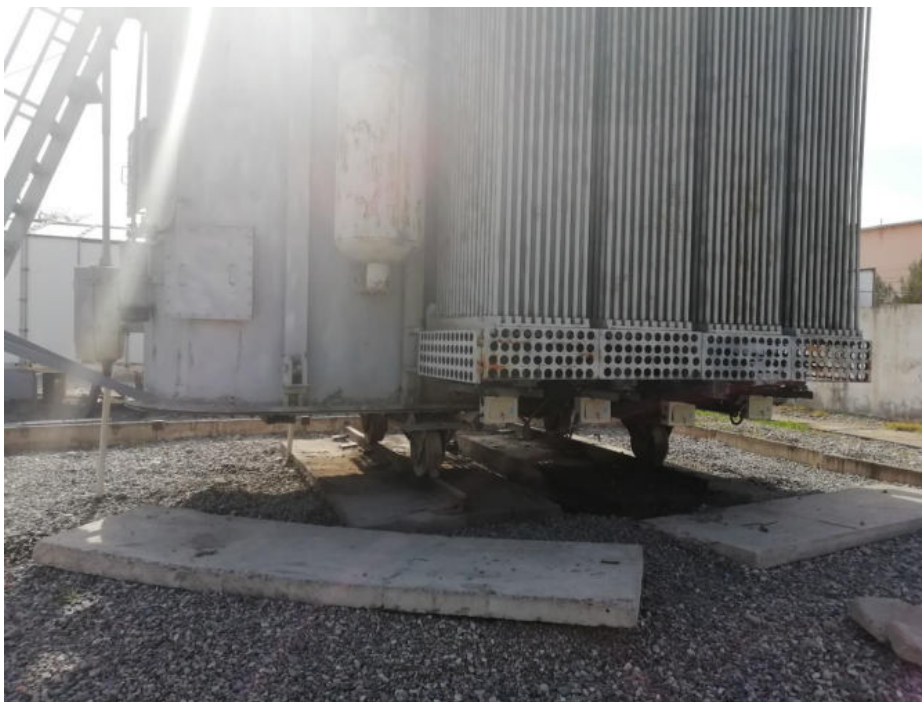
Figure 25. Polluted gravel and soil due to refrigeration oil dripping from an old auto-transformer. Shursay SS. Dushanbe. November 2019.

72. It is recommended that a plan is set in place in order to safely dispose the polluted gravel and soil below most of the old auto-transformers and refrigeration oil tanks (outside of the project scope) in the substations along the country since they generally suffer from refrigeration oil dripping. It is recommended to analyze first if those oils contain PCBs.

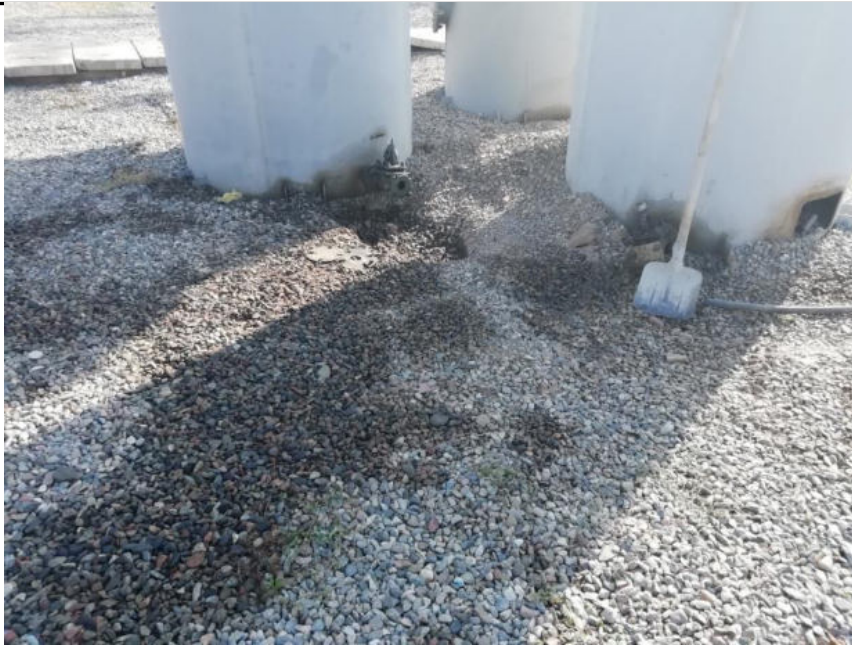
Figure 26. Polluted gravel and soil due to refrigeration oil dripping from old refrigeration oil tanks. Vostochmaya SS. Dushanbe. November 2019

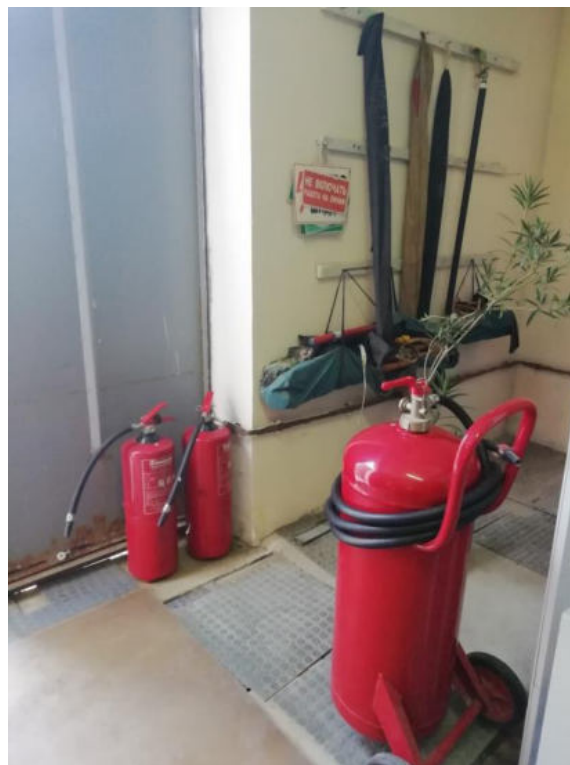
Figure 27. Fire extinguishers bottles partially blocking the way out of the control room. Academgorodok SS. Dushanbe. November 2019.

73. It is a bad practice to block the way out of the main door of the control room of a substation, in case there is need to escape from any hazard or ask for help due to any risk, even if the door is wide. It is recommended that the fire extinguishers bottles that block the way out in Figure 27 are hung aside.

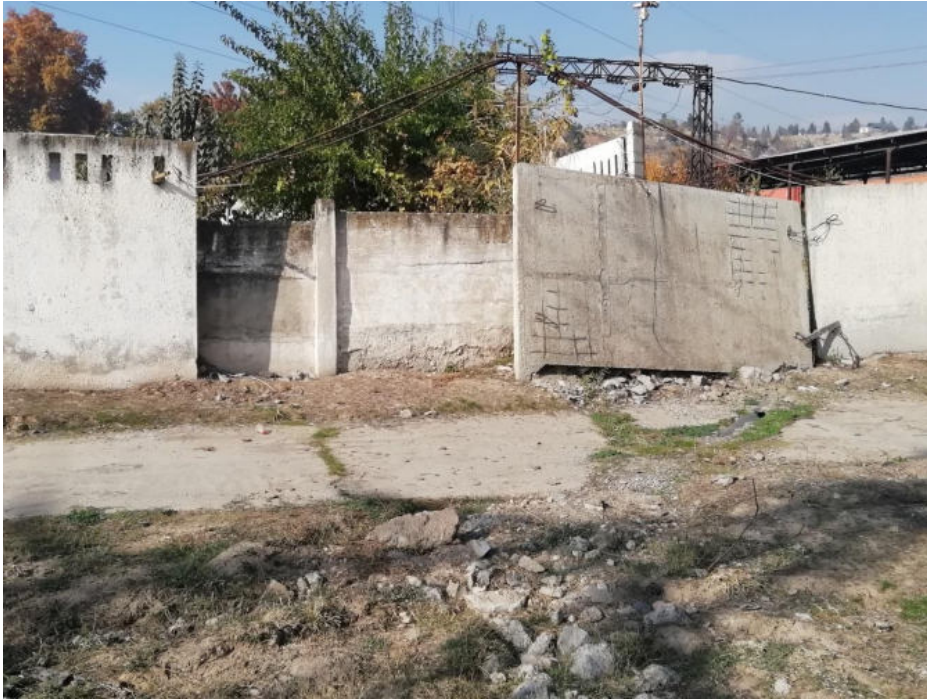
Figure 28. Walls of the substation. Vostochmaya SS. Dushanbe. November 2019.

74. The condition of the fence walls of most of the small size substations along the country pose health and safety risks due to not being continuous, being broken (Fig. 26) or being too low rise (Fig. 27). The plans of Barki Tojik for bringing the SSs walls up to a minimum of 3 meters high in the near future are very much welcomed.

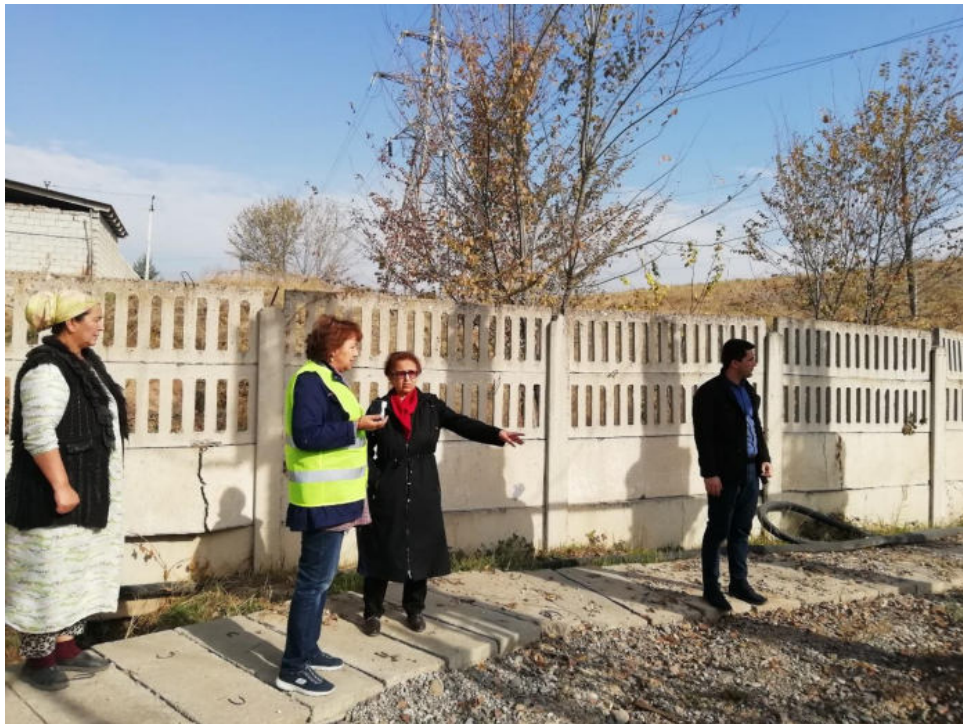
Figure 29. Walls of the substation are too low rise. Academgorodok SS. Dushanbe.  
November 2019.

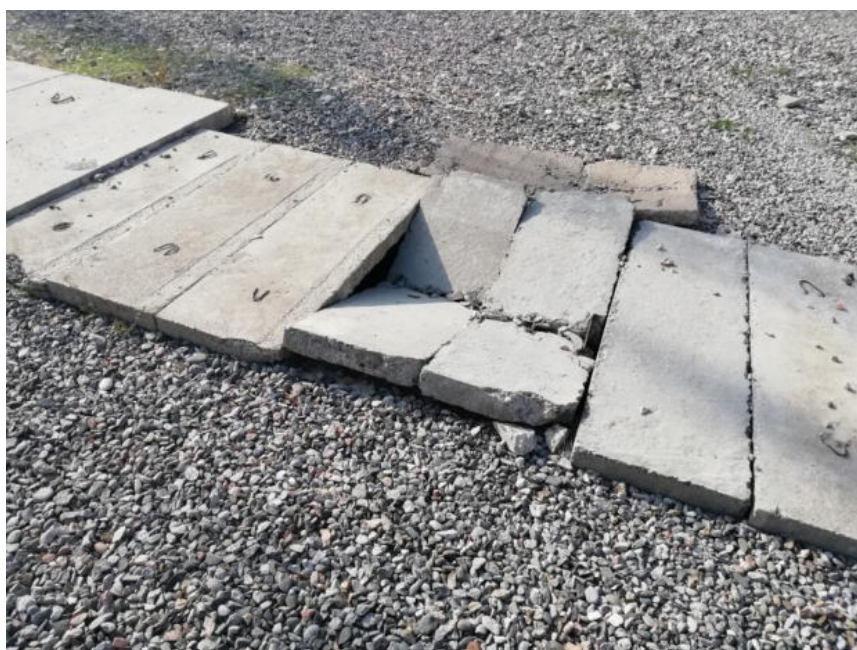
Figure 30. Broken concrete laps in the walkway. Academgorodok SS. Dushanbe.  
November 2019

75. It is recommended to improve the condition of the concrete laps over the cable ducts that act as walkways in the substations. It is common to see many broken concrete laps in the visited substations, which poses health and safety risks.

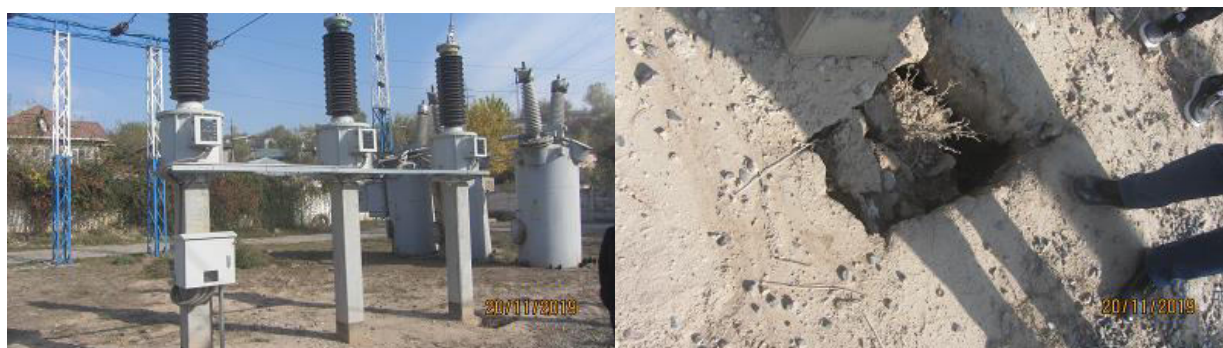
Figures 31 and 32. No compacting and gravelling done. Vostochnaya substation. Dushanbe.  
November 2019.

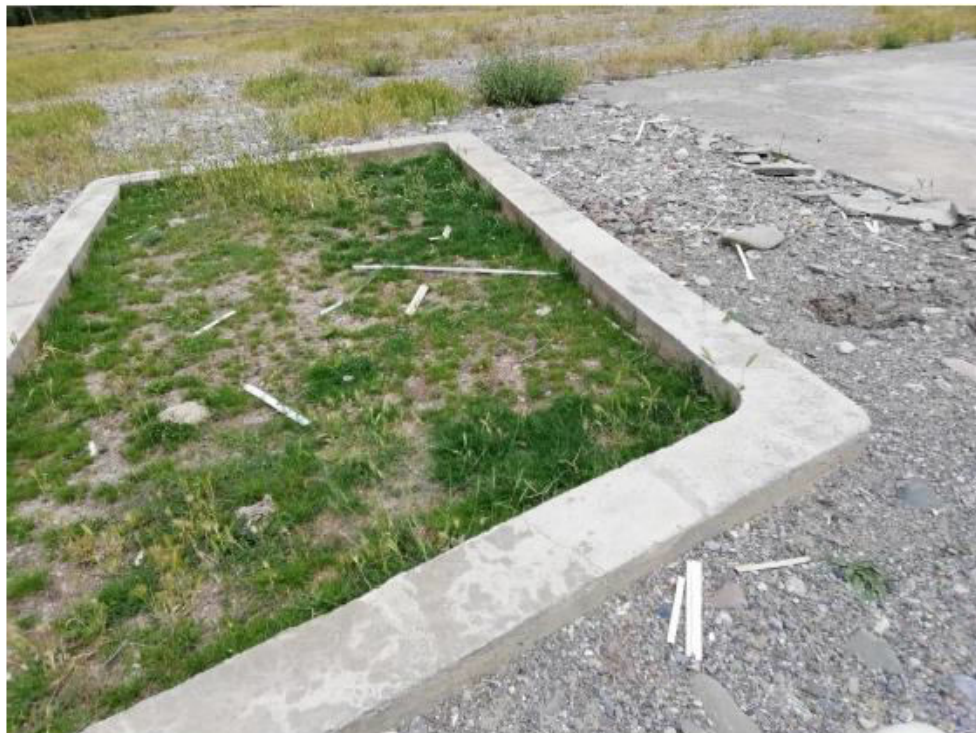
Figure 1: Presence of concrete floors.

| Issues, actions and responsible party | Criteria | Schedule |
|--|--|---|
| 3. During the visit in November 2019 to the former Ayni labor camp, the set concrete floors were still in place. Ayni local council has to make a decision on whether they want the concrete floors to remain or to be broken down and the site being brought back to the previous condition before the installation of the labor camp. | Environmental and Social Management Plan. | A decision will be taken by the Ayni local council by February 2020. If the local council decides that the concrete floors shall be broken, the Contractor has to implement that decision within the following 4 weeks. |

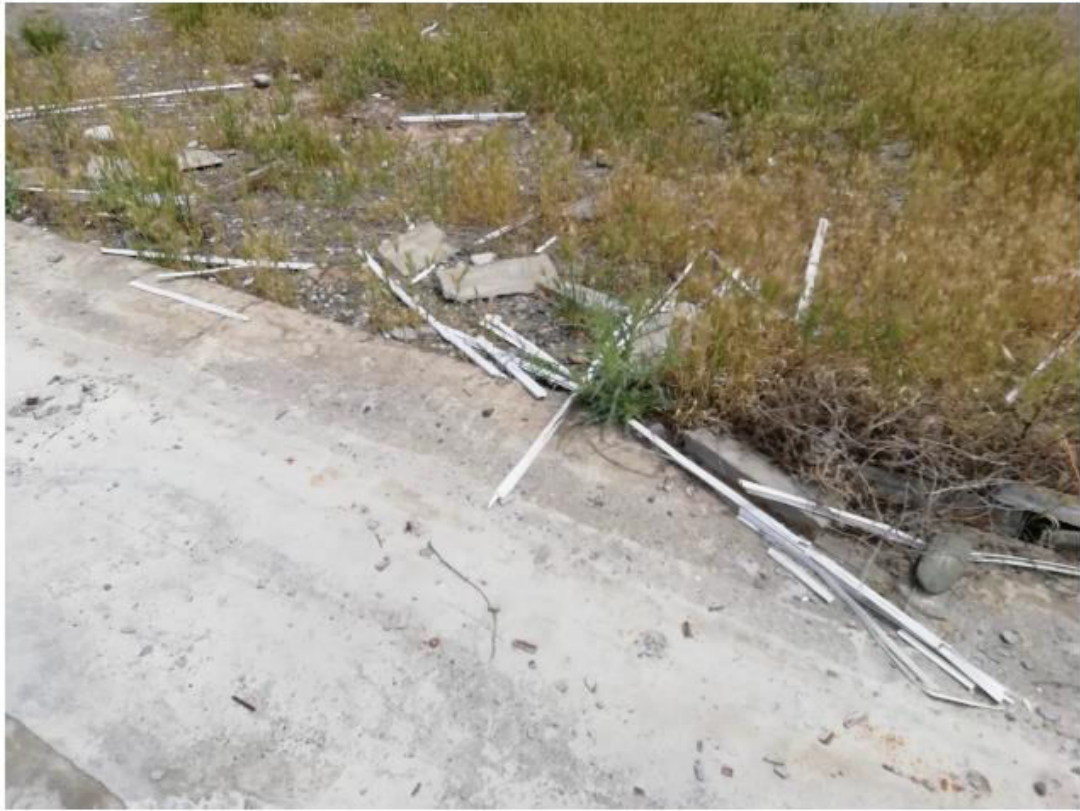
Figure 2: Presence of construction material waste after dismantling the camp.

| Identified violations | Recommendations | Responsible persons, data |
|---|--|---|
| 4. Waste generated after the dismantling of working camp near SS Ayni is not disposed. | 4. Waste generated after dismantling of working camp near SS Ayni should be collected and safely disposed. | TBEA<br>October 31, 2019. |

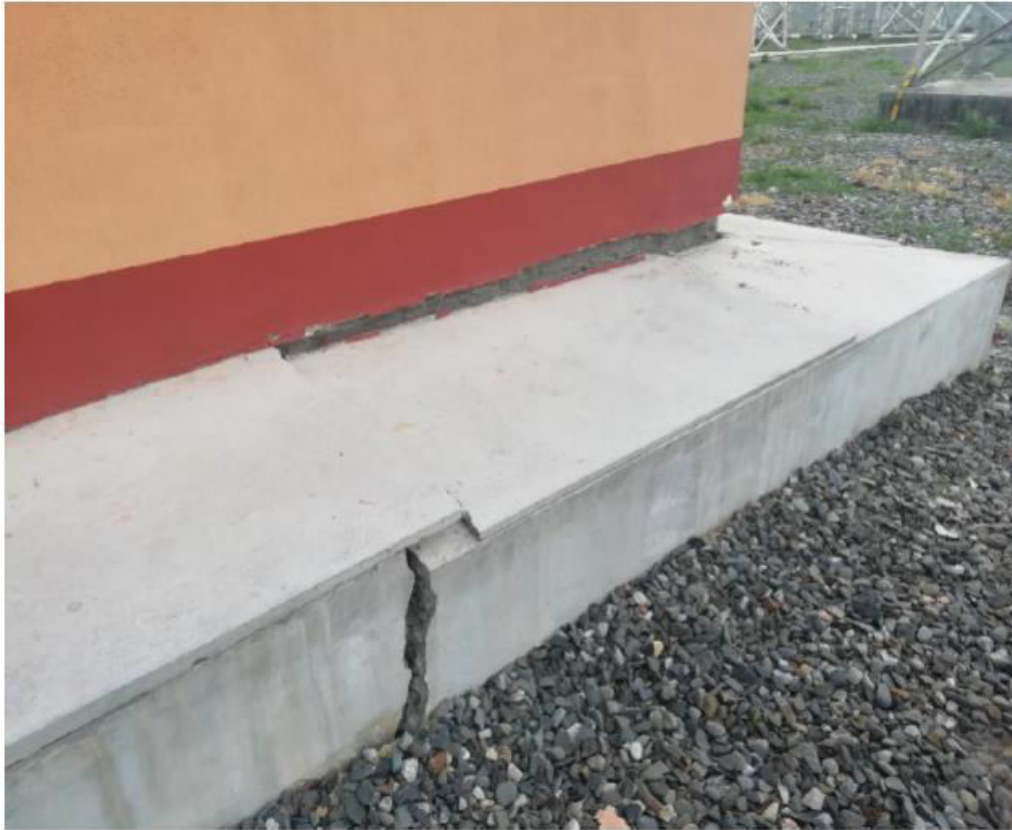
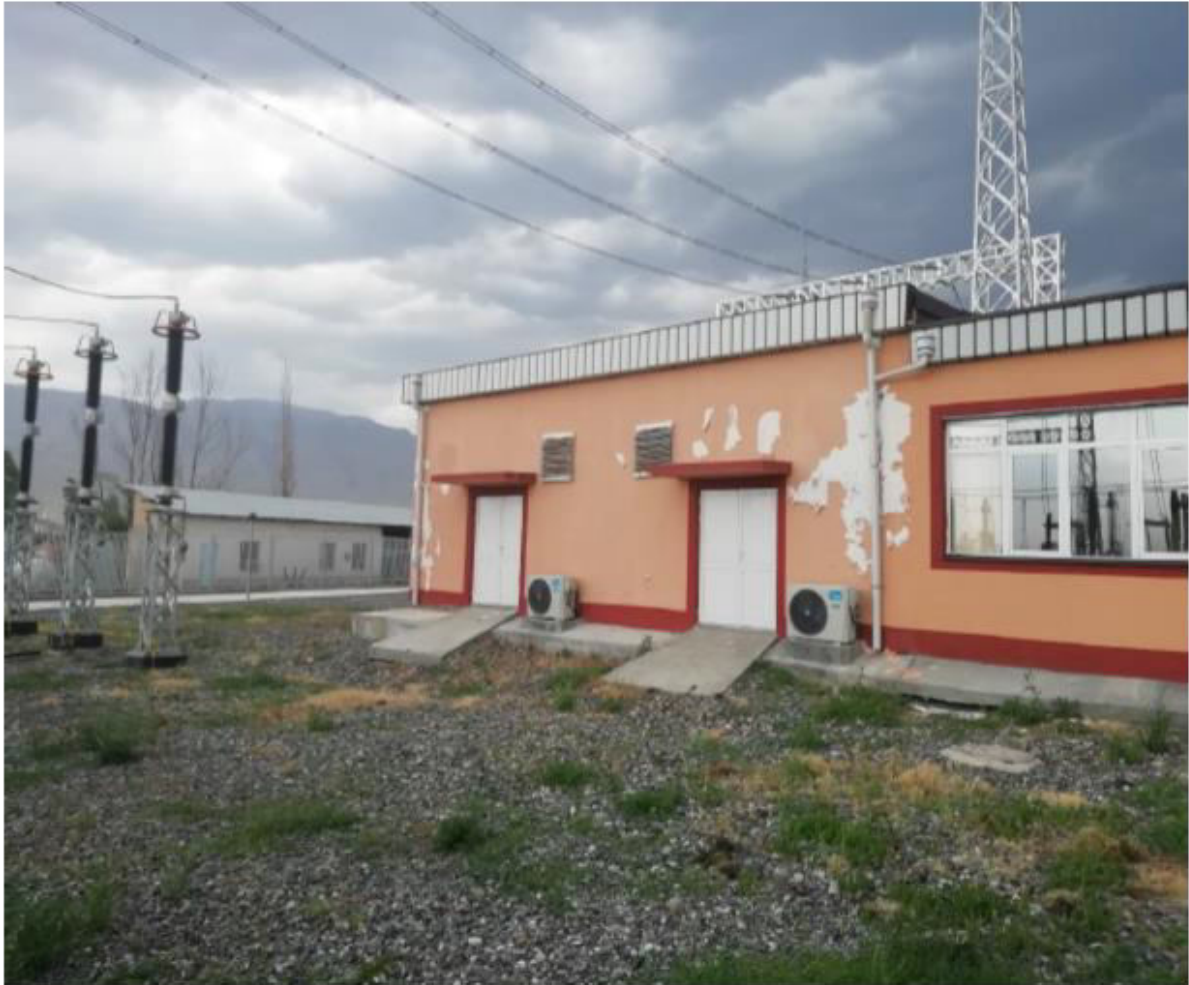
| Identified violations | Recommendations | Responsible persons, data |
|---|--|---|
| 3. Damage is observed at Rudaki substation due to a lack of compaction during construction. | 3. Eliminate all damage at Rudaki substation caused by a lack of compaction during construction, and therefore reduce risks for H & S. | TBEA<br>October 21, 2019 |

Figure 3: Damage at Rudaki substation due to lack of compaction.

Figure 4: Damage at Rudaki substation due to lack of compaction.
