Environmental Monitoring Report

Project No.: 47017-003
July - December 2020
April 2021

Tajikistan: Wholesale Metering and Transmission Reinforcement Project

Prepared by: the State Establishment «Project Management Unit for Electro-Energy Sector» (SE «PMUES») for the Open Joint Stock Holding company “Barqi Tojik” and the Asian Development Bank

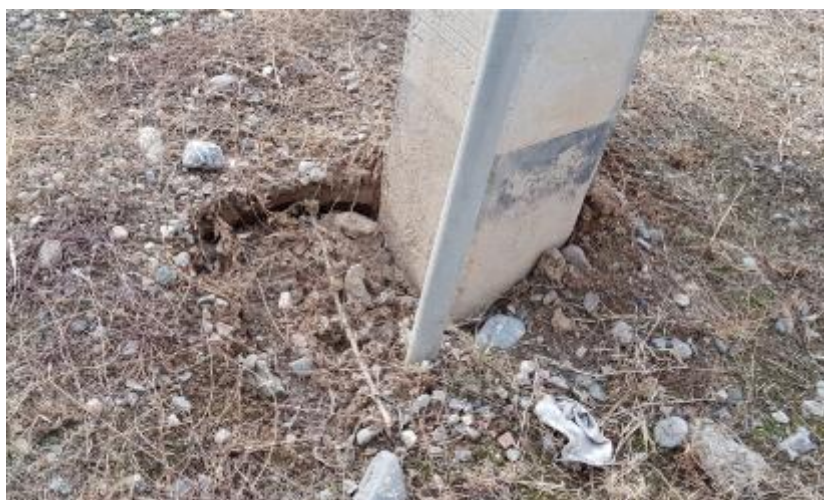
30. Subsidence has occurred under some of the poles where equipment under LOT 1 was installed. This is happening due to the lack of compaction of the land. In some poles the leveling was not performed and the gravel was not put back. This poses a health and safety risk and the stability of some of the poles is even threaten. Pictures taken with poles with

Figure 4. Effects of the lack of compaction, levelling and gravel put back in a pole in Buston substation, Dushanbe, December 2020.

these issues in Buston, Promishlenaya and Shursay substations can be found below. It is recommended that Barqi Tojik follow-up closely on the re-compaction, leveling and graveling of the poles affected by the project activities under LOT 1 since many of them might be affected by shortcomings. Barqi Tojik should make sure the mitigation activities get implemented before the LOT 1 is officially accepted by the Government. It is suggested that a working group is created for this purpose.

- 65. It is recommended that Barqi Tojik follows up closely on the re-compaction, leveling and graveling of the poles affected by the project activities under LOT 1 since many of them might be affected by shortcomings. Barqi Tojik should make sure the mitigation activities get implemented before the LOT 1 is officially accepted by the Government. It is suggested that a working group is created for this purpose.

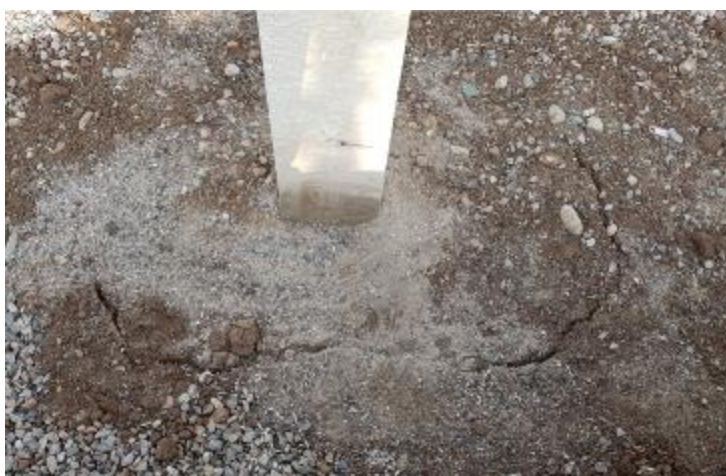
Figure 5. Effects of the lack of compaction, levelling and gravel put back in a pole in Promishlenaya substation, Dushanbe, December 2020.

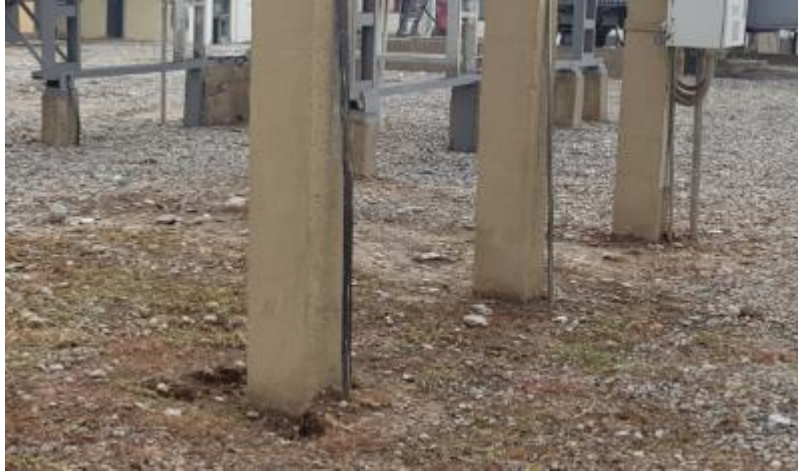
Figure 6. Effects of the lack of compaction, levelling and gravel put back in a pole in Shursay substation, Dushanbe, December 2020.

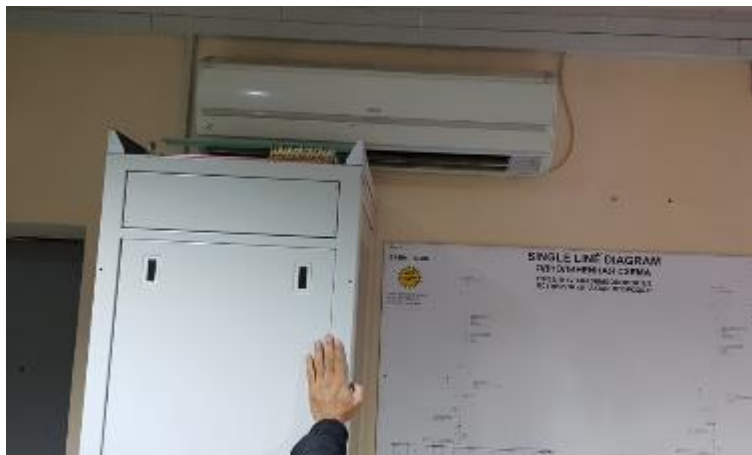
31. Meter rack in Akademgorodok SS is mounted under split air conditioning unit (image 13). This may cause short circuit of meters or risk of electric shock in event of condensation or water leakage to the meter rack. The Contractor TBEA has to move the meter rack or Barqi Tojik to move the AC unit so the AC unit is not anymore directly on top of the meters rack. Barqi Tojik to make a decision on what is the preferred and most adequate solution and then making sure it gets implemented.

Figure 7. AC split unit located on top of a meters rack, Akademgorodok Substation, Dushanbe, December 2020

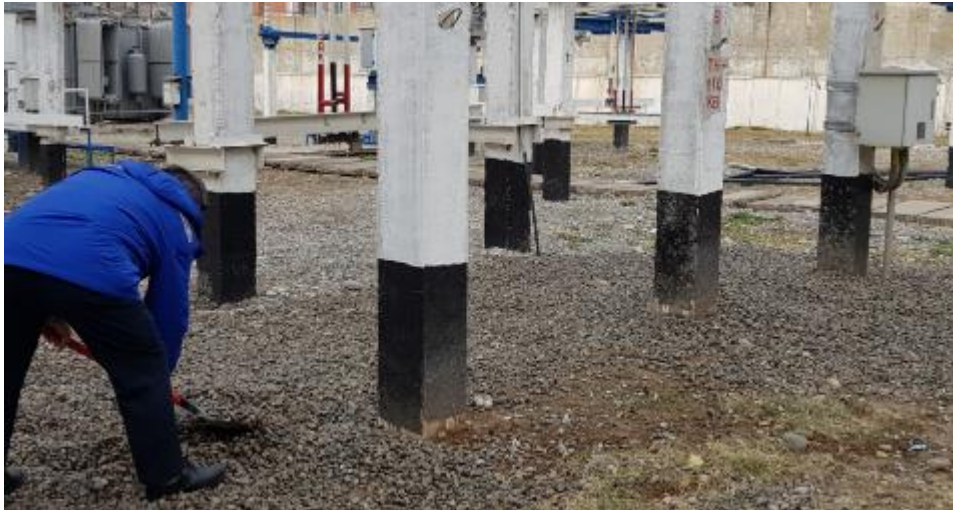
58. Barqi Tojik initiated the land-levelling and graveling activities in Shahri Substation, performing them also in the TBEA-installed power transformers. Although it is the responsibility of the Contractor to fix that situation, it is still a good practice that Barqi Tojik is mending it.

Figure 10. Barqi Tojik staff performing land-levelling and graveling activities, Shahri Substation, Dushanbe, December 2020.

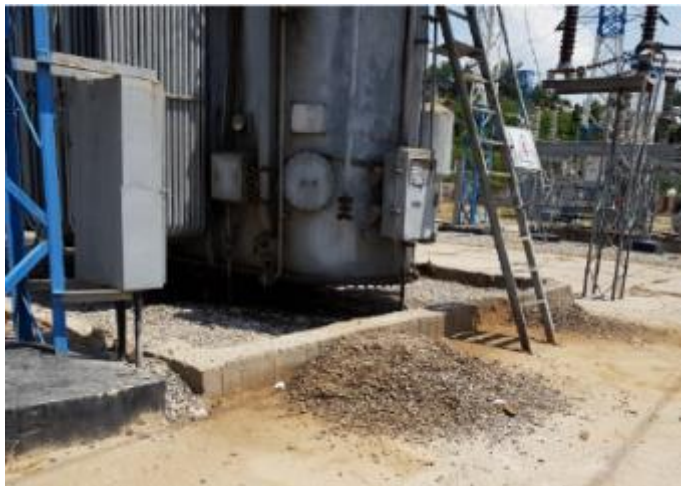
60. Almost each of the visited substations under LOT 1 had autotransformers that had leaked upon filling the insulation oil. Though those transformers were out of project scope, Barqi Tojik and substation staff were recommended to take actions on preventing the further pollution of the soil and gravel, and potentially water. PIC environmental specialist gave relevant recommendations to the PMU regarding safe handling and disposal of the oil-polluted soil and gravel.

Figure 12. Gravel polluted with auto-transformer oil, Vostochnaya Substation, Dushanbe, December 2020.

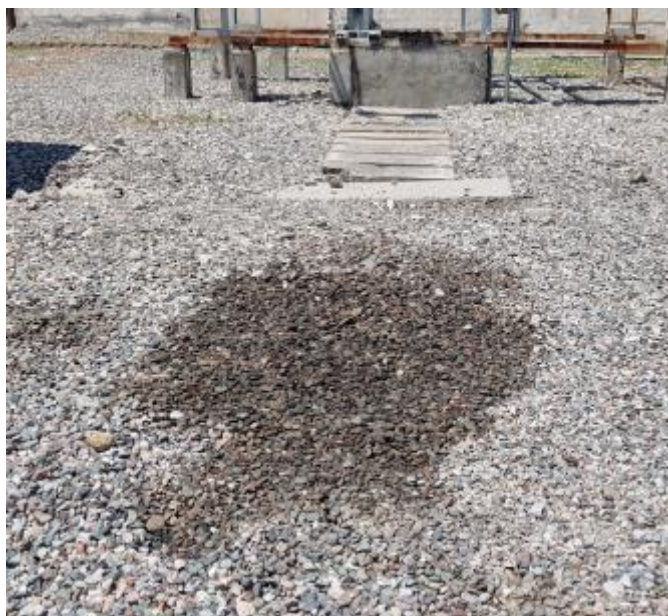
Figure 13. Gravel polluted with oil, Shursay Substation, Dushanbe, December 2020.

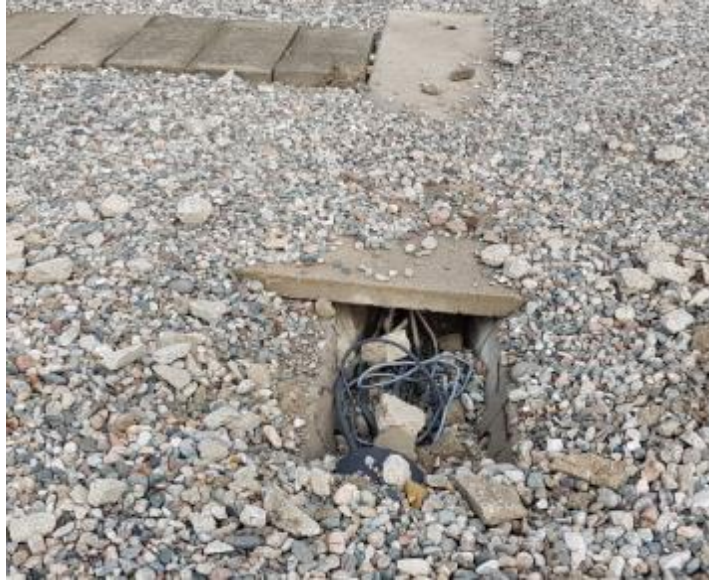
61. It was observed in Shursay Substation that the cables are exposed at the cable duct. This poses an electric shock risk for the Substation staff.

Figure 14. Cables exposed in a cable duct, Shursay Substation, Dushanbe, December 2020.
