Environmental Monitoring Report

Semi-Annual Report (July to December 2018)
May 2019

MYA: Maubin-Phyapon Road Rehabilitation Project

SEMI-ANNUAL ENVIRONMENTAL MONITORING REPORT No. 6

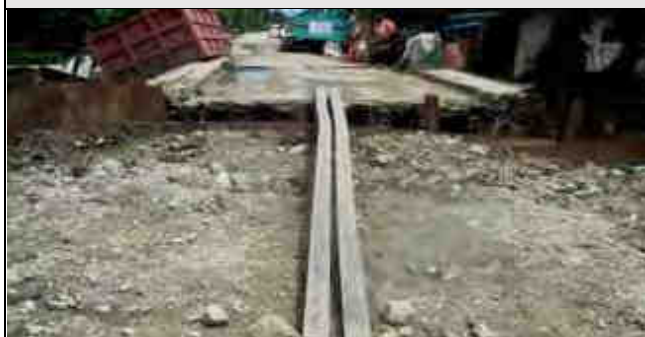
Figure 7. Construction of Phayar Chaung Bridge at Kyaiklatt, July 2018

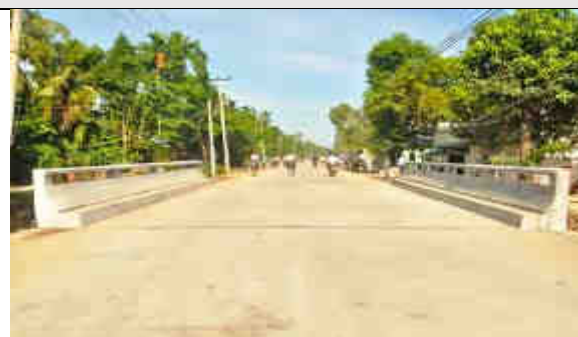
Figure 8. Construction of Phayar Chaung Bridge at Kyaiklatt, November 2018

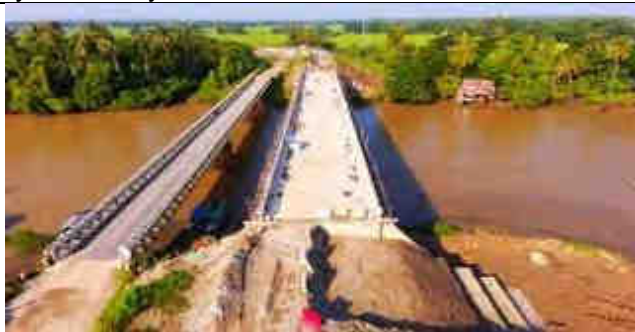
Figure 9. Oo Yin Chaung Bridge Work in October 2018

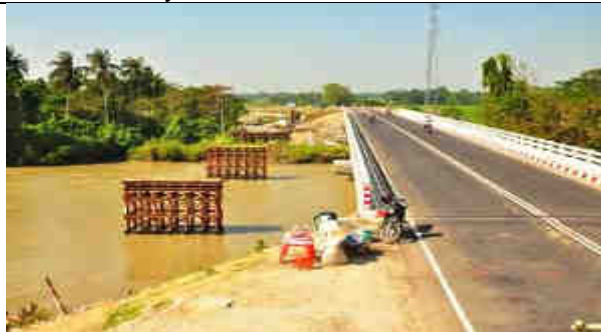
Figure 10. Oo Yin Chaung Bridge Work in December 2018

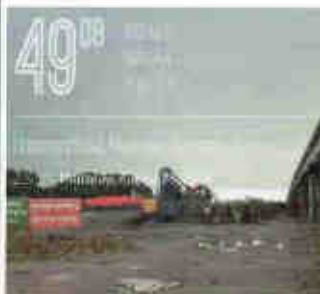
<p>Although there is no activity but high sound because there is a sound reaching from the others</p>

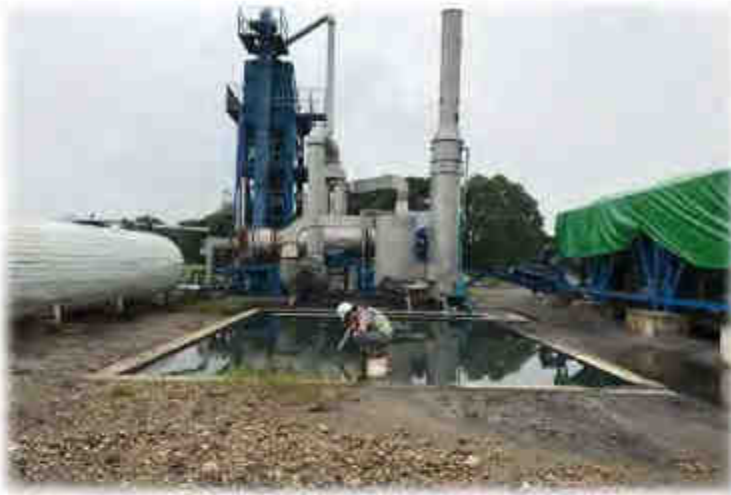
Point : Asphalt Plant Settlement Water Pond	
Notice Date	: 30-Jul-2018
Testing Date	: 31-Jul-2018
Parameter	: pH
Measured Result	: 7 (Approximately)
Baseline Result	: -
Standard Result	: 6 to 9
(Approved CEMP)	
Remark	<p>: All paving works were completed on the month of May 2018; hence, the Asphalt Plant is currently idle.</p> <p>The waste water pond was previously cleaned and emptied. Due to the rainy season, the tank was filled with rainwater.</p>
Photo

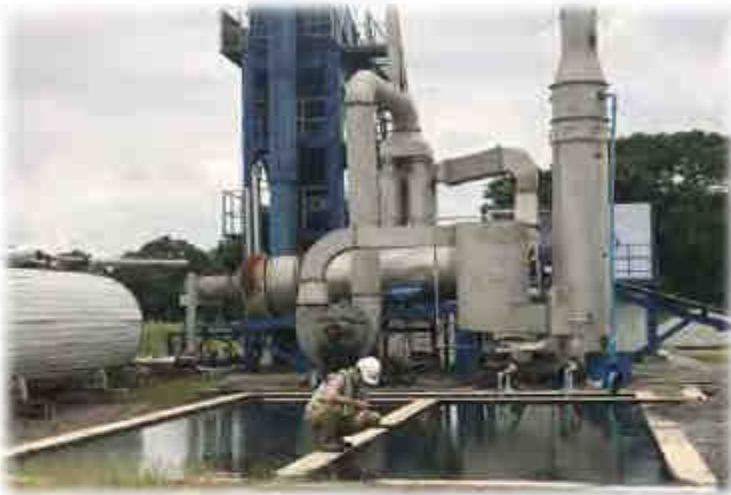
Point : Asphalt Plant Settlement Water Pond	
Notice Date	: 30-Aug-2018
Testing Date	: 31-Aug-2018
Parameter	: pH
Measured Result	: 7 (Approximately)
Baseline Result	: -
Standard Result	: 6 to 9
(Approved CEMP)	
Remark	: All paving works were completed on the month of May 2018; hence, the Asphalt Plant is currently idle. The waste water pond was previously cleaned and emptied. Due to the rainy season, the tank was filled with rainwater.
Photo	:

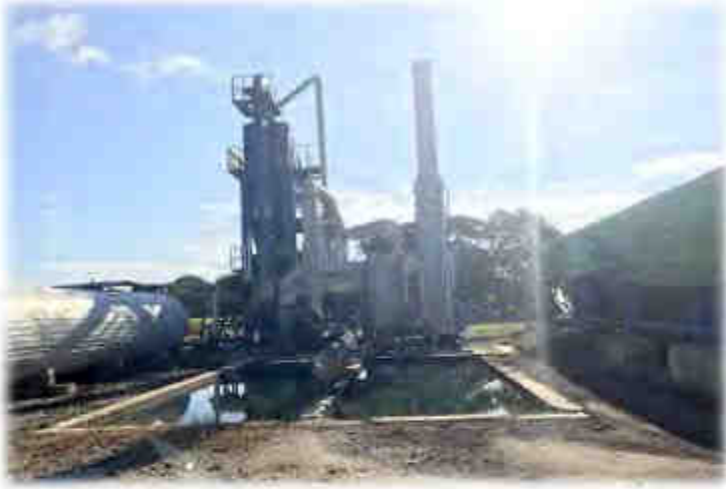
Point : Asphalt Plant Settlement Water Pond	
Notice Date	: 26-Sep-2018
Testing Date	: 27-Sep-2018
Parameter	: pH
Measured Result	: 7 (Approximately)
Baseline Result	: -
Standard Result	: 6 to 9
(Approved CEMP)	
Remark	: All paving works were completed on the month of May 2018; hence, the Asphalt Plant is currently idle. The waste water pond was previously cleaned and emptied. Due to the rainy season, the tank was filled with rainwater.
Photo	:

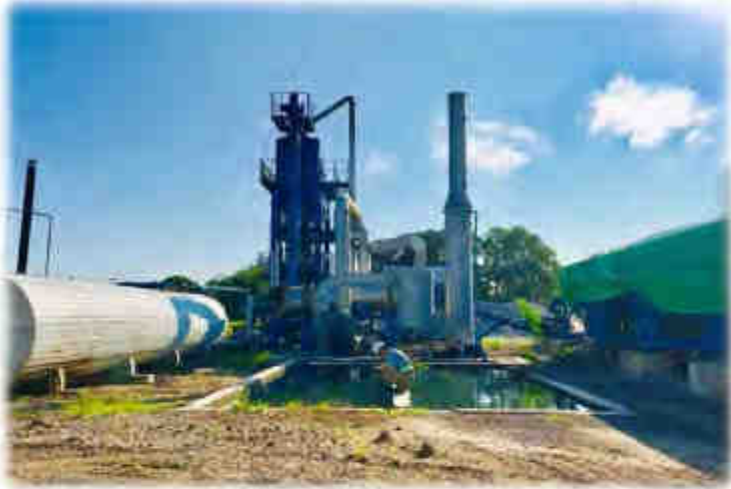
Point : Asphalt Plant Settlement Water Pond	
Notice Date	: 29-Oct-2018
Testing Date	: 30-Oct-2018
Parameter	: pH
Measured Result	: 7 (Approximately)
Baseline Result	: -
Standard Result	: 6 to 9
(Approved CEMP)	
Remark	: All paving works were completed on the month of May 2018; hence, the Asphalt Plant is currently idle. The waste water pond was previously cleaned and emptied. Due to the rainy season, the tank was filled with rainwater.
Photo	:

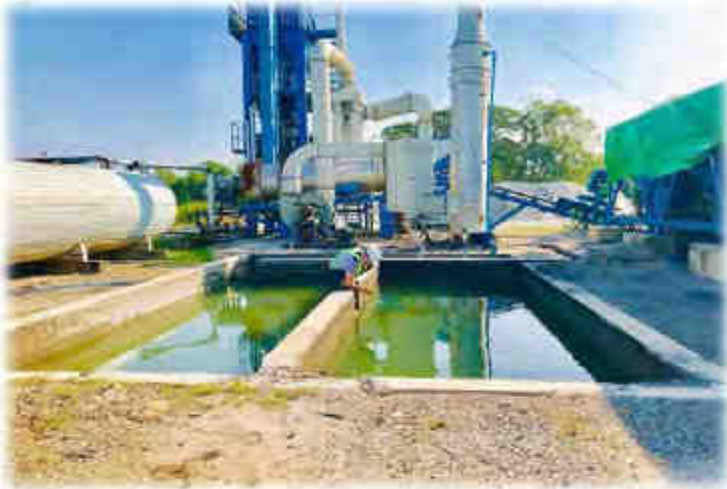
Point : Asphalt Plant Settlement Water Pond	
Notice Date	: 29-Nov-2018
Testing Date	: 30-Nov-2018
Parameter	: PH
Measured Result	: 7 (Approximately)
Baseline Result	: -
Standard Result	: 6 to 9
(Approved CEMP)	
Remark	: All paving works were completed on the month of May 2018, hence, the Asphalt Plant is currently idle. The tank is filled with rainwater from the previous month.
Photo	:

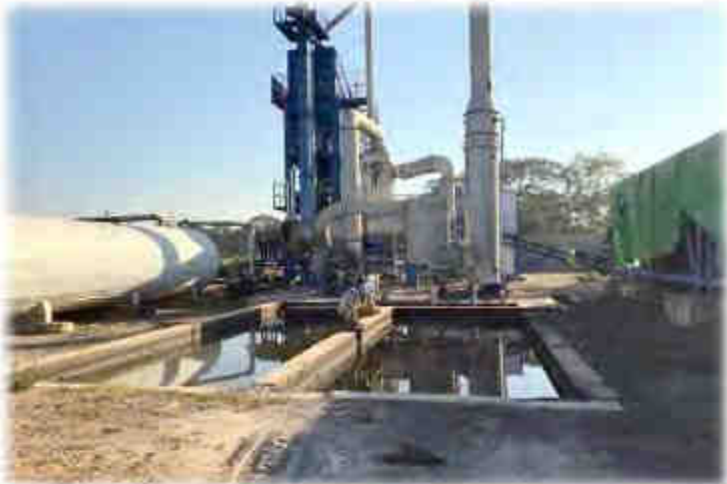
Point : Asphalt Plant Settlement Water Pond	
Notice Date	: 27-Dec-2018
Testing Date	: 28-Dec-2018
Parameter	: PH
Measured Result	: 7 (Approximately)
Baseline Result	: -
Standard Result	: 6 to 9
(Approved CEMP)	
Remark	: All paving works were completed on the month of May 2018, hence, the Asphalt Plant is currently idle. The tank is filled with rainwater from the previous month.
Photo	:

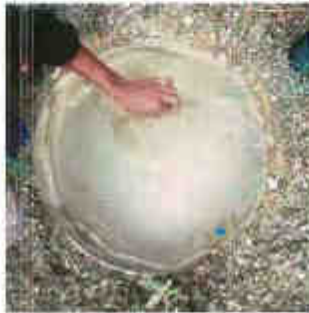
Point 3 : Batching plan (Water Treatment) Drain 3

Testing date: Sept 25, 2018
Parameter: pH
Measured Result: 12
Baseline Result: 7.3
Standard Result: 6 to 9
Remark: *The current result is higher than the top of the standard line limit (out of limit)*

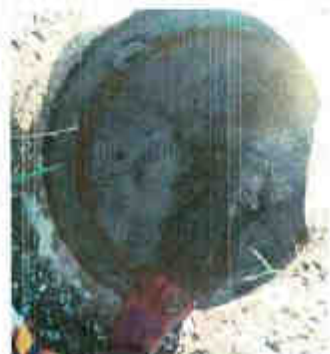
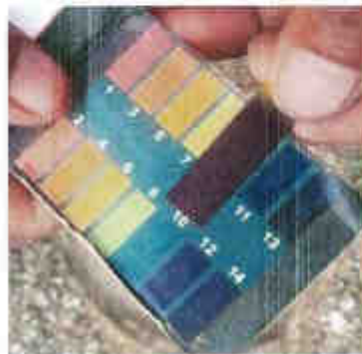
Point 4 : Batching plan (Water Treatment) Drain 3

Testing date: Sept 25, 2018
Parameter: pH
Measured Result: 12
Baseline Result: 7.3
Standard Result: 6 to 9
Remark: *The current result is higher than the top of the standard line limit (out of limit)*

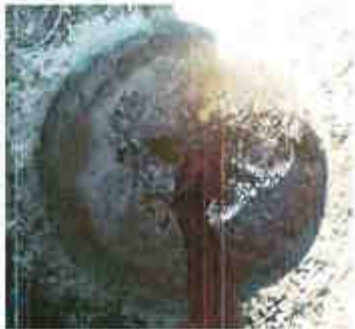
Point 5 : Batching plant (Water Treatment) Drain 4

Remark *The current result is higher than the top of the standard line limit (out of range)*

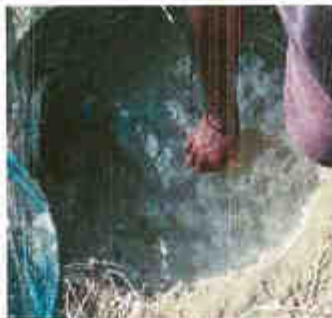
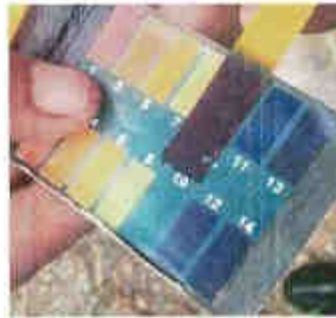
Point 6 : Batching plant (Water Treatment) Drain 5

Remark *The current result is higher than the top of the standard line limit (out of range)*

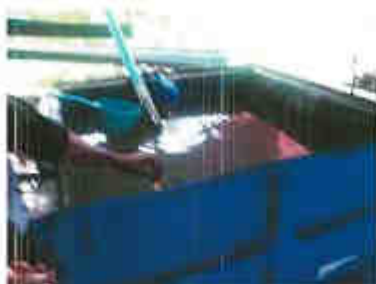
Point 7 : (Water Treatment) Drm. Cameng

Testing date: Sept 25, 2018
Parameter: pH
Measured Result: 6
Baseline Result: 7.3
Standard Result: 6 to 9
Remark: Current result is Standard with baseline and standard limit

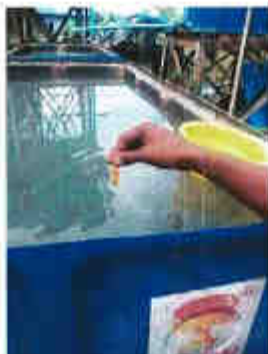
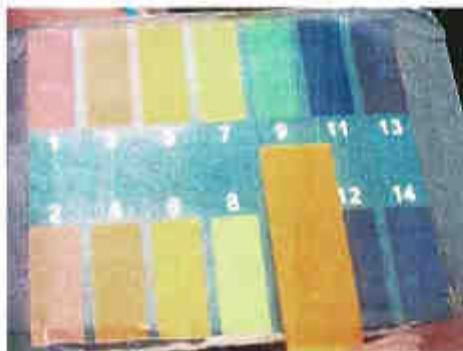
Point 10: Clean Water Treatment Plant

Testing date: Sept 25, 2018
Parameter: pH
Measured Result: 7
Baseline Result: 7.3
Standard Result: 6 to 9
Remark: Current result Standard with baseline and standard limit.

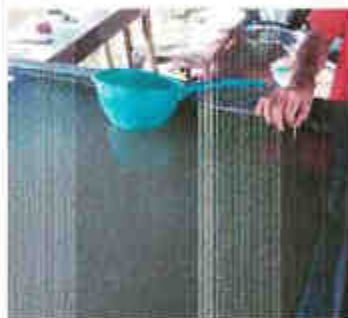
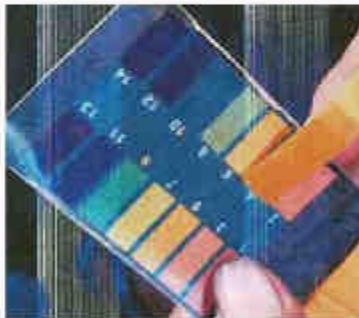
Point 2 : (Water Treatment) Drum Context

Testing date : November 13, 2018
 Parameter : pH
 Measured Result : 6
 Baseline Result : 7.3
 Standard Result : 6 to 9
 Remark : *The results of measurement are still according to the standard*

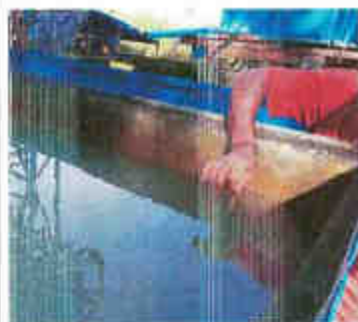
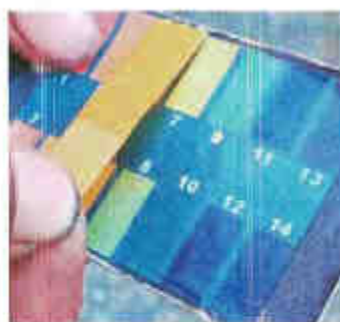
Point 3 : Domestic Waste Water Treatment (drainage)

Testing date : November 13, 2018
 Parameter : pH
 Measured Result : 7
 Baseline Result : 7.3
 Standard Result : 6 to 9
 Remark : *The results of measurement are still according to the standard*

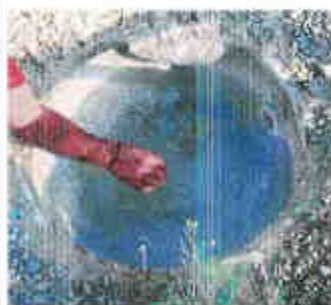
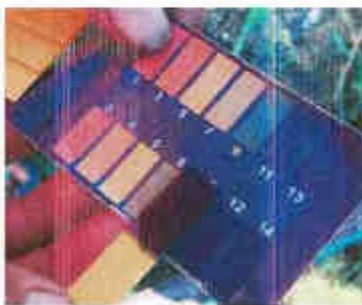
Point 5 : Batching plant (SS size Treatment) (10/11/2018)

Remark : *The results of measurement are above the recommended standards*

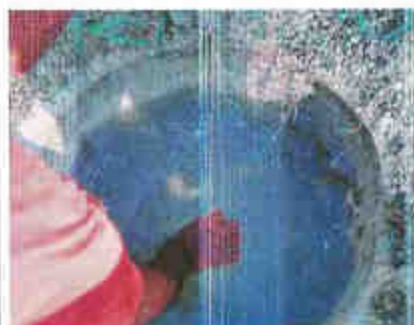
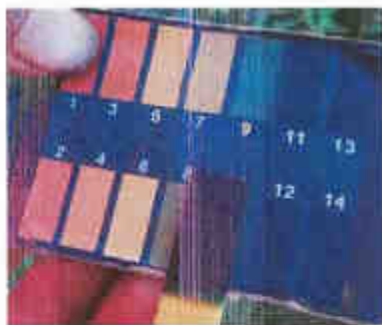
Point 6 : Batching plant (SS size Treatment) (10/11/2018)

Remark : *The results of measurement are above the recommended standards*

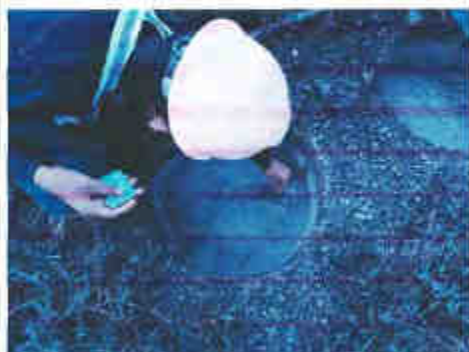
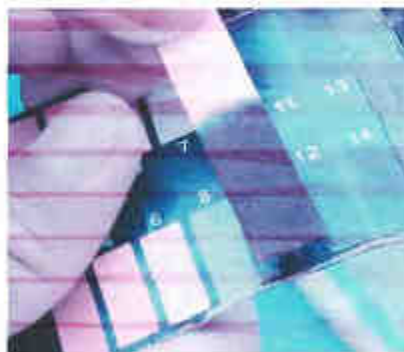
Point 3 : Batching plan (Water Treatment) Drum 2

Testing date : December 10, 2018
Parameter : pH
Measured Result : 12
Baseline Result : 7,3
Standard Result : 6 to 9
Remark : *The results of measurement are above the recommended standards*

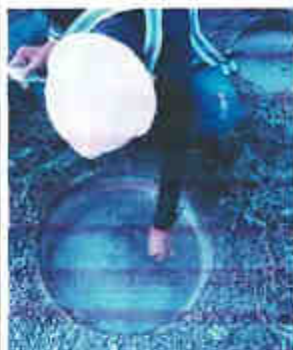
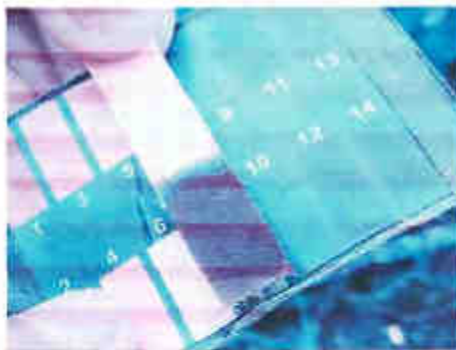
Point 4 : Batching plan (Water Treatment) Drum 3

Testing date : December 10, 2018
Parameter : pH
Measured Result : 12
Baseline Result : 7,3
Standard Result : 6 to 9
Remark : *The results of measurement are above the recommended standards*

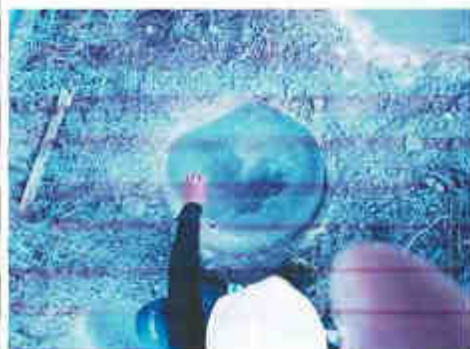
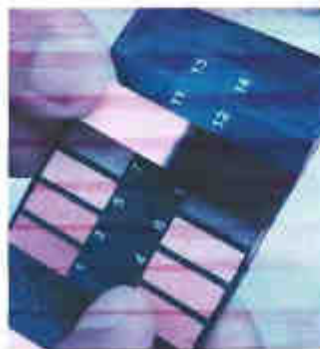
Point 5 : Batching plan (Water Treatment) Drum 4

Remark : *The results of measurement are above the recommended standards*

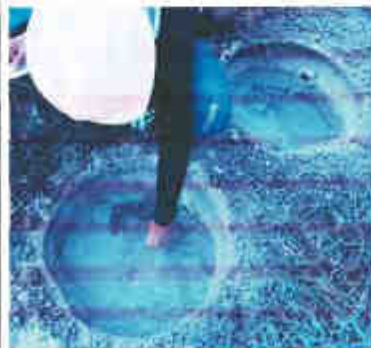
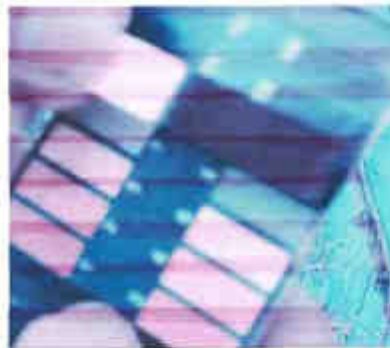
Point 6 : Batching plan (Water Treatment) Drum 5

Remark : *The results of measurement are above the recommended standards*

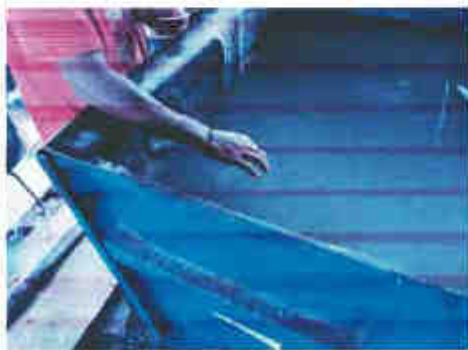
Point 7 : (Water Treatment) Drum Canter

Testing date : December 10, 2018
Parameter : pH
Measured Result : 6
Baseline Result : 7.3
Standard Result : 6 to 9
Remark : *The results of measurement are still according to the standard*

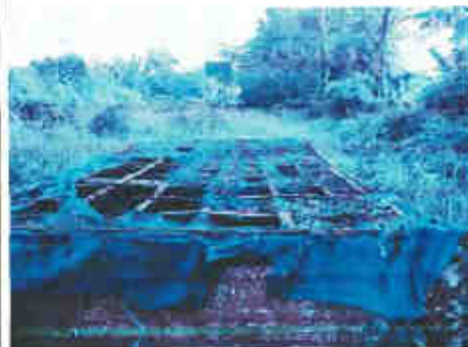
**Point 8 : Domestic Waste Water Treatment Drainage**

Testing date : December 10, 2018
Parameter : pH
Measured Result : 7
Baseline Result : 7.3
Standard Result : 6 to 9
Remark : *The results of measurement are still according to the standard*
