# Environmental Monitoring Report

## SRI: Integrated Road Investment Program – Tranches 2, 3 & 4

### PIC 03 – Sabaragamuwa, Central Provinces and Kaluthara District

**ENVIRONMENTAL SAFEGUARD  
MONITORING ANNUAL REPORT**  
[January – December 2018]

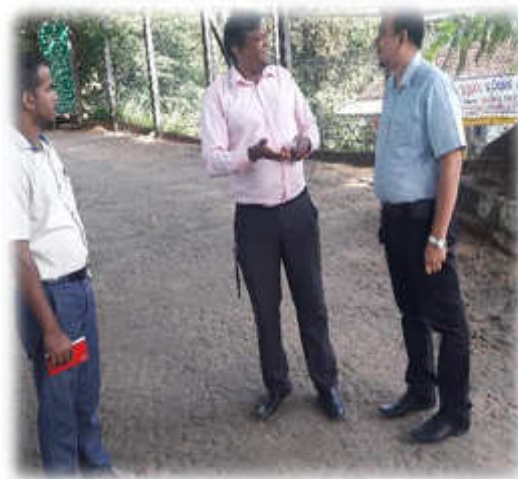
**Images 4.19 and 4.20 NE1 drainage system discharging untreated waste water from the Rikillagaskada Hospital to the road (Road ID. No.11) and educating the Medical Superintendent of the Hospital by ES of PIC03 on 1 October 2018 on how to avoid the situation through the introduction of a proper waste water treatment system**

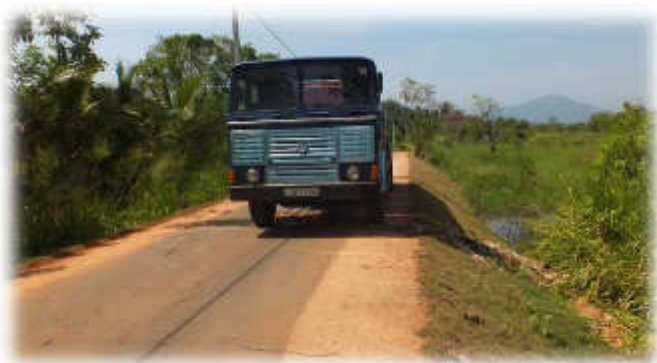
**Image 5.1.1 Watering Road No. 9, CH:0 +210 in the MA 2 Package for dust control**

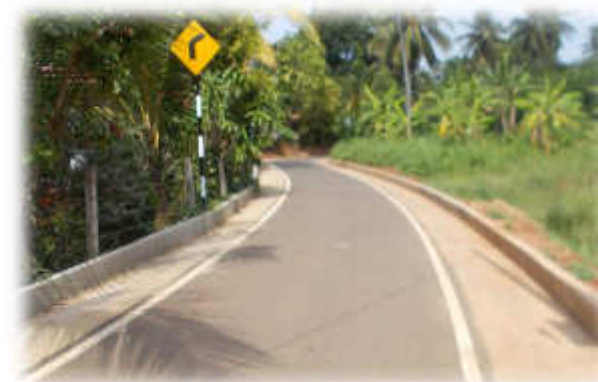
**Image 5.1.3 Hard shoulder and L drain of the Road No 52, CH:0+090 in the MA 2 Package constructed for erosion control**

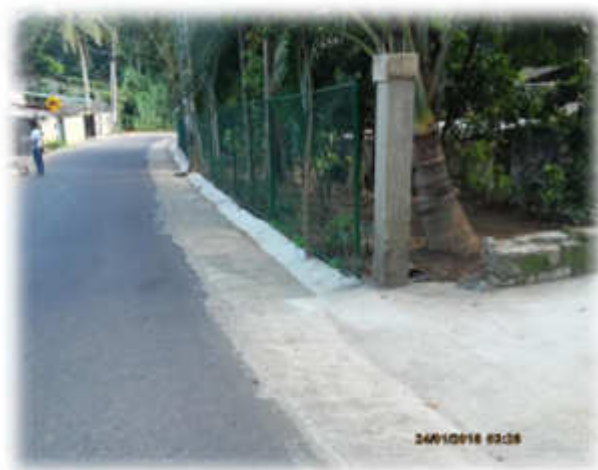
**Image 5.1.4 Hard solder for erosion control at Road No 41 at CH: 0+550 in the KA1 Package**

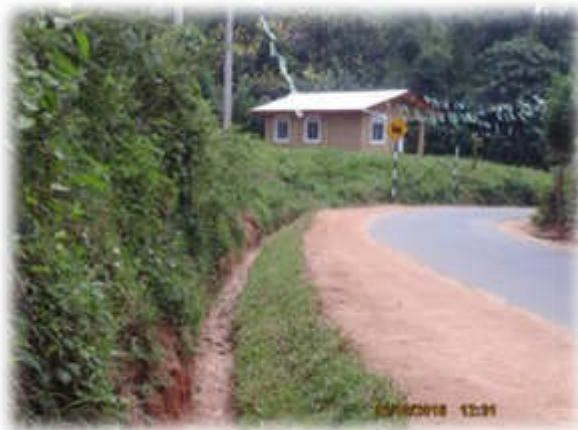
**Image 5.1.8 Turfing for erosion control at Road No 41, 1+910-LHS in the KA1 Package**

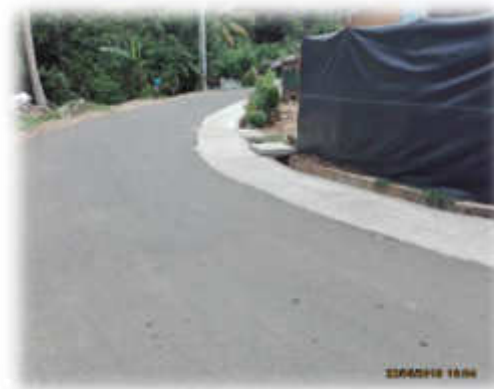
**Image 5.1.12 Hard solder for erosion control at Road No 43 at 3.350 in the KA1 Package**

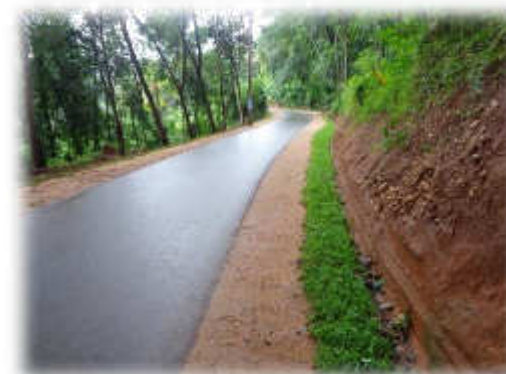
**Image 5.1.15 Hard shoulder for erosion control at Road No. 37, CH-3+730 in the KA3 Package**

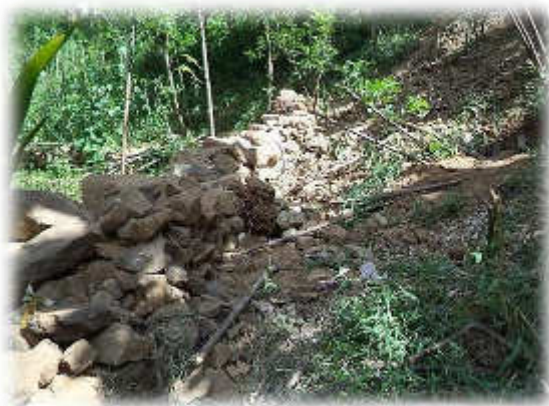
**Image 5.1.16 Boulder packing for erosion control at the dumping yard of Road No.11 in the NE1 Package**

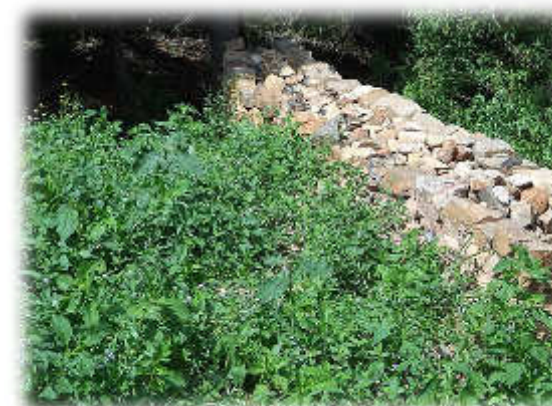
**Image 5.1.18 Boulder packing for erosion control at the dumping yard of Road No.8 in the NE1 Package**

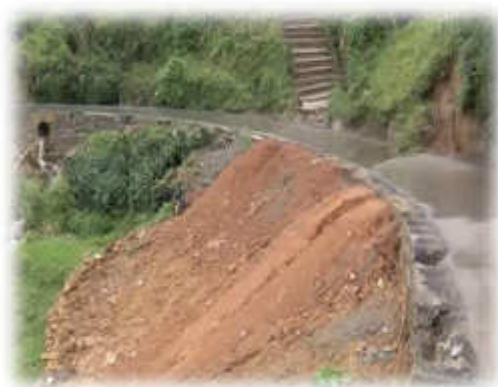
**Image 5.1.19 Toe wall developed for erosion control at Road 16. (CH:3+800 RHS)**

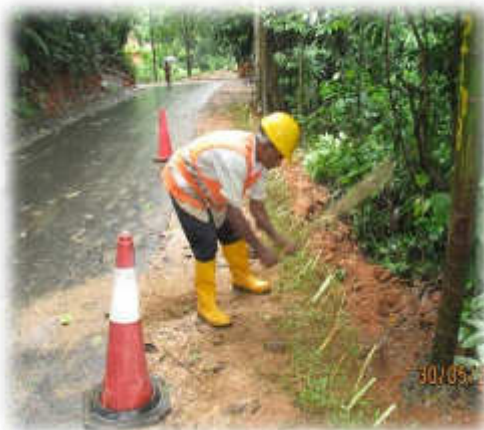
**Image 5.1.22 Turfing to control erosion at CH: 5+400 LHS of Road No. 47 in the NE3 Package**

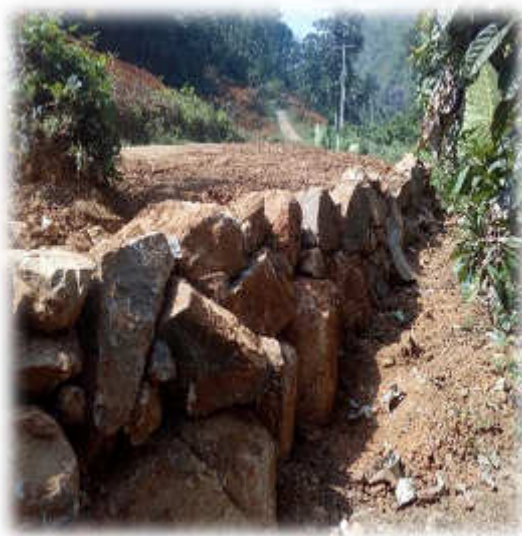
**Image 5.1.31 Boulder packing to control water pollution and soil erosion at Road No.27 (CH: 3+050 RHS), KE 2 Package**

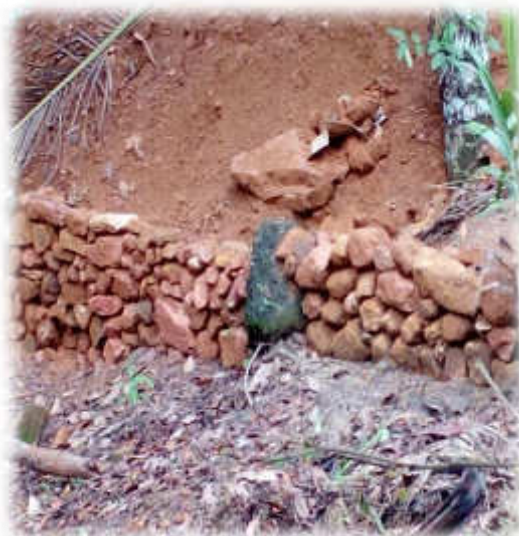
**Image 5.1.32 Boulder packing to control water pollution and soil erosion at Road ID. 26 (CH:2+110) KE 2 Package**

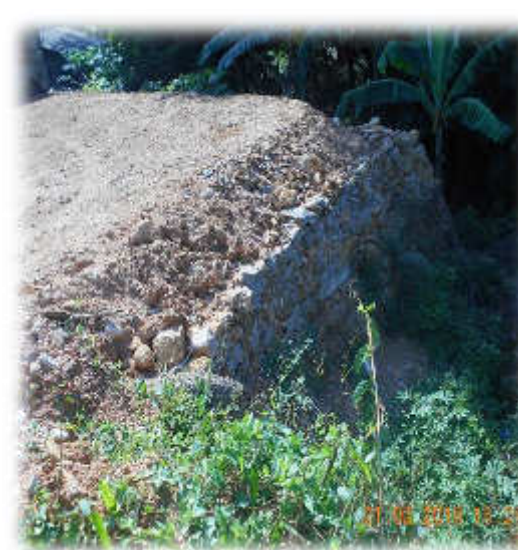
**Image 5.1.33 Boulder packing to control water pollution and soil erosion Road ID. 22 (0+200 RHS) in the KE 2 Package**

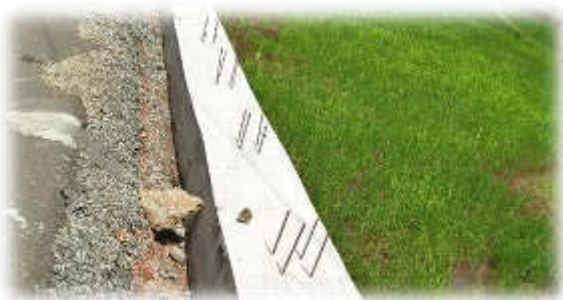
**Image 5.1.38 Reinforcing bars on the culvert head wall which have been reserved for guard stones at Road No. 46 in the KE3 Package**

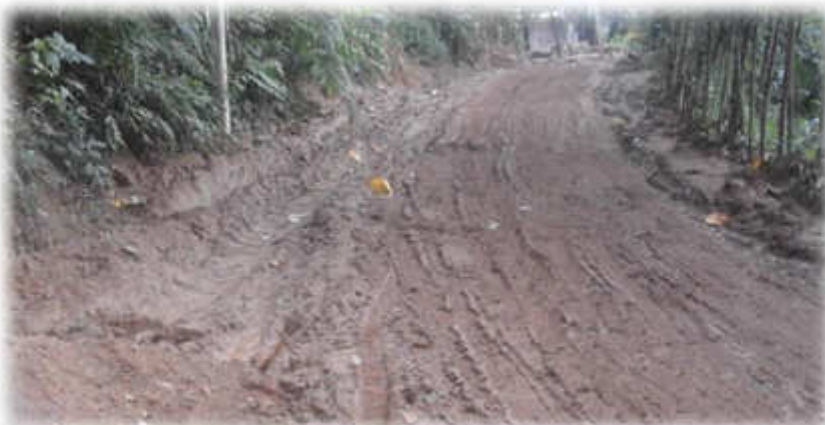
Image 5.1.40 Poor road surface of Road No. 56 in the KE3 Package

Image 5.1.41 Completed road surface of Road No. 56 in the KE3 Package

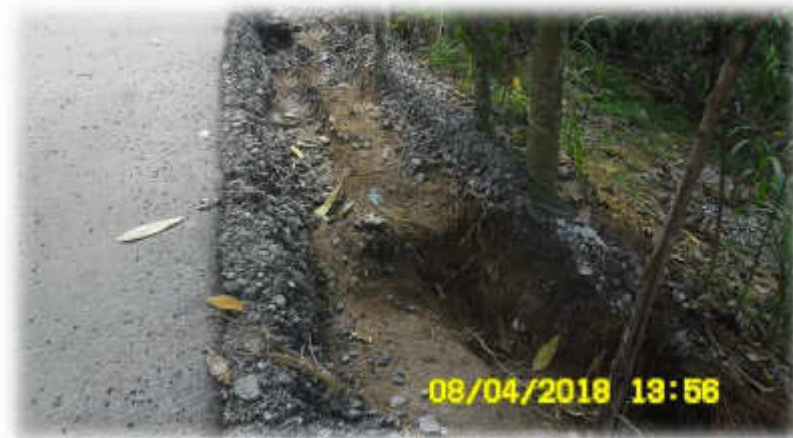
Image 5.1.42 Eroded road edge of Road No. 29 in the KE3 Package and the flooded house

Image 5.1.43 L drain at Road No. 29 in the KE3 Package

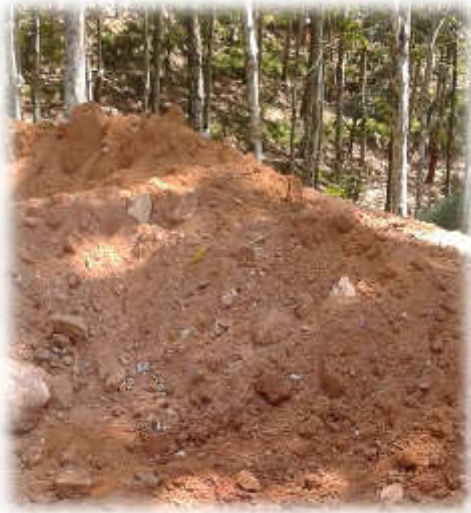
**Image 5.2.13 Erosion at the disposal yards at Road No.10 A, CH:4+380 RHS in the R3 Package**

**Image 5.2.14 Construction of boulder packing at the disposal yards for erosion control at Road No. 10 A in the R3 Package**

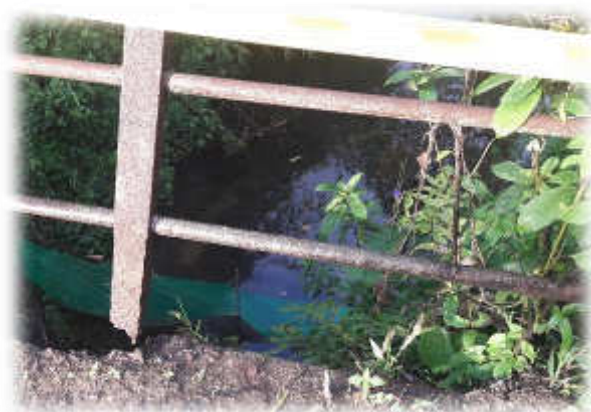
**Image 5.2.19** Water polluted by eroded soil from the water stream near Road No. 53 in the KL2 Package, in which endemic fish species were found

**Image 5.2.20** Stream after cleaning and the net fixed to avoid the migration of endemic fish to the disturbed area of the stream near Road No. 53 in the KL2 Package

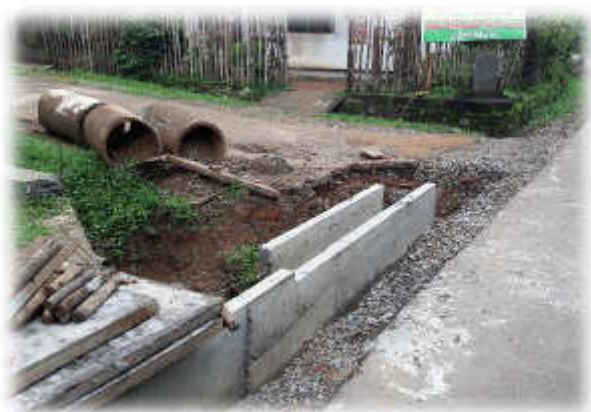
**Image 5.2.21.** Damage caused to the entrance of a sales outlet due to road construction activities, of Road No. 15 in the KL1 Package

**Image 5.2.22** Repaired entrance of the sales outlet of Road No. 15 in the KL1 Package
