### SRI: Integrated Road Investment Program Improvement, Rehabilitation and Maintenance of A003 Road from Kochchikade (CH 38 + 000 km) to Puttalam (CH 126 +800 km)

Prepared by the Road Development Authority, Ministry of Highways for the Asian Development Bank.

**Improvement, Rehabilitation and Maintenance of  
The section of A003 Road from Kochchikade Bridge to  
Chilaw**

## **Initial Environmental Examination Report**

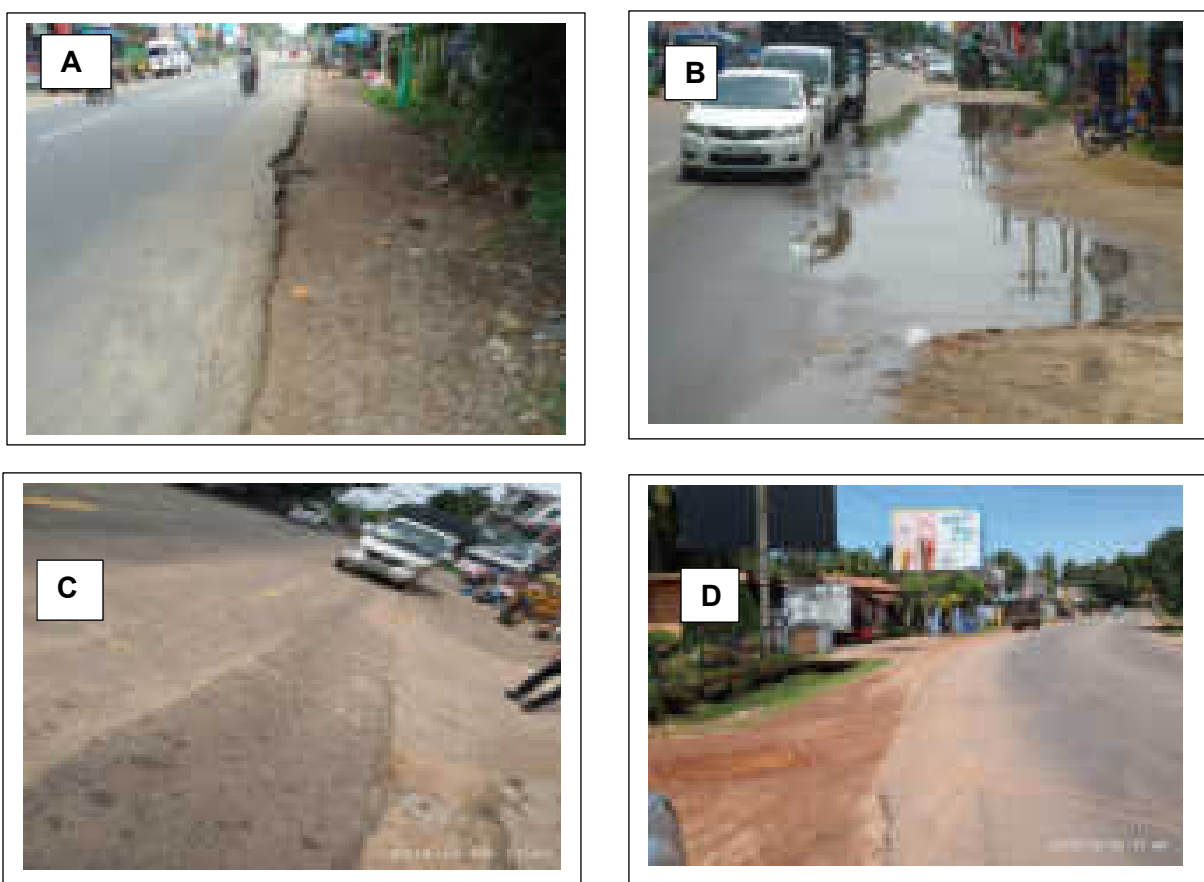
**Figure IV-3: Existing conditions of the shoulders in the project area.**

67. The existing carriageway of the road varies from 5.0 m to 7.0 m in width within the ROW, generally providing adequate space to support for the proposed widening of the road, where required. The road generally follows good horizontal and vertical alignments and have good drainage provisions. But, due to the lack of proper maintenance, they need improvement. Hard shoulders are found in the major towns, such as Wennappuwa, Mahawewa and Chilaw intermittently with the soft shoulders. About 90% of the shoulders are soft shoulders, and are subjected to the pavement edge erosion, presenting a safety hazard to traffic and to the pedestrians, who must use the shoulder as a walkway and also riding bicycles and motor bicycles. Some samples exhibiting the conditions of the existing shoulder are given in **Figure IV-3**.

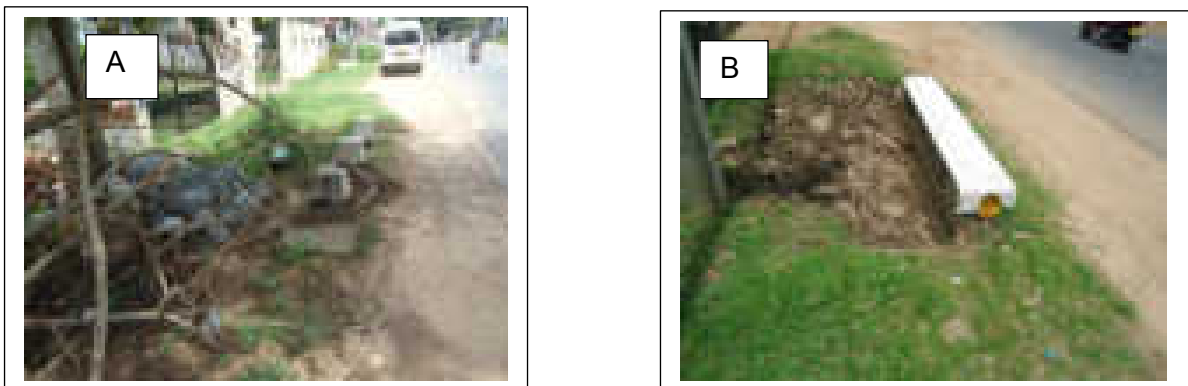
**Figure IV-4: Present conditions of the drains in the project area**

70. Details of the hydraulic condition shall be studied prior to the detailed design. Almost all of them are in need of at least, clearing and cleaning.

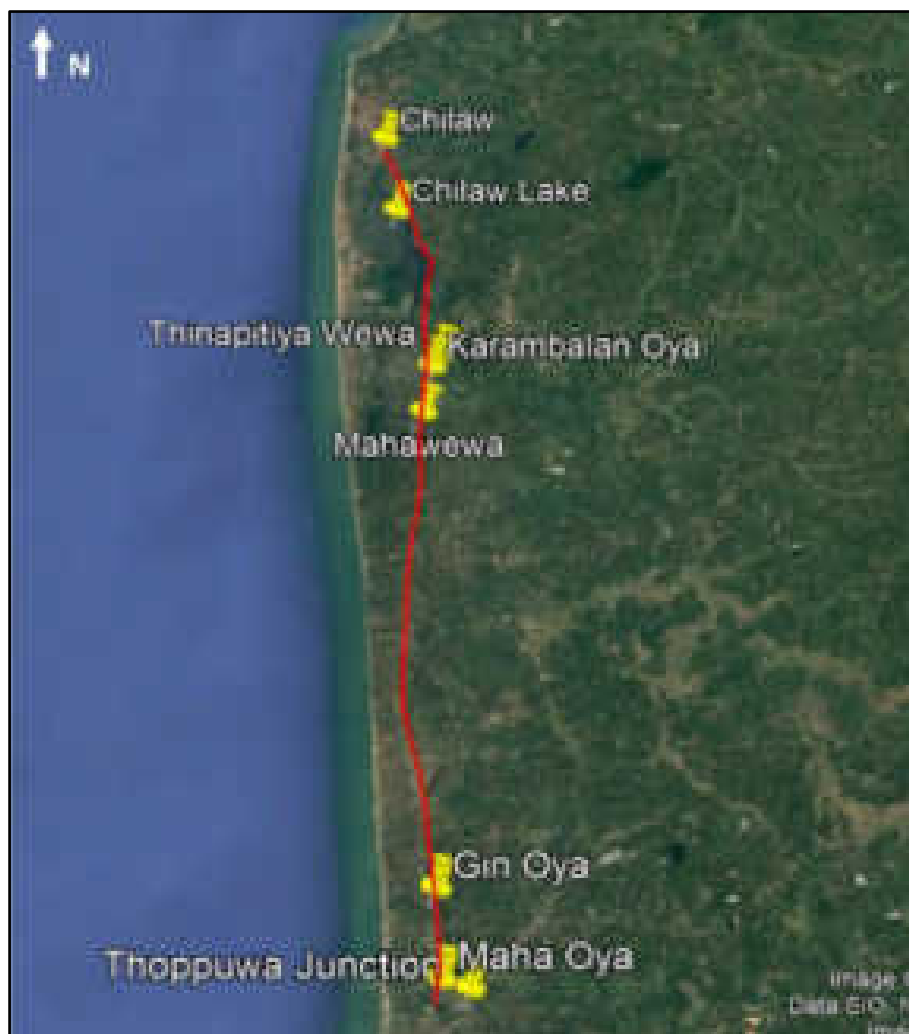
**Figure IV-9:** Main water bodies from Thoppuwa junction to Chillaw

80. The interested section of the road starts from Kochchikade bridge at Thoppuwa junction and ends at Chillaw town. The distance in between these two points is 36 km. The main water bodies in this stretch are Maha Oya, Gin Oya, Maha Wewa, Karambalan Oya (Lunu Oya) and Thinapitiya Wewa (**Table IV-3**). In addition to these main surface water bodies, a large number of seasonal streams also cross the road throughout the stretch.

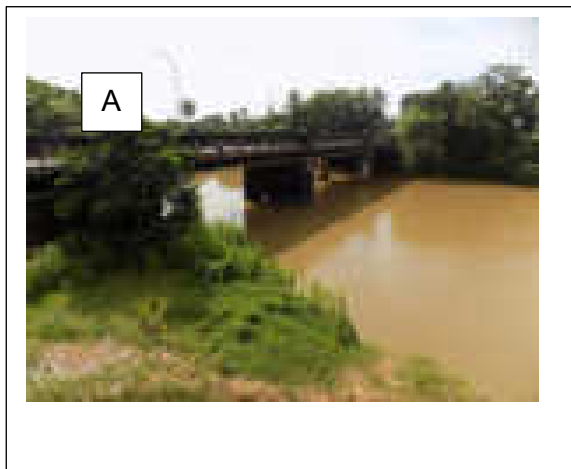
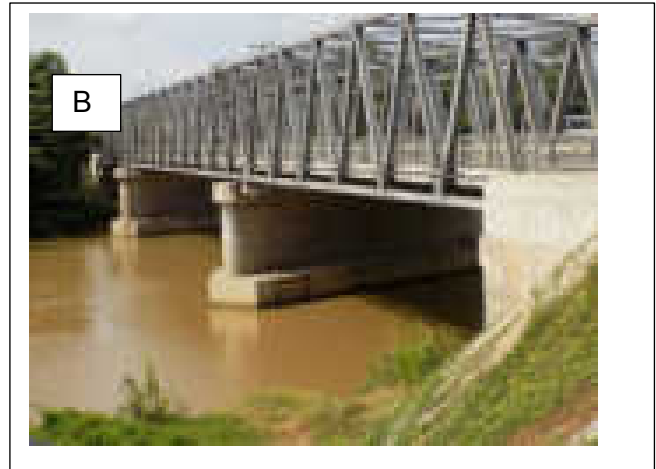
**Figure IV-10: View of the Kochchikade Bridges**

82. The road section proposed for rehabilitation and improvement starts from Maha Oya. In this location the river width is around 85 m. Maha Oya starts from Aranayake area in Kegalle district and enters sea from Sindathriya in Wayikkala area. The total length of the river is 134 km and the catchment area is 1,510 km<sup>2</sup>. The annual flow is around 1,240 MCM. The distance from the bridge to sea is 3.5 km. The location Map is given in **Annex IV.5 (Figure 1)** and the pictorial view of the bridge is given in **Figure IV-10**.

**Note:** A- - Old Bridge, B- View of the new Kochchikade Oya Bridge

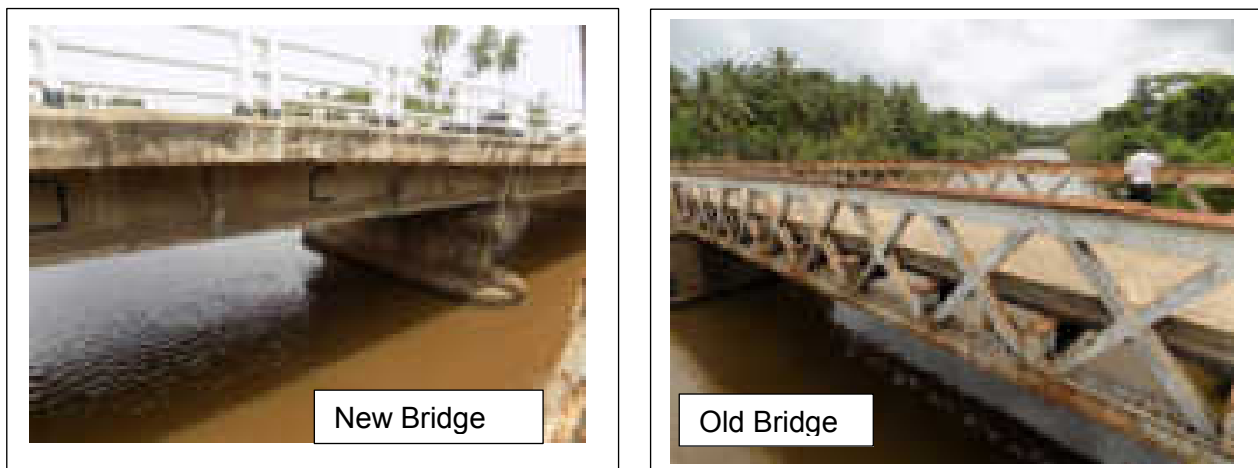
**Figure IV-11:** Gin Oya new and old bridges

83. Gin Oya crosses the road in between 41 – 42 km posts. The catchment of Gin Oya closer to the road is large around 14 km of river mostly flows parallel to the road. The catchment area at bridge is around 290 km<sup>2</sup>.

84. When the river reaches close to the sea, a branch of it connects with Maha oya. In the north direction, the river is connected to Negambo – Puttalam canal. The location of the Gin Oya is given in **Annex IV-5 (Figure 2)** and the **Figure IV-11** shows the bridges that cross the Maha Oya.

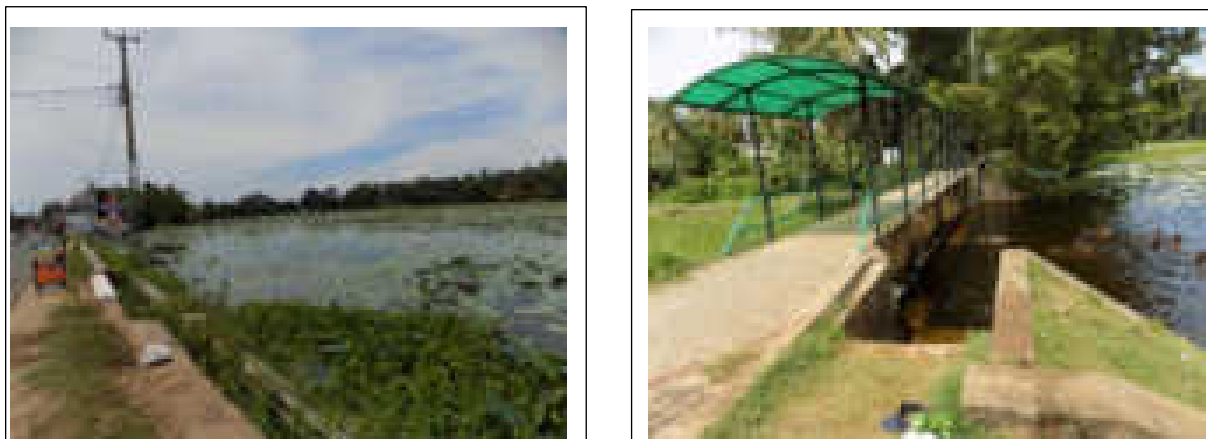
**Figure IV-12:** Mahawewa and its spill

85. Mahawewa is a tank located in between 59 – 60 km postson the road. The tank is maintained by the Irrigation Department of the North-Western Provincial Council. The spill water flows through a canal, which passes through Mahawewa town. Normally tank spills every year. The full spill water level of the tank is around 0.8 m below the road level. **Figure IV-12** shows the Mahawewa and its spill.

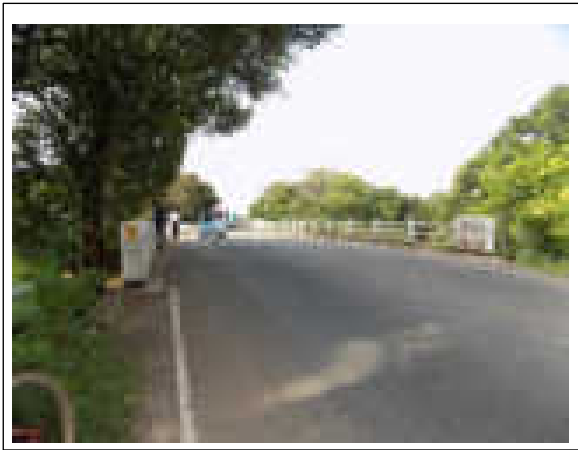
**Figure IV-13:** Karambalan Oya bridge and Karambalan Oya

87. The catchment area at the bridge is around 658 km<sup>2</sup>. Karambalan Oya has a larger catchment close to the road. Hence, the chances of flooding the road is high. Karambalan Oya is formed by adding several small rivers like, Lunu Oya, Kadupitiya Oya, Yatakalan Oya, Kalubulu Oya, Karaththamankade Ela, Udawatte Ela, Gulagedara Ela, Poluliyadda Yoda Ela, Dambodagalla Ela, Doowa Ela and Godakumbura Oya. The location map is given in **Annex IV.5 (Figure 3)** and the view of the Karambalan Oya bridge and Karambalan Oya and flooding areas before and after Karambalan Oya bridge are given in **Figure IV- 13 and 14** respectively.

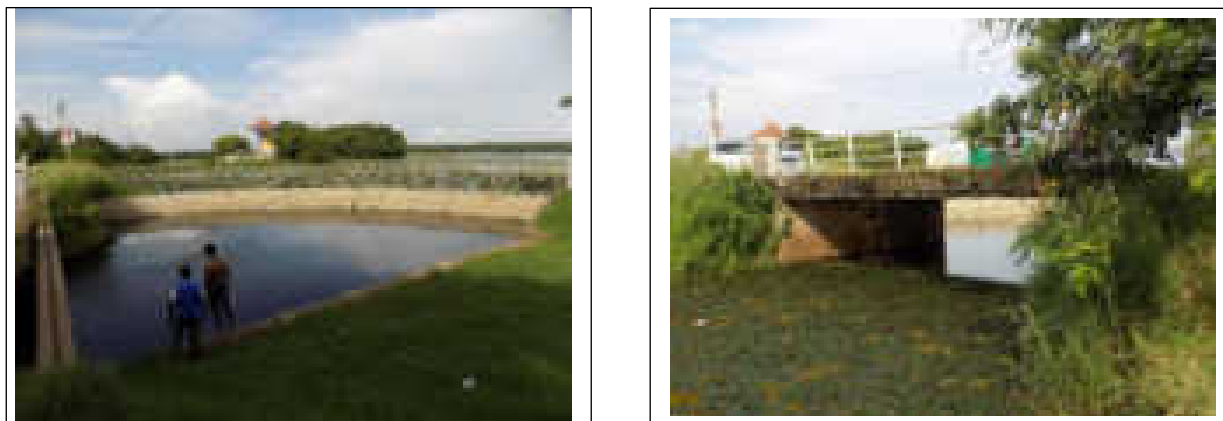
**Figure IV-15:** Thinipitiya tank spill and bridge in spill tail canal

88. The tank is maintained by the Irrigation Department of the North-Western Provincial Council. The spill is very close to the road. Spill water flows under the bridge. Thinipitiya tank spill and bridge in spill tail canal is shown in **Figure VI-15**.

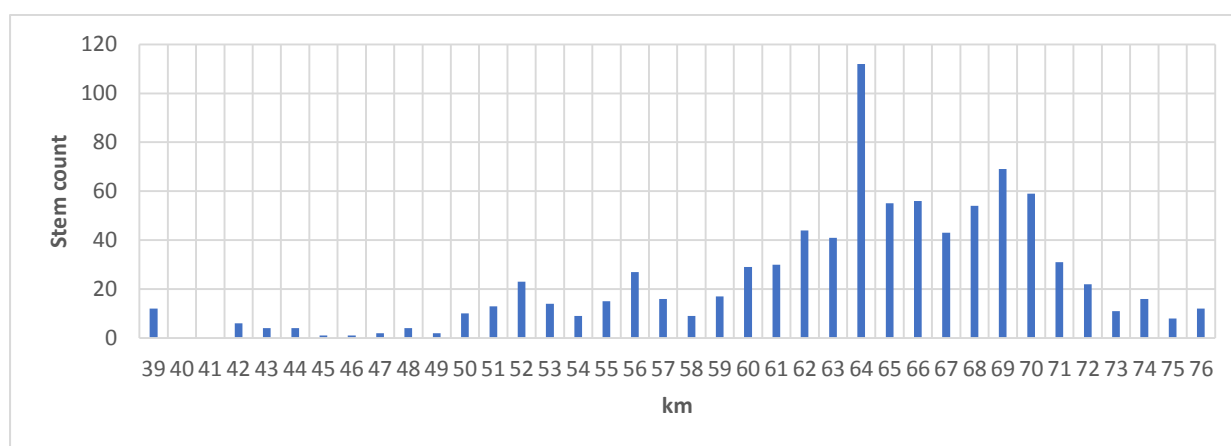
**Figure IV-18: Recorded stems in the waysides from 38km to 76km on A003 road.**

114. Considering the vegetation of the ROW, there are number of trees ( $\geq 150$  cm girth at the breast height) covering or blocking the roadways were observed. Within 66 km range, seven (7) Maha nuga (*Ficus benghalensis*) trees and two (2) Maha nuga (*Ficus benghalensis*) trees near 63+400 km were observed (**Figure IV-17 B**). Continuous tree belt of Kumbuk (*Terminalia arjuna*) was recorded from 59+700 to 61+100 km area (on left side from Colombo to Puttalam direction) with large number of trees above 150 cm girth at the breast height. According to the recorded data from ROW vegetation, a 'green zone' can be identified from 59+700 to 72+800 range due to availability of wayside trees (Ref. **Figure IV-18**).

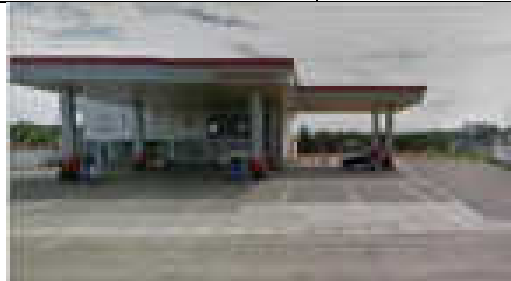
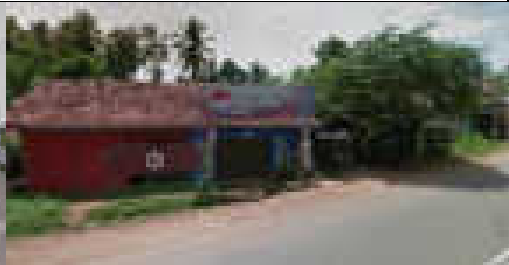
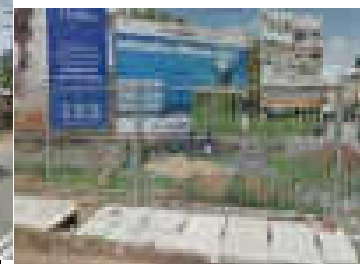
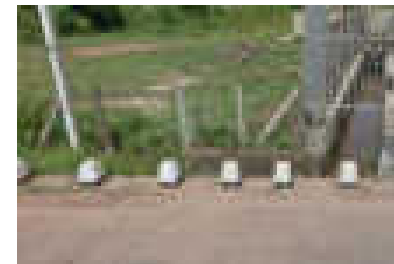
Left side				Right Side			
1. Covering From (KM):	38 Km	To:	39 Km	1. Covering From (KM):	38 Km	To:	39 Km
2. Details of Drainage	Start	End	Length	2. Details of Drainage	Start	End	Length
○ D1	38+250	38+300	50 m	○ D1	38+80m	38+130m	50m
○ D2	38+840	38+890	50m	○ D2	38+250m	38+325m	75m
○ D3				○ D3			
3. Condition	D1 - 50m length, located Infront a fuel station. Concrete covered box drains discharges to the nearby bare land D2 - 50m length, connected to culvert 39/1, earth drain, partly silted, water reaches about 2m - 3m to the road due to the stagnation and insufficient capacity of the road drain			3. Condition	D1–Covered with concrete slab from the Thoppuwa Junction bend towards chilaw Infront of existing vegetable market  D2 – 75m length earth drain available in opposite to the fueling station in Waikkala. Box drain, the right side of the wall is damaged. Need improvement.

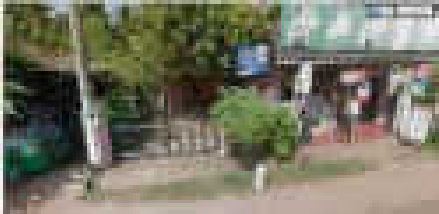
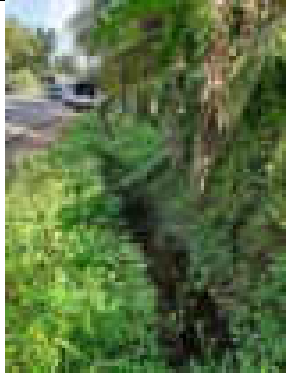
Left side				Right Side			
1. Covering From (KM):	39 Km	To:	40 Km	1. Covering From (KM):	39 Km	To:	40 Km
2. Details of Drainage	Start	End	Length	2. Details of Drainage	Start	End	Length
○ D1	39+500m	39+525	25m	○ D1	39+500m	39+570m	70m
○ D2	39+900	39+950	50m	○ D2	39+850m	40+050m	200m
○ D3	39+950	40+220	270m	○ D3			
<b>3. Condition</b>	<b>D1</b> - 25 m length, box drain, partly silted, no major issues of flooding <b>D2</b> - 50 m box concrete drain, good condition water overtopping up to 2-3m to the road. Water stagnated due to the erosion of the soft shoulder is observed intermitted places. <b>D3</b> – 300m length earth drain available.			<b>3. Condition</b>	<b>D1</b> - 70m length open earth drain available <b>D2</b> - The part of the drain is construct structured and covered by vegetation with partly damaged.

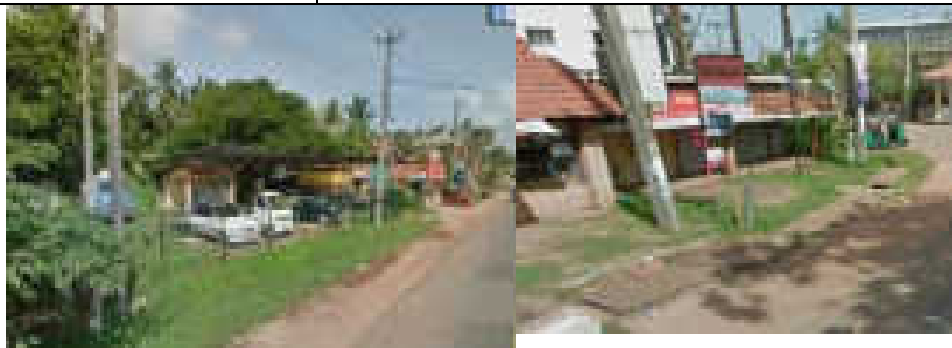
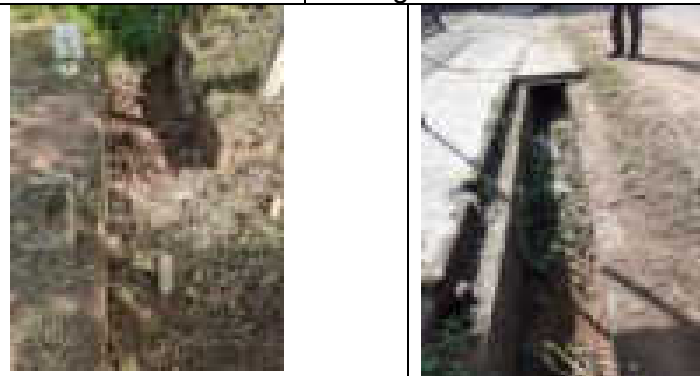
Left side				Right Side			
1. Covering From (KM):	40 Km	To:	41 Km	1. Covering From (KM):	40 Km	To:	41 Km
2. Details of Drainage	Start	End	Length	2. Details of Drainage	Start	End	Length
○ D1	39+950	40+220	270m	○ D1	40+000	40+375	375m
○ D2	40+560	40+585	25m	○ D2	40+400	40+475	75m
○ D3				○ D3	40+800	40+850	50m
3. Condition	D1 - water overtopping up to 2-3m to the road. Water stagnated due to the erosion of the soft shoulder is observed intermitted places. D2 - 25 m length, box drain, partly silted, the slabs are damaged			3. Condition	D1 - Open concrete drain structure is available. D2 – Open concrete drain structure, found some garbage disposal nearby. D3 – Open and covered with concrete. Initially, the drain was covered with concrete slab, but currently, part of drain damaged and silted.

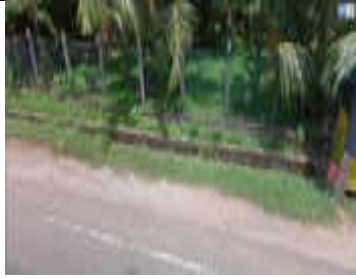
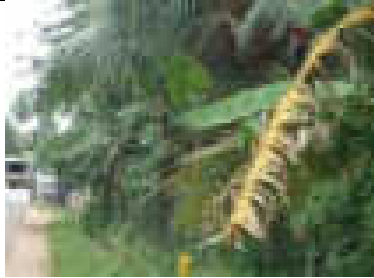
Left side				Right Side			
1. Covering From (KM):	41 Km	To:	42 Km	1. Covering From (KM):	41 Km	To:	42 Km
2. Details of Drainage	Start	End	Length	2. Details of Drainage	Start	End	Length
○ D1	No Drain			○ D1	41+300	41+390	90m
○ D2				○ D2	41+850	42	150m
○ D3				○ D3			
3. Condition				3. Condition	<b>D1</b> - Open concrete drain structure in available. <b>D2</b> - Open concrete drain structure in available.

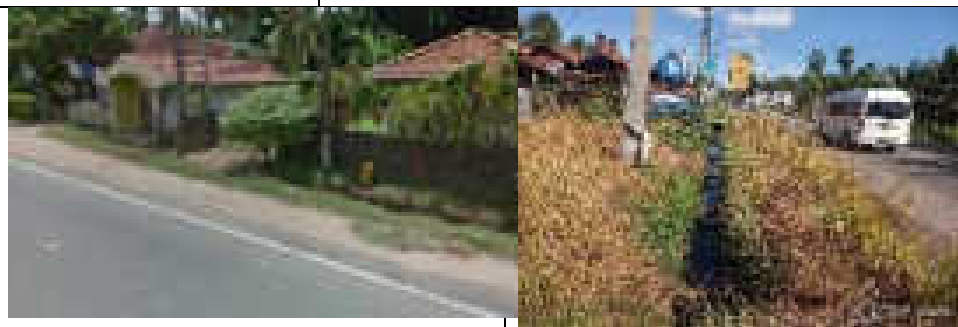
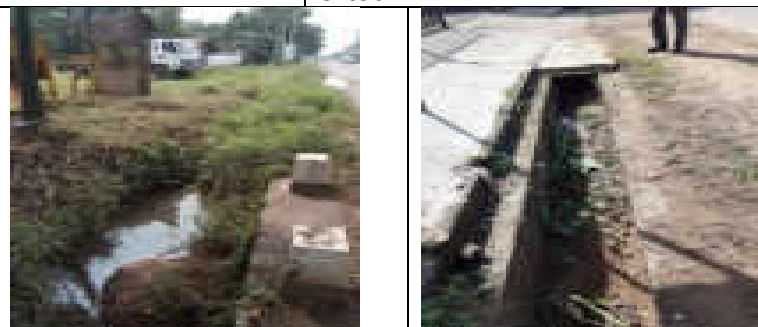
Left side				Right Side			
1. Covering From (KM):	42 Km	To:	43 Km	1. Covering From (KM):	42 Km	To:	43 Km
2. Details of Drainage	Start	End	Length	2. Details of Drainage	Start	End	Length
○ D1	42+740	42+790	50m	○ D1	42+150	42+250	100m
○ D2				○ D2	42+400	40+550	150m
○ D3				○ D3			
3. Condition	D1 - 50m length, connected to culvert42/2, Earth drain and concreted, partly silted,			3. Condition	D1 - Concrete drain network available at this town area (Nainamadama town), part of the drainage is damaged and silted D2 - Open concrete drain structure partly silted

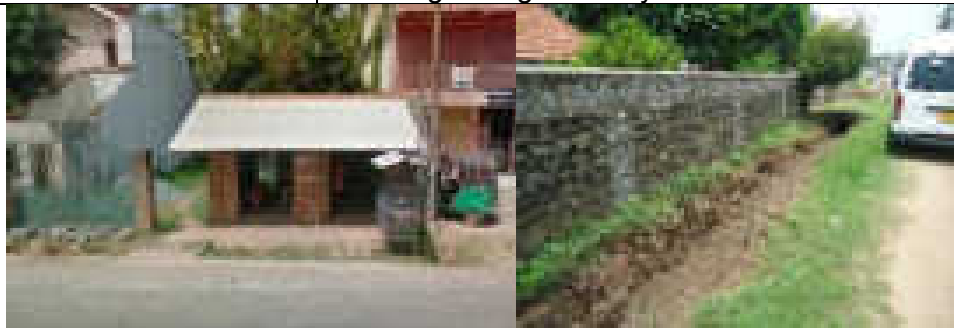
Left side				Right Side			
1. Covering From (KM):	43 Km	To:	44 Km	1. Covering From (KM):	43 Km	To:	44 Km
2. Details of Drainage	Start	End	Length	2. Details of Drainage	Start	End	Length
○ D1				○ D1	No Drain		
○ D2	43+525m	43+550	25m	○ D2			
○ D3				○ D3			
3. Condition	D1 - 25 m earth drain, silted and covered with vegetation. No lead way drain. Water stagnated. Flooding during the rainy season			3. Condition

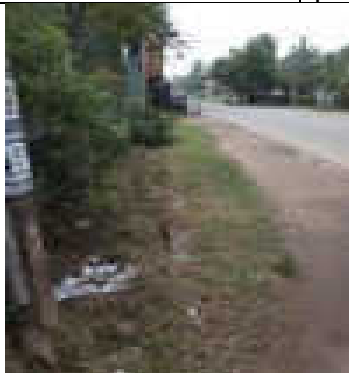
Left side				Right Side			
1. Covering From (KM):	44 Km	To:	45 Km	1. Covering From (KM):	44 Km	To:	45 Km
2. Details of Drainage	Start	End	Length	2. Details of Drainage	Start	End	Length
○ D1	No drain			○ D1	44+900	45	100m
○ D2				○ D2			
○ D3				○ D3			
3. Condition				3. Condition	D1 - Open and covered with concrete slab drain. Basically, the drain was fully covered with concrete slab but currently, part of drain damaged and Silted.

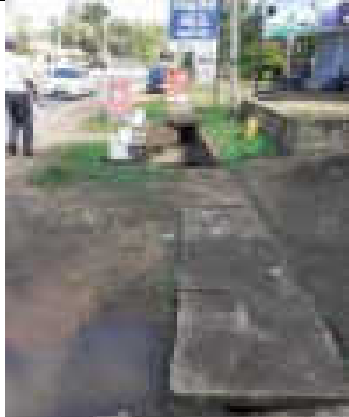
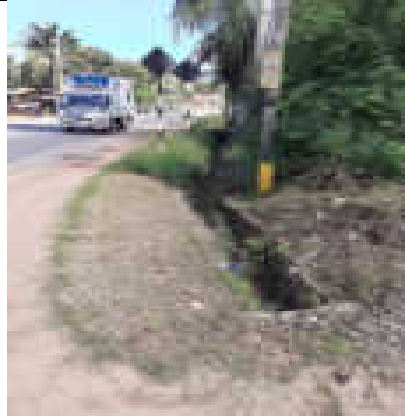
Left side				Right Side			
1. Covering From (KM):	45 Km	To:	46Km	1. Covering From (KM):	45 Km	To:	46Km
2. Details of Drainage	Start	End	Length	2. Details of Drainage	Start	End	Length
○ D1	No drain			○ D1	45+000	45+280	280m
○ D2				○ D2			
○ D3				○ D3			
3. Condition				3. Condition	D1 - Open and covered with concrete. Basically, the side walls are damaged and silted.

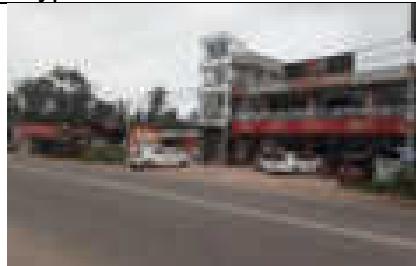
Left side				Right Side			
1. Covering From (KM):	46 Km	To:	47 Km	1. Covering From (KM):	46 Km	To:	47 Km
2. Details of Drainage	Start	End	Length	2. Details of Drainage	Start	End	Length
i. D1	No drain			ii. D1	46	46+550	550m
iii. D2				iv. D2	46+575	46+650	75m
v. D3				vi. D3			
3. Condition				3. Condition	D1 - Covered drain is covering the entire Wennappuwa town area. Majority of drain system was fully covered and some are "V" Ditch type drain

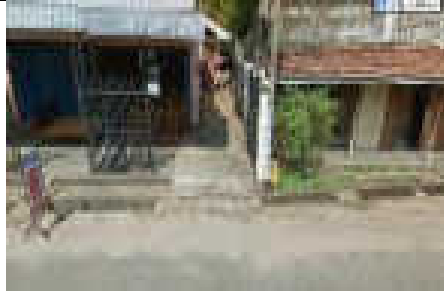
Left side				Right Side			
1. Covering From (KM):	48 Km	To:	49Km	1. Covering From (KM):	48 Km	To:	49Km
2. Details of Drainage	Start	End	Length	2. Details of Drainage	Start	End	Length
i. D1	48+300	48+400	100m	ii. D1	48+330	48+380	50m
iii. D2				iv. D2			
v. D3				vi. D3			
3. Condition	D1 - 100 Box drain, good condition, end part silted. Need improvements			3. Condition	D1 - Open concrete drain structure. Partly damaged and silted. This drain is located in the market area. Dumping of solid waste into the drain is observed.

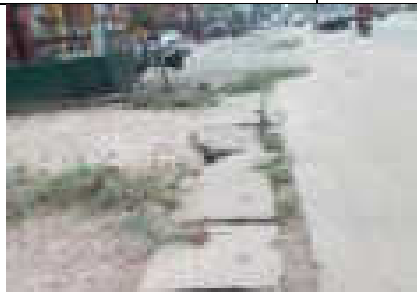
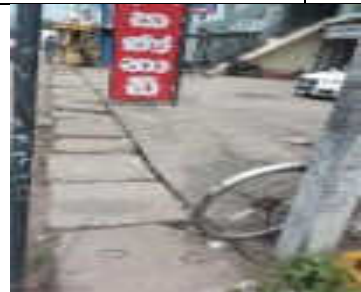
i. D1	54+330	54+460	130m	ii. D1	54+400	54+550	150m
iii. D2				iv. D2	54+600	54+650	50m
v. D3				vi. D3			
3. Condition	D1 - 130m, Box drain, most of the area is covered. However, certain areas are kept open. The open drain has a threaten to the safety of the pedestrians. The drain turns to Church road towards left side			3. Condition	D1 - Concrete drain structure (Marawila Town Area). In some segment that open is observed with some of damaged system and silted. D2 - Concrete v ditch drain system continue with D1

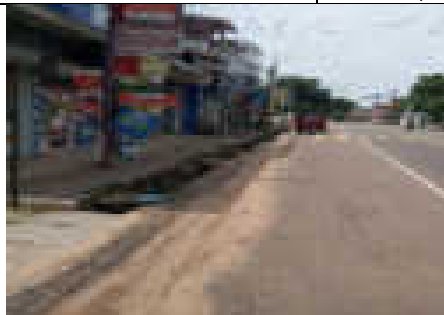
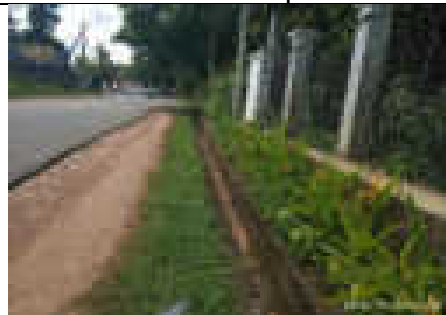
i. D1	59+140	59+340	200m	ii. D1	59+360	59+440	80m
iii. D2	59+390	59+700	410m	iv. D2	59+450	59+625	175m
v. D3	59+720	59+760	40m	vi. D3			
3. Condition	<p><b>D1</b> - 200m box drain, in good condition, partly silted, part of the drain is covered. Located near Mahawewa. Water directed to Left side through the DS office.</p> <p><b>D2</b> - Open box drain. The drain start at 62/3 culvert and ends at the Doduwawa Junction and continue to Left hand side of the Duduwawa road. The access to the houses and shops are covered with the slabs. In good condition. Overflowing is not reported.</p> <p><b>D3</b> - Continue from the right hand side of the Duduwawa road and end at the bridge 62/3. Box culvert, open and access to the shops are covered.</p>			Condition	<p><b>D1</b> - Earth Drain (Near the Mahawewa) and silted.</p> <p><b>D1</b> - Open and covered concrete drain. This segment covers Mahawewa Town where commercial activities are taking a place. Majority of drain systems are damaged and silted.</p>

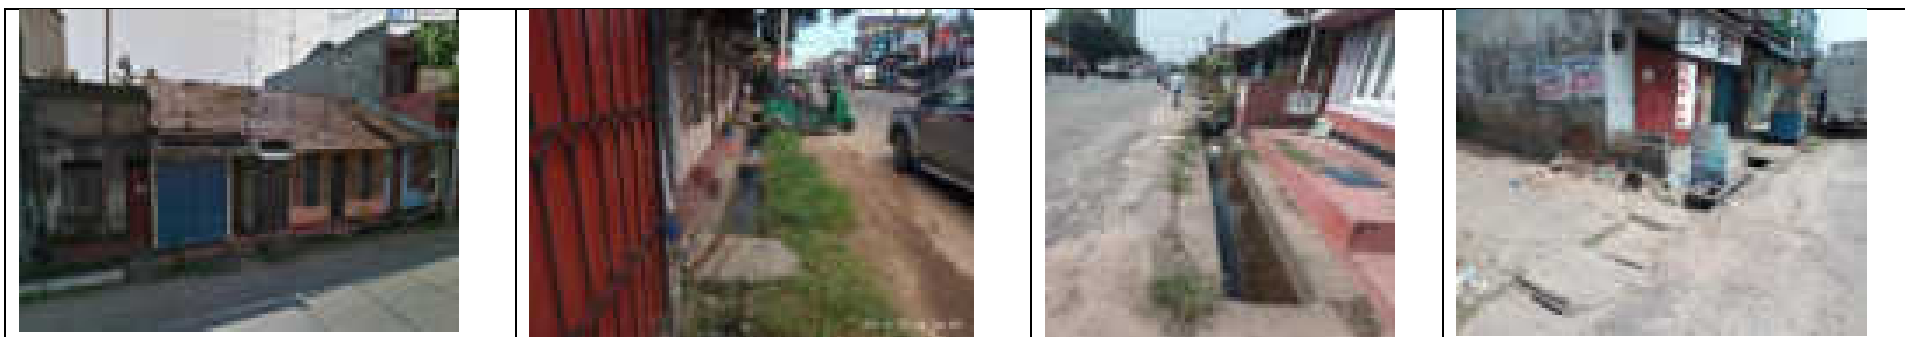
Left side				Right Side			
1. Covering From (KM):	61 Km	To:	62 Km	1. Covering From (KM):	61 Km	To:	62 Km
2. Details of Drainage	Start	End	Length	2. Details of Drainage	Start	End	Length
i. D1	61+710	61+720	10m	ii. D1	61+750	62	250m
iii. D2				iv. D2			
v. D3				vi. D3			
3. Condition	<b>D1</b> - Box drain. Covered for access for the houses and shops. Located in the Old Madampe Town. Waste water from the houses are discharged to this drain. The drain connects to culvert 62/1. Mosquito breeding is observed. Bad smell from the stagnated water was felt.			3. Condition	<b>D1 – part of the drain is covered.</b> This segment covers Madampe Town. Drains are damaged and silted.

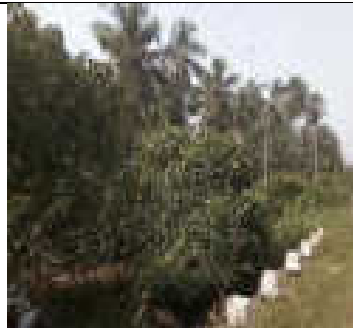
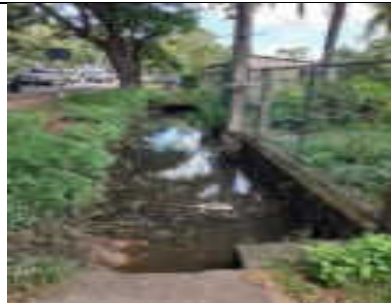
Left side				Right Side			
1. Covering From (KM):	63 Km	To:	64 Km	1. Covering From (KM):	63 Km	To:	64 Km
2. Details of Drainage	Start	End	Length	2. Details of Drainage	Start	End	Length
D1	63+300	63+390	90m		63	64	
D2	63+950	64+000	50m				
3. Condition	D1 - Earth drain, covered with vegetation			3. Condition	D1 – This drain continues from previous section. Earth drain about 1.5 m width. Water stagnated due to lack of lead way darins .

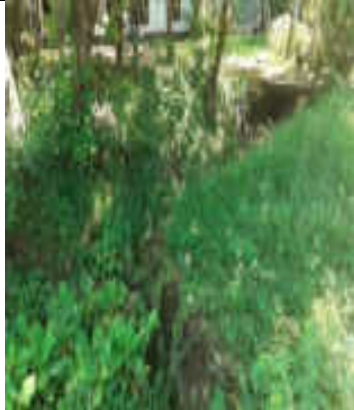
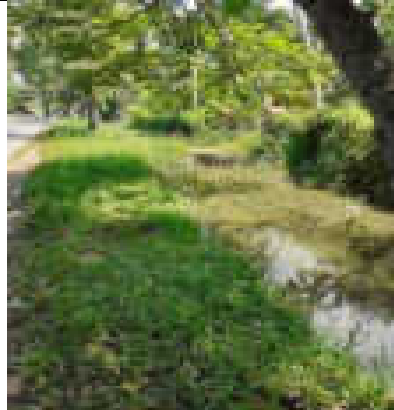
Left side				Right Side			
1. Covering From (KM):	64 Km	To:	65 Km	1. Covering From (KM):	64 Km	To:	65 Km
2. Details of Drainage	Start	End	Length	2. Details of Drainage	Start	End	Length
i. D1	No drain			ii. D1	64	64+800	800m
iii. D2				iv. D2			
v. D3				vi. D3			
3. Condition				3. Condition	D1 - Madampe murugan kovil religious places covered within this area. Open earth drain. Bunds are damaged

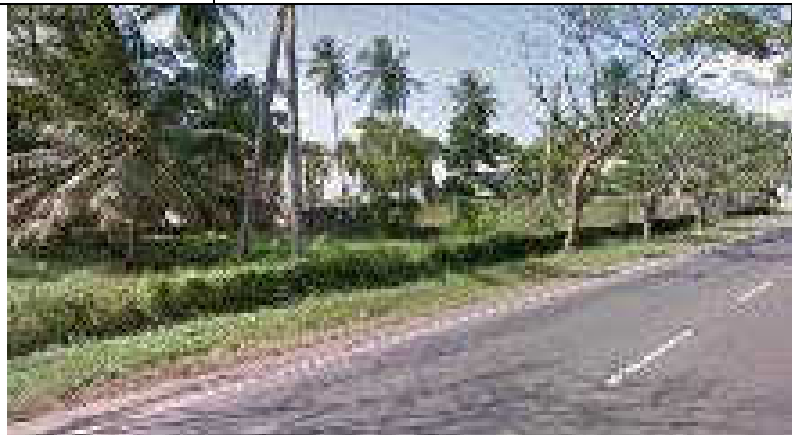
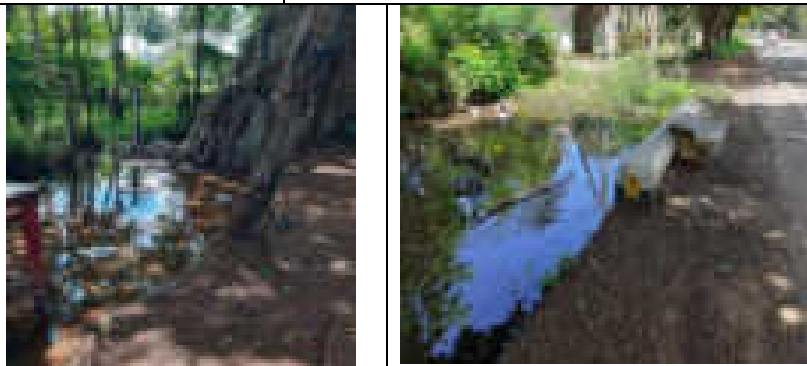
Left side				Right Side			
1. Covering From (KM):	65 Km	To:	66 Km	1. Covering From (KM):	65 Km	To:	66 Km
2. Details of Drainage	Start	End	Length	2. Details of Drainage	Start	End	Length
i. D1	65+750	66	250m	ii. D1	65	66	1km
iii. D2				iv. D2			
v. D3				vi. D3			
3. Condition	Earth drain			3. Condition	D1 – Earth drain, silted. Stagnation of water.

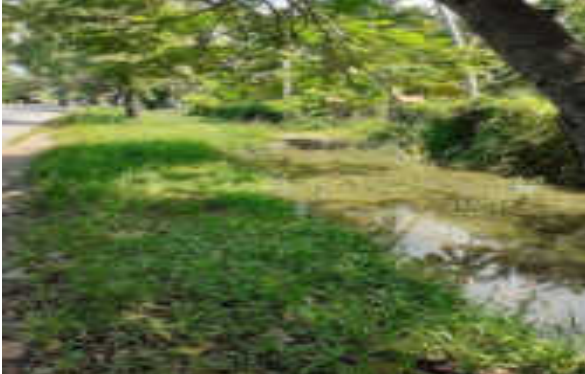
Left side				Right Side			
1. Covering From (KM):	66 Km	To:	67 Km	1. Covering From (KM):	66 Km	To:	67 Km
2. Details of Drainage	Start	End	Length	2. Details of Drainage	Start	End	Length
i. D1	No drain			ii. D1	66	66	1km
iii. D2				iv. D2			
v. D3				vi. D3			
3. Condition				3. Condition	D1 – Earth drain, silted. Above drain continued

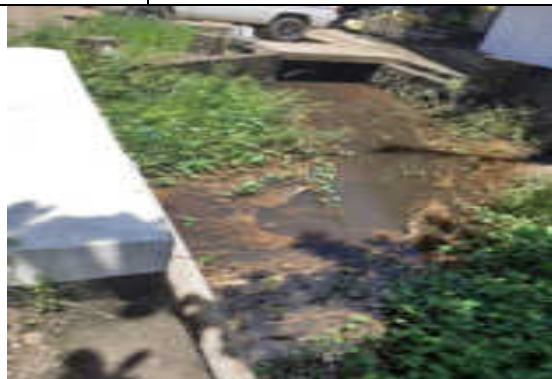
Left side				Right Side			
1. Covering From (KM):	69 Km	To:	70 Km	1. Covering From (KM):	69 Km	To:	70 Km
2. Details of Drainage	Start	End	Length	2. Details of Drainage	Start	End	Length
i. D1	No drain			ii. D1	69+220	69+370	150m
iii. D2				iv. D2			
v. D3				vi. D3			
3. Condition				Condition	D1 - D1 - Earth drain road side wall is concreted. Partly covered with vegetation and silted.

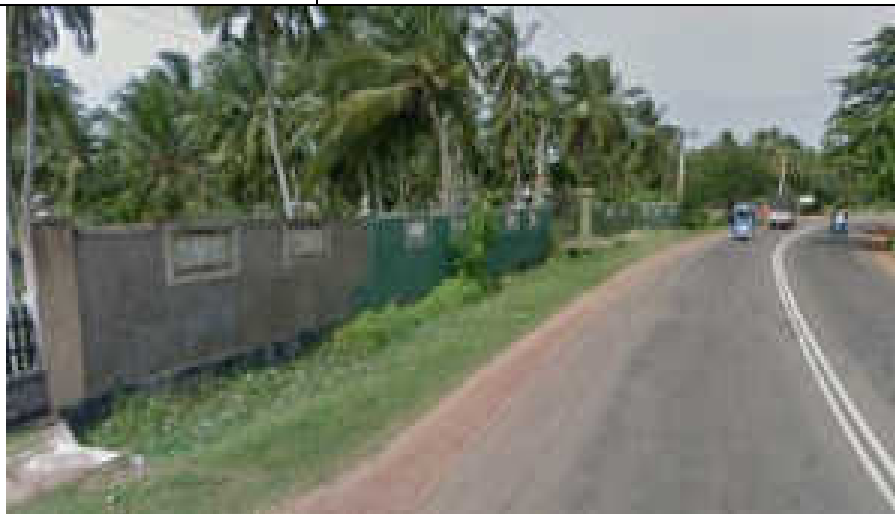
Left side				Right Side			
1. Covering From (KM):	70 Km	To:	71 Km	1. Covering From (KM):	70 Km	To:	71 Km
2. Details of Drainage	Start	End	Length	2. Details of Drainage	Start	End	Length
i. D1	70+700	70+900	200m	ii. D1	70+300	71+200	100m
iii. D2				iv. D2			
v. D3				vi. D3			
3. Condition	Earth Drain. Boundary wall constructed along the left-hand side			Condition	D1 - Earth drain was available -covered by vegetation and silted.

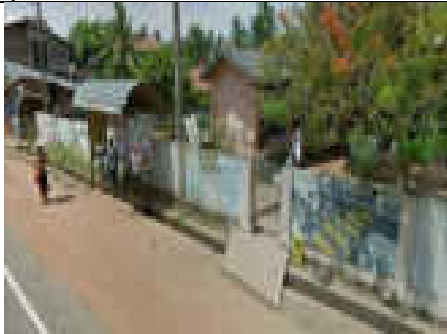
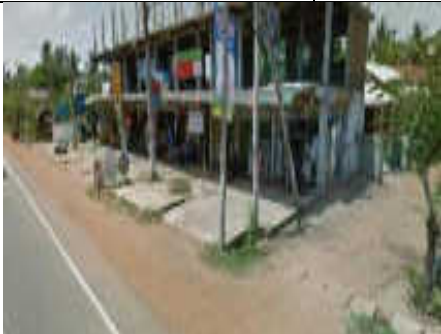
Left side				Right Side			
1. Covering From (KM):	71 Km	To:	72 Km	1. Covering From (KM):	71 Km	To:	72 Km
2. Details of Drainage	Start	End	Length	2. Details of Drainage	Start	End	Length
i. D1	71+690	71+915	225m	ii. D1	71+200	71+660	460m
iii. D2				iv. D2			
v. D3				vi. D3			
3. Condition	A bout 50m drain has concreted and covered for the access purposes			Condition	D1 - Earth drain -End in Culvert drain No - 72/1 and continue

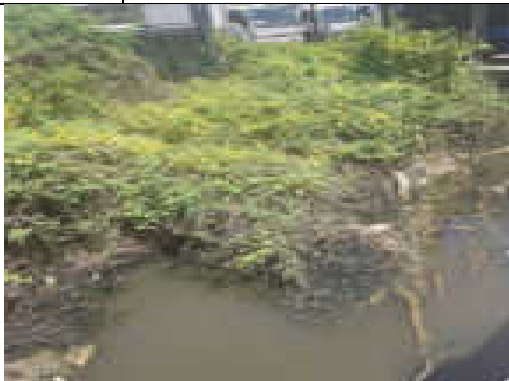
Left side				Right Side			
1. Covering From (KM):	72 Km	To:	73 Km	1. Covering From (KM):	72 Km	To:	73 Km
2. Details of Drainage	Start	End	Length	2. Details of Drainage	Start	End	Length
i. D1	No drain			ii. D1	72	72+100	100m
iii. D2				iv. D2	72+100	72+570	470m
v. D3				vi. D3			
3. Condition				Condition	<b>D1</b> - Earth drain -covered by vegetation and silted. <b>D2</b> - Earth drain

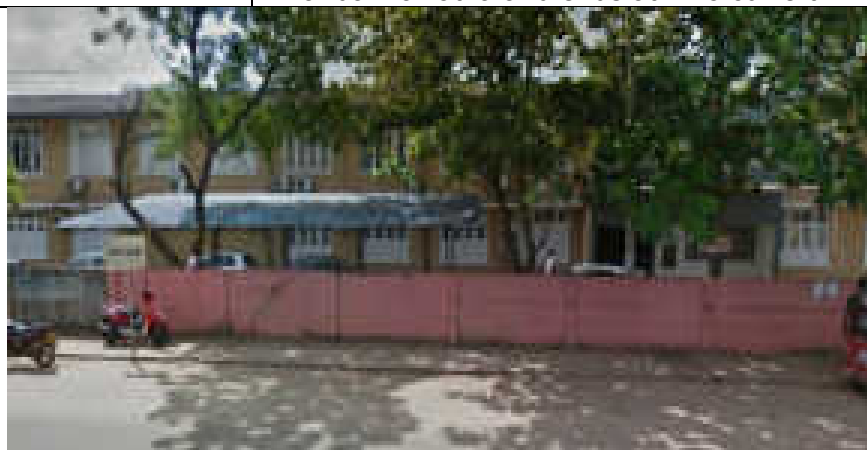
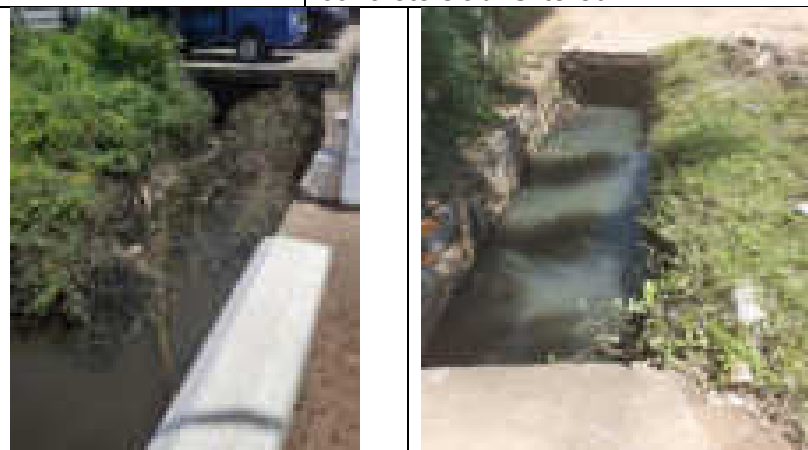
Left side				Right Side			
1. Covering From (KM):	73 Km	To:	74 Km	1. Covering From (KM):	73 Km	To:	74 Km
2. Details of Drainage	Start	End	Length	2. Details of Drainage	Start	End	Length
i. D1	73+520	73+975	455m	ii. D1	73+600	73+825	225m
iii. D2				iv. D2	73+900	74+150	250m
v. D3				vi. D3			
3. Condition	D1 - The Drain is located within the Chilaw town. Concrete drain with covered slab. Starts from Ananda Mawatha and ends at 72/3 culvert			Condition	D1 - The located within the Chilaw town. D2 - Concrete drain partly covered with concrete slab. Siltered

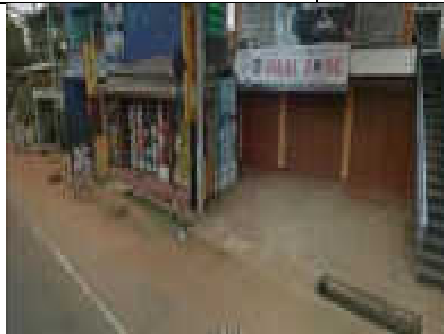
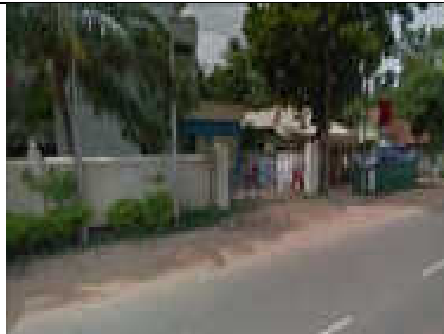
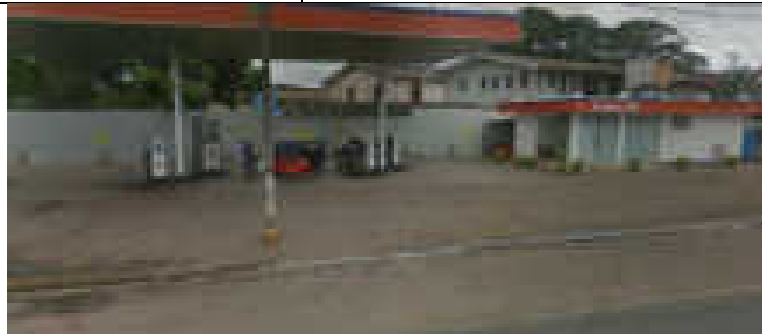
Left side				Right Side			
1. Covering From (KM):	74 Km	To:	75 Km	1. Covering From (KM):	74 Km	To:	75 Km
2. Details of Drainage	Start	End	Length	2. Details of Drainage	Start	End	Length
i. D1	74+480	74+675		ii. D1	74+400	74+500	100m
iii. D2	74+965	75+105		iv. D2			
v. D3				vi. D3			
3. Condition	D1 - Box drain, open drain, covered only for the access. Certain points the drain is damaged. Need improvement.  D2 - Concrete Drain			Condition	D1 - Concrete v ditch

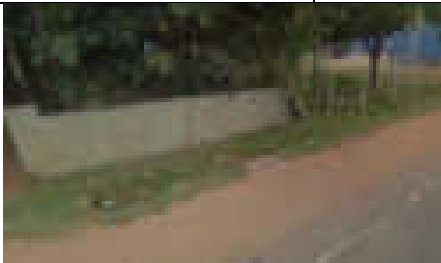
Left side				Right Side			
1. Covering From (KM):	75 Km	To:	76 Km	1. Covering From (KM):	75 Km	To:	76 Km
2. Details of Drainage	Start	End	Length	2. Details of Drainage	Start	End	Length
i. D1	75+110	75+150	40m	ii. D1	No drain		
iii. D2				iv. D2			
v. D3				vi. D3			
3. Condition	D1 - Earther Drain			Condition

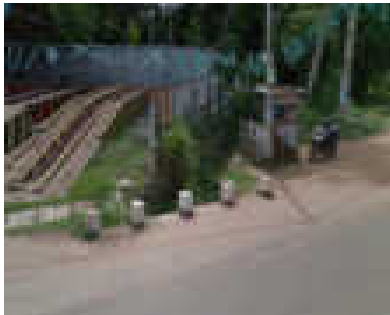
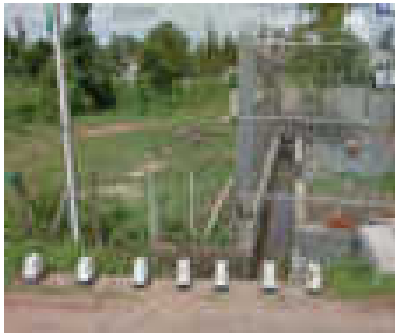
39/2		Completely silted	Inlet clear
About 1 m diameter Hume pipe culvert, 4 m length	38+400

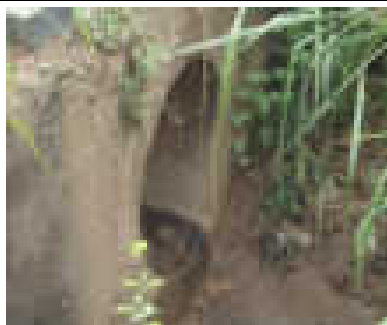
40/1		Partly silted	Stagnation of water due to siltation in the culvert
Two box culverts, each 1.25 span. About 4 m length	39+500

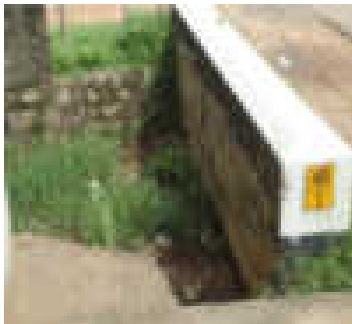
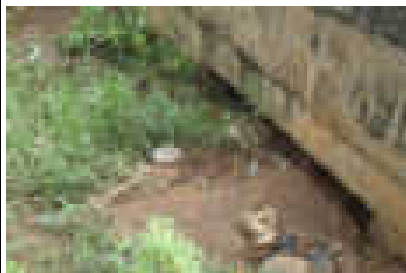
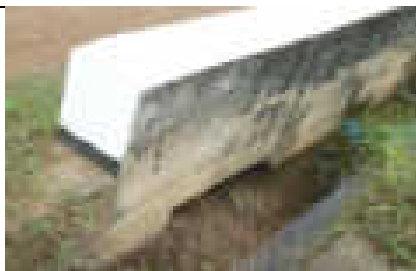
40/2		Partly silted. Stagnation of water due to siltation of road drains	Partly silted. Stagnation of water due to siltation in the culvert. The feeding canal is blocked by vegetation

Culvert No.	Chainage	Left	Right
1m diameter Hume pipe culvert, the structure is in good conditions	39+800

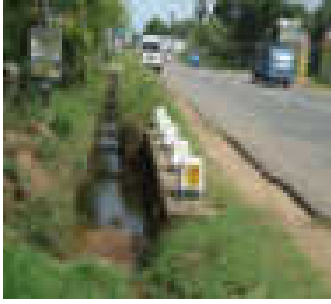
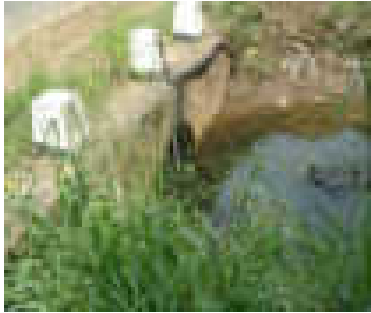
40/3		lead canal partly blocked, Water stagnated	Culvert partly blocked due to siltation. Water stagnated
Hume pipe. .75 dia	39+900

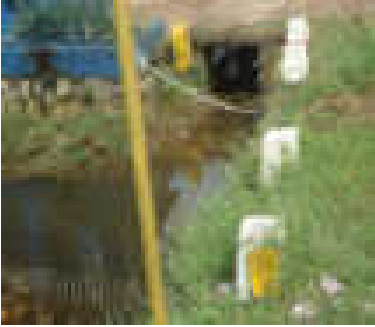
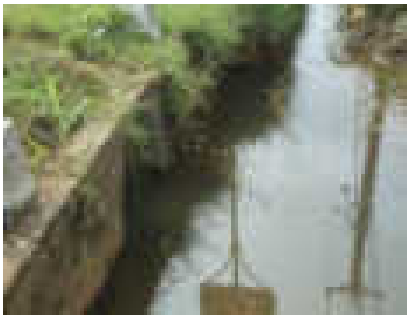
40/4		Completely silted and blocked by dumping of construction materials by the near by resident. Lead way drain completely blocked and silted	The culvert is feed only from northern side. Silted
1m dia Hume pipe

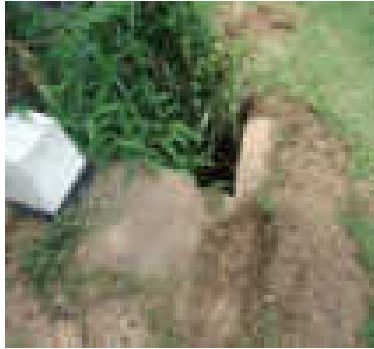
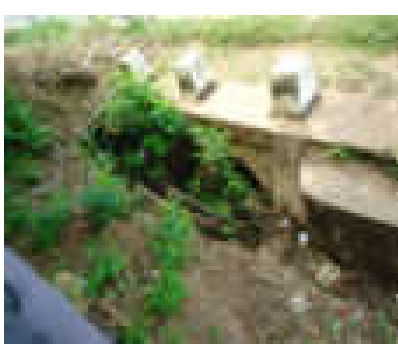
41/1		The drain is covered by the shop owner. The water goes along the Bolawatte Junction where there is no proper drainage. Flooding during the rainy season	Partly blocked by due to siltation
Box culvert 5 m length	40+200

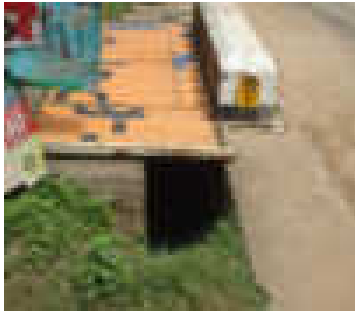
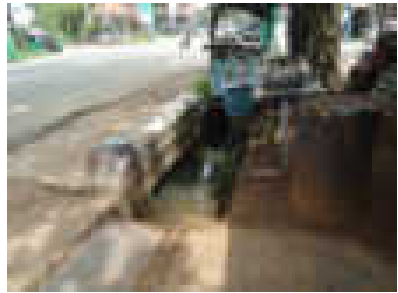
41/3		Completely Blocked due to siltation. The neighboring shops and house get flooded up to one foot at the shop and two feet at the houses. Details included in the flood report	The culverts are blocked
	40+800

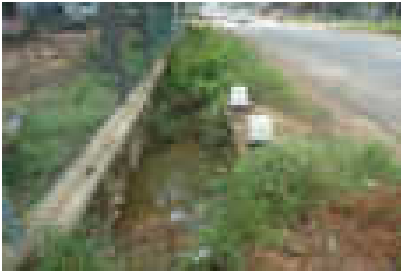
42/2		Completely blocked. Lead way drain goes through a private property	Completely blocked with siltation and vegetation
Size can not be seen	41+400

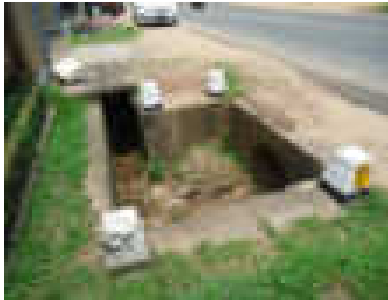
43/3		Level different. Outlet drain is higher than the culvert outlet. Siltation observed.	The inlet drains in both sites silted. Possibility of overtopping water
Box culvert. About 1 m span. Good condition	42+700

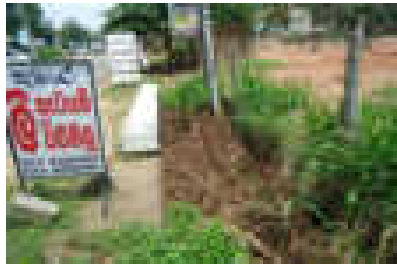
48/1		Half drain silted	No flow, stagnation of water
Box culvert. About 1 m span. Good condition	47+800

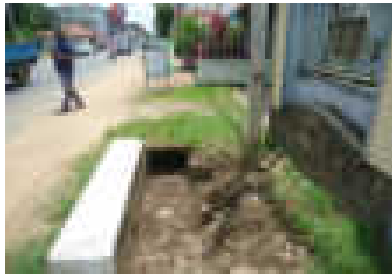
51/1		completely Blocked	Completely Blocked
No culvert could be seen. About 3 meter length. No lead drain.

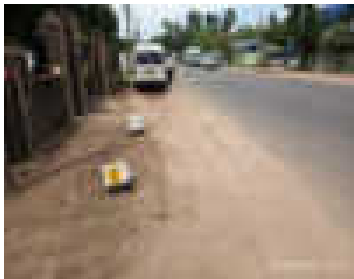
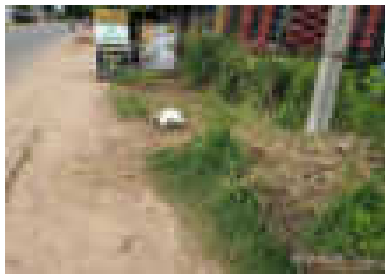
54/1		Completely Blocked	Completely Blocked
The culvert could not be seen. About 4m length	54+000

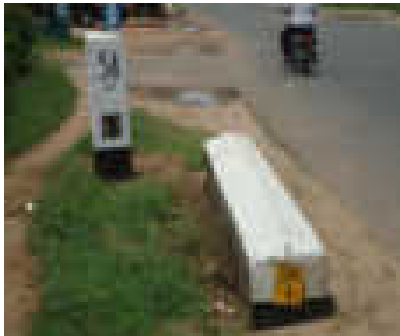
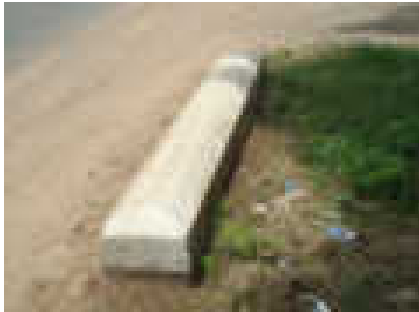
56/1		Completely Blocked	Completely Blocked

Culvert No.	Chainage	Left	Right
The culvert could not be seen	55+600

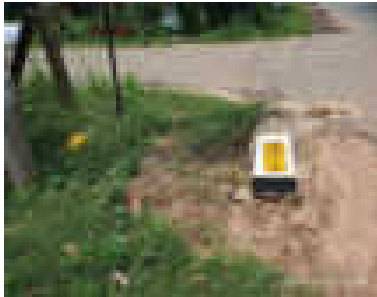
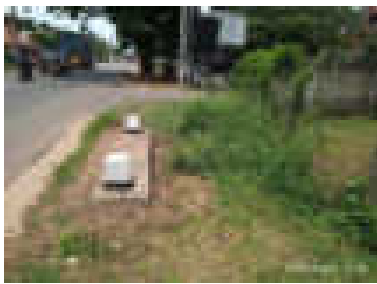
60/2		Half of the culvert Blocked.	Completely Blocked. Recently clean the inlet drain
Located in the Mahawewa town. Hume pipe 1m dia.	59+300

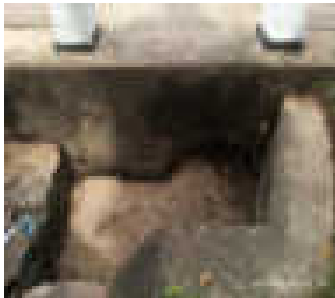
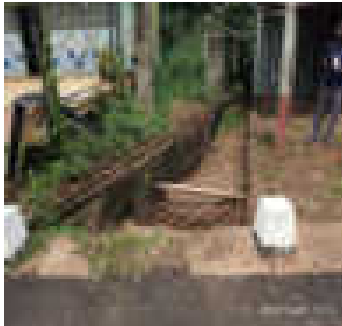
60/3		Covered by the shop owner	Outlet clean, no stagnation
1m dia Hume pipe, good condition	59+500

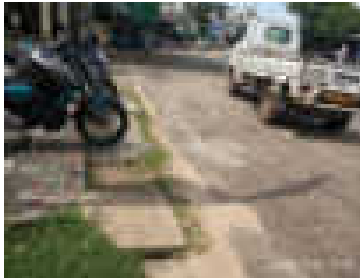
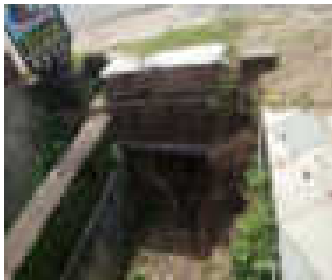
60/4		Partly silted and vegetation covered in the lead canal	Blocked with water hyacinth

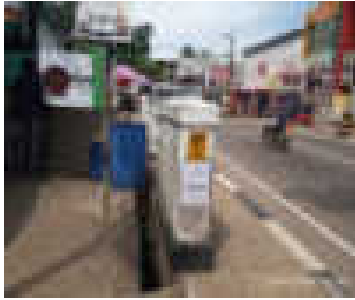
Culvert No.	Chainage	Left	Right
Bridge about 5 m span. Good condition	59+700
