### SRI: Integrated Road Investment Program Improvement, Rehabilitation and Maintenance of A003 Road from Kochchikade (CH 38 + 000 km) to Puttalam (CH 126 +800 km)

Prepared by the Road Development Authority, Ministry of Highways for the Asian Development Bank.

**Improvement, Rehabilitation and Maintenance of  
The section of A003 Road from Kochchikade Bridge to  
Chilaw**

## **Initial Environmental Examination Report**

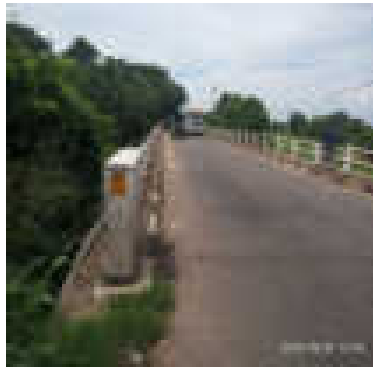
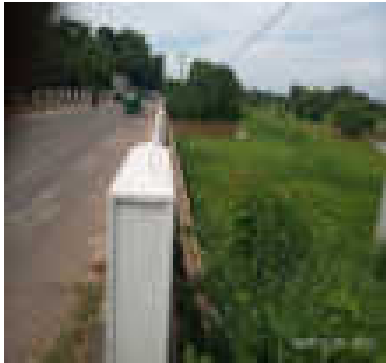
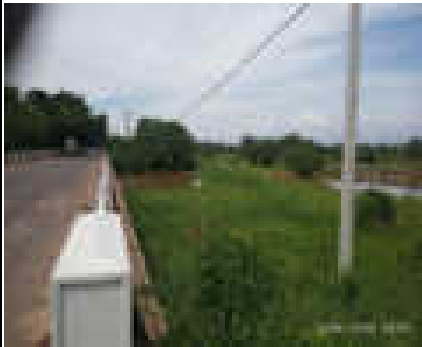
Left blank intentionally
61/1			
Bridge. 30 m length, in good condition	60+100

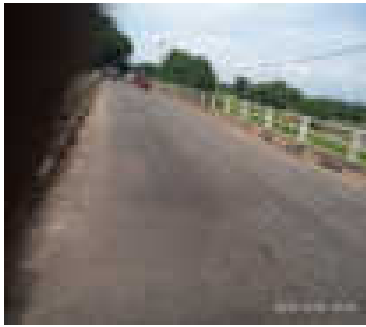
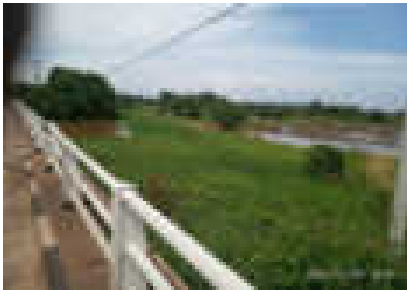
61/2		Half silted	Covered with vegetation
Bridge. About 8m length.	60+200

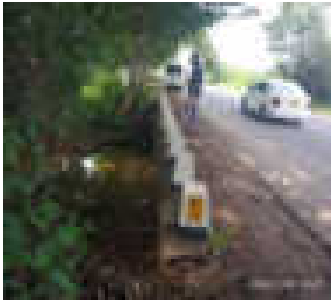
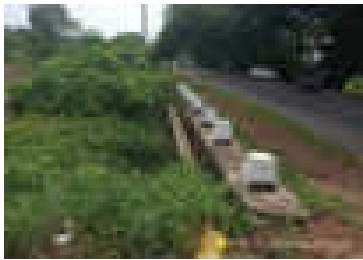
61/3			
5 m length. Span 3 m. Box culvert	60+300

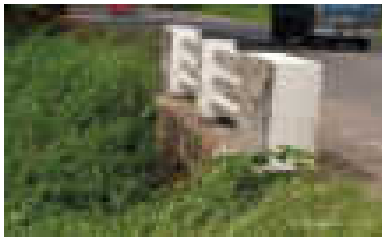
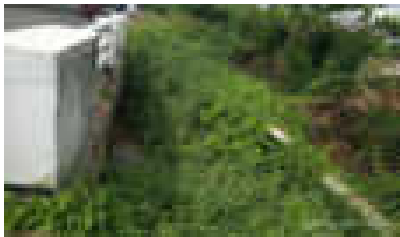
61/4		Partly silted	Covered with vegetation
10 m length. Three Hume pipe culvert	60+600

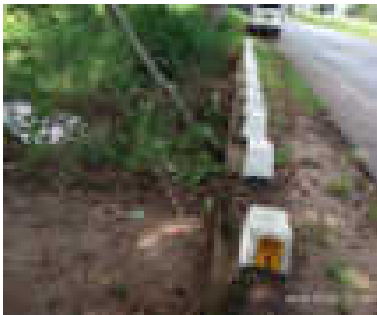
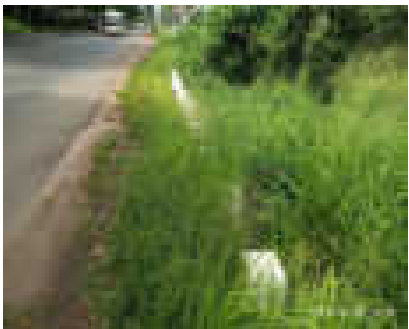
61/5		Completely silted and blocked. Covered with vegetation	Partly blocked and covered with vegetataion
4 Box culverts, about 15 m length	60+800

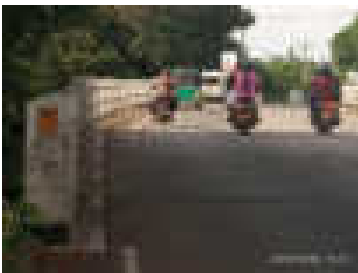
62/2		Blocked with vegetation	Blocked with vegetation
several small culverts, 100 m	61+300

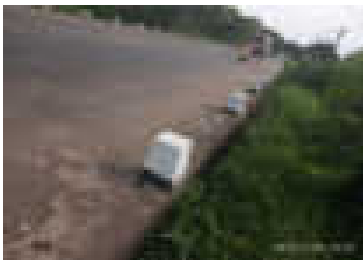
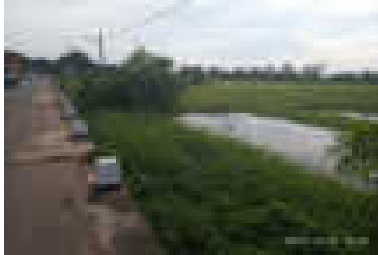
62/3		Blocked with vegetation	Partly open

Culvert No.	Chainage	Left	Right
5 m dia culverts. Good conditions. 10 m length	61+300

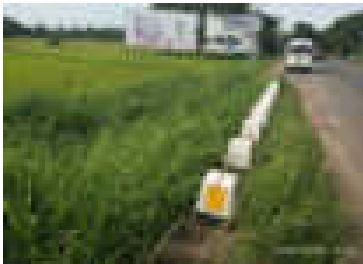
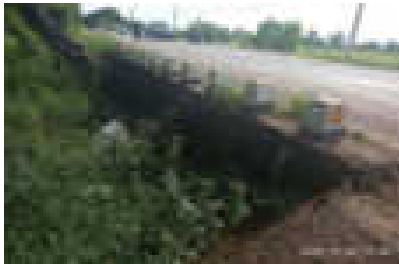
62/4		Partly block by the vegetation, hand drains damaged	No blocks attached to the Thinipitiya wewa
Bridge-spill from Thinipitiya wewa is discharge through this bridge for the downstream paddy cultivation. 10 m length	61+500

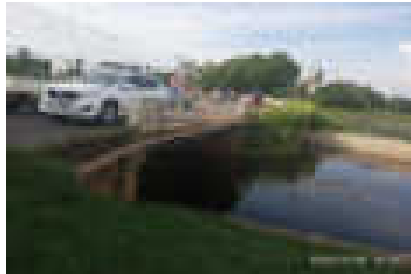
62/5		Completely stagnated. The wastewater from the Old Madampe town is directed to the canal	A slues structure is available to regulate the Thinipitiya Wewa water
Located near Madampe Town. The bridge is used for the discharge of water from the Thinipitiya Wewa for agricultural purposes	61+600

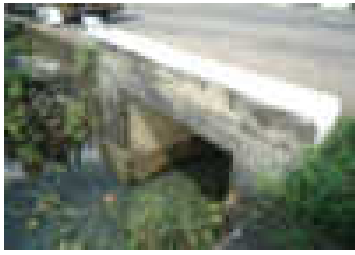
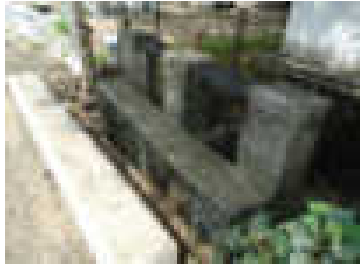
62/6		Completely blocked and the stagnation of wastewater from the near by residence and shops discharges in to the road drain	Completely blocked and the stagnation of wastewater from the near by residence and shops discharges in to the road drain
0.75 dia Hume pipe culvert.	61+800

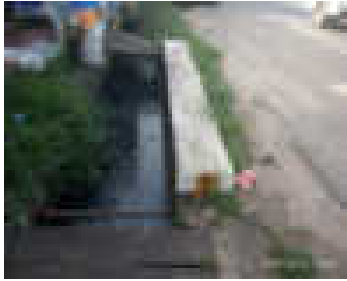
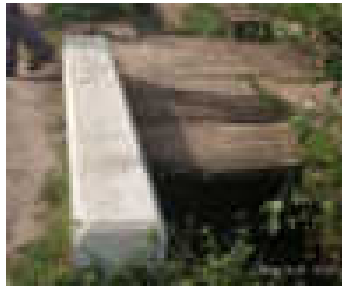
63/1		Covered. Block with the sludge due to waste water discharge	Covered. Block with the sludge due to waste water discharge
Infront of Madampe town, about 3 m length. 07.57 dia Hume pipe	62+100

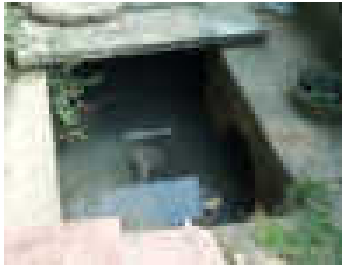
63/2

Culvert No.	Chainage	Left	Right
Located in the near Madampe Town. 2m length. Type of culvert could not be seen due to the bridge is used for the discharge of water from the Thinipitiya Wewa for agricultural purposes	62+200

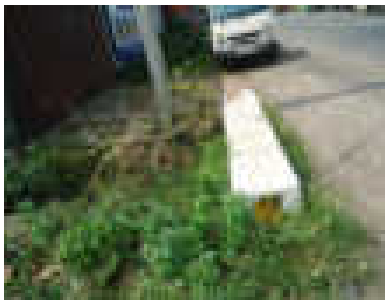
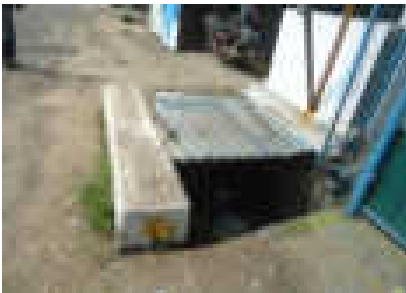
63/3		The culvert could not be seen	Covered. Culvert Could not be seen
Located in the Old Madampe Town. The drains are filled with the sludge from the waste water discharged from the Houses and shops	62+300

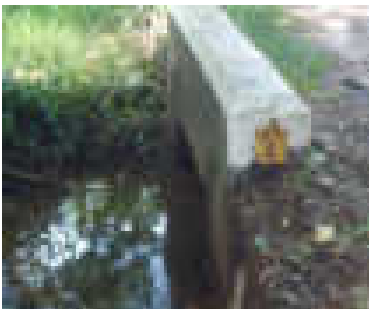
64/1		lead drain blocked. Water flow ,limited	inlet canal silted. Water stagnated.

Culvert No.	Chainage	Left	Right
5m length, 3 Hume pipes	63+200

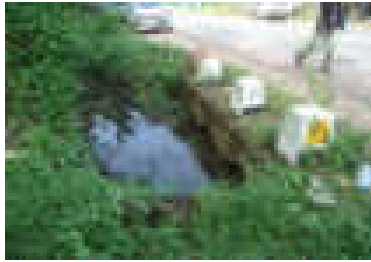
64/2		Completely blocked by the vegetation	Completely Blocked
Culvert could not be seen due to the coverage of vegetation	63+300

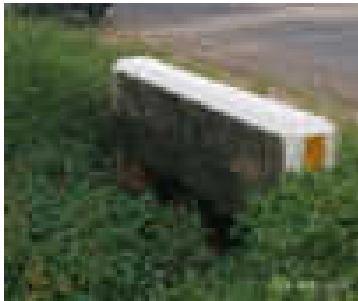
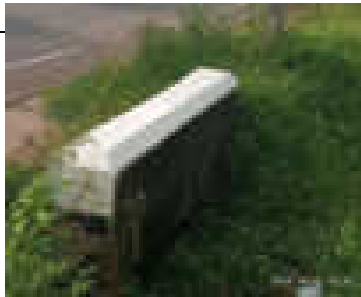
65/2		Partly blocked and water stagnated	Partly blocked

Culvert No.	Chainage	Left	Right
4 Hume pipe culverts, 10 m length	64+500

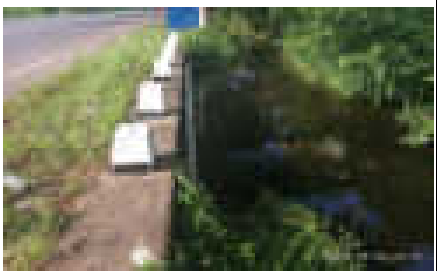
65/3		Blocked. Covered with covered slues	
2 Hume pipes, .75 m dia	64+700

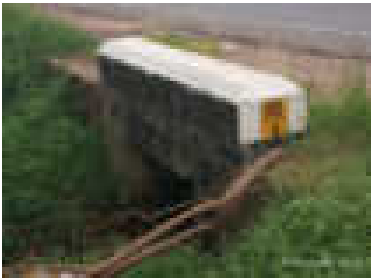
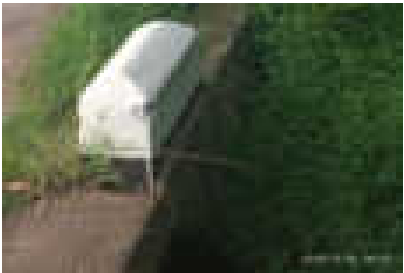
66/1		Silted and blocked by the vegetation	Blocked by the vegetation
Box culvert. 1.5 m span	65+600

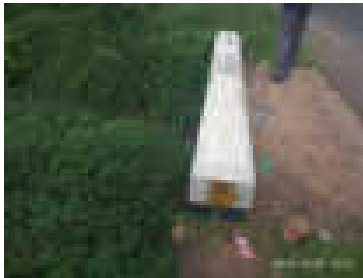
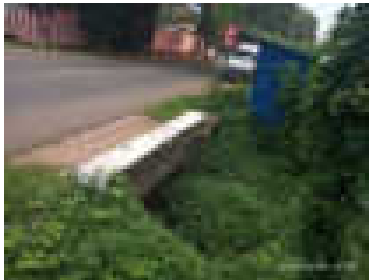
67/1		Silted and blocked by the vegetation	Silted and blocked by variation

Culvert No.	Chainage	Left	Right
2 Hume pipes, 1 m dia, 6 m length	66+200

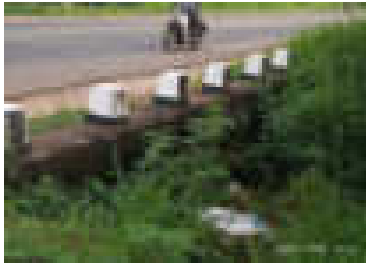
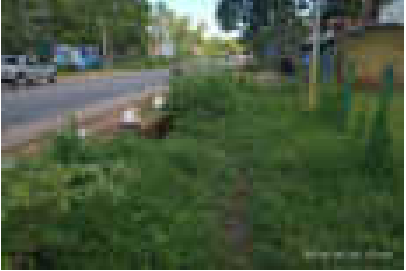
67/2		Blocked by the vegetation	Cleaned. Water stagnation
Bridge 6m length	66+600

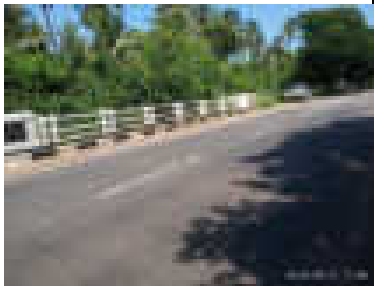
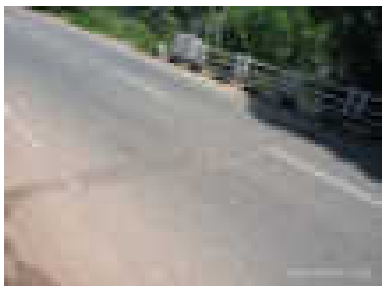
Culvert No.	Chainage	Left	Right
67/3		Blocked	Clean water not flowing
Box culvert 2m span, 4 m length	66+700

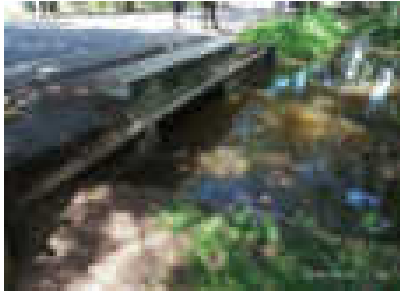
67/4		Block with siltation	Clean but, no water flow and stagnated
4 Box culvert each 2m span, 8m length	66+900

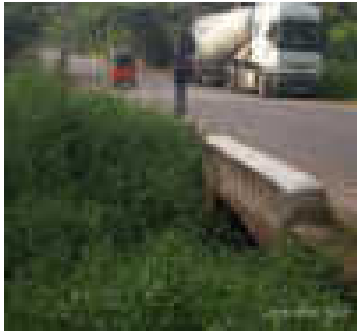
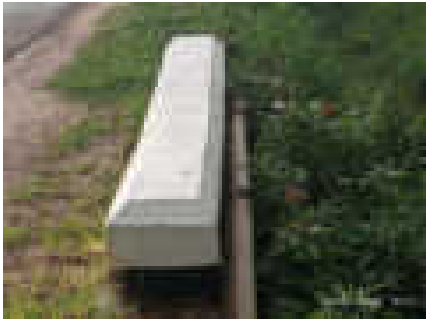
68/1		Covered with vegetation	Covered with vegetation
Covered with vegetation	67+200

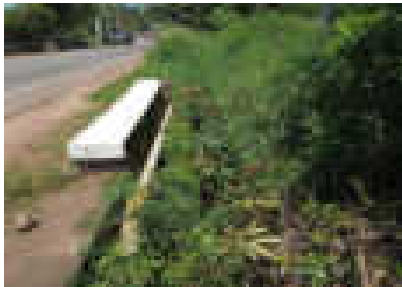
68/2		Covered with vegetation	Cover with Vegetation
5m length, Box culvert.	67+700

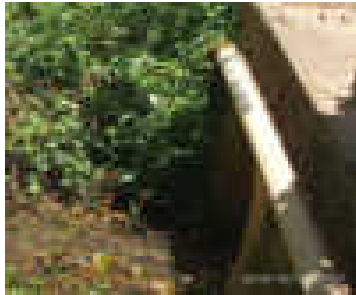
69/1		Partly Silted, and covered with vegetation	Stagnation of water observed.
4m length, Box culverts	68+500

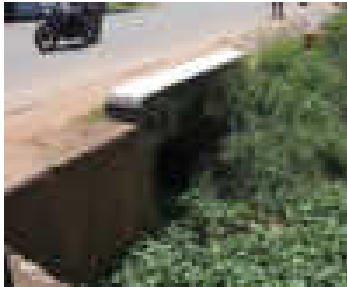
69/2		Completely covered with vegetation	Completely covered with vegetation
5m length, Type of culvert could not be seen	68+600

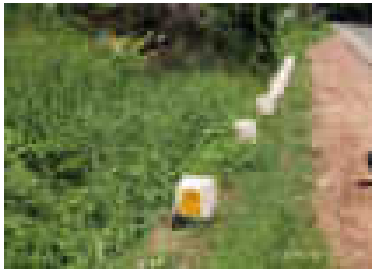
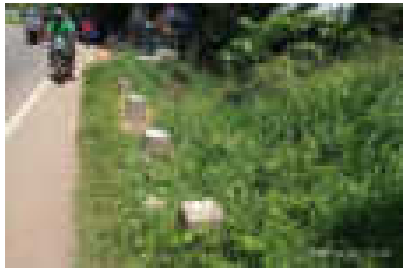
70/1		Partly silted	Partly silted
6 m length, Box culvert	69+300

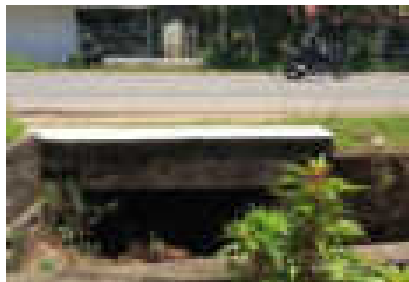
70/3			
5m length	69+900

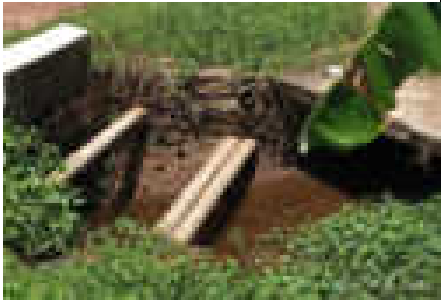
72/1		Feeding Darin silted and water stagnated in the area	Lead canel siltered and polluted water stagnated
10 length, 3 hume pipe	71+200

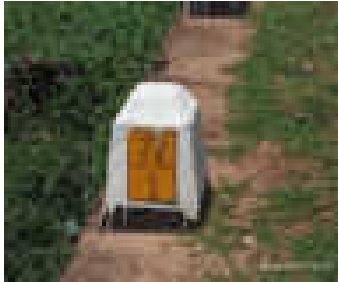
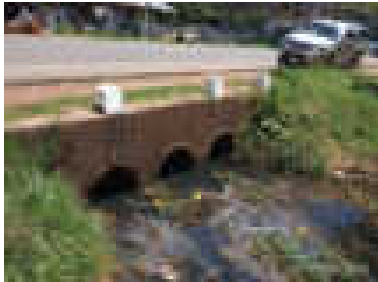
72/2		Lead Darin silted and water stagnated in the area	Feeding canal silted and water stagnated
5m box culvert. Waterwater from the near by residence discharge to the canal and bad smell felt.	71+500

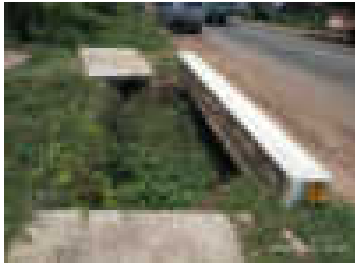
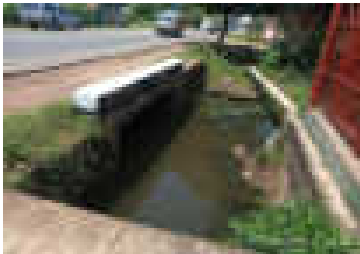
73/2		partly silted	Partly silted. Vegetaion cover also observed
5m length	72+600

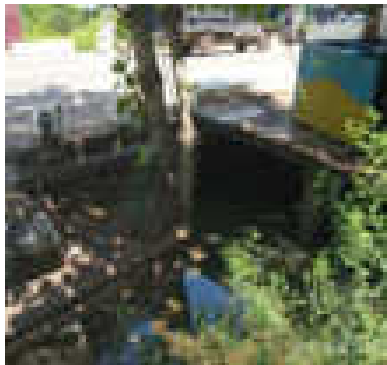
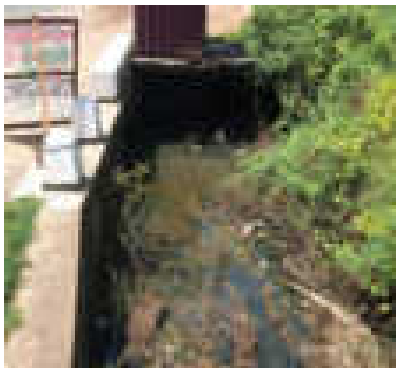
74/1		Some cracks observed in the wall	Good conditions
3m length	73+400

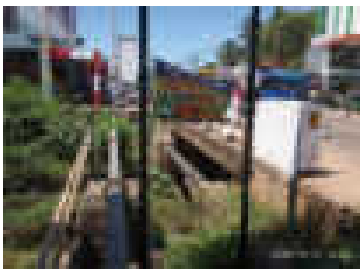
76/1		Damage embankment	Completely covered with vegetation
50m, Bridge,	75+200

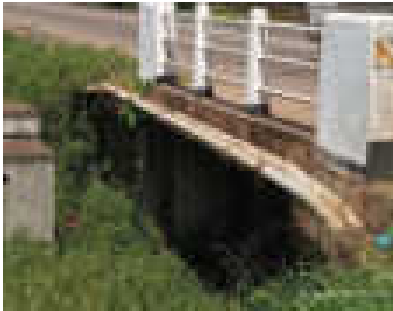
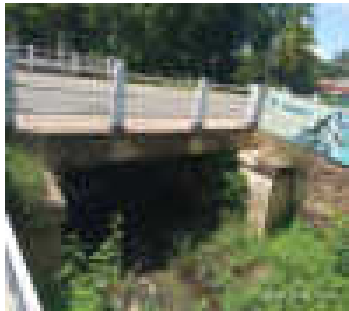
Culvert No.	Chainage	Left	Right
76/3		Filled with water and water plants	Covered with vegetation
Hume pipe culvert, could not see the size due to stagnation of water

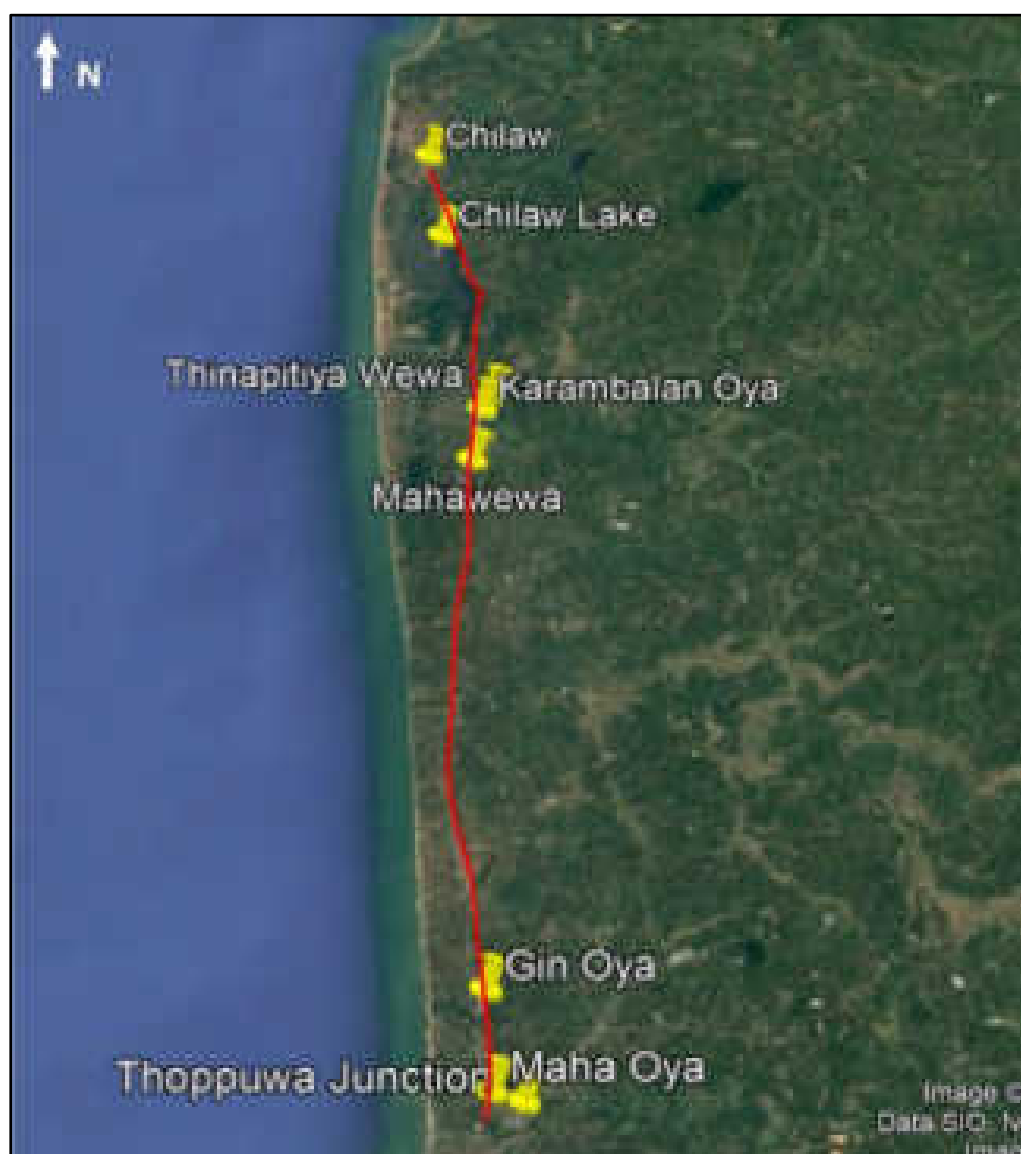
### Surface water sampling locations

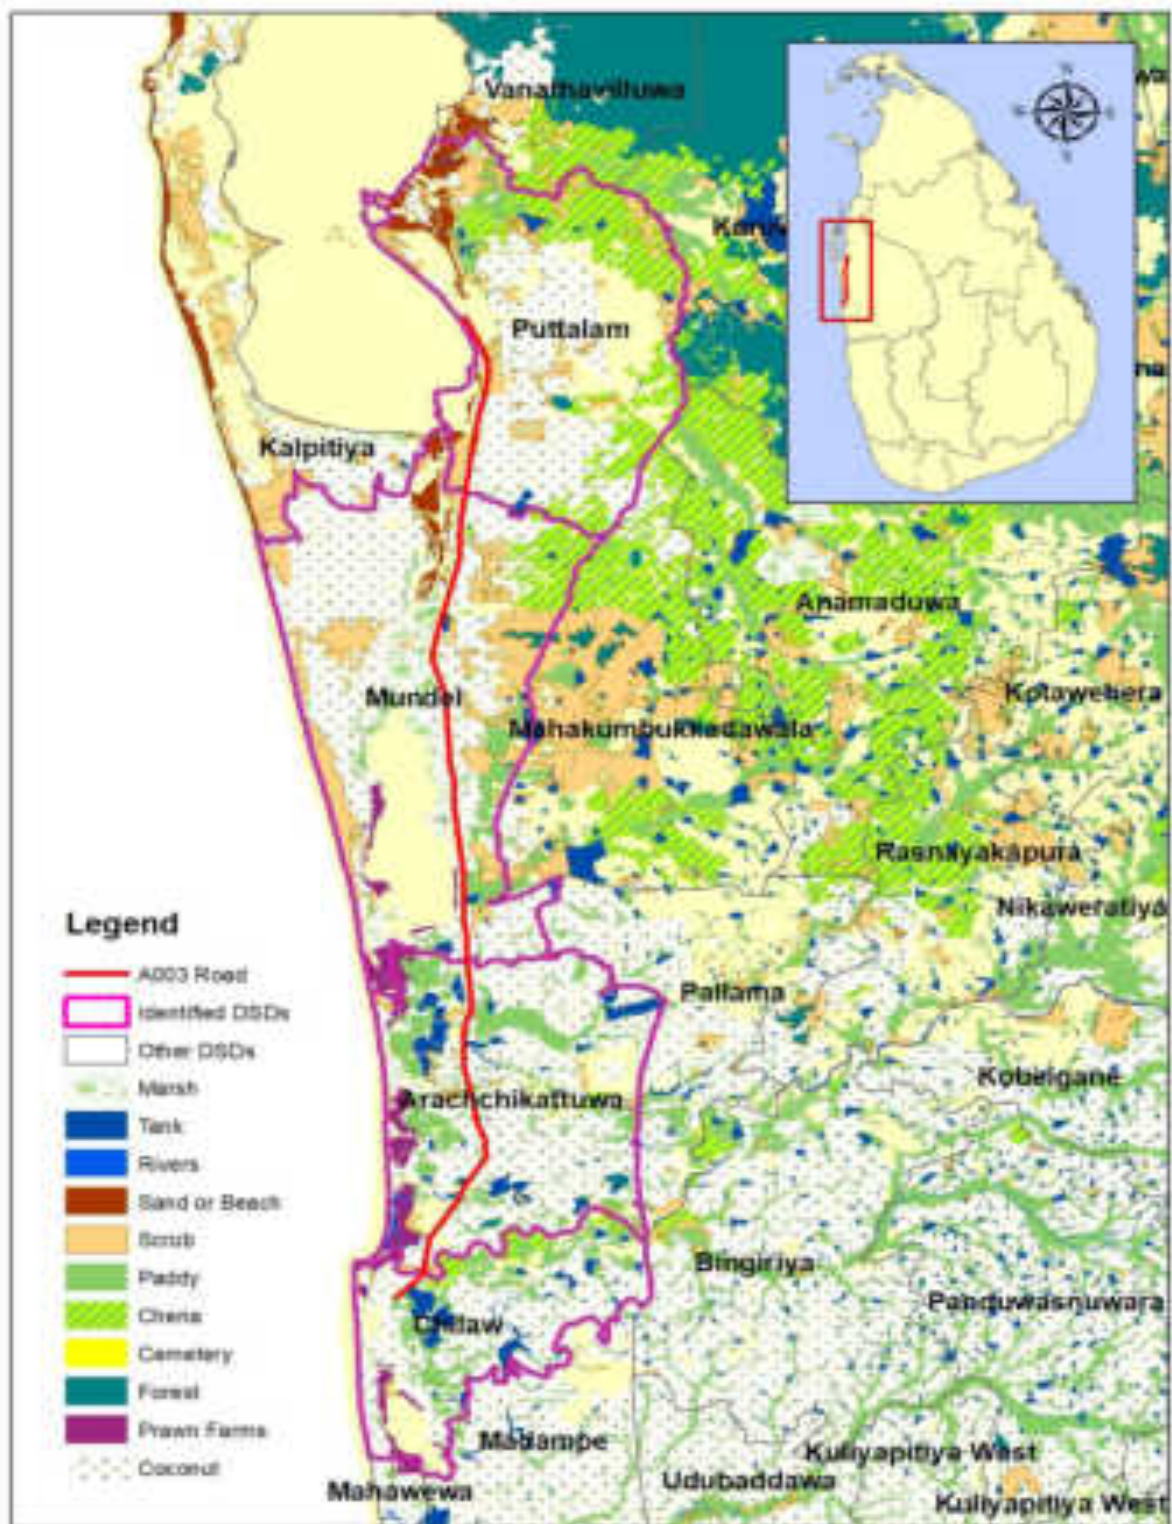
Figure 3-1: Location Map of the section of Peliyagoda – Puttalam road (A003) from Chilaw to Puttalam (76th km to 126.8th km)

42. The location map of the road is shown in Figure 3-1 and Annex 1.

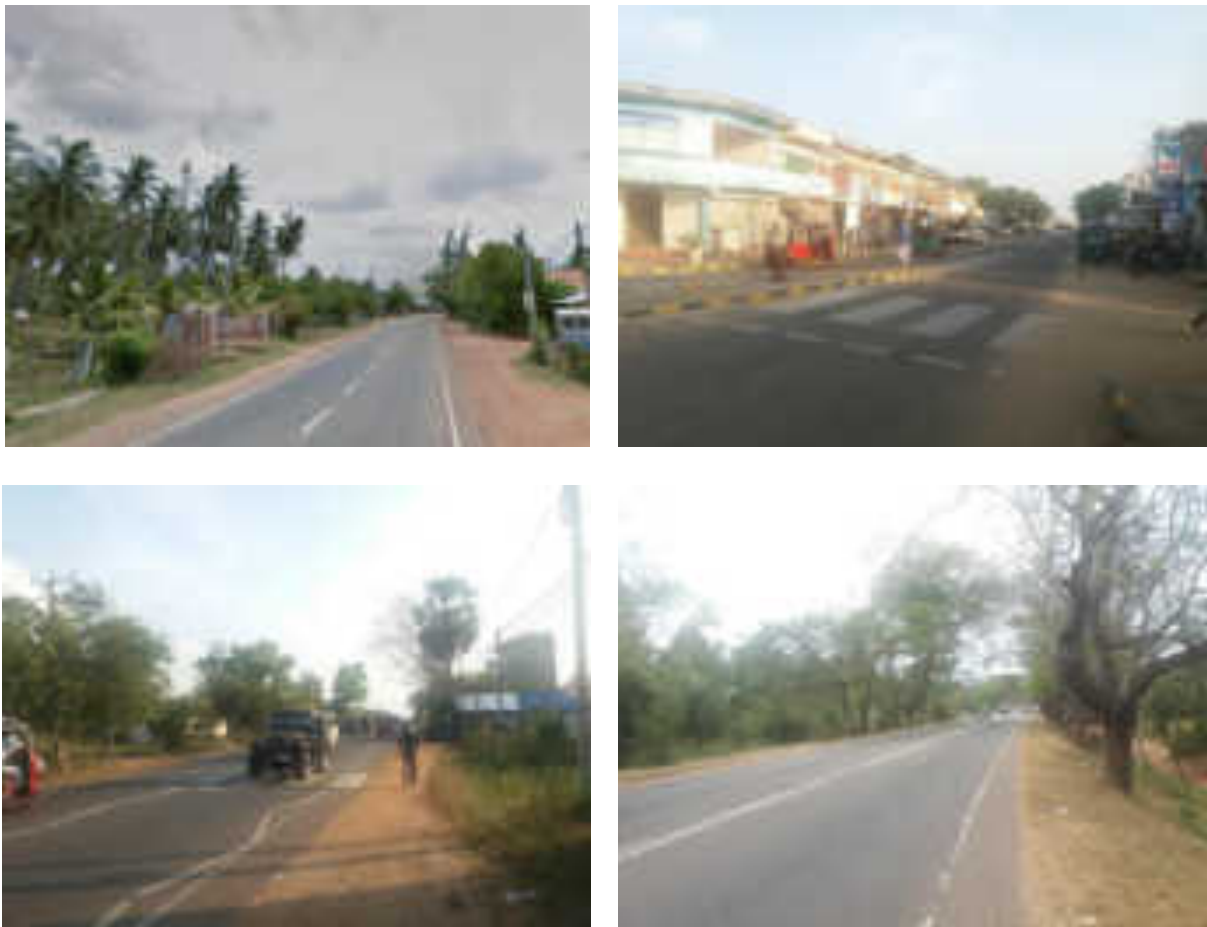
**Figure 4-1: Existing land use along the A003 road from Chilaw to Puttalam**

57. The selected section of A003 road is from Chilaw (76 km) to Puttalam (126.8 km) covering a length of 50.8 km. The whole section of the road falls within Puttalam district and traverses through flat terrain within 5 km from the Western coastal zone of the country. The road passes areas of urban, semi-urban and agricultural in nature. The road crosses several rivers and streams and the largest waterway intersected by the road section is Deduru Oya. The economy of the area is mainly dependant on fishery, agriculture, and industries. Coconut farms, other agricultural land can be seen on either side of the road.

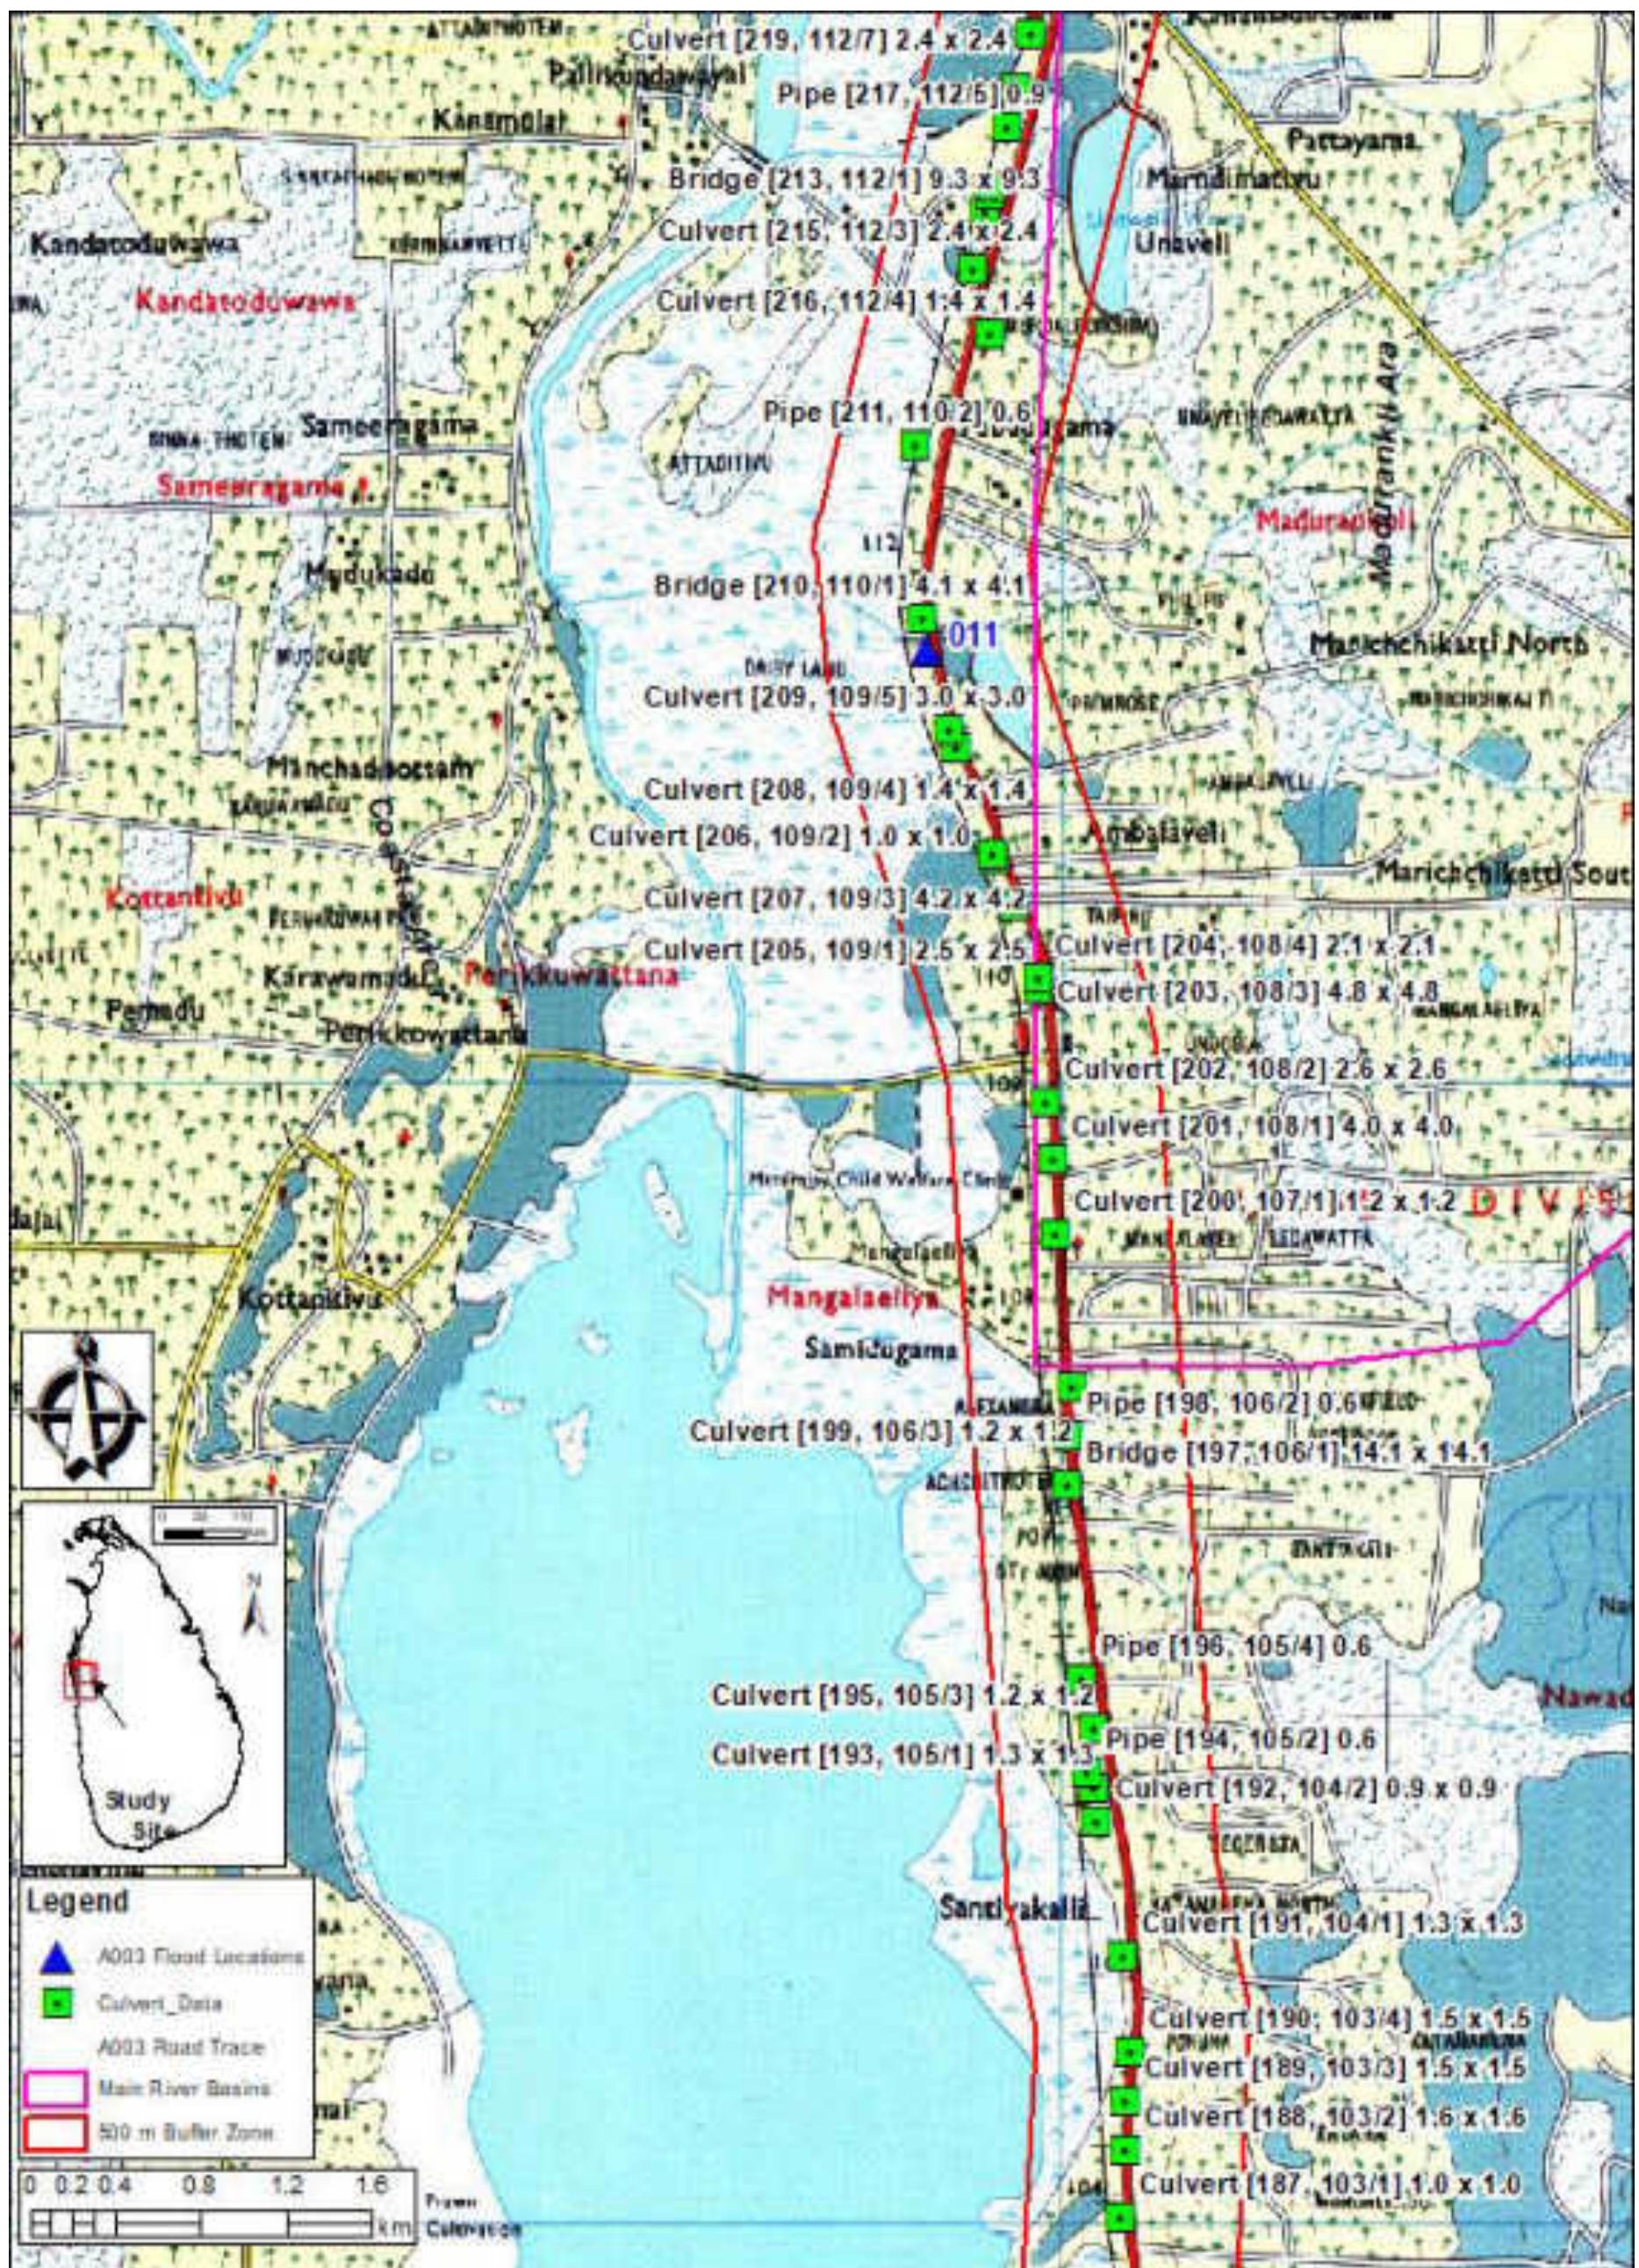
Figure 4-11: Location Map of candidate road sections with their hydrological setting  
(Base Map: 1:50,000 Topographical Maps, Survey Department, Sri Lanka)

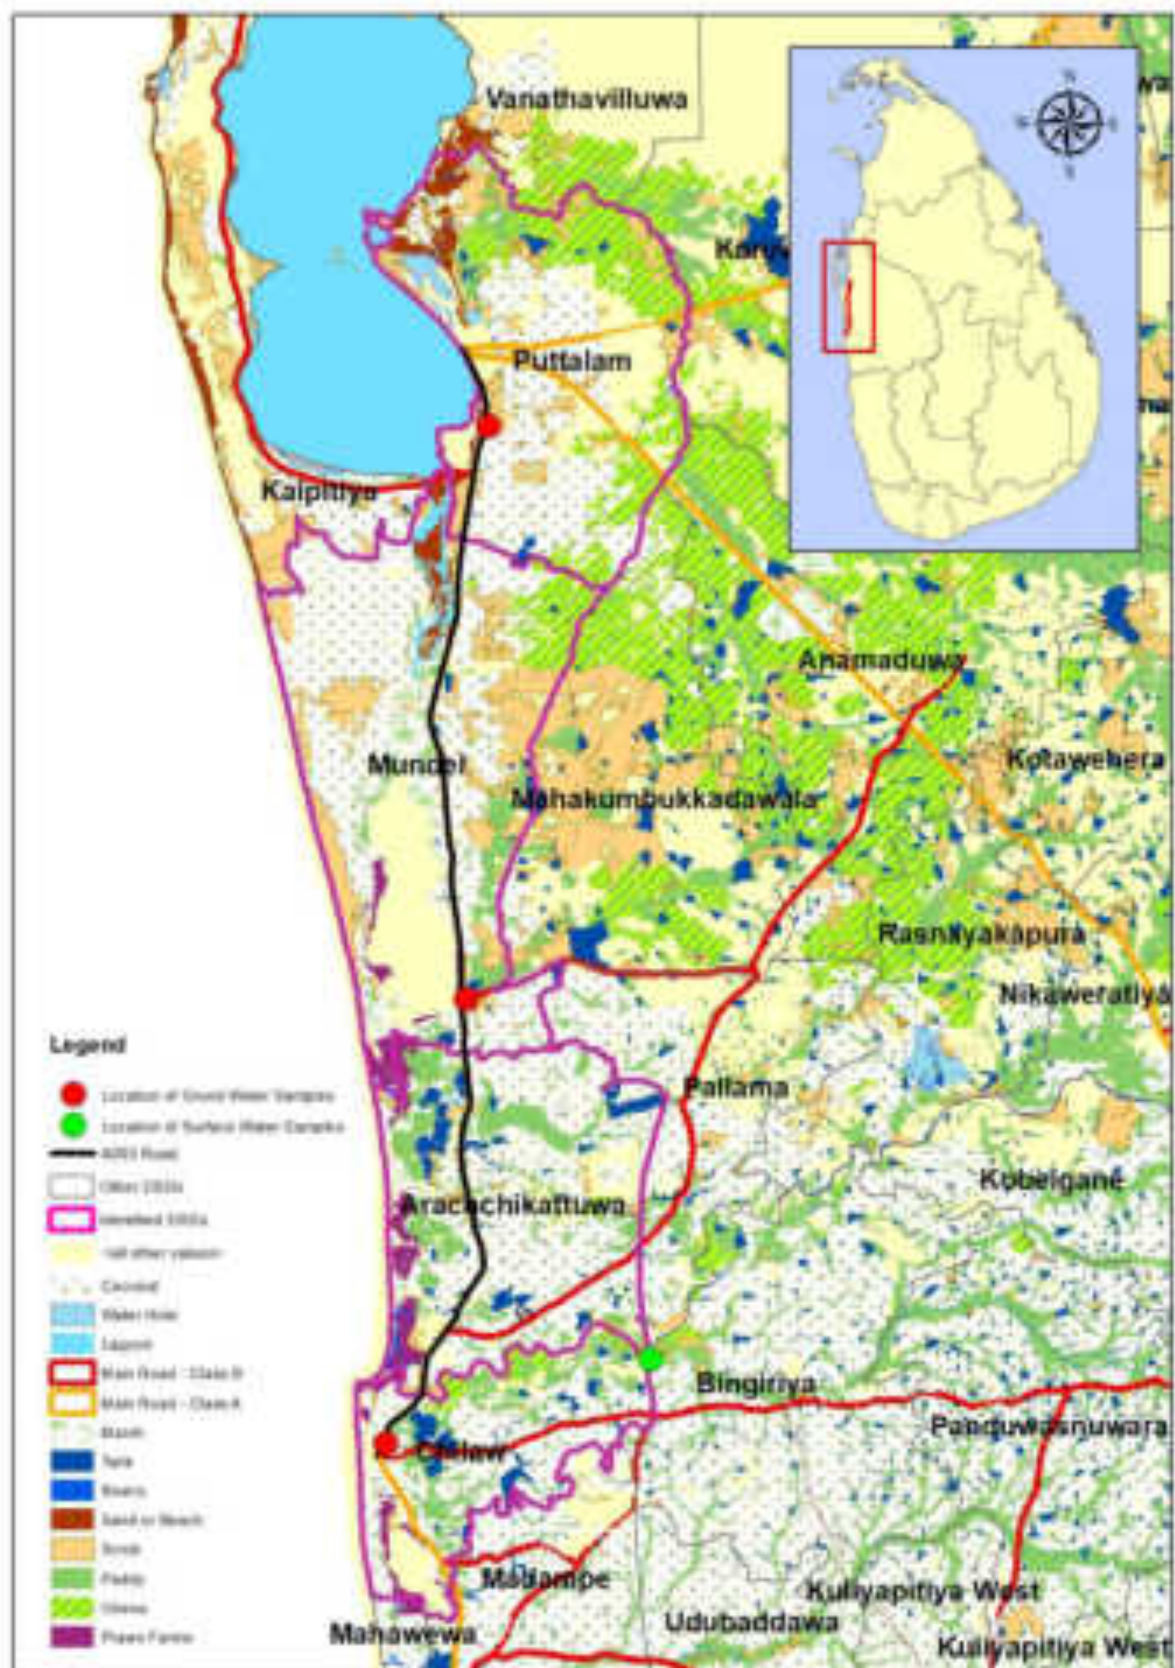
### Annex 3- Locations where water samples were collected for quality analysis

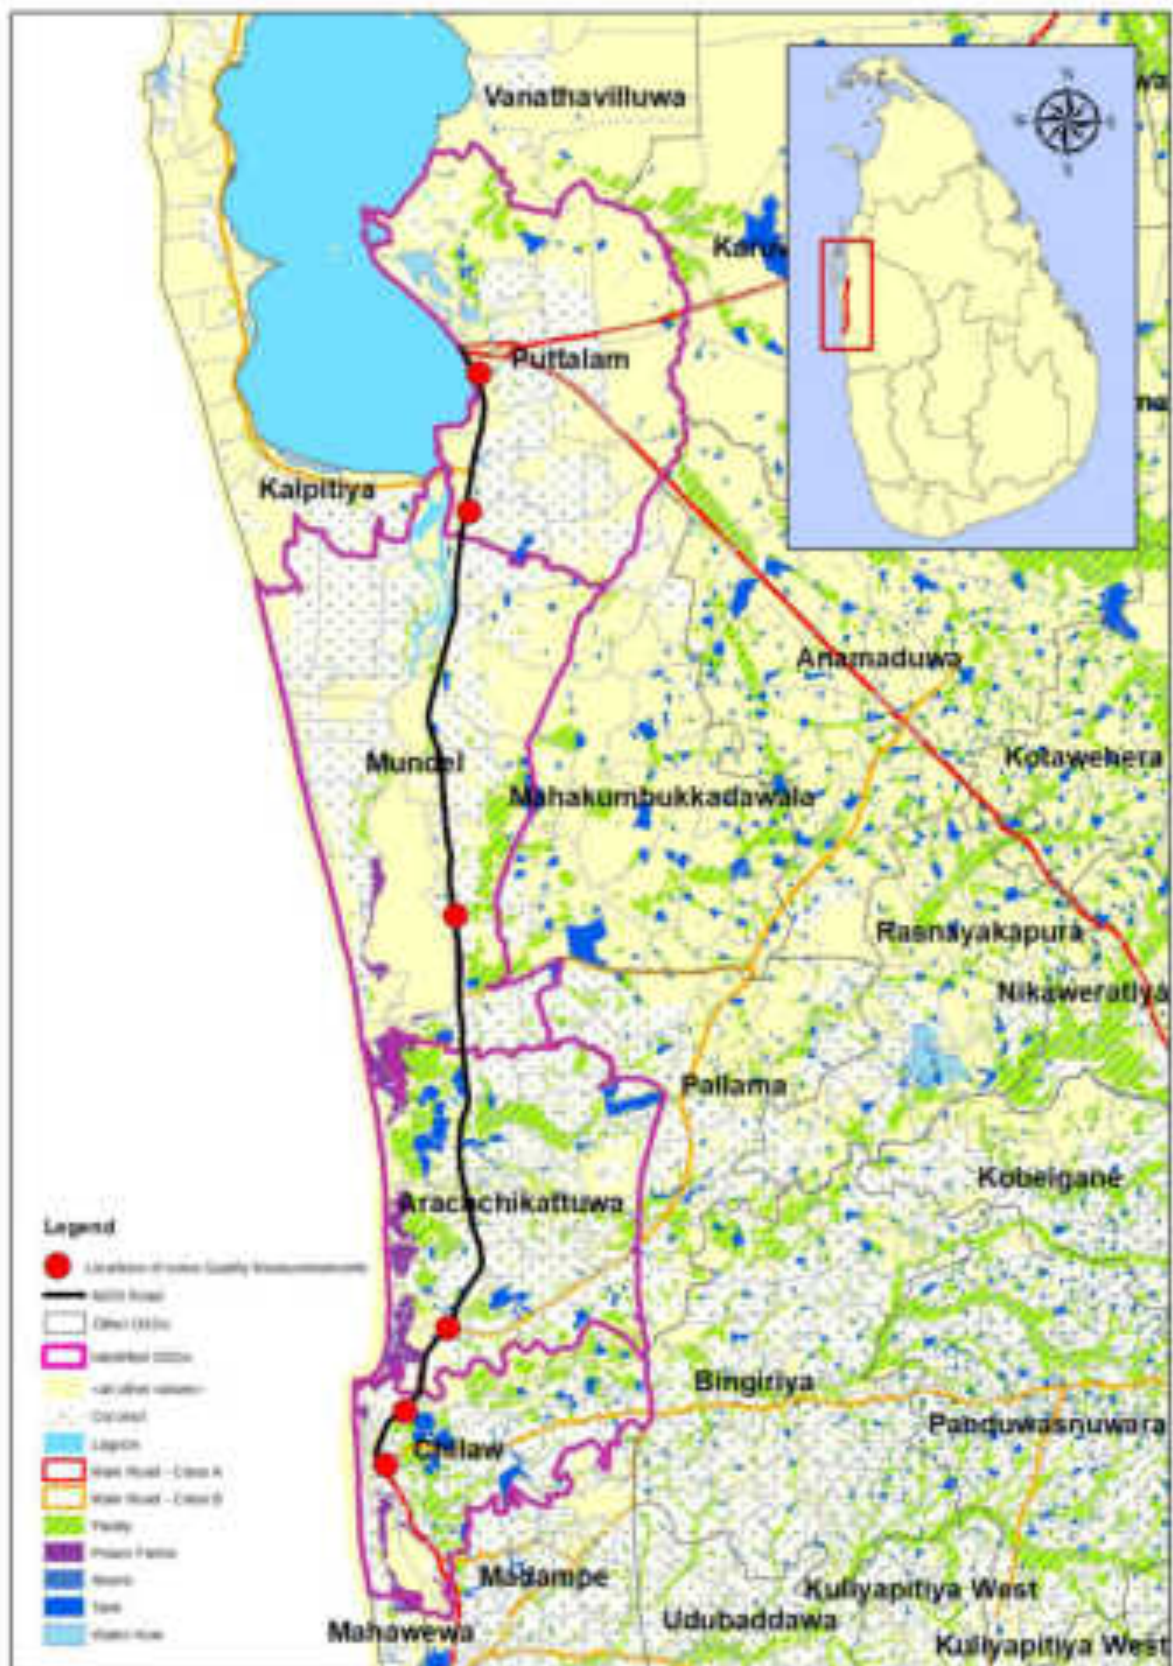
## Annex 4- Locations where noise levels were measured
