Environmental Monitoring Report

Semi-Annual Report no. 10
For the period covered July to December 2021
Project Numbers: 47381-002, 47381-005
March 2022

Sri Lanka: Mahaweli Water Security Investment Program – Tranches 1 and 2

North Western Province Canal Project (NWPCP)

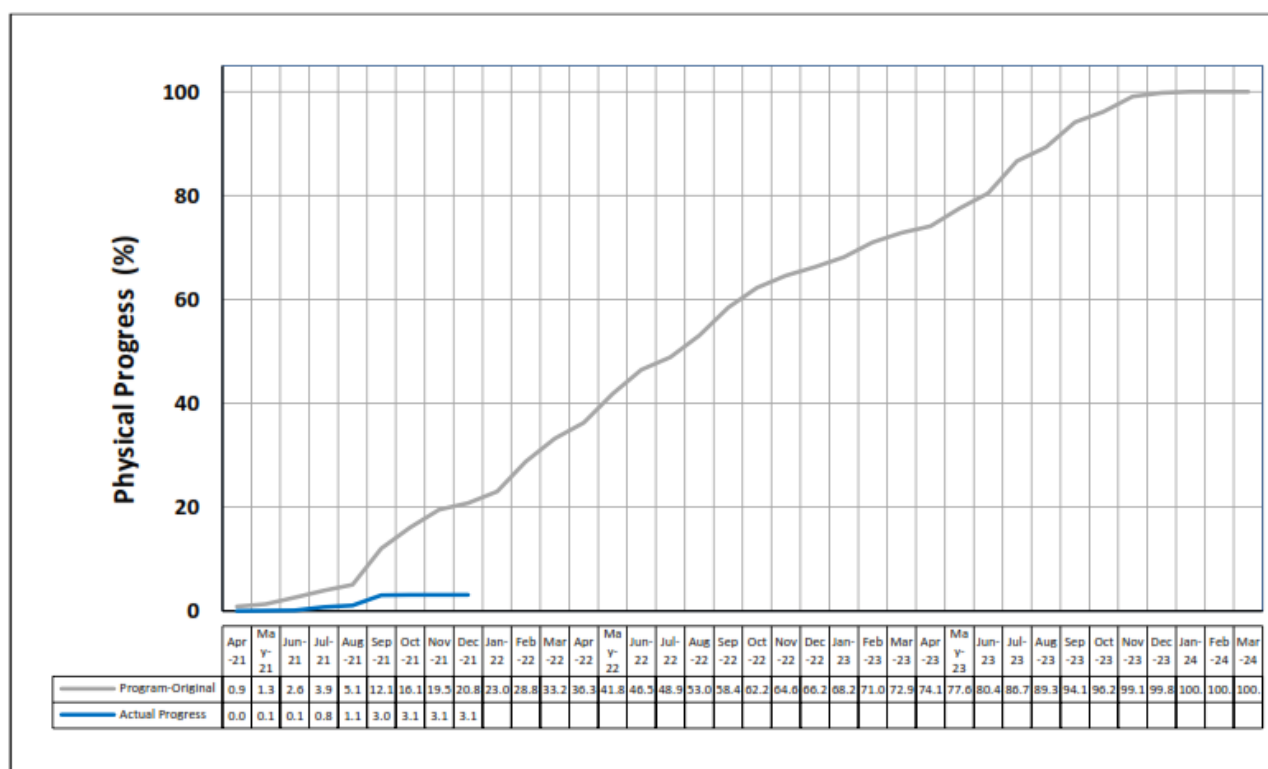
Figure 1-2: Overall physical progress of NWPCP-ICB-1 as of end December 2021

9. The baseline construction program for NWPCP-ICB-1 was approved in August 2021. Construction of Contractor's facilities continues, while construction work is in progress. Physical progress was recorded as 3.1% by end of December 2021. **Figure 1-2** explains the updated progress by end of reporting period, December 2021.

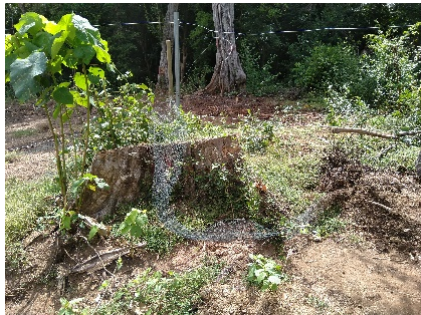
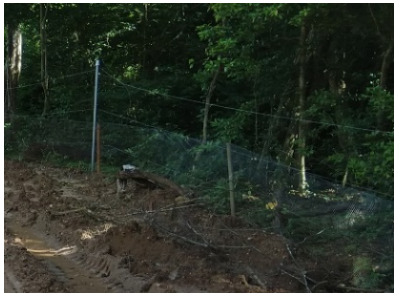
Location	Environmental Issue Recorded and Date	Actions taken
Ch 18+500 to 19+250 & 20+750 to 21+700 (Within the Wildlife area)	<p>a) Small mesh net to prevent falling of small animals is not maintained in some of places of wild life area</p>

<ul style="list-style-type: none"> NCR issues by RE on 01 October 2021 (NWPCP/ICB1/NCR/0110). By mid-November 2021 the Contractor restored all locations and NCR closed on 22 November 2021

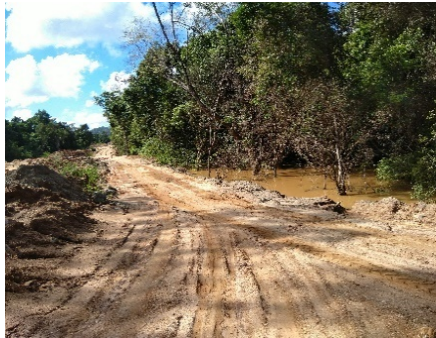
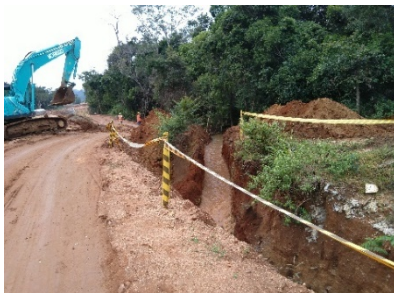
Ch 19+950, 21+050, 21+098, 21+200, 21+330 etc.	<p>a) Unmanaged streams without attending required mitigation measure particularly within wildlife area observed</p> <p>b) During rainy season it caused water logging in upstream areas and signs of dieback of trees were visible under long term submerged condition in November 2021.</p>

<ul style="list-style-type: none"> Construction work in final stage in all problematic locations and final solutions pending upon completion of DUCs. Remaining issues to be addressed with site restoration plans. Contractor implemented temporary corrective actions for some of locations, such as clearing blocked hume pipes etc. At 21+050, which had the major problem of tree dieback due to water logging, temporary drain path opened to next DUC located at 21+098

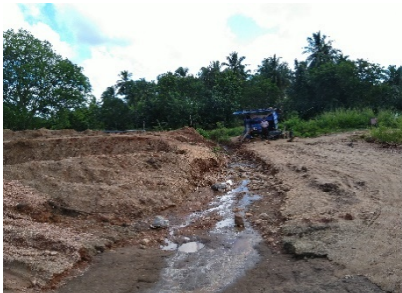
Ch 20+055	<p>a) A location prone for erosion without attending required mitigation measures observed in November 2021. Due to excavation of open canal section there, few small drainage paths concentrated to one location.</p> <p>b) High risk of siltation in agricultural lands downstream during heavy rains since a stockpile also located LB side of the canal</p>	<ul style="list-style-type: none"> The Contractor informed to take suitable action and corrective action pending

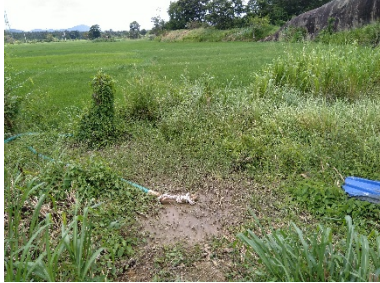
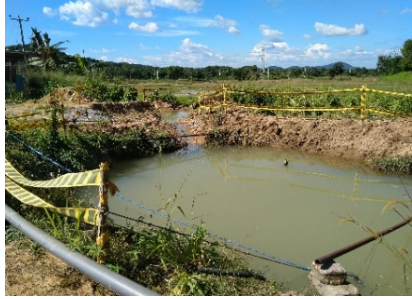
Location	Environmental Issue Recorded and Date	Actions taken
Ch 14+250 Nilagama Tunnel outlet	<p>a) Water due to tunnel dewatering at Nilagama tunnel outlet released to the adjacent tank or paddy fields through an inadequate sedimentation tank system (July 2021)</p>

<ul style="list-style-type: none"> The Contractor informed to take suitable action November 2021. They prepared tank system on ground

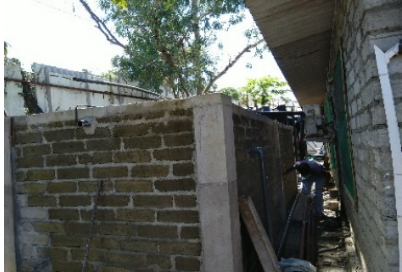
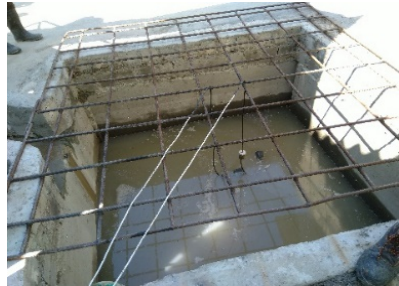
Batching plant	<p>a) Wastewater management in batching plant area was not properly functioned and the sedimentation tanks seems to be not functioning properly</p>	<ul style="list-style-type: none"> The Contractor had implemented corrective actions for wastewater management by the end of November by constructing automated wastewater treatment system.

<p>a) The sludge was dumped mixed with other waste material at open dump which made the site untidy and polluted.</p> <p>b) No proper waste management system in the batching plant. Open burning of waste observed which violate the EPL/CEA conditions.</p>	<ul style="list-style-type: none"> Corrective actions attended by the Contractor. Awareness programme has conducted by EO for all staff members of the batching plant regarding proper environmental management practices including EPL conditions.

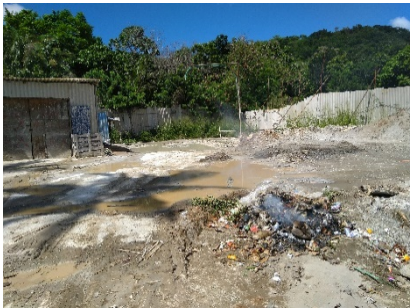
Backfilled areas / stockpile areas	<ul style="list-style-type: none"> Backfilling work completed in some areas including wildlife areas of the canal trace. and backfilling work being progress but restoration plan still not submitted. 	<ul style="list-style-type: none"> CSCEC is reminded to prepare restoration plans on such locations
Cut and cover section below The Nilagama tunnel	<ul style="list-style-type: none"> The hard and visual barricades that were been provided are damaged and have not been re-established creating falling hazards to workers and farmers. 	<ul style="list-style-type: none"> Contractor was instructed to re-establish hard and visual barricades to avoid falling into deep excavations.
Ranwadi-yawa inlet tunnel	<ul style="list-style-type: none"> Silt contained in the tunnel wastewater is not set down in the ponds since no adequate retention time due to sedimentation tank being always full of sediments. 	<ul style="list-style-type: none"> Cleaning frequency must be increased and Contractor was instructed for the action

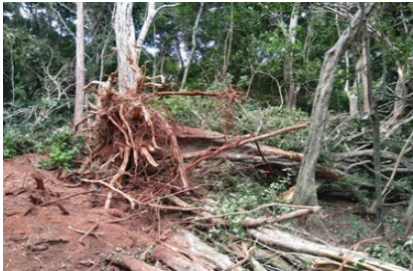
Location	Environmental Issue Recorded and Date	Actions taken
Ma-hakithula RB	<ul style="list-style-type: none"> Damaging forest while clearing of 1A-R access road without approval and without informing the Engineer at Ma-hakithula RB The Contractor had removed 43 large trees above 30 cm DBH and several small trees / bushes. They have not followed Engineer Approved Drawings for whole cleared stretch of 300 m and around half of distance been deviated from the drawings

<p>9 August 2021</p>	<ul style="list-style-type: none"> E-NCR issued (E-NCR No. 1 dated 18 August 2021) DWC inspected the site and prepared tree list The contractor has proposed to use cleared trace as 1A-R road including deviated section (CAMCE-QMCG/NWPCP-Site/PMDSC/S-325 dated 18 Sep 2021) As evaluated by the PMDSC, the proposal can be implemented once the road designs finalized with the approval of DWC. PMDSC agreed to the proposal. Road designs are in final stage now and with the approval of DWC the road can be constructed. Any additional cost for the new trace to be borne by the contractor compared to the proposed trace. Upon completion of the road work E-NCR No. 01 can be closed.

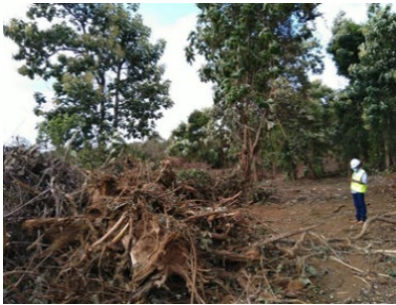
Ma-hakithula LB	<ul style="list-style-type: none"> On 16 August 2021, the Contractor cleared approx. 0.4 ha forest area to conduct a topographical survey at LB end of the bund of proposed Ma-hakithula tank without any approval and without informing the Engineer. The Contractor was instructed by the Engineer to stop the work. The Contractor disregarded instruction given by the Engineer, by next morning (17 August 2021) the Contractor had started clearing the area again. The total area cleared was about 1.3 ha including several small trees and bushes The E-NCR No. 02 issued due to clearing of forest (bushes and small trees) for surveying work without approval. Since the part of cleared area used for dam construction work and a temporary access road, restoration work cannot be proceeded now. Upon completion of the construction work (temporary road will be used during entire project period), 	<ul style="list-style-type: none"> DWLC, PIU and PMDSC jointly inspected the area and thoroughly warned the Contractor (17 August 2021). E-NCR issued (E-NCR No. 02 dated 20 August 2021) Corrective actions pending. Since there was a possible design change issue at LB end it was unable to identify which area needs to be restored during the months (part of cleared area may need to clear for construction work)

<ul style="list-style-type: none"> Relevant area to be restored by the Contractors own cost based on a SCAP. DWC, PMU, PIU and PMDSC thoroughly advised the Contractor about 2 incidents and the Contractor refrained from causing undue disturbances of similar nature to the forest furthermore.

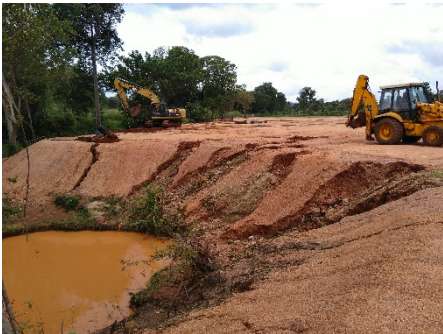
New sub campsite -Irudeni-yaya	Severe soil erosion observed due to heavy rain fall on 11 October 2021	<ul style="list-style-type: none"> Immediately stopped the work and the Contractor was instructed to take necessary actions to prevent further erosion. Warning letter issued (PMDSC-NWP-

Location	Environmental Issue Recorded and Date	Actions taken
	<p>Part of Soil bund constructed to prevent erosion washed away due to heavy rain fall on 18 November 2021</p>

<p>Site/ICB-1/CAMCE-QMCG/294 dated 13 October 2021).</p> <ul style="list-style-type: none"> ▪ The Contractor constructed soil bund and few concrete vertical drains (slope drain) in the slope to facilitate runoff water flow as a temporary mitigatory measure. ▪ Turfing work also conducted as a slope protection measure. ▪ Required measures were implemented after washing away on 18 November 2021 to prevent further erosion ▪ As a permanent measure proper drainage system to be constructed with the development of subcamp site.  
Ma-hakithula Borrow area 9	<p>No erosion protection measures were implemented. Main stream blocked at 2 locations with soil (one location used as a temporary road). Heaps of soil dumped along both sides of streams creating major risk of washed away during rainy season</p>
