Environmental Monitoring Report

Semi-Annual Report no. 10
For the period covered July-December 2021
Project Numbers: 47381-002, 47381-005
March 2022

Sri Lanka: Mahaweli Water Security Investment Program – Tranches 1 and 2

North Central Province Canal Project (previously Upper Elahera Canal Project)

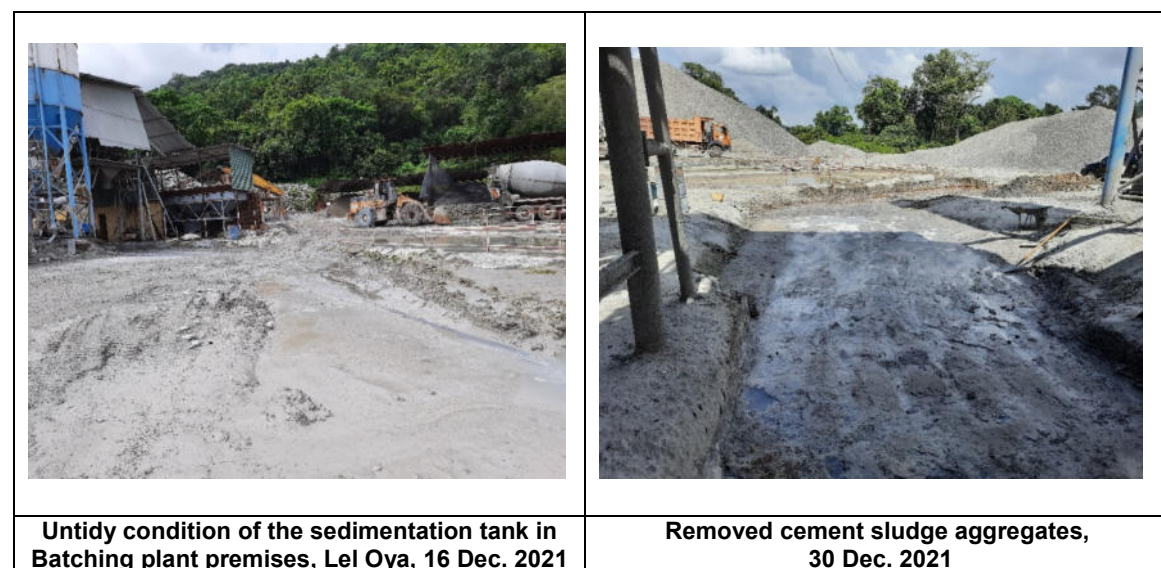
Figure 2-2: Photographic records – KMTC

<p>Used tyres are left at the site and noted water remained inside, 9 Oct. 2021</p>	<p>Removed the used tyres from site, 15 Oct. 2021</p>

<p>Solid waste is not managed in proper way at section -d site office, 10 Nov. 2021</p>	<p>Removed from worksite, 10 Nov. 2021</p>

<p>Poor housekeeping at the worksite in section-d, 5 Nov.2021</p>	<p>Removed debris from the worksites, 7 Nov. 2021</p>

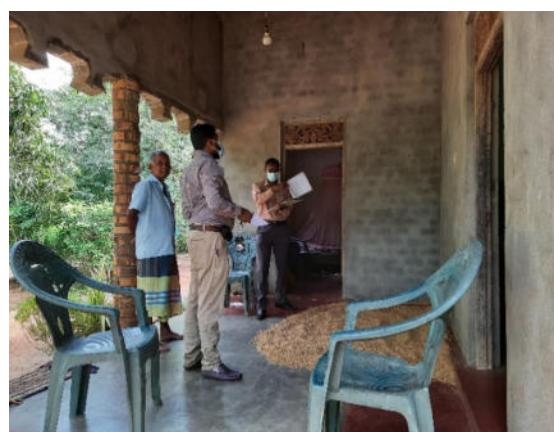
Crack survey is carried out along the tunnel trace-UEC ICB-2A, 31 Dec. 2021
