Semi-Annual Report no. 9  
For the period covered January to June 2021  
Project Numbers: 47381-002, 47381-005  
August 2021

## Sri Lanka: Mahaweli Water Security Investment Program – Tranches 1 and 2

North Western Province Canal Project (NWPCP)

## Semi Annual Environmental Monitoring Report (SAEMR) No. 09 for North-Western Province Canal Project (NWPCP) (January to June 2021)

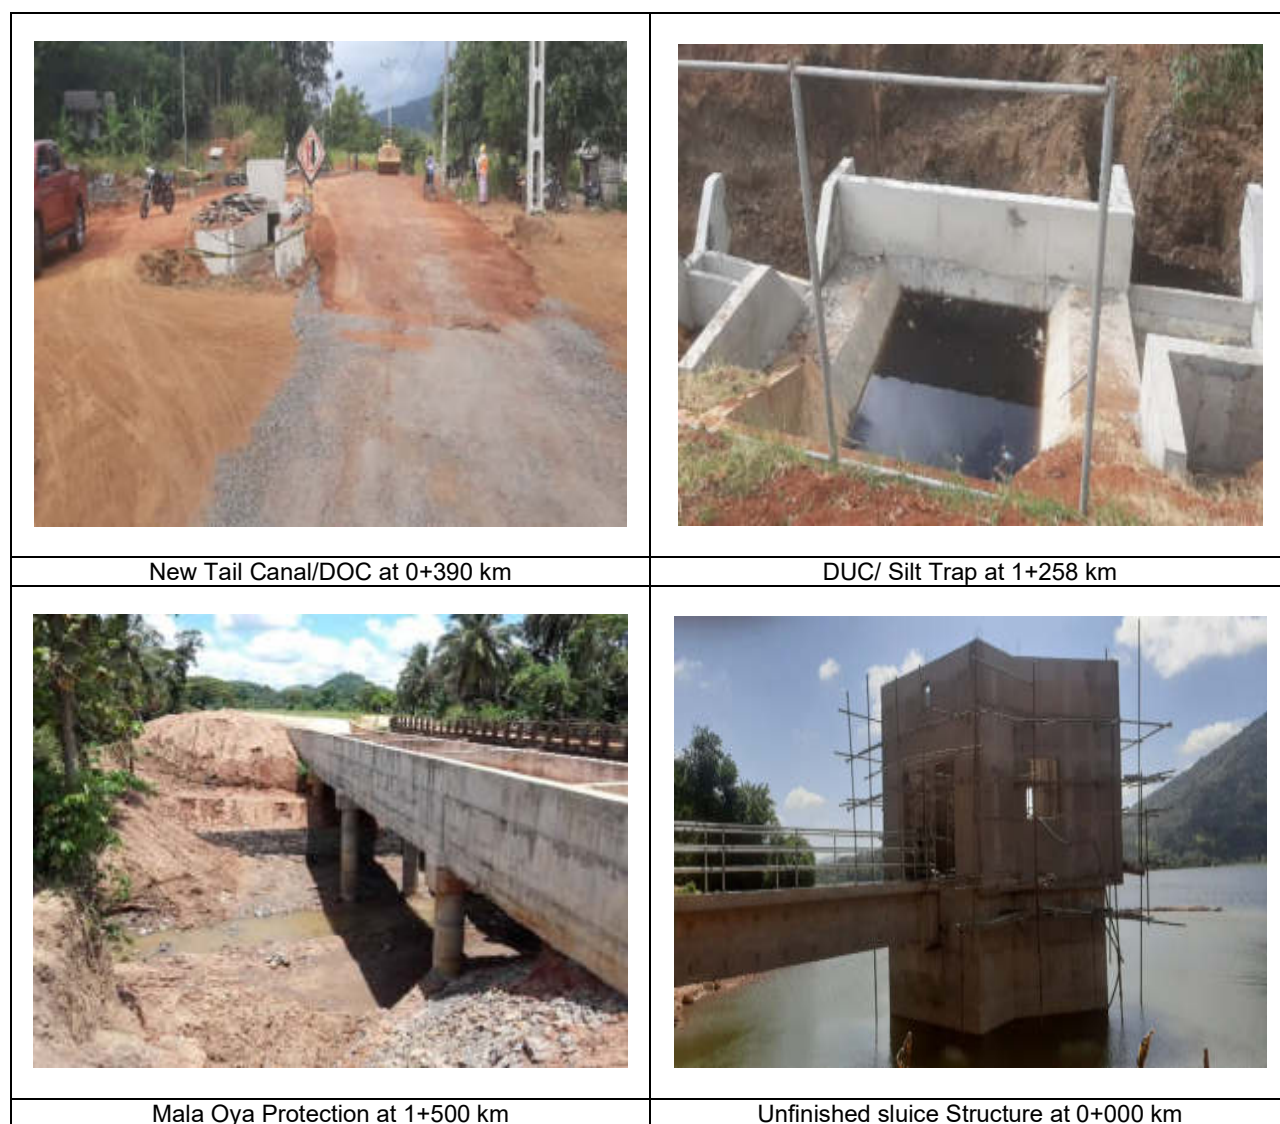
**Figure 3-1: Photographic records of the NWP-NCB-1 area**

28. In Figure 3-1 some photographic evidence of the NWPCP-NCB-1 area as of June 2021 is provided.

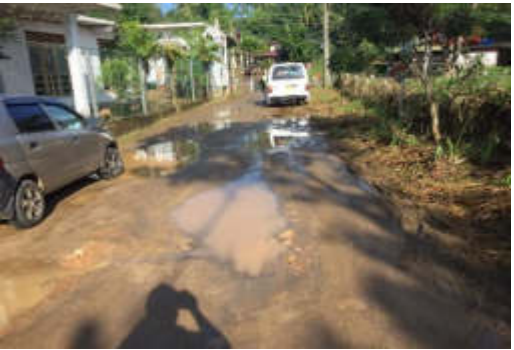
(i)	<b>Boundary demarcation of the construction areas</b> RoW is not clearly demarcated in most of the parts. No visible construction area / boundary demarcation most of the places along the canal, including DWC area (other than electric fence)	As per Conditions of the contract under Sub-clause 1.3.5 “Right of Way” - Section 1 of the Conditions of the Contract Vol II and ADB requirements, all boundaries to be clearly marked to avoid trespassing, disturbances to surrounding habitats, community, or agriculture fields
(ii)	<b>Access road maintenance</b> E- NCR # 16 was issued due to the poor condition of access roads which are used by contractor as well as the public which is located in front of Olcott Buddhist School at Ranwediya (at 8+700 km of NWP ICB 2 canal) on 21 Jan 2021. Due to heavy construction related vehicle traveling, the road had damaged with lots of potholes and the principal complained to the Engineer	This was rectified within few days and the NCR was closed in Feb 2021

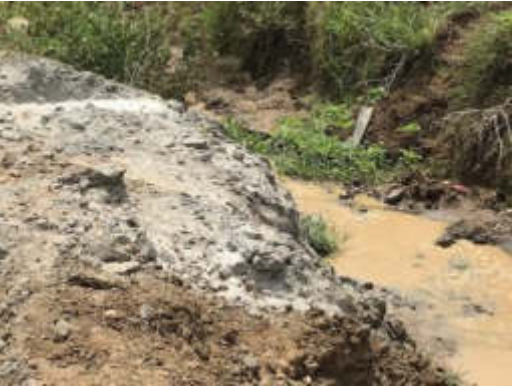
<i>Observation at Approx. Chainage 8+000 km</i>

(iii)	<b>Waste Management</b>	
a.	Cement waste still not managed properly which is related to NCR 09 and 11, which violates <ul style="list-style-type: none"> <li>Sub-clause 1.6.7 and 1.17.4.3 under the Section 1 of the Conditions of the Contract Vol II</li> <li>Sub-clause 9.1 of the Conditional Environment Approval issued by CEA on 23.02.2016 (Ref. 08/EIA/Water/07/2012 given under Vol IV – part B EMP)</li> <li>Table 6.1 of the EMP in the contract document Vol IV – Part B, highlighting the National standards to be followed to protect environment from hazardous waste like cement</li> </ul>

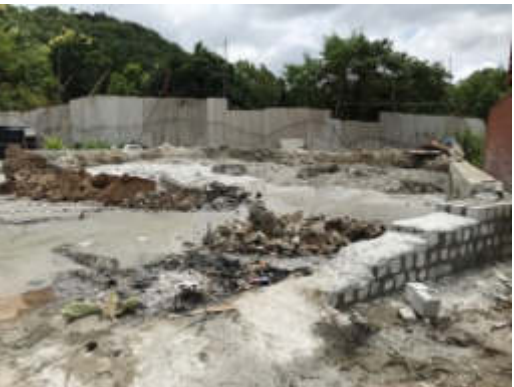
<i>Photo at Batching plant – Moragolla on 30.06.2021</i>

b.	<ul style="list-style-type: none"> <li>Sludge waste is just dumped openly inside the batching plant area without proper arrangement for sludge disposal which violates EPL/CEA conditions. The sludge is just dumped mixed with other waste material, which makes the site untidy and polluted.</li> <li>CSCEC was advised repeatedly to identify a recycling solution of this sludge waste, which can be used for cement/ concrete products</li> </ul>

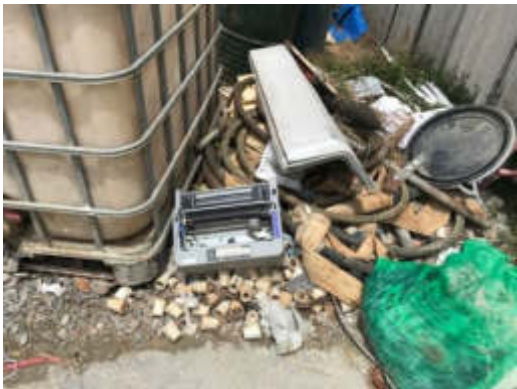
<p><b>Photo at Batching plant – Moragolla on 30.06.21</b></p>

c.	<ul style="list-style-type: none"> <li>Other waste disposal also has no proper arrangement in the site, and no designated places for waste collection.</li> <li>In batching plant premises, all types of waste including e-waste, asbestos waste (which are hazardous and needs special disposal arrangements as per CEA regulations) is just dumped outside. No dust bins placed.</li> <li>CSCEC and EO was repeatedly asked to submit the waste management plan, but not yet submitted for Engineer's approval which is a CEA requirement.</li> </ul>

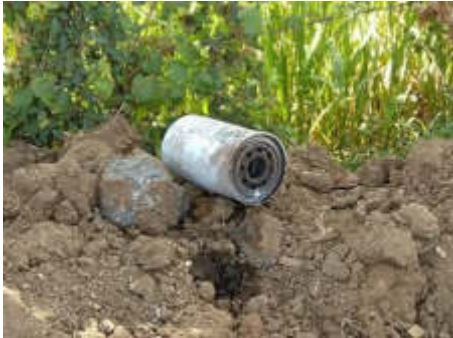
d.	<ul style="list-style-type: none"> <li>Disposal of oil filter of a heavy vehicle with oil negligently at the edge of construction access road close to the paddy field at approx. chainage 5+450 km.</li> </ul>

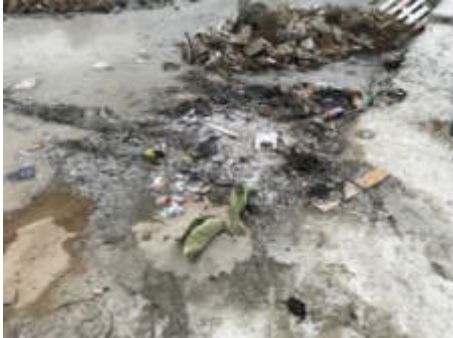
e.	<ul style="list-style-type: none"> <li>Burning waste inside the batching plant area which violates CEA and EPL conditions (recorded on 30.06.21).</li> </ul>

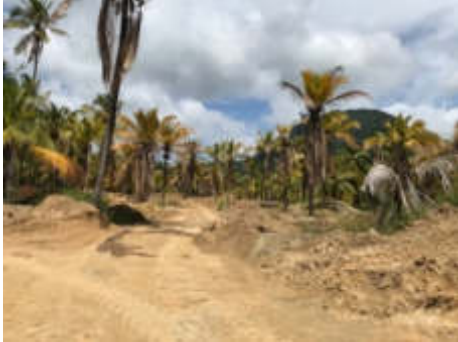
f.	<ul style="list-style-type: none"> <li>Due to unplanned disposal of tunnel waste at Ran-wediyawa tunnel portal area (9+850 km), coconut trees belong to National Livestock Development Board (NLDB) have died.</li> </ul>

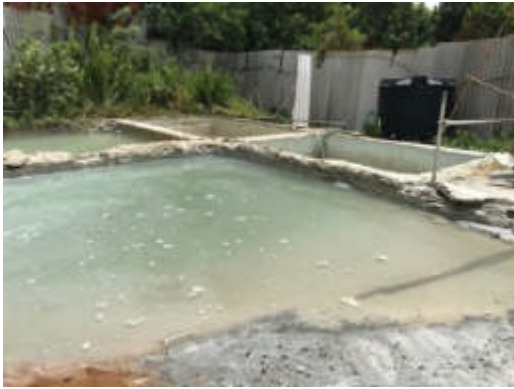
<p><i>Photo at Batching plant – Moragolla on 30.06.21</i></p>

d.	<ul style="list-style-type: none"> <li>Wastewater management in batching plant area is not clear, as the sedimentation tanks seems to be not functioning properly as the channels in between the compartments are blocked with cement waste.</li> <li>Wastewater, sewage, and other domestic wastewater management in the tunnel portals needs to be explained in the waste management plan as there is no approved document covering such aspects related to NWPCP-ICB-2</li> </ul>

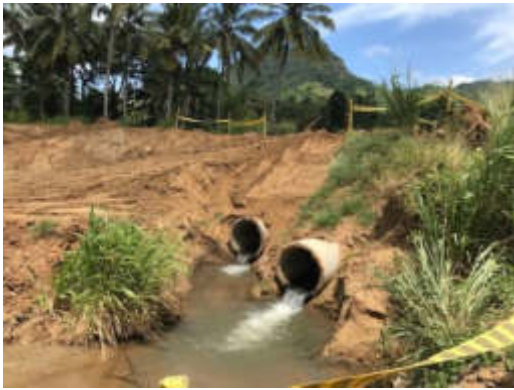
(v)	<b>Drainage management/ erosion</b>	
a.	<p>Stream diversion done without any erosion protection measures, and just directed to the natural streams without silt traps or other mitigation measures which violates:</p> <ul style="list-style-type: none"> <li>Employers' requirements – Specification Section 2 of Vol II; Section 5.3.7 – "Control of Water" under Conditions of the Contract Vol II</li> <li>Sub-clause 2.5 of CEA Environment Conditional Approval (Ref. 08/EIA/Water/07/2012 on 23.02.2016) – "Hydrological Aspects"</li> </ul>

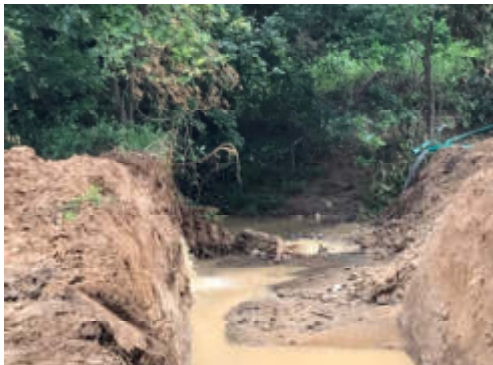
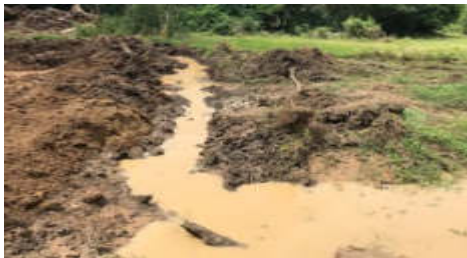
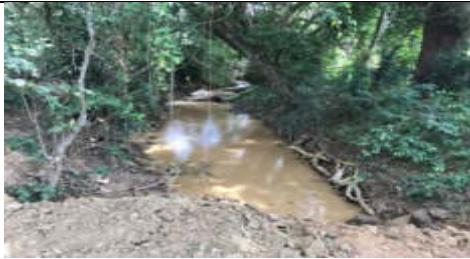
b.	<p>Release of silt-laden water to natural streams resulted from dewatering at the canal trace around chainage 8+000 km</p>

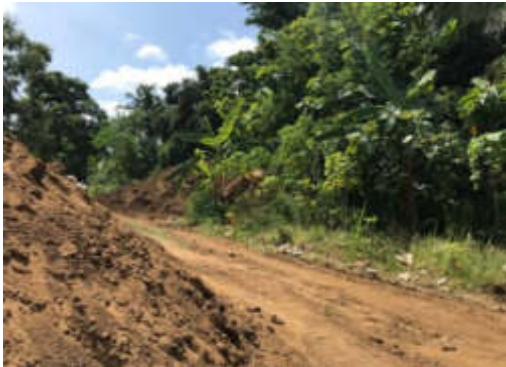
<b>Stockpiles approx. at 7+450 km</b>

(vi)	<b>Stockpile management / Restoration</b>	
	<ul style="list-style-type: none"> <li>There is a list of 26 stockpiles included in the monthly progress report, which is repeated each month without any status update by EO-CSCEC. But in the site, most of these stockpiles has been used for backfilling and some stockpile areas are now changed its land use as cultivated lands.</li> <li>EO needs to submit an updated list of existing stockpiles with their approval status, and the site restoration plans for the stockpiles, including handing over documents which is important to keep records for ADB/CEA post-monitoring and as evidence for grievances which can be raised in latter part of the project.</li> <li>At chainage 7+430 km and 7+960 km, excavated soil from the canal is dumped in adjacent private lands out of the construction boundaries. It is to be confirmed whether these are approved stockpiles.</li> </ul>

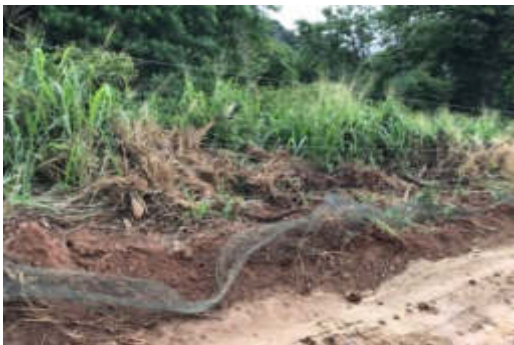
(vii)	<b>Environment issues in Wildlife Area</b>	
	<ul style="list-style-type: none"> <li>Poor environment safeguard management recorded in the DWC area sections due to following observations:               <ol style="list-style-type: none"> <li>Small mesh net is not maintained and just thrown away. This unmanaged small mesh net can damage the feet of small mammals as well as hooved mammals such as spotted deer which can be trapped in the net.</li> <li>No clear site boundaries marked, and most of the workers use forest area outside the construction boundaries as their resting places which is prohibited as per Wildlife Act. This can aggravate illegal activities such as hunting, poaching in DWC areas, as well as polluting the areas due to waste dumping, open defecation etc.</li> <li>No notices are displayed for workers which is one of the conditions by DWC.</li> </ol> </li> </ul>

<b>Broken small mesh fence inside DWC area</b>

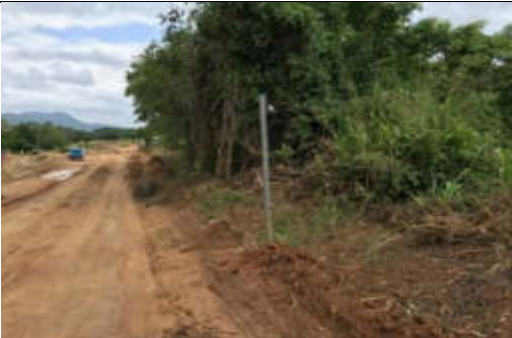
<p>(d) Unmanaged streams, stagnated water areas, and areas prone for erosion are there without attending required mitigation measures.</p> <p>(e) Backfilled areas are used for stockpiling excavated material from other sections. Once back-filling is over that section should kept free for animal movements re-arranging electric fence with a proper site restoration plan by the Contractor.</p> <p>(f) Observed firing remnants within construction boundaries of wildlife areas. Making open fire in wildlife sanctuary area is strictly prohibited which is well explained in EMP and conditions of Environmental approval.</p>

<p><b>Construction areas without small mesh fence inside DWC area</b></p>

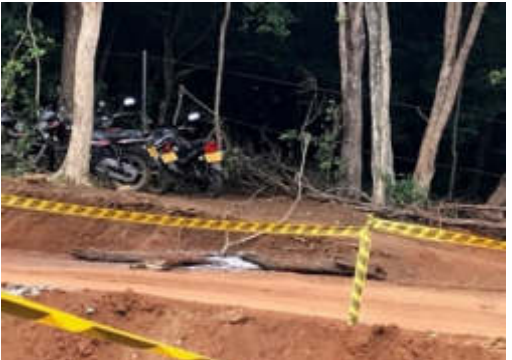
<p><b>Fire remnants in construction area inside wildlife sanctuary</b></p>
(viii)	<p><b>Unmanaged dust issues</b></p> <ul style="list-style-type: none"> <li>It was agreed by CSCEC to submit the dust management plan indicating the locations that needs dust barricades, watering plan etc. at the meeting held with CSCEC on 29.06.2020, but so far, no action taken.</li> <li>Serious dust issues observed in the construction areas adjacent to settlements, agriculture lands, as well as in the batching plant area</li> <li>In such areas no dust barriers or the existing dust barriers are properly maintained.</li> </ul>

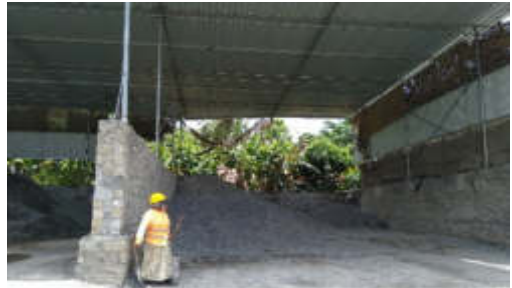
<p><b>Broken dust barricades and boundry wall in batching plant material storage area which result for windblown dust for the houses located nest to the plant – 30.06.2021</b></p>

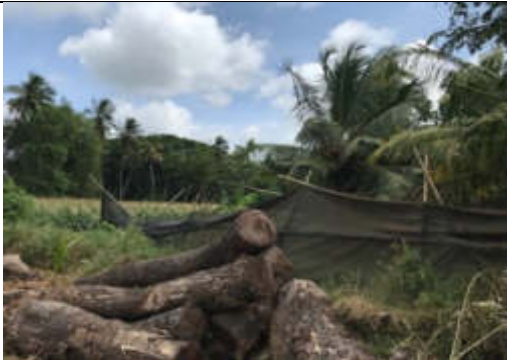
<p><b>Damaged dust barriers</b></p>
(ix)	<b>Site restoration plans for backfilled areas</b>	
	<ul style="list-style-type: none"> <li>It was observed that now backfilling work completed in Galapitawewa tank area at 17+100 to 17+400 km.</li> <li>CSCEC was reminded to prepare restoration plans on such locations in accordance with conditional approval from the Deputy Commissioner of the Agrarian Services Department (Matale) with the letter reference 5/3/2/1/2019 on 08.08.19.</li> <li>In addition, all other backfilled areas, stockpile areas need to have a detail restoration plan prepared by EO-CSCEC and approved by Engineer for implementation.</li> </ul>

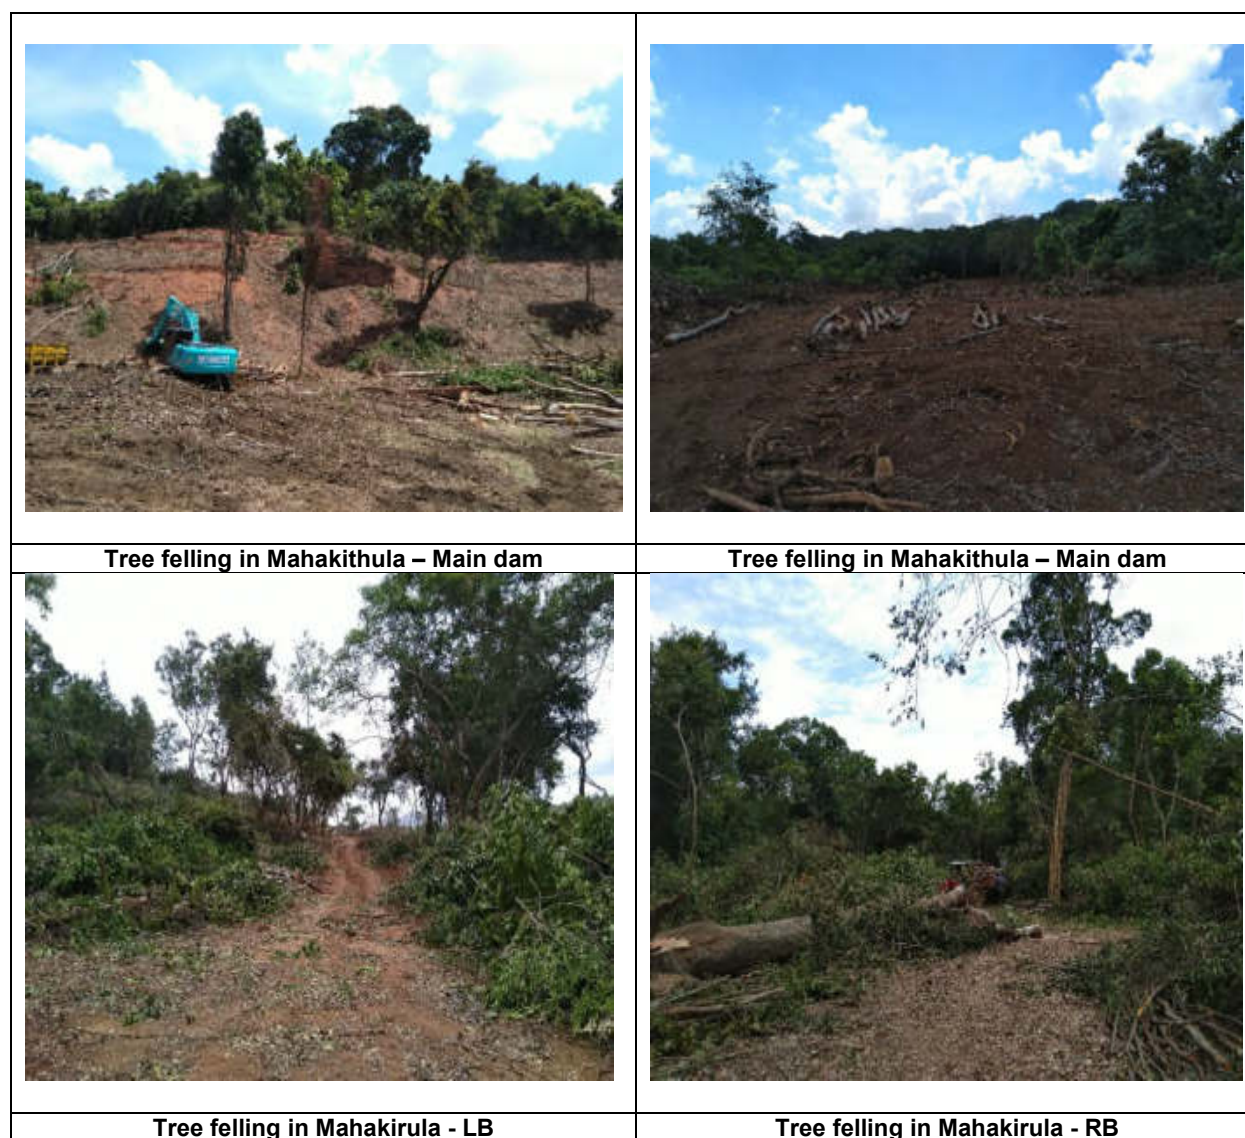
**Figure 3-2: Photographic Records of NWPCP-ICB-1 area by end June 2021**

44. Figure 3-2 shows some photographic records of the NWPCP-ICB 1 area.

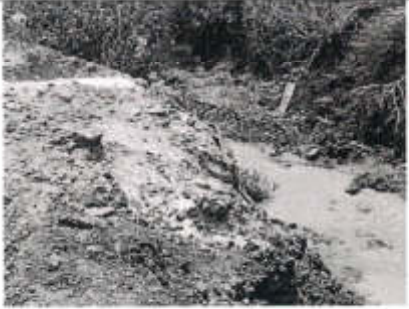
<p><b>Observation at Approx. Chainage 8+000 km</b></p>

a.	<p>Cement waste still not managed properly which is related to NCR 09 and 11, which violate</p> <ul style="list-style-type: none"> <li>Sub-Clause 1.6.7 and 1.17.4.3 under the Section 1 of the Conditions of the Contract Vol II</li> <li>Sub-clause 9.1 of the Conditional Environment Approval issued by CEA on 23.02.2016 (Ref. 08/EIA/Water/07/2012 given under Vol IV – part B EMP)</li> <li>Table 6.1 of the EMP in the Contract Document Vol IV – Part B, highlighting the National standards to be followed to protect environment from hazardous waste like cement</li> </ul>

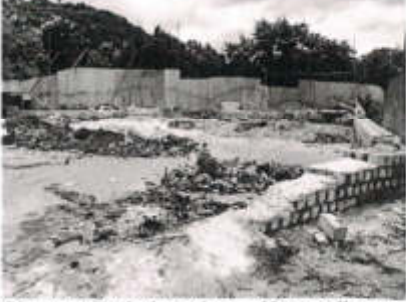
<p><i>Photo at Batching plant – Moragolla on 30.06.21</i></p>

b.	<ul style="list-style-type: none"> <li>Sludge waste is just dumped openly inside the batching plant area without proper arrangement for sludge disposal which violates EPL/CEA conditions. The sludge is just dumped mixed with other waste material, which makes the site untidy and polluted</li> <li>The Contractor was advised repeatedly to identify a recycling solution of this sludge waste, which can be used for cement/ concrete products</li> </ul>

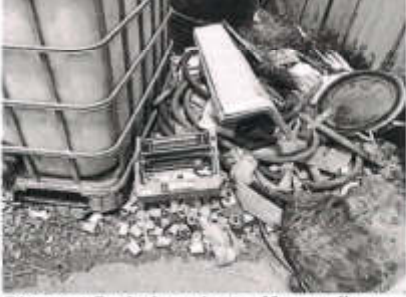
c.	<ul style="list-style-type: none"> <li>Other waste disposal also has no proper arrangement in the site, and no designated places for waste collection</li> <li>In batching plant premises, all types of waste including e-waste, asbestos waste (which are hazardous and needs special disposal arrangements as per CEA regulations) is just dumped outside. No dust bins placed</li> <li>The Contractor and EO was repeatedly asked to submit the waste management plan, but no yet submitted for Engineer's approval which is a CEA requirement</li> </ul>

<p><i>Photo at Batching plant – Moragolla on 30.06.21</i></p>
	<ul style="list-style-type: none"> <li>Disposal of oil filter of a heavy vehicle with oil negligently at the edge of construction access road close to the paddy field at approx. chainage Ch.5+450 km</li> </ul>

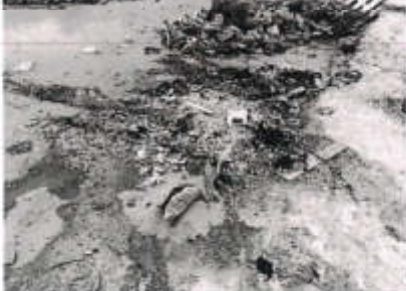
<ul style="list-style-type: none"> <li>Burning waste inside the Batching plant area which violates CEA and EPL conditions (recorded on 30.06.21)</li> </ul>

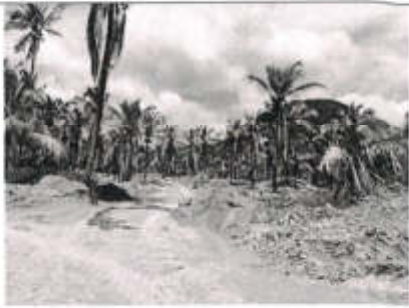
<ul style="list-style-type: none"> <li>Due to un-planned disposal of tunnel waste at Ranwidiyawa tunnel portal area (Ch.9+850 km), coconut trees belong to National Livestock Development Board (NLDB) has been died</li> </ul>

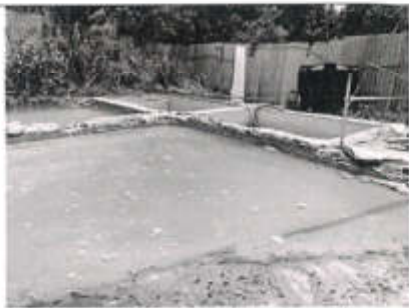
<p><i>Photo at Batching plant – Moragolla on 30.06.21</i></p>
(iv)	<b>Drainage management/ erosion</b>

d.	<ul style="list-style-type: none"> <li>Wastewater management in batching plant area is not clear, as the sedimentation tanks seems to be not functioning properly as the channels in between the compartments are blocked with cement waste</li> <li>Wastewater, sewage, and other domestic wastewater management in the tunnel portals needs to be explained in the waste management plan as there is no approved document covering such aspects related to NWPCP ICB 2</li> </ul>

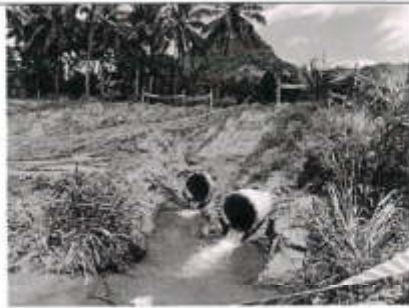
a.	<p>Stream diversion done without any erosion protection measures, and just directed to the natural streams without silt traps or other mitigation measures which violates:</p> <ul style="list-style-type: none"> <li>Employers' requirements – Specification Section 2 of Vol II; Section 5.3.7 – "Control of Water" under Conditions of the Contract Vol II</li> <li>Sub-clause 2.5 of CEA Environment Conditional Approval (Ref. 08/EIA/Water/07/2012 on 23.02.2016) – "Hydrological Aspects"</li> </ul>

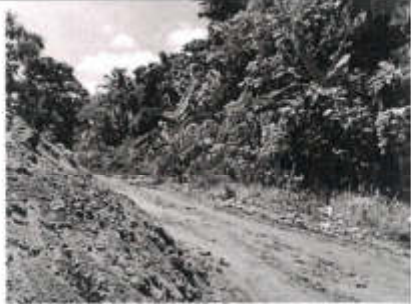
<i>Stockpiles approx. at 7+450 km</i>

(v)	<b>Stockpile management / Restoration</b>	
	<ul style="list-style-type: none"> <li>There is a list of 26 stockpiles included in the monthly progress report, which is repeated each month without any status update, by EO-CSCEC</li> <li>But in the site, most of these stockpiles has been used for backfilling and some stockpile areas are now changed its land use as cultivated lands.</li> <li>EO needs to submit an updated list of existing stockpiles with their approval status, and the site restoration plans for the stockpiles, including handing over documents which is important to keep records for ADB/CEA post-monitoring and as evidence for grievances which can be raised in latter part of the project</li> <li>At chainage Ch.7+430 km and Ch.7+960 km, excavated soil from the canal is dumped in adjacent private lands out of the construction boundaries. Are these approved stockpiles?</li> </ul>

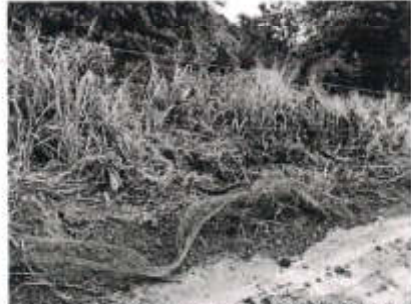
(vi)	<b>Environment issues in Wildlife Area</b>	
	<ul style="list-style-type: none"> <li>Poor environment safeguard management recorded in the DWC area sections due to following observations:               <ol style="list-style-type: none"> <li>Small mesh net is not maintained and just thrown away. This unmanaged small mesh net can damage the feet of small mammals as well as hooved mammals such as spotted deer which can be trapped in the net</li> <li>No clear site boundaries marked, and most of the workers use forest area outside the construction boundaries as their resting places which is prohibited as per wildlife act. This can aggravate illegal activities such as hunting, poaching in DWC areas, as well as polluting the areas due to waste dumping, open defecation etc.</li> </ol> </li> </ul>

<i>Broken small mesh fence inside DWC area</i>

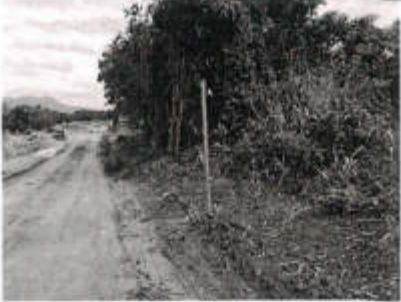
<p>(c) No notices are displayed for workers which is one of the conditions by DWC</p> <p>(d) Unmanaged streams, stagnated water areas, and areas prone for erosion are there without attending required mitigation measures</p> <p>(e) Backfilled areas are used for stockpiling excavated material from other sections. Once backfilling is over that section should kept free for animal movements re-arranging electric fence with a proper site restoration plan by the contractor.</p> <p>(f) Observed firing remnants within construction boundaries of wildlife areas. Making open fire in wildlife sanctuary area is strictly prohibited which is well explained in EMP and conditions of Environmental approval.</p>

<p><b>Construction areas without small mesh fence inside DWC area</b></p>

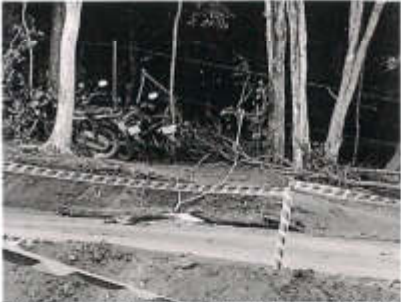
<p><b>Fire remnants in construction area inside wildlife sanctuary</b></p>
(vii)	<p><b>Unmanaged dust issues</b></p> <ul style="list-style-type: none"> <li>It was agreed by the Contractor to submit the Dust management plan indicating the locations that needs dust barricades, watering plan etc. at the meeting held with the Contractor on 29.06.2020, but so far, no action taken</li> <li>Serious dust issues observe in the construction areas adjacent to settlements, agriculture lands, as well as in the batching plant area</li> <li>In such areas no dust barriers or the existing dust barriers are not properly maintained</li> </ul>

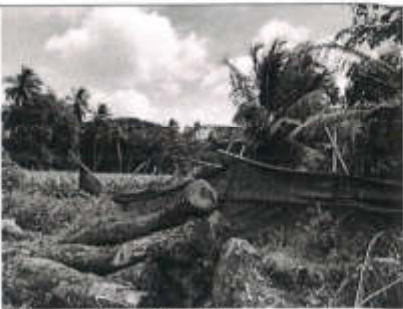
<i>Damaged dust barriers</i>
(viii)	<b>Site restoration plans for backfilled areas</b> <ul style="list-style-type: none"> <li>▪ It was observed that now backfilling work completed in Galapitawewa tank area at Ch.17+100km to Ch.17+400 km</li> <li>▪ The Contractor is reminded to prepare restoration plans on such locations in accordance with conditional approval from the Deputy Commissioner of the Agrarian Services Department (Matale) with the letter reference 5/3/2/1/2019 on 08.08.19</li> <li>▪ In addition, all other backfilled areas, stockpile areas needs to have a detail restoration plan prepared by EO-CSCEC and approved by Engineer to implement</li> </ul>
