# Environmental Monitoring Report

Semi-Annual Report no. 4  
For the period covered January to June 2019  
Project Number: 47381-002  
December 2019

## SRI: Mahaweli Water Security Investment Program – Tranche 1

North Western Canal Project (NWPCP)

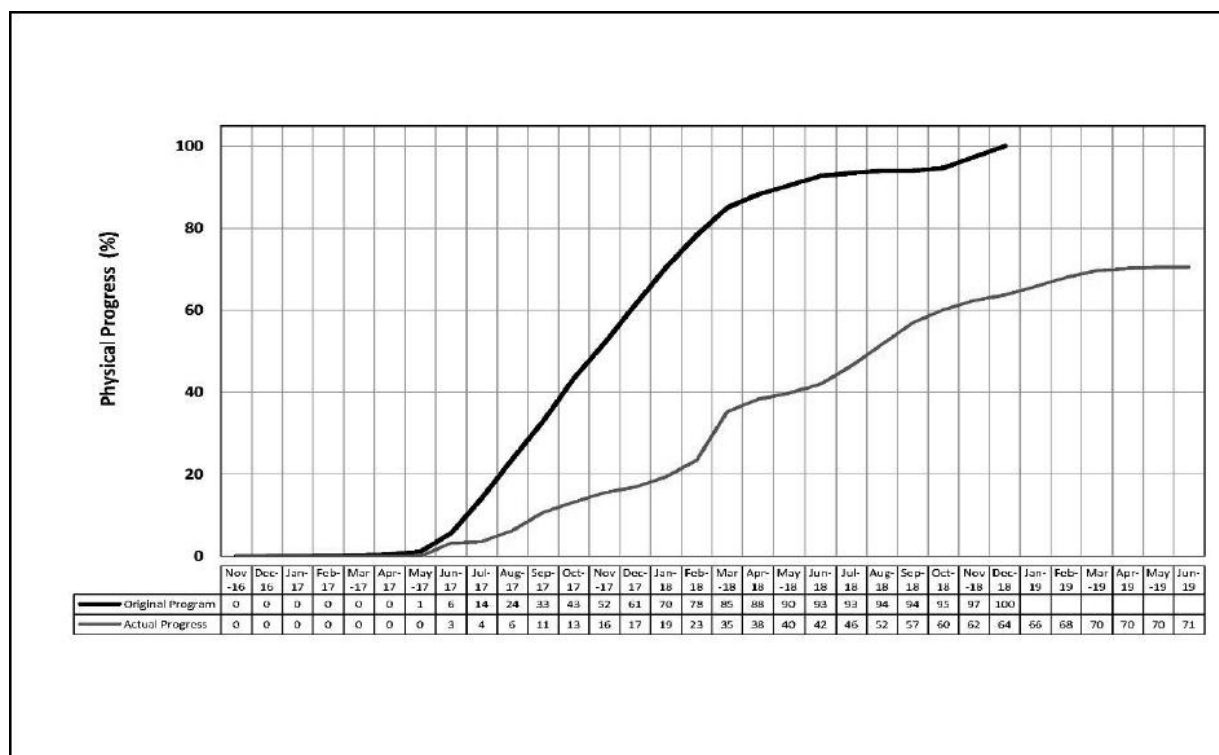
**Figure 1-3: Physical progress of NWPCP-NCB-1 as of June 2019**

7. The Contractor has failed to complete the construction work as per the original intended completion date 29 December 2018, and also the provisionally extended completion date of 30 May 2019 (to be finally determined pending the assessment of submitted claims by the Contractor for an Extension of Time). Cumulative physical progress by June 2019 is about 71 % of the total work to be done, as shown in **Figure 1-3**.

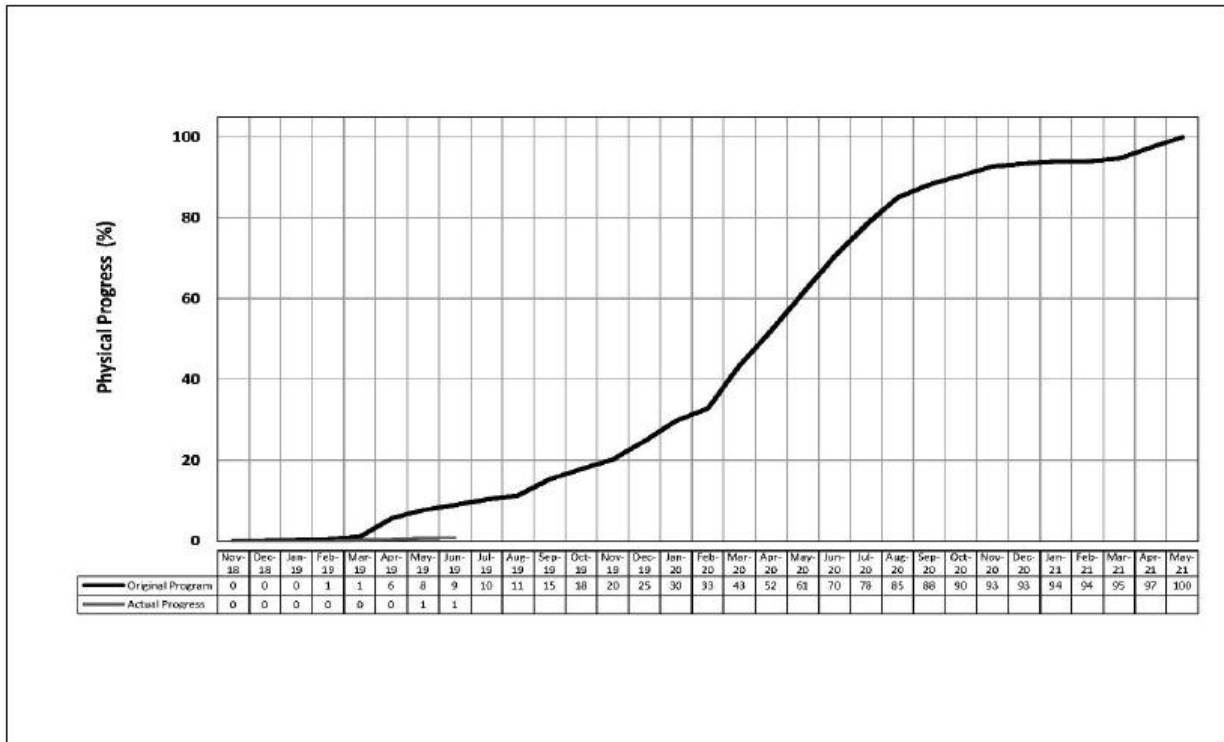
**Figure 1-4: Physical progress of NWPCP-ICB-2 as of June 2019**

9. The establishment of Contractor's facilities and site clearing, excavation work from 17+000 km to 18+500 km started in NWPCP-ICB-2 package during the reporting period from January to June 2019. Concrete work also started in some sections between 17+650 km to 17+750 km. Physical progress by June 2019 is slowly picking up (**Figure 1-4**).

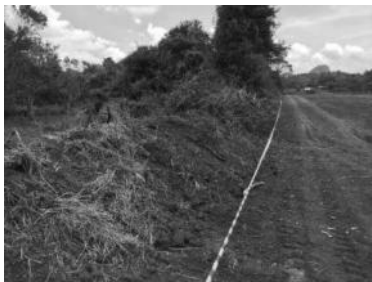
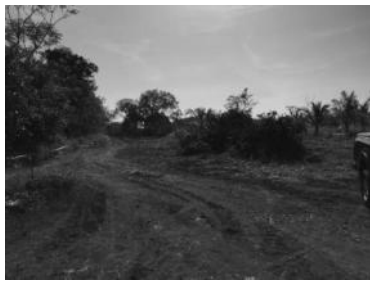
Location	Environmental issues	Date observed, Action by PMDSC	Corrective measures by Contractor
17+000 km to 17+500 km at Galapitawewa tank	<ul style="list-style-type: none"> <li>Debris that has been generated due to land clearing dumped outside RoW.</li> </ul>	03.05.19 E-NCR issued and monitoring to confirm that the Contractor attended the recommended corrective actions.	<ul style="list-style-type: none"> <li>Removed all debris and temporally dump within the RoW on the same day, and material was just dumped within the RoW</li> <li>The material transferred to the approved disposal site in June 2019</li> </ul>

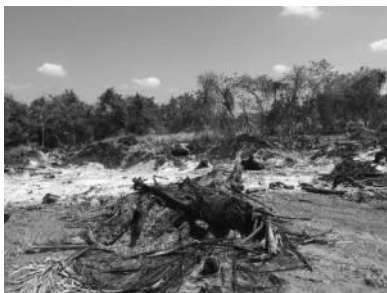
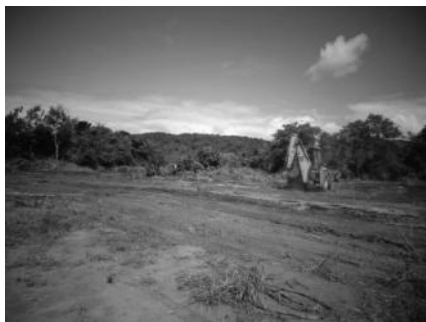
<p>After</p>
16+790 km	<ul style="list-style-type: none"> <li>Fire at dump site.</li> </ul>	08.04.19 E-NCR issued and monitoring to confirm that the Contractor attended the recommended corrective actions (refer Table 3-4).	<ul style="list-style-type: none"> <li>The site was restored to the landowner's consent and handed over by end April 2019</li> </ul>

08.04.19	Extensive Fire at the Dumping Site No. 3 at 16+790 km.	This disposal site was banned for further use, as it may trigger social unrest in the area as the landowner had permitted this site only for the vegetative parts to be dumped, enabling the improvement of soil fertility, for future use of the land for cultivation purpose by the landowner. With this fire the objective was lost. The site was restored to the landowner's consent and handed over. A separate disposal site was found and required approvals were obtained.

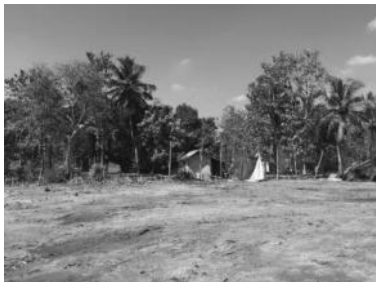
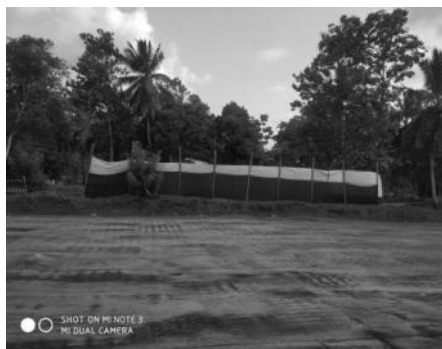
17+000 km to 18+200 km	<ul style="list-style-type: none"> <li>Damaged dust covers.</li> </ul>	12.04.19 E-NCR issued and monitoring to confirm that the Contractor attended the recommended corrective actions.	<ul style="list-style-type: none"> <li>Dust covers were reinstated by end May 2019</li> </ul>

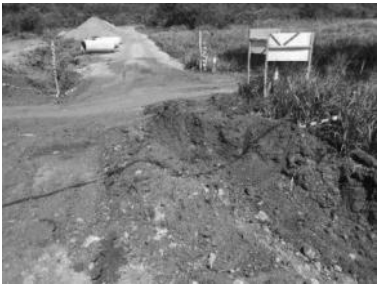
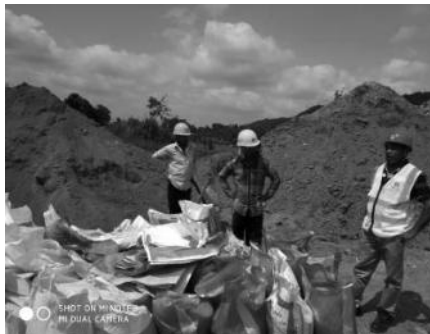
Location	Environmental issues	Date observed, Action by PMDSC	Corrective measures by Contractor
17+450 km to 17+550 km	<ul style="list-style-type: none"> <li>Large stockpile of earth is placed at the edge of a natural drainage path with no erosion protection measures.</li> <li>The stockpile is not managed in a proper way with respect to slope protection and covering to mitigate dust and erosion.</li> </ul>

<p>Before</p>	<p>End April 2019</p> <p>Informed the Contractor verbally during the monitoring visits and meetings.</p> <p>Monitoring to confirm that the Contractor attended the recommended corrective actions.</p>

<ul style="list-style-type: none"> <li>The contractor attended required mitigation measures partly by end May 2019</li> </ul>
			Sandbag preparation

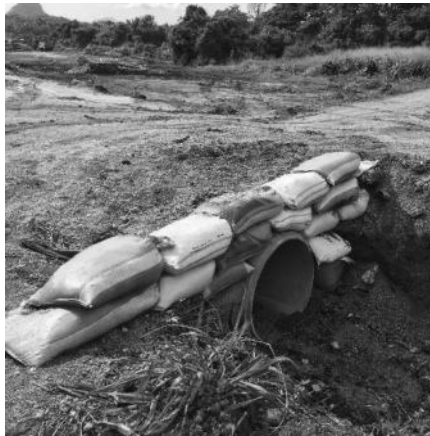
<ul style="list-style-type: none"> <li>Restoration of drainage path at this location was attended by 1<sup>st</sup> week of May 2019</li> </ul>

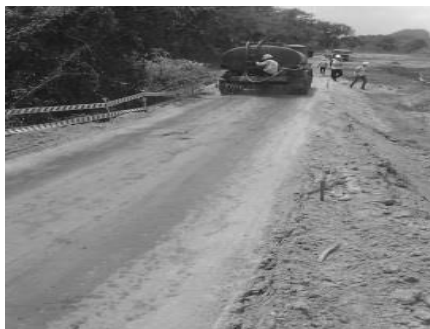
16+675 km to 18+500 km, and 19+650 km to 20+760 km	<ul style="list-style-type: none"> <li>Dust emission during construction activities.</li> </ul>	<p>During May 2019</p> <p>Informed the Contractor verbally during the monitoring visits and meetings.</p> <p>Monitoring to confirm that the Contractor attended the recommended corrective actions.</p>	<ul style="list-style-type: none"> <li>Awareness discussion held with labours and supervision staff.</li> <li>Arranged watering twice a day, increased number of bowser and replaced broken down bowser.</li> </ul>

<ul style="list-style-type: none"> <li>Watering and required measures were implemented by end May 2019</li> </ul>

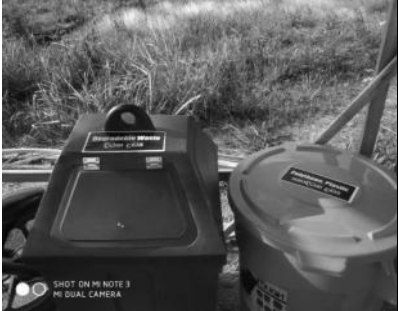
Location	Environmental issues	Date observed, Action by PMDSC	Corrective measures by Contractor
16+675 km to 18+500 km	<ul style="list-style-type: none"> <li>Haphazard waste disposal along the site.</li> </ul>		<ul style="list-style-type: none"> <li>The labours and officers were educated regarding the waste management.</li> <li>Daily collection systems were arranged by end May 2019</li> </ul>

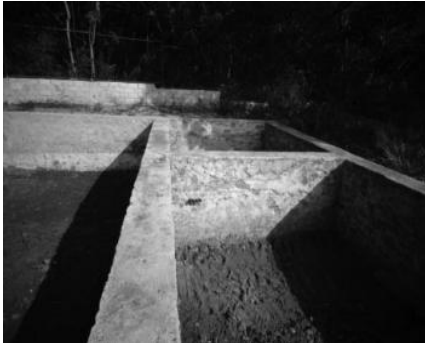
Batching Plant	<ul style="list-style-type: none"> <li>Concrete batching plant wastewater treatment issues identified.</li> </ul>		<ul style="list-style-type: none"> <li>Settling tanks and treatment system for concrete waste were established by end May</li> </ul>

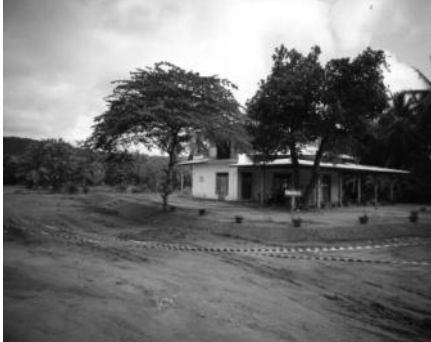
<p>Disposal site 1</p>

Disposal site - 01	<ul style="list-style-type: none"> <li>Disposal of soil waste arising due to clearing and grubbing and excavation of canal from 17+000 km to 17+400 km.</li> </ul>		<ul style="list-style-type: none"> <li>The land was prepared to prevent soil erosion establishing drains around the stockpile by end June 2019</li> <li>But progress not satisfactory as no covering of stockpiles, sandbags for erosion not attended by end of reporting period</li> </ul>

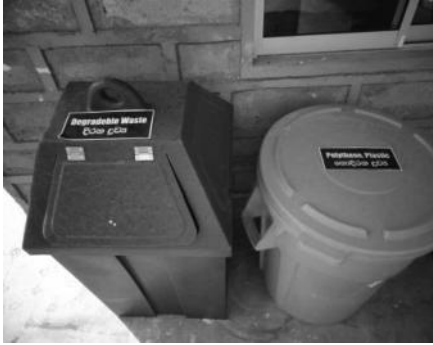
Batching plant and 16+675	<ul style="list-style-type: none"> <li>Haphazard waste disposal at batching plant area recorded</li> </ul>		<ul style="list-style-type: none"> <li>Labours and officers were educated regarding the waste management.</li> </ul>

Location	Environmental issues	Date observed, Action by PMDSC	Corrective measures by Contractor
km to 18+500 km	April 2019, and instruction issued early May 2019		<ul style="list-style-type: none"> <li>▪ Daily collecting systems were arranged for solid waste contacting Local authority by end June, but not periodical collection take place</li> <li>▪ No arrangement for sludge disposal in place</li> </ul>

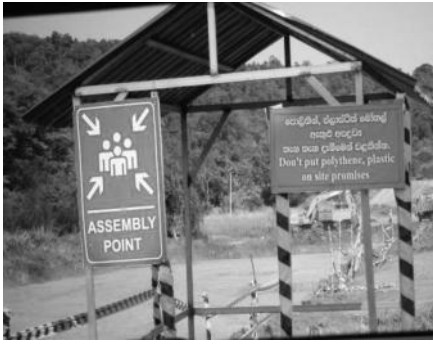
17+160 km	<ul style="list-style-type: none"> <li>▪ Aggregation of water in excavated area observed in June 2019 with the activation of rains</li> </ul>		<ul style="list-style-type: none"> <li>▪ No proper dewatering mechanism in place, and Dewatering MS not approved by end of reporting period</li> <li>▪ Temporary solutions were made diverting pumped water to the existing natural stream path</li> </ul>
17+000 km to 18+500 km	<ul style="list-style-type: none"> <li>▪ Social unrest due to improper drainage arrangement, disturbance to the access etc.</li> </ul>		<ul style="list-style-type: none"> <li>▪ People educating sign board was placed near the road.</li> </ul>

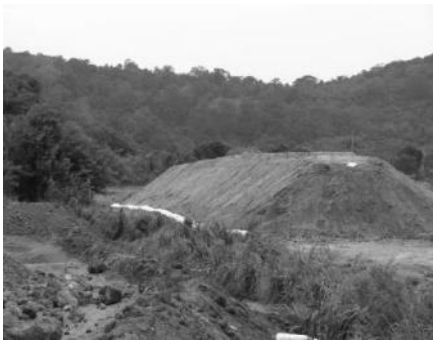
17+450 km to 17+550 km	<ul style="list-style-type: none"> <li>▪ Large earthen stockpile is placed at the edge of a natural drainage path with no erosion protection measures.</li> <li>▪ The stockpile is not managed in a proper way with respect to slope protection and covering to mitigate dust and erosion.</li> <li>▪ This was recorded and corrective actions were proposed by mid May 2019</li> </ul>

<ul style="list-style-type: none"> <li>▪ The land was prepared to prevent soil erosion establishing drains around the stockpile by end June 2019</li> <li>▪ But progress not satisfactory as no covering of stockpiles, sandbags for</li> </ul>

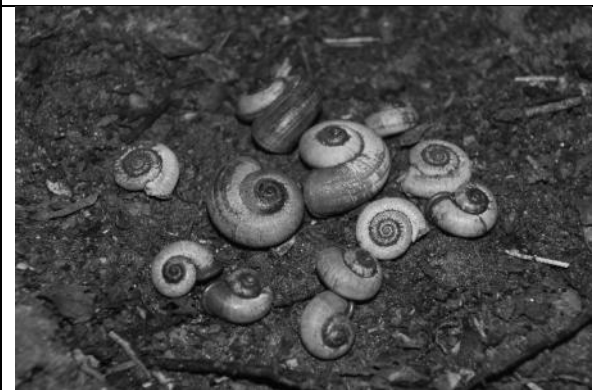
Collecting Fauna	Collecting Fauna

Translocated Area	Translocated Area

<i>Aulopoma itieri</i> & <i>Micraulax coeloconus</i>	<i>Beddomea tifasciatus</i>

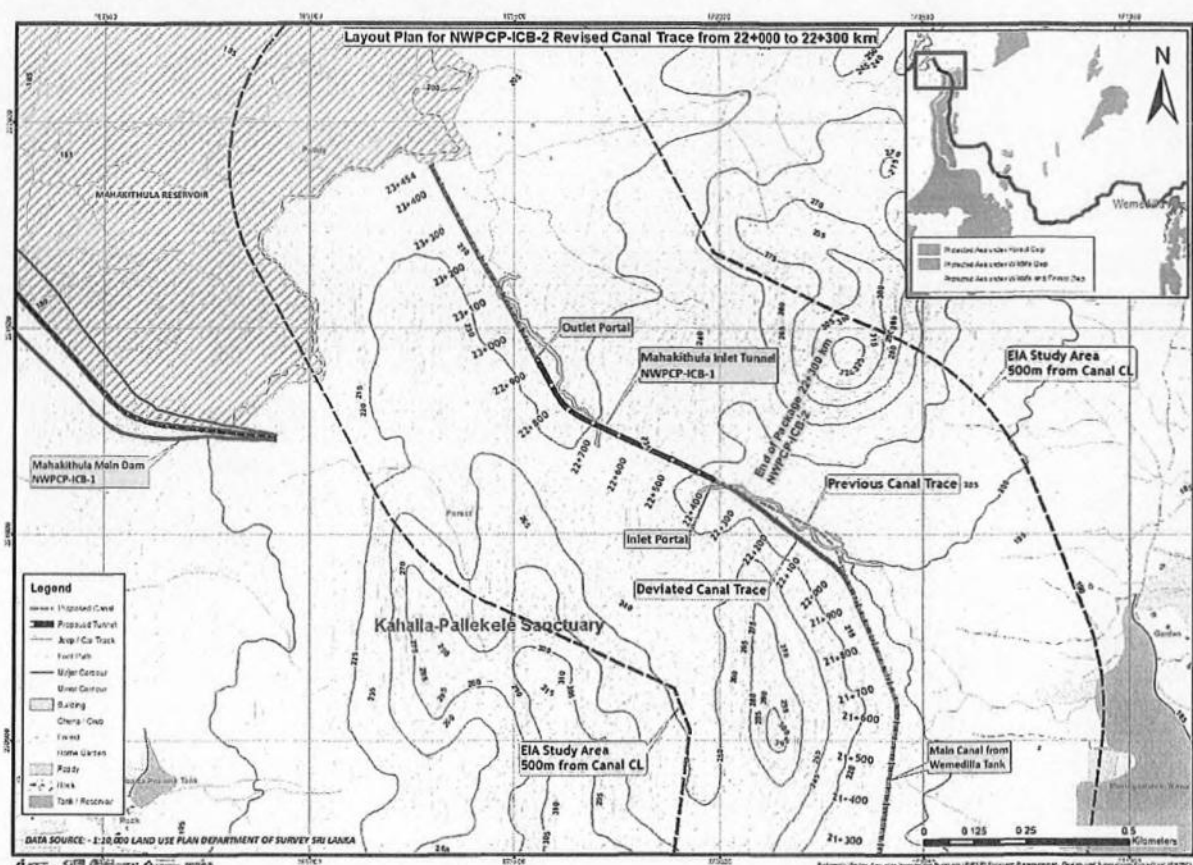
Figure 2-1: Map showing the alignment change between 21+943 to 22+340 km

8. The canal alignment between 21+943 to 22+340 km is proposed to be shifted 40 m from the original canal trace towards south from the original alignment where the proposed change is within the EIA study area of 500 m. The map of the canal alignment is shown in Figure 2-1.

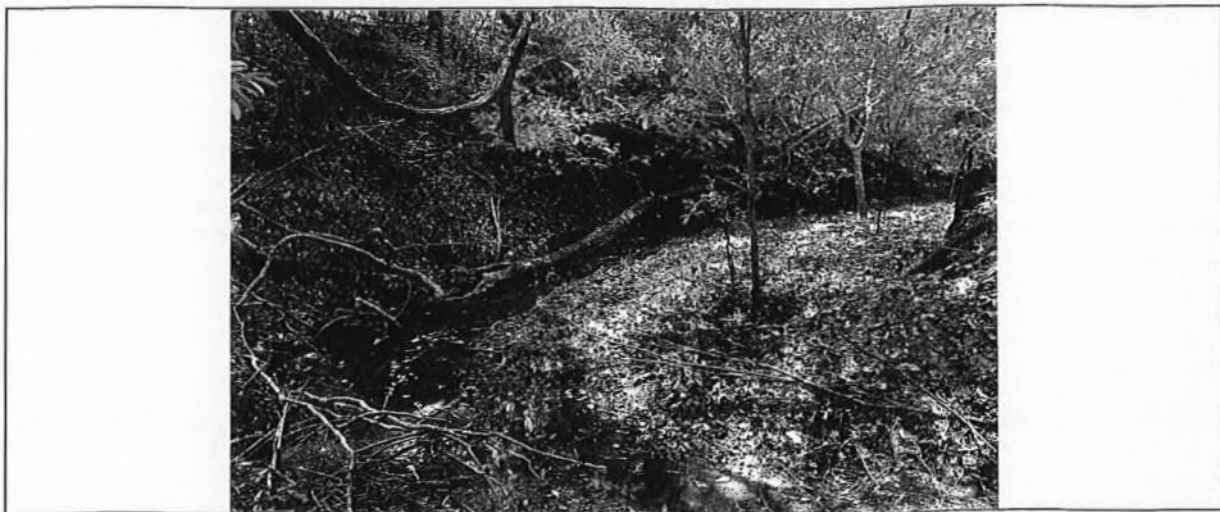
**Figure 3-1: Photographic evidences to show the ecological significance of the critical stream and associated habitats avoided by realignment**

19. With respect to fauna species, fish species, *Devario malabaricus* (Giant Danio / Dankola Sayala), *Rasbora microcephalus* (Thin line Rasbora / Caveri Randiya), *Lepidocephalichthys thermalis* (Common spiny loach / Thith Ahirawa), *Channa kelaartii* (Brown snakehead / Paradel Kanaya) and mammalian species, *Lutra lutra* (Otter) were observed. Of them, *Channa kelaartii* (Brown snakehead / Paradel Kanaya) is endemic to the country and *Lutra lutra* (Otter) is nationally vulnerable (VU) species.

20. The ecological significance of the area is shown with photographic evidence in the Figure 3-1.
