Semi-Annual Report no. 5
For the period covered January-June 2019
Project Number: 47381-001
December 2019

SRI: Mahaweli Water Security Investment Program

Upper Elahera Canal Project (UECP)

Semi Annual Environmental Monitoring Report (SAEMR) No. 05 (January to June 2019) for Upper Elahera Canal Project (UECP)

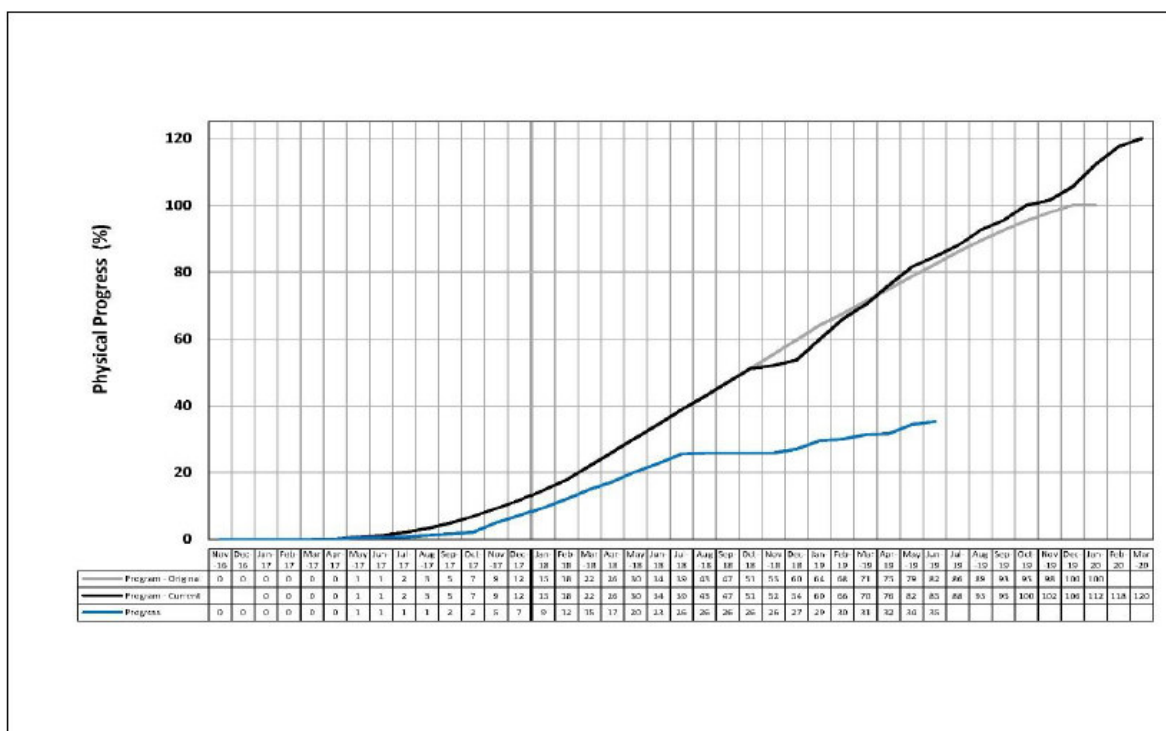
Figure 1-1: Physical progress of UECP-ICB-1 as of June 2019

8. Summary of the physical progress as of June 2019 by the UEC-ICB-1 Contractor M/s. CML-MTD Construction Limited is described in the table below and in **Figure 1-1**.

circular conduit - progress 25%
	Backfilling works with Reforestation: - progress 5%
Concrete batching plant:	Batching plant installed and in operation; field laboratory in operation
Construction activities	Slow construction progress: inadequate manpower deployment and resources
Issues effect on progress	Financial difficulties of the Contractor have continued, resulting in further progress delays.

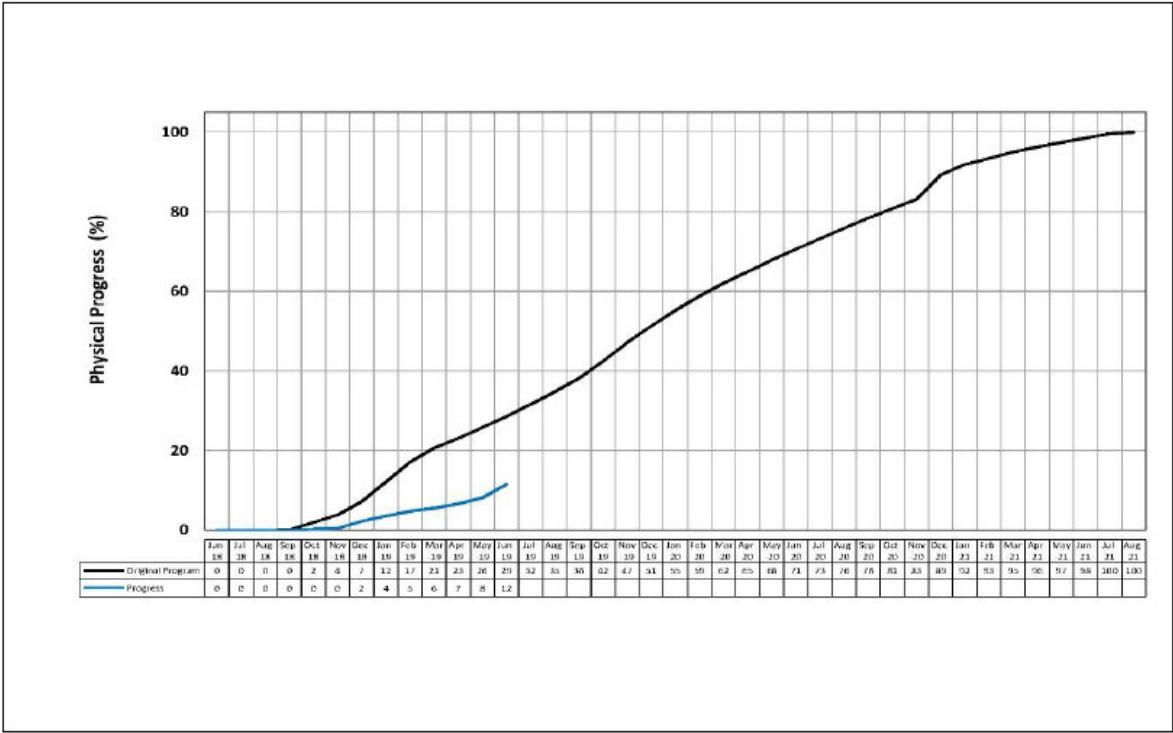
Figure 1-2: Physical progress of UECP-ICB-2B as of June 2019

9. Summary of the physical progress as of June 2019 by the UEC-ICB-2B Contractor M/s. Sinohydro Corporation Ltd. is described in the table below and in **Figure 1-2**.

Topographic surveys:	Completed except access road section 'd'; road section 'd' complete 10%
Preparation of Construction Drawings by Contractor:	Tunnel excavation support works 100%, Bridge 25%, Tunnel permanent support 0%, Open canal 50%, Access road 10%
Construction work:	Completed 11.7%
Concrete batching plant construction Progress:	Leloya - 95%, Kambarawa - 50%
Construction activities	Tunnel 1: 31.3 m of 1,910 m Excavation Tunnel 2: 161.1 m of 6,040 m Excavation All tunnel portal excavations completed except T1 Inlet portal. Other structures: Cut-and-cover excavation completed Ch: 2,620 to 2,720 km

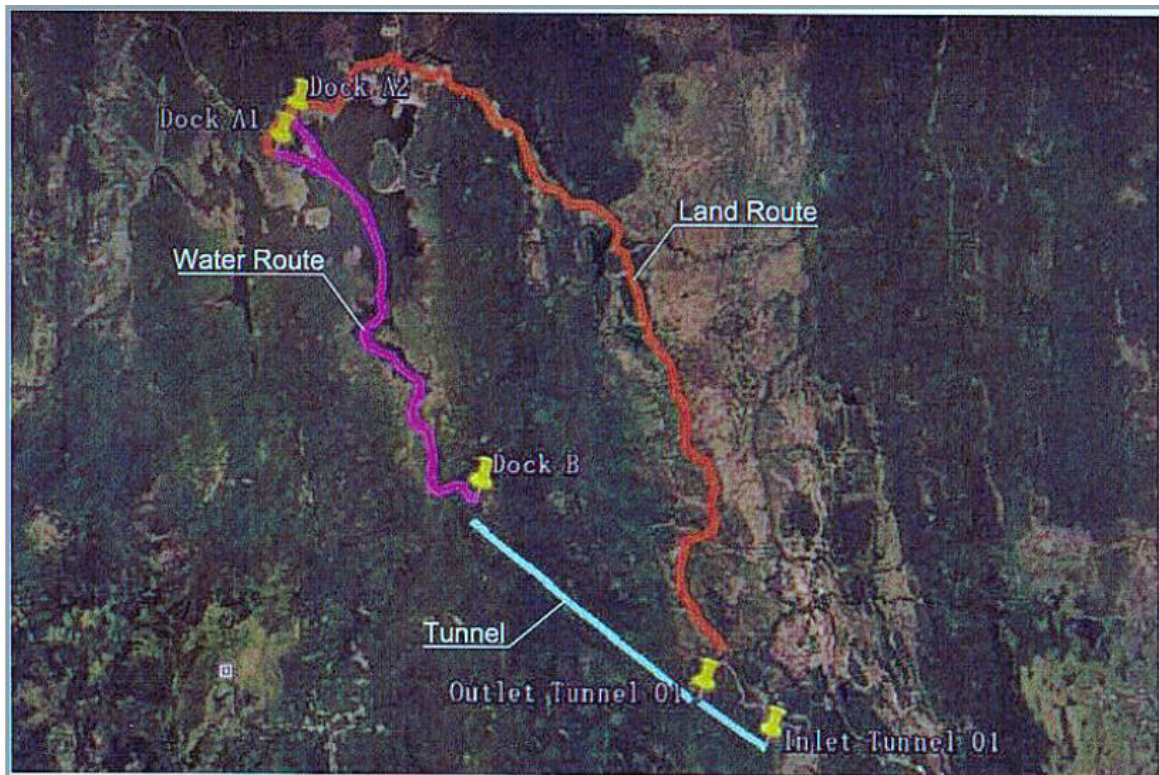
Figure 2-1: Proposed road map for the water transfer

19. The route considered by the Contractor until the Bridge No. 2 is constructed upon lifting the suspension order of using section “f” access road fulfilling required conditions is as follows (**Figure 2-1**):

- (i) From Hattota Amuna to Dock A near the Moragahakanda Contractor’s camp by land (alternative locations A1 and A2);
- (ii) Using the water way of Moragahakanda reservoir from Dock A to Dock B near Tunnel 2 outlet portal by using a 10-ton boat;
- (iii) The route for a 60-ton boat is from Hattota Amuna to Dock A1, via Moragahakanda reservoir to Dock B and T2 Outlet portal.

20. Method Statements considering the environmental and safety requirements were submitted by the Contractor and approved by the Engineer. Approval from the Mahaweli Authority was granted by the Director, Hattota Amuna Operation and Maintenance on 18 March 2019 through the letter ref. DIR/DS&SP/MORA -29, highlighting that any damage to the reservoir or the associated environment should be bared by the project.

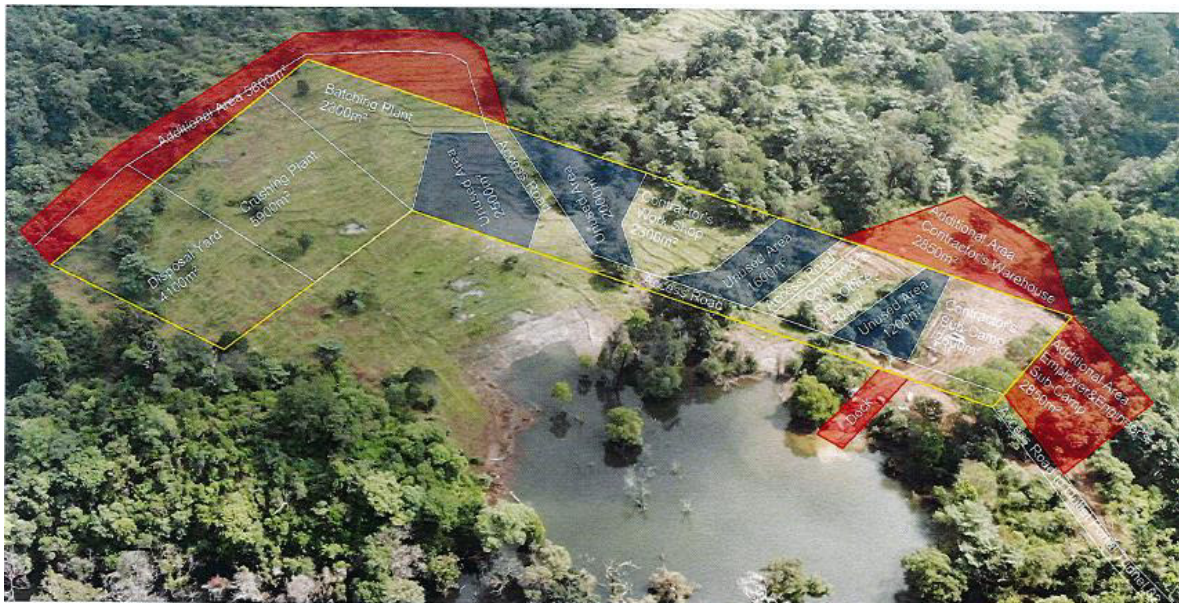
Figure 2-2: Additional area at Tunnel 2 Outlet portal, for which approval was sought

22. This additional land requirement has arisen to replace sensitive water sources and springs found within the 0.73 ha of the lands fall within the previously allocated 3 ha of lands released for construction purposes. The FD had granted the approval subject to following conditions:

23. The above additional land substitution has been communicated to the CEA for their concurrence on 25 April 2019 through letter ref. PD/UEC/ENV/Tunnel/47-A1/59 enclosing the FD approval, but CEA has not yet responded to this matter.

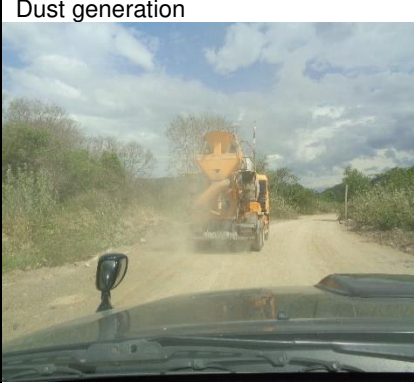
Description of issue / date/ photo	Location	Env. Impact/ Significance	Corrective action taken/ photo
Dust generation

Entire project area	Air pollution and health hazards

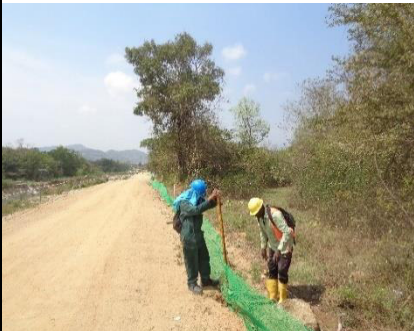
Damaged small mesh net and poor maintenance to the electrical fence

Section 2	Falling of big animals into deep excavation

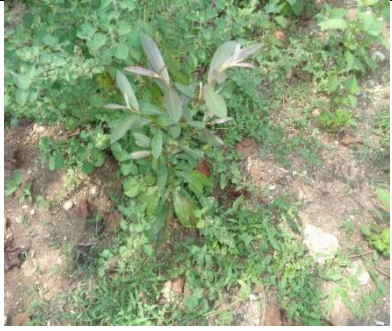
Poor maintenance of planted trees and no periodical progress reports submitted	Section 1	Plants weak and tend to die
