# Environmental Monitoring Report

## SRI: Mahaweli Water Security Investment Program – Tranche 1

Minipe Left Bank Canal Rehabilitation Project (MLBCRP)

## Annual Environmental Monitoring Report (AEMR) No. 03 for Minipe Left Bank Canal Rehabilitation Project (MLBCRP) – July 2018 to June 2019

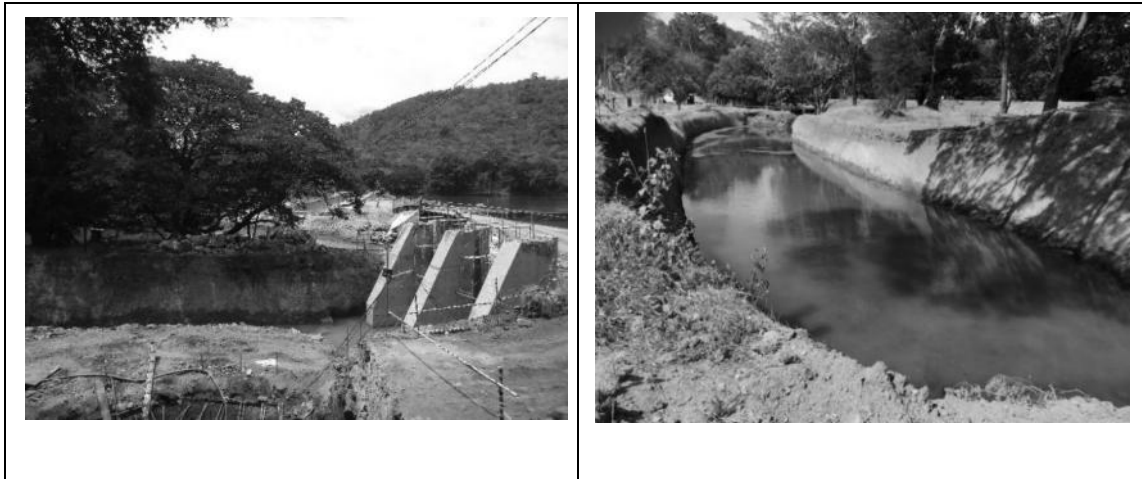
**Figure 2-1: Status of temporary bypass canal under construction as of end June 2019**

12. This bypass canal has to be functional until the completion of anicut heightening, the new head regulator and the silt ejector. The approximate canal length is 327.8 m and some photographic records of the bypass under excavation as of June 2019 are given in **Figure 2-1**.

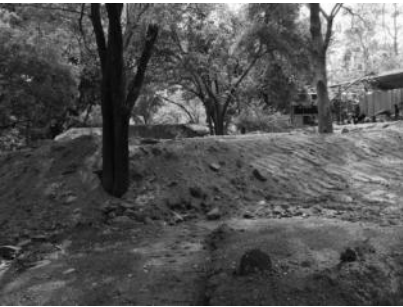
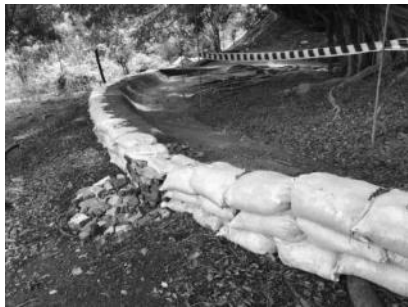
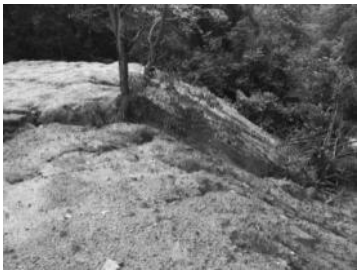
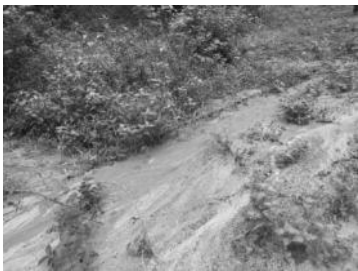
Date	Incident	Corrective Action
Aug 2018	Temporary disposal yard No. 1 overreached its capacity creating environmental damage to the area	<ul style="list-style-type: none"> <li>Stockpile rearranged to an acceptable height with adequate erosion control measures, silt trap etc by Sept 2018.</li> </ul>

<ul style="list-style-type: none"> <li>Engineer's Approval Sheet (Ref. MA-ICB 1-MS-05-C dated as 29.08.2018) responding to Contractor's letter Ref. CGGC-MIN-IPE/ICB-1/RE/101, Engineer informed that that the proposed land was rejected, and not to use it as a disposal or stock piling area. The instruction considered the anticipated significant environmental impacts, as well as per the decision made by Independent Environmental Monitoring Specialist (Mr Attygala) reporting to ADB during his joint site visit made in 21st August 2018 with contractor's EO and EMS of PMDSC.</li> </ul>	<ul style="list-style-type: none"> <li>Stockpile yard was suspended by the Engineer. Contractor attended to erosion control measures immediately and cleared waste by end December. Corrective actions attended to by the Contractor were informed to RE on 01 Jan 2019 through letter Ref. CGGC-Minipe/ICB 1/RE/245</li> <li>The Contractor restored the land and handed it over to the landowner in February 2019.</li> </ul>

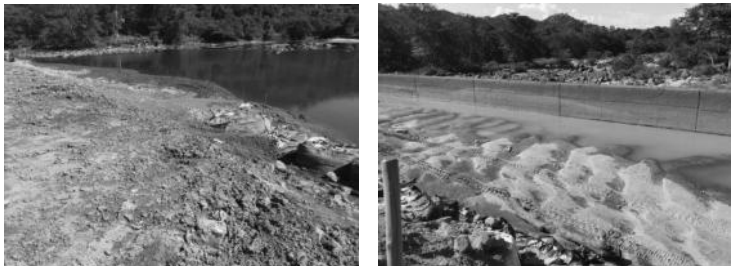
03 April 2019

<ul style="list-style-type: none"> <li>The coffer dam material is heavily eroded and has created siltation and sedimentation in both upstream and downstream areas of the anicut. The end section of the coffer dam is built without erosion protection measures, and heavy erosion and siltation are observed in the water course above the Minipe anicut.</li> <li>Large amount of silt is washed off to both upstream and downstream sections, which caused significant water pollution in the LB canal and the associated critically endangered flora species in the downstream area of the anicut (refer to the photographic evidences shown in Section 3.2.2)</li> <li>The river and canal water are used by the general public, and this siltation will cause social impacts as well</li> </ul>	<ul style="list-style-type: none"> <li>Payments deducted for not attending to the required mitigations and the Contractor was instructed to attend to the following corrective actions: <ul style="list-style-type: none"> <li>a. Clear the silted material and provide adequate erosion protection measures using jumbo sandbags – attended</li> <li>b. Provide silt traps where appropriate to protect the downstream area – not attended</li> <li>c. After attending to the required mitigation to remove silt, erosion protection etc. water quality testing was inspected to ensure that the surface water quality parameters (particulate matter, Total Suspended Solids, pH, DO) meet the relevant CEA standards – this was not attended to.</li> </ul> </li> </ul>

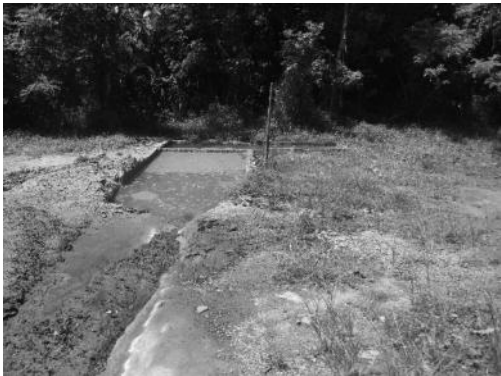
Pack-age	Incident	Corrective Action
NCB-1	<ul style="list-style-type: none"> <li>July 2018 - issues in the sedimentation pond of the batching plant installed in Morayaya due to inadequate capacity of the sedimentation tanks when the plant runs in full capacity</li> </ul>

<ul style="list-style-type: none"> <li>Contractor submitted restoration plan on 10 Sept 2018. The sedimentation tank was emptied, and the capacity increased, while a green belt including banana and grasses was established at the edge of the sedimentation tank to prevent contamination of the adjacent stream</li> <li>The tank was continuously emptied and thereafter maintained the treatment</li> </ul>

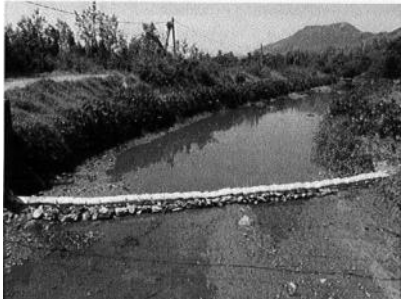
<ul style="list-style-type: none"> <li>18 Sept 2018, the Contractor was notified about not having proper disposal sites to dispose spoil generated by excavations at chainages 19+395 km and 26+446 km.</li> </ul>	<ul style="list-style-type: none"> <li>Excavated material was used for sandbag cofferdams and the balance was disposed to identified and approved disposal areas</li> </ul>

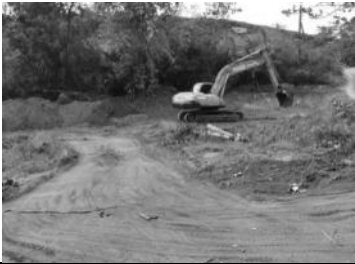
<p>New borrow pit identified in July 2018, and operation commenced at Pimburagala, Kolongoda</p>	<ul style="list-style-type: none"> <li>All required approvals were obtained, including GSMB, Divisional Secretary office, Central Environmental Authority, Archaeology Department, National Building Research Organization, Pradhesisya saba, Land Commissioning Department, and police station</li> <li>MS got approved from RE for operation of burrow pit and restoration plan and copies of the approvals submitted by contractor on 23.08.19</li> </ul>
	<ul style="list-style-type: none"> <li>Sept 2018 - Unmanaged stockpile, and unattended balance material in the canal susceptible to erosion and siltation once water issued in the canal</li> </ul>	<ul style="list-style-type: none"> <li>Stockpiles were surrounded by the sandbags and protected from erosion</li> </ul>
	<ul style="list-style-type: none"> <li>Jan 2019 – gully formation in stockpiles</li> </ul>

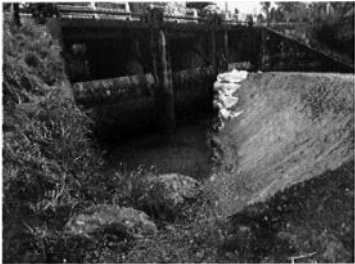
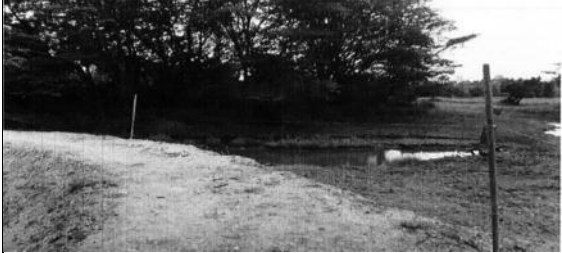
<ul style="list-style-type: none"> <li>Coffer dam constructed at Gemburu Oya for rehabilitating radial gates was inside the electric fence and the elephants were entering the area. This was identified as a risk, as there is a possibility of elephants falling from the coffer dam</li> </ul>

<ul style="list-style-type: none"> <li>The Contractor was informed about this on 28 June 2018, and the site was visited by the ES / EMS of PMDSC jointly, who arranged a special meeting with DWC, Wasgamuwa. This was held on 18 July 2018 requesting a solution.</li> <li>On 19 July 2018, DWC officers temporarily rearranged the electric fence avoiding the risk.</li> </ul>

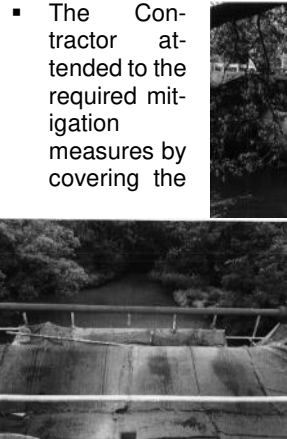
Pack-age	Incident	Corrective Action
	<ul style="list-style-type: none"> <li>It was noted and informed on 18 Sept 2018, that the Contractor had performed sand blasting activities without arranging for the required mitigation measures to prevent dust</li> </ul>	<ul style="list-style-type: none"> <li>The Contractor attended to the required mitigation measures by covering the</li> </ul>

<p>area using wet gunny bags as shown here.</p>
	<ul style="list-style-type: none"> <li>The Contractor was directed by ES-PMDSC to check the sandblast waste for the presence of any heavy metals prior to identifying the disposal method.</li> </ul>	<ul style="list-style-type: none"> <li>Sand blasting waste was collected and temporarily stored as of end Sept 2018.</li> <li>The waste was tested by ITI and the test report was issued on 25 Oct 2018 (<b>Annex 2</b>) which concluded that the waste contained some traces of Lead (1.8 mg/Kg as Pb), Zinc (184 mg / Kg as Zn), Chromium (3 mg/Kg as Cr) and Arsenic (0.72 mg/kg as As). Cadmium (Cd) and Mercury (Hg) were not detected.</li> <li>The waste sand material was reused for brick and veranda column manufacturing as to avoid environmental contamination by disposing it openly. The relevant details are given in <b>Annex 2</b>.</li> </ul>

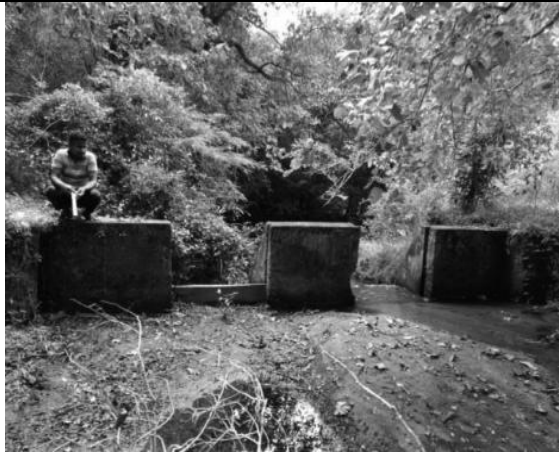
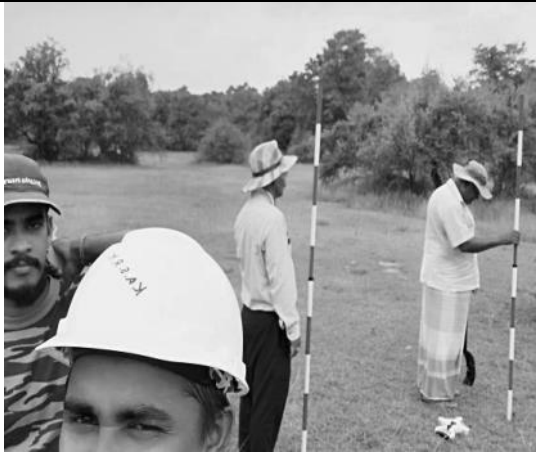
**Figure 4-1: Photographic records in MLBCRP area**

During Muththettuthanna wewa survey visit with DWC officials	Survey works of Thalkolapitiya wewa

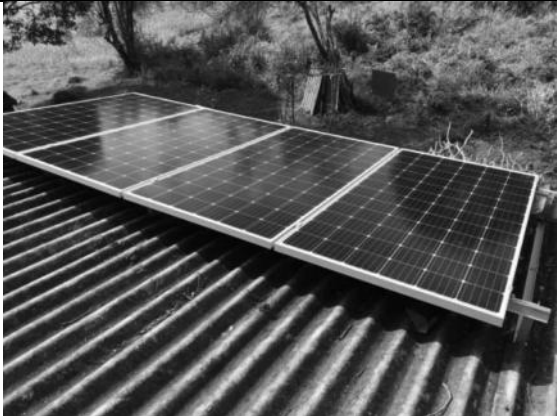
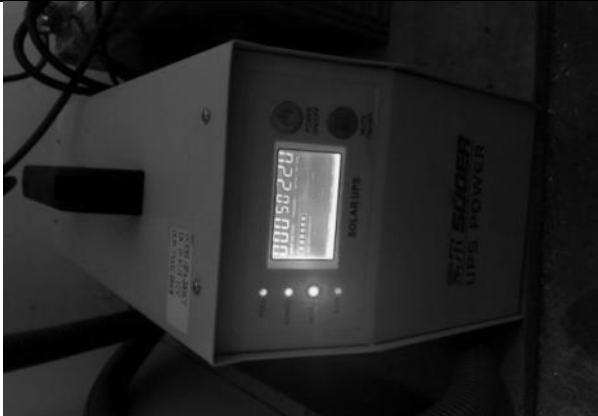
Gamburuoya Beat Office with solar power supplied
