Semi-Annual Report no. 6  
For the period covered July to December 2019  
Project Number: 47381-002  
January 2020

## SRI: Mahaweli Water Security Investment Program – Tranche 1

North Western Canal Project (NWPCP)

## Semi Annual Environmental Monitoring Report (SAEMR) No. 06 for North Western Province Canal Project (NWPCP) (July to December 2019)

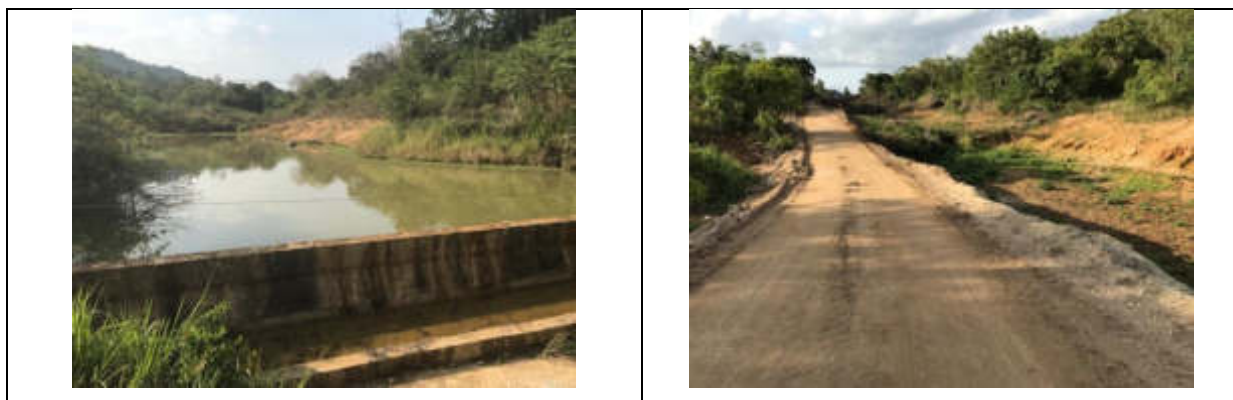
Figure 2-4: Existing water hole and bisecting access road

20. The canal construction at 18+500 km will disturb the wildlife movements as there is a water whole constructed by DWC for the use of elephants and other wildlife connected with a natural stream. As a mitigation measure, discussions took place with the Engineer and DWC to agree on alternative until the construction is completed. The Engineer submitted an alternative design proposal for an additional water hole through letter NWPCP/PIU/PD/ENV/DWC/2019/04 dated 11 September 2019.

21. The proposal to construct an additional water hole away from the construction area closer to the previous pond was approved by the DWC through letter WL/6/1/1/321 dated 08 November 2019. A view of the existing pond and the present access road bisecting the ponding area is shown in **Figure 2-4**.

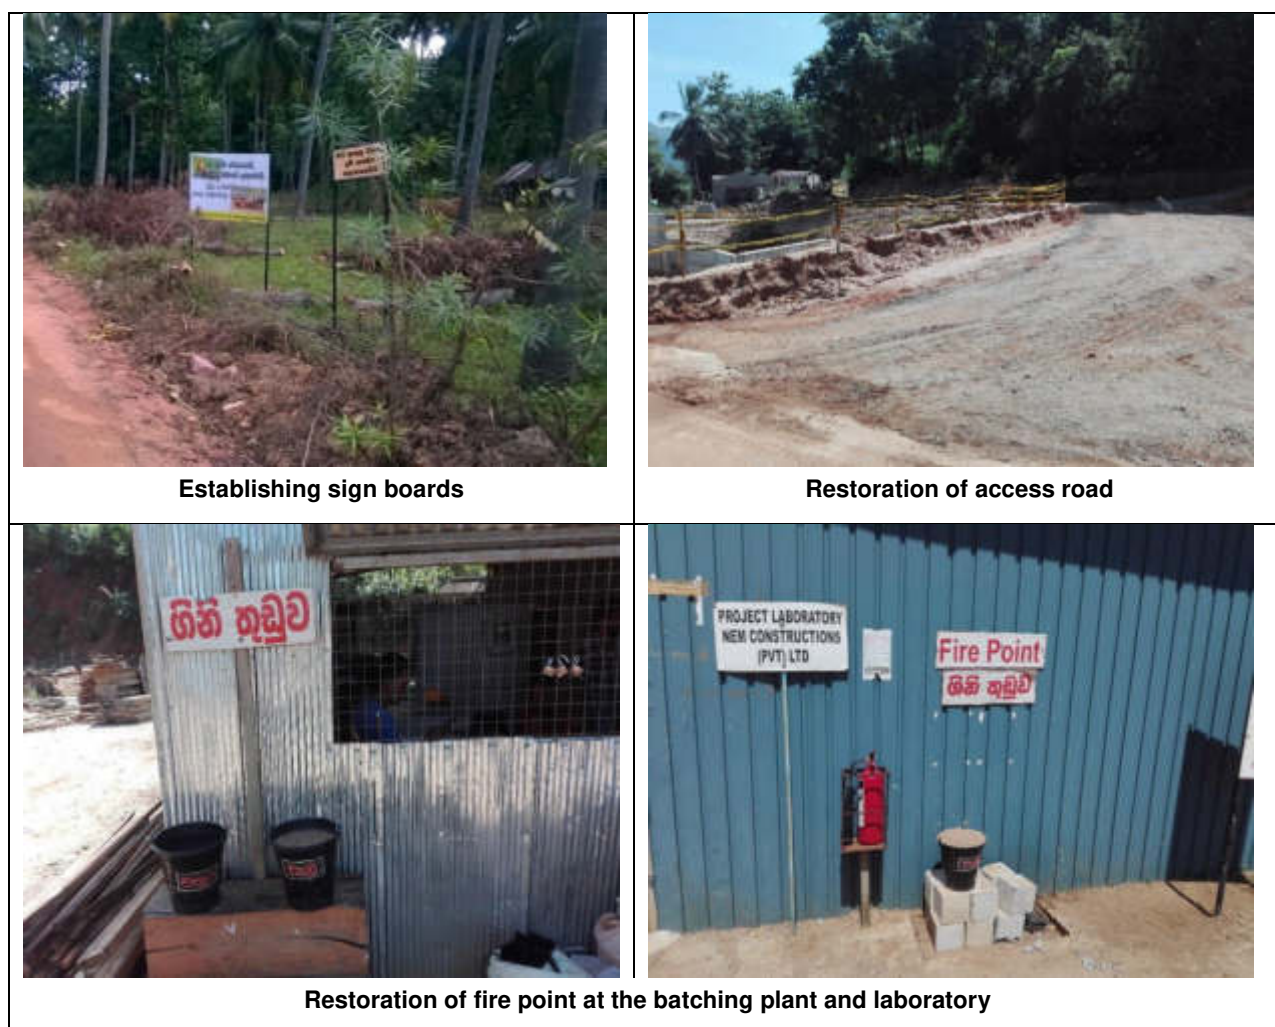
**Figure 3-1: Best practices adopted by the Contractor during the monitoring period**

24. The best practices adopted by the Contractor during the monitoring period after his remobilization are shown in **Figure 3-1**.

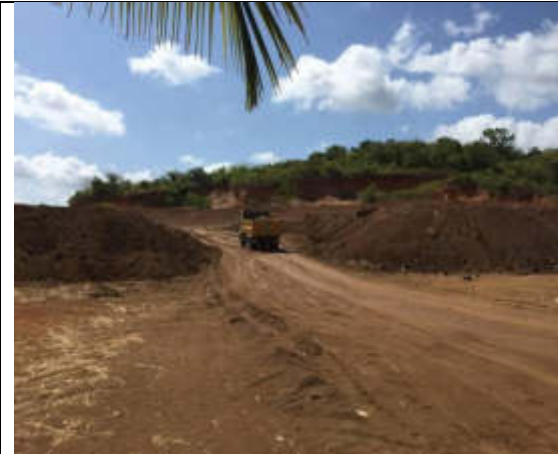
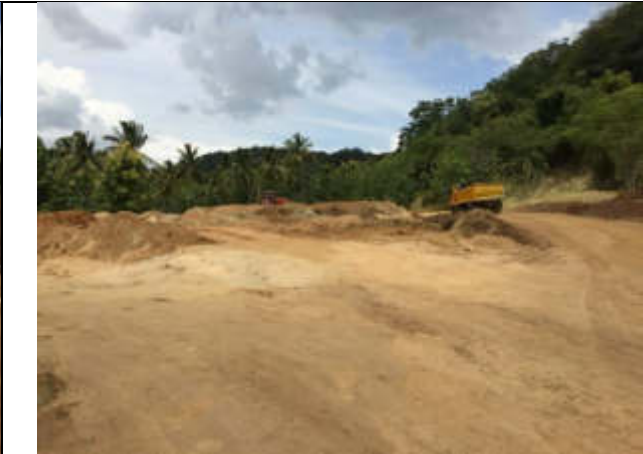
<p><b>Operating large-scale (&gt;1 ha land area) soil and earth dump and/or stockpile yards without required approvals at 11+400 km, 16+400 km, 18+200 km, 18+500 km and 19+300 km; related to NCR No. 4</b></p>

ii.	NCR No. 04 Env: Operating large-scale (>1 ha land area) soil and earth dump and / or stockpile yards without Central Environment Authority (CEA) approval at 11+400 km, 16+400 km, 18+200 km, 18+500 km and 19+300 km	07.08.2019	<ul style="list-style-type: none"> <li>All operations immediately stopped by CSCEC temporarily</li> <li>MS submitted including the approvals (CEA/ Local Government Authority) on 07.09.2019</li> <li>Restoration plans for dumping sites submitted on 28.09.2019</li> <li>Rectification of damaged well of Mr. Thushara at 16+400 km, including supply of alternative water source, with tank, cleaning the well, etc., was reported by Contractor on 13.12.2019, but the affected party was not satisfied</li> <li>A new tube well was agreed to be provided by CSCEC in early January 2020</li> </ul>
iii.	NCR No. 05 Env: Washing off the stockpiles and overflowing streams located upstream has resulted - due to lack of proper diversion during canal excavation – in crop damage, siltation of wells etc.	01.10.2019	<ul style="list-style-type: none"> <li>Well purification was attended immediately but the problem was not fully controlled until the end of the month</li> <li>Damages were paid for 2 agriculture fields by 29 October 2019; relevant documentation is in progress for another payment</li> <li>Implementation of covering stockpiles, arranging diversions, and erosion control measures started on 25 October 2019, but was not fully controlled; reminders were issued during daily inspections by EMS, verbally and in writing</li> <li>Corrective actions were completed for NCR No. 4 and No. 5 on 26.12.2019; NCR was closed with conditions</li> </ul>

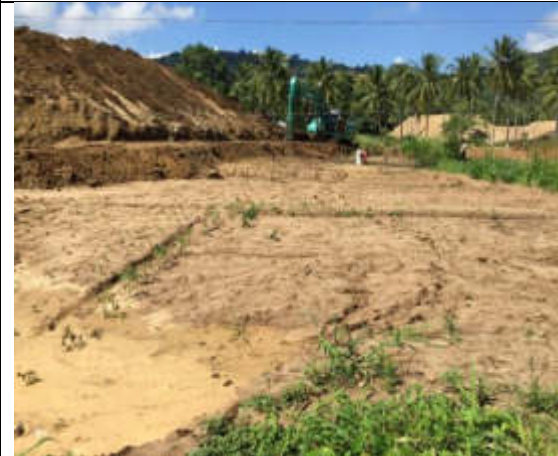
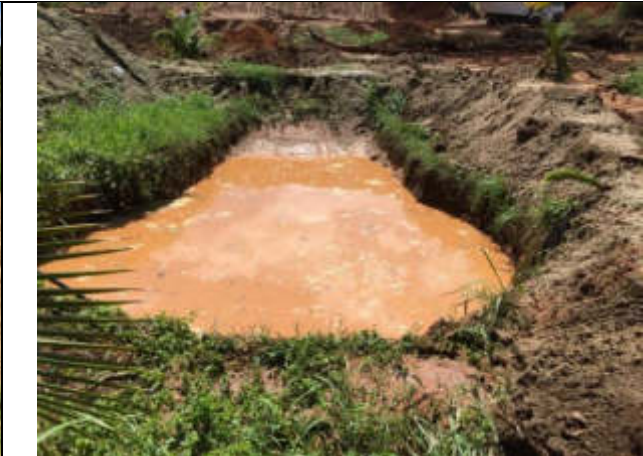
<p><b>Washing off the stockpiles and overflowing the streams in the upstream due to lack of proper diversion during canal excavation affecting agriculture fields, wells, access roads etc.; related to NCR No. 05</b></p>

vi.	Environmental Issue recorded on damaging private properties due to soil wash off from unprotected stockpile at 20+100 km (linked with NCR No. 05)	01.12.2019	<ul style="list-style-type: none"> <li>MS for storm water management (at ch.15+650 to ch.16+250 km) was submitted on 04.12.2019 (ref. CSCEC-ICB2-PMDSC-816-2019)</li> <li>Compensation for damaged private properties of Mr. Chanaka due to wash-off soil at ch. 20+100 km was attended by CSCEC by paying LKR 80,000.- as well as obtaining his land for stormwater drainage</li> <li>Evidences were shared with RE on 06.12.2019 (ref. CSCEC-ICB2-PMDSC-831-2019)</li> <li>Required rectification to the properties of vulnerable women Ms Renuka was unattended at the end of December 2019</li> </ul>
vii.	Env issue recorded related to access inundation due to construction work at 16+300 km	23.12.2019	<ul style="list-style-type: none"> <li>The Contractor was immediately advised by EMS to dewater the inundated section, and to prepare the access enabling the community to use the road</li> <li>It was rectified on the same day; access was opened to the public</li> </ul>

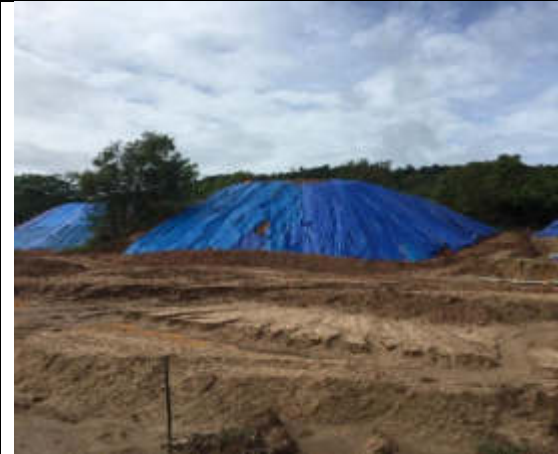
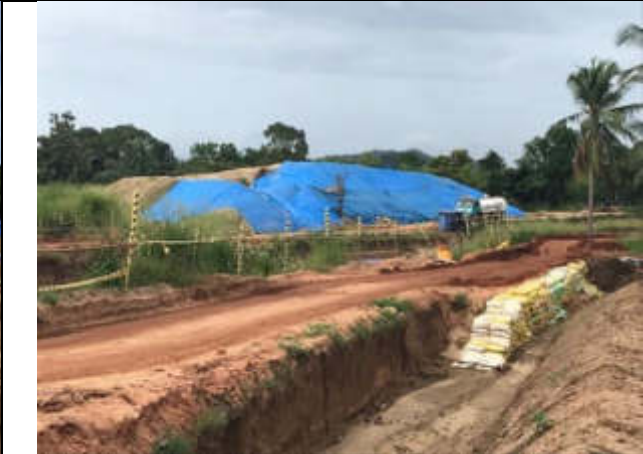
<p><b>Covered stockpiles</b></p>	<p><b>Halfway covered stockpiles (25.11.2019)</b></p>

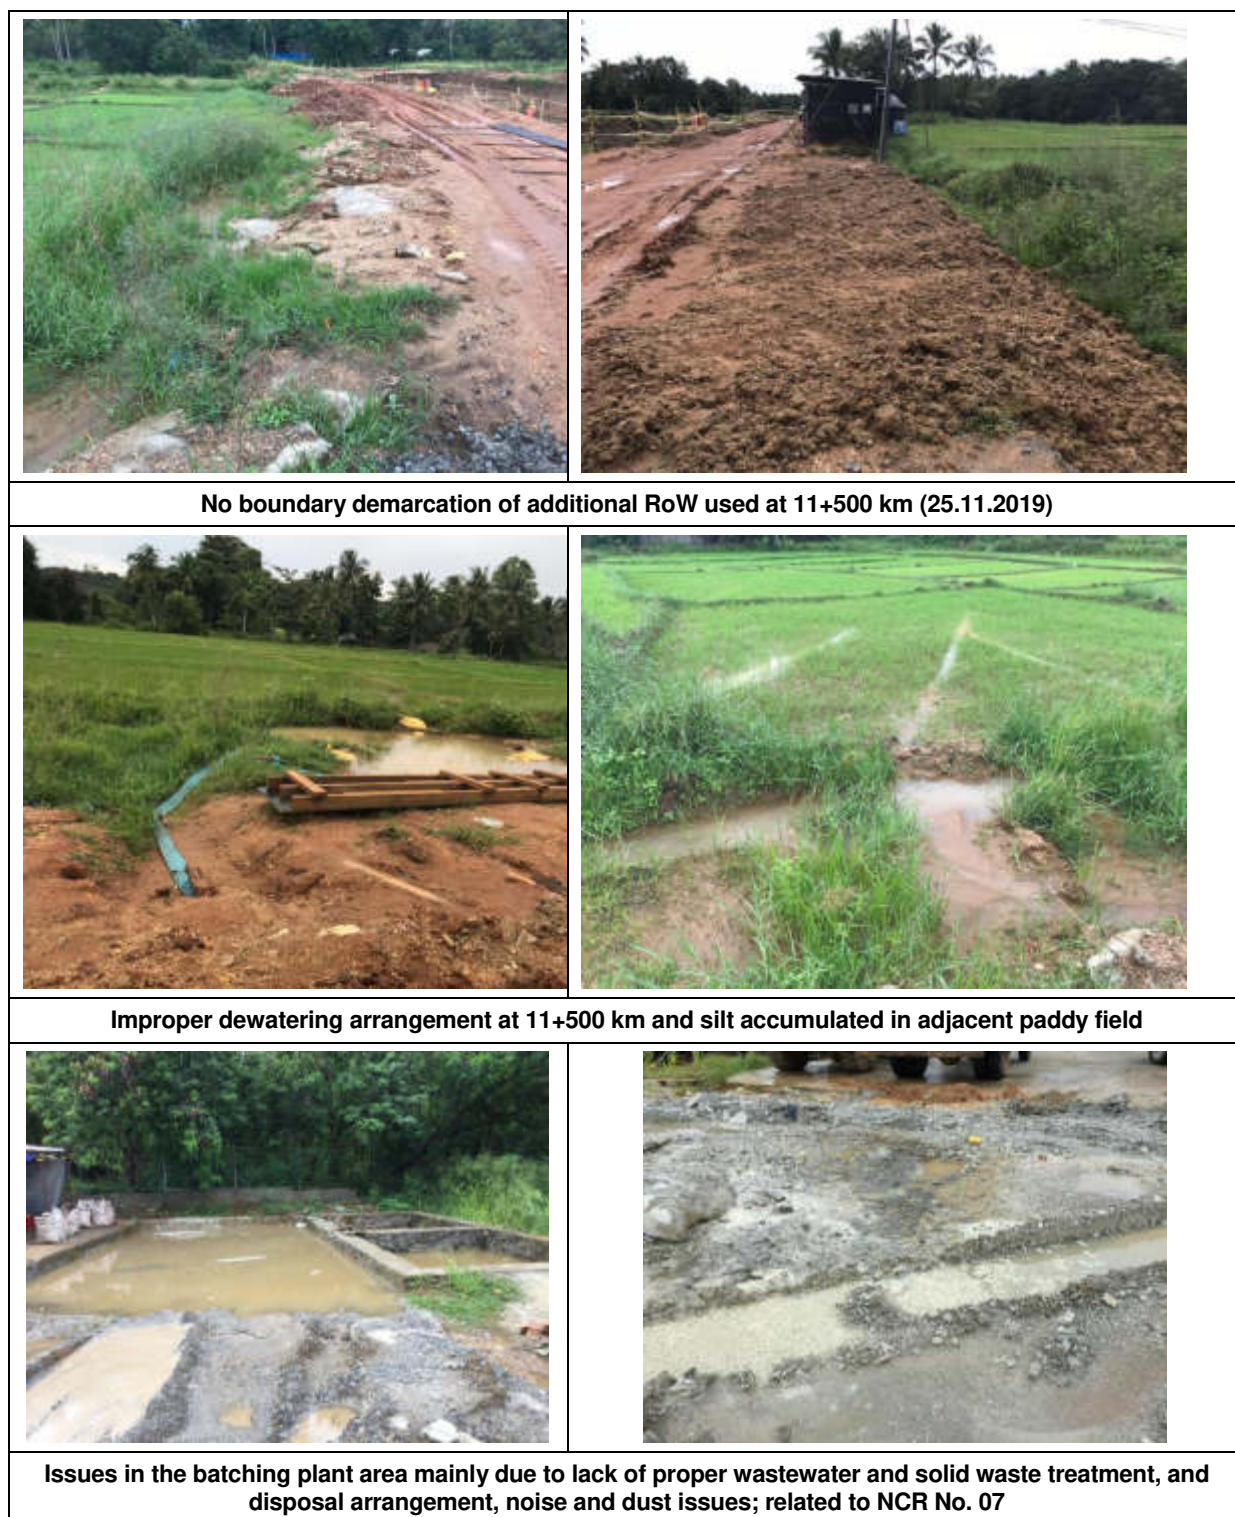
**Figure 3-3: Photographic evidences for the monitoring findings in NWPCP-ICB-2 area**

<p><b>Washed off silt traps (01.12.2019)</b></p>	<p><b>Halfway covered and re-affected well of Mr. Chanaka due to stockpiling at 20+100 km (01.12.2019)</b></p>

<p><b>Re-affected paddy field of Mr. Chanaka and access road of Ms. Renuka due to stockpile at 20+100 km (01.12.2019)</b></p>

<p><b>Drinking water and cleaned well compensated by CSCEC to Mr. Thushara (well affected due to stockpile at 16+400 km) (25.11.2019)</b></p>

- The "waste dump" matter is not about the "waste" but due to the inadequate RoW, the excavated soil gets temporarily dumped either sides and has been washed off (about 10 m away from the acquired RoW) again to nearby agriculture fields (at 11+500 km). ADB/Ms Rebeka highlighted this as a social / land matter rather than as an environmental matter. Hence, the Contractor was advised to obtain consent letters from the landowners where they need such additional areas to be used during construction. The RE needs to be copied by the Contractor to keep records. In addition, PIU needs to coordinate discussing these issues with the Grievance Redress Committee (GRC).

- Further, the NWPCP-ICB-2 Contractor was advised to clearly mark the acquired land boundaries (some are marked, but some places where construction is going on the barricading tapes are damaged; the Contractor acknowledged and will improve it).

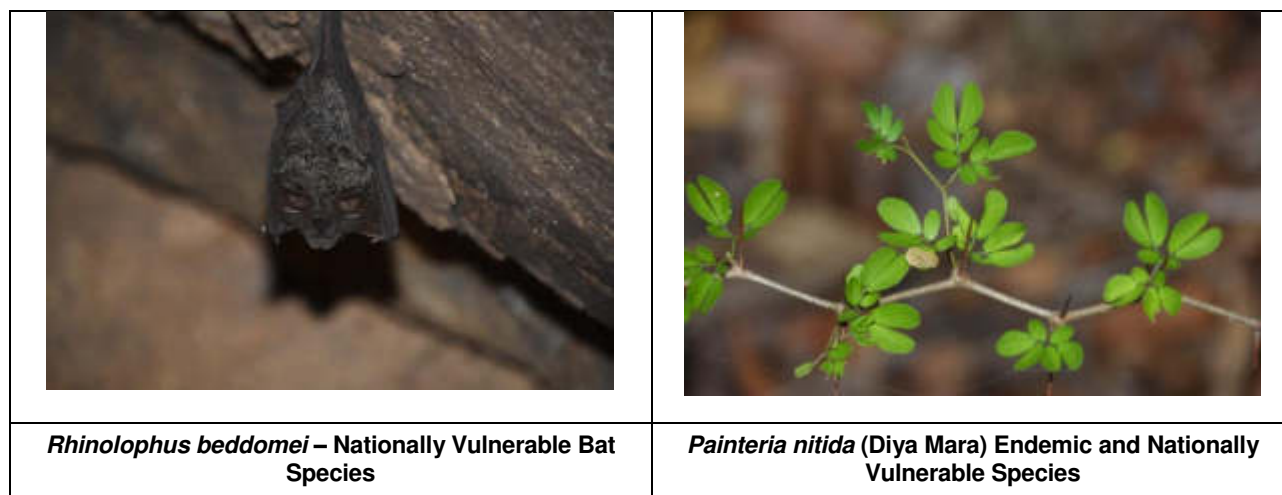
**Figure 4-1: Photographic records of the biodiversity survey carried out in the Nilagama tunnel area**

48. Some photographic records of the area, and endemic, endangered fauna and flora species found during the survey are shown in **Figure 4-1**.

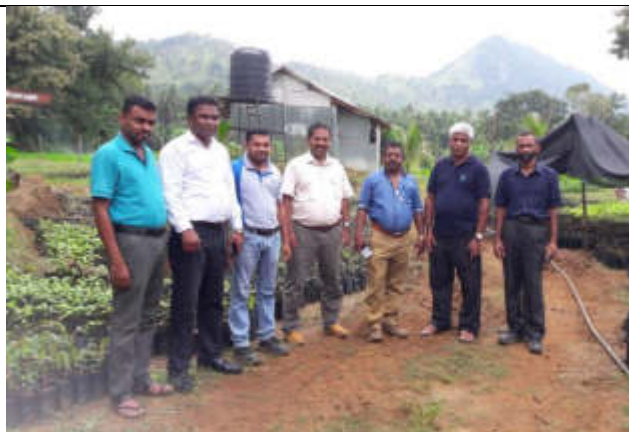
**Plant Nursery inspection with PMU, PIU & FD officers - 17.12.2019**

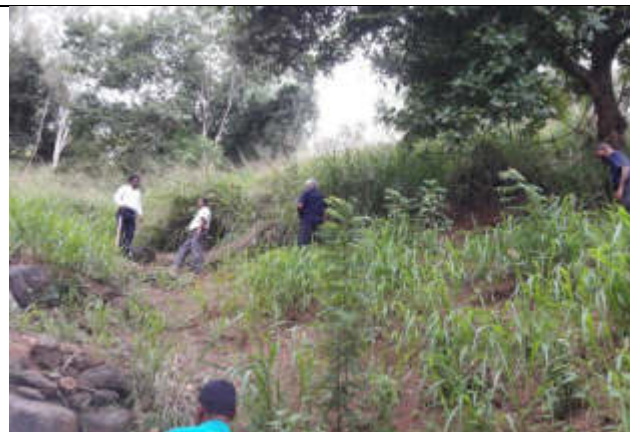
**Beligamuwakanda Reforest area inspection with PMU, PIU & FD officers - 17.12.2019**

4.a	Implementation of non-construction-based recommendations of EIAR, e.g. reforestation	Nursery establishments and site survey in progress for reforestation program of the Beligamuwa Kanda forest area	<ul style="list-style-type: none"> <li>LKR 6.87 million released to FD for 45 ha replanted work</li> </ul>

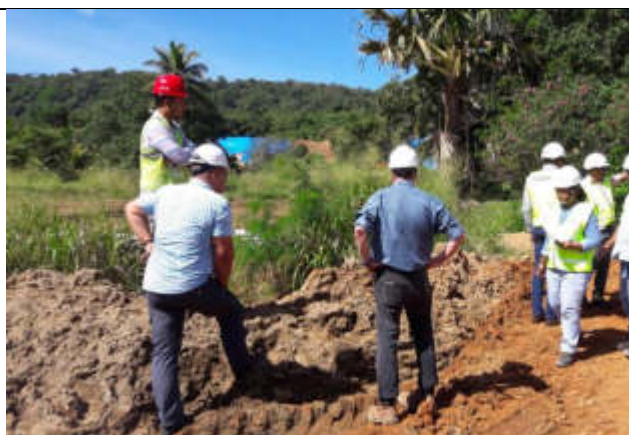
**Joint Site inspection by environmental unit (PMU,PIU,PMDSC & Contractor - 01.11.2019**

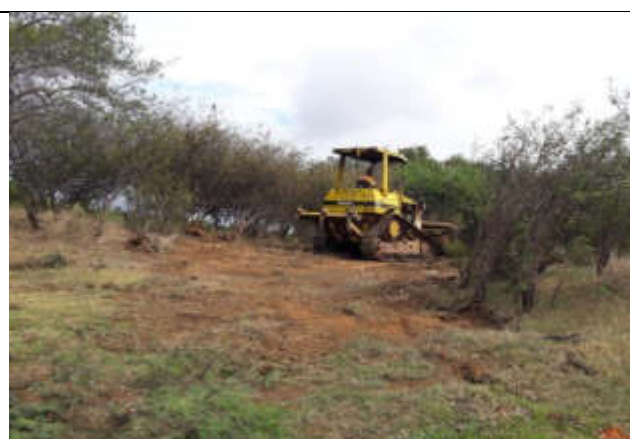
**Removing of Mimosa Pigra in Wemedilla Tank for Norms preparation – 25.09.2019**
