Environmental Monitoring Report

SRI: Mahaweli Water Security Investment Program – Tranche 1

Upper Elahera Canal Project (UECP)

Semi Annual Environmental Monitoring Report (SAEMR) No. 06 (July to December 2019) for Upper Elahera Canal Project (UECP)

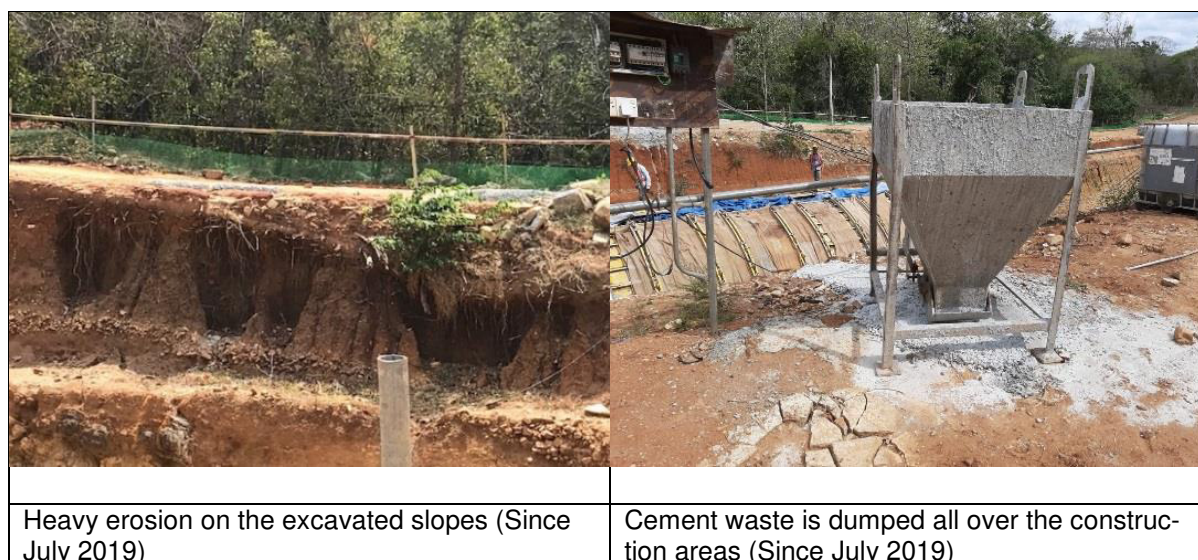
Figure 2-1: Photographic records of Environmental Monitoring in UECP-ICB-1

<p>Flooding and collapse banks in section 4 (December 2019)</p>	<p>Overflow Welankatuwa natural water ways due to block by canal (December 2019)</p>

<p>Lack of drainage and erosion, siltation at section 2</p>	<p>Dust barriers in the crusher and batching plant areas broken (Sept 2019)</p>

<p>Sub contractor's is not provided with toilet facilities and labourers entering the protected wildlife areas outside the approved boundaries for defecation (Sept 2019)</p>	<p>Burning waste / left over cigarette buds were observed which can cause wildfires (August 2019)</p>

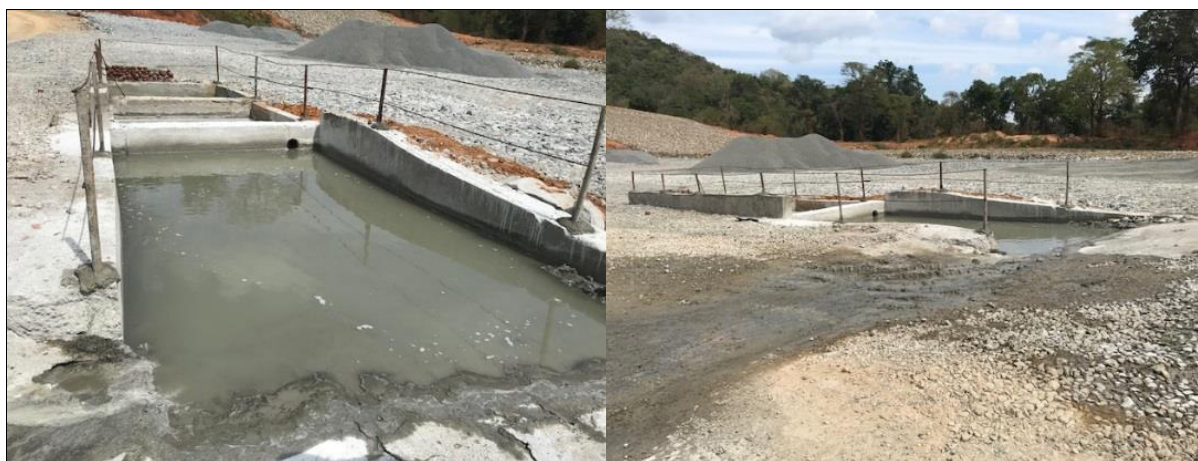
Improper wastewater and storm water management in Batching Plant No. 01 and crusher plant at Lel Oya (Sept 2019)

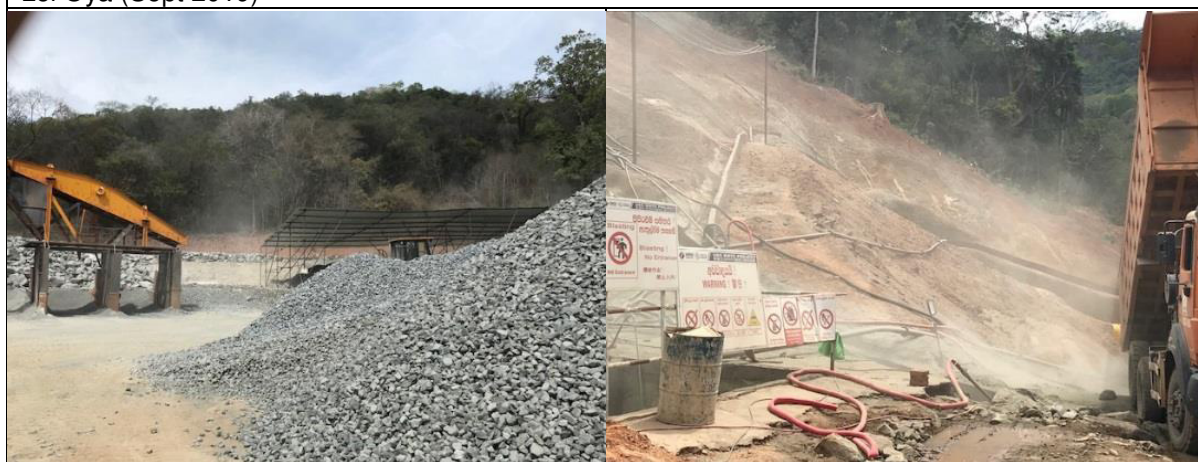
Dust issues in the Lel oya area batching plant and Kabarwa portal (Sept 2019)

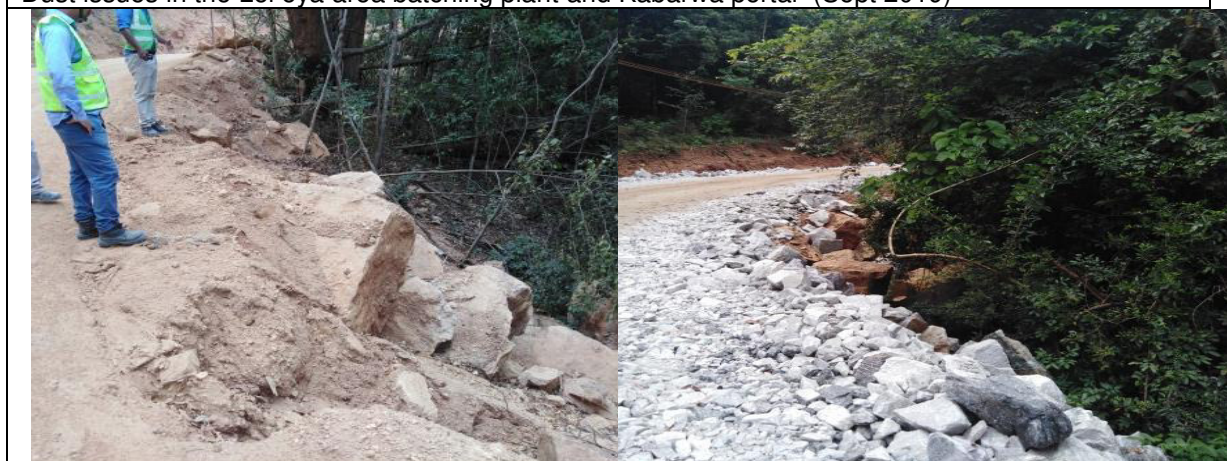
NCR No. 005 for Disposing excavated earth materials on the slope of access road section -f (Sept 2019)

After attending mitigation by slope protection and removing all loose material
