Environmental Monitoring Report

Semi-Annual Report no. 7
For the period covered January to June 2020
Project Number: 47381-002
September 2020

Sri Lanka: Mahaweli Water Security Investment Program – Tranche 1

North Western Province Canal Project (NWPCP), Part 1 of 2

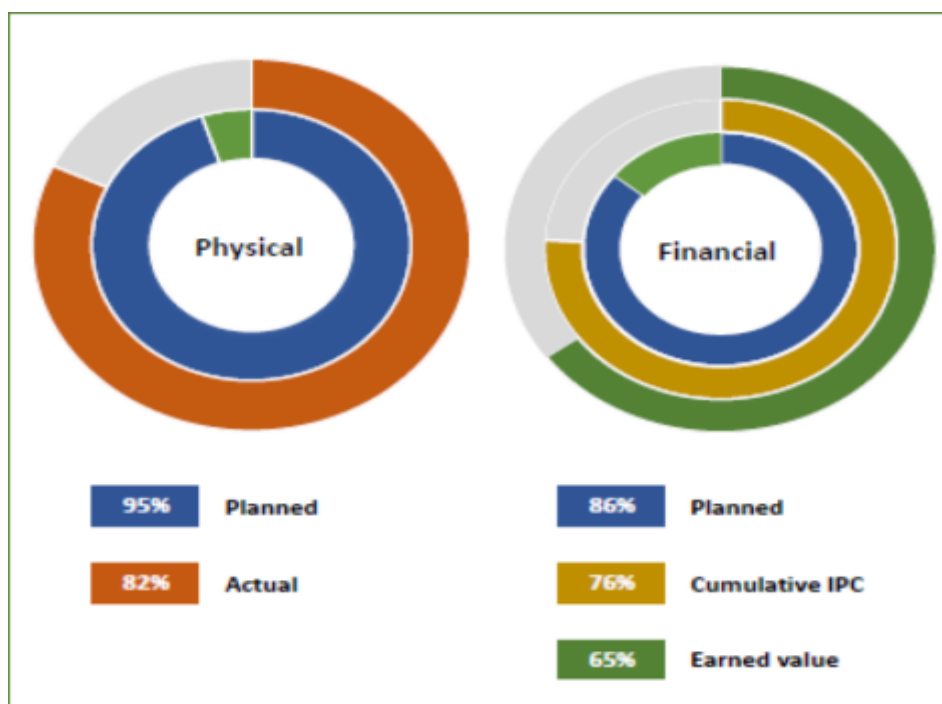
Figure 1-1: Overall package progress of NWPCP-NCB-1 as of end June 2020

7. **Figure 1-1** shows the graphical representation of the overall progress of the NWPCP-NCB-1 package by end June 2020.

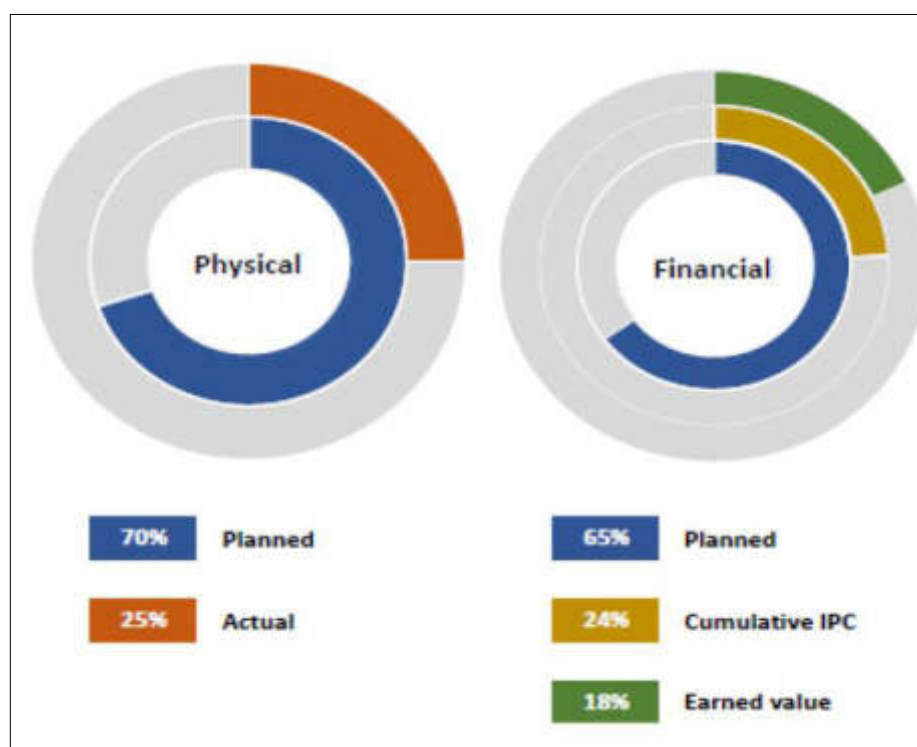
Figure 1-2: Overall package progress of NWPCP-ICB-2 as of end June 2020

9. About 19 months after starting the construction in NWPCP-ICB-2 package, the actual construction progress is recorded as 25% by end of June against the planned construction progress of 70%. **Figure 1-2** shows the graphical representation of the overall progress of the NWPCP-ICB-2 package by end June 2020.

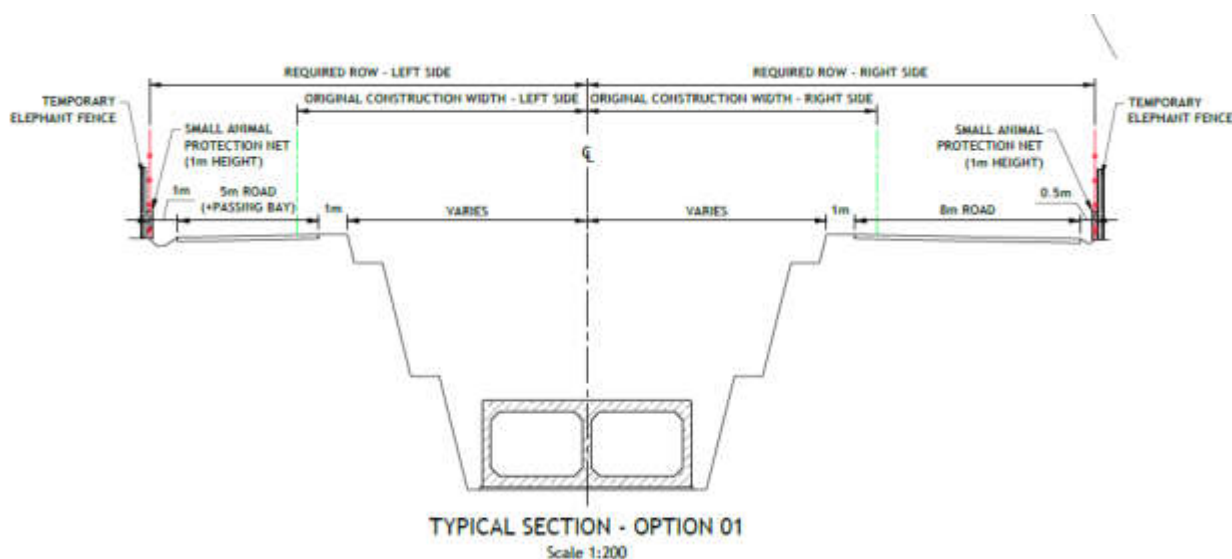
Figure 2-1: Typical section to install both electric fence and small animal protection net at the edge of approved additional RoW

17. Accordingly, the CSCEC was informed through letter Ref. PMDSC-NWP-Site/ICB 2/CSCEC/0847 on 27.01.2020) to start construction in the respective chainage located inside the DWC protected area, as per the Option 1 (See **Figure 2-1**) included in TN.

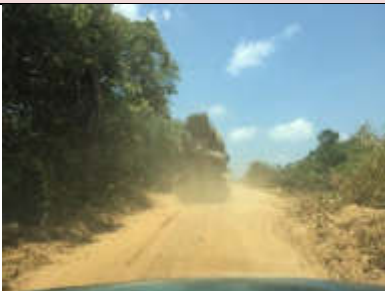
Nature and cause of Impact	Corrective Actions	Remarks
Dust		
<ul style="list-style-type: none"> Dust issue is significant during dry and windy weather conditions Not properly and regularly attend water sprinkling or apply water. Watering for dust on roads remain mud patches, which is risky for community drive / walk on road There are public complains on dust issues. 	<ul style="list-style-type: none"> CSCEC attending the corrective actions on the dust issues by watering through the bowzers designated for each construction area following the repeated reminders of the PMDSC. However, to streamline and regularize the required mitigation measures PMDSC directed the CSCEC on following: <ol style="list-style-type: none"> to submit a realistic watering plan with the available resources (bowzers) with CSCEC covering entire ongoing construction areas and access roads. Bowser arrangement for watering - water frequency per day, number of bowzers, designated areas for watering, details of the bowzers with vehicle number, vehicle condition report, owner, driver, or helpers contact details to follow up Clean mud patches on the main access roads, periodically

<p>Dust in Wildlife area</p>

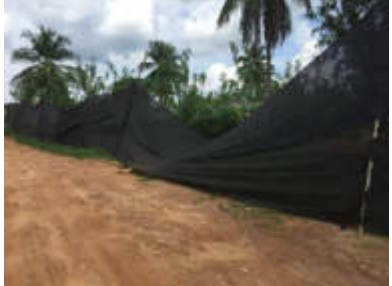
<p>12+375km / LHS in end April 2020</p>
Cement Wastes		
<ul style="list-style-type: none"> ▪ Poor waste management in the site, and workers throw all rubbish everywhere in the site. ▪ Concrete spills from truck mixers, cement waste not dumped at designated places. ▪ Batching plant No. 1 washing bay is not used for washing truck mixers, and instead they are washed in the site ▪ Water pollution of the Dehigaha Ela was observed due to cement wastes at 18+490km ▪ No required mitigations effectively adopted as per ENCR 9 and 11. 	<ul style="list-style-type: none"> ▪ CSCEC already implemented the awareness training and rehabilitated the sedimentation tank in the batching plant with the washing bay to wash truck mixers at the proper locations. ▪ However, since the attending corrective actions are in slow progress, and continuous follow up requires by the PMDSC, to streamline and regularize the required mitigation measures PMDSC directed the CSCEC on following: <ol style="list-style-type: none"> a) Waste management plan to be submitted overall construction area including required stockpiles/ disposal areas. b) EO CSCEC was nominated as the responsible person on this and educating truck drivers to follow the location plan.

Dust Barricades		
<ul style="list-style-type: none"> Dust barricades in the residential areas are poor in condition, not effective and not maintaining. Therefore, some are already collapsed. There are public complains about quality, effectiveness and maintaining. Some locations that need to be installed dust barricades still vacant 	<ul style="list-style-type: none"> CSCEC attending the corrective actions on the dust issues by erecting dust barriers following the repeated reminders of the PMDSC. However, to streamline and regularize the required mitigation measures PMDSC directed the CSCEC on following: <ol style="list-style-type: none"> Include in the plan indicating material to be used, location/chainages where the barricades to be installed Use long lasting or durable, effective materials. Fix properly to the ground otherwise easily damage due to wind. Require proper maintenance. Install in all required locations

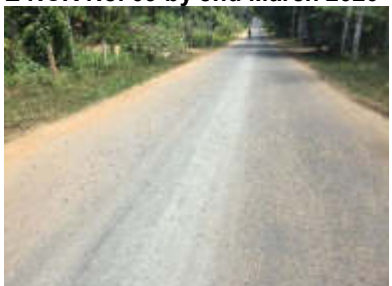
<p>Spilled cements on the Moragolla main road in Aluthwewa area from truck mixers (E-NCR 11)</p>

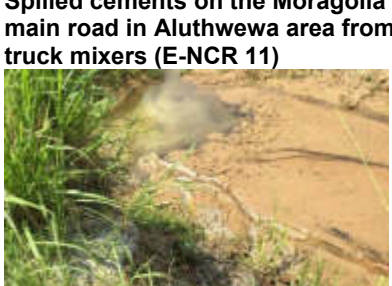
<p>Cement waste in Dehigaha ela</p>

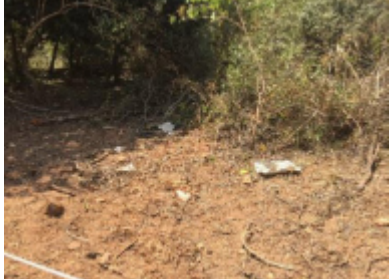
Site Cleaning		
<ul style="list-style-type: none"> ▪ No proper solid waste management plan is implementing in the site. Garbage, debris found inside and outside of the excavated areas, and outside of the RoW. 	<ul style="list-style-type: none"> ▪ Cleaned all wastes in the site periodically ▪ And instructed to implement proper waste management plan.

Nature and cause of Impact	Corrective Actions	Remarks
Stockpiles		
<ul style="list-style-type: none"> Toe protection, toe drains with silt traps not implemented, and wash off material has damaged surrounding canals, tanks, agriculture areas. Height of the stockpiles not maintained as per the standards. Stockpile affecting Bamburawahana oya is at high risk area. CSCEC not maintained canal reservations when establish stockpiles Due to stockpile located RHS at 18+300km, the Dehigaha Ela and few water wells located adjacent to the Dehigaha Ela completely silted and there are public complains. Unauthorized stockpile operation observed at LHS of 19+700km, RHS of 12+350km and Kandabodaya near outlet portal of the Nilagama Tunnel. No adequate mitigatory measures are taken as per the ENCR 5. GRC decisions agreed by CSCEC at the previous GRC meeting, related to stockpile not yet implemented 	<ul style="list-style-type: none"> Due to the increased excavation progress, and slow progress in backfilling, the extent of stockpile areas had been increased, and management has become an issue. Hence, to streamline and regularize the required mitigation measures PMDSC directed the CSCEC on following: <ol style="list-style-type: none"> Apply checklist for all supervisors prior to select any stockpile. Template to be shared by EO-CSCEC. If required guidance to be given by EMS Awareness to be done by PM – CSCEC to his staff – supervisors obtain approvals from Engineer before implementing project related activities EO to list all the stockpiles in active mode, detail list to be updated including approval requirements, quantities, and land details etc. as per the template already shared by the PMDSC Env team Submit MS for new areas for the lands which have not obtained engineer's consent The stockpile areas identified damaging existing water bodies, drainage arrangements to be shifted to suitable, approved locations. Attend mitigation measures to prevent erosion, siltation in the downstream areas, toe protection etc. as already instructed in the NCR No. 5. Once all mitigations are attended, CSCEC to inform RE to attend site monitoring to close the NCR No. 5 RHS side 18+300 km stockpile to be used first for backfilling 	  <p>Stockpile at 16+400km / LHS in May</p>

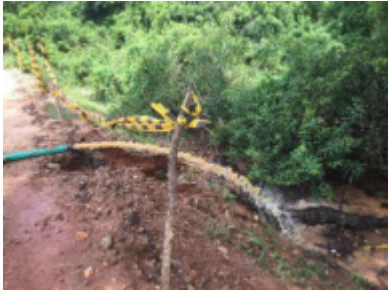
<p>Galapitagala Tank / 22nd April 2020</p>

Nature and cause of Impact	Corrective Actions	Remarks
Stagnant Water in Excavated Area		
<ul style="list-style-type: none"> Stagnant water can be observed in some excavated areas where the construction is not yet started and there is a risk to public health due to Mosquito breeding (in May 2020) 	<ul style="list-style-type: none"> Properly dewater and maintain. 	
Dewatering		
<ul style="list-style-type: none"> No adequate measures are taken to control siltation (silt traps) during dewatering as per the approved MS Dewatering damaging existing natural water ways (Galapitagala Tank Polluted water due to dewatering captured on 22nd April 2020) 	<ul style="list-style-type: none"> Contractor is directed to stick to standard practices during dewatering establishing silt traps To clean silted public streams, tanks etc. responding to grievances To nominate officer responsible and timeline to complete as CSCEC did not respond when asking for such information at the meeting

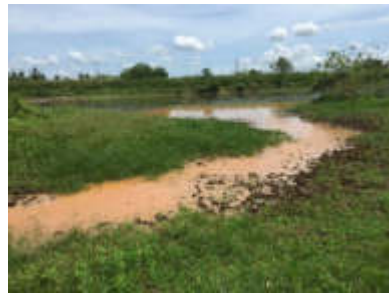
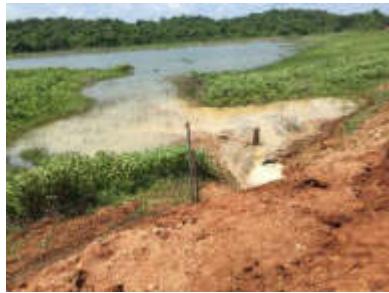
<p>Tank in DWC area silted due to dewatering</p>

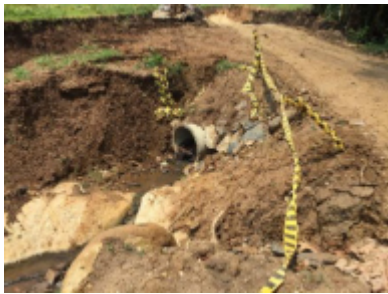
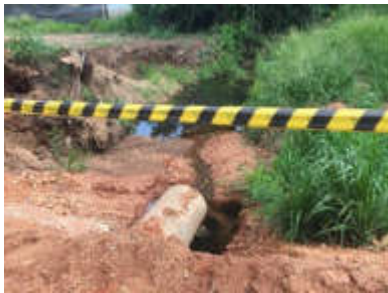
<p>Bambaruwahana oya</p>

Blockage of Drainage Paths and Streams		
<ul style="list-style-type: none"> No adequate measures were taken to facilitate drainage paths that cross the NWP canal. At about 14+800km, across the Walawwela stream only one Hume pipe was placed to facilitate water flow. It is not sufficient to facilitate water flow. 	<ul style="list-style-type: none"> Effectively manage drainage paths using appropriate engineering techniques

Nature and cause of Impact	Corrective Actions	Remarks
<ul style="list-style-type: none"> At about 15+828km, across the Kellamerichcha Ela, no Hume pipe are placed to facilitate water flow and there are public complains. Due to access road to the 19+700km stockpile, natural waterway to the tank at DWC area was blocked. Due to access road to Kandabodayaya stockpile small waterway from nearby tank was blocked.

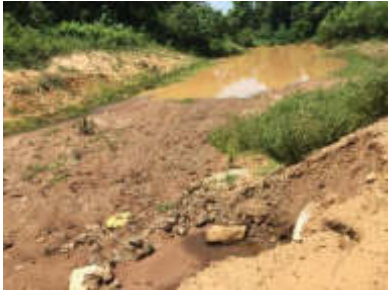
<p>Kellamerichcha Ela</p>
Soil Erosion and Siltation		
<ul style="list-style-type: none"> Many soil erosion areas can be seen in the RoW (in addition to stockpile areas). No adequate measures are taken to prevent or minimize soil erosion and siltation. In particular, at about 12+450km (Bambaruwahana oya), at about 14+800km (Walawwela natural stream), at about 17+150km (Galapitagala Tank), at about 18+490km (Dehigaha Ela) and excavated area inside the DWC/FD lands, soil erosion and siltation observed during field visits. 	<ul style="list-style-type: none"> Take necessary measures to control erosion and siltation as per CEMP and EMP.

<p>Elephant pond at DWC area</p>

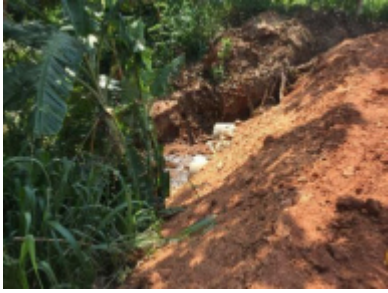
<p>Bambaruwahana Oya</p>

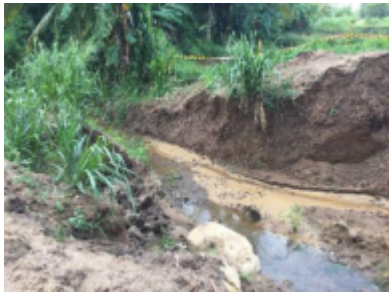
Nature and cause of Impact	Corrective Actions	Remarks
		<p>Walawwela natural stream</p>

Disturbances to the fauna and flora in the project area		
<ul style="list-style-type: none"> Issues with the electric fence, no proper maintenance. Small mesh fence is not maintained, and lot of damage and gap areas observed. Complaint from DWC on CSCEC working night time on 26 June 2020 within the wildlife protected area (19+000 km to 19+650 km). Night work is not allowed after 6 pm as per the FFPO and Environmental approval issued by CEA / DWC 	<ul style="list-style-type: none"> CSCEC cleared the bushes touch with the fence but need to check the power and sufficiency for entire night-time, and adopt regular check-up and maintenance plan PD-PIU informed to RE (Ref. NWPCP/PIU/PD/ENV/ICB 2/ /PMDSC/20/07 on 25 June 2020) about the incident of night time working and CSCEC was informed through RE letter about the DWC complain made to PIU on the same violation and instructing not to repeat (PMDSC-NWP-Site/ICB 2/CSCEC/1300 dated as 29 June 2020) (Refer Annex 5) CSCEC was advised to use long lasting or durable material for small mesh fence and needs to be fixed properly to the ground otherwise easily collapse.

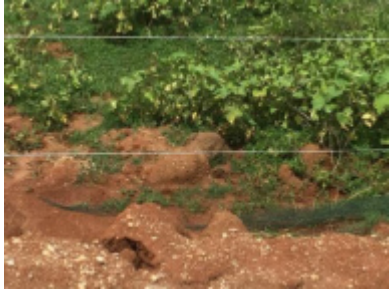
<p>Breakdown small net fence</p>
