Semi-Annual Report no. 8  
For the period covered July to December 2020  
Project Number: 47381-002  
January 2021

## Sri Lanka: Mahaweli Water Security Investment Program – Tranche 1

North Western Province Canal Project (NWPCP)

## Semi Annual Environmental Monitoring Report (SAEMR) No. 08 for North Western Province Canal Project (NWPCP) (July to December 2020)

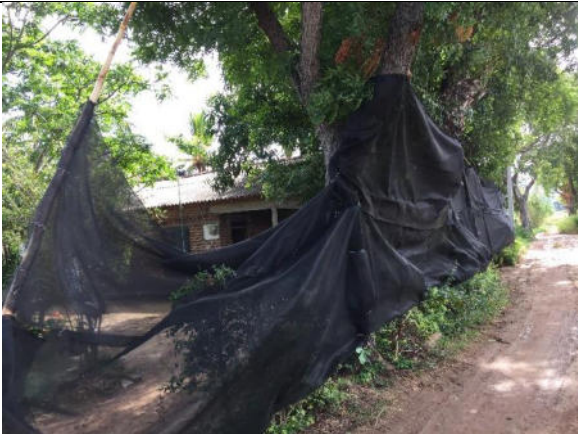
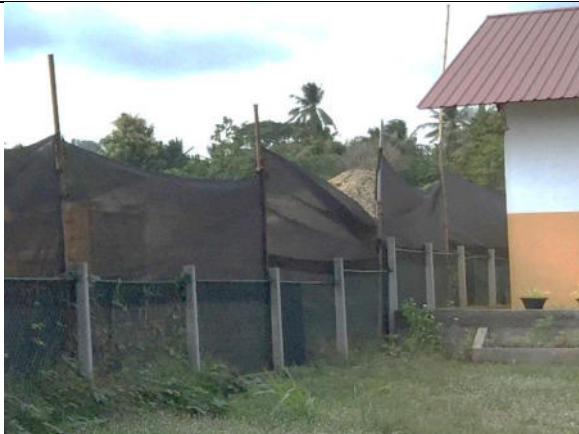
<b>Dust &amp; Dust Barricades</b>

Dust barricades in the residential areas are damaged, some are collapsed and not effective due to no periodical maintenance by CSCEC.	
<b>Cement Wastes</b>

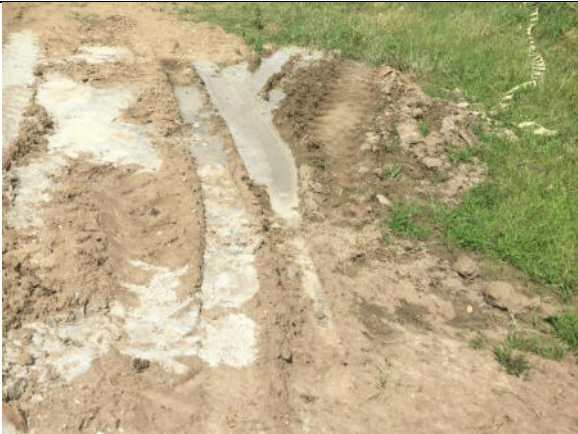
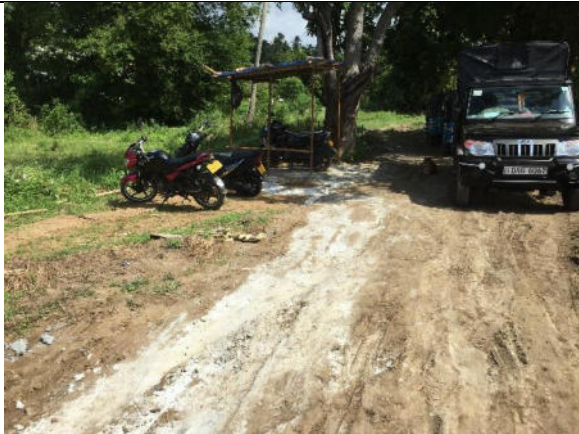
Cement wastes can be observed most of the places in the construction area in and outside of the RoW due to washing of cement truck mixers and pump cars.	
<b>Site Cleaning</b>

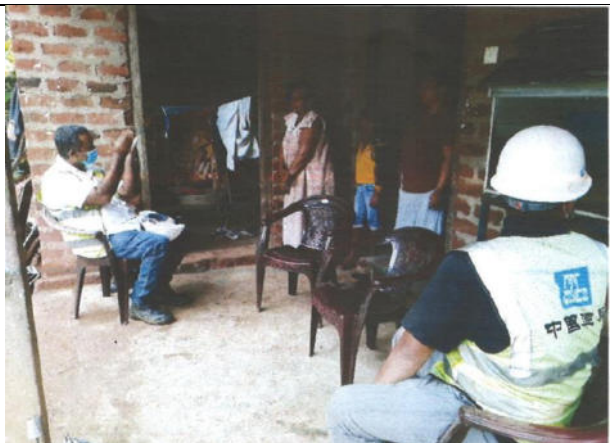
Conducted awareness to the batching plant workers on EHS requirements on 02.12.2020.	Consultation of the community in the batching plant area

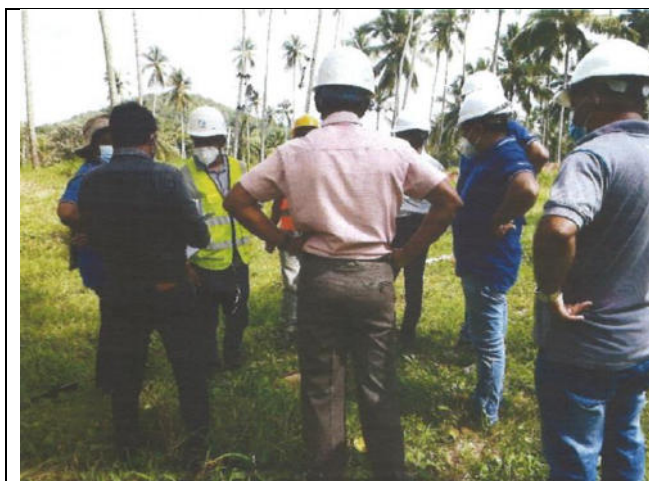
Joint visit with National Water Resources Board to investigate Ground water depletion issue at Ranwediya (Dec 2020)

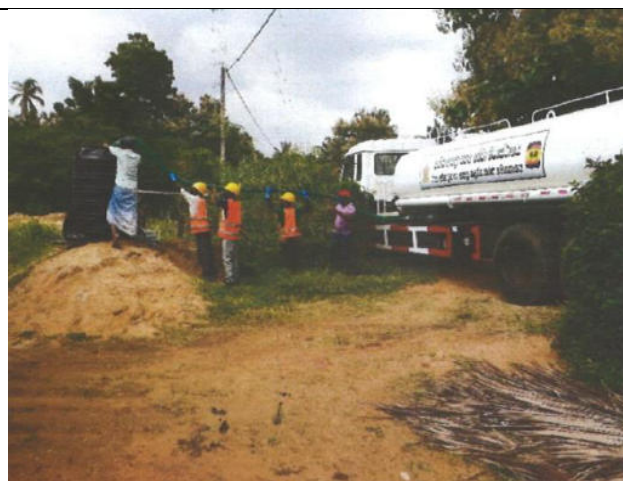
Drinking water distribution by the Contractor in Ranwediya area for the affected families
