Environmental Monitoring Report

Semi-Annual Report no. 5
For the period covered July 2020–June 2021
Project Number: 47381-002
September 2021

Sri Lanka: Mahaweli Water Security Investment Program – Tranche 1

Minipe Left Bank Canal Rehabilitation Project (MLBCRP)

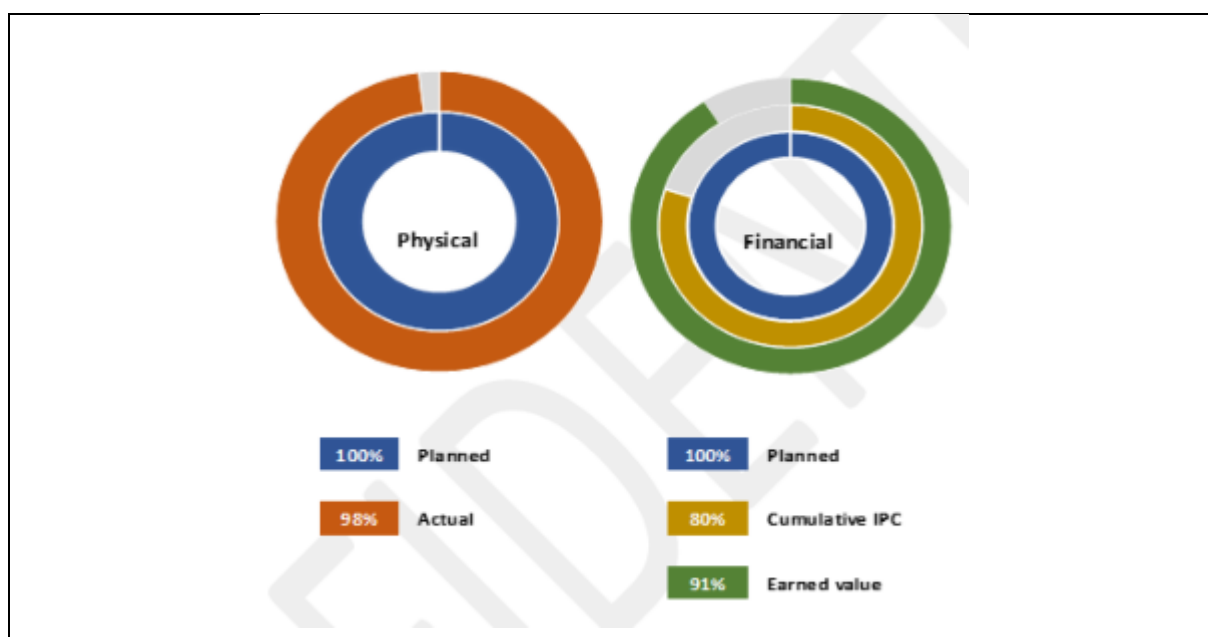
Figure 1-2: Overall physical progress of MLBCRP-NCB-1 package by June 2021

Target	Achieved
1 Earthworks	100%	81%
2 Causeways	100%	99%
3 Bridges	100%	100%
4 Turnouts	100%	98%
5 Curtain walls	100%	96%
6 Retaining walls	100%	100%
7 Cross Regulators - New	100%	97%
8 Bathing Steps	100%	98%
9 Canal Spills	100%	99%

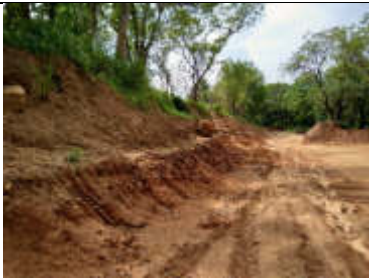
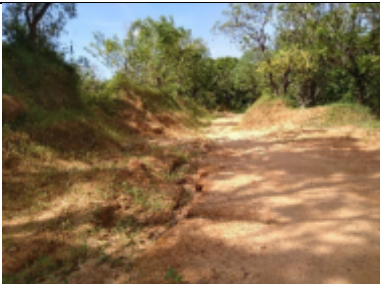
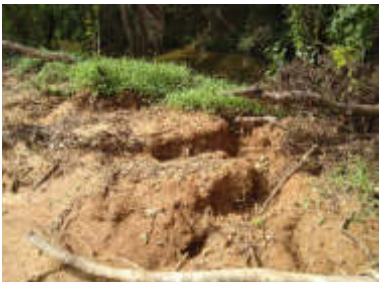
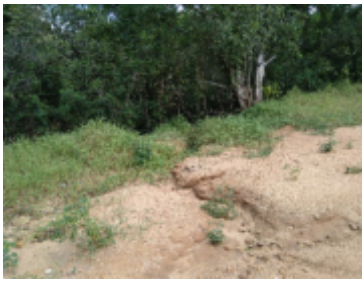
Figure 2-1: Photographic evidence for environmental monitoring findings during reporting period

The soil excavation site in LB canal bund road (Ch 11+350-11+650) in Oct 2020	The soil excavation site in LB canal bund road (Ch 11+350-11+650) in July 2021

<p>Unauthorized site used as a disposal site located at the Minipe pond reservation (status in Jan 2021 above, July 2021 below)</p>	<p>Remaining waste concrete at field concrete testing area (above) and useful concrete products made using waste concrete (below)</p>

<p>An attempt to release polluted water from excavations near LB head regulator area to the environmentally sensitive area – July 2021</p>	<p>Poor house keeping of the site in June 2021</p>

#	Issue	Date of Record	Incident summary, Corrective Actions taken and progress summary with the dates
i.	Absence of E-flow arrangement at environmentally sensitive area.	28 Aug 2020	<ul style="list-style-type: none"> Installation of temporary environmental flow tube to sensitive area at the D/S to LB silt ejector, as conditioned in the CEA conditional approval has been neglected by the Contractor. The Contractor's reply was not acceptable (on the E-NCR issued on 28.08.2020) and a letter sent to CGGC on 22.10.2020 (letter ref: PMDSC-ML-Site/ICB-1/CGGC/727), in addition to verbal instructions given. No permanent solution except watering time to time during dry season
ii.	Release of wastewater mixed with grout to the river upstream,	04 Aug 2020	<ul style="list-style-type: none"> Corrective action taken by 5 Aug with restoration of affected area
iii.	The Contractor neglected to restore the soil excavation site in LB canal bund road (Ch 11+350-11+650) and had left the excavation site without performing any restoration work. Severe soil erosion and sedimentation in canal bed observed.	24 Nov 2020	<ul style="list-style-type: none"> New borrow site opened in the Canal Bund Road Ch 11+300 to 11+650 approved by ID and GSMB, was not attended with required mitigation measures to control dust, safe access to the community. The Contractor informed through a letter on 08.10.2020 followed by joint site monitoring, and as no response, Contractor informed through a letter on 11.11.2020 (letter ref: PMDSC-ML-Site/ICB-1/CGGC/770), E-NCR issued on 24.11.2020 (letter ref: PMDSC-ML-Site/ICB-1/CGGC/807), and the contractor started restoration work in end December, by digging a drain but left the site even without removing loose soil resulted due to digging of the drain. Residents of the area complained about access difficulties to their homes due to partially completed drain. The Consultant jointly inspected the site with PIU on 20th January 2021 and decided to refill the drain excavated by the Contractor. The drain has been filled by the contractor without compacting the soil and leaving loose soil along canal bund. By June 2021, most of areas covered with grasses except road surface. The Contractor verbally reminded several times, finally on 25.06.2021, but not yet satisfactorily restored the affected areas

iv.	Use of unauthorized site as a disposal site located at the Minipe pond reservation neglecting		<ul style="list-style-type: none"> The Contractor has used an unauthorized site as a disposal site located at the Minipe pond reservation neglect-

#	Issue	Date of Record	Incident summary, Corrective Actions taken and progress summary with the dates
	the instruction given by the Consultant		<p>ing the instruction given by the Consultant since 2018 (approval sheet ref. MA-ICB 1-MS-05-C dated 29.08.2018, EIR 002 dated 17.12.2018 and letter PMDSC-ML-Site/ICB-1/CGGC/134 dated 09.01.2019).</p> <ul style="list-style-type: none"> 05.01.2021 (In response to PD-PIUs letter), the Contractor instructed to submit an incident report on this issue (letter ref PMDSC-ML-Site/ICB-1/CGGC/848 dated 12.01.2021). The Contractor has replied through a letter (CGGC-MIN-IPE/ICB-1/ RE/1433 dated 17.01.2021). They have not performed any restoration work or implemented any soil conservation method. In mid-February they have disposed few loads of boulders to the site. The Contractor instructed to display clear notice near disposal yard prohibiting dispose any material under MLBCRP (04.03.2021)

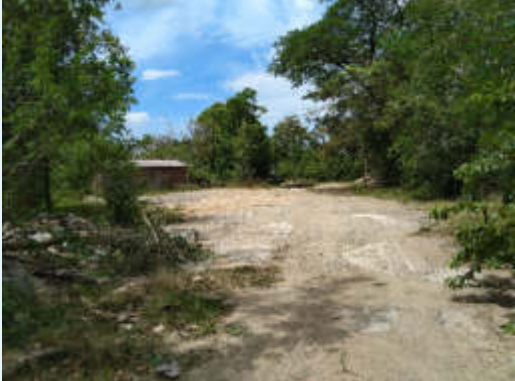
Incident	Corrective Action
NCB-1	<ul style="list-style-type: none"> Feb 2020 - EPL of batching plant had expired on 22nd February 2020 Letter issued to remind the renewal of EPL on 20 May 2020 Though the Contractor pretended that they are not using the plant further, they have operated it time to time until Oct 2021. E-NCR issued after inspection by ES-PMDSC and EMS on 22 Oct 2021 (Letter ref: PMDSC-ML-Site/NCB-1 /E&C/445) 	<ul style="list-style-type: none"> The contractor disassembled the plant. Restoration of the land partially completed

<p>View of the land in June 2021</p>
NCB-3	<ul style="list-style-type: none"> E-NCR issued on 1st November 2019 regarding following issues <ol style="list-style-type: none"> Stockpiles along the canal bank without proper environmental safeguard measures, and coffer damming with loose soil in the canal bed without applying standard methods. Batching plant area – no proper method implemented to dispose sludge, and the sedimentation tank in the batching plant not functioning properly which cause increase of alkalinity in soil and water in the adjacent areas. Oil spill from a construction vehicle (crane) on the road & near the canal bank unattended for months. 	<ul style="list-style-type: none"> Most of previously identified environmental issues were unattended by the Contractor & continuing work with negligence.

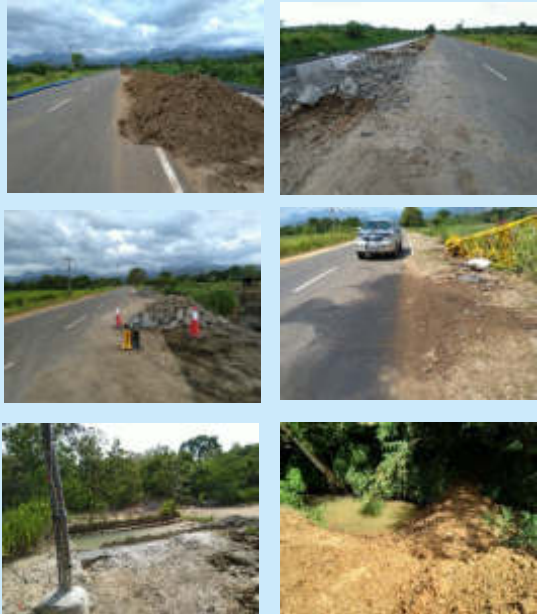
<ul style="list-style-type: none"> The Contractor neglected restoration of the Namini Oya Tank soil excavation site violating the conditional approval from Dept. of Agrarian Services Oct-Nov 2020:

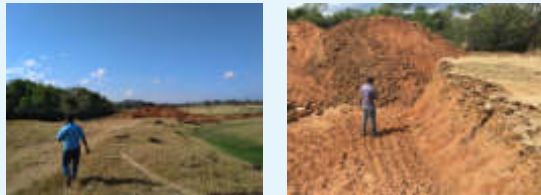
<ul style="list-style-type: none"> During rainy period in December 2020 borrow area submerged and restoration possible upon depletion of water during next dry season Dec 2020:

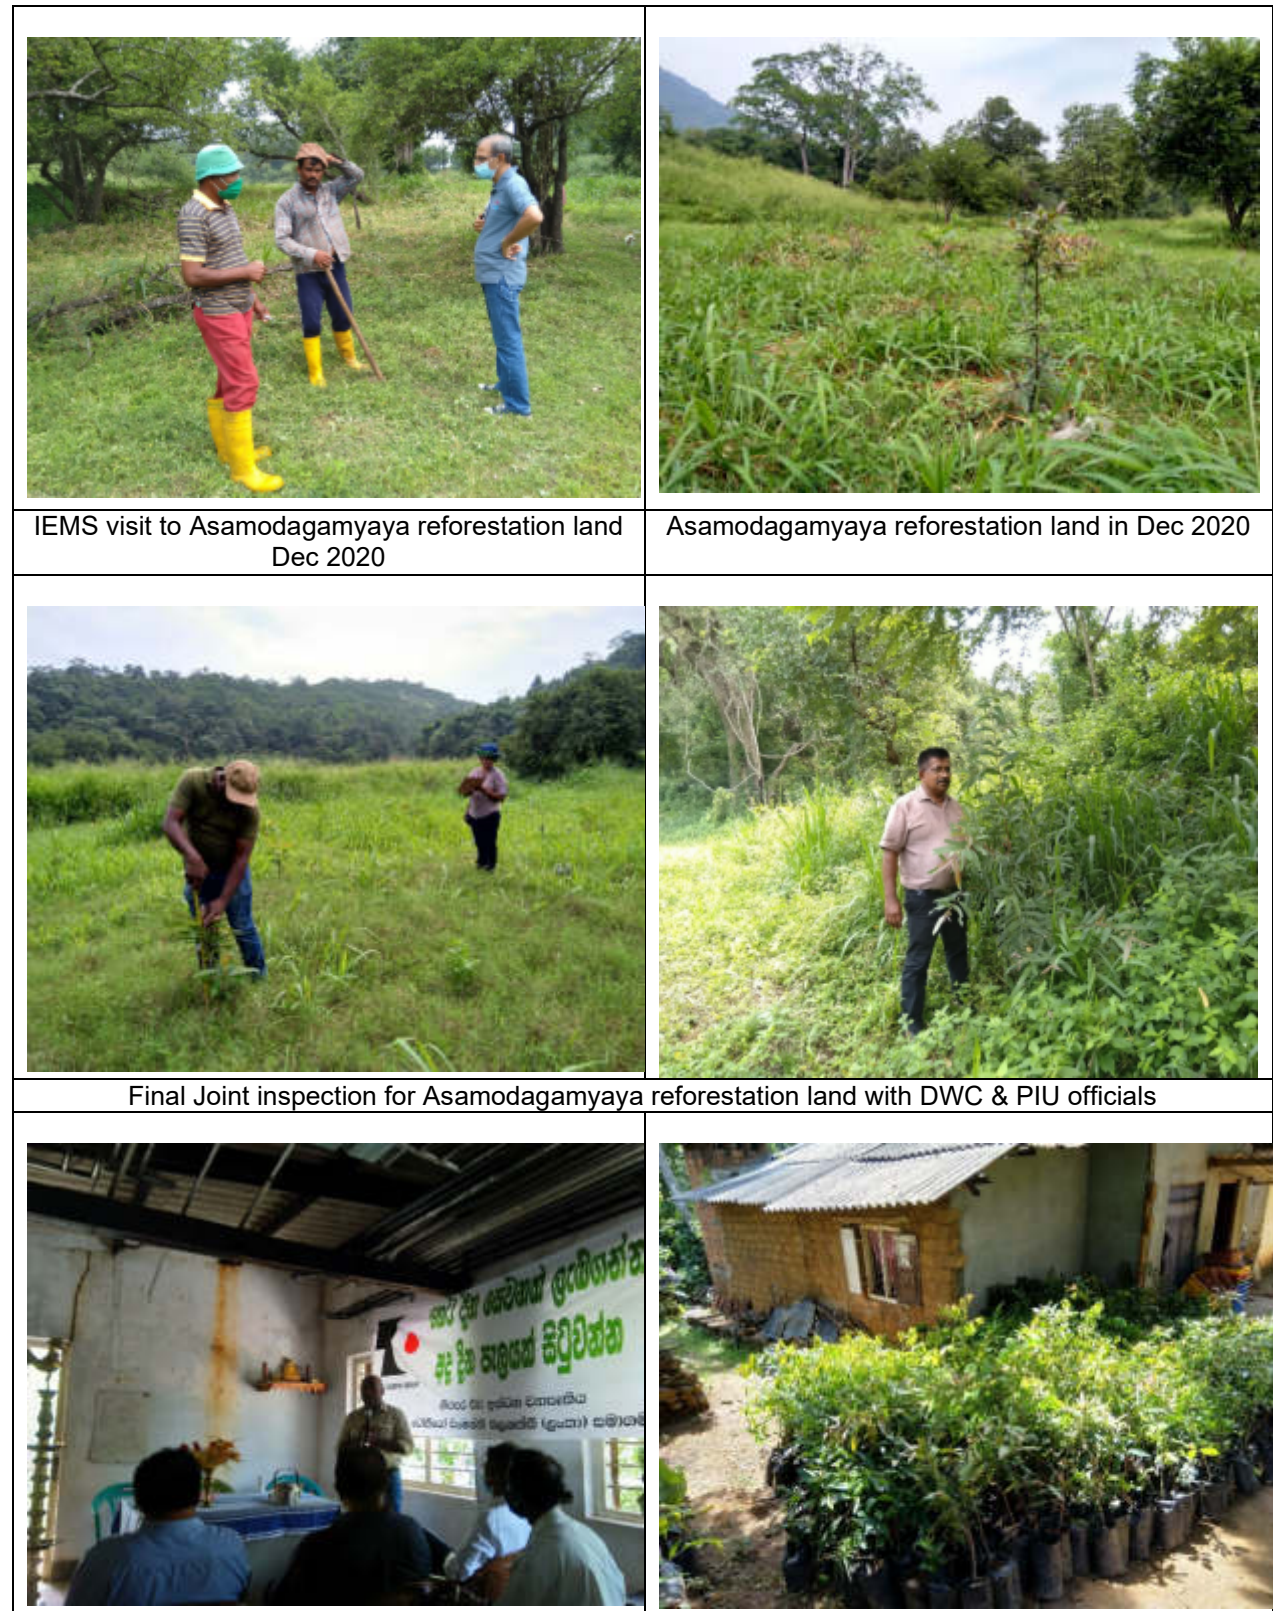
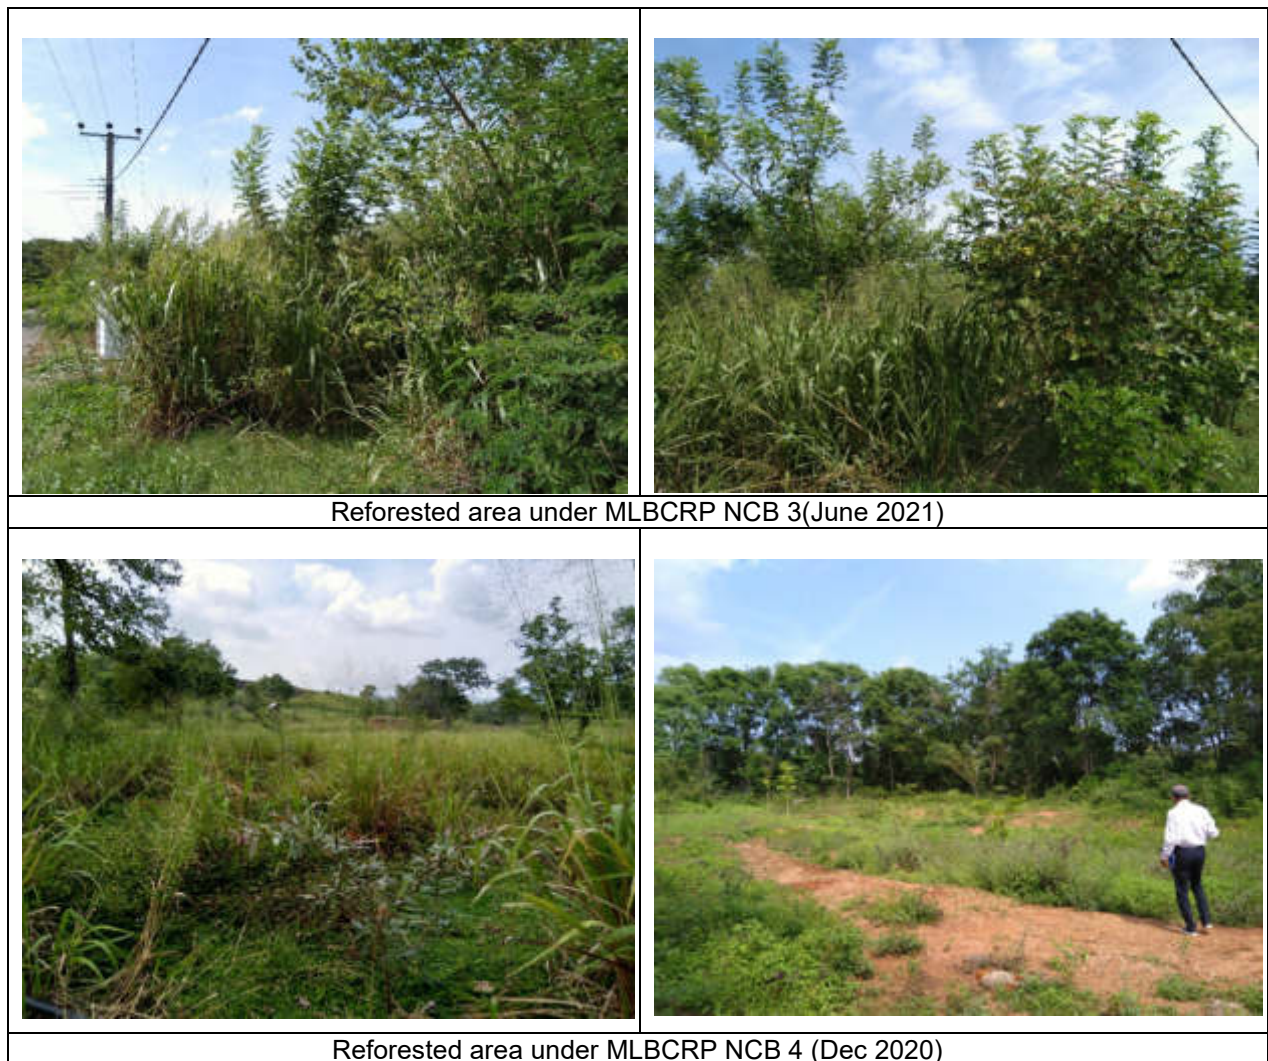
Figure 3-1: Photographic records related to reforestation activities conducted during the reporting period

Awareness Meeting for Theripaha Reforestation land on 18 Nov 2020	Potted plants for Theripaha Reforestation land

Theripaha Reforestation land by January 2021

Theripaha Reforestation land by April 2021	Theripaha Reforestation land by June 2021

MLBCRP-NCB-1 site at Morayaya School (Dec 2020)	Reforested area under MLBCRP NCB 2(Dec 2020)
