# Environmental Monitoring Report

Semi-Annual Report  
For the period covered July to December 2017  
Project Number: 47381-002  
March 2018

## SRI: Mahaweli Water Security Investment Program - Tranche 1

North Western Canal Project (NWPCP)

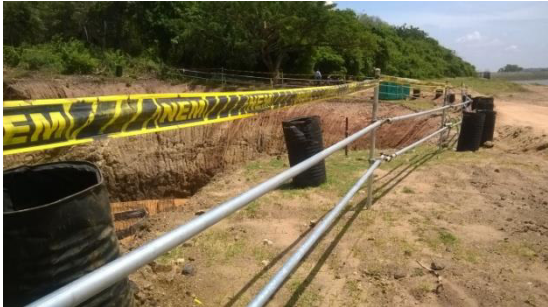
<ul style="list-style-type: none"> <li>At two locations 1.5 feet height coffer dam was constructed before release the water to the downstream as a silt trap.</li> </ul>

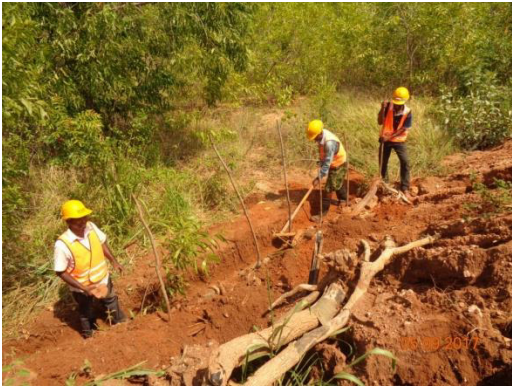
<ul style="list-style-type: none"> <li>Re-vegetation of the open areas using tree species found from surrounding area to minimize the erosion.</li> </ul>

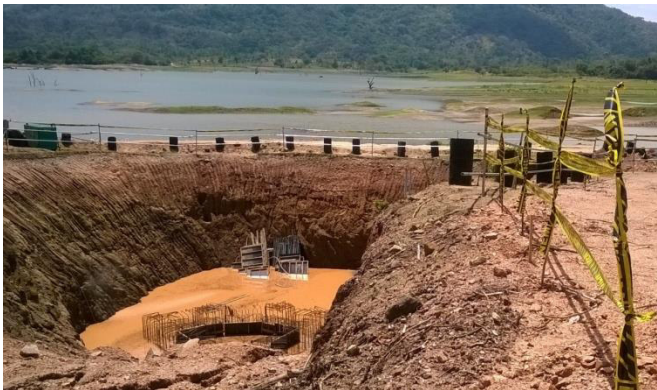
<ul style="list-style-type: none"> <li>Maintaining the 1.5 feet height cofferdam which was constructed previously before release the water to the downstream as a silt trap.</li> </ul>	Daily site monitoring by EO and monthly monitoring by Environmental Manager

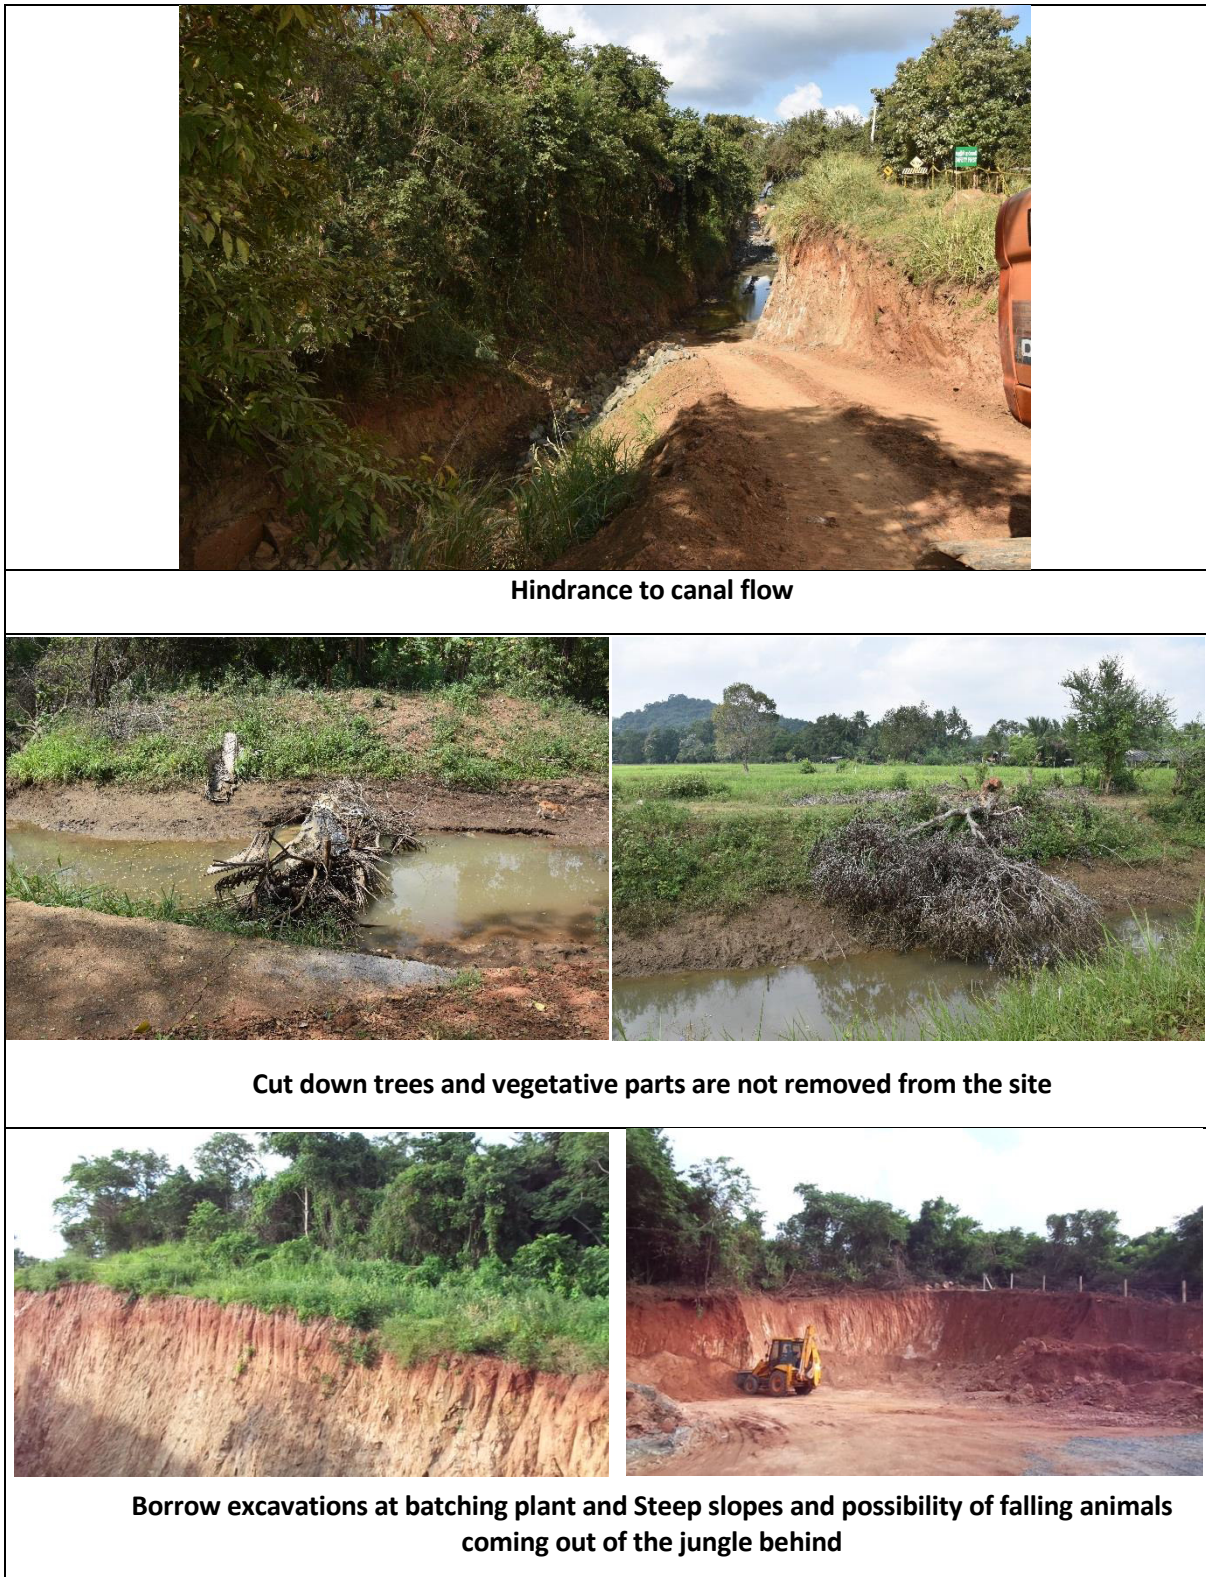
**Figure 3-1: Photographic Monitoring Records**

**Improper solidwaste management in the site**

40. Photographic evidences to show above list of non-conformances are given in Figure 3-1.

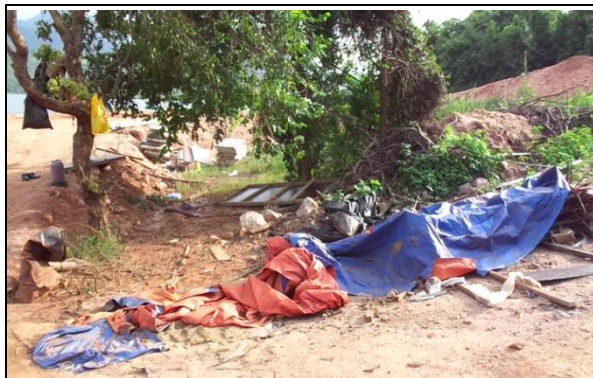
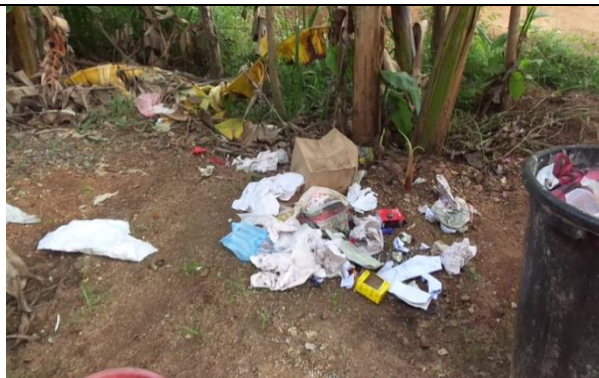
- iii. Disorder at some of the working places along the canal and store premises was noted. Continuous monitoring of implementing waste management practices was instructed as highlighted in Table 3-1.

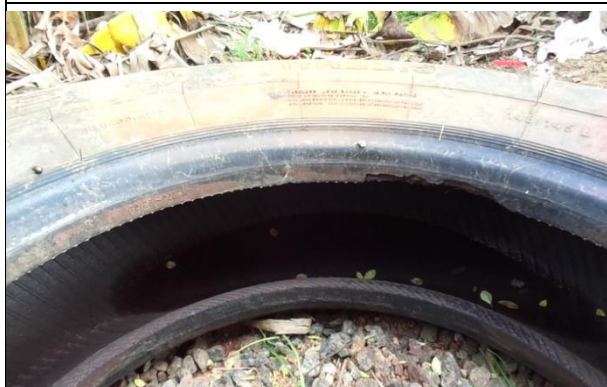
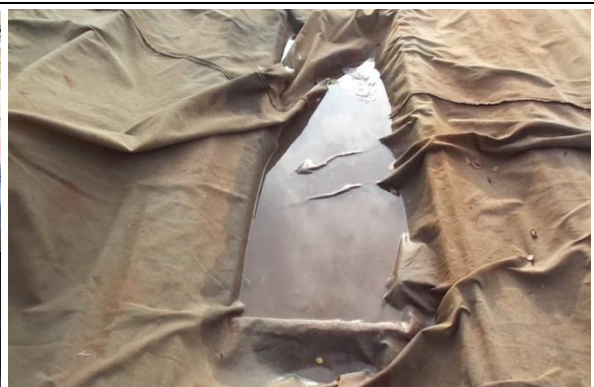
**Water retained locations and used tyres are left at store premises**

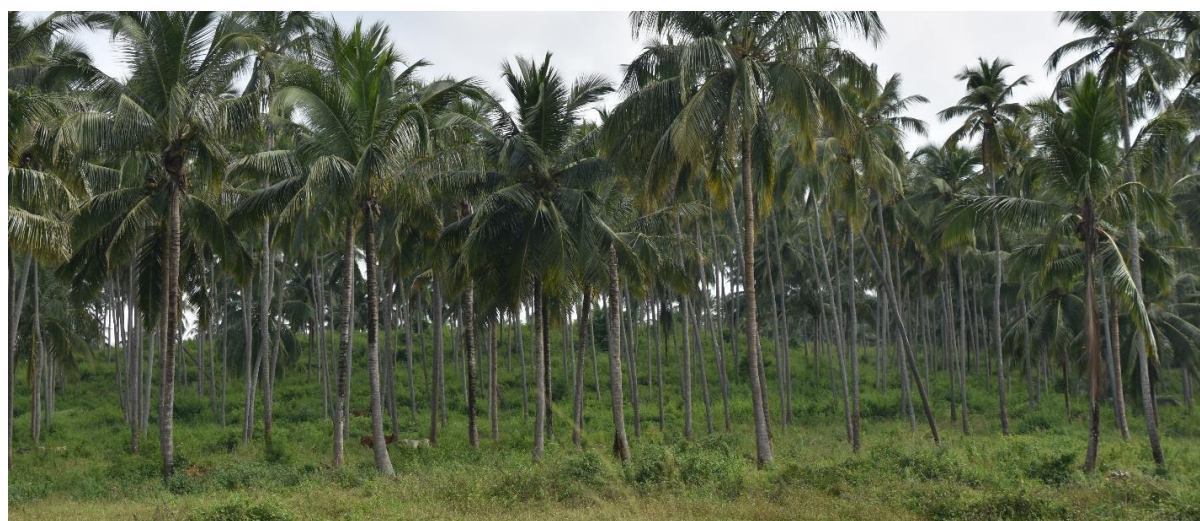
**Figure 4-2: Habitat diversity in Ranwediya Tunnelling area**

44. Additional Ecological Surveys responding to CEA clarifications made on the addendum to EIA for Tranche 1 packages were carried out in early December 2017 in the Ranwediya and Neelagama Tunnel areas to update information about the habitat conditions and biodiversity to ensure that no critical habitat or species is affected. Figure 4-1 and Figure 4-2 respectively show the habitat conditions in Neelagama and Ranwediya Tunnel areas, which form part of contract package NWPCP-ICB-2.

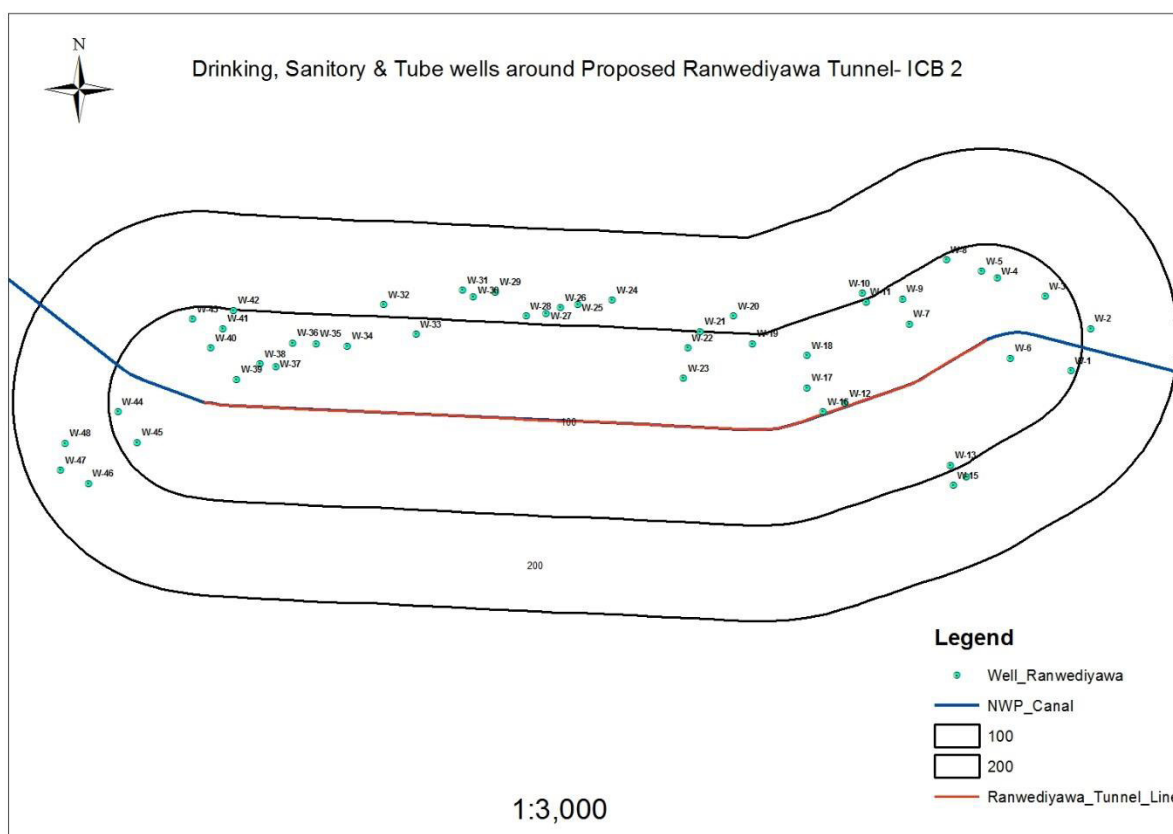
**Figure 4-3: Map of the tunnel area with selected wells in Ranwediya Tunnel area**

45. Measurement of groundwater levels around the proposed Neelagama and Ranwediya Tunnel areas have been carried out by PIU Senior Environmental Office (SEO), to maintain baseline conditions. 50 drinking/sanitary wells have been identified within a 100m buffer zone around the proposed Ranwediya Tunnel under package NWPCP-ICB-2 for water level measurement in wells. Table 4-3 shows the details of drinking, sanitary and tube wells within 100 m zone around proposed Ranwediya Tunnel.

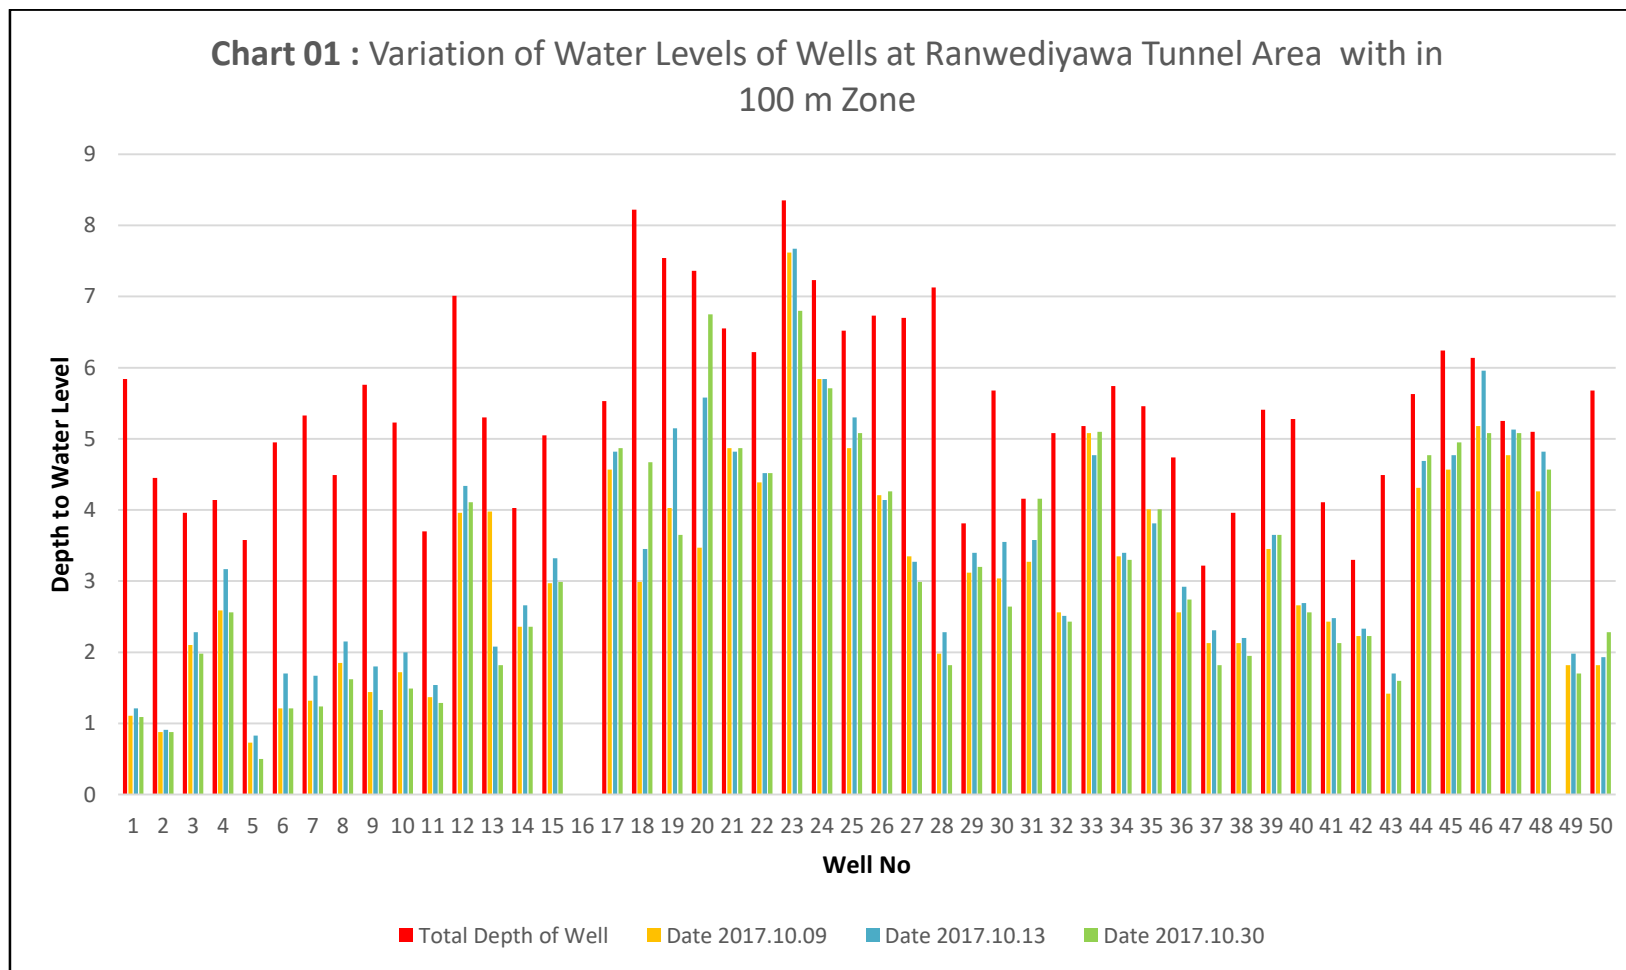
**Figure 4-4: Variation of water level s of wells at Ranwediya Tunnel areas within 100 m distance**

46. Depths to the water levels are being measuring two days per month (1st and 15th) as from 3 September 2017. These depths have been measured three times: on 3, 13 and 30 October 2017. The map of the identified wells around Ranwediya Tunnel area is shown in Figure 4-3 and the depth to the water levels and the variation with three days shown in Figure 4-4.
