Environmental Monitoring Report

Kazakhstan: CAREC Corridors 1 and 6 Connector Road (Aktobe–Makat) Reconstruction Project

Reporting Period: July-December 2020

REPUBLIC OF KAZAKHSTAN: CAREC CORRIDORS 1 AND 6 CONNECTOR “AKTOBE-MAKAT” ROAD RECONSTRUCTION PROJECT (SECTION KM160-330)

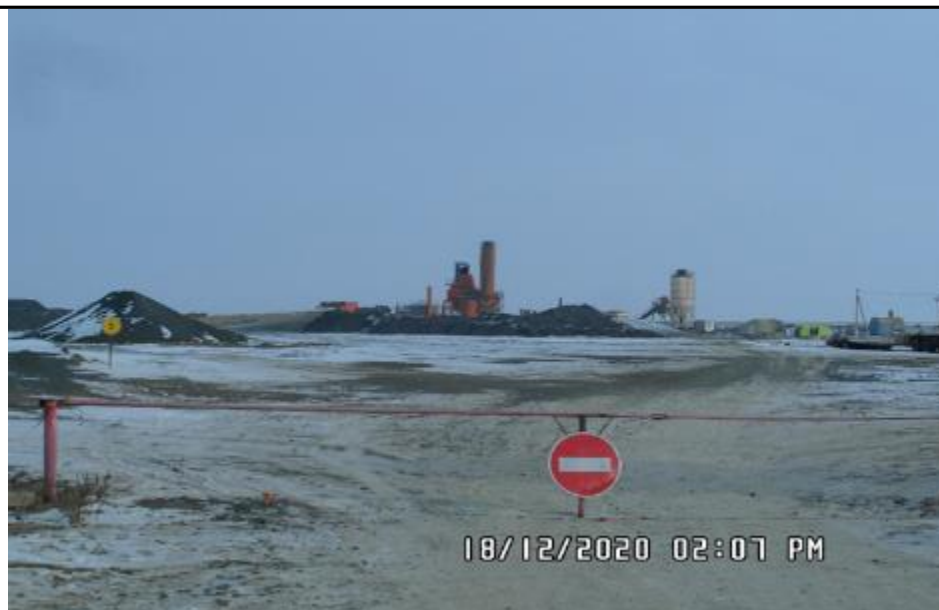
Figure 6. Construction site of Lot 2 in Karauylkeldy village. CHP and security. December 2020

46. For lot 2, in the previous reporting period, the Engineer's instructions were issued to replace the septic tank cover, to bring the septic tank into proper condition, since the soil around the septic tank has settled and there is a possibility of soil subsidence. The irrational use of water from an underground source organized from a well at the construction site was also noted. Water flowed through a hose to the adjacent territory. The reason for the absence of the plug / valve is associated with the unstable operation of the pump installed on the well. The engineer recommended improving the mechanisms into proper condition, to exclude the irrational use of water resources. It was not possible to conduct an audit of the site during the specified period since the construction camp was suspended. Construction work was suspended.

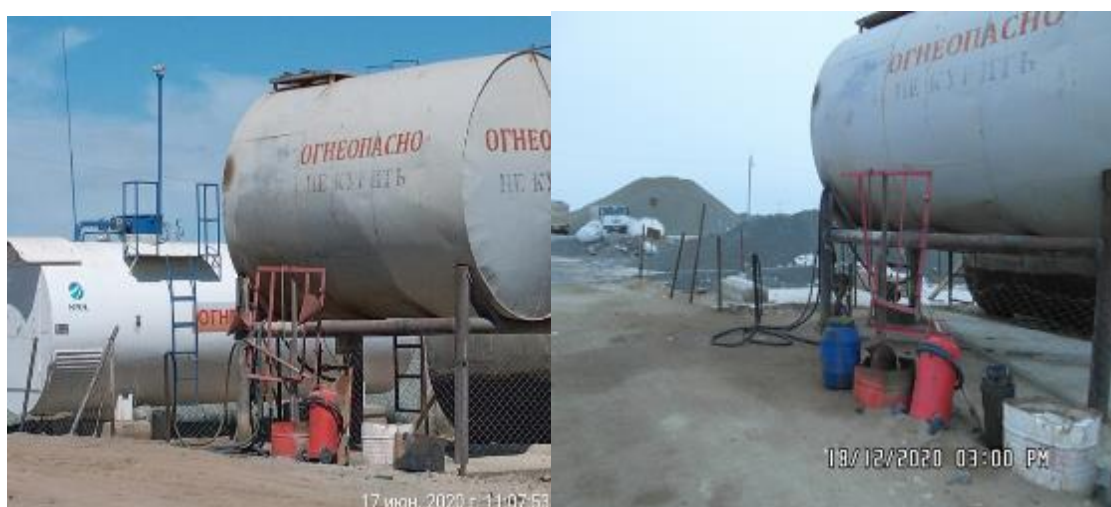
47. For Lot 3, the inconsistencies identified in the previous period were eliminated, but in the absence of proper control over the observance of safety measures and protective measures, they led to the fact that the territory was again contaminated with local spills, there were no safety equipment on the fire shield. Below in Figure 7 is attached the indicated discrepancy in comparison with June and September of the 2020.

Figure: 7. Fuel storage area, Production base "Nogayty". Lot 3, June 17, 2020 On the left is a photo dated 06/17/2020, on the right this object is 09/15/2020.

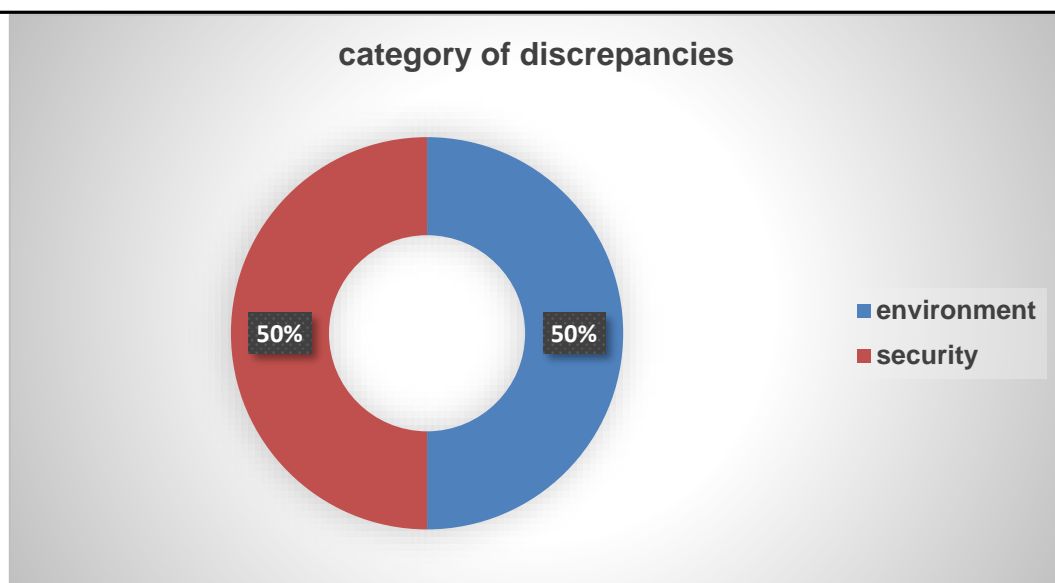
Figure 8. Chart of nonconformity categories remaining open during the reporting period

51. The diagram in Figure 8 shows the nonconformity categories for the reporting period. Compared to the previous period (the first half of 2020), there is a positive trend in the number of non-conformities, which is from 8 to 2. During the reporting period, one non-conformity was registered for one environment and safety, and both were registered at Lot 3.

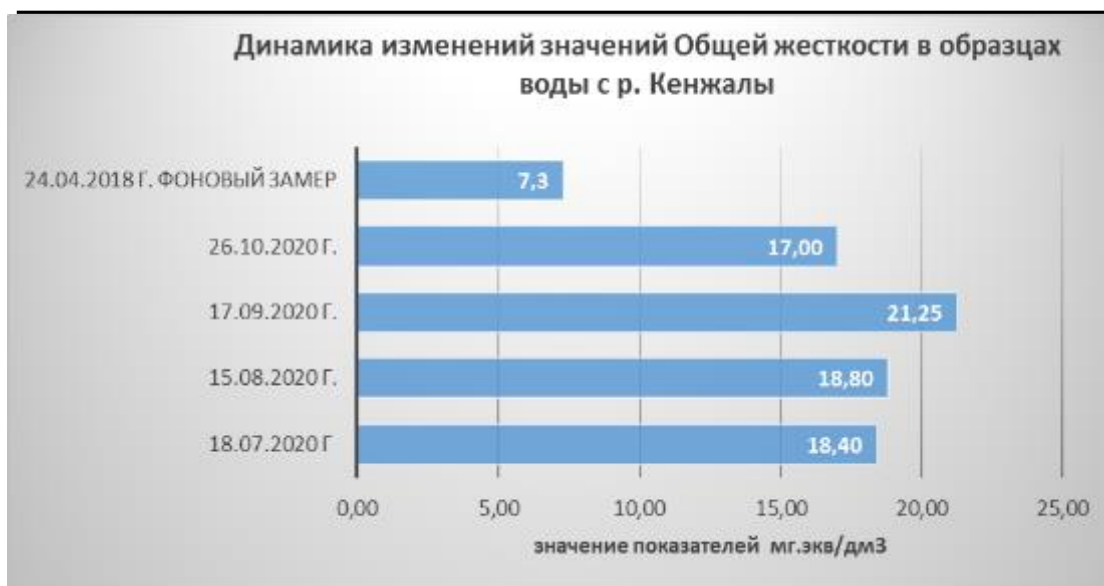
Figure 10. Dynamics of the total water hardness values in the river Kenjaly

75. The source of the increase in hardness in the Kenzhaly river is primarily associated with the influence of groundwater, which, as a rule, has a higher hardness than surface water. Since no impacts from the Project took place. The contractor takes out all his waste in accordance with the concluded contracts for utilization and placement at a special landfill. Along the Shieli river, the content of harmful substances, chlorides and sulfates (Fig. 11), does not exceed the permissible concentration for watering livestock.
76. For the rest of all indicators, the level of pollution does not exceed the maximum permissible concentration for each of the determined indicators obtained during baseline analysis. . Laboratory analysis data are presented in Annex No. 2.

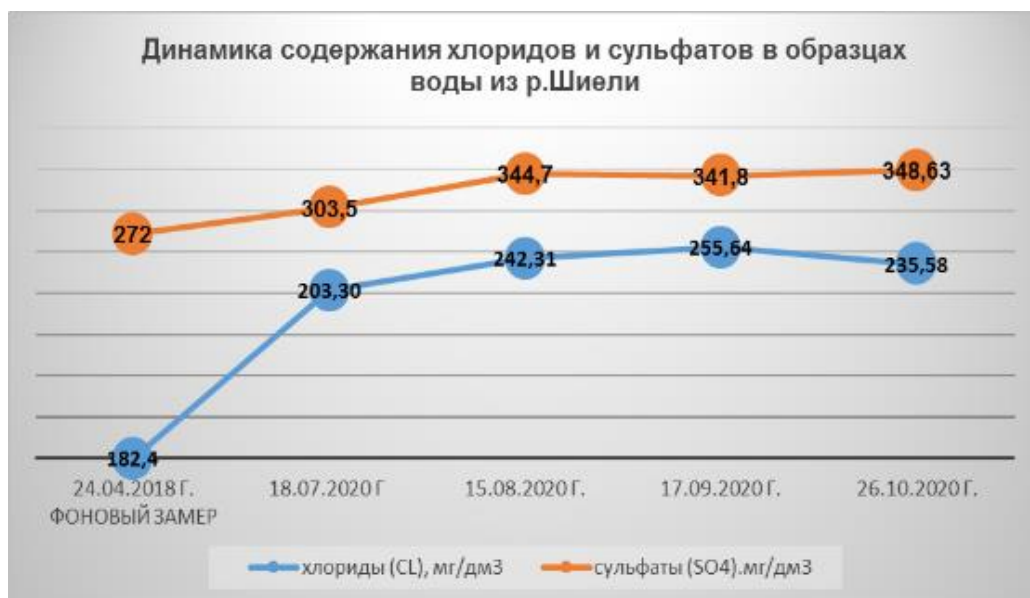
Fig. 11. Dynamics of the chlorides and sulfates content in the water of the river Shieli

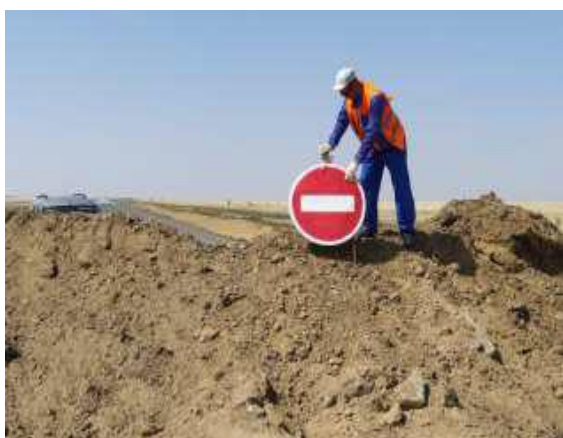
Road closure at PK 121+00

108. Works to close 4 newly formed unauthorized exits / exits to the road under construction for vehicles (PK 121 + 00; PK 209 + 00; PK 245 + 00; PK 272 + 00) were carried out in July. The works to close 10 newly formed unauthorized exits / exits to the road under construction for transit transport (PK 121 + 00; PK 209 + 00; PK 230 + 00; PK 247 + 00, PK 272 + 00, PK 362 +00, PK444 + 00, PK 455 + 00, PK 458 + 00) were carried out in August 2020.

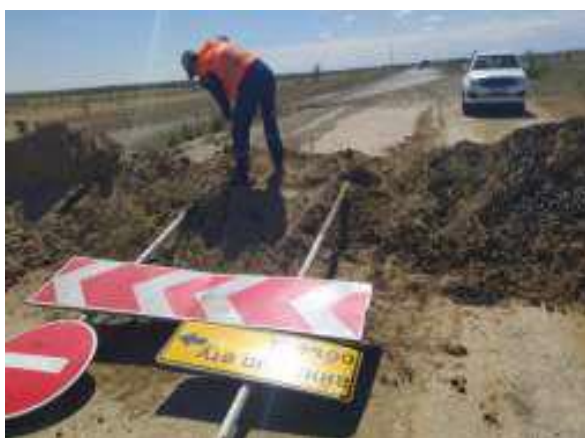
Restoration of the embankment and installation of safety signs on PK 455 + 00

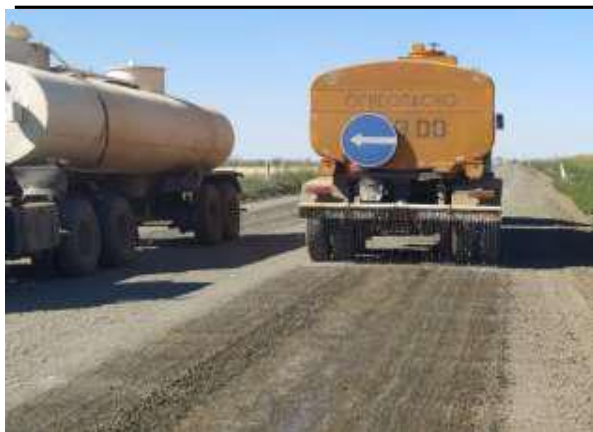
Dust suppression at PK 82+00

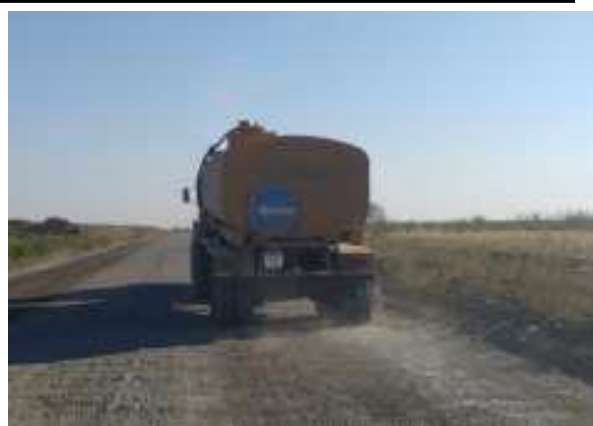
Dust suppression at PK 209+00

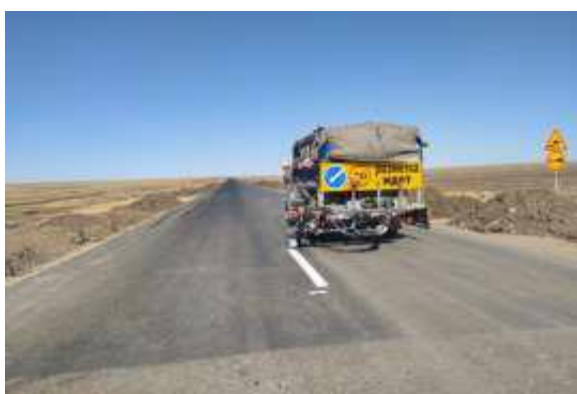
Temporary markings on the project road

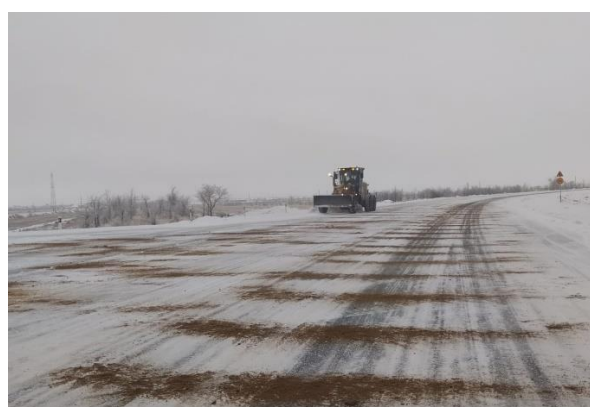
Anti-icing measures at PK 247

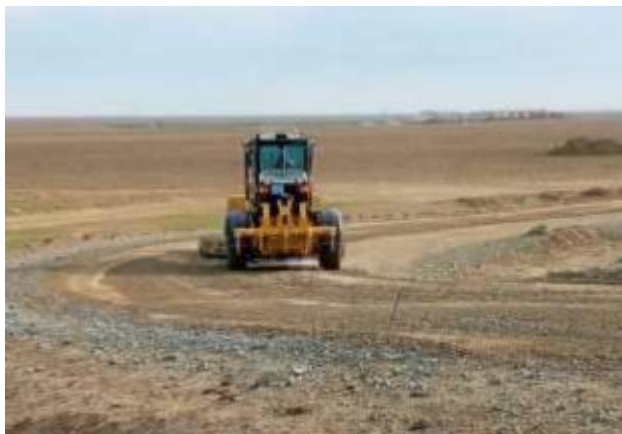
Blading of bypass road at PK 551+00

112. During the reporting period, in the frame of road maintenance, backfilling of the bypass road with milled material from PK 349 + 00 to PK 352 + 00 was carried out. The blading works on the bypass road at PK 272 + 00 to PK 551 + 00 was performed.

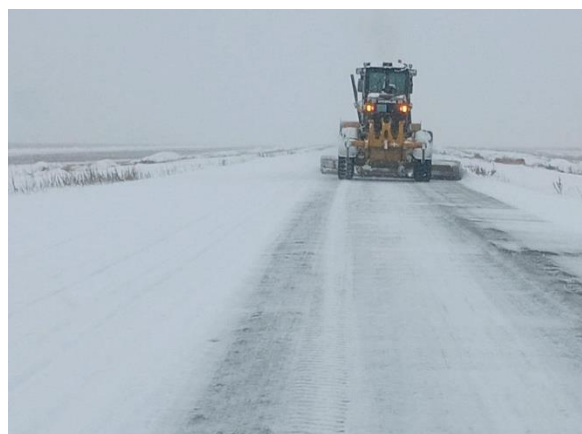
snow clearance at PK 349+00
