Environmental Monitoring Report

Project Number: 48424-002
Semestral Report: January–June 2021
September 2021

Kazakhstan: CAREC Corridors 1 and 6 Connector Road (Aktobe–Makat) Reconstruction Project

Reporting Period: January-June 2021

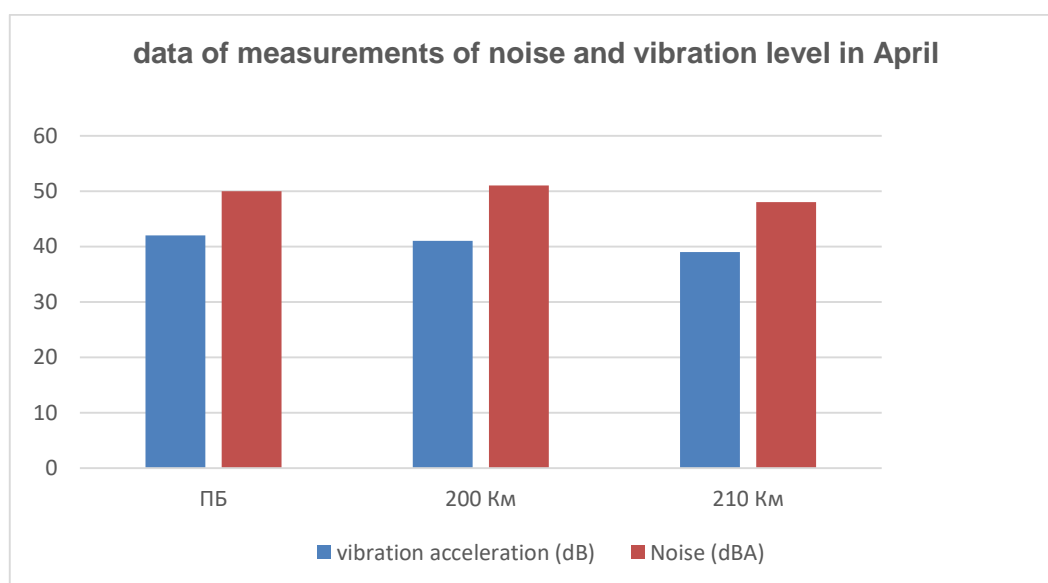
Figure 7: The data for the noise and vibration levels measurement in April 2021

58. National standard (GN Order No. 169 dated February 28, 2015) determines MPL of noise level on the construction area of 80 dBA and for operator work in laboratories, asphalt plant- 90 dBA, and MPL in residential areas - 60 dBA. This report adopts the IFC standard with a threshold of 55 dBA, so this threshold is considered as the strictest threshold for monitoring. Figures 7, 8 and 9 below show the data from the protocols of measurements carried out by the laboratory during the period of April, May and June.

59. With an admissible level of 80 dBa for workplaces of drivers of road-building equipment (this PDU is taken from Appendix 2 to the order of the Minister of National Economy of the Republic of Kazakhstan "On the approval of Hygienic standards for physical factors affecting a person" dated February 28, 2015 No. 169 "Remote control of sound pressure, sound levels equivalent sound levels for the main most typical types of work activities of workplaces") the highest value is equal to 52.0 dBa at the site of the production base in the month of May and the lowest within the value of 44.0 dBa in May and June months at the site of Km 220. These figures are below the state standard and the IFC threshold.

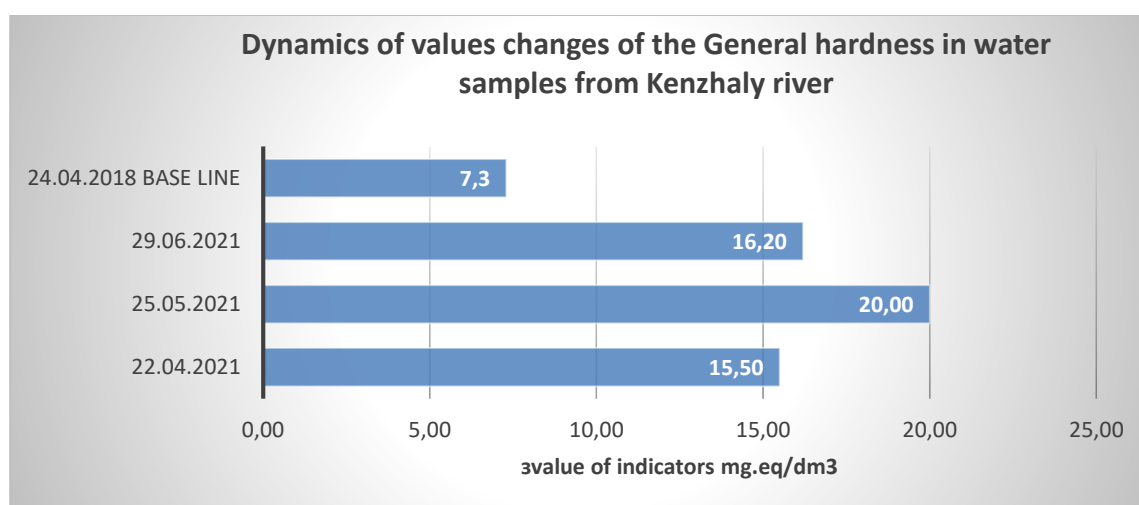
66. The main regulatory and methodological documents that guided the monitoring of natural waters in the Shiyeli rivers at Km 181 + 600, the Kenzhaly river Km 204 + 500: ND No. 209 dated March 16, 2015 Water sampling was carried out in accordance with GOST ST RK GOST R 51592-2003 "Water. General requirements for sampling"². Analyzes were performed in accordance with approved standards. Water sampling was carried out in the reporting period from the Shieli and Kenzhaly rivers in April, May and June of the reporting period.
67. According to the laboratory data of the Measurement Protocols (Appendix No. 2) for the indicator: Total hardness in the samples taken from the Kenzhaly River, an excess of the primary measurements was noted. But they do not exceed the MPC. Figure 10 below shows the dynamics of changes.

Figure 10. Dynamics of the total water hardness values in the river Kenzhaly

68. The source of the increase in hardness in the Kenzhaly river is primarily associated with the influence of groundwater, which, as a rule, has a higher hardness than surface water. Since no impacts from the Project took place. The contractor takes out all his waste in accordance with the concluded contracts for utilization and placement at a special landfill. Along the Shiyeli river, the content of harmful substances, chlorides and sulfates, does not exceed the permissible concentration⁴ for livestock watering.
69. For the rest of all indicators, the level of pollution does not exceed the maximum permissible concentration for each of the determined indicators obtained during baseline analysis. Laboratory analysis data are presented in Annex No. 2.

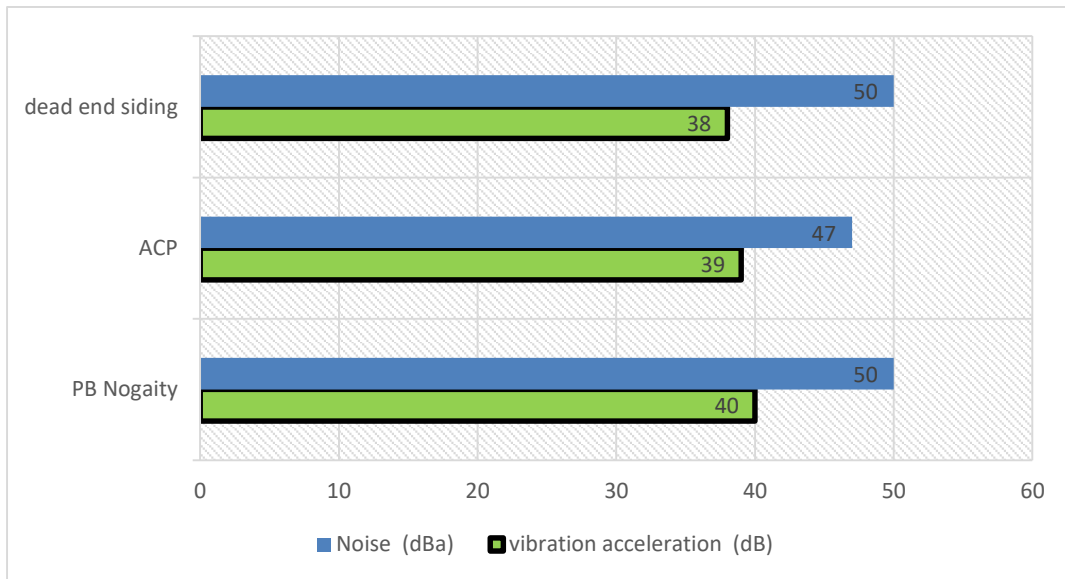
76. Measurements on the level of noise and vibration were carried out at the following points: ACP, Production base "Nogayty", railway deadend, BSU section, km 275, km 285, km 300, km 310, km 320. Based on the results of measurements for the reporting period there was no excess of MPD. Analysis of the data from the Measurement Protocols shows that the sound level in July was recorded within the range of 47dBA - 57dBA, in August - 46dBA - 55dBA, in September - 46dBA - 59dBA, in October - 47dBA - 55dBA. These values do not exceed the permissible sound level of 80 dBA. Vibration acceleration values are fixed within 38 dB - 51 dB with an admissible equivalent vibration acceleration level - 95 dB.

Figure 11. Results of measurements of vibration and noise level in April 2021

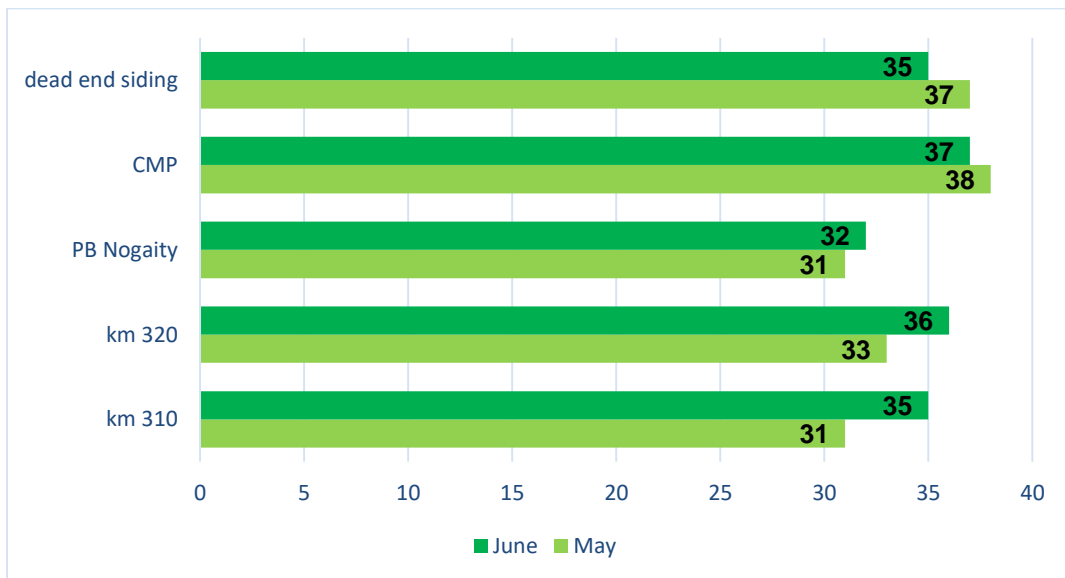
Figure 12. Results of vibration level measurements in May and June 2021

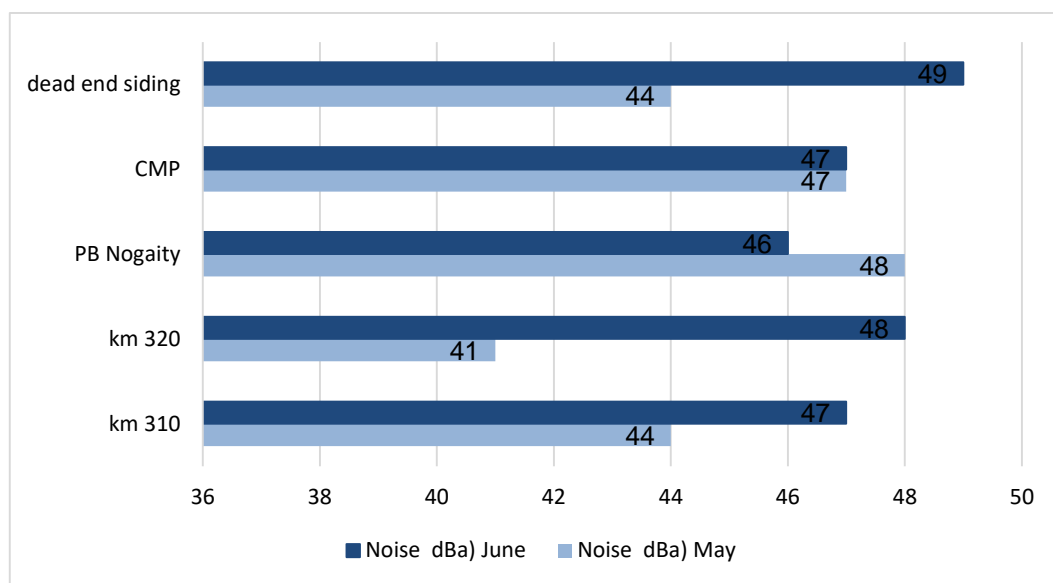
Figure 13. Results of noise level measurements in May and June 2021

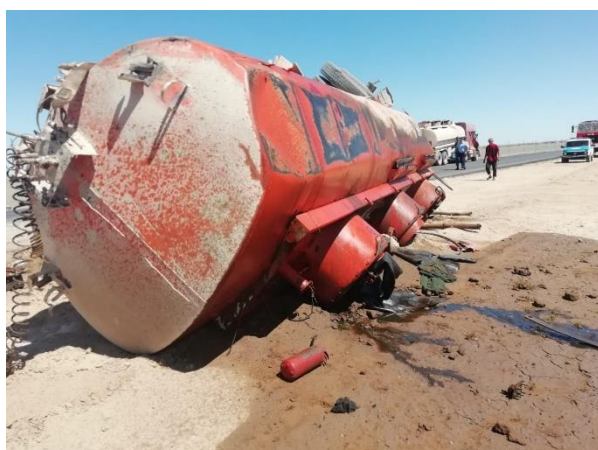
98. 1 accident was recorded on Lot 3 During the reporting period:
- On June 18, 2021 at about 10:35 am. local time at km 278 there was an accident involving 2 vehicles. ATC: HOWO with plate number 253SCA04 and KAMAZ with plate number 252NAZ04. When overtaking KAMAZ vehicle, a tanker was disconnected, and the HOWO vehicle following it collided with a tanker loaded with crude oil. As a result of the collision, the disconnected tank car toppled over to the side of the road, and a crude oil product spilled onto the roadside and cuverts. The drivers of both vehicles did not receive any injuries and did not need medical assistance. The place of the accident is an area open to traffic, the surface is even, without pits and bumps; unlimited visibility; weather conditions at the time of the accident are clear, no precipitation, +30 0C. The oil-contaminated soil was removed from the accident place by the carrier IE "Azamat Dauren" under the supervision of the Contractor's safety specialists and disposed at special landfill (as per information of the Department of Emergency Situations in Baiganin district). After cleaning the territory, representatives of the Akimat of Zharly rural district of Baiganin district came to the place of spill and accepted the remediation work.

Fig. 14. Lot 3 km 278 accident place. 18.06.21.

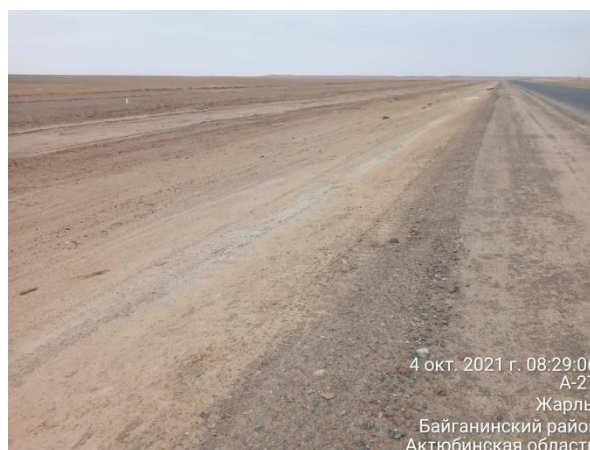
Fig. 15. Lot 3 km 278 place of accident after cleaning up oil product spill. 04.10.2021

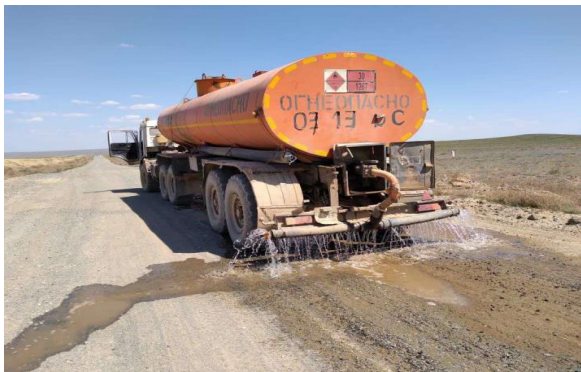
Dust suppression at PK 340+20

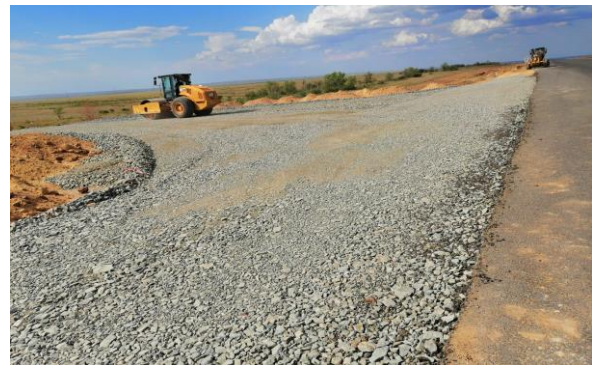
Crushed stone base, access road at PK 343+29

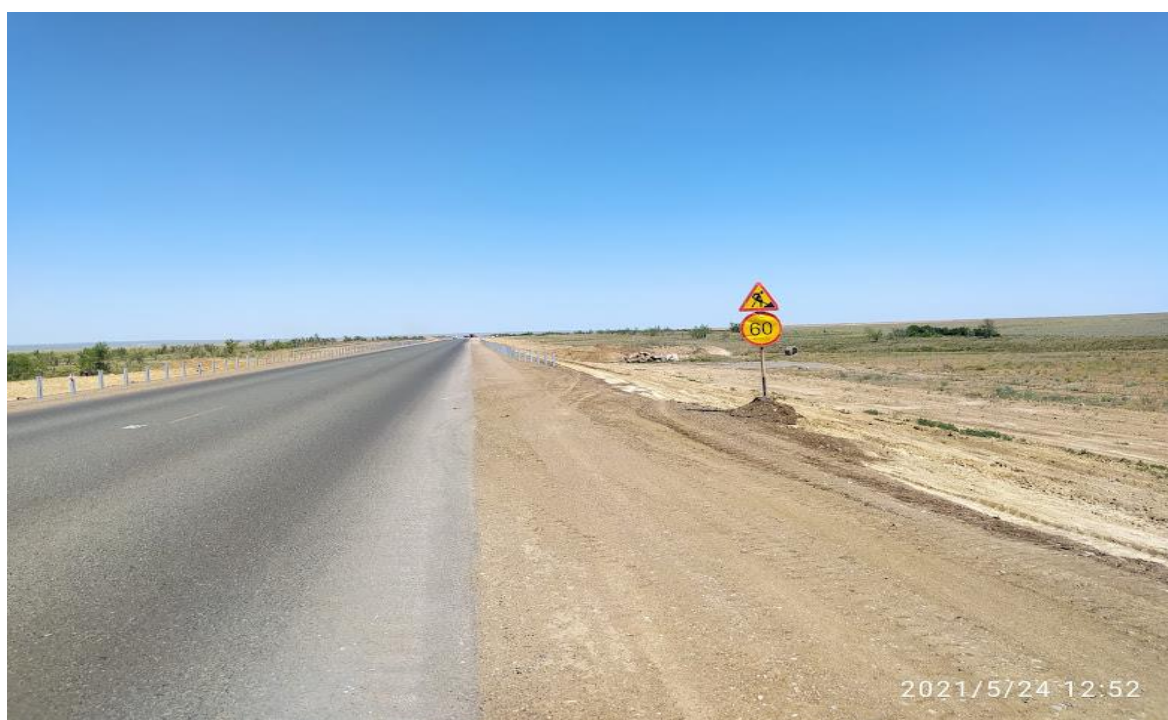
- On May 24, 2021 an accident occurred on the site of the project;
- All warning and safety signs at the accident place are in acceptable condition and the driver could not help but see them;
- The cause of the accident is the driver's ignorance of the traffic rules resulting in the death of a passenger and injury to 6 passengers;
- Both vehicles of the road accident participant are not designed, they belong to local residents;
- There is no direct or indirect impact of the project on this accident.

Safety signs in the scene of traffic accident at km 195 (PK 350 + 00)
